## HOME INSPECTION

47124 El Menara Cir  
Palm Desert, CA 92260

09/14/2026

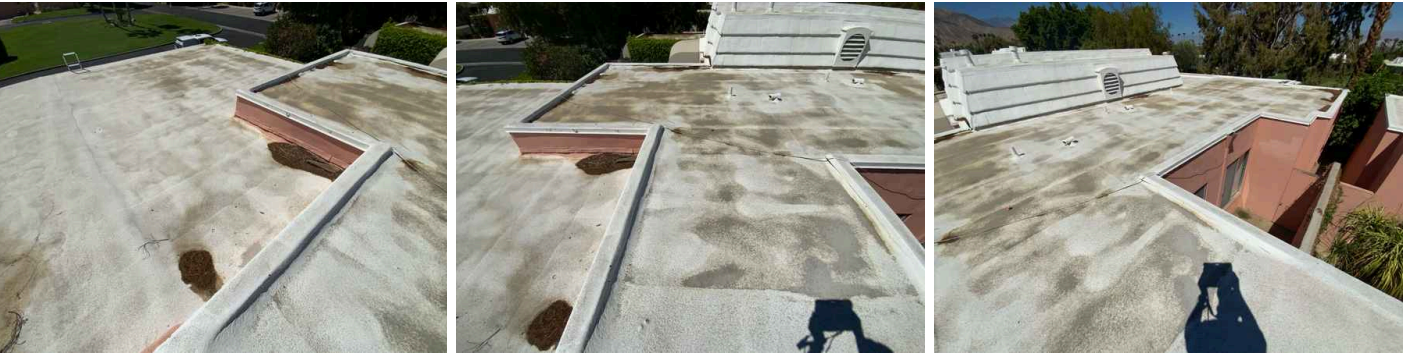
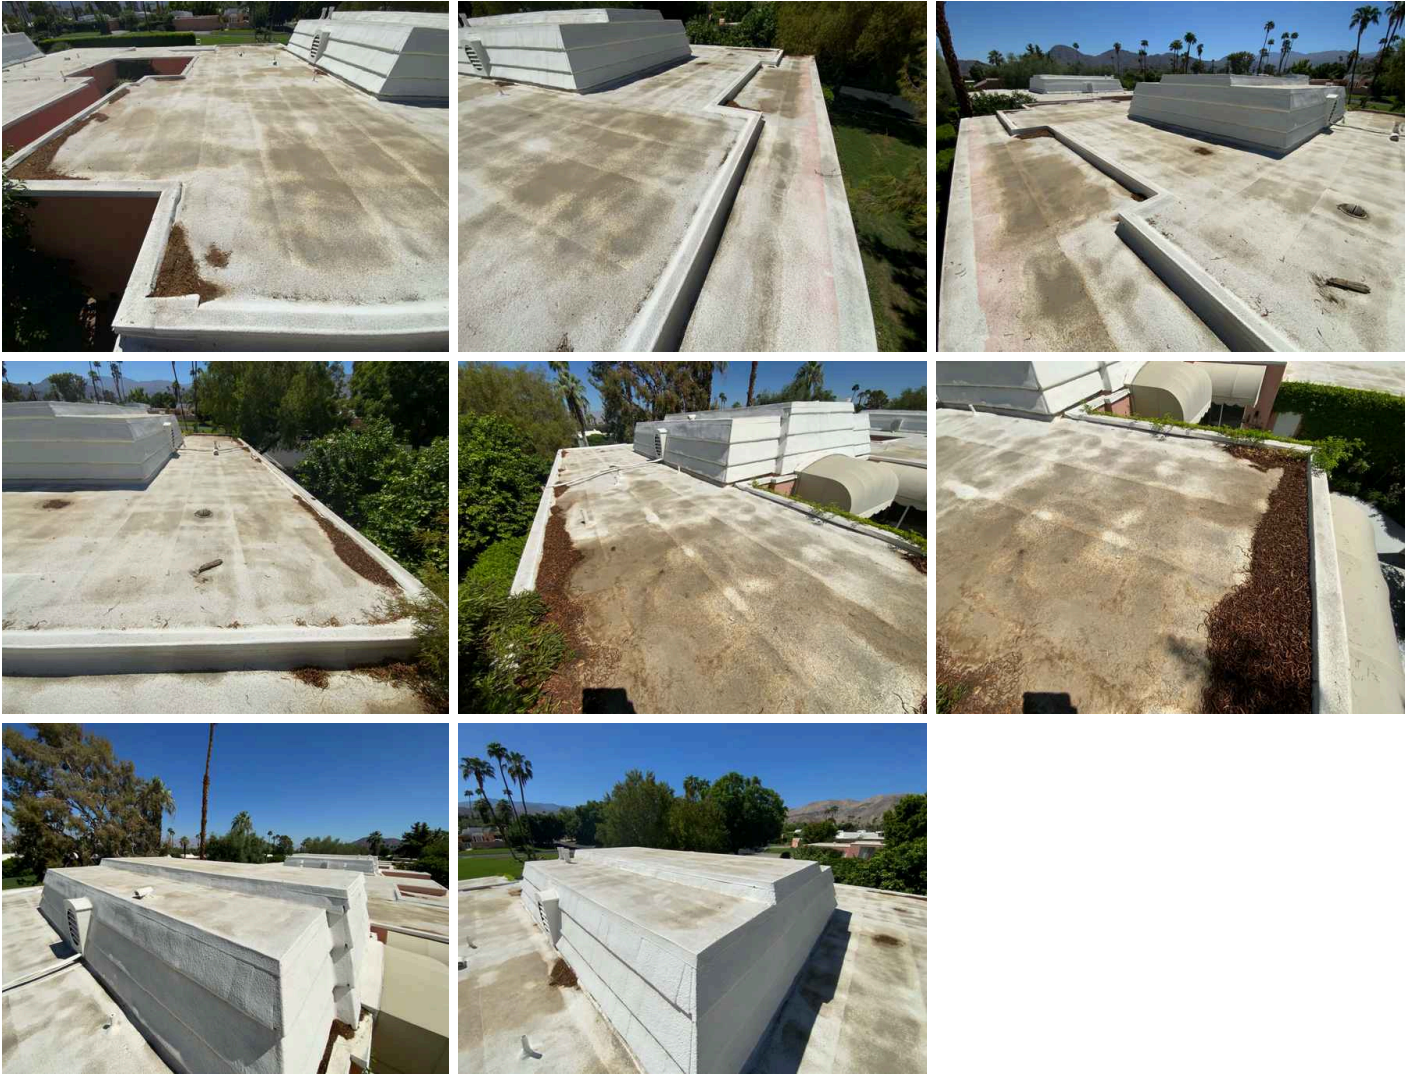
Roof Covering: Type of Roof-Covering Described  
Flat Roof Material

I observed the roof-covering material and attempted to identify its type. This inspection is not a guarantee that a roof leak in the future will not happen. Roofs leak. Even a roof that appears to be in good, functional condition will leak under certain circumstances. We will not take responsibility for a roof leak that happens in the future. This is not a warranty or guarantee of the roof system.

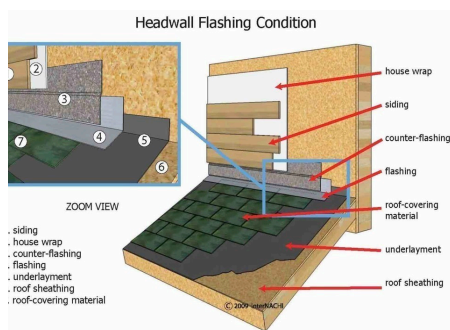
Flashing Details

I looked for flashing where the roof covering meets a wall or siding material. There should be step and counter flashing installed in these locations. This is not an exhaustive inspection of all flashing areas.

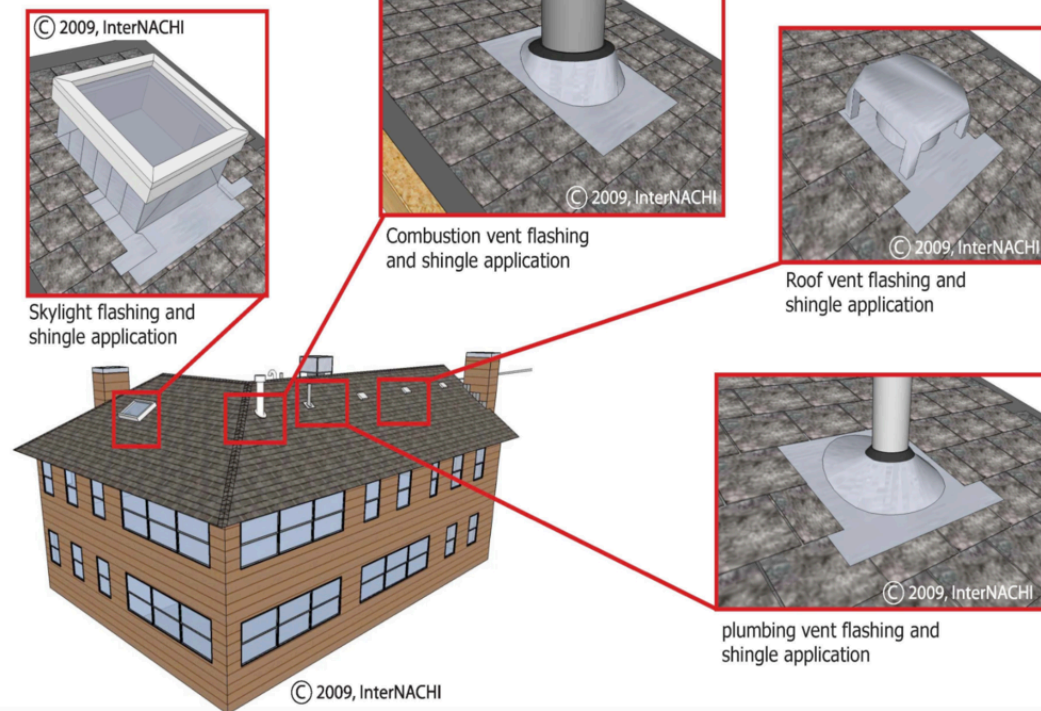
## Roof penetrations and flashing

I looked at flue gas vent (if present) and plumbing (drain, waste and vent) pipes that pass through the roof covering. All gas-fired appliances must be connected to venting systems that goes to the exterior. There should be watertight flashing installed around the flue gas vent and plumbing vent pipes, typically a metal or black rubber type of material. The vent pipes should extend far enough above the roof surface as required by the California Building Code.

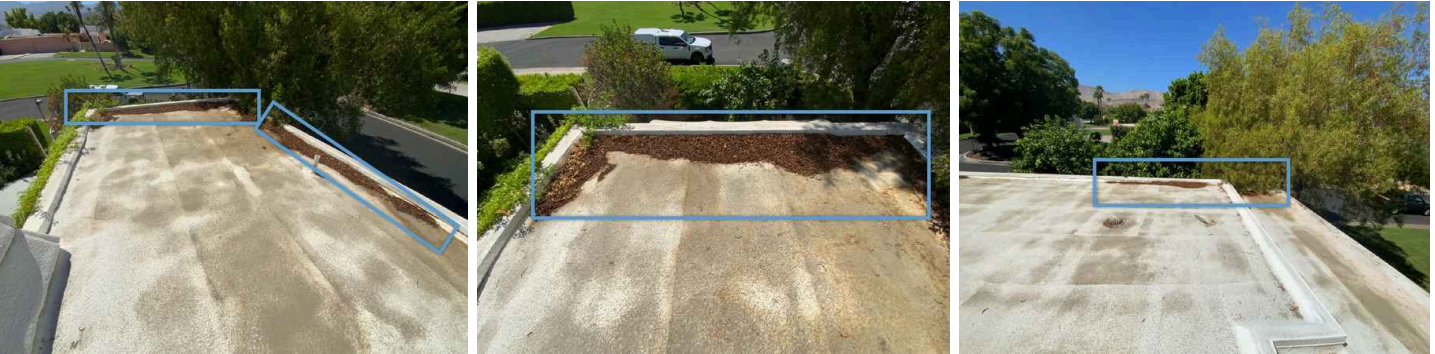
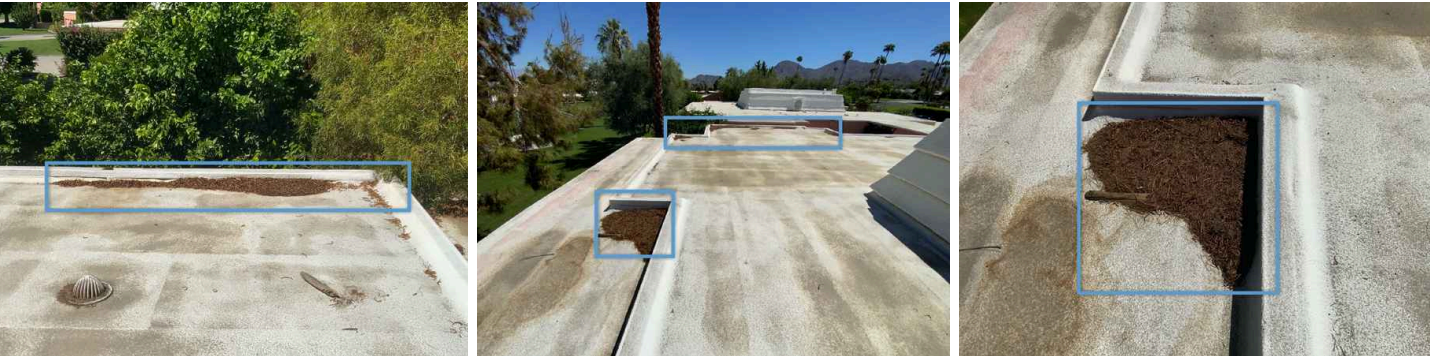
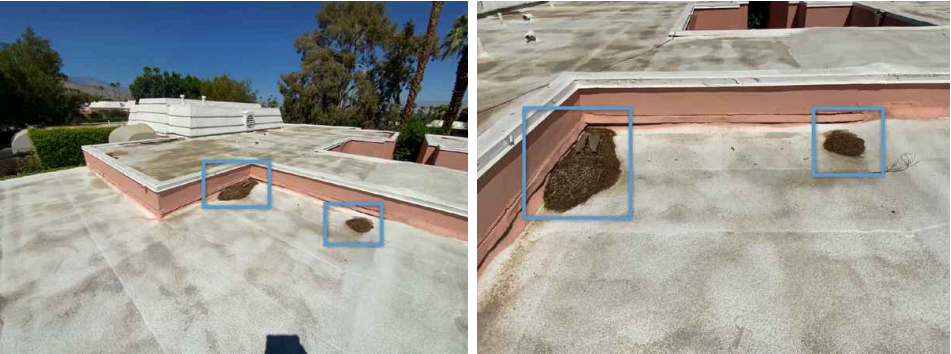
I observed dirt, bird feces, tree debris, construction debris, or other material accumulating on the roof surface. This buildup may interfere with proper drainage, retain moisture, and contribute to deterioration of the roofing materials.

Recommend cleaning and removal of the accumulated debris by a qualified roofing contractor or other qualified professional and maintaining the roof surface as needed.

Recommendation  
Contact a qualified professional.

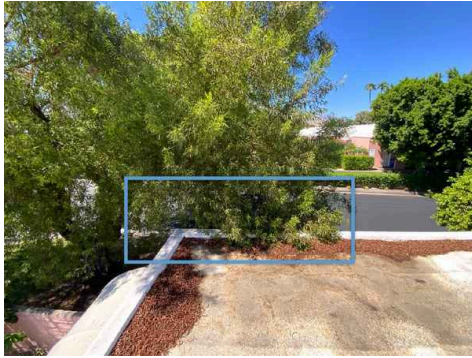
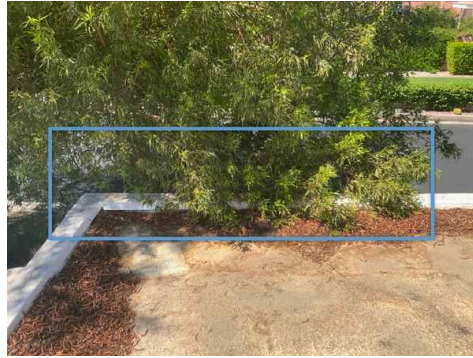
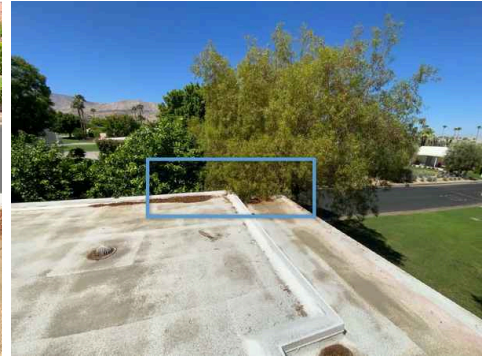
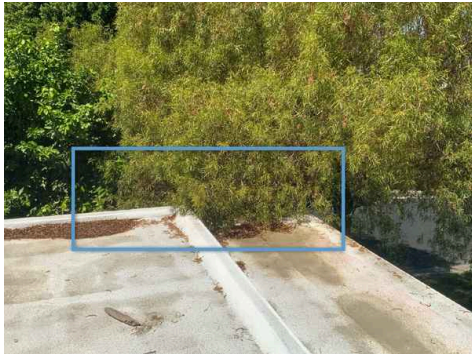
I observed indications that a tree and or tree branches were overhanging the roof and maybe in contact with it. Tree branches and vegetation can damage the roofing covering and allow a way for pest, like mice and rats to gain access to the roof. Recommend a qualified professional trim the tree back to keep it from contacting the house or roof.

## Recommendation

Contact a qualified landscaping contractor

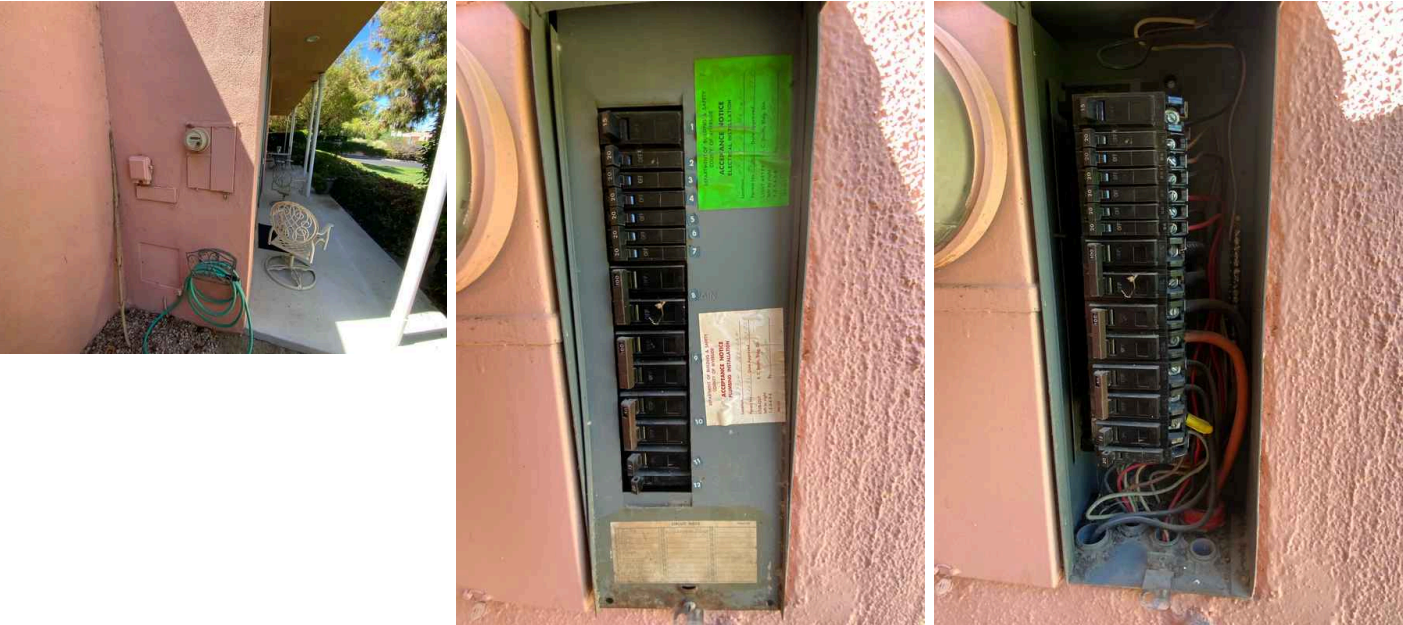
Panelboards & Breakers: Inspected Main Panelboard & Breakers

I inspected the electrical panelboards and over-current protection devices (circuit breakers and fuses).

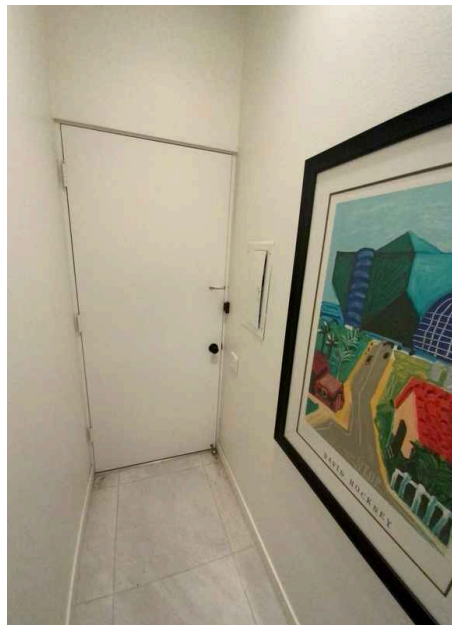
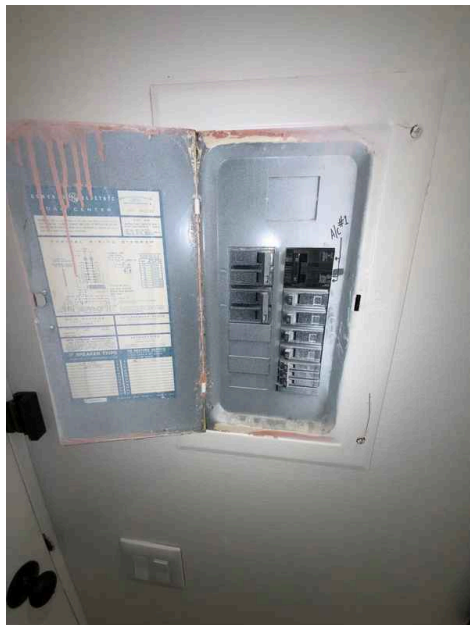
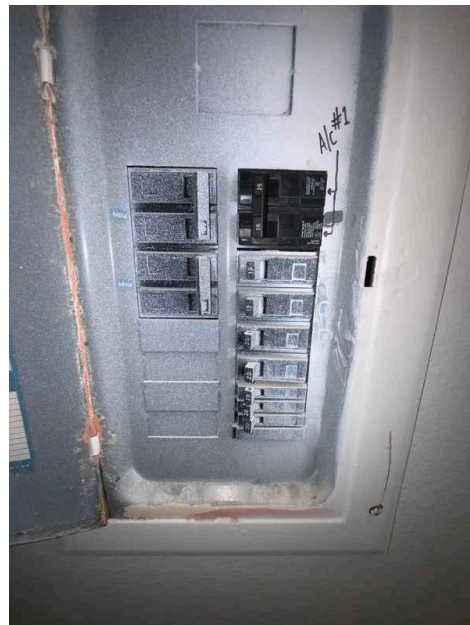
Panelboards & Breakers: Inspected Subpanel & Breakers

I inspected the electrical subpanel and over-current protection devices (circuit breakers and fuses).

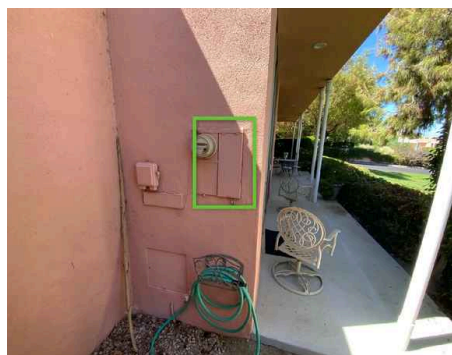
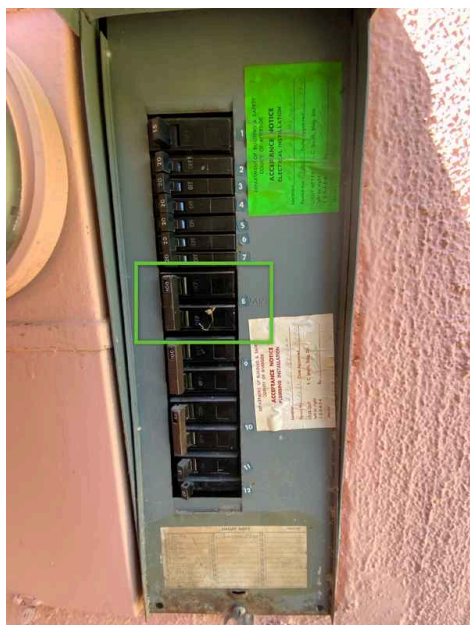
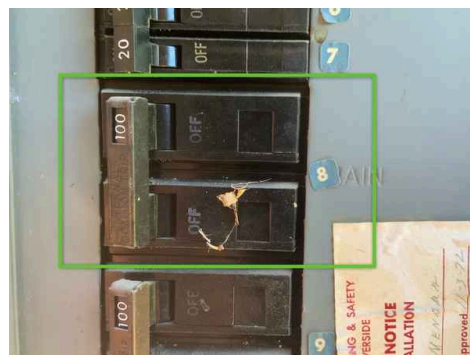
Close up

I observed indications of the main service disconnect's amperage rating.

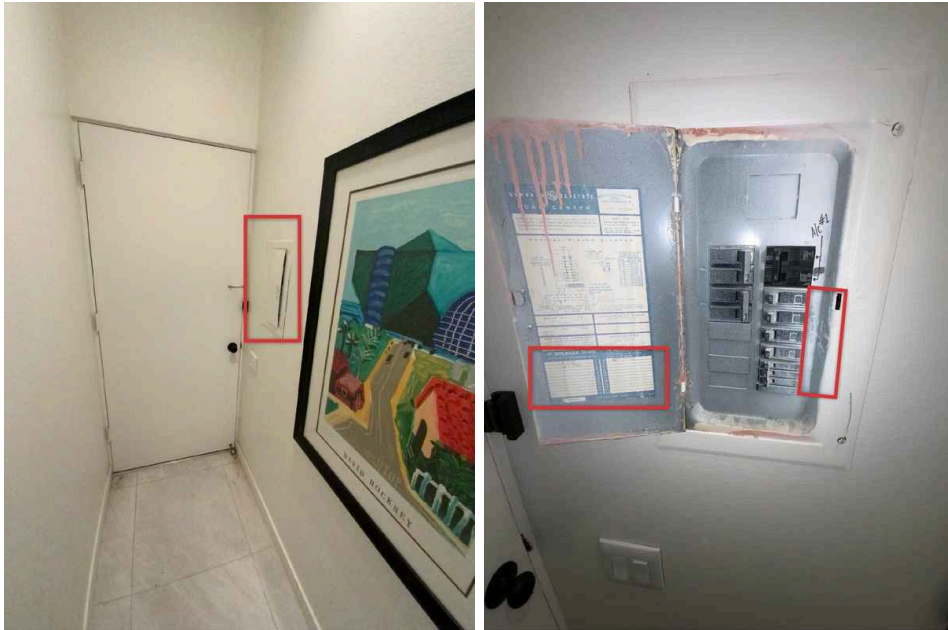
**MISSING/ILLEGIBLE IDENTIFICATION OF DISCONNECTS AT PANEL**

I observed missing and/or inadequate identification of the electrical circuits within the service panel. Circuit directories should clearly and accurately identify the specific area or equipment served by each breaker, using plain English descriptions. Duplicate, vague, or missing labels can delay power shutoff during an emergency and make future servicing or troubleshooting more difficult.

Recommend a qualified licensed electrician accurately identify, test, and permanently label each circuit so that every breaker is clearly identified and no two circuits are labeled the same.

Contact a qualified electrical contractor.

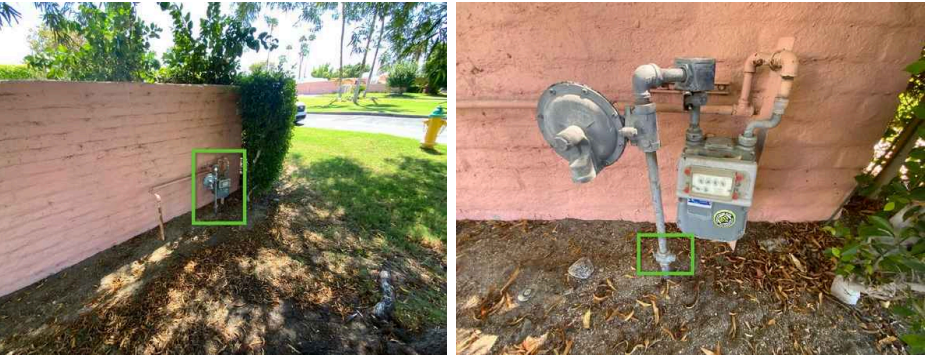
Close up

Main Fuel Supply Shut-Off Valve: Location of Main Shut-Off Valve

Left Side

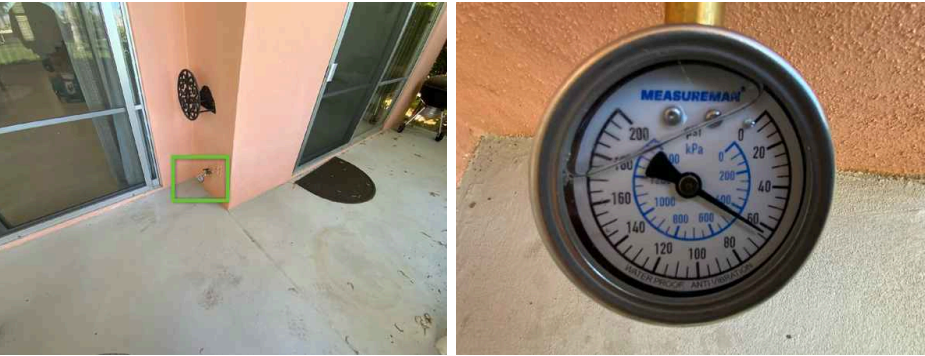
Water Pressure Readings: Pressure Reading

The water pressure was tested. The readings were between the recommended industry standard of 40-80 psi.

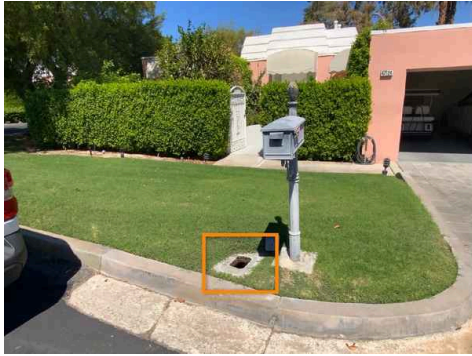
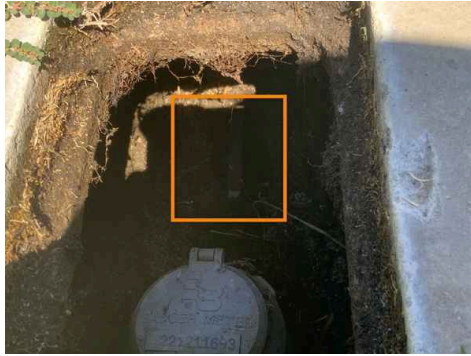
### 7.1.1 Main Water Shut-Off Valve

I observed that the home's main water shut-off appears to be located at the municipal water meter.

Recommendation

Contact a qualified plumbing contractor.

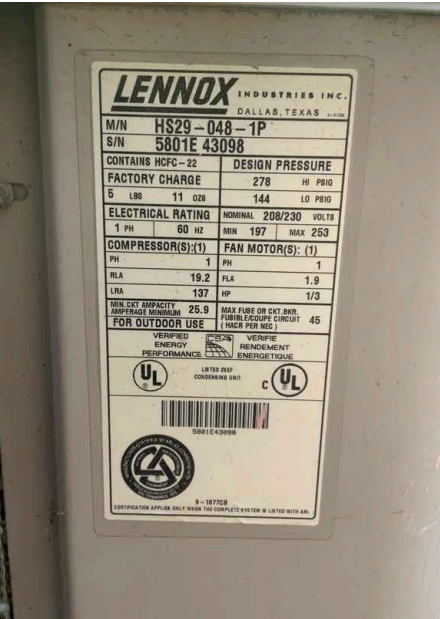
Cooling System Information: Air  
Conditioner Date (Approximate)  
05/01/2001

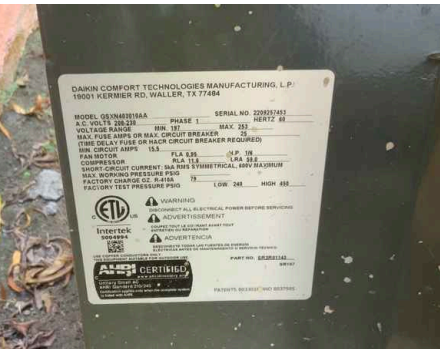
Cooling System Information 2: Air  
Conditioner Date (Approximate)  
09/01/2022

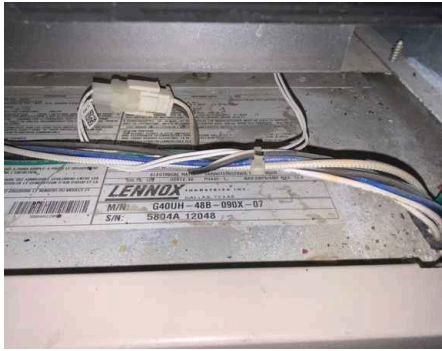
**Heating System Information:**  
**Heat Source Date (Approximate)**  
 01/01/2004

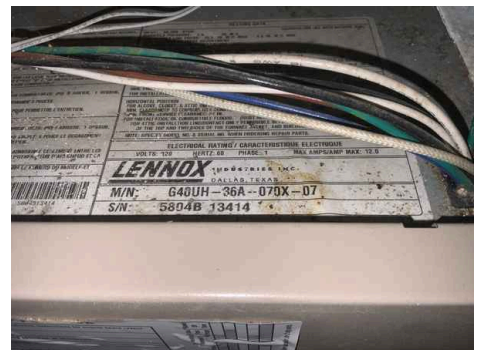
**Heating System Information 2:**  
**Heat Source Date (Approximate)**  
 02/01/2004

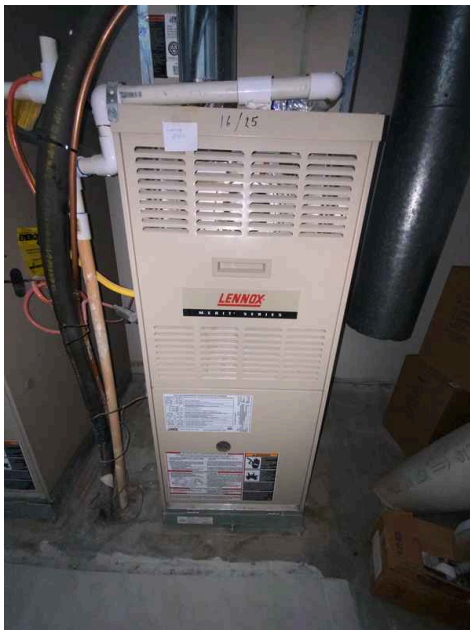
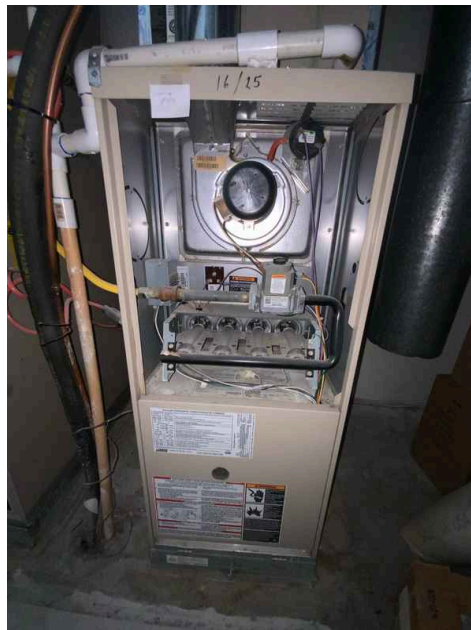
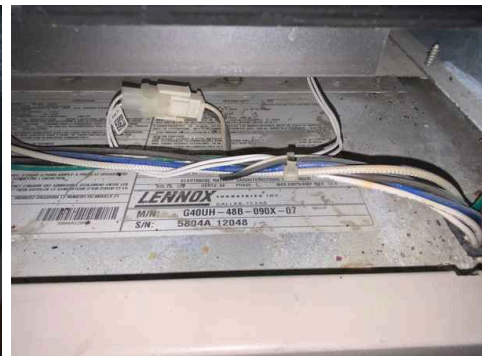
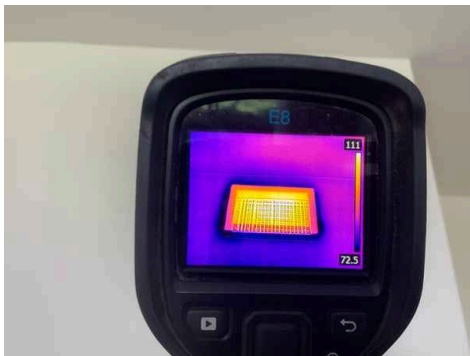
**HEATING - AGED, FUNCTIONING AS DESIGNED**

The heating system appeared to be old, based on the year of manufacturing; but was functioning as designed, at the time of the inspection. Ask the homeowner or occupant about its recent performance or if there are any service records available. Regular maintenance and monitoring of its condition is recommended. Budgeting for repairs and future replacement is recommended. [InterNACHI's Standard Estimate Life Expectancy Chart for Homes](#)

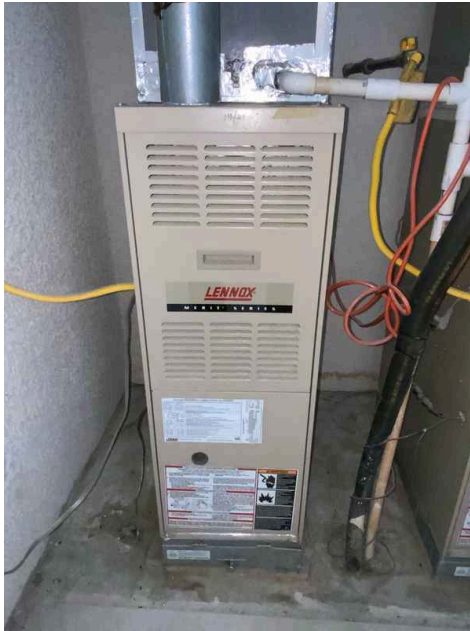
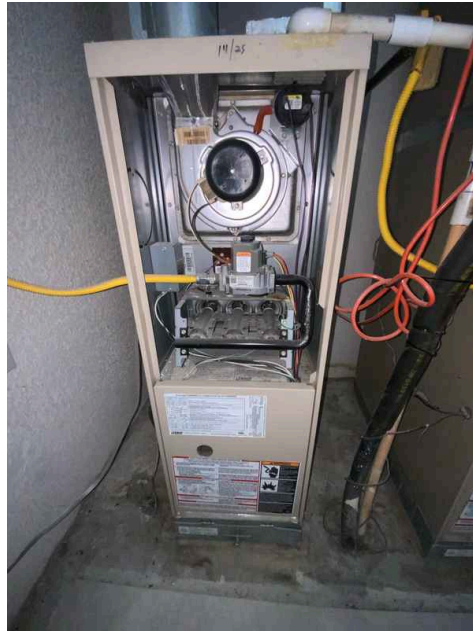
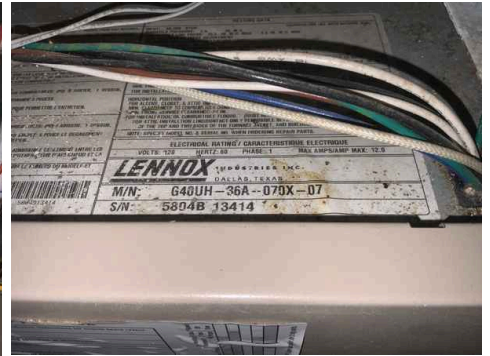
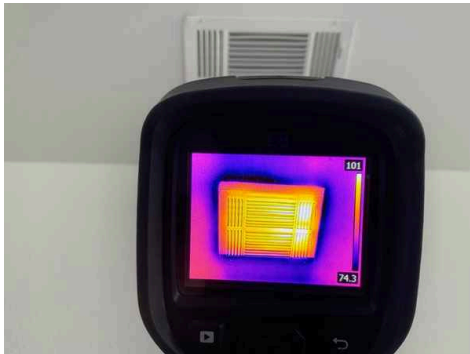
**HEATING - AGED, FUNCTIONING AS DESIGNED**

The heating system appeared to be old, based on the year of manufacturing; but was functioning as designed, at the time of the inspection. Ask the homeowner or occupant about its recent performance or if there are any service records available. Regular maintenance and monitoring of its condition is recommended. Budgeting for repairs and future replacement is recommended. [InterNACHI's Standard Estimate Life Expectancy Chart for Homes](#)

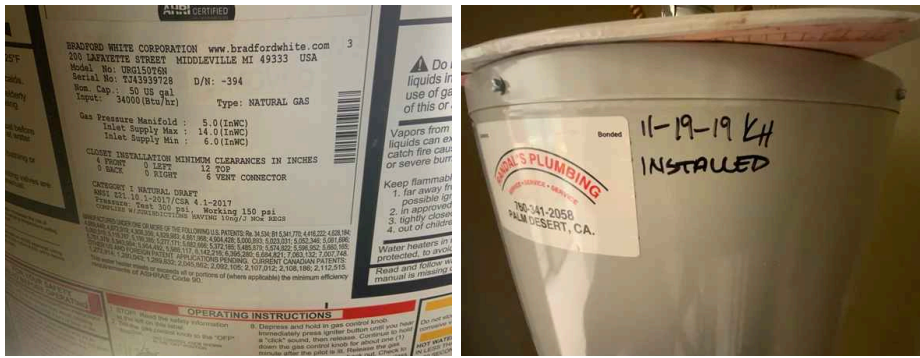
#### Hot Water Source: Build or Install Date

09/01/2019

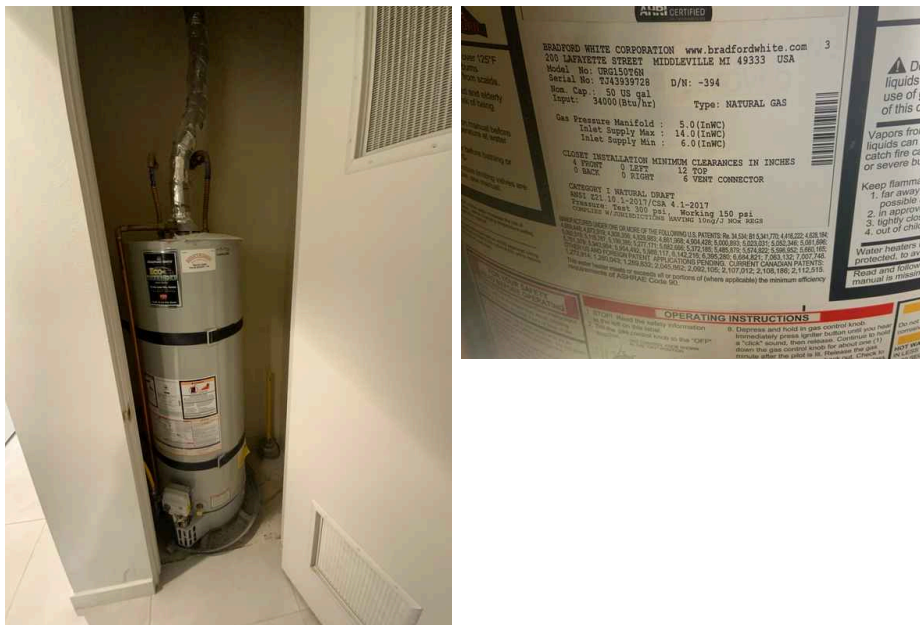
I recommend flushing & servicing your water heater tank annually for optimal performance. Water temperature should be set to at least 120 degrees F to kill microbes and no higher than 130 degrees F to prevent scalding.

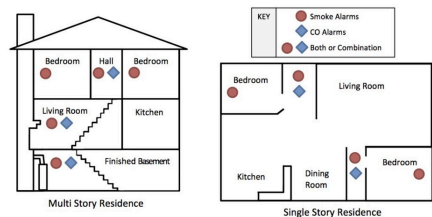
#### MOKE & CARBON MONOXIDE ALARMS

I inspected for the presence of smoke and carbon-monoxide detectors. There should be a smoke detector in every sleeping room, outside of every sleeping room, and one on every level of a house.

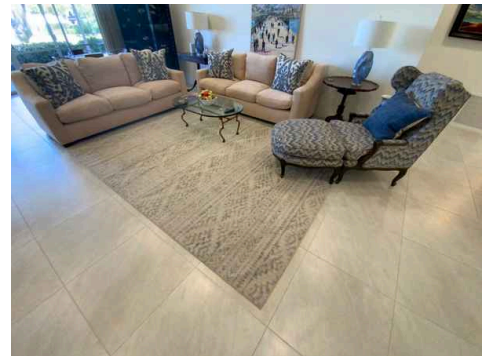
There were rugs/carpets/paper covering the flooring. I tried to move as many rugs/carpets/paper, as possible, to see the flooring. There were some rugs/carpets/paper I was unable to move. Inspection limitation.

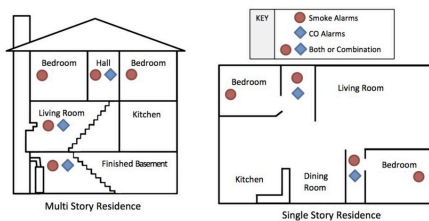
Bedroom

**SMOKE DETECTOR(S) - MISSING/NOT INSTALLED**

I observed missing smoke detector(s). Smoke and carbon monoxide detectors should be stand alone from a security monitored alarm system. **The monitored smoke and/or carbon monoxide alarms can be added as an additional system, but a separate hardwired or battery operated smoke and/or carbon monoxide alarm system should be installed, at a minimum.**

Recommend a qualified professional install according to manufactures directions.

Contact a qualified professional.

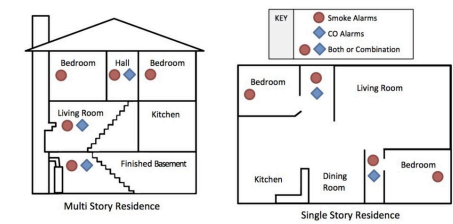
Bedroom Hallway

**MISSING BOTH - SMOKE AND CARBON MONOXIDE DETECTORS****Smoke and Carbon Monoxide Alarm Recommendations**

Recommend updating the home's smoke and carbon monoxide alarm system as needed to provide proper coverage, placement, and operation.

Contact a qualified professional.

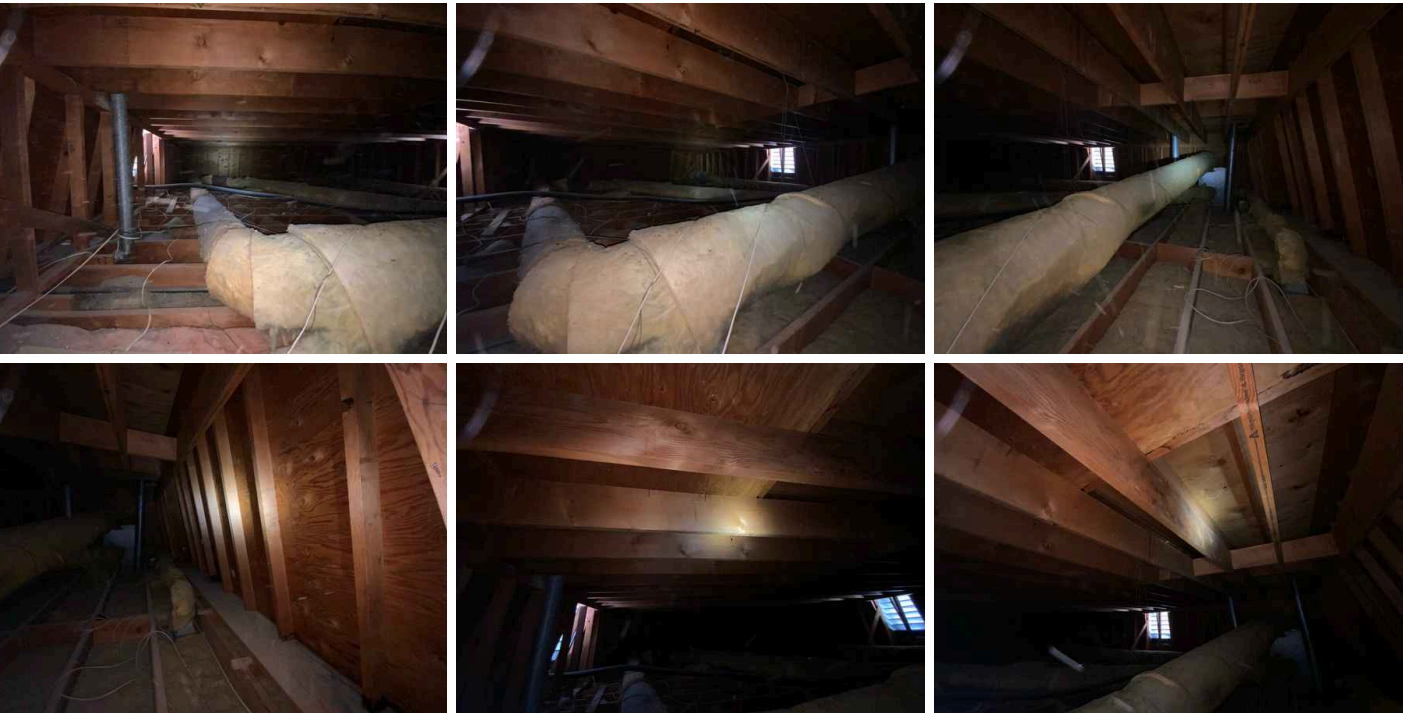
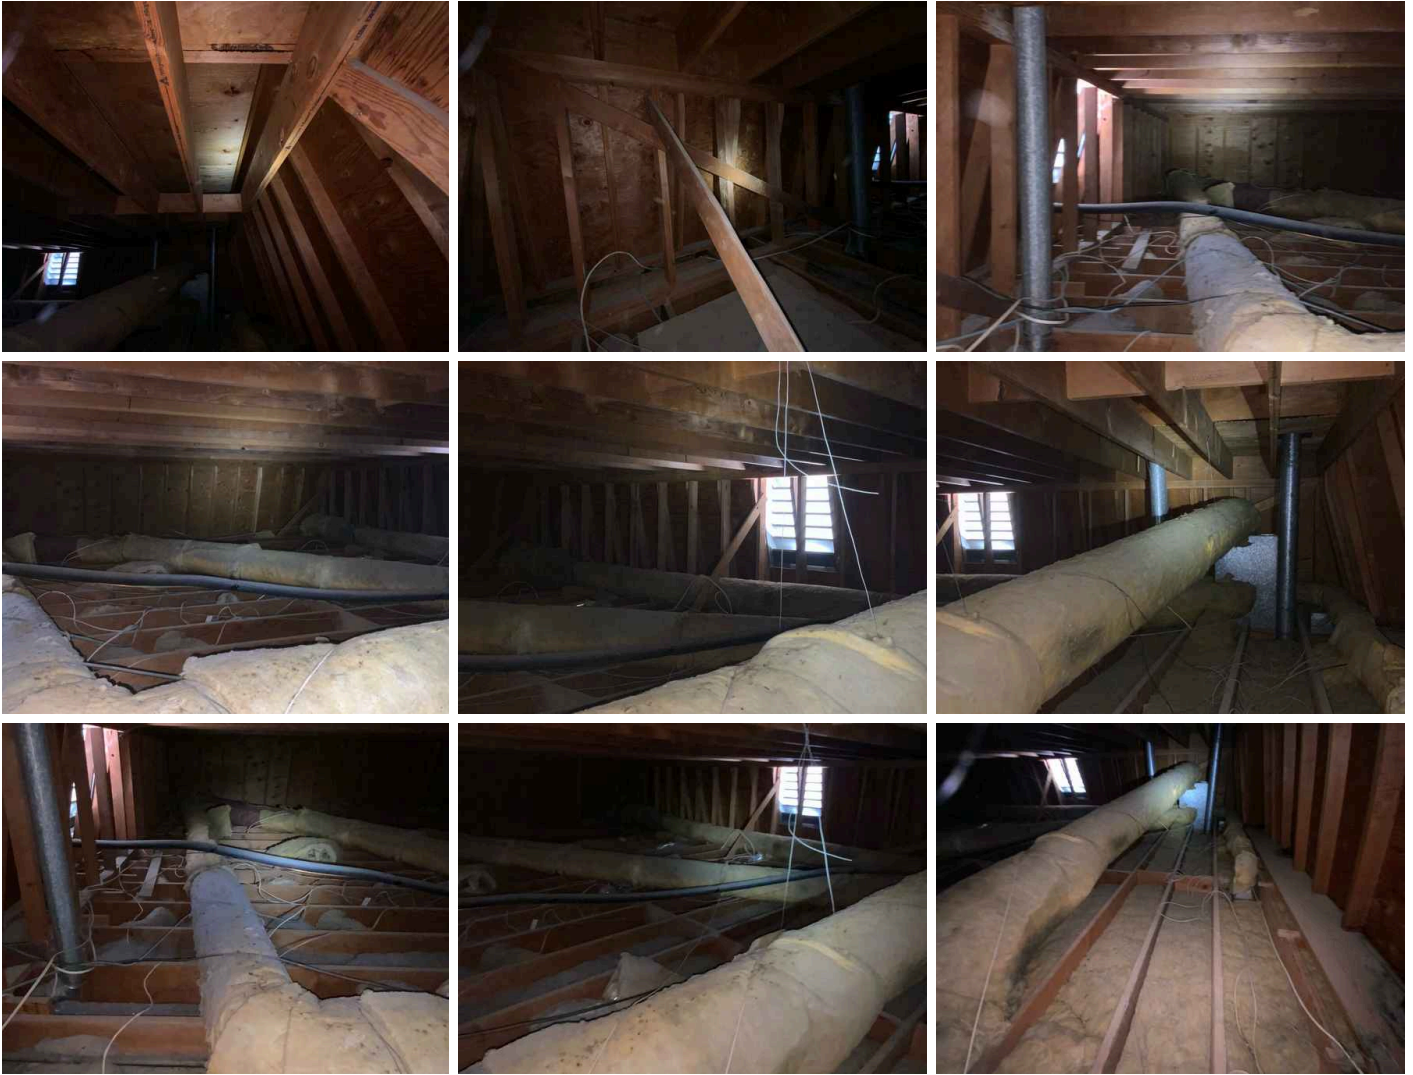
**Structural Components & Observations in Attic: Structural Components Were Inspected**  
Structural components were inspected from the attic space according to the [Home Inspection Standards of Practice](#).

3-6 inches
