WOOD DESTROYING PESTS AND ORGANISMS INSPECTION REPORT

Building No. 5537	Street Gladehollow	City Agoura Hills	ZIP 91301	Date of Inspection 03/12/2024	Number of Pages 5
----------------------	-----------------------	----------------------	--------------	----------------------------------	----------------------

GENERAL DESCRIPTION: Furnished, stucco and frame house on a concrete slab with a composition roof.	Inspection Tag Posted: Garage Other Tags Posted:
--	--

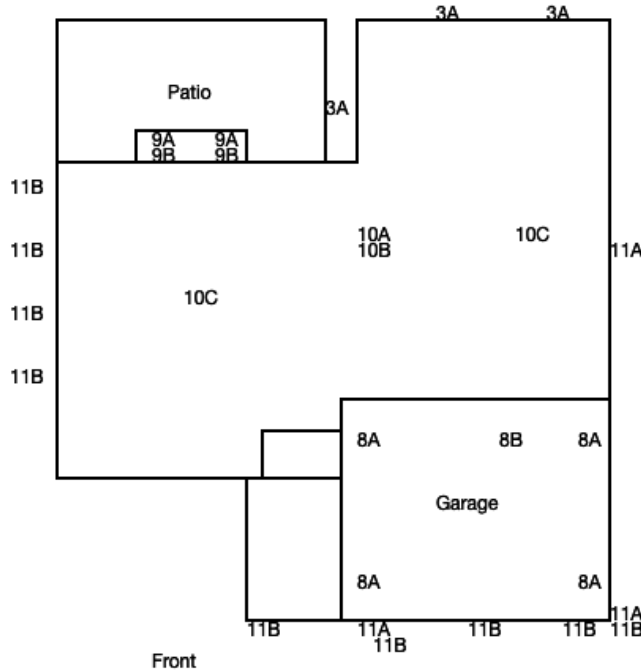
Diagram Not To Scale

Finding: Fungus and drywood termite damage noted to the cantilever joist framing at the balcony.as marked per diagram.

Finding: Fungus and drywood termite damage noted to the eave fascia, roof sheathing and exposed beams as marked per diagram.

Recommendation: Remove the damaged wood and replace with new wood. Contact a licensed contractor to make corrections.

Recommendation: Remove the damaged wood and replace with new wood.
