## CONDO INSPECTION

1501 India St Unit 508  
San Diego, CA 92101

07/21/2026

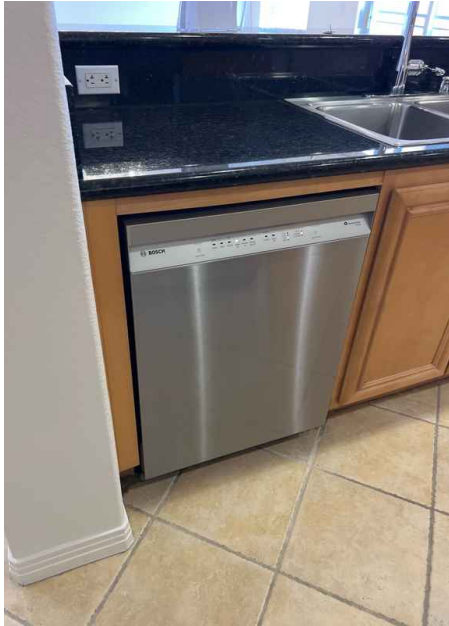
The dishwasher was tested and functioned properly at the time of the inspection. This is not an exhaustive test and does not verify the cleaning efficiency of the dishwasher. Notable exceptions will be listed below.

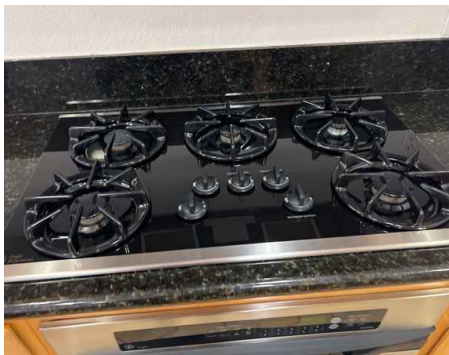
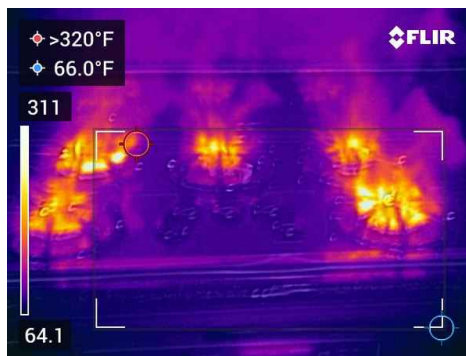
**RANGES/COOKTOP: Cooktop - INSPECTED**

The cooktop was tested and was functional at the time of the inspection. This test is not exhaustive and does not confirm the performance, accuracy, or effectiveness of the cooktop.

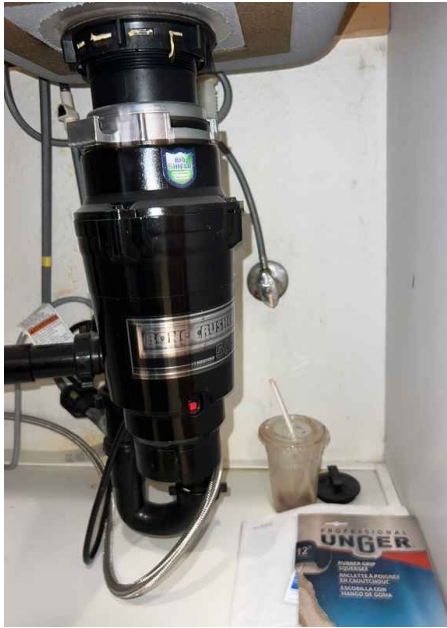
**FOOD WASTE DISPOSER: Disposer - INSPECTED**

The disposer was tested and was functional at the time of inspection.

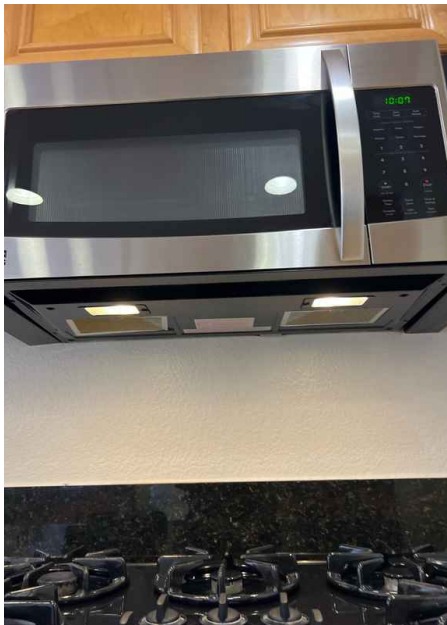
**RANGE HOOD/VENT: Vent - Inspected**

The range exhaust vent was tested and was functional at time of the inspection. This is not an exhaustive test, and does not evaluate the performance or effectiveness of the range hood.

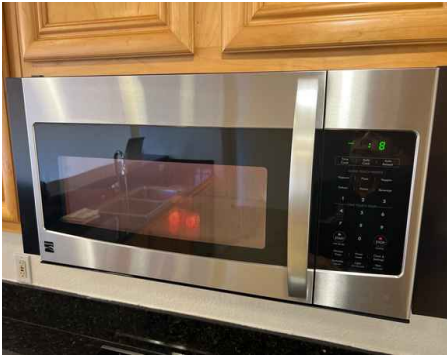
**MICROWAVE COOKING EQUIPMENT (Built-in): Microwave - INSPECTED**

The microwave was tested with a testing device and was functional at time of the inspection. This is not an exhaustive test, and does not predict the performance of the microwave.

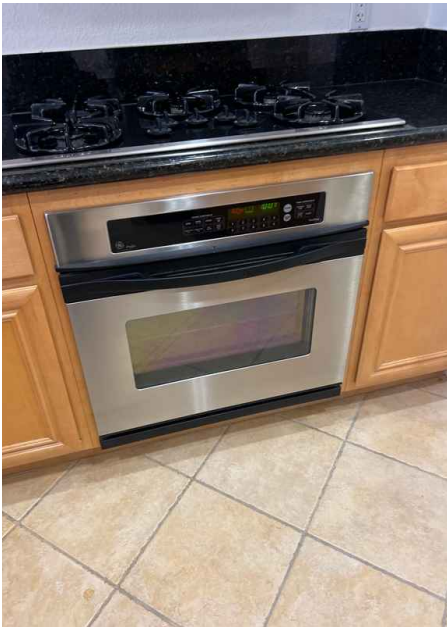
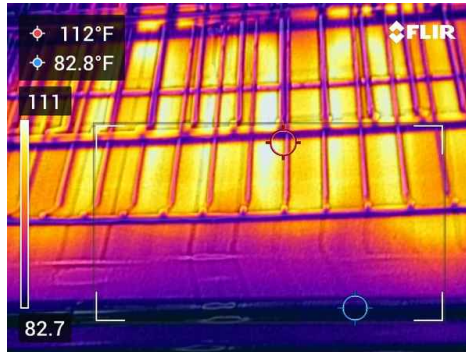
**WALL OVEN: Electric Wall Oven - INSPECTED**

The electric wall oven was tested and was functional at the time of inspection. This test is not exhaustive and does not evaluate the accuracy or performance of the oven.

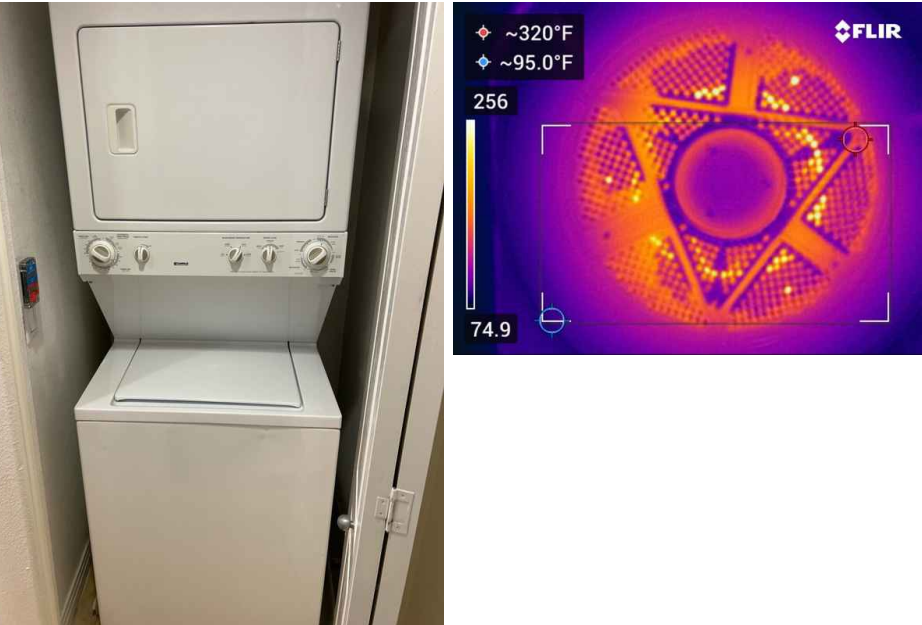
**WASHER/DRYER: CLOTHES WASHER/DRYER - INSPECTED**

The clothes washer and dryer were run through a short cycle during the inspection and appeared to be functional. This is not an exhaustive test and does not verify the cleaning efficiency of the clothes washer/dryer. Washers and dryers are not moved to inspect the walls/floors/other components behind them. We recommend that you keep a good home warranty in place, which covers the appliances.

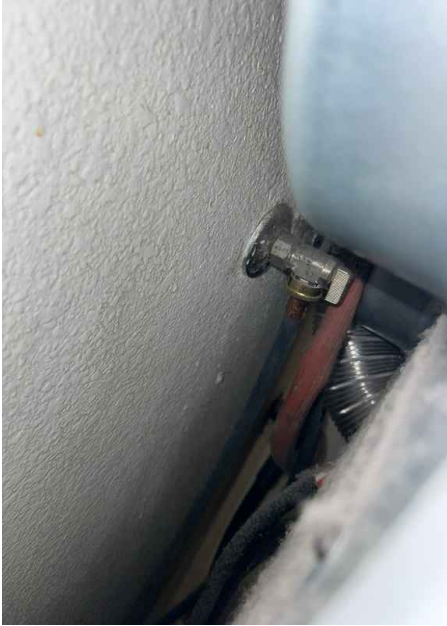
## WASHER/DRYER: Washer Hoses Replace

Washer hoses are a common source of flooding in a home. We recommend installing new braided steel washer hoses to reduce the risk of leaks caused by burst hoses in the house. Any hoses left in the house or more than 5 years old should be replaced.

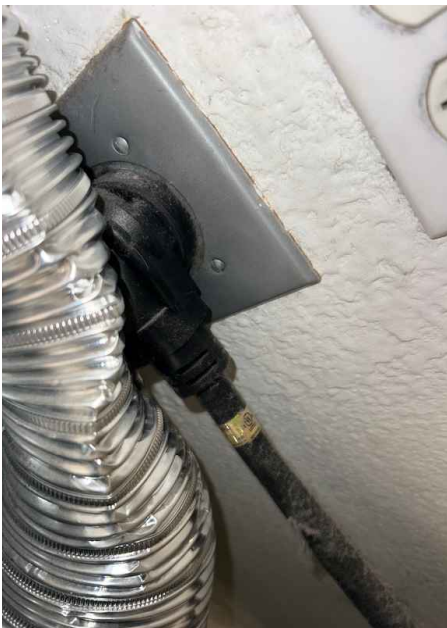
## WASHER/DRYER: Recep 220 - 3 prong upgrade

TIP: There is a three-prong 220-volt receptacle in the laundry. Many new electric dryers require a four-prong receptacle. If you install an electric dryer, you may need to upgrade the receptacle or the dryer power cord. This should be performed by a licensed electrician.

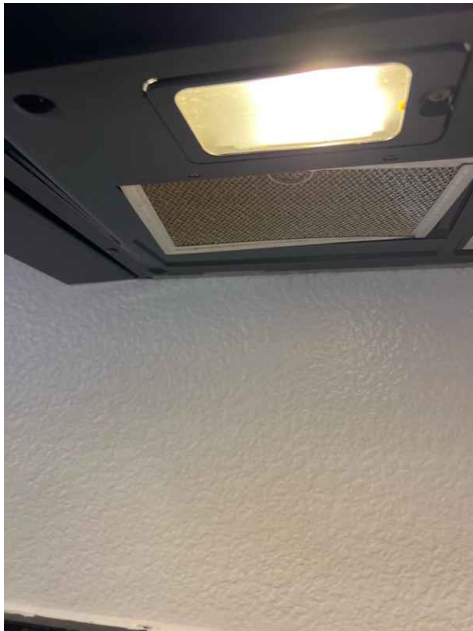
### 2.5.1 RANGE HOOD/VENT

The grease filter is dirty and requires replacement.

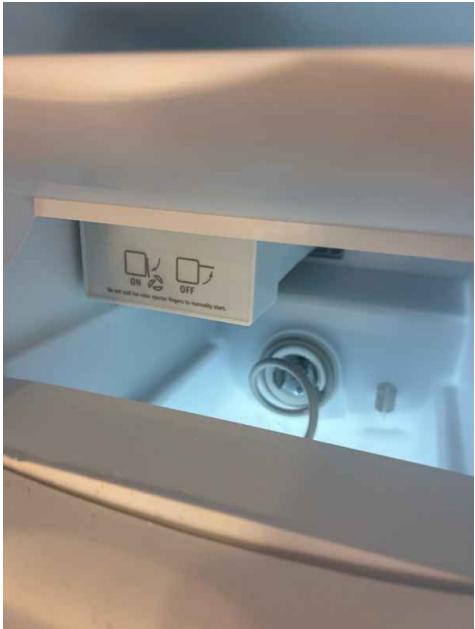
2.8.1 REFRIGERATOR  
**NO ICE IN FREEZER**

No ice was observed in the ice maker in the freezer. The absence of ice may indicate that there is no water supplied, the ice maker was off, or there is a problem with the ice maker. We advise further review with the seller to demonstrate function or further review with qualified appliance technician.

Recommendation  
Contact a qualified appliance repair professional.

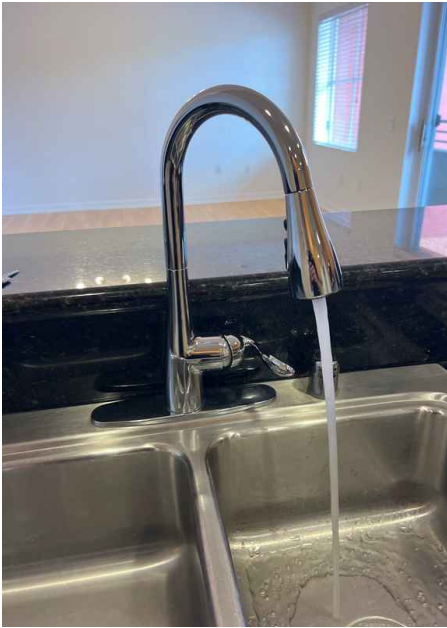
**FAUCETS, VALVES AND CONNECTED FIXTURES: Faucets, Valves, Connected Fixtures - Inspected**

All faucets, valves, and fixtures were inspected and appeared to function as intended.

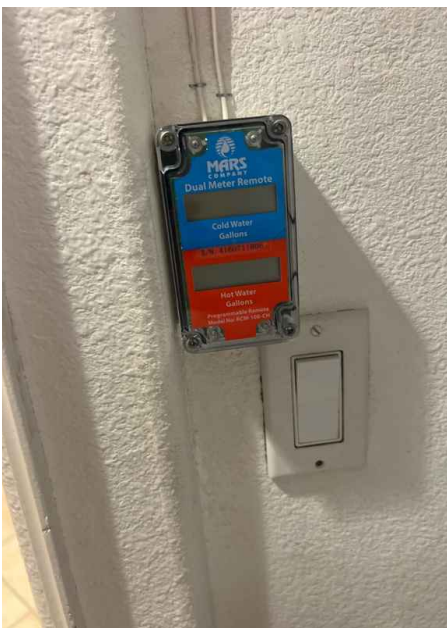
**WATER SUPPLY AND DISTRIBUTION SYSTEM: Water Meter - Checked**

Note: The water meter was observed for an extended period of time with plumbing fixtures, washing machine, dishwasher, sprinkler system, and any other water-using systems, devices and fixtures turned off. No movement of the water meter was observed.

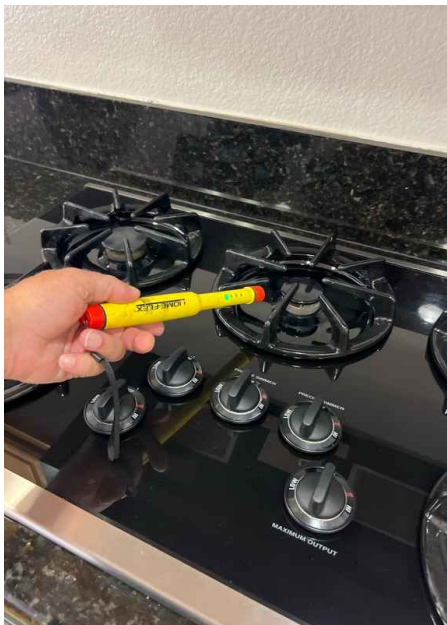
## GAS STORAGE AND DISTRIBUTION SYSTEMS: Gas Leak Test - Inspected

During the inspection, a gas leak test was performed using a hand-held combustible gas leak detector. Readily accessible gas fittings/appliances were tested. No gas leaks were observed. Note: This is not a guarantee against leaks.

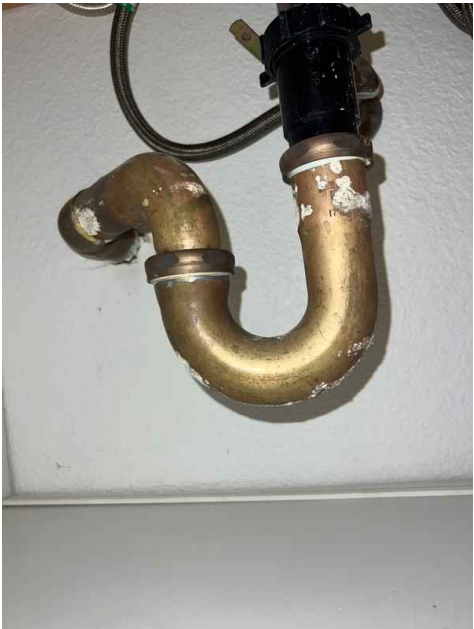
METAL TRAP - CORRODED

Metal drain components are present under the sink which are deteriorating. Although there is currently no leak, there may be one in the future. When replacing the pipes, we recommend replacing with plastic piping by a licensed plumber.

Recommendation  
Contact a qualified plumbing contractor.

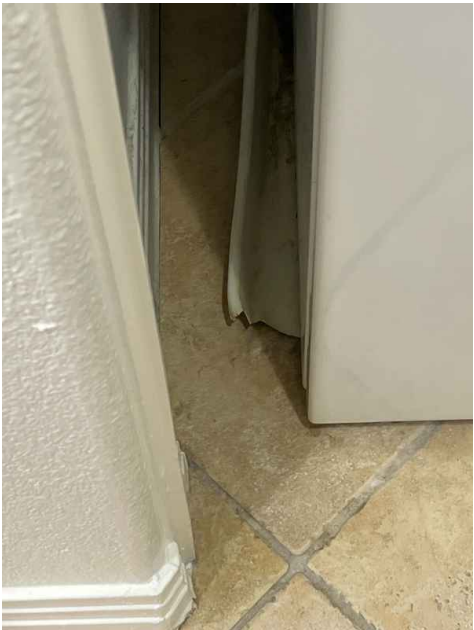
3.2.2 INTERIOR DRAIN, WASTE AND VENT SYSTEMS

WASHER PAN - DAMAGED

The washer pan installed under the washing machine is damaged or cracked. The washer pan and drain line are installed to prevent damage caused by an overflowing washer or a leak. We recommend repair or replacement.

Recommendation  
Contact a qualified professional.

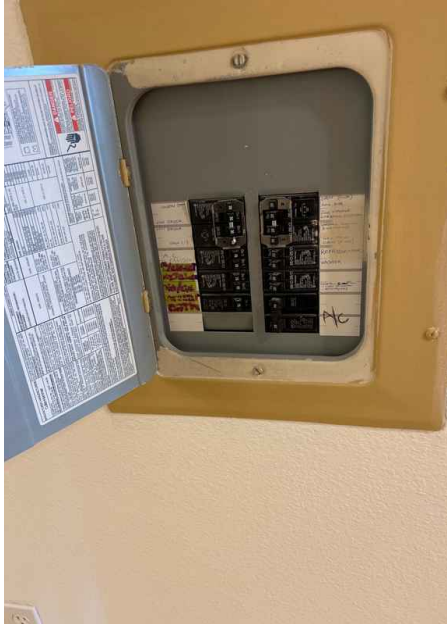
**MAIN AND DISTRIBUTION PANELS: Panel(s) - Inspected**

Electrical panels are visually inspected only; the inspector does not perform load calculations to determine service capacity or adequacy.

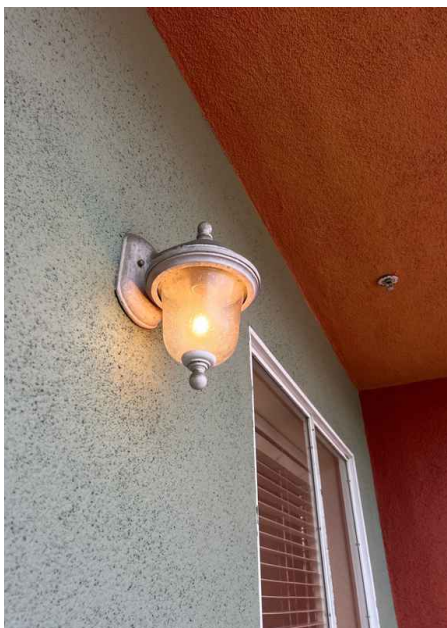
## **EXTERIOR LIGHTING - ATTACHED (Daylight sensors and landscape lights excluded): Exterior Lights - Inspected**

Switch-operated exterior lights were tested and were functional at the time of the inspection.

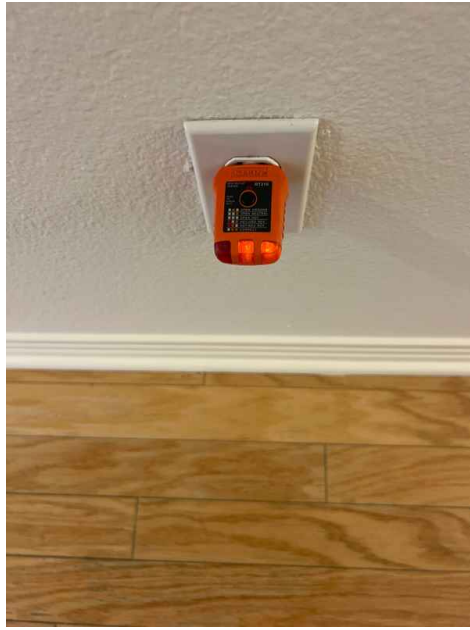
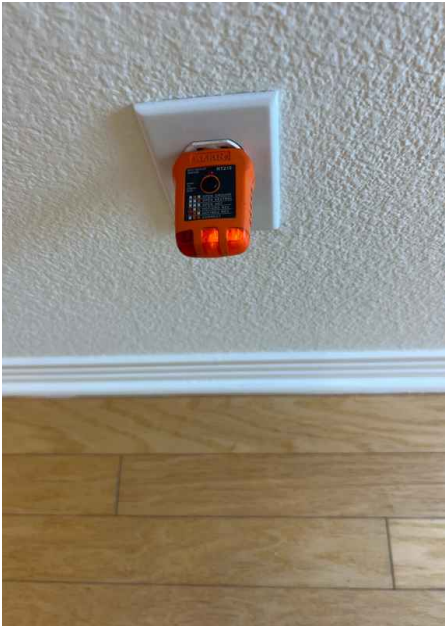
**POLARITY AND GROUNDING OF RECEPTACLES: Receptacles - Inspected**

A representative number of receptacles were tested for power, polarity, and grounding according to standards of practice.

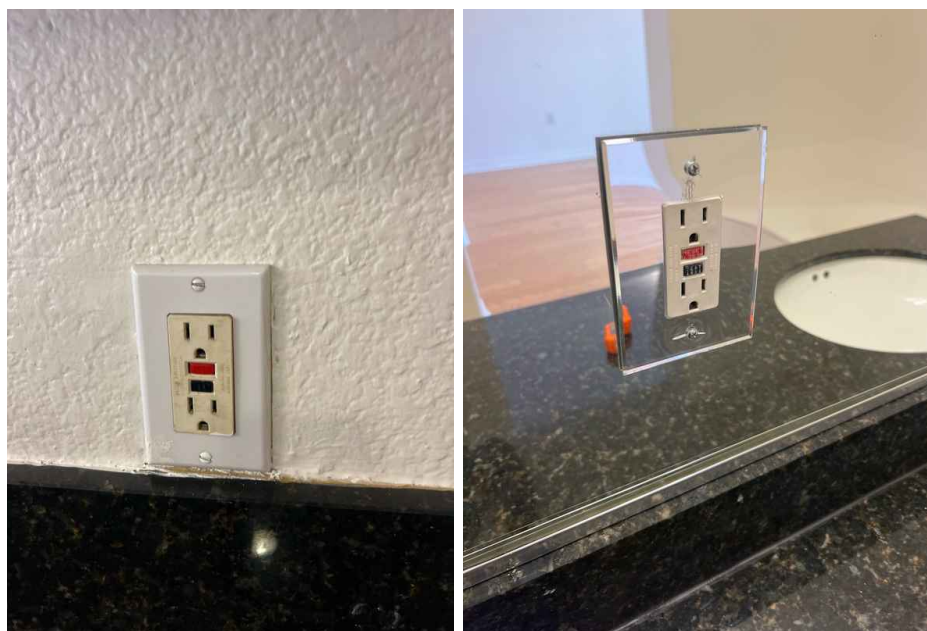
## OPERATION OF GFCI (GROUND FAULT CIRCUIT INTERRUPTERS): GFCI - Inspected

All accessible GFCI receptacles were tested and were functioning properly unless otherwise noted.

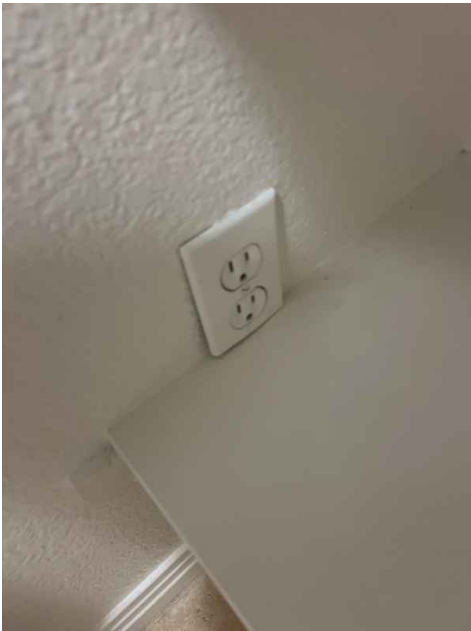
Pantry

### RECEP - LOOSE

Receptacle was loose in the wall. This puts stress on the circuit wires which should not be moved. We recommend securing the junction box properly in the wall by a qualified person.

Contact a qualified professional.

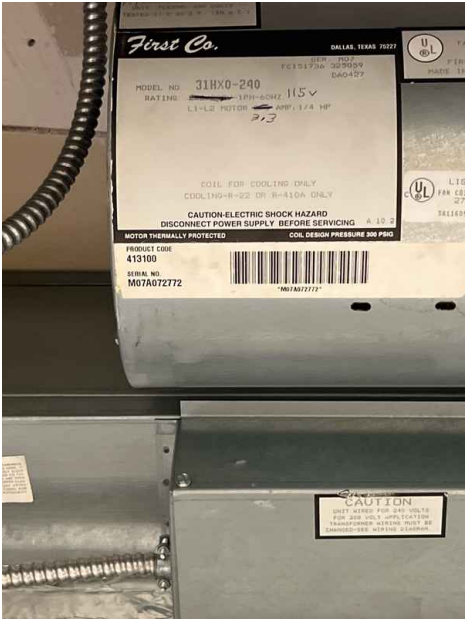
**General: AGE OF HEAT PUMP**  
Less Than 15 Years

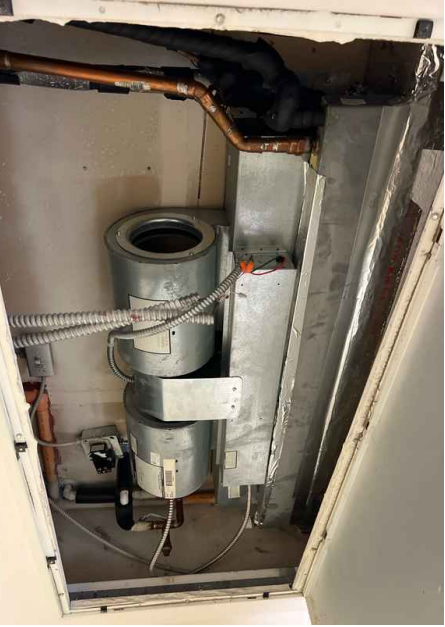
HEAT MODE: Heat Pump - INSPECTED

The Heat pump was tested in normal operating mode and was functional. The temperatures were measured to determine if the unit is heating the air adequately. The temperature at the return was measured and the temperature at the registers was measured. The change in temperature was adequate. With a heat pump, many factors affect the change in temperature including the outside air temp, age of the system, and condition of the filters, ducts, and fans. It appears that the functionality of the heat pump in heat mode was normal. Notable exceptions will be listed below.

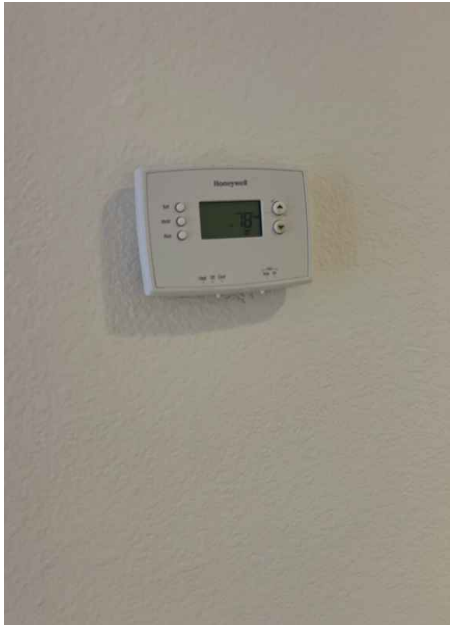
NORMAL OPERATING CONTROLS (Thermostat): Thermostat - Functional

The thermostat was operational when used to operate the HVAC system. Programmable thermostats are not adjusted, and no testing is done to check the accuracy or programmed settings of the thermostat.

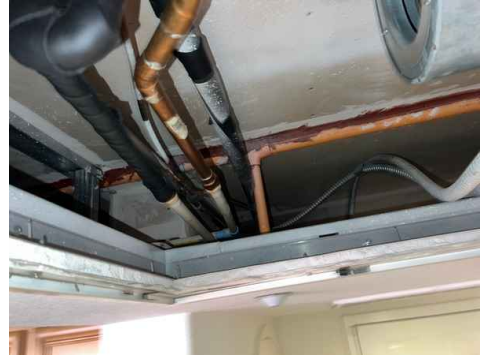
A vented trap must be installed in the condensation drain line to prevent vapor lock and possible condensation leaks in the house. No trap was installed. We recommend correction by a licensed HVAC contractor.

Contact a qualified heating and cooling contractor

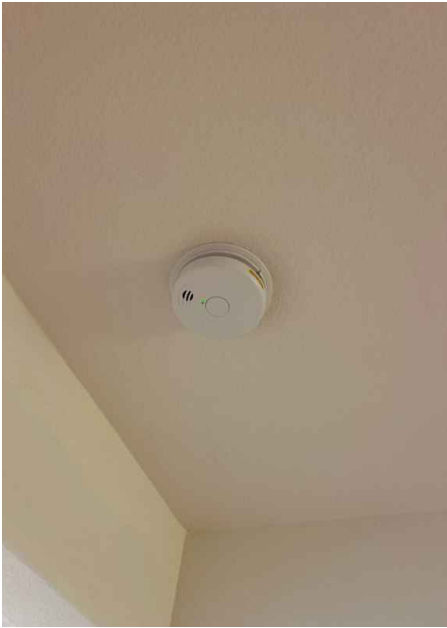
**SMOKE DETECTORS: Smoke Detectors - Present (one-story)**

Smoke detectors were installed in the proper locations in hallway and in each bedroom, however they were not tested. We recommend testing the detectors for proper function before occupying the home.

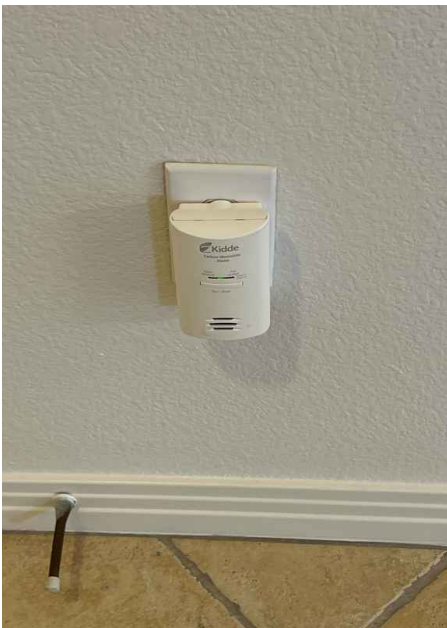
**CARBON MONOXIDE DETECTOR(S): CO Detector - Enough Present**

Carbon Monoxide detectors are required in homes with any gas-burning appliances (furnace, range, water heater), fireplaces, or wood-burning stoves and/or an attached garage. Please see the new law regarding Carbon Monoxide detectors. This house has CO detector(s) installed as required.

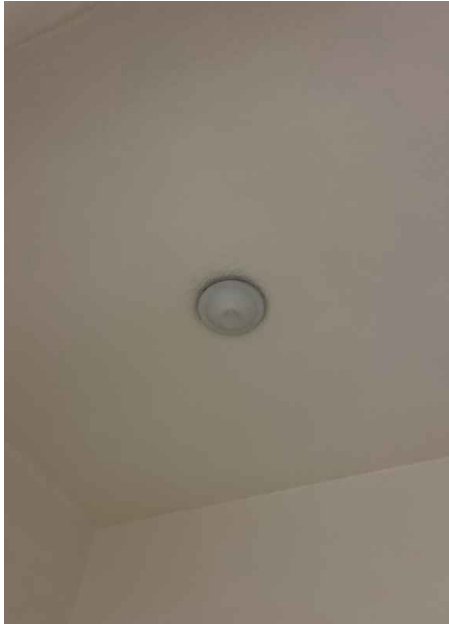
**FIRE SPRINKLERS/CONTROL: Fire Sprinklers - Present**

Fire Sprinklers are present in the house. No evidence of leaking was observed. Pressure at the gauge was within normal range. It is beyond the scope of a home inspection to inspect the fire suppression system. While there is no requirement for you to have the fire sprinkler system inspected at all, this service does exist. We recommend having the fire sprinkler system inspected periodically. During this inspection, the fire sprinkler inspector should check for proper installation, and proper function of the pressure switch, bell, shut-off valve, and drain valve. They should also check to make sure the sprinkler heads have not been recalled. If the house is within an HOA, they may have information regarding any problems with fire sprinklers.

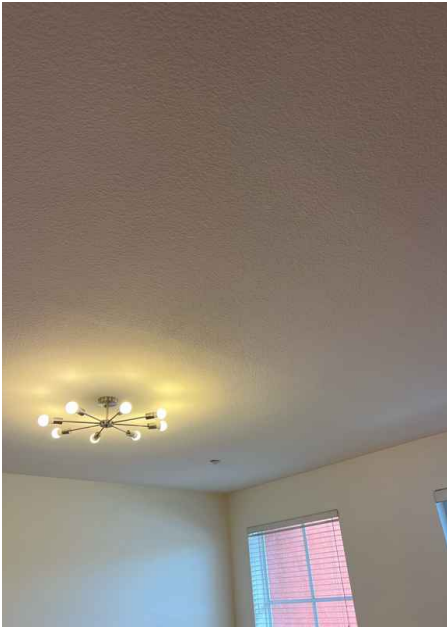
**CEILINGS: Ceilings - Inspected**

At the time of the inspection, the Inspector observed no deficiencies in the condition of ceilings in the home.

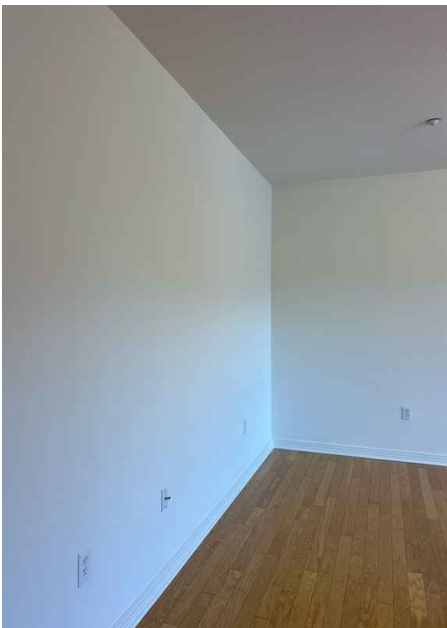
**WALLS: Walls - Inspected**

At the time of the inspection, the Inspector observed no deficiencies in the condition of walls in the home interior.

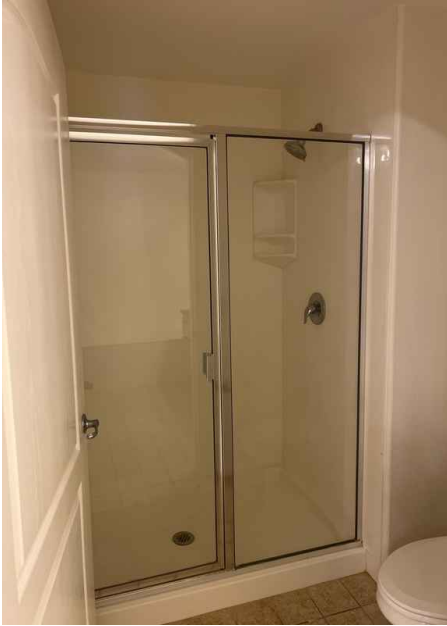
**TUB/SHOWER ENCLOSURE: Tub/Shower Enclosures - Inspected**

The bathing enclosure(s) appeared to be in serviceable condition at the time of the inspection.

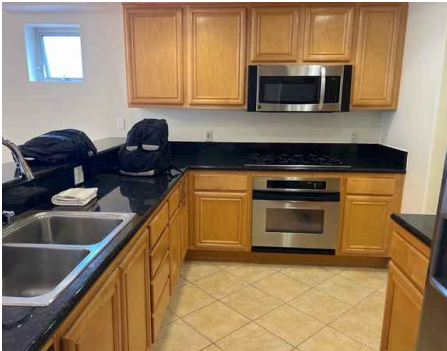
**COUNTERS AND A REPRESENTATIVE NUMBER OF CABINETS: Cabinets - Inspected**

At the time of the inspection, the Inspector observed no deficiencies in the condition of the cabinets.

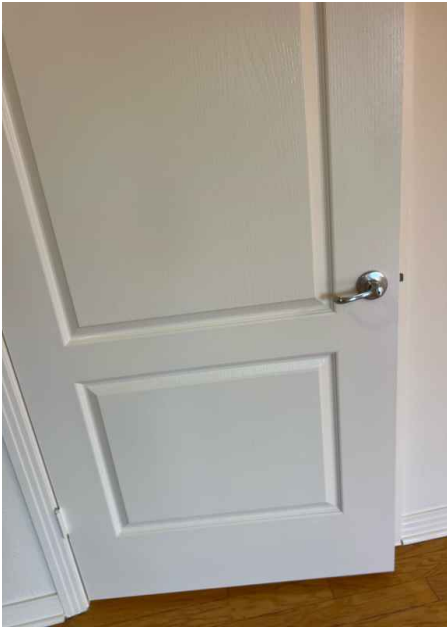
**DOORS (REPRESENTATIVE NUMBER): Doors - Inspected**

At the time of the inspection, the Inspector observed no deficiencies in the condition of interior doors.

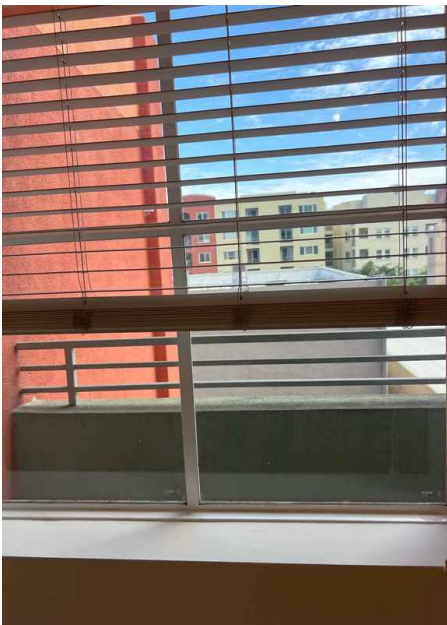
**WINDOWS (REPRESENTATIVE NUMBER): Window - Representative**

Only a representative number of accessible windows are checked for operation during this inspection in accordance with the standards of practice of a home inspection. In some instances, the inspector may not be able to disclose the exact condition of every window. This includes reporting on the condition of the locks, springs, counterbalance mechanisms, or evidence of leaking if the furniture, personal items, or window coverings prevent access to windows and surrounding areas.

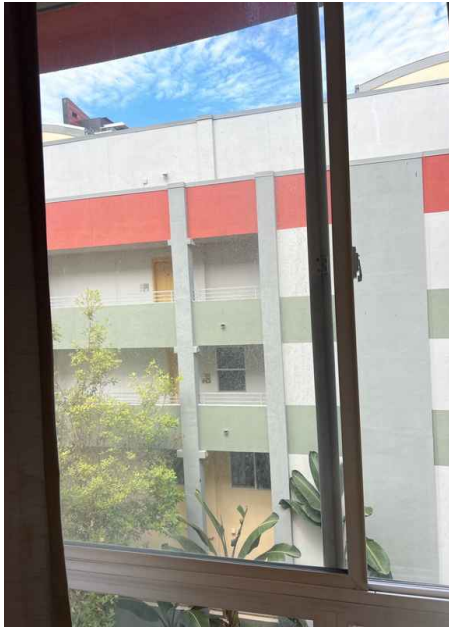
**WINDOWS (REPRESENTATIVE NUMBER): Double Pane - Info**

**Note about double-pane windows:** Failed seals in insulated glass (double-pane) windows are not always detectable. In some instances inspector may not be able to disclose the exact condition of every window, depending on the ambient conditions (weather) or if the windows are dirty at time of inspection. Moisture between panes of glass in a double-pane window with a failed seal may or may not be observable depending on variations in ambient conditions such as temperature and humidity. Windows are reported as they are observed at the time of the inspection only. If you have present or future concerns regarding the integrity of thermal pane seals, it is strongly suggested that you consult with a Professional Fenestration Specialist for further evaluation. This inspection is not a warranty or guarantee of any kind regarding the integrity of the windows. The life span of double-panel windows seals averages 8-20 years. See: [InterNACHI Life Expectancy Chart](#)

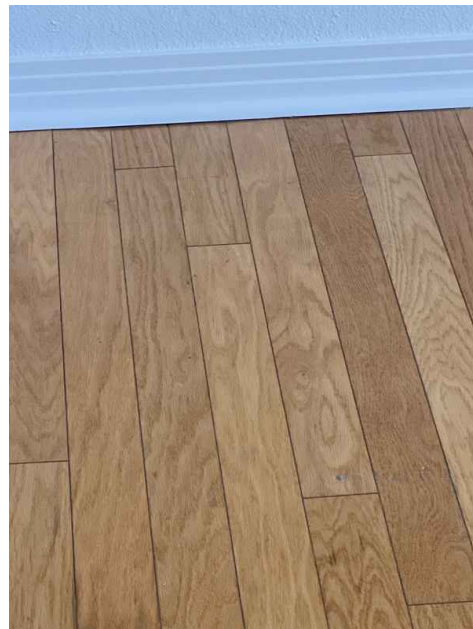
### 8.5.2 FLOOR COVERINGS

#### FLOOR

Contact a qualified professional.

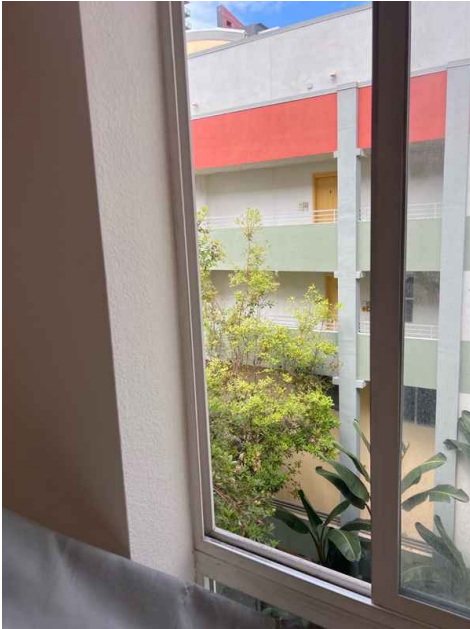
#### 8.10.1 WINDOWS (REPRESENTATIVE NUMBER)

##### **SCREEN - MISSING/DAMAGED**

Contact a qualified professional.

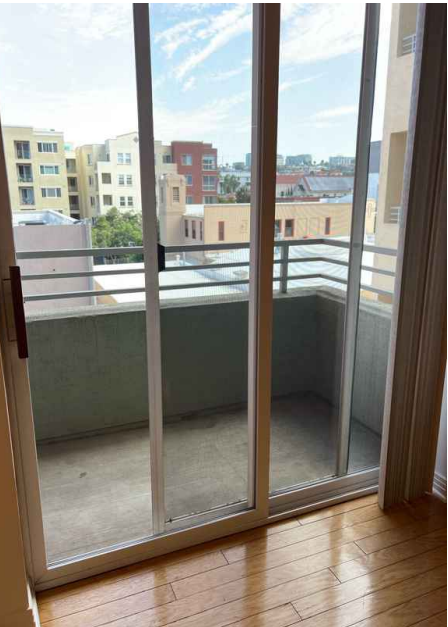
**DOORS (Exterior): Doors - Inspected**

At the time of the inspection, the Inspector observed no deficiencies in the condition of exterior doors.

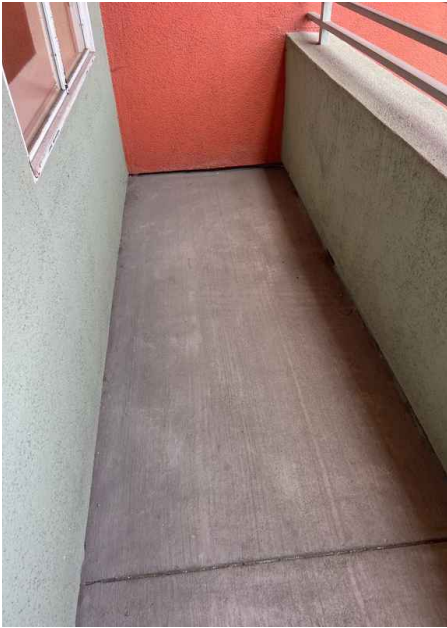
## BALCONIES (Railing, Decking Material): Balcony/Deck Coating - Inspected

Note: The decking material/coating showed normal wear for its age and type. All decks require periodic maintenance to prolong the life of the deck and avoid leaks. No evidence of leaking was observed.

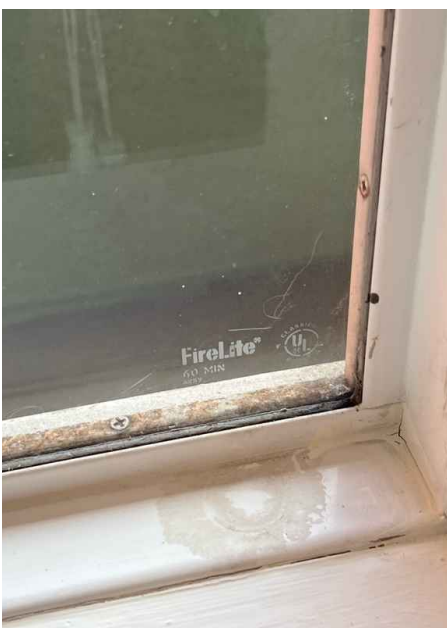
## SAFETY GLASS: TEMPERED GLASS - Inspected

The glass at the glass doors is tempered, which is indicated by a stamp or marking on the glass.

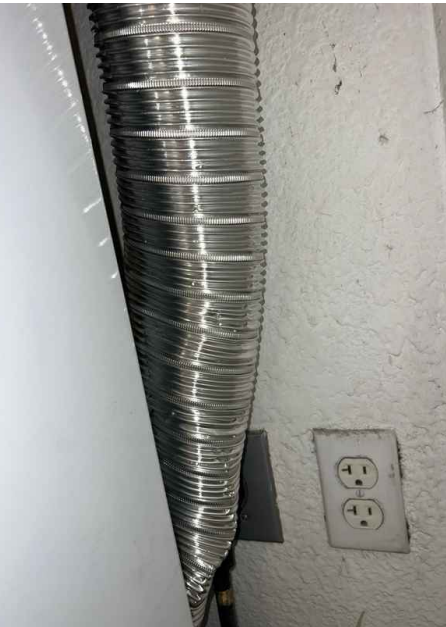
**CLOTHES DRYER VENTING SYSTEM: Dryer vent - Inspected**

At the time of the inspection, the Inspector observed no deficiencies in the condition of the dryer vent.

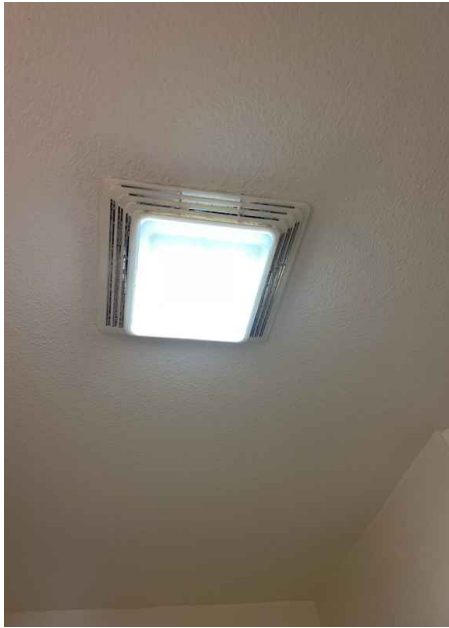
### BATHROOM VENTING: Exhaust Fans - Inspected

The exhaust fan(s) were tested and were functional at the time of inspection. (This is not an exhaustive test, and does not evaluate the performance or effectiveness of the vent(s).)

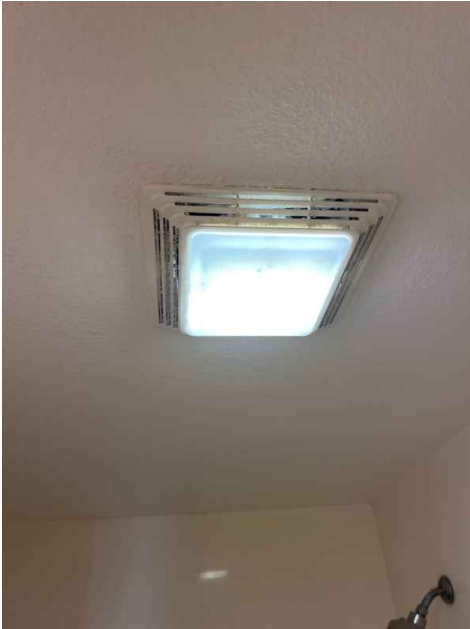
Master Bathroom

### 12.5.1 BATHROOM VENTING

The bathroom fan is excessively dirty. We recommend cleaning to improve efficiency.

Recommendation

Recommended DIY Project

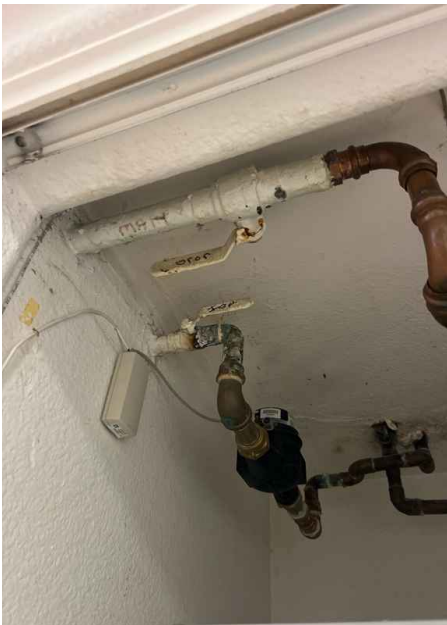
Laundry Room

#### **MAIN WATER SHUT-OFF DEVICE: Location -laundry room**

The main water shut-off valve is located in the laundry room.

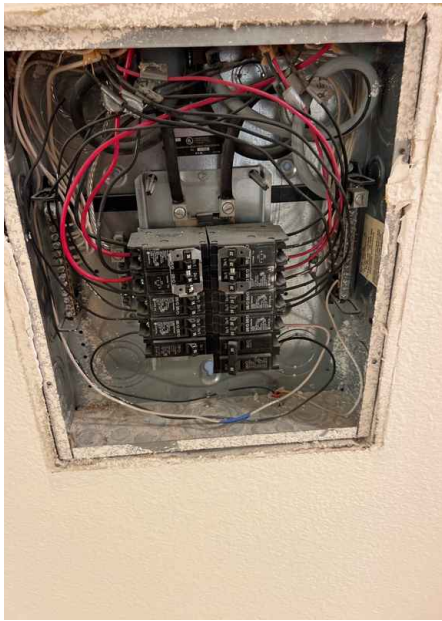
Master Bedroom

### PANELS: Sub-Panel - Location

Picture of Sub-panel.

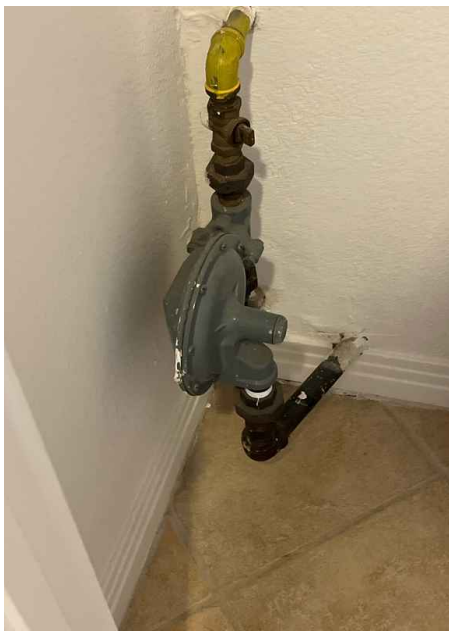
Closet

### MAIN GAS SHUT OFF VALVE: Gas Shut Off

The main gas shut off valve is located at the gas meter at the closet of the house.
