TRITON HOME INSPECTIONS

2987 Demeter Way  
San Diego, CA 92139

06/11/2026

Inspector

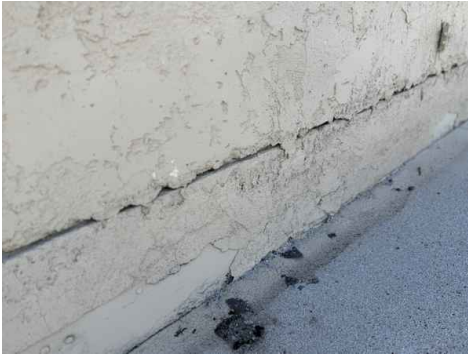
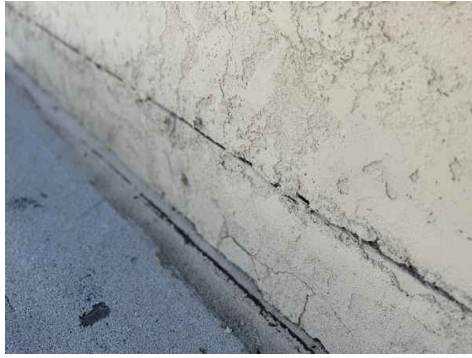
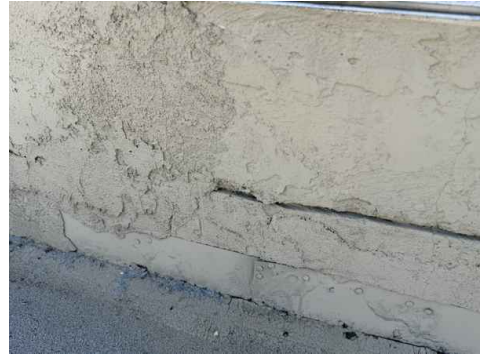
Moderate to major cracking was observed at one or more points on the exterior where an addition may have been built. This needs further evaluation by a licensed building contractor.

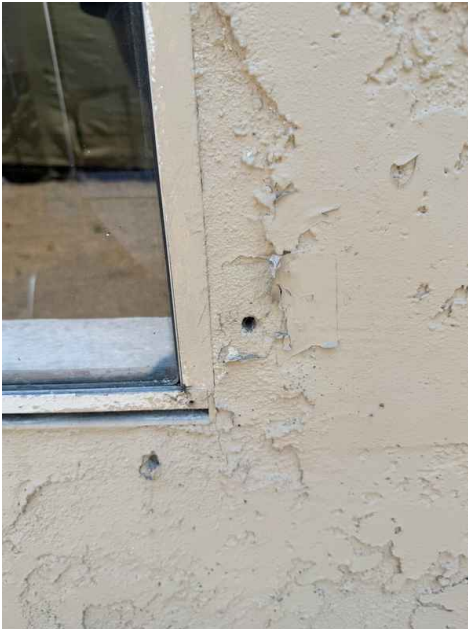
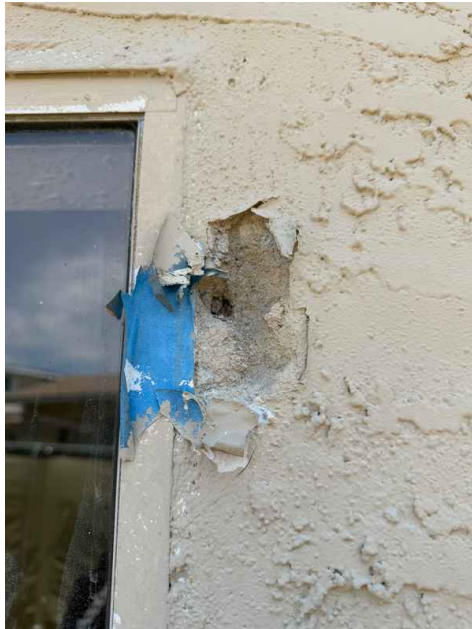
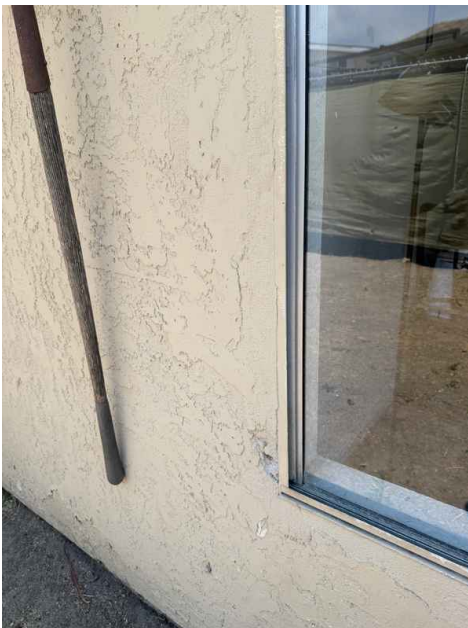
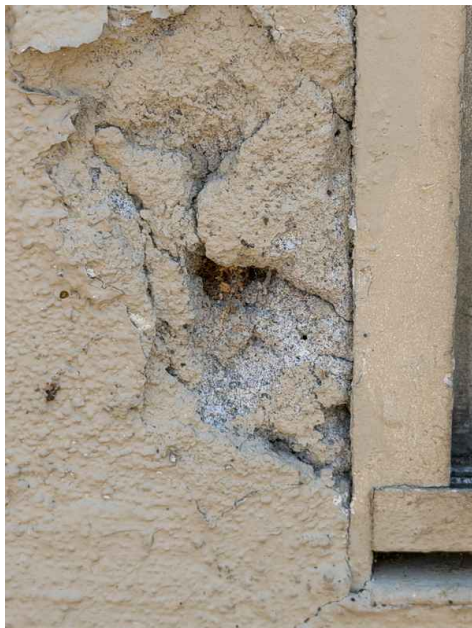
### 2.2.2 Siding, Flashing & Trim

#### **DAMAGE SIDING**

Contact a qualified professional.

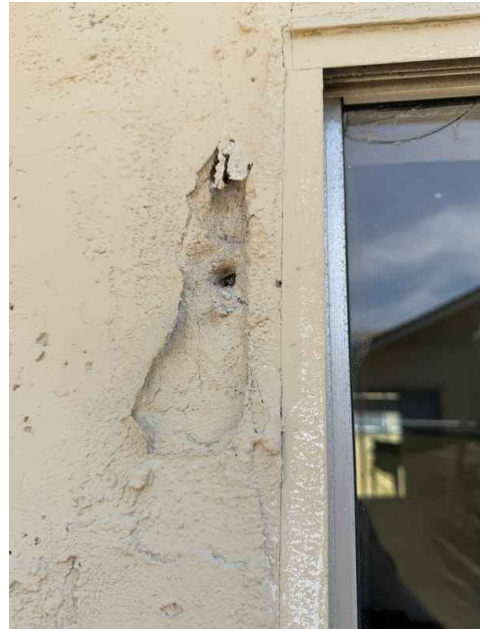
Stucco siding is damaged at several areas.

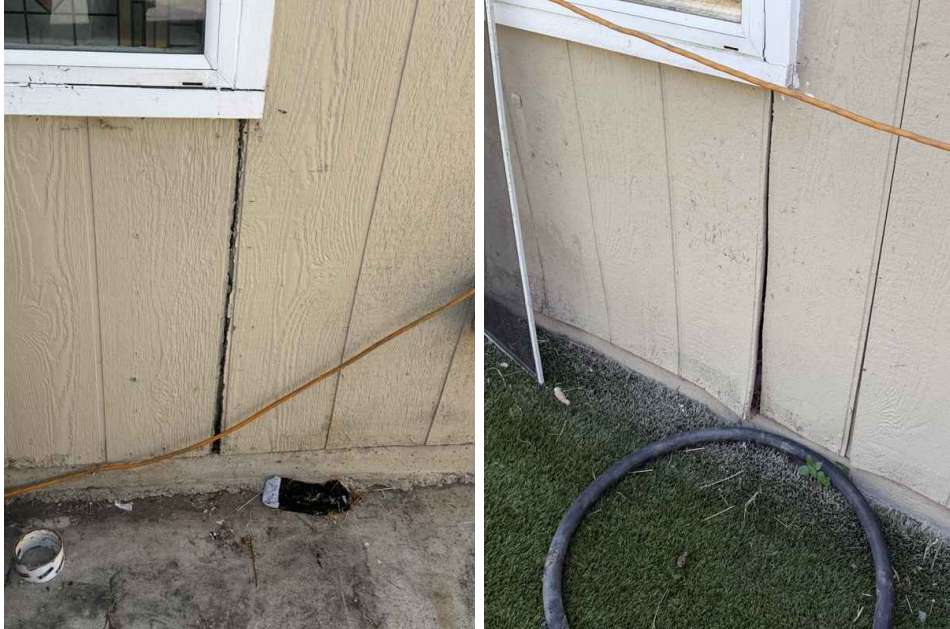
#### LOOSE SIDING BOARDS

Loose boards were observed in the siding during exterior inspection. Loose siding can allow water infiltration behind the boards, potentially causing rot, mold, or structural damage. The loose boards should be secured or replaced by a qualified siding contractor to restore the integrity of the exterior envelope.

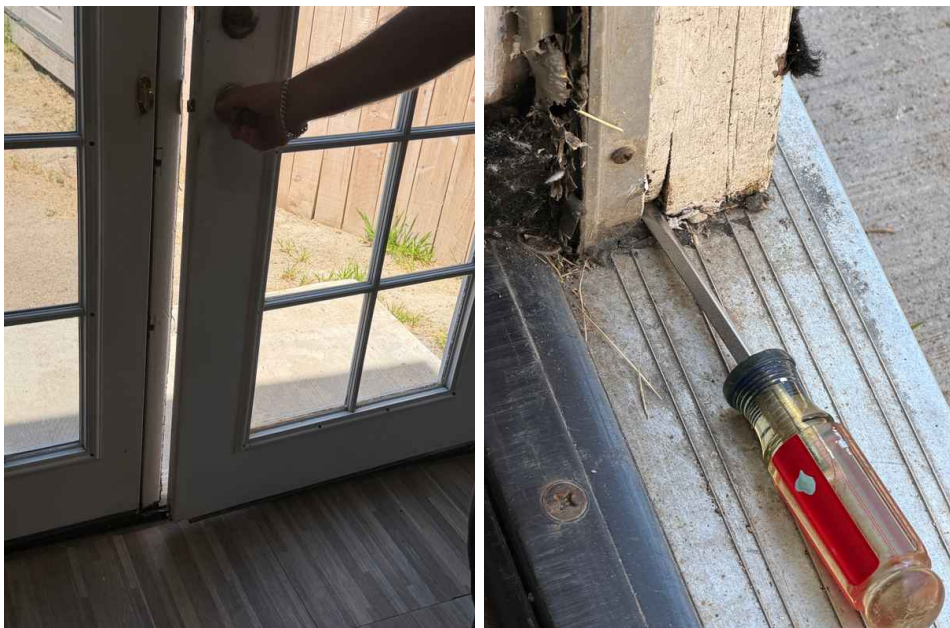
#### WOOD ROT

Back exterior door has wood rot at the bottom trim area.

Contact a qualified professional.

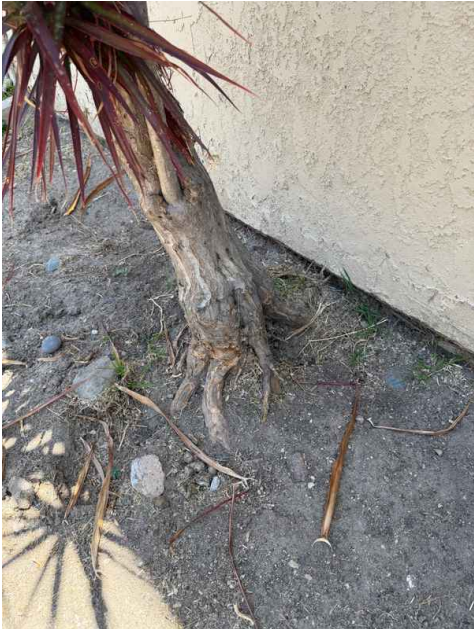
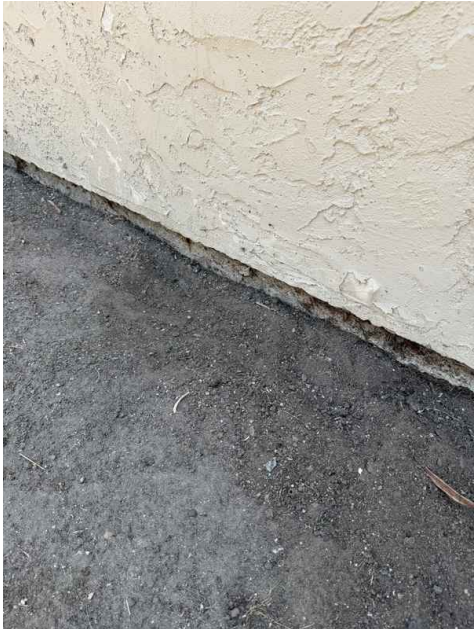
#### CORRODED WEEP SCREED

Corrosion was observed on the weep screed during the exterior inspection. Weep screeds are metal flashings installed at the base of exterior walls to direct water away from the foundation. Corrosion compromises the screed's ability to shed water effectively, potentially allowing moisture to penetrate behind the wall assembly and cause water damage, mold growth, or foundation issues and can allow for vermin entry into the home's wall cavity. A masonry or stucco contractor should evaluate the extent of corrosion and recommend repair or replacement of the affected sections.

Contact a qualified professional.

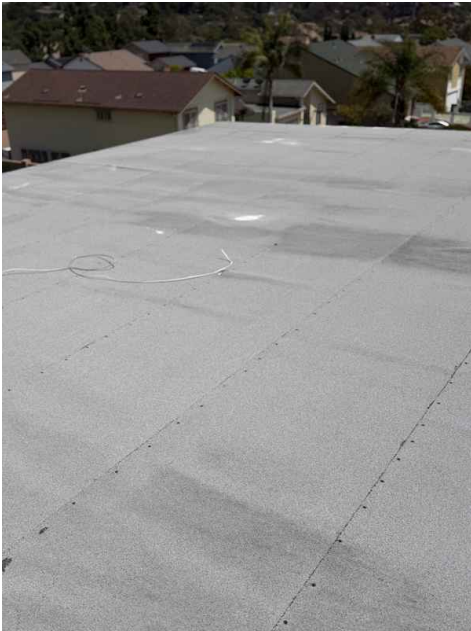
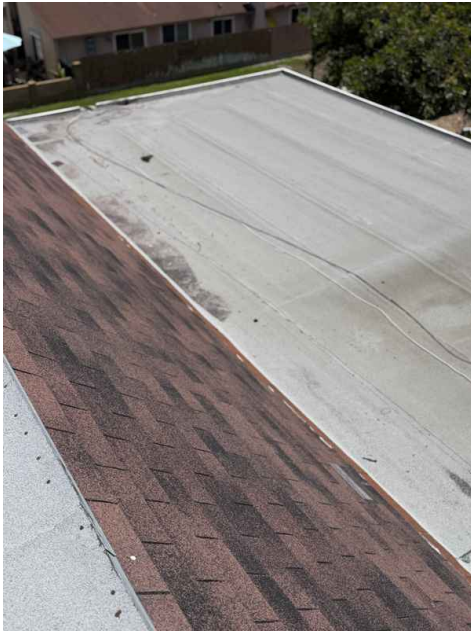
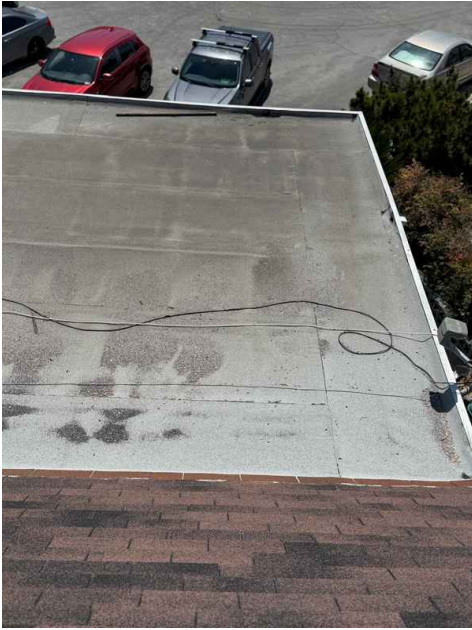
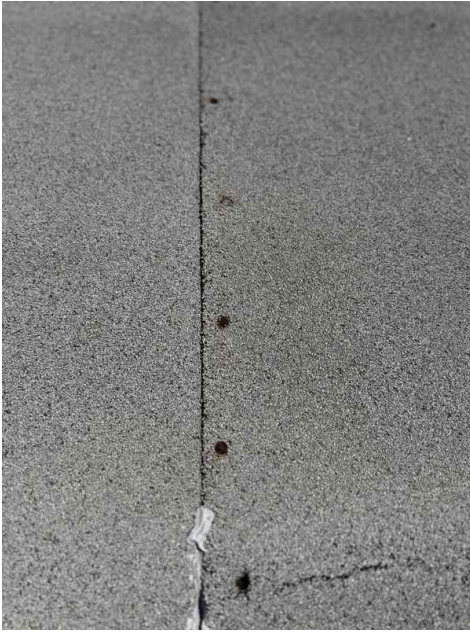
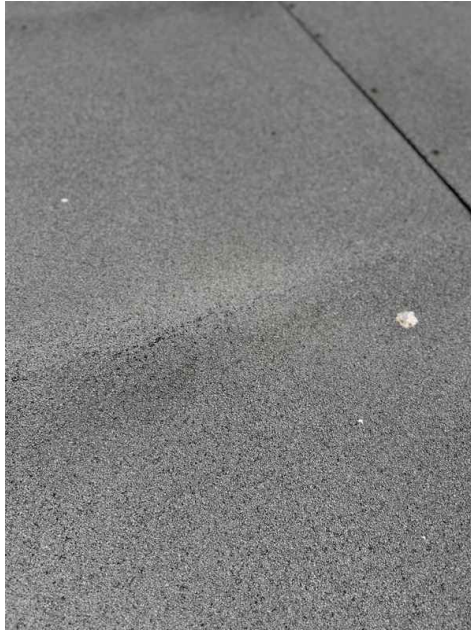
Blisters observed on the roof covering during inspection and many areas of exposed nail heads. These are bubbles or raised areas in the roofing material that indicate moisture has become trapped beneath the surface. Blisters can eventually rupture, allowing water infiltration and leading to leaks and interior water damage. A roofing professional should evaluate the extent of the blistering and recommend repair or replacement as needed.

Contact a qualified professional.

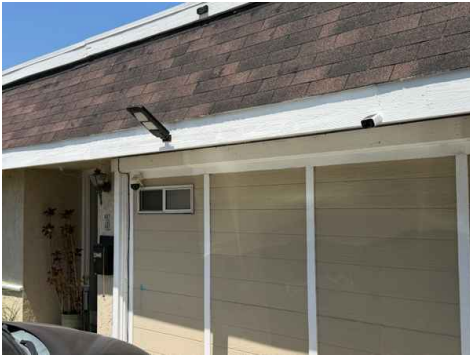
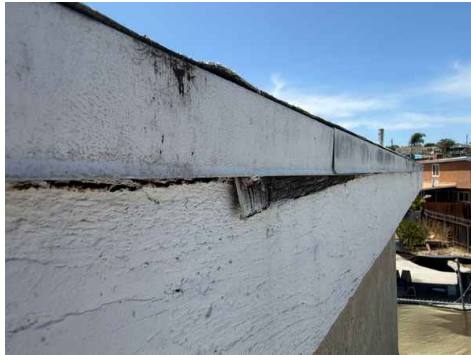
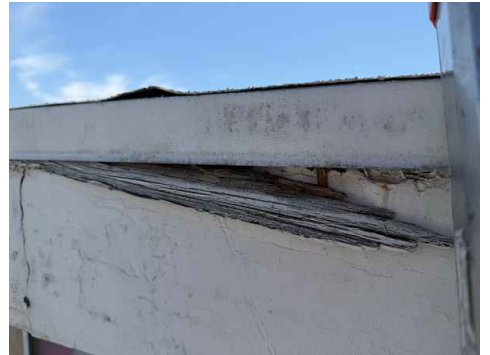
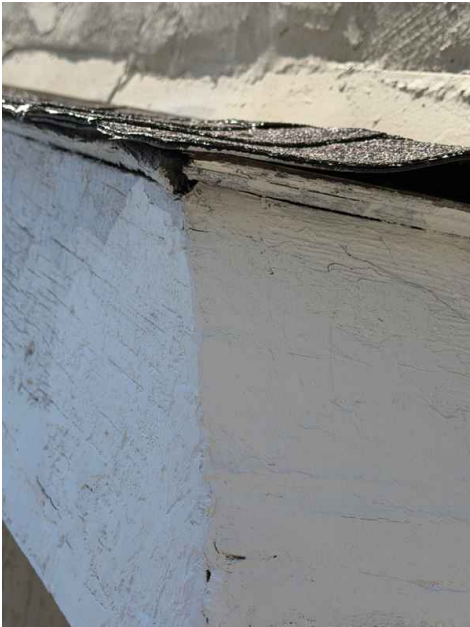
### 3.2.2 Coverings

Roof sheathing deterioration was observed during inspection. Deteriorated sheathing compromises the structural integrity of the roof system and can allow water infiltration into the attic and home interior. A qualified roofing professional should evaluate the extent of deterioration and recommend necessary repairs or replacement.

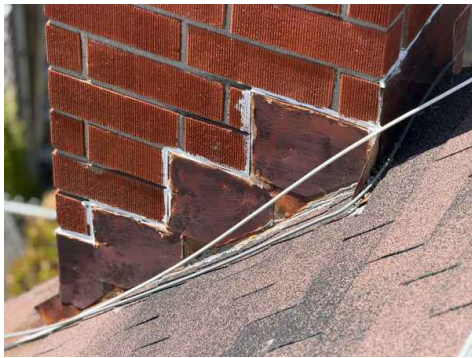
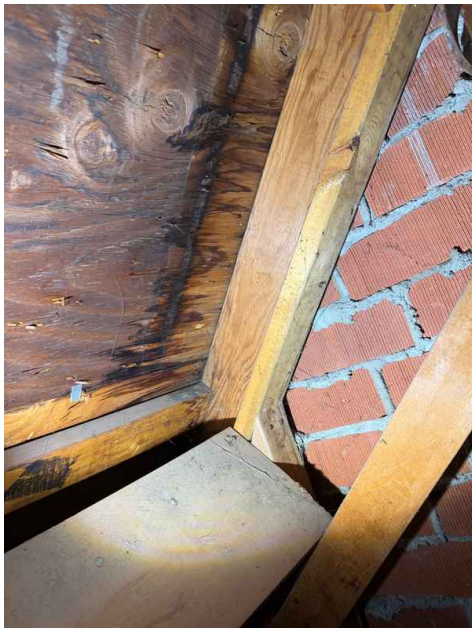
### 3.4.1 Flashings

#### **DETERIORATED CHIMNEY FLASHINGS**

Contact a qualified professional.

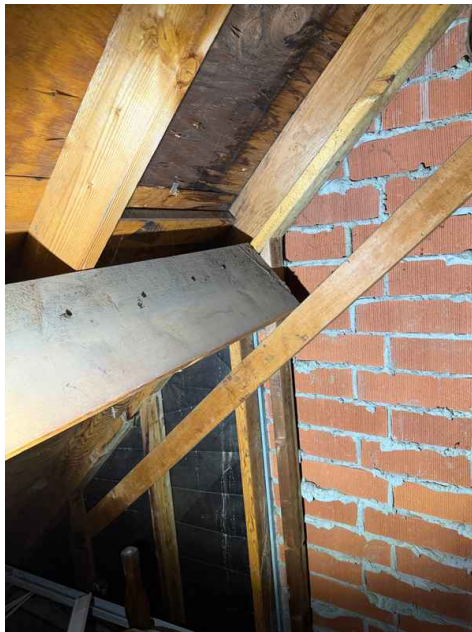
Chimney flashings showed signs of deterioration during roof inspection. Damaged or failing flashings allow water to penetrate the roof-to-chimney joint, potentially causing water intrusion into the attic and interior spaces. A qualified roofing professional should inspect and reseal or replace the flashings to prevent water damage and maintain roof integrity.

There is staining in the attic where the chimney is installed. The staining is on the roof's sheathing so there may be flashing issues with the chimney.

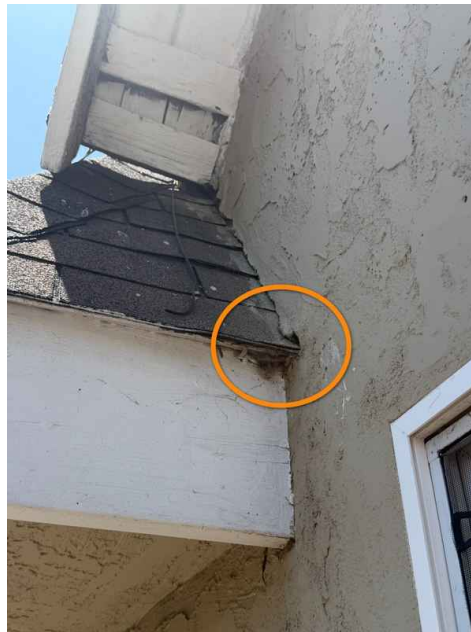
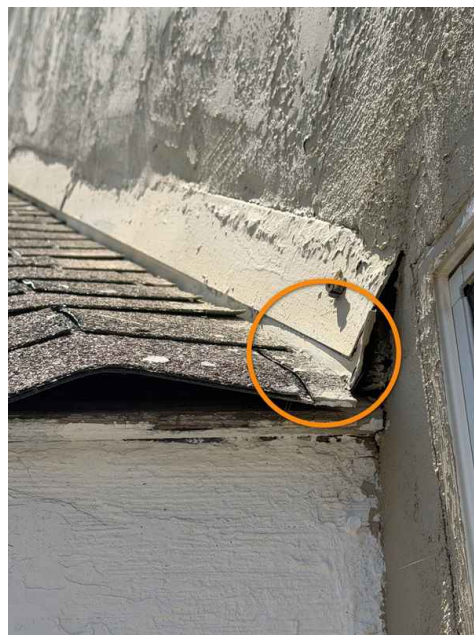
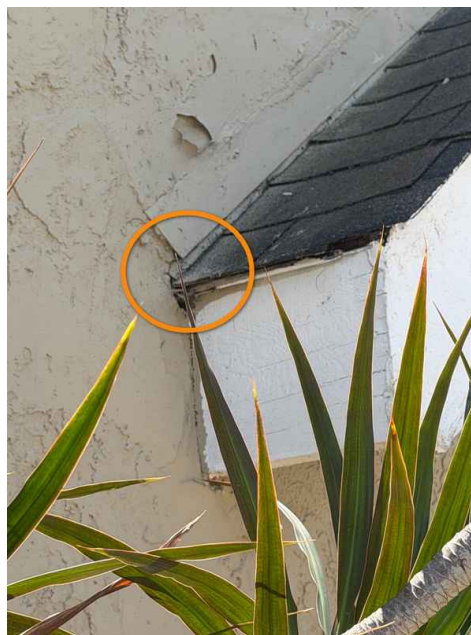
**KICKOUT FLASHINGS**

Kickout flashings, critical for preventing water intrusion, were not observed at critical roof-to-wall intersection points. This creates a potential pathway for water to penetrate behind exterior wall surfaces, which can lead to significant moisture damage, wood rot, and potential structural compromise. Proper installation of kickout flashings is essential to redirect water away from wall surfaces and prevent hidden moisture-related deterioration.

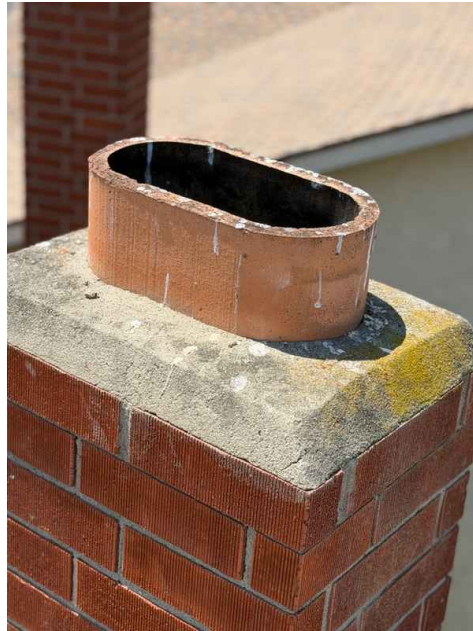
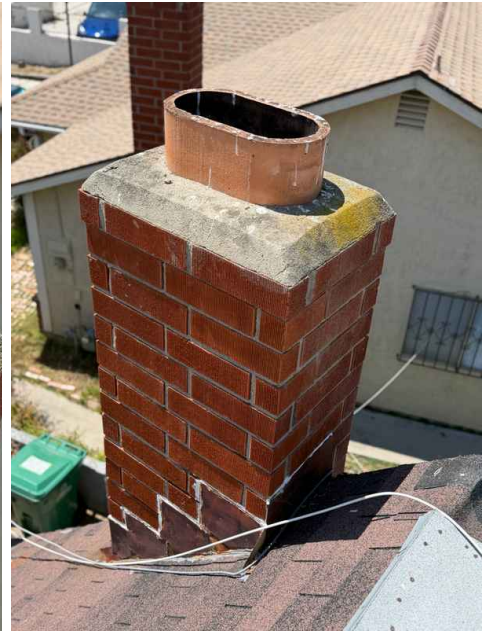
**CHIMNEY CAP MISSING**

### Missing a chimney cap/spark arrestor

Chimney caps prevent unwanted hazards from entering the chimney and keep sparks from escaping and causing roof fires. Without a cap, water, sleet, snow, and hail can enter your home and cause damage to your flue. Also, small animals or birds can enter the chimney and build nests that create a dangerous blockage.

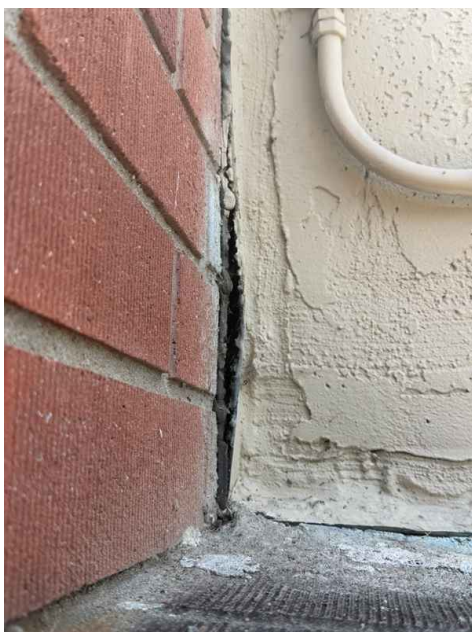
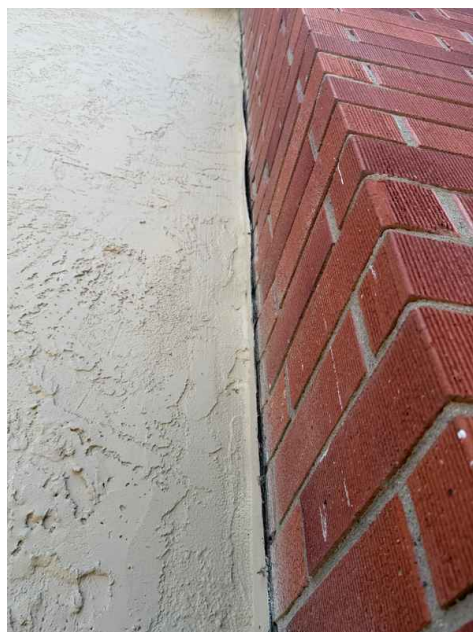
#### **DETERIORATED CAULKING AT ROOF PENETRATIONS**

Caulking around chimney was observed to be deteriorated, cracked, or missing during inspection. Compromised caulking allows water infiltration around these penetrations, creating potential for roof leaks and interior water damage. The affected caulking should be removed and replaced with appropriate roofing sealant by a qualified professional.

Contact a qualified professional.

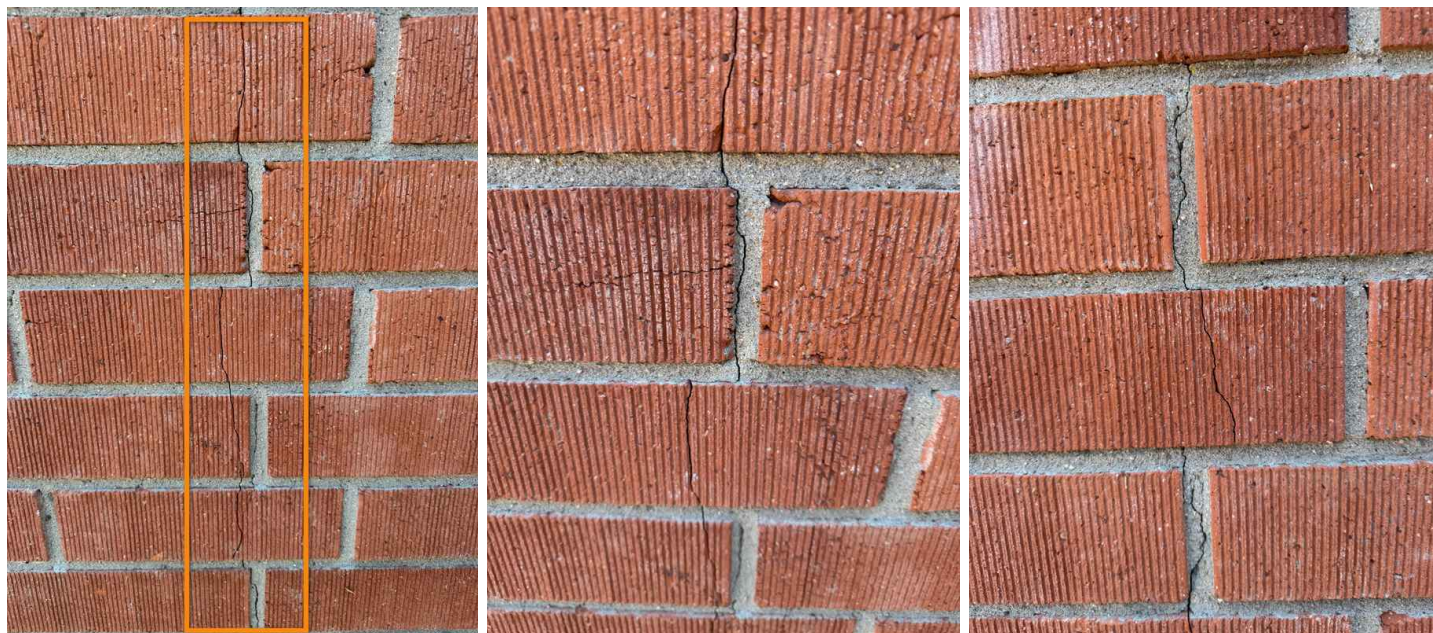
#### **CRACKED CHIMNEY**

Chimney crack discovered during roof inspection indicates potential structural compromise. This damage can allow moisture penetration and potentially lead to further deterioration of the chimney's masonry. Safety risks include potential water damage to interior walls and compromised structural integrity. Recommend professional chimney inspection and repair by a qualified masonry contractor to prevent progressive damage.

Contact a qualified professional.

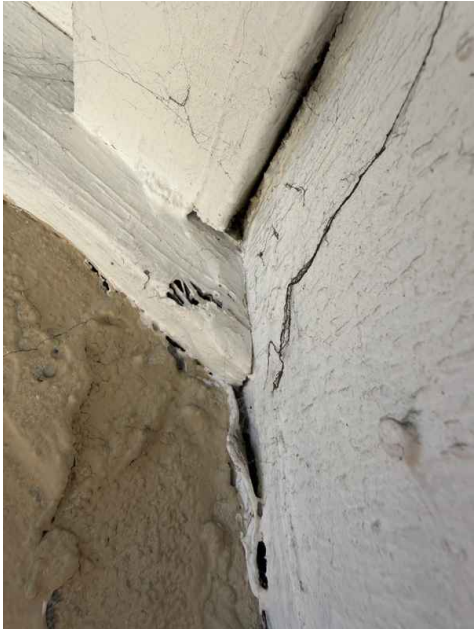
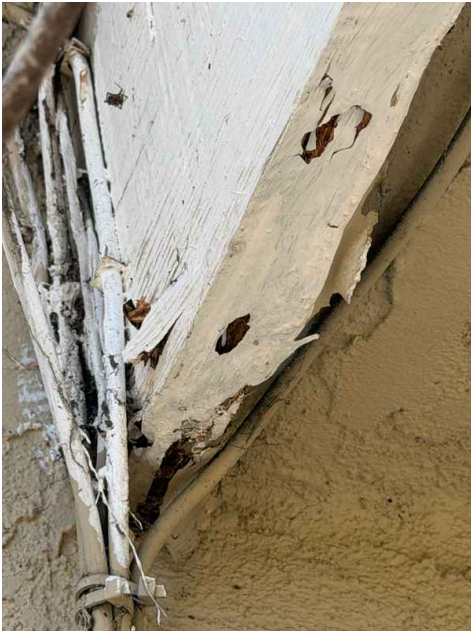
#### **WOOD ROT IN EAVES, SOFFITS, AND FASCIA**

Contact a qualified professional.

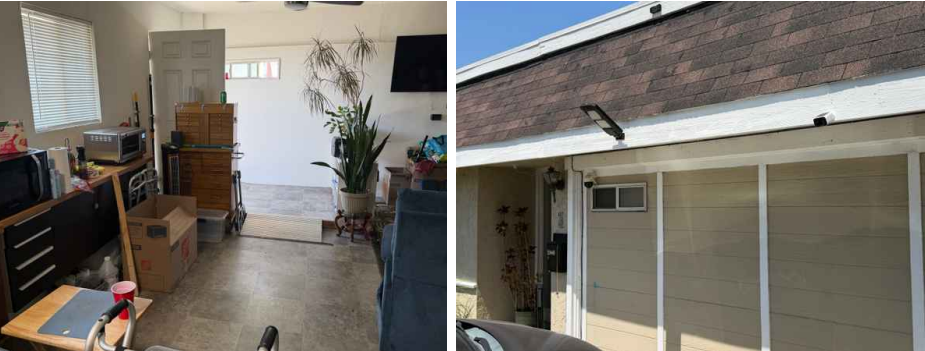
No garage at property. It has been converted into livable space. Recommend to see if permits were applied to this converted garage.

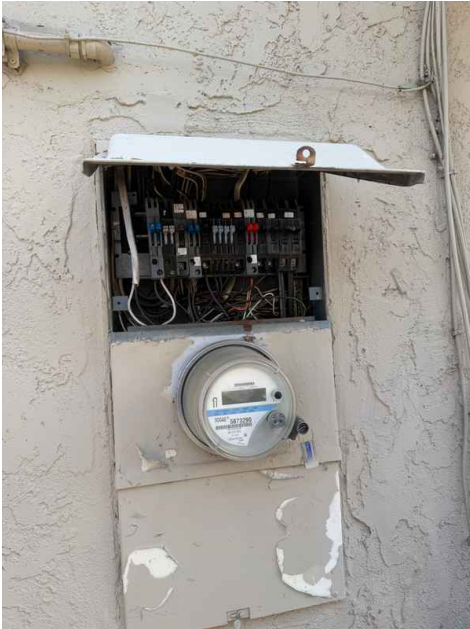
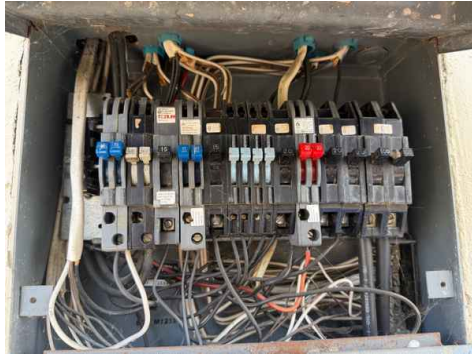
### 6.3.2 Main & Subpanels, Service & Grounding, Main Overcurrent Device

#### **MISSING DEAD FACE COVER**

**Safety Hazard**

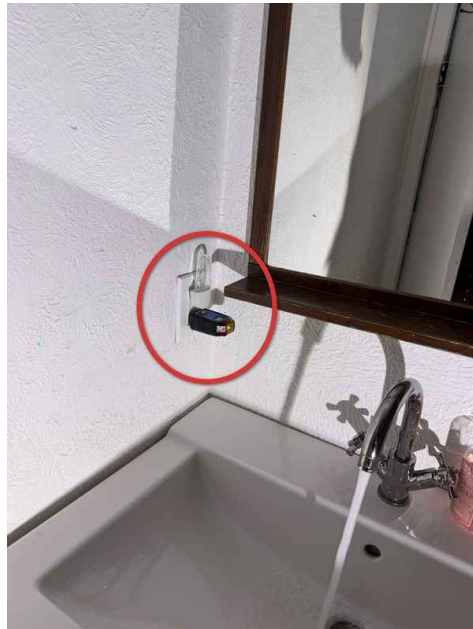
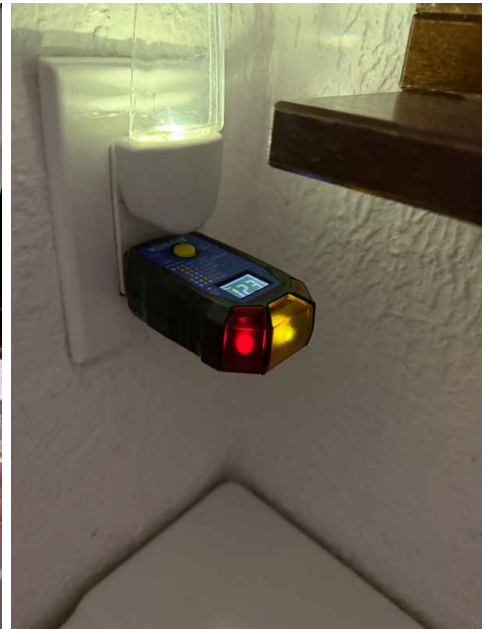
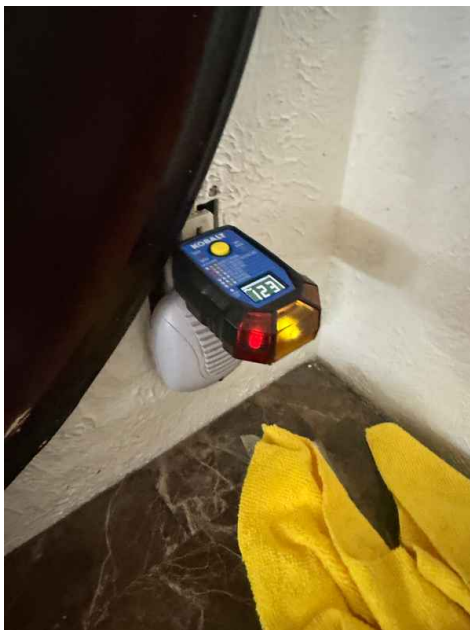
## 6.5.3 Lighting Fixtures, Switches &amp; Receptacles

2 bathroom receptacles have been wired with reverse polarity. This can create a shock hazard. Recommend licensed electrician evaluate & repair.

**Reversed polarity**

Contact a qualified electrical contractor.

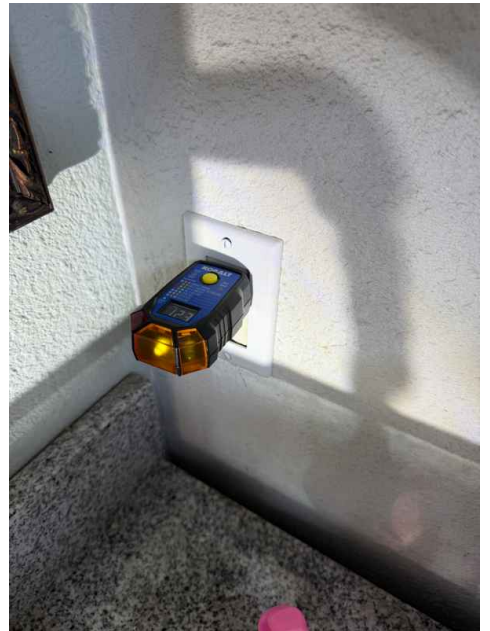
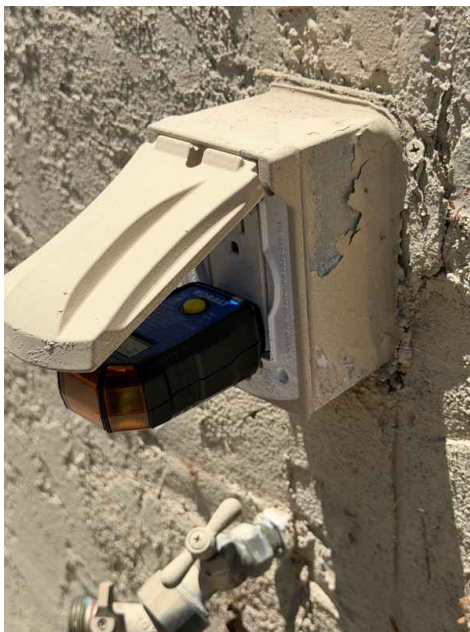
#### 6.5.4 Lighting Fixtures, Switches & Receptacles

##### **UNGROUNDED RECEPTACLE**

Ungrounded electrical receptacles pose a significant electrical safety risk. During the inspection, receptacles without a proper ground connection were discovered. This creates potential shock and fire hazards as devices lack a safe path to dissipate excess electrical current. A licensed electrician should evaluate and upgrade receptacles to modern grounded three-prong configurations to ensure electrical safety.

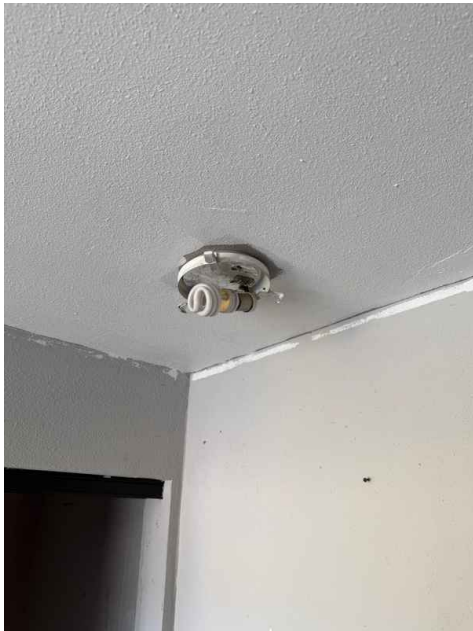
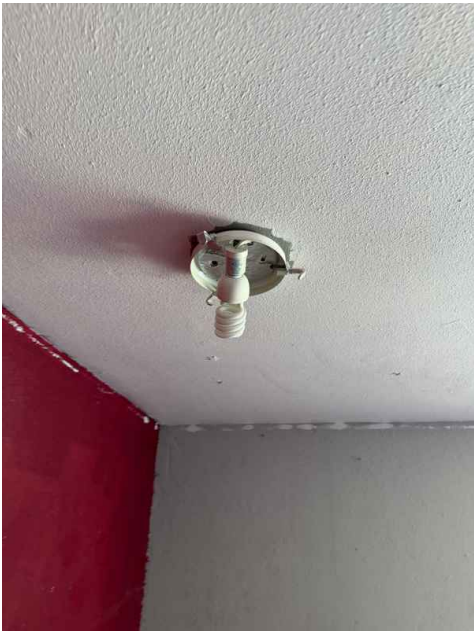
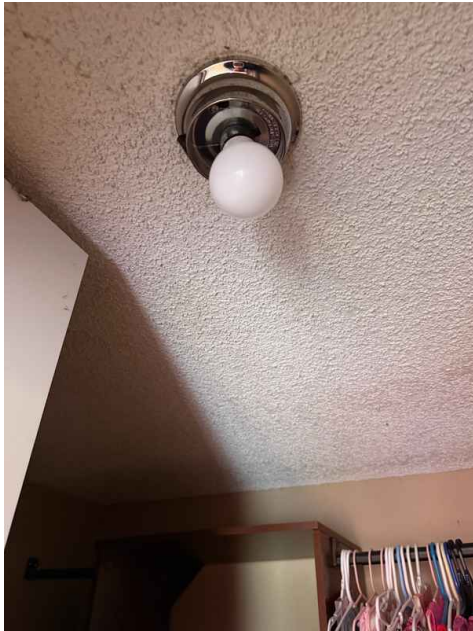
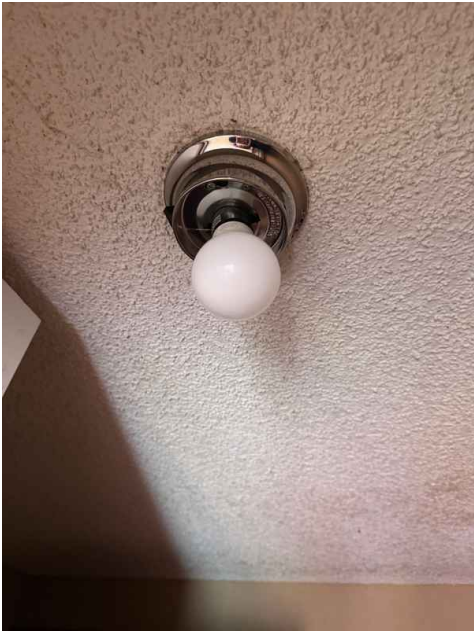
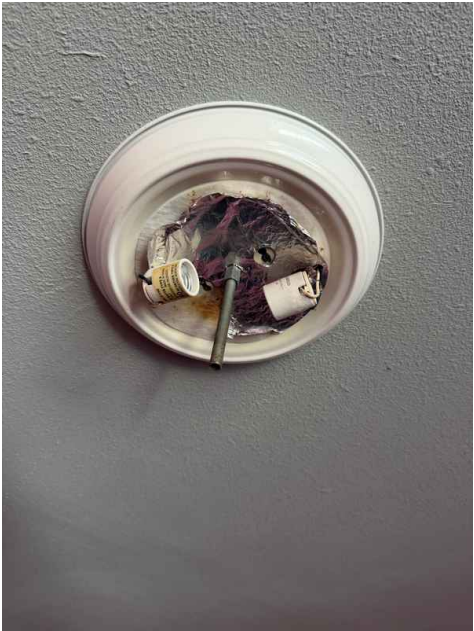
##### **GLOBE COVER MISSING**

A globe or cover for lighting fixtures are missing or damaged. Recommend replacing as necessary to avoid exposed bulbs.

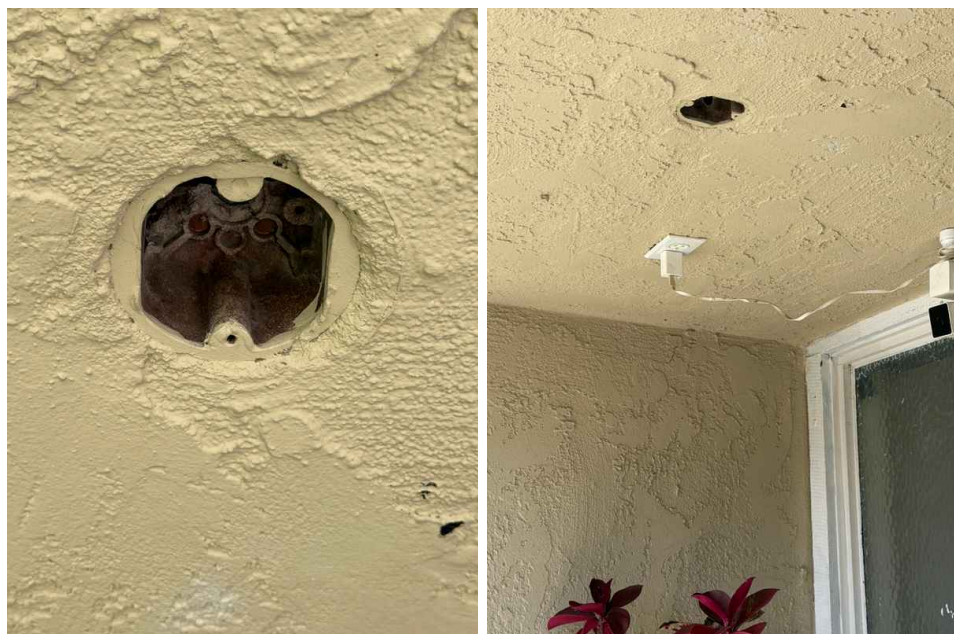
## 6.5.6 Lighting Fixtures, Switches &amp; Receptacles

**MISSING LIGHTING FIXTURE**

A lighting fixture is absent from its outlet box in the electrical system. This creates an open electrical outlet that poses a shock hazard and allows potential pest entry. The missing fixture should be replaced with an appropriate light fixture or the outlet box should be properly covered with a blank cover plate.

Contact a qualified professional.

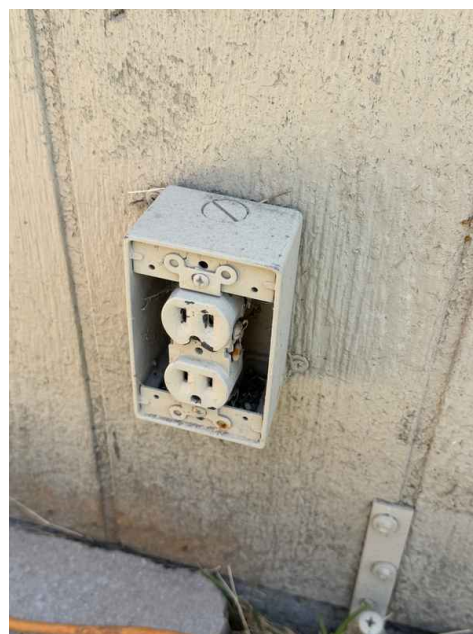
## 6.5.7 Lighting Fixtures, Switches &amp; Receptacles

**NO POWER TO LIGHTING FIXTURES**

This exterior outlet is not receiving electrical power. This was discovered during testing of the electrical system. A loss of power indicates a tripped breaker, blown fuse, or wiring issue that prevents safe operation of these outlets and fixtures. Contact a qualified electrician to identify the cause, reset any tripped breakers, and verify proper circuit function.

Contact a qualified professional.

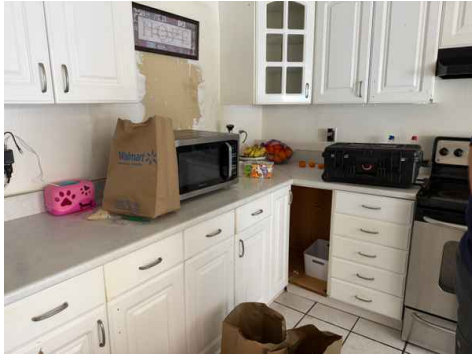
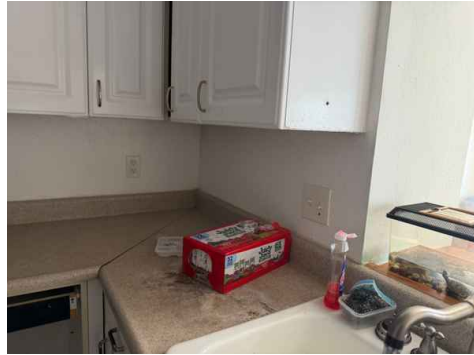
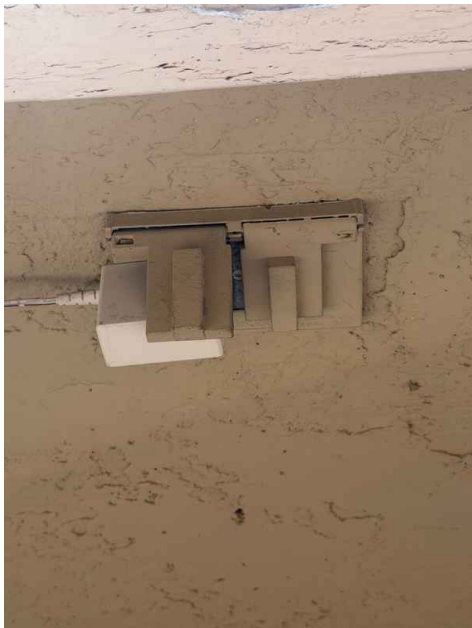
## 6.6.1 GFCI &amp; AFCI

**NO GFCI PROTECTION INSTALLED**

Kitchen, bathrooms and the exterior are missing GFCI outlets.

Ground Fault Circuit Interrupter (GFCI) protection is a critical electrical safety feature designed to prevent electrical shock in areas with water exposure. During the inspection, locations were identified without proper GFCI protection. This creates a significant electrical hazard, potentially exposing occupants to dangerous shock risks in wet environments like kitchens, bathrooms, and exterior outlets. Recommend hiring a licensed electrician to install GFCI outlets or circuit breakers in all required areas to ensure electrical safety.

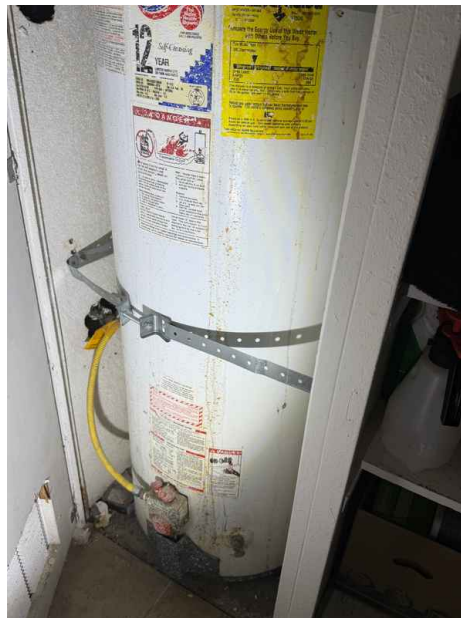
#### Hot Water Systems, Controls, Flues & Vents: Location

Interior Closet

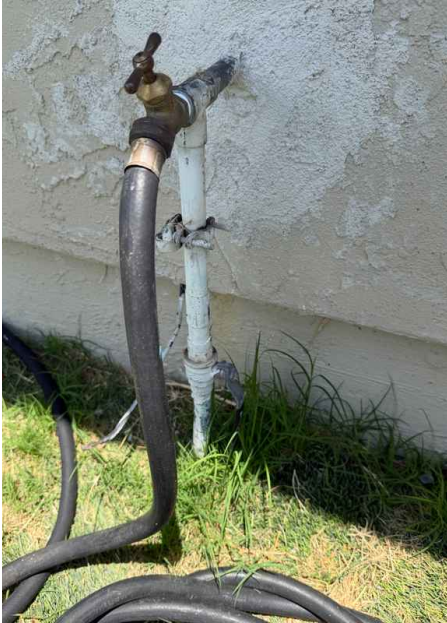
## Main Water Shut-off Device: Location

### Front

This is where you go if you have an emergency water shutoff situation or are going out of town and want to shut the water off. This is always a good idea to do when leaving town for an extended period of time.

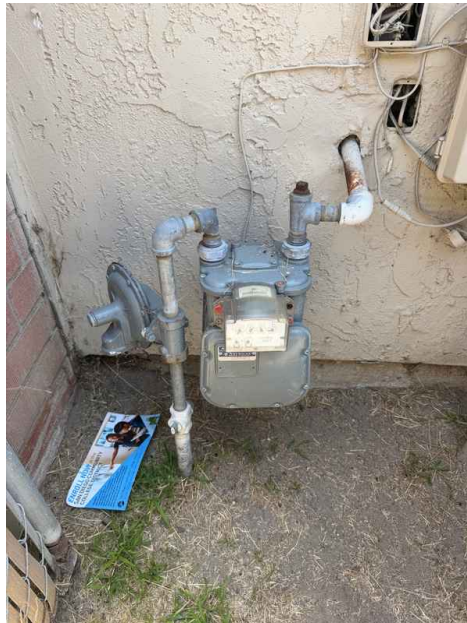
## Fuel Storage & Distribution Systems: Main Gas Shut-off Location

### Gas Meter

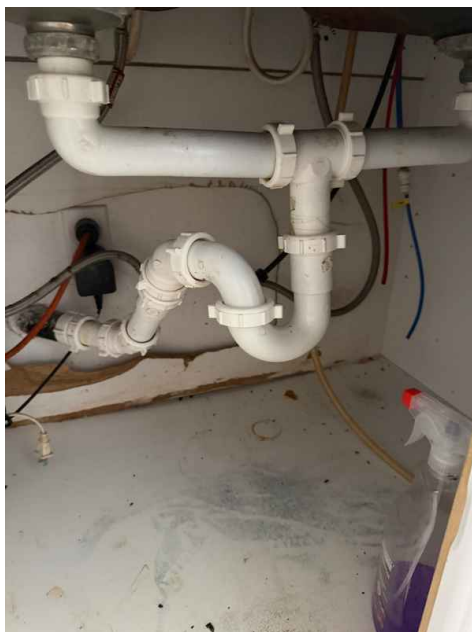
#### S-Trap vs. P-Trap

The drain pipe used an S-trap rather than a P-trap, or no P-trap was visible. Siphons and sudden flows of water in S-Traps can drain all the water out of the trap, leaving it dry. Sewer gases can then enter living areas. Recommend that a qualified plumber repair per standard building practices.

Contact a qualified professional.

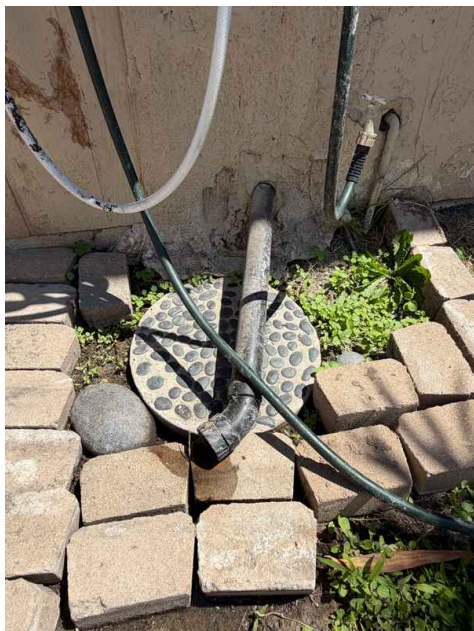
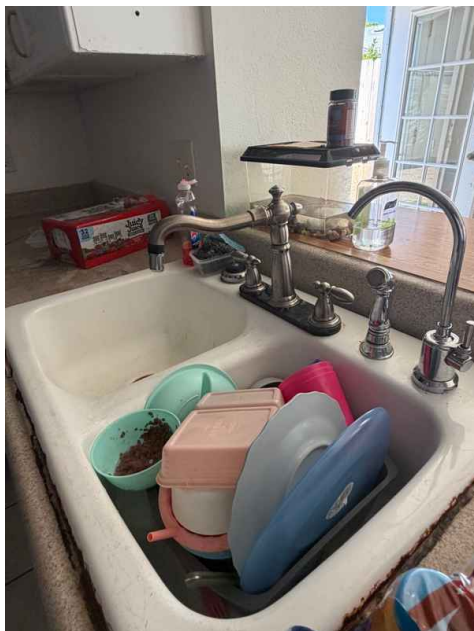
Gray water from the kitchen sink discharges out into the back yard.

You cannot legally discharge kitchen sink gray water directly onto your yard or into the open ground. Because kitchen wastewater contains fats, oils, and food particles, state and local plumbing codes classify it as "black water," requiring it to be connected to the city sewer or an approved septic system

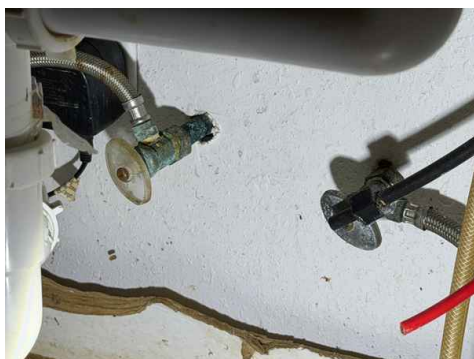
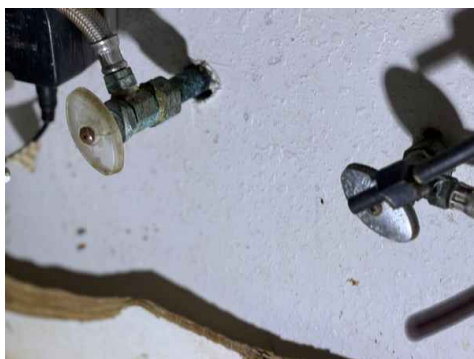
##### **CORRODED WATER SUPPLY VALVES**

Corrosion was observed at the water supply valves under the kitchen sink during inspection. Corroded valves can restrict water flow, develop leaks, and eventually fail to shut off properly. A plumbing contractor should evaluate the extent of corrosion and replace affected valves to ensure reliable water shutoff capability and prevent future water damage.

Contact a qualified professional.

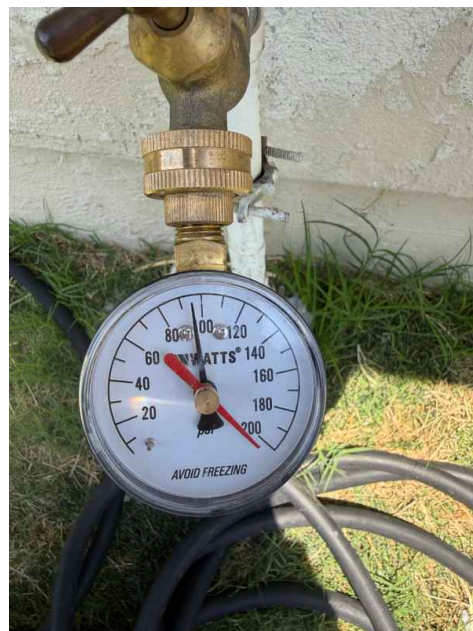
95psi

##### **HIGH WATER PRESSURE**

Water pressure was higher than the max of 80psi. 40-80psi is the recommended pressure for water supply to a home.

Water pressure should be adjusted prior to close of escrow. Adjusting the water pressure requires the pressure regulator to be adjusted. The pressure regulator was not and is not operated by the home inspector during a home inspection. The pressure regulator performance and internal condition is excluded from this inspection report.

Contact a qualified professional.

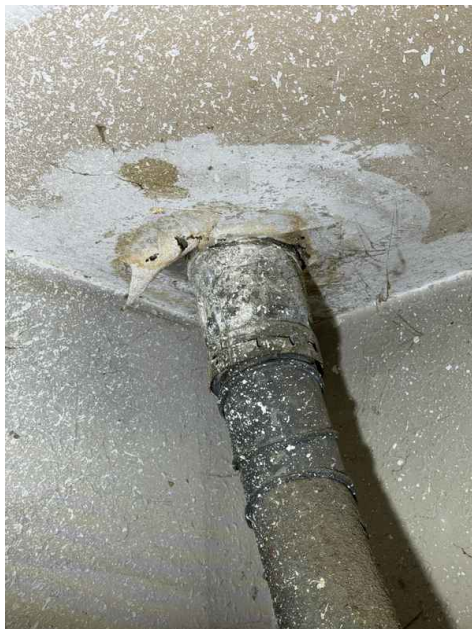
Water heater's section of B-vent flue pipe is too close to combustible materials and/or insulation. This type of vent requires a minimum of 1 inch clearance to such materials. This is a fire hazard. Recommend that a qualified person repair as necessary. For example, by moving insulation, moving the flue pipe, installing a shield or making modifications to surrounding structures.

Contact a qualified professional.

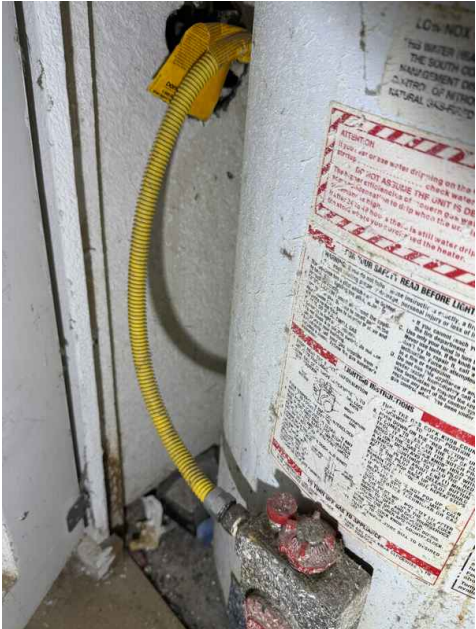
Gas water heater is not equipped with a sediment trap drip leg. Current standards require a drip leg at the gas connection. Seek licensed plumbing contractor for repairs.

Contact a qualified professional.

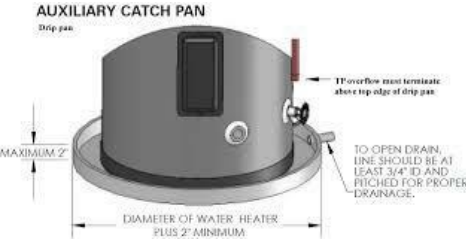
7.5.5 Hot Water Systems, Controls, Flues & Vents

NO DRIP PAN

Water heater installations require a drip pan to capture potential leaks and prevent water damage. During the inspection, no drip pan was discovered beneath the water heater, which creates a risk of undetected water leakage and potential structural damage to surrounding floors and walls. A professional plumber should install a properly sized, code-compliant drip pan with an appropriate drain line to mitigate potential water damage risks.

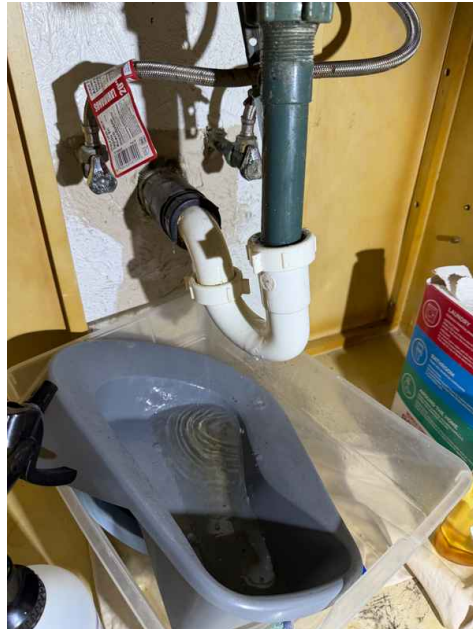
7.7.1 Sinks

LEAKING SINK

A leak was observed at the sink during inspection. Leaks can lead to water damage, mold growth, and structural deterioration if left unaddressed. A plumbing contractor should inspect and repair the leak source to prevent further water damage and potential health hazards.

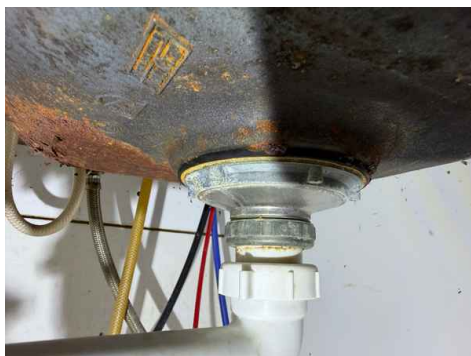
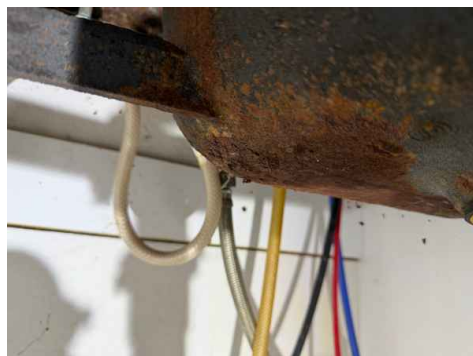
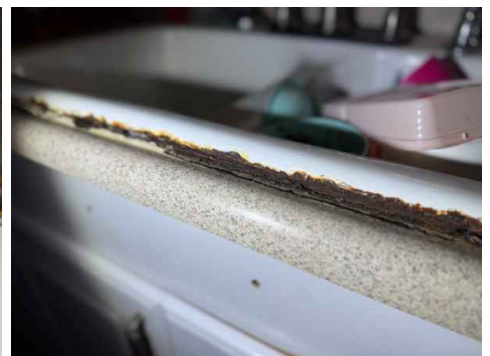
### 7.7.2 Sinks

#### **CORROSION**

Kitchen sink has significant corrosion underneath at the base and around the exterior trim.
