TRITON HOME INSPECTIONS

2987 Demeter Way  
San Diego, CA 92139

06/11/2026

Inspector

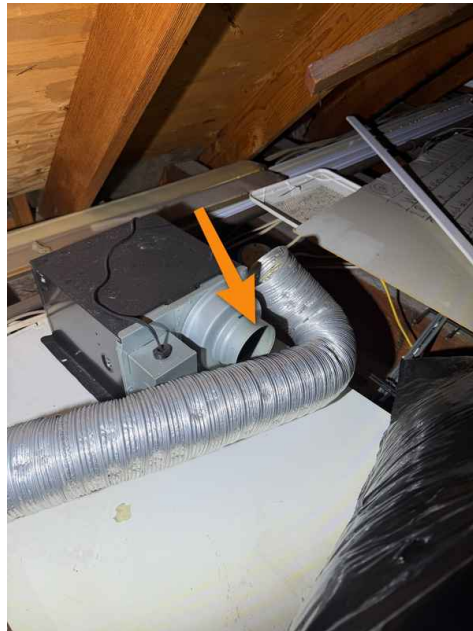
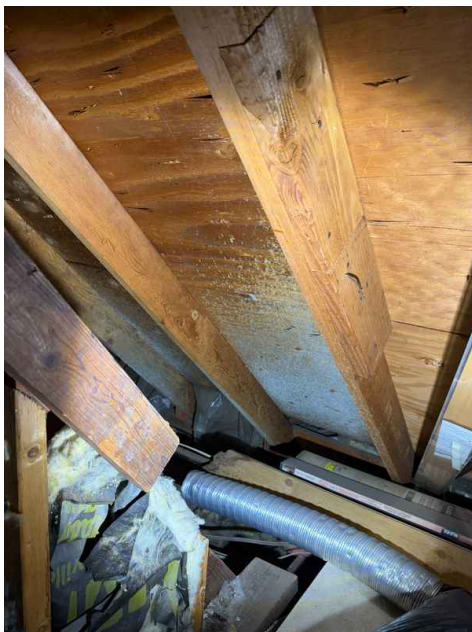
Bathroom vent fan is venting into the attic space. This can result in increased moisture levels inside the structure and is a conducive condition for wood-destroying organisms. Recommend that a qualified person make permanent repairs as necessary.

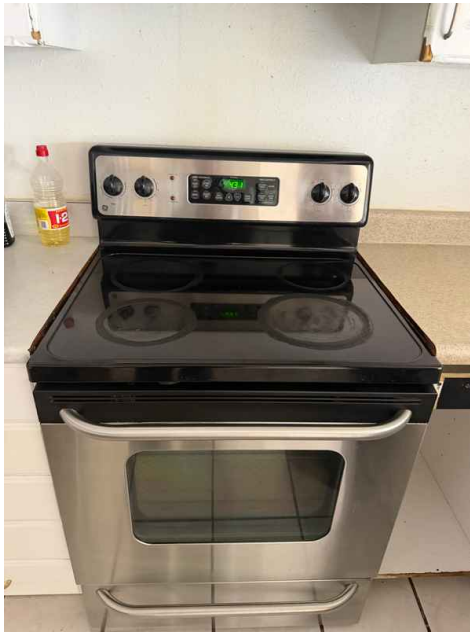
An anti-tip bracket is a safety device designed to prevent freestanding ranges (stoves) from tipping forward, especially when the oven door is open and bearing weight. These brackets are crucial for preventing accidents, particularly in households with children.

Recommend installing an anti tip bracket to prevent any type of tipping of the range.

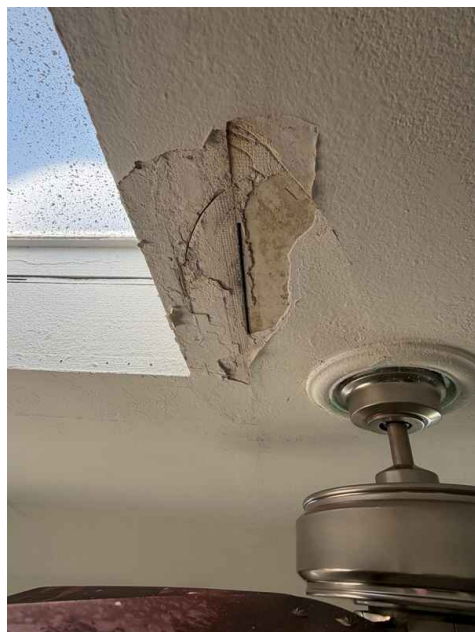
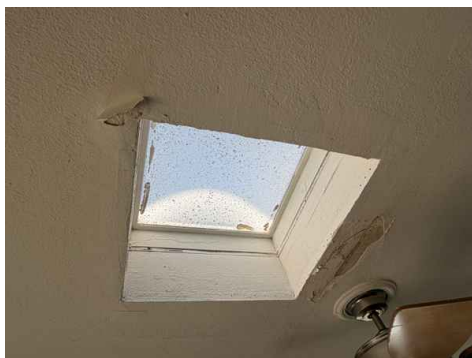
#### MOISTURE DAMAGE

Moisture damage around the skylight indicating possible issues with the skylight's flashings at the roof where there could be leakage. This needs further evaluation by a professional roofer.

Contact a qualified professional.

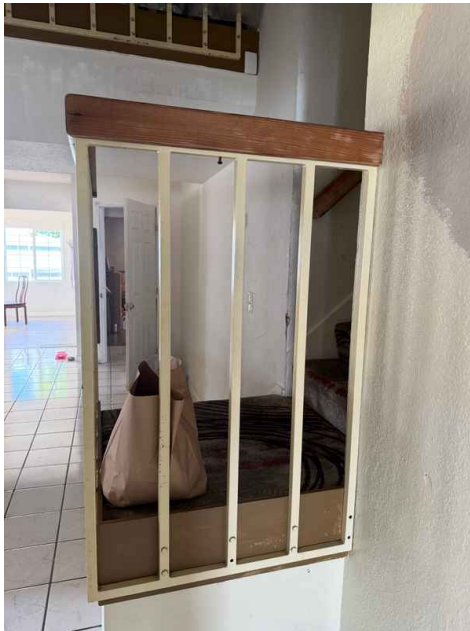
#### BALUSTER SPACES TOO WIDE

The baluster space is not up to modern safety standards. The space between balusters should not allow passage of a 4 3/8-inch sphere for child safety. Recommend a qualified handyman or original installer repair and bring up to code.

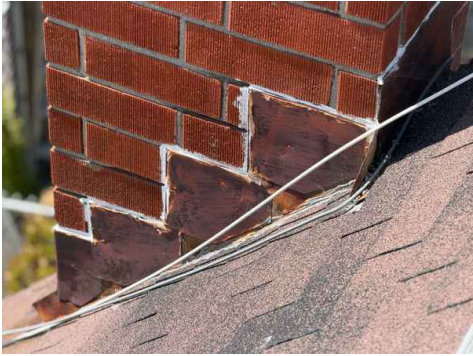
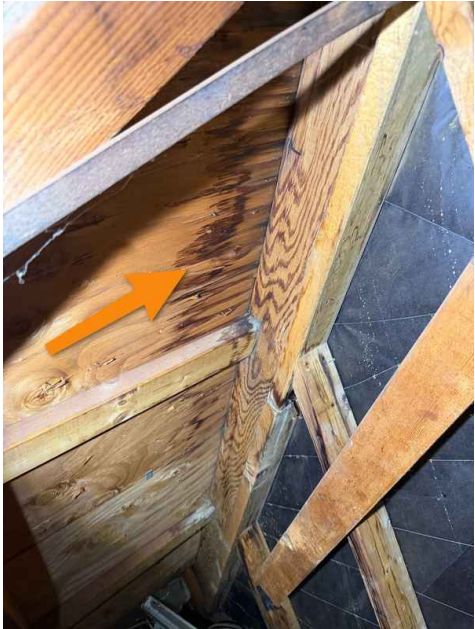
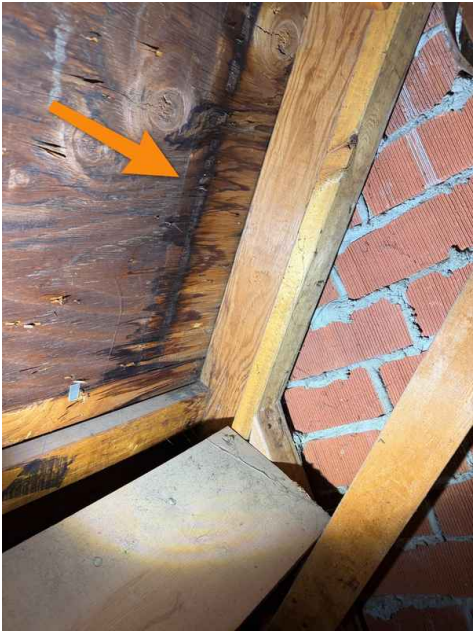
#### DETERIORATED CHIMNEY FLASHINGS 2

Chimney flashings showed signs of deterioration during roof inspection. Damaged or failing flashings allow water to penetrate the roof-to-chimney joint, potentially causing water intrusion into the attic and interior spaces. A qualified roofing professional should inspect and reseal or replace the flashings to prevent water damage and maintain roof integrity.

There is staining in the attic where the chimney is installed. The staining is on the roof's sheathing so there may be flashing issues with the chimney.

Contact a qualified professional.
