PROPERTY INSPECTION **REPORT**

310 E San Jose Rd, Palm Springs, 92264 CA

DATE OF INSPECTION: 1/31/2023

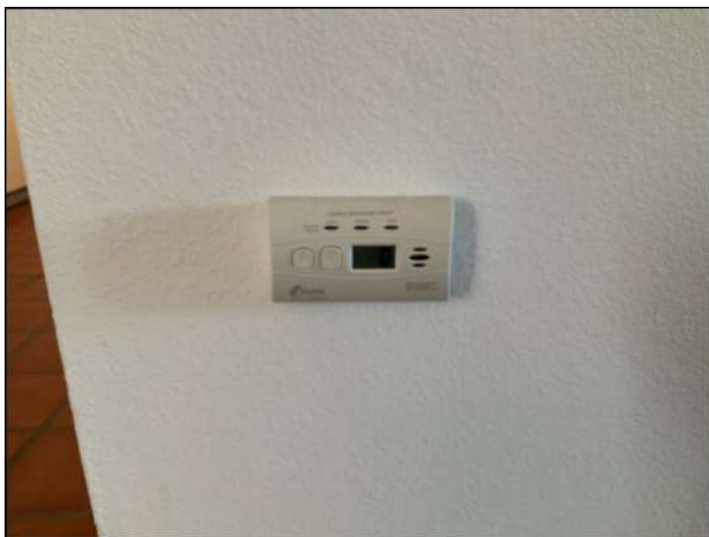
Carbon monoxide detector

Smoke detector. Location: outside Bedroom

Recommend qualified technician install missing smoke detector prior to close. Location: outside Bedroom 2

Page 5 Item: 1	Smoke Detectors	• Recommend qualified technician install missing smoke detector prior to close. Location: outside Bedroom 2
Living Room

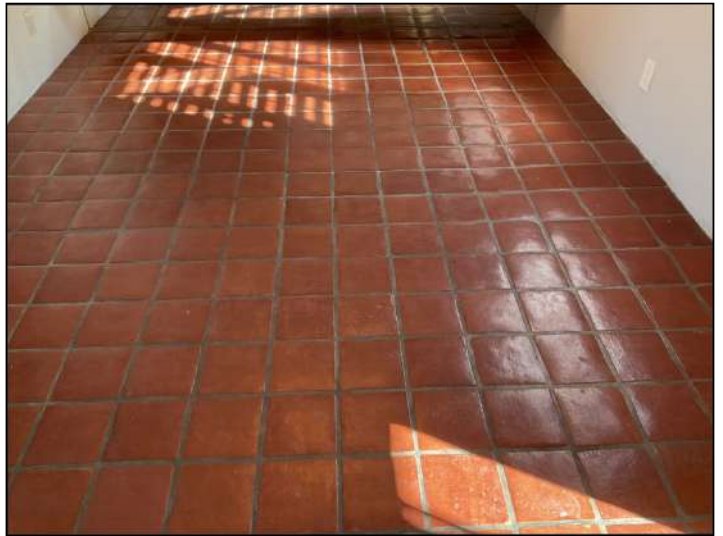
Visible scuffs noted

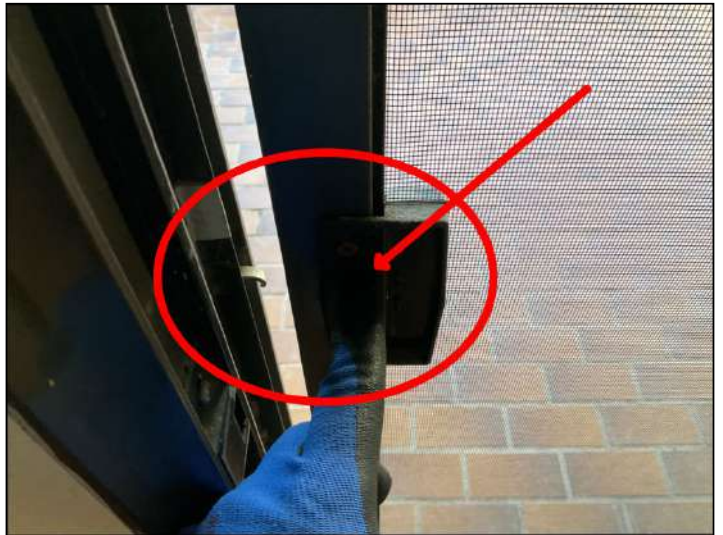
Missing screen door locking mechanism.
Recommend licensed technician Repair/Replace.

Page 21 Item: 8	Doors	• Missing screen door locking mechanism. Recommend licensed technician Repair/Replace.
Bathroom

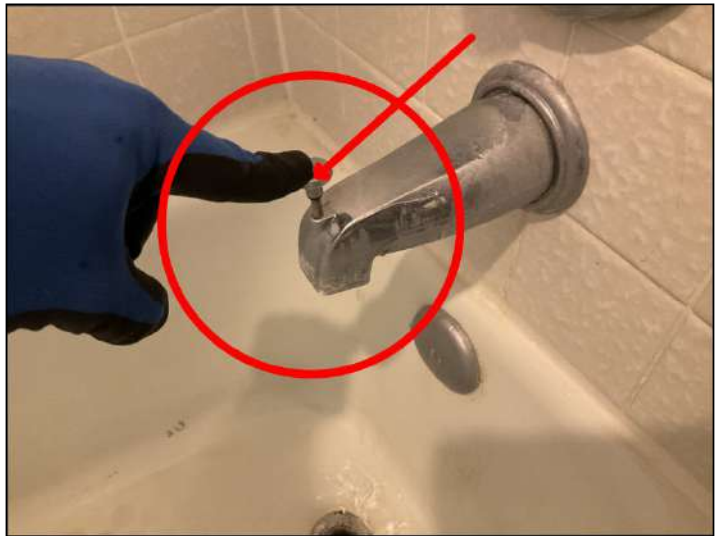
Recommend licensed plumber Repair/Replace diverter. Diverter was stuck in the shower mode. The inspector could not press it down when tested.

Page 28 Item: 12	Bath Tubs	• Recommend licensed plumber Repair/Replace diverter. Diverter was stuck in the shower mode. The inspector could not press it down when tested.

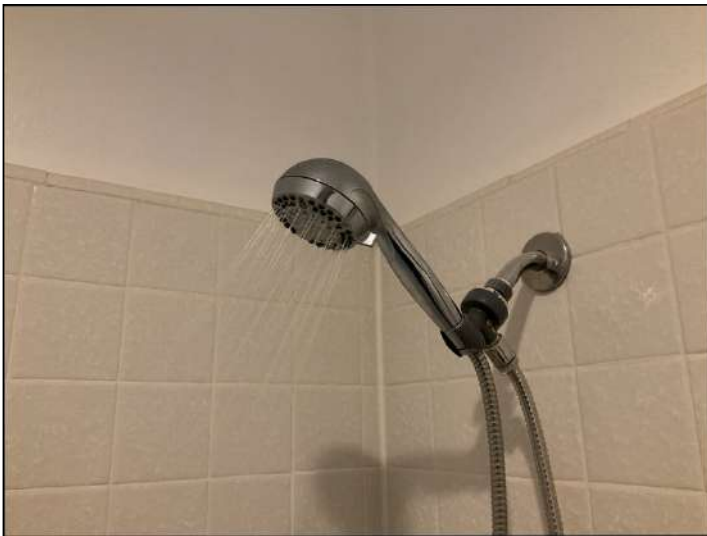
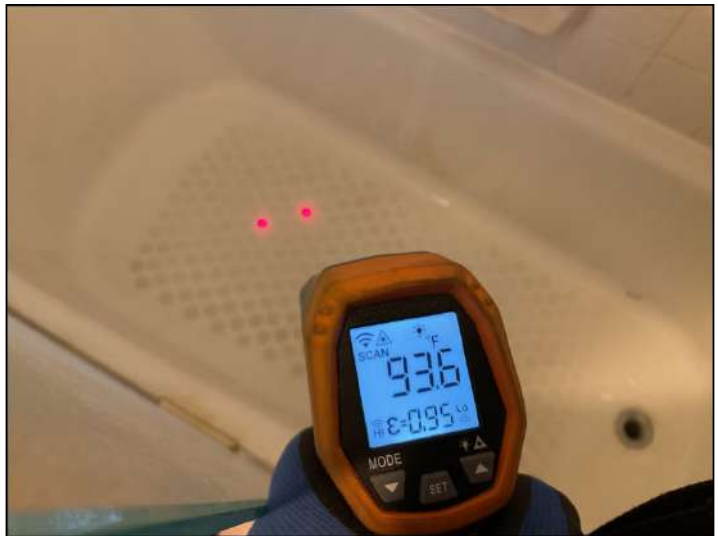
Recommend licensed plumber Repair/Replace leaking shower head/hardware.

Page 29 Item: 14	Showers	• Recommend licensed plumber Repair/Replace leaking shower head/hardware.
Kitchen

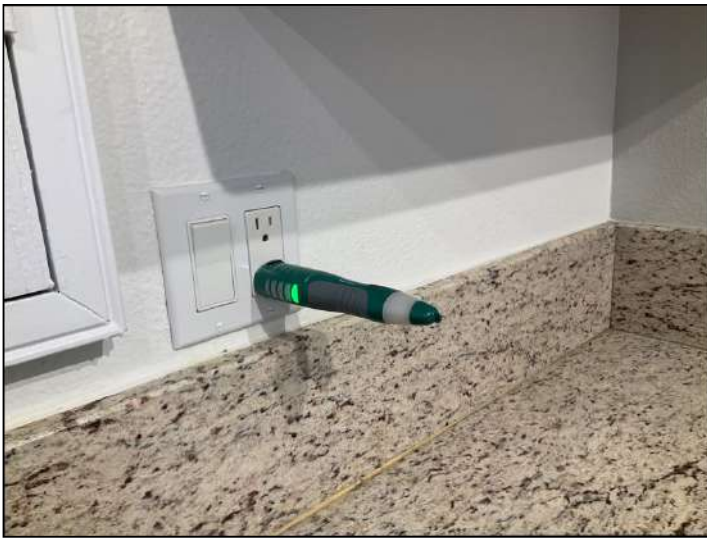
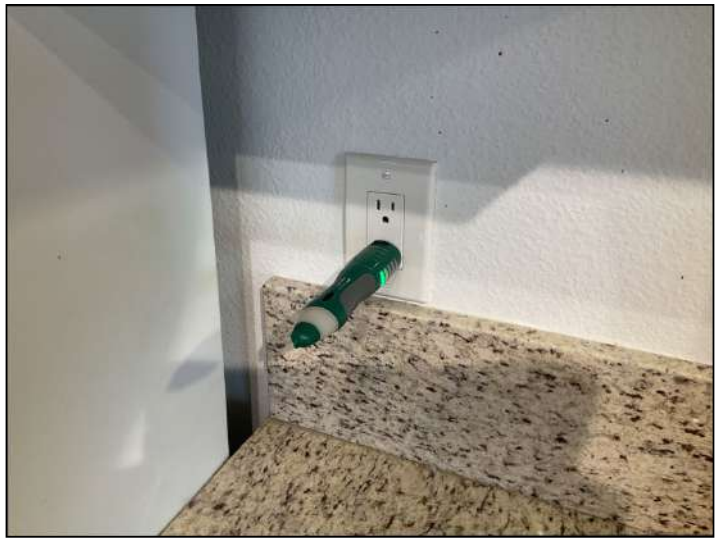
Recommend licensed electrician Repair/Replace open ground electrical outlet. Location: right electrical outlet when facing oven.

Page 47 Item: 15	Electrical	• Recommend licensed electrician Repair/Replace open ground electrical outlet .
Exterior Areas

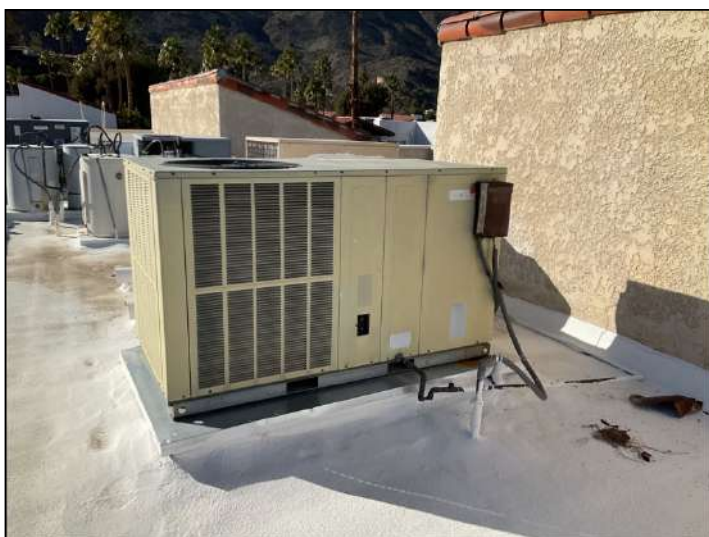
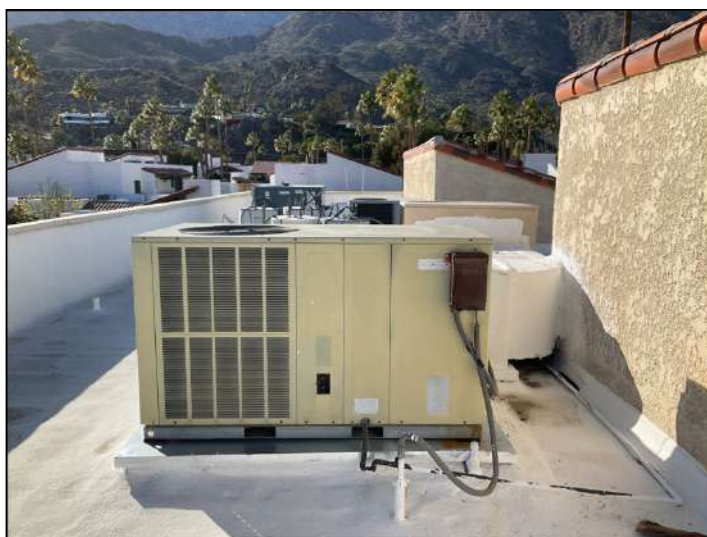
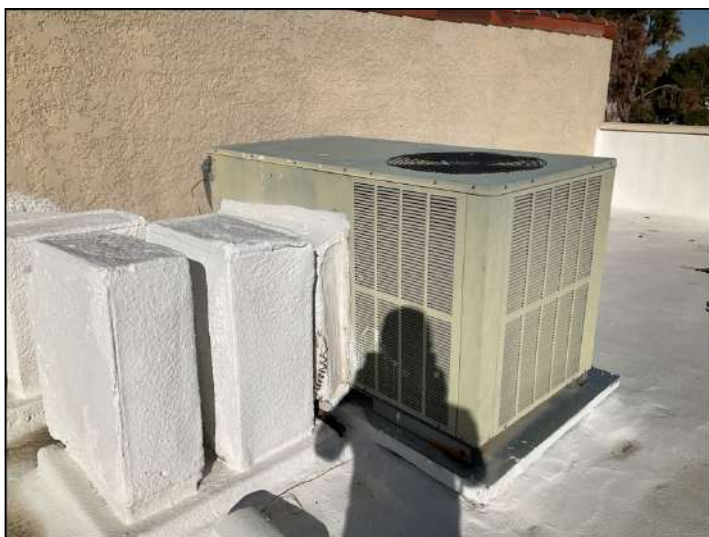
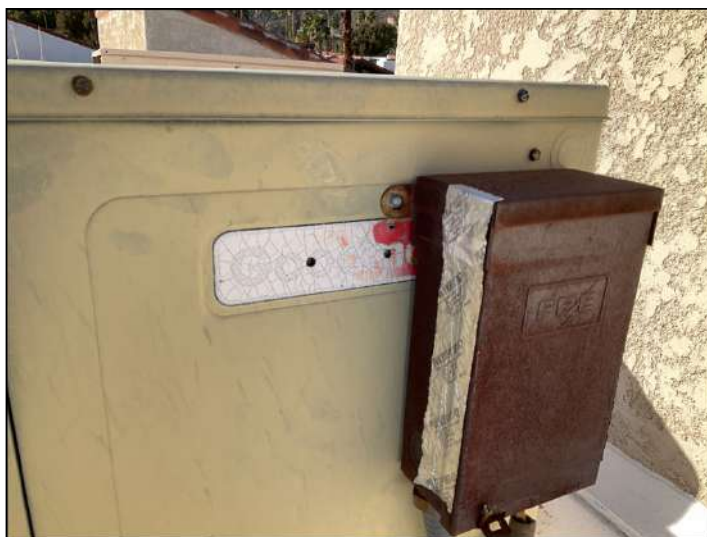
Brand: Goodman
 Model number: PPH1348H21AB
 Serial number: 0709010573
 Approximate Age: 16 years old

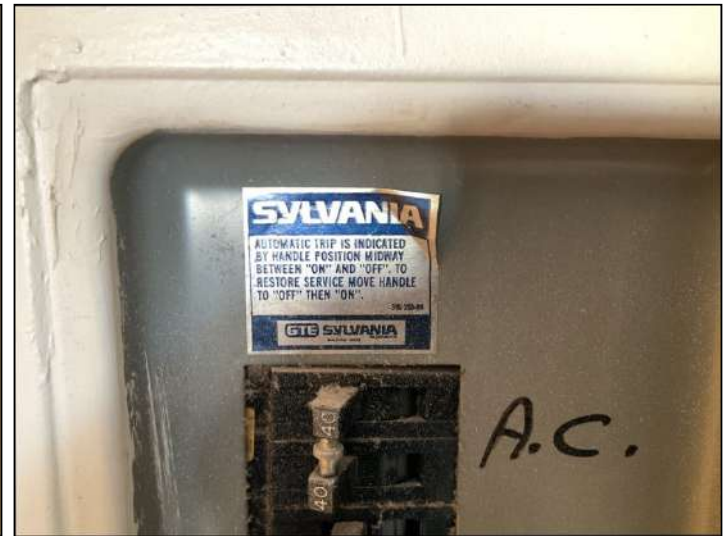
• Buyer beware: Sylvania electrical panel present. Issues with the panel: After installation of the panel was wide-spread, fire and shock hazards began to arise. To summarize the issues, the bus bar of the electrical panel could easily melt and overheat. This would lead to the breakers melting and not properly turning off the power to a circuit.

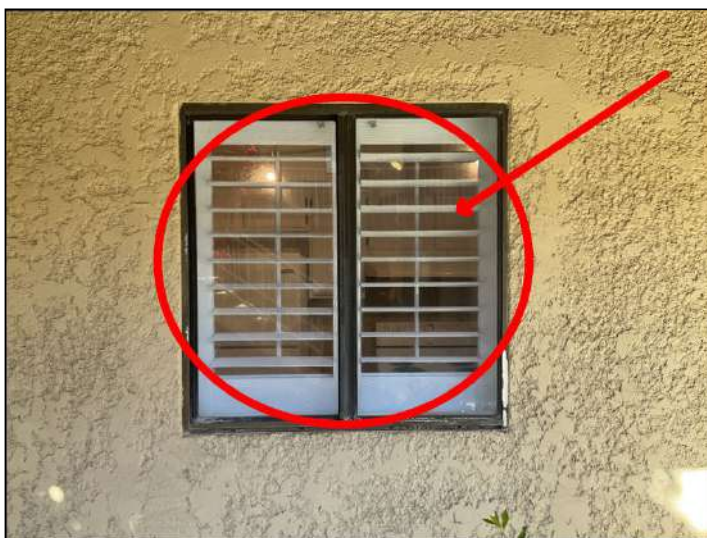
Missing window screen(s). Location: Kitchen

Page 66 Item: 3	Window Condition	• Recommend qualified technician Repair/Replace all bent, torn, damaged, missing window screens.

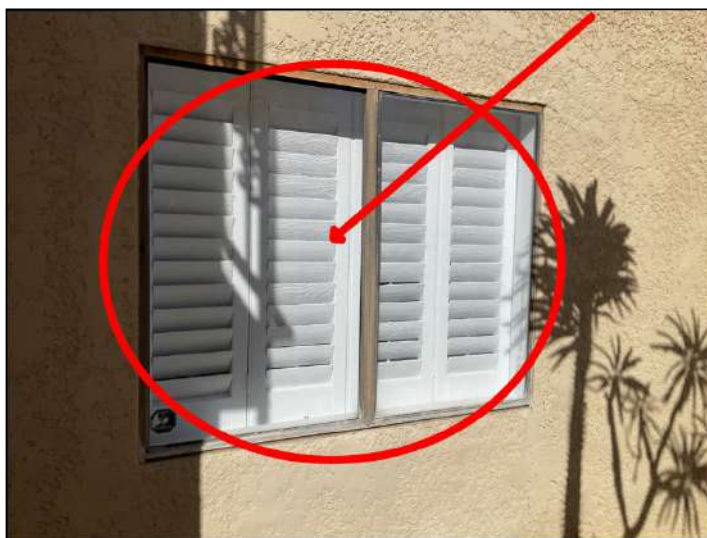
Missing window screen(s). Location: Dining room
