PROPERTY INSPECTION REPORT

1000 Genter St 103
San Diego, CA 92037

Tim Murphy
01/27/2025

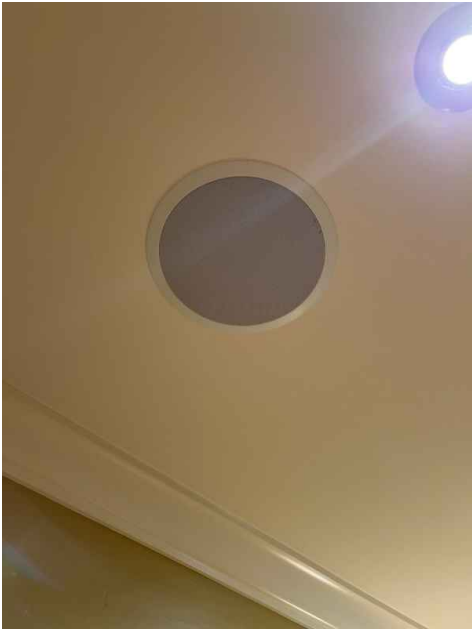
SPEAKERS / SOUND SYSTEM(S) BEYOND SCOPE

The stereo system and or speakers is beyond the scope of this inspection. Further evaluation may be desired.

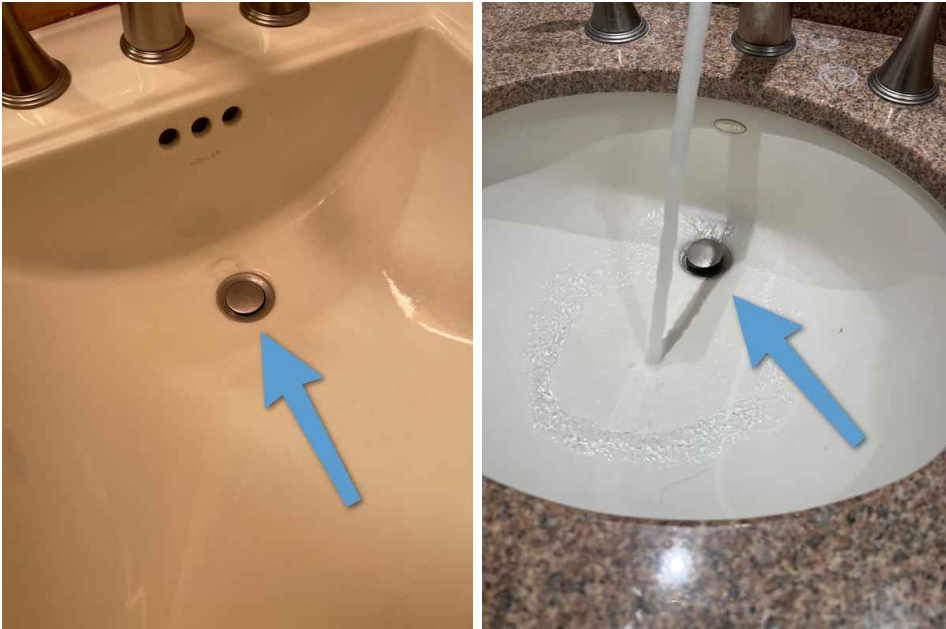
One or more sink drain stops were inoperable, missing, difficult to operate and/or ineffective. Corrections are recommended.

Contact a qualified plumbing contractor.

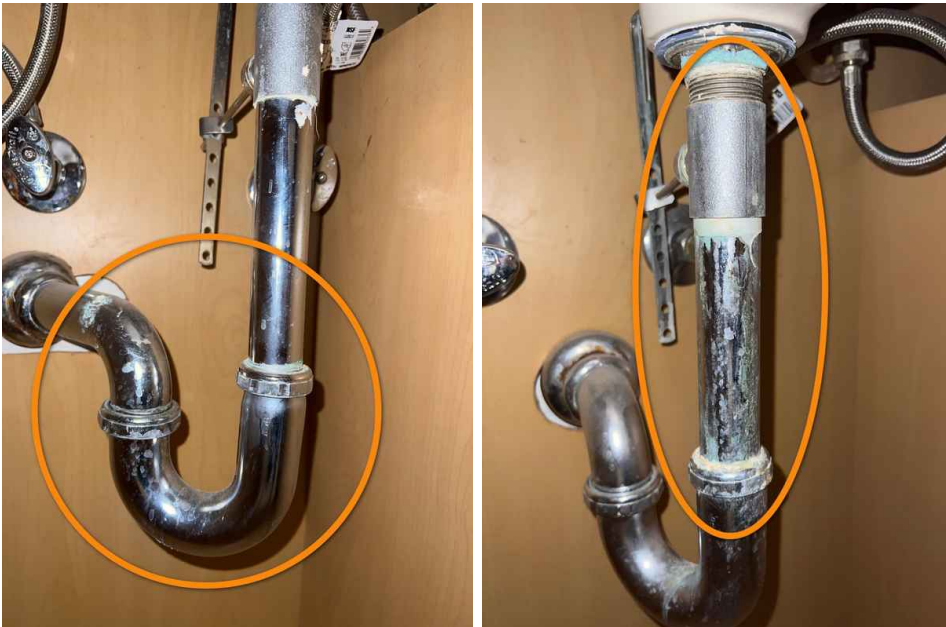
5.5.2 Sinks / Fixtures

CORROSION / DAMAGE - DRAIN LINES

Corrosion and/or damage was found at drain lines and/or fittings under one or more sinks. This can indicate past leaks, or that leaks are likely to occur in the future. Further evaluation by a licensed plumber before the end of your contingency period to determine repairs may be desired.

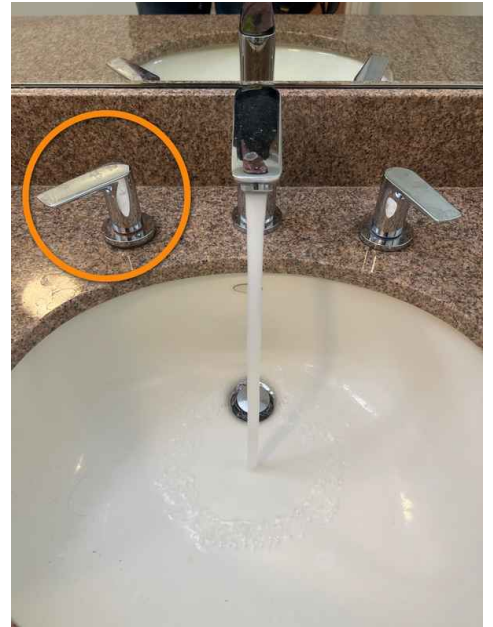
5.5.3 Sinks / Fixtures

LOOSE FIXTURE

A loose fixture was noted at one or more areas. Correction is recommended.

Contact a qualified professional.

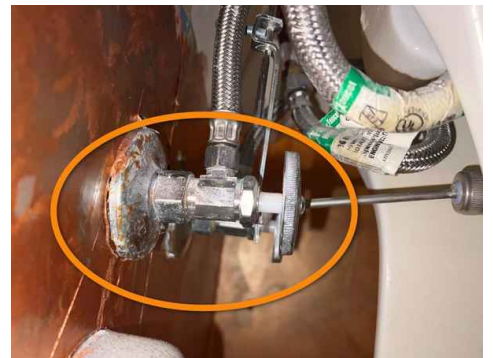
5.5.4 Sinks / Fixtures

OLD ANGLE STOP(S)

Old or original angle stops are installed at some or all sinks and toilets. We recommend replacing all of these older angle stop valves with new valves and braided steel supply lines to avoid leaks.

Contact a qualified plumbing contractor.

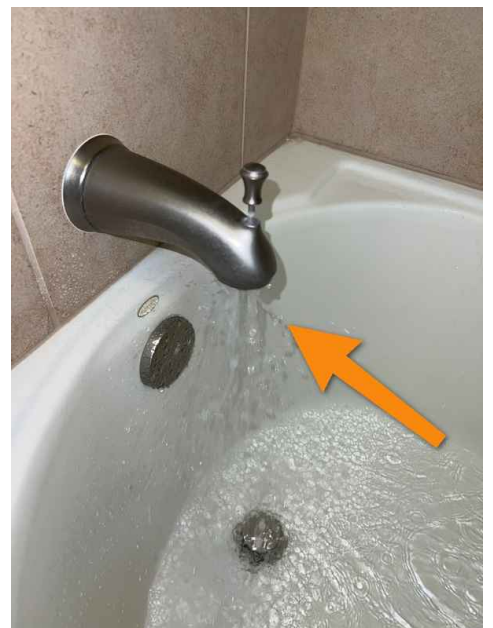
5.6.1 Bathtubs / Showers

TUB DIVERTER

The tub diverter(s) did not function properly at the time of the inspection. Water sprays from shower head and tub spout at the same time. This is typically due to corrosion and or hard water build-up. Recommend further evaluation and repair by a licensed plumber.

Contact a qualified professional.

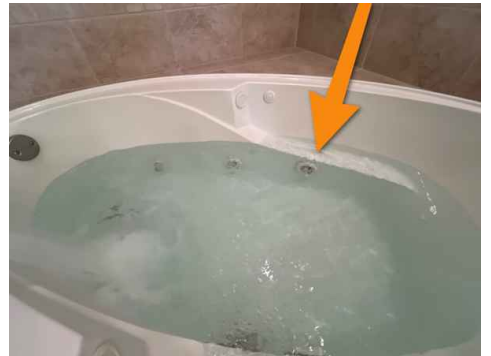
5.6.3 Bathtubs / Showers

One or more jets in the jetted tub were not operating at time of inspection. Recommend qualified plumber evaluate and repair.

Contact a qualified plumbing contractor.

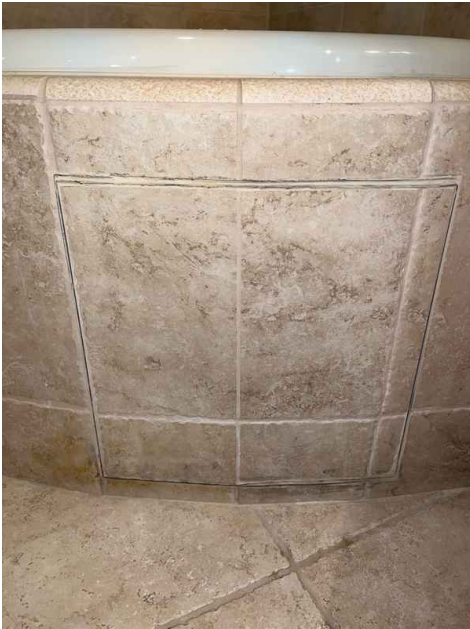
Jetted tub access panel appears to be sealed during the time of inspection. Unable to determine and inspect the components located under the jetted tub. Recommend verifying condition to determine proper GFCI receptacles and condition during usage.

Contact a qualified professional.

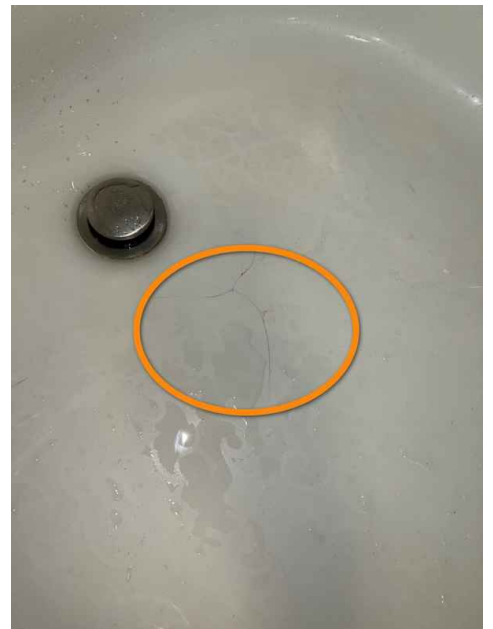
5.6.6 Bathtubs / Showers

HAIRLINE CRACKS

Hairline cracks were noted in the tub and or shower. Recommend repair by a licensed contractor.

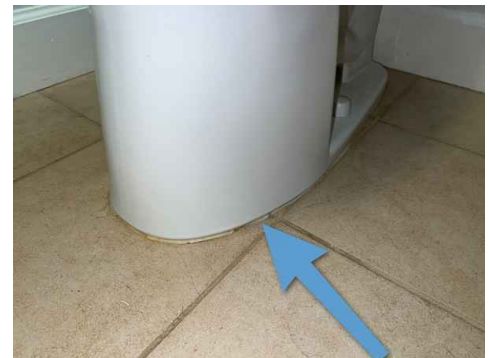
5.7.1 Toilets

The caulking at the floor connection at the toilet was substandard/missing at one or more locations. A licensed plumber is recommended to further evaluate and correct as needed.

Contact a handyman or DIY project

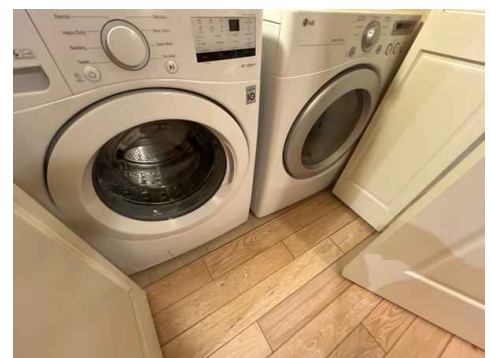
5.8.1 Laundry

A clothes washer was or can be installed over a finished space or in an area where leaking can cause damage, and no catch pan or drain was installed. Catch pans and drains prevent water damage to finished interior spaces below if or when the washing machine leaks, overflows or is drained. If concerned, consult with a qualified contractor about installing a catch pan. Note that installing a drain line for a catch pan routed to the outdoors may not be feasible. As an alternative, a water alarm can be installed in the catch pan.

Contact a qualified professional.

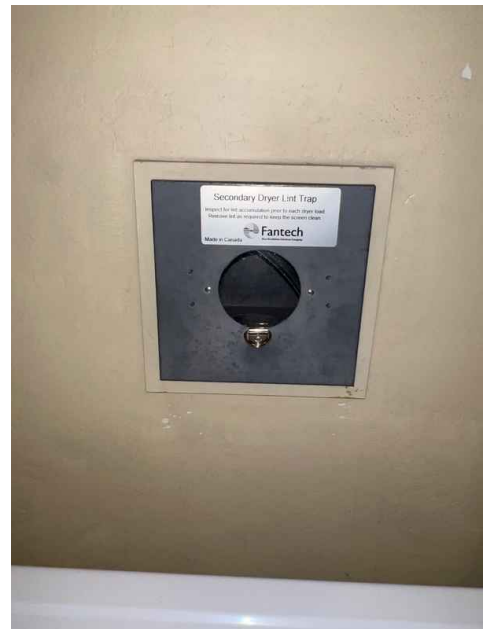
5.8.3 Laundry

LINT TRAP AND/OR BOOSTER FAN

Contact your local homeowners association

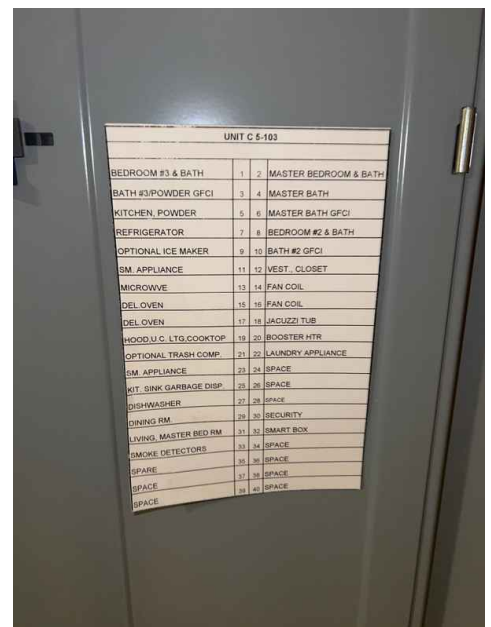
LABELING ACCURACY NOT VERIFIED

Inspectors do not verify the accuracy of the labeling, but it appears to be typical. When the opportunity arises, we suggest verifying the labeling by manually operating the breakers.

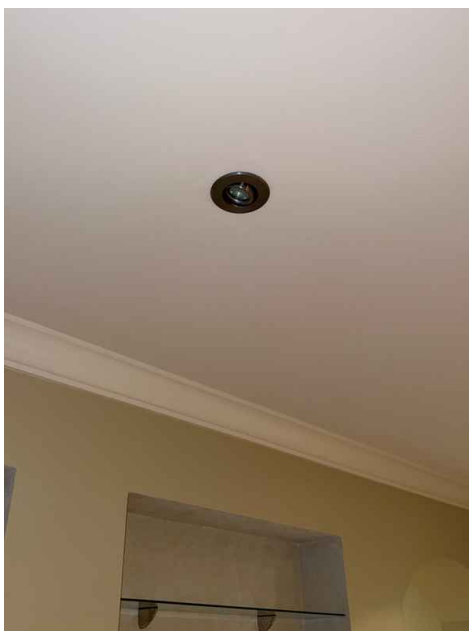
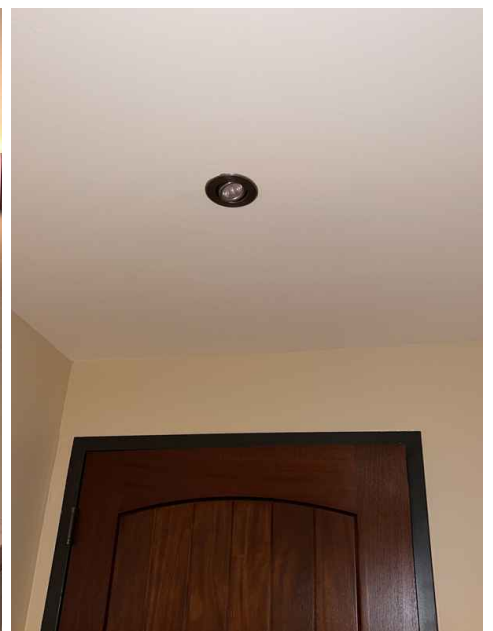
BULBS MISSING / INOPERABLE

Recommended DIY Project

Seller hired a licensed electrician to replace these light bulbs

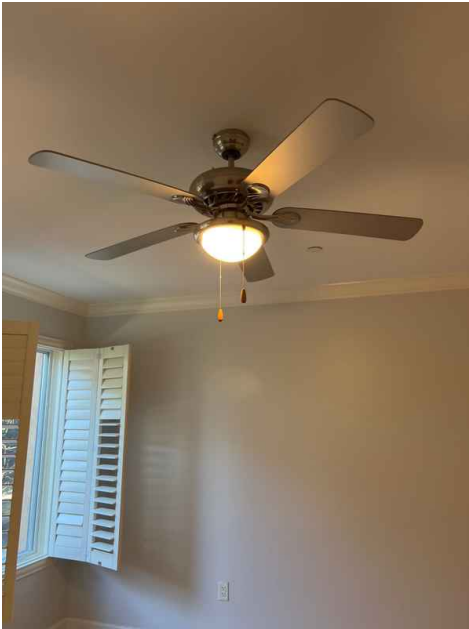
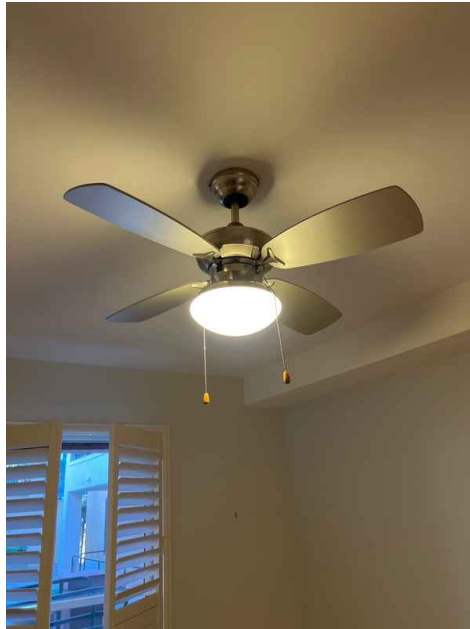
6.6.2 Outlets / Switches / Lighting / Fans

INOPERABLE CEILING FAN(S) NOTED

These two ceiling fans are operable. Each of them are controlled by a remote which will be given to the buyer at close of escrow.

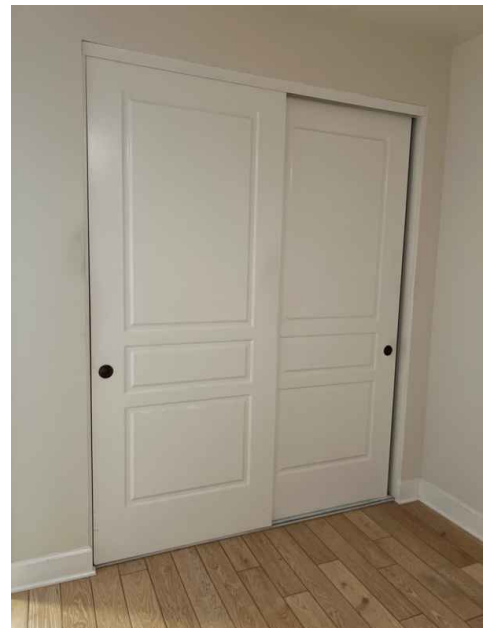
8.3.2 Interior Doors

DOOR(S) DRAG / DIFFICULT

Contact a handyman or DIY project

This has been repaired and closet door does not drag/is no longer difficult to open

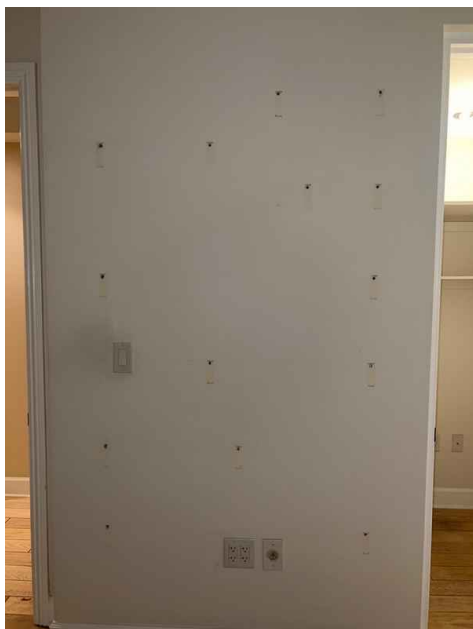
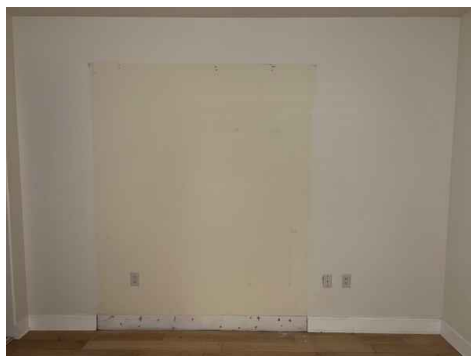
8.6.1 Walls

HOLE(S) IN WALL

Contact a qualified professional.

The holes in the wall have been patched and painted.

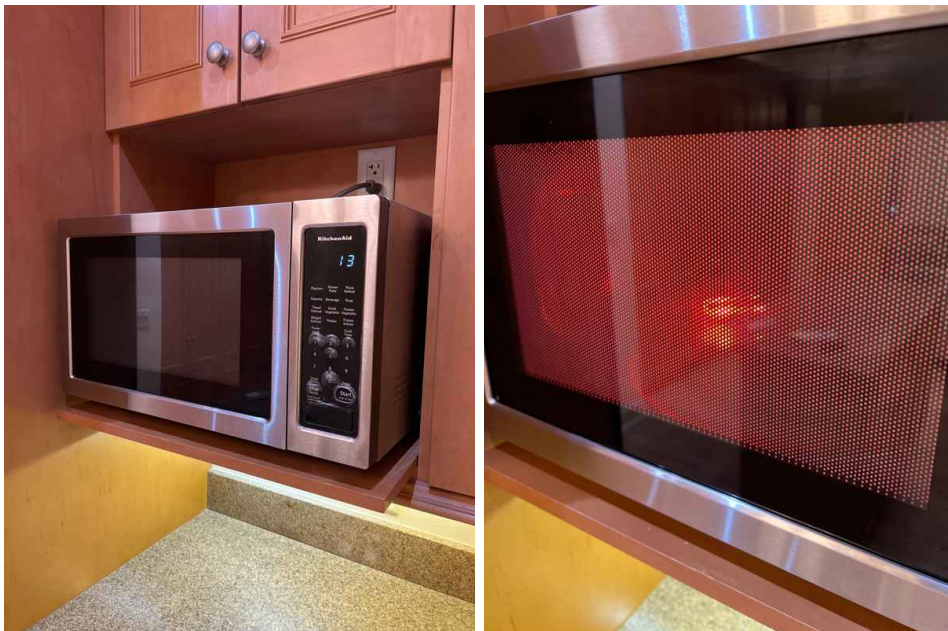
PORTABLE UNIT - NOT INSPECTED

A portable unit was noted, which is beyond the scope of this inspection. It is unknown if this appliance covveys with the property.
