TRITON HOME INSPECTIONS

29419 Shady Ln  
Murrieta, CA 92563

FEBRUARY 15, 2025

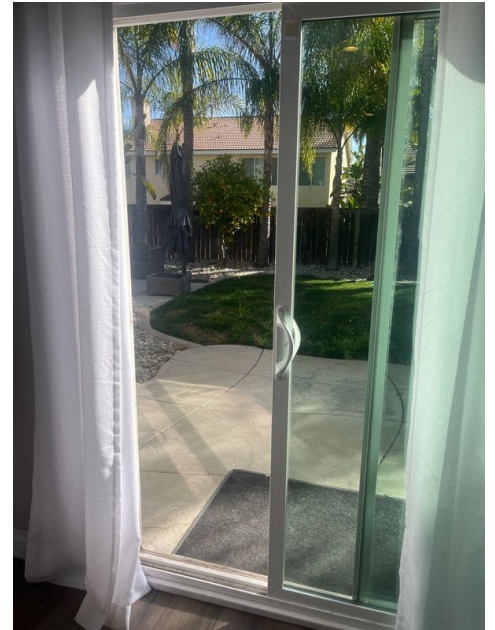
##### **SCREEN DOOR MISSING**

Missing the screen door.

Contact a qualified professional.

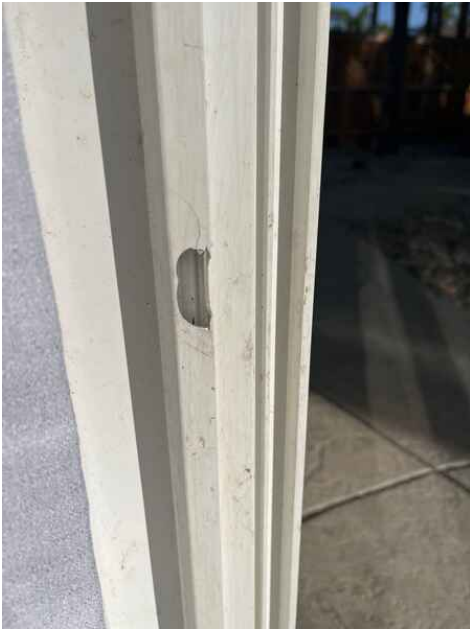
#### 2.3.2 Exterior Doors

##### **DOOR TRIM**

Damaged door trim here at the glass slider.

Contact a qualified professional.

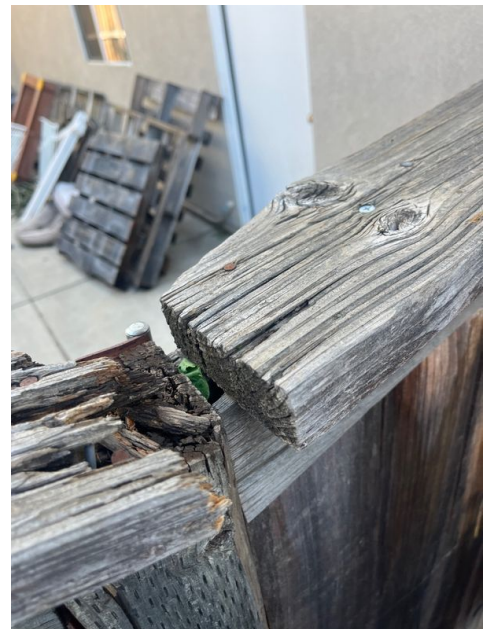
2.7.1 Fences and Gates

**FENCES AND GATES**

Gate is deteriorated.

Contact a qualified professional.

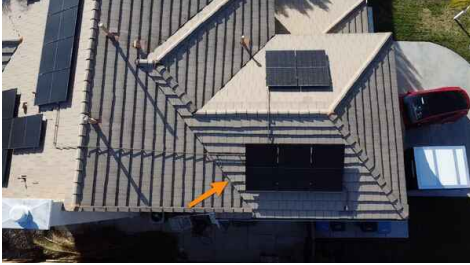
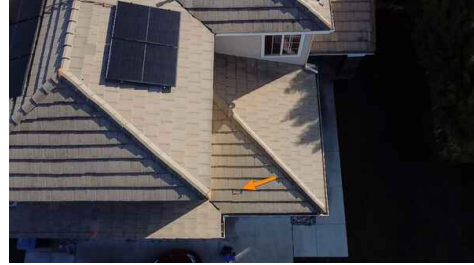
### CRACKED ROOF TILES

Cracked tiles noted. The roof covering was inspected by a drone and attic to avoid damaging the roof covering, and possibly voiding the warranty. This is in accordance with the Inter-NACHI standards of practice. The entire roof was not visible, and there may be additional defects. I recommend further evaluation of the entire roof before the end of your contingency period by a licensed roofer and repair as needed to ensure the roof functions properly.

Previously cracked and repaired but it is cracking again. This is why you want new tiles and not just a bandaid of sealant.

Contact a qualified roofing professional.

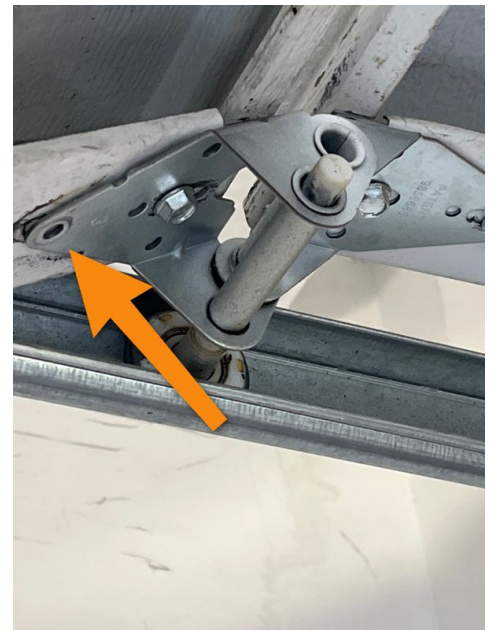
##### **MISSING HARDWARE**

Missing an important piece of hardware here at this garage door hinge.

Contact a qualified professional.

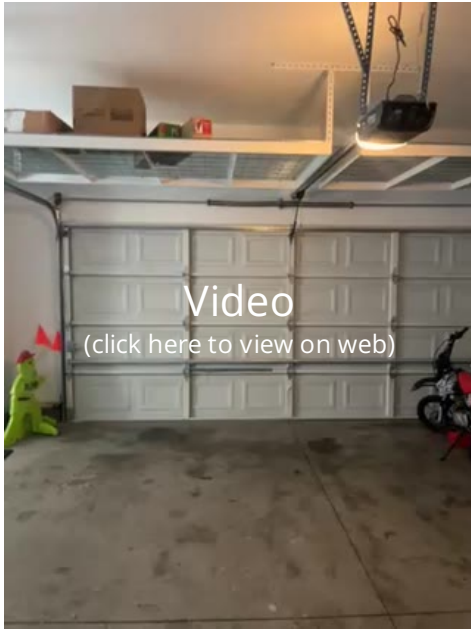
#### 4.5.2 Garage Door

##### **OPERATION**

Contact a qualified professional.

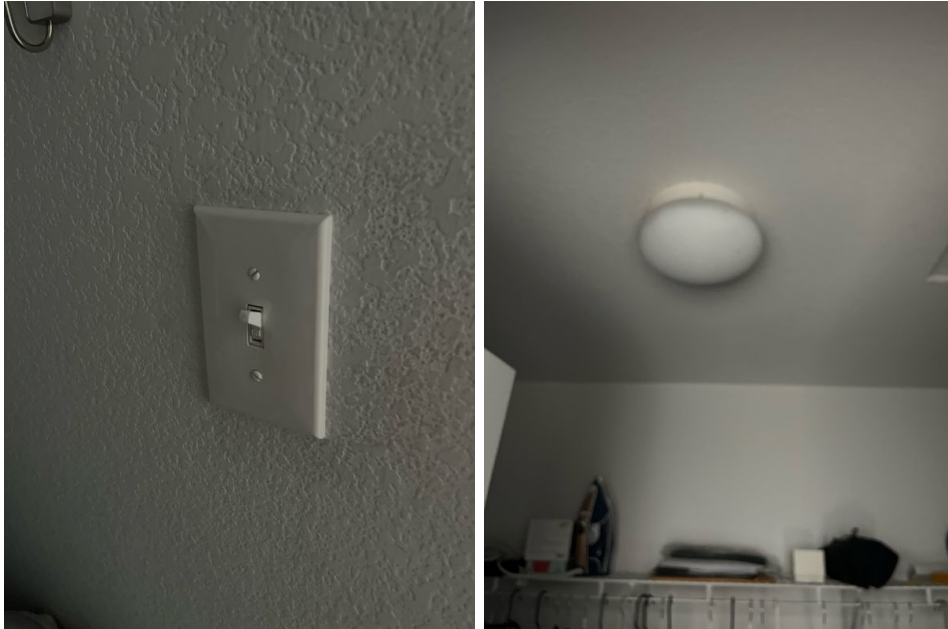
This closet light fixture was inoperable (didn't turn on when nearby switches were operated). Recommend further evaluation by replacing bulbs and/or consulting with the property owner. If replacing bulbs doesn't work and/or no other switch(es) can be found, then recommend that a qualified electrician evaluate and repair or replace light fixtures as necessary.

Contact a qualified professional.

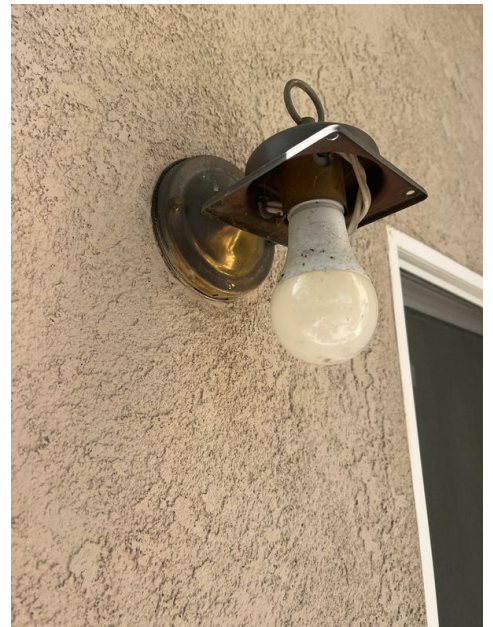
## 6.5.2 Lighting Fixtures, Switches &amp; Receptacles

**GLOBE COVER MISSING**

A globe or cover for exterior light fixture is missing. Recommend replacing as necessary to avoid exposed bulbs.

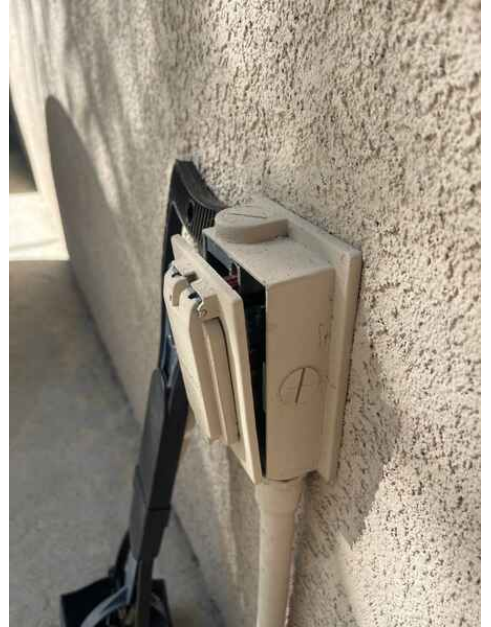
## 6.5.3 Lighting Fixtures, Switches &amp; Receptacles

**LOOSE OUTLET**

Safety Hazard

Loose outlet exposing the electrical wiring. This is a safety hazard and need repair.

Contact a qualified electrical contractor.

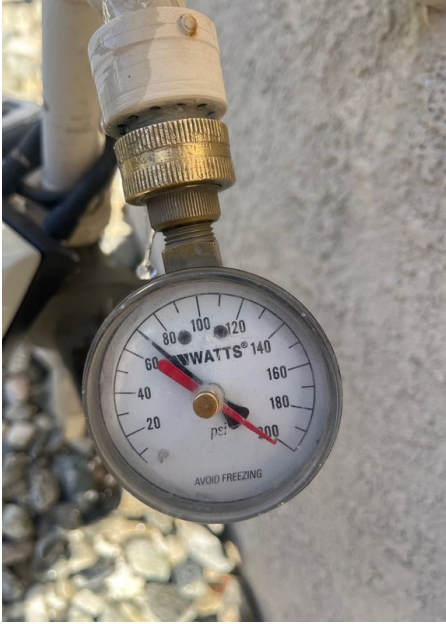
## Water Supply, Distribution Systems & Fixtures: Water Pressure

Water pressure measured at 70psi. 40-80PSI is the recommendation for residential water pressure.

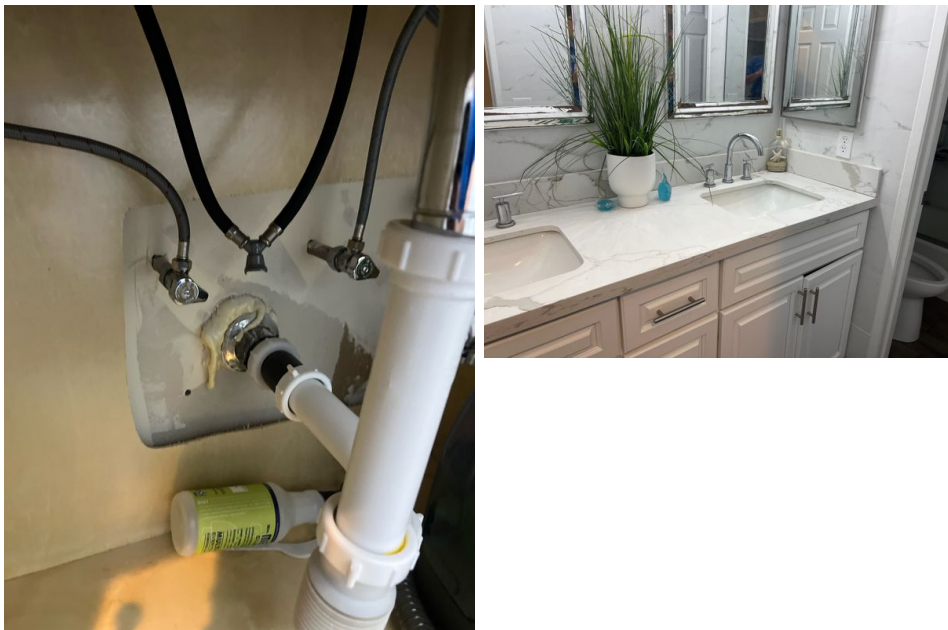
### 7.4.1 Water Supply, Distribution Systems & Fixtures

The hot and/or cold water supply flow for this bathroom sink was inoperable. Recommend that a qualified plumber evaluate and repair as necessary.

Contact a qualified professional.

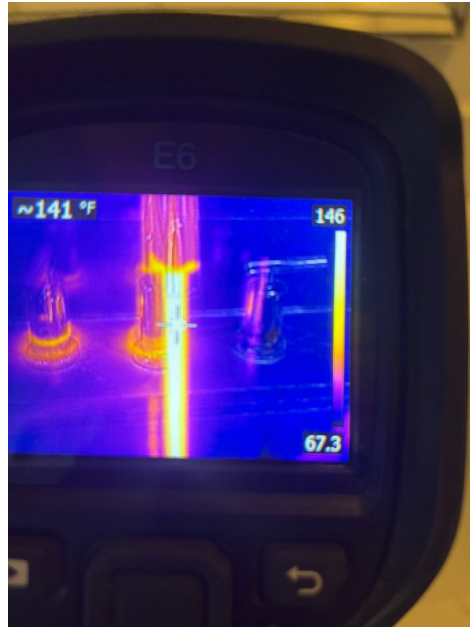
### 7.4.2 Water Supply, Distribution Systems & Fixtures

#### **WATER TEMP**

The water temperature exceeds 120. Possible scalding hazard. See chart

Recommend you adjust the water temperature at the water heater prior to move-in.

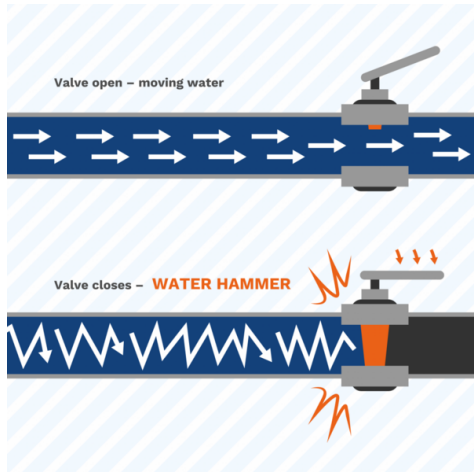
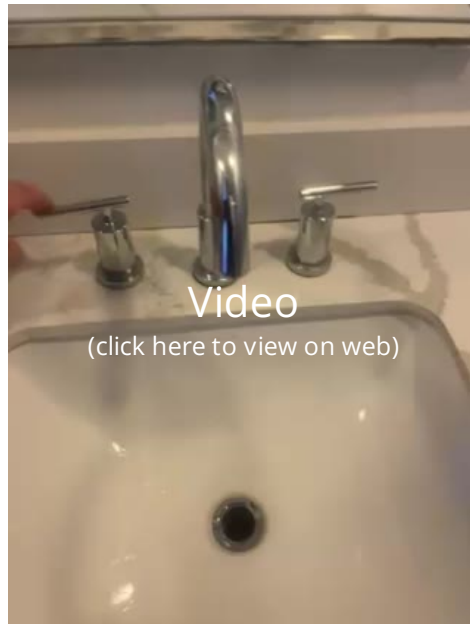
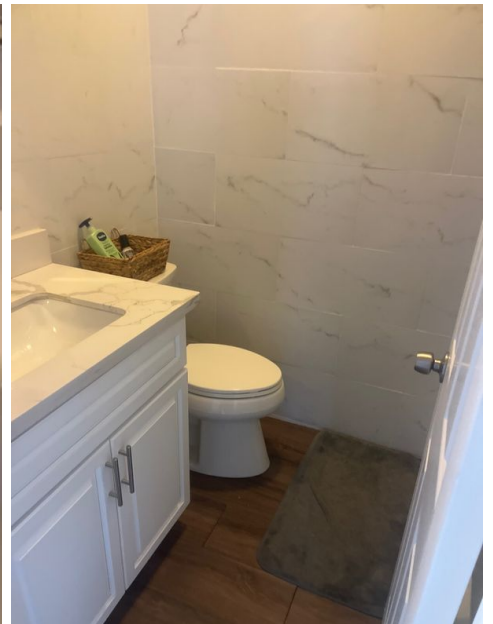
7.4.3 Water Supply, Distribution Systems & Fixtures

**WATER HAMMER**

Contact a qualified professional.

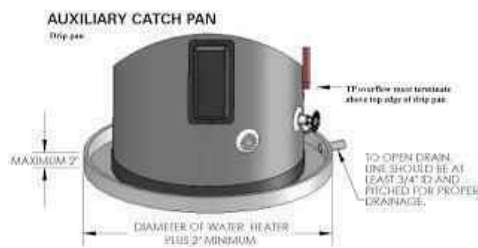
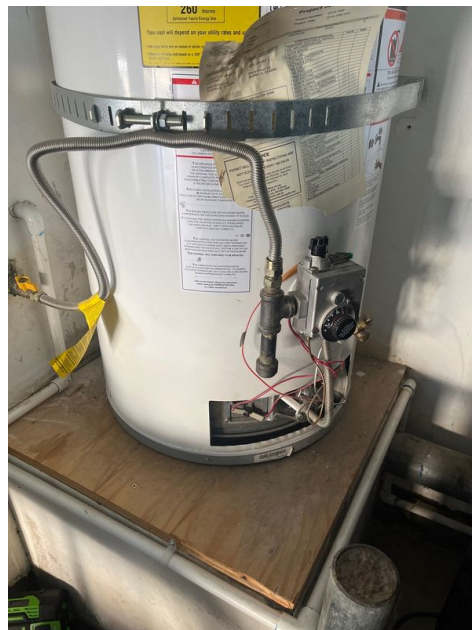
### 7.5.3 Hot Water Systems, Controls, Flues & Vents

#### **NO DRIP PAN**

No drip pan with a drain line to the exterior was present. Recommend installation by a qualified plumber.

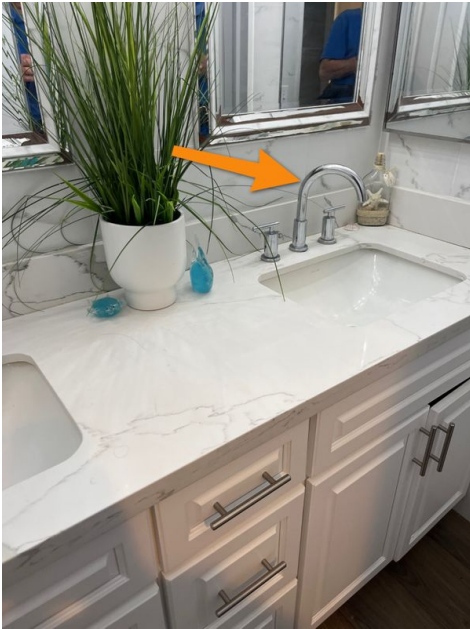
### 7.7.1 Sinks

#### **FAUCET**

Loose bathroom sink faucet.

Contact a qualified professional.

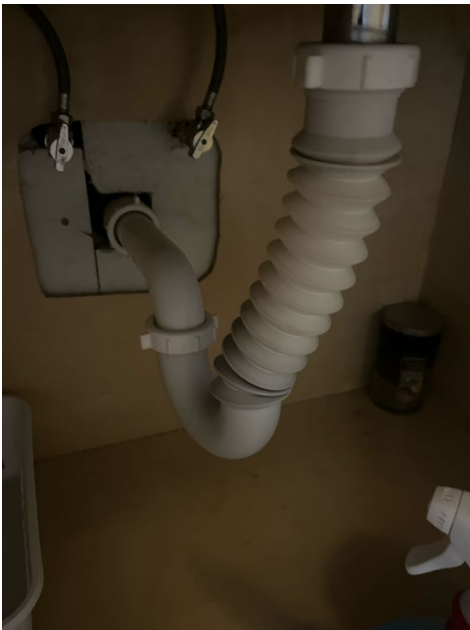
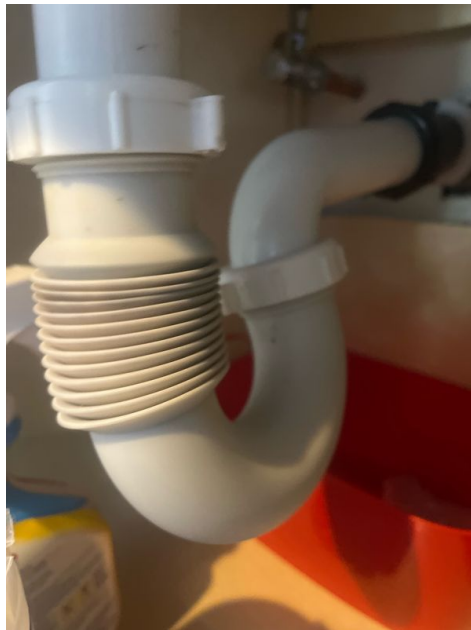
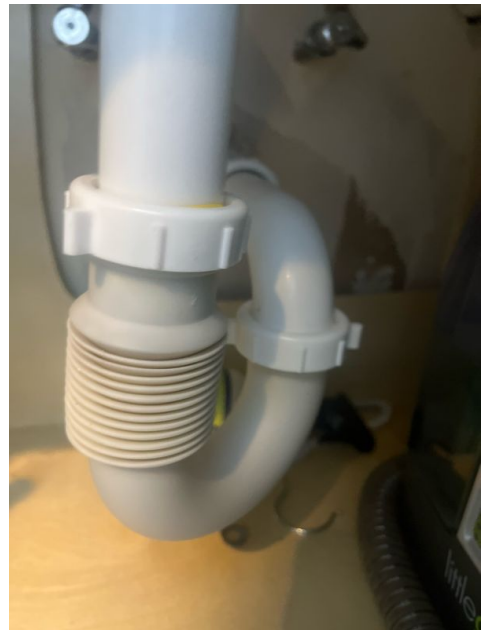
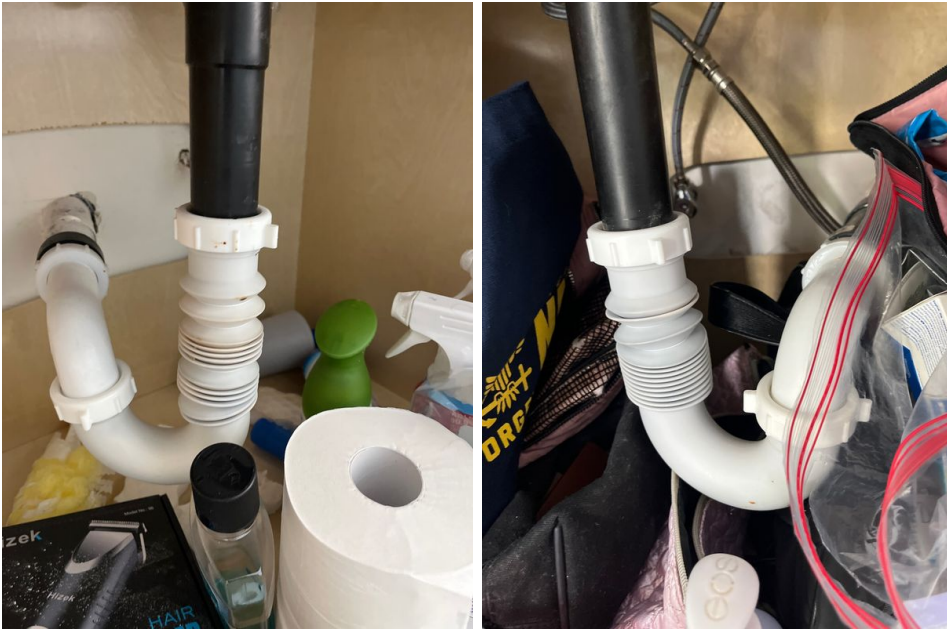
### 7.7.2 Sinks

#### **FLEX LINE**

Ribbed, flexible drain pipe was used at the bathroom sinks. This type of drain pipe accumulates debris more easily than smooth wall pipe and is likely to clog. Recommend that a qualified plumber replace flexible piping with standard plumbing components (smooth wall pipe) to prevent clogged drains.

Contact a qualified professional.

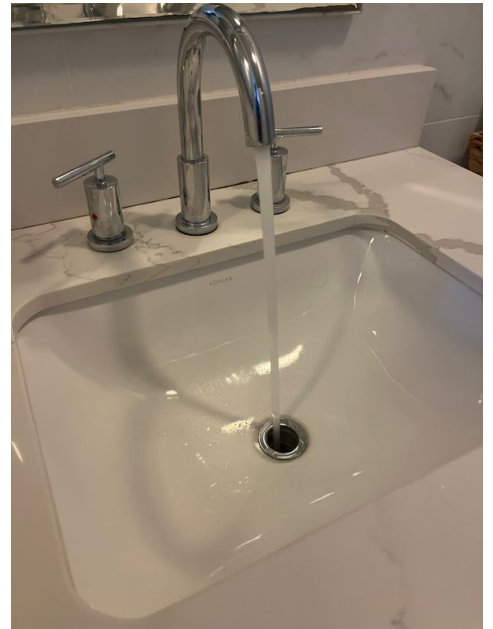
### 7.7.3 Sinks

#### **DRAIN PLUG**

Missing a drain plug for this bathroom sink.

Contact a qualified professional.

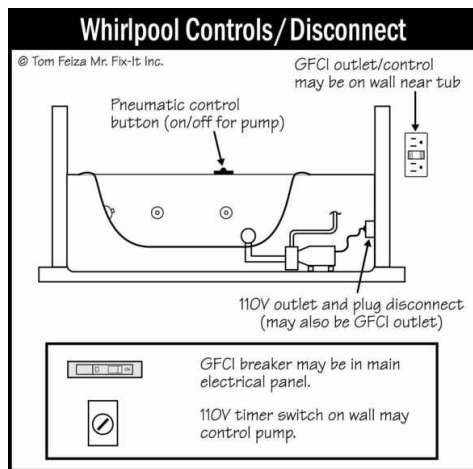
### 7.8.1 Jetted Tub

#### **EQUIPMENT ACCESS**

No equipment access for the jetted tub was found.

If you don't have an access panel to your Jacuzzi, then you will have one of two problems: either there will be an opening that is vulnerable to damage and safety risks, or access to your Jacuzzi's components are (illegally) sealed, and you cannot repair or maintain your tub.

Contact a qualified professional.

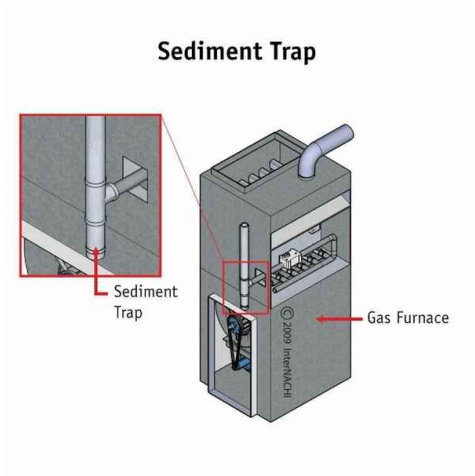
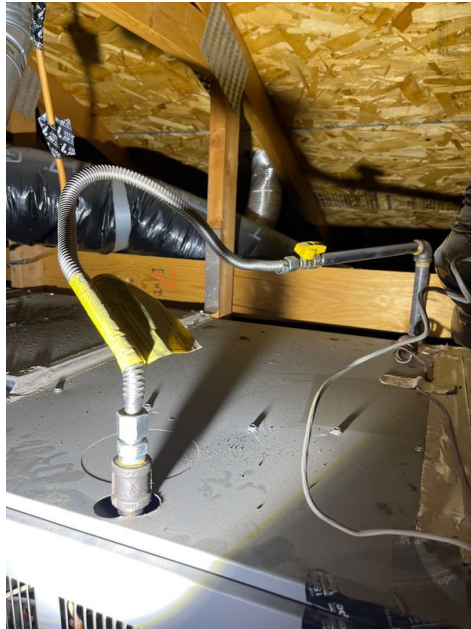
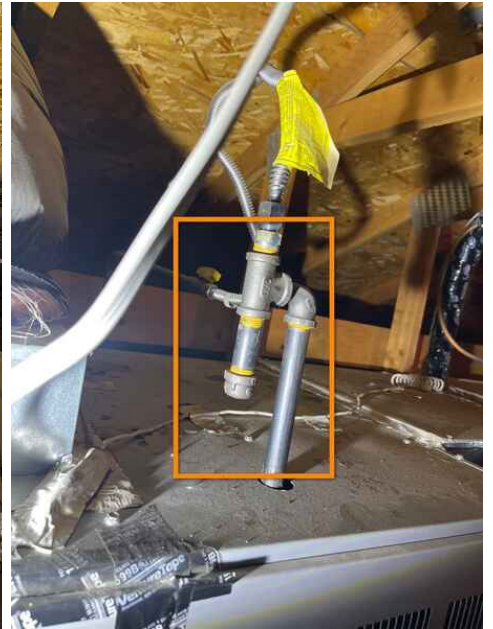
Here is the second furnace that has the sediment trap.

Contact a qualified HVAC professional.

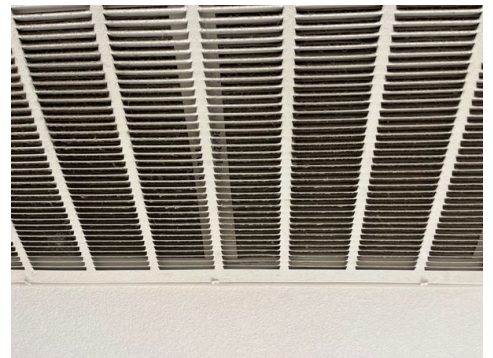
#### 8.4.1 Distribution Systems

Recommend changing out this dirty filter.

Contact a qualified professional.

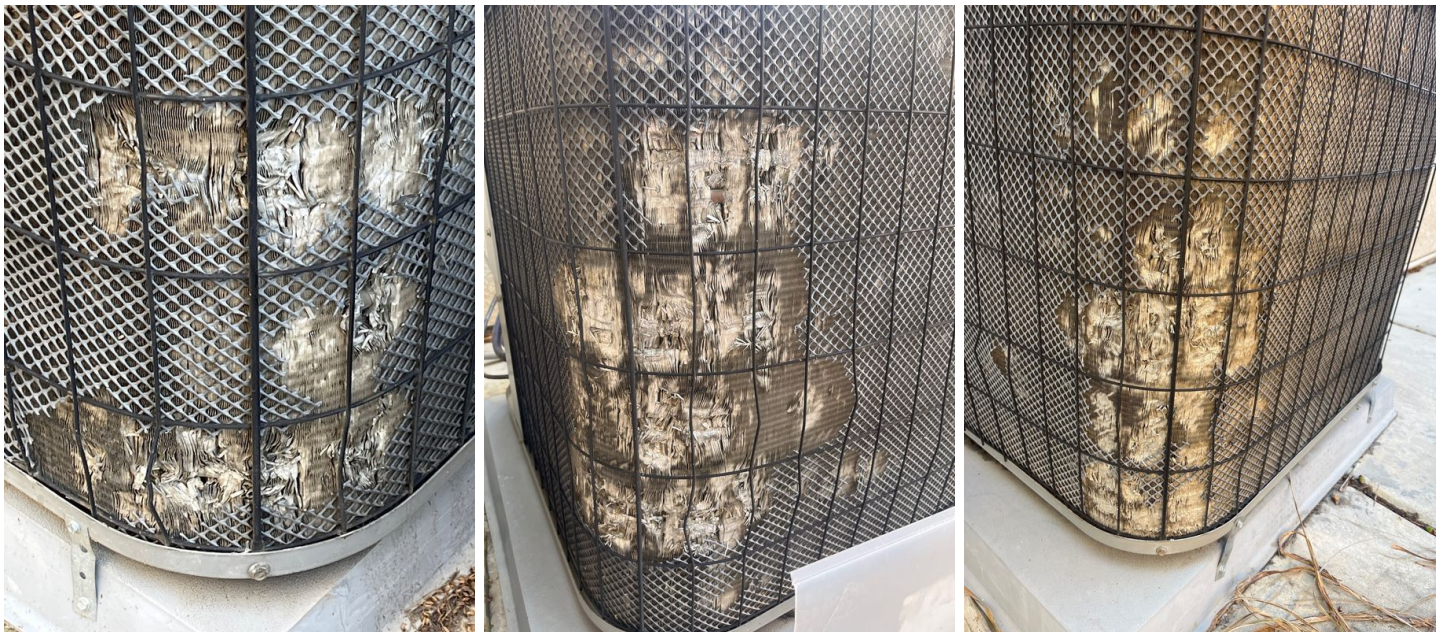
### 9.2.1 Cooling Equipment

Damaged fins on both the condensers. The performance and efficiency may be affected with the air conditioner. Recommend service and repair, if that is possible.

Contact a qualified professional.

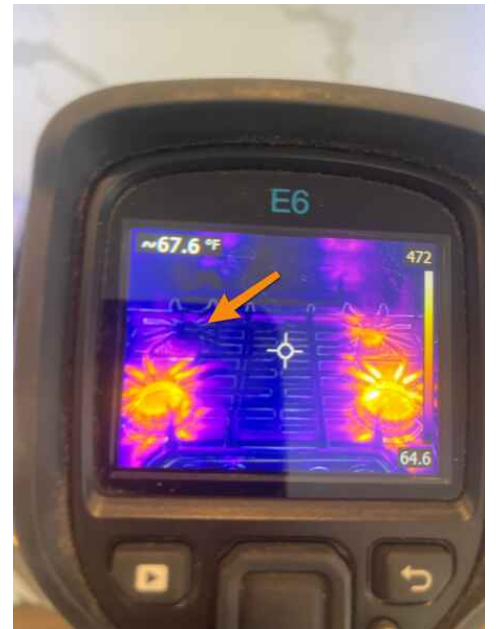
#### **BURNER NOT LIGHTING**

The back burner did not ignite when prompted.

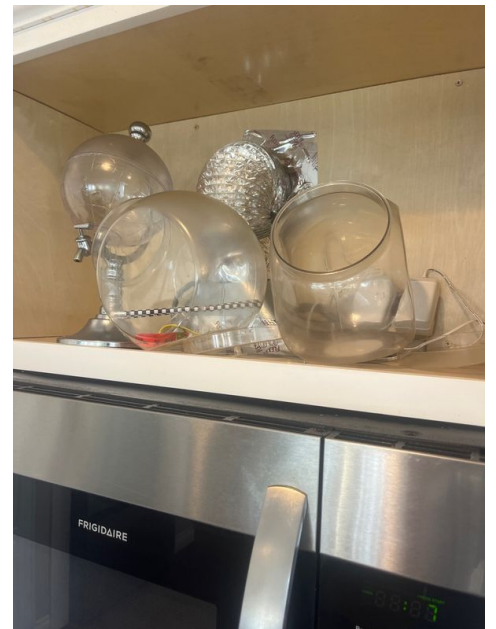
#### 11.7.1 Ventilation System

##### **FAN RECIRCULATES**

Contact a qualified professional.

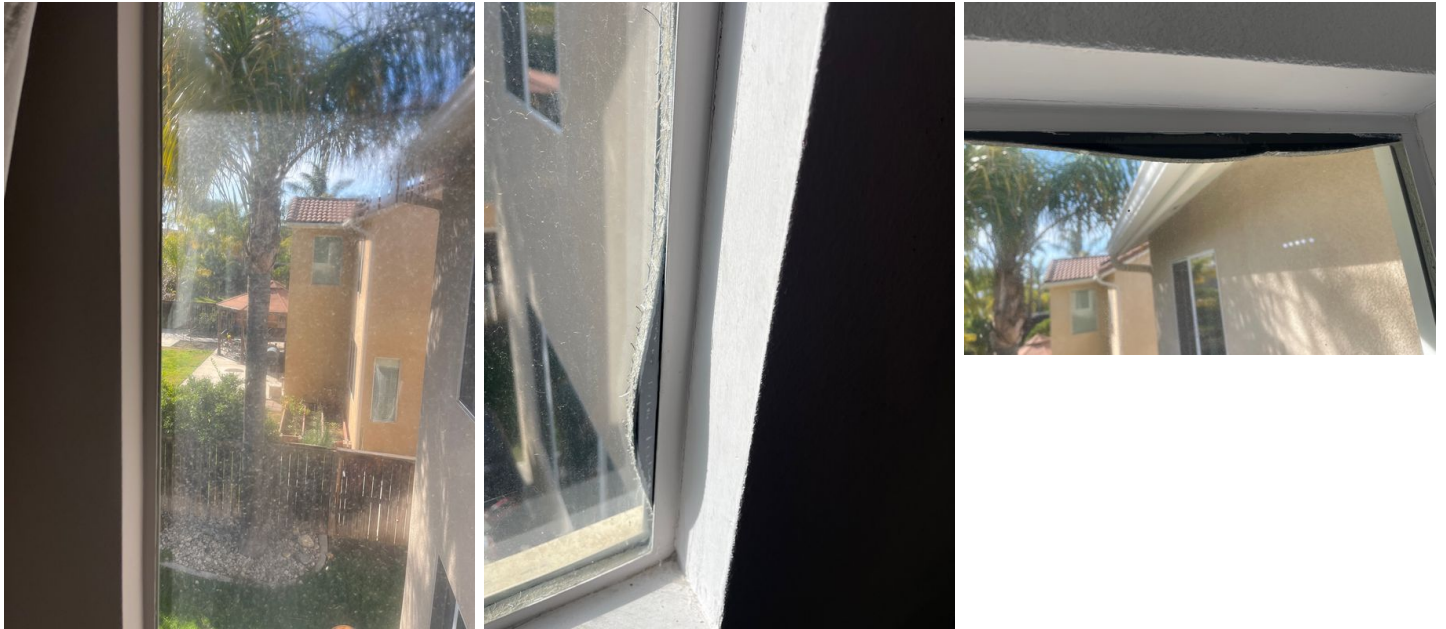
12.3.1 Windows

### **FAILED SEAL**

Be aware that evidence of failed seals or desiccant may be more or less visible depending on the temperature, humidity, sunlight, etc. Windows or glass-paneled doors other than those that the inspector identified may also have failed seals and need glass replaced. It is beyond the scope of this inspection to identify every window with failed seals or desiccant.

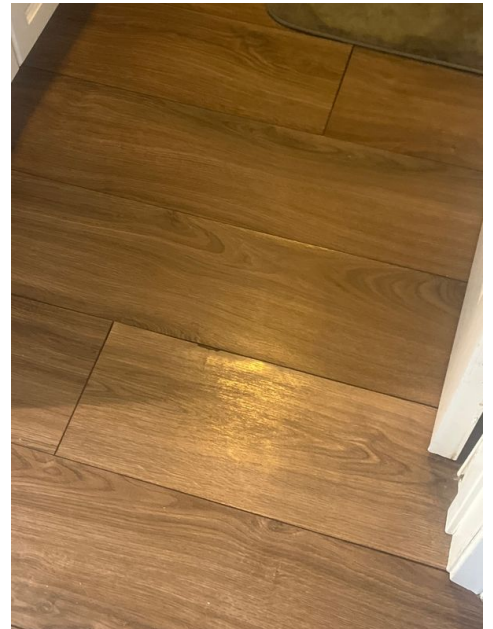
12.4.1 Floors

**WARPING**

Contact a qualified professional.

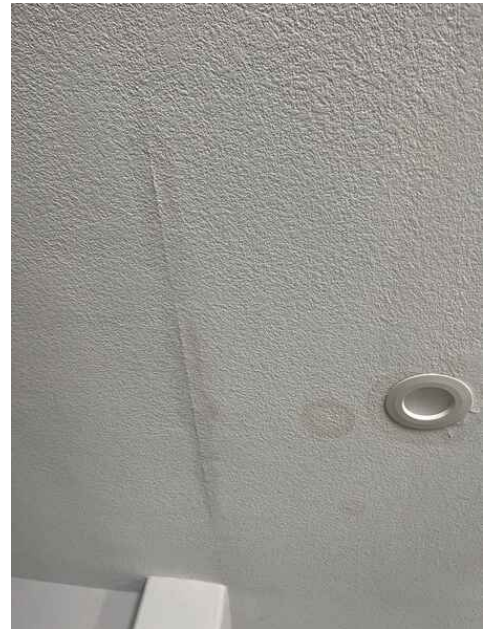
### 12.6.1 Ceilings

#### **DRY MOISTURE STAIN**

Contact a qualified professional.

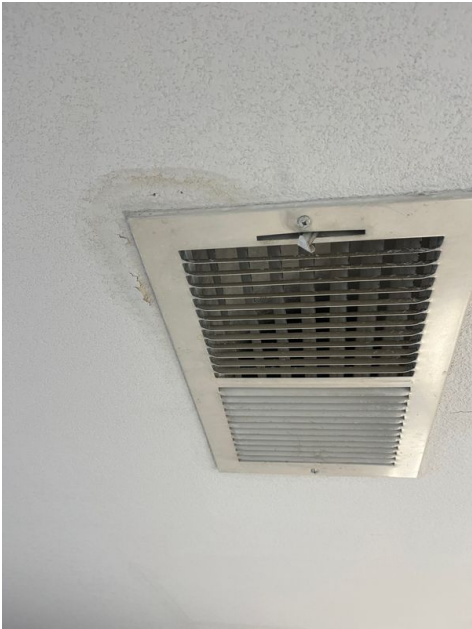
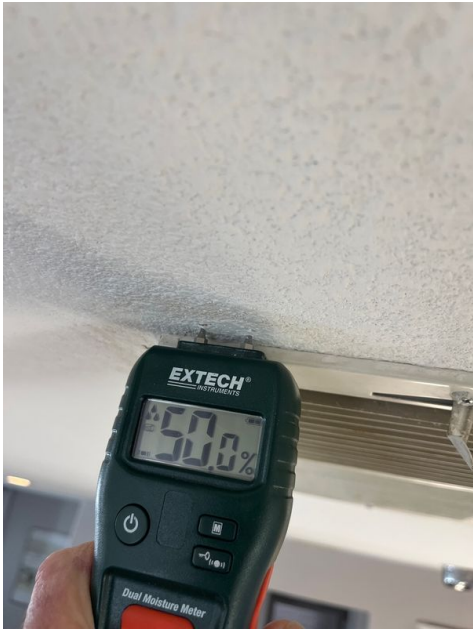
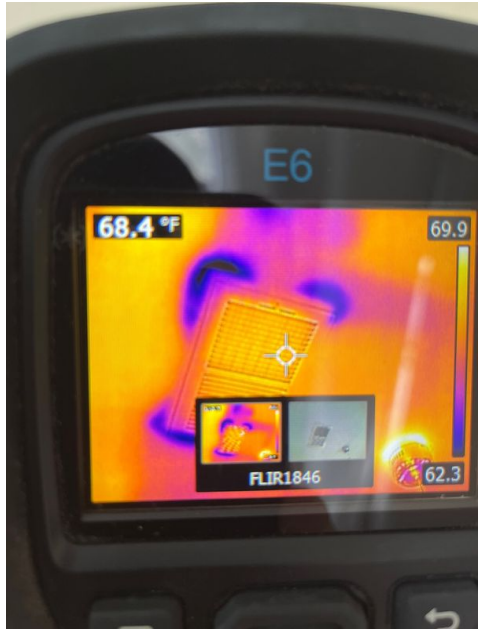
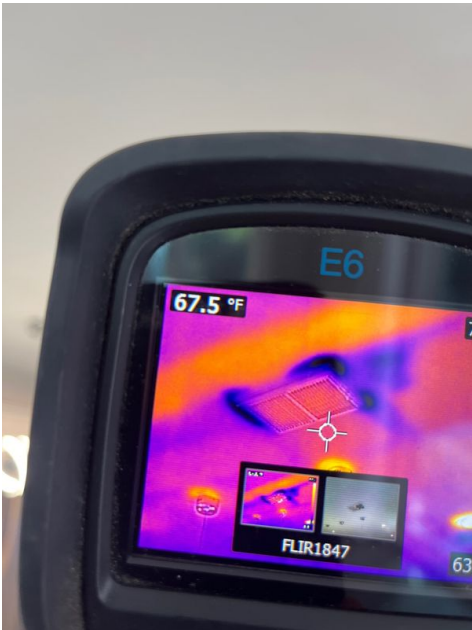
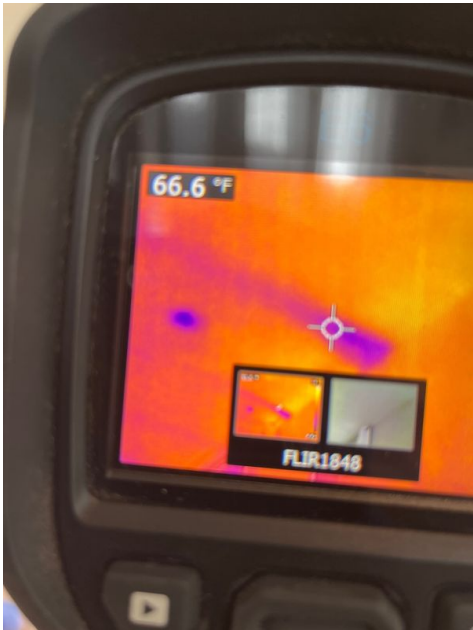
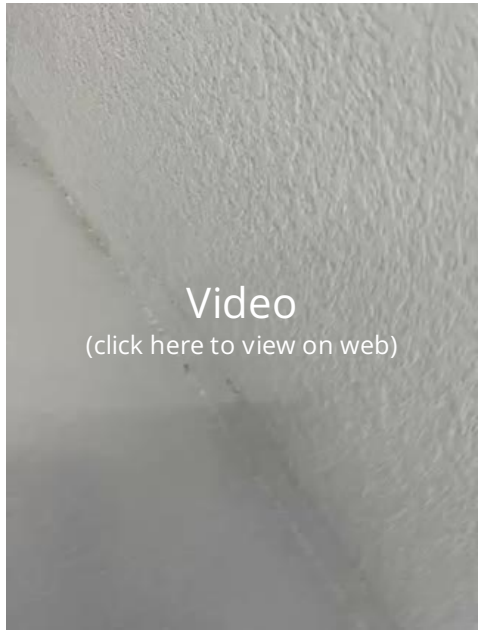
### 12.6.2 Ceilings

#### **MOISTURE**

Contact a qualified professional.
