RESIDENTIAL PROPERTY INSPECTION

1510 S Redwood St
Escondido, CA 92025

06/29/2023

Licensed Engineer And General Contractor for 30
years, Certified Home Inspector

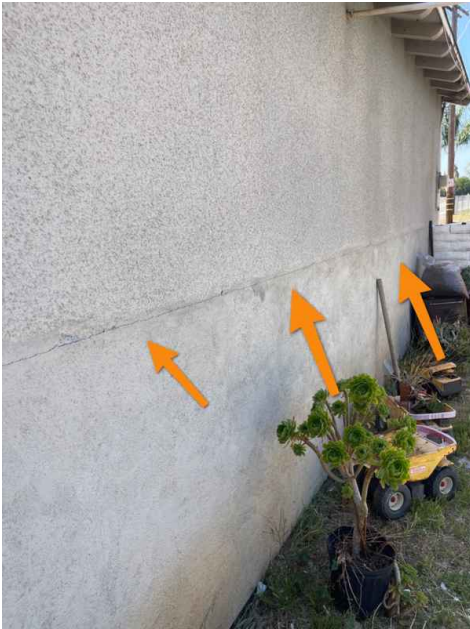
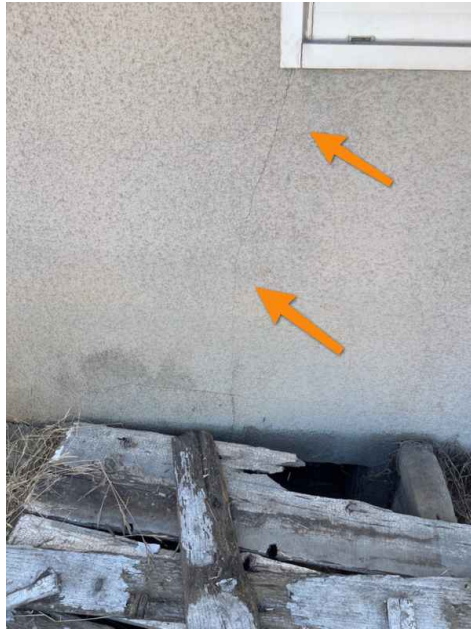
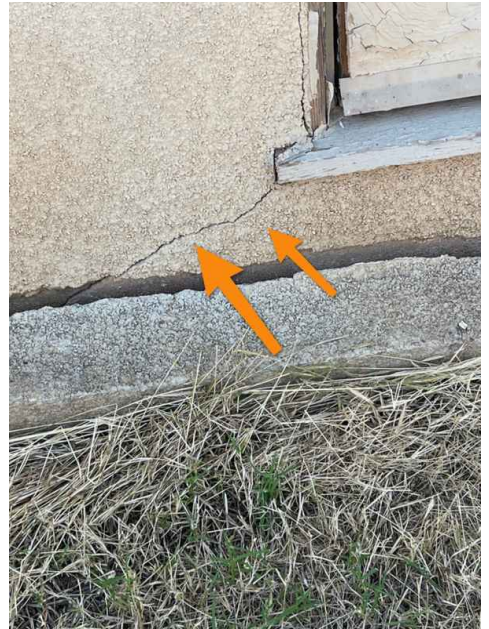
STUCCO - MINOR CRACKING

Minor cracking was present in the stucco in areas. Rain water can infiltrate these cracks. Properly sealing or repairing any cracking is recommended to be conducted by a masonry contractor as needed.

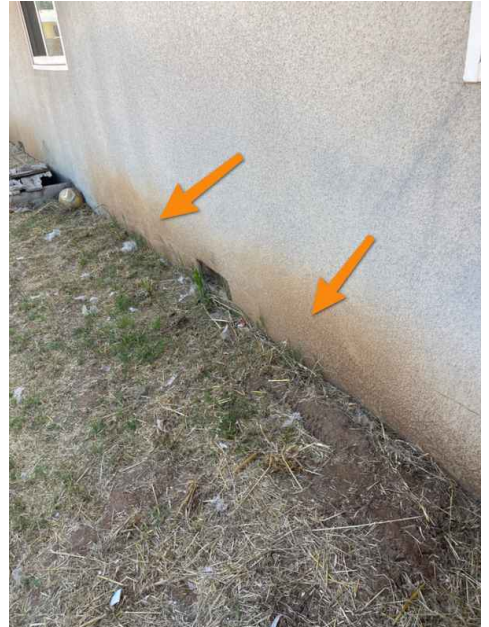
1.2.2 Stucco / EIFS

STUCCO IS DISCOLORED

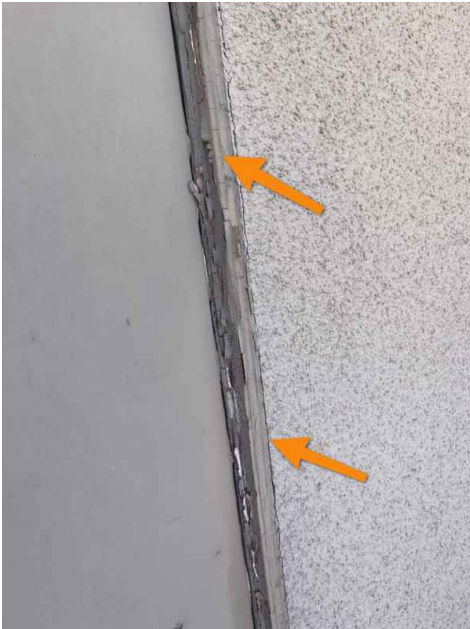
1.4.1 Wood Trim

WOOD TRIM HAS CRACKING AND NEEDS REPAIR WORK AND PAINTING

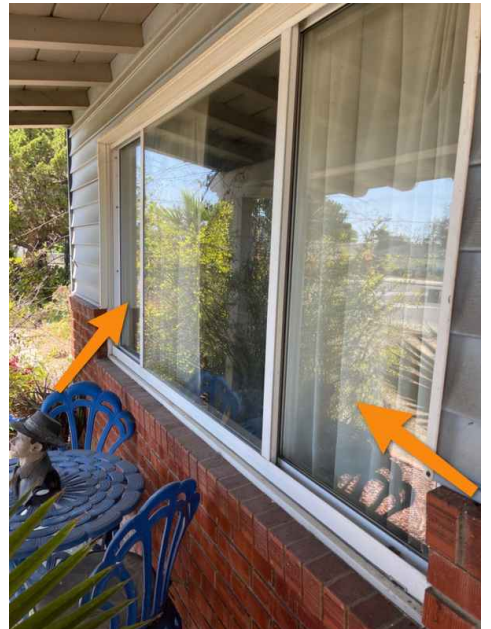
1.5.1 Window Exteriors

WINDOW SCREEN MISSING

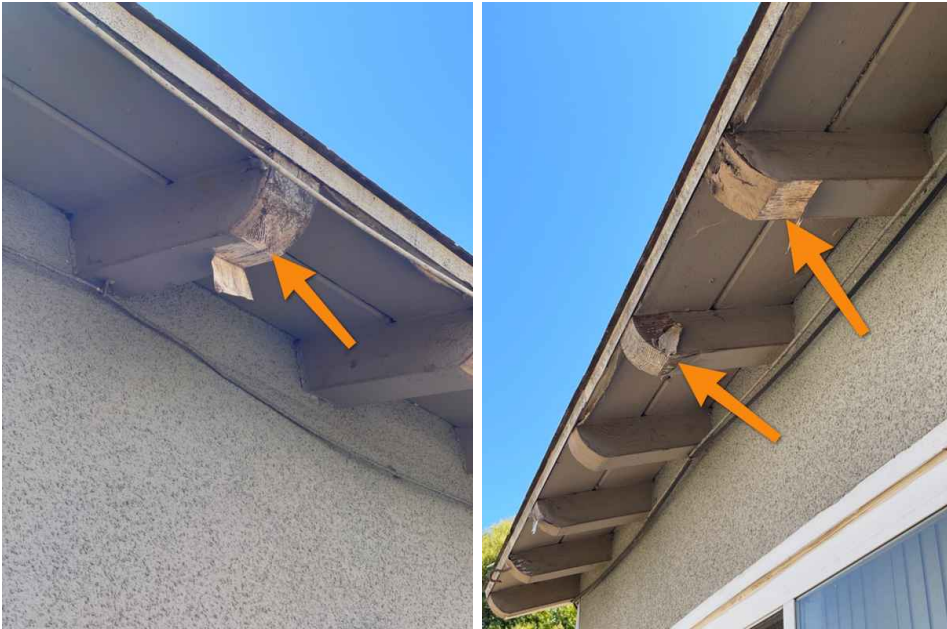
1.6.1 Eaves/Overhangs/Fascia

ROOF BEAMS ARE WEATHERED AND PATCHED

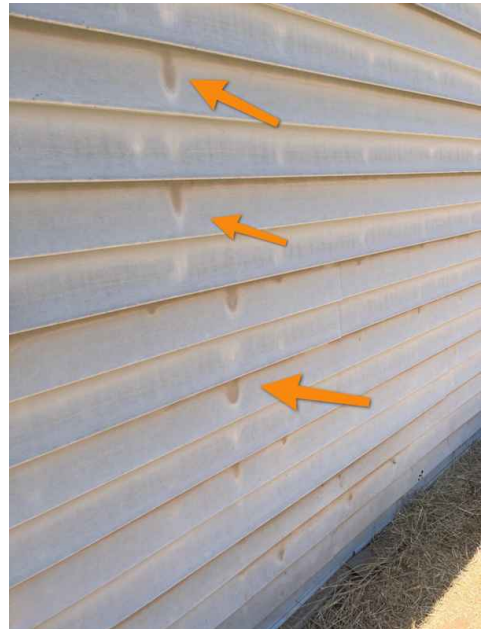
1.9.1 Vinyl Siding

VINYL SIDING IS FADED IN AREAS

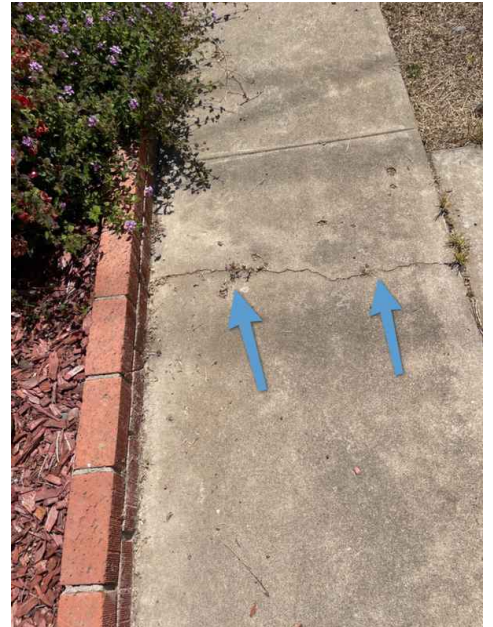
2.2.1 Driveway and
Walkway Condition

CONCRETE - HAIRLINE CRACKS

Contact a qualified professional.

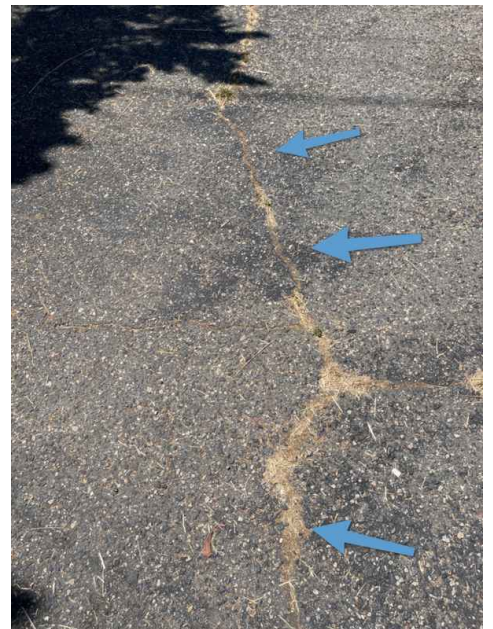
2.2.2 Driveway and
Walkway Condition

ASPHALT - CRACKING

There were cracks present on the asphalt driveway. Rainwater can freeze in these cracks in winter months allowing for additional damage to the asphalt. Properly sealing the cracks is recommended to be conducted by a qualified person.

Contact a qualified professional.

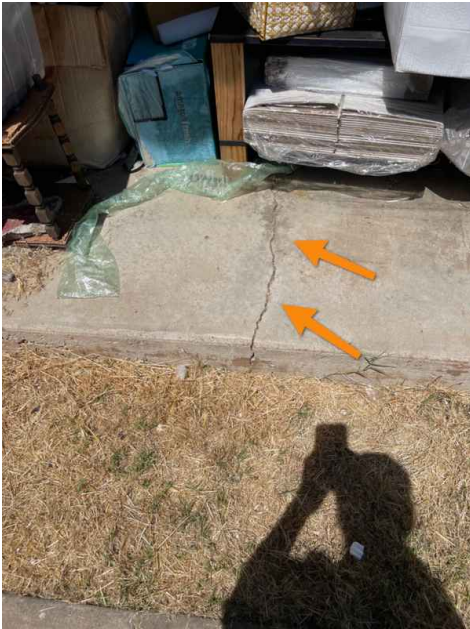
2.4.1 Patio

PATIO SLAB - MODERATE CRACKING

Moderate settlement cracks were present on the patio surface. if a concern, repairs are recommended to be conducted as deemed necessary by a concrete contractor.

Contact a qualified concrete contractor.

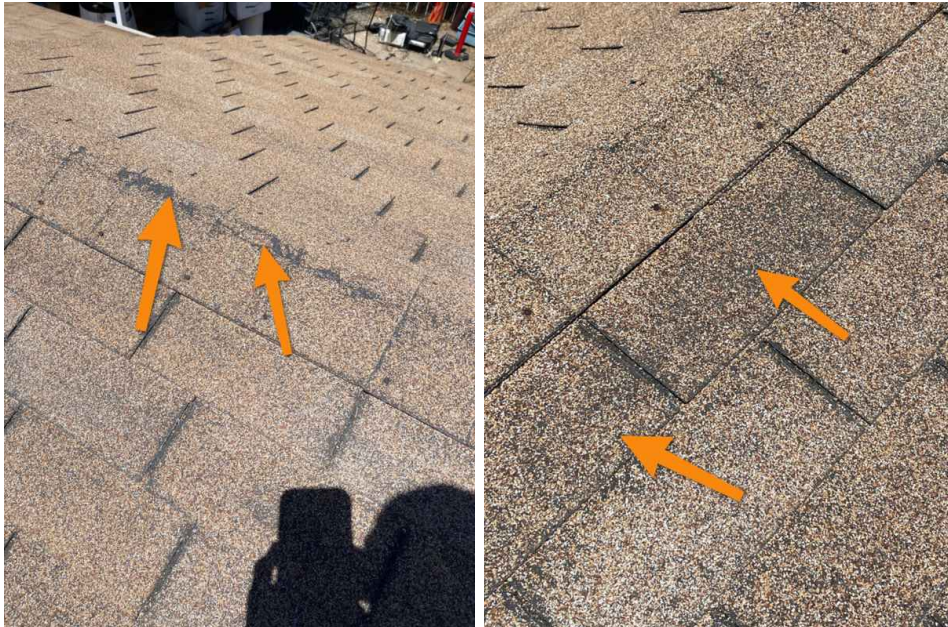
The shingles had heavy granule loss in areas. While granule loss is a typical part of the aging process, heavy granule loss is an indicator that the shingles are nearing the end of their useful life, and the loss appeared to be somewhat excessive for the age of the shingles. An evaluation of the roof covering is recommended to be conducted by a qualified roofing contractor to ascertain a better understanding of the remaining life of the shingles.

Contact a qualified roofing professional.

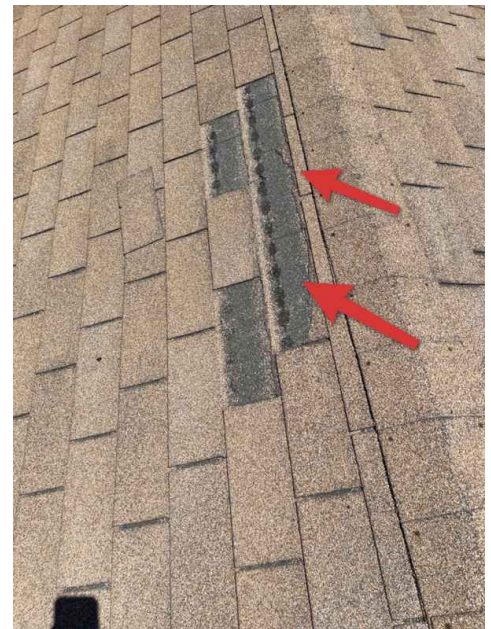
4.4.2 Shingles

SHINGLES - MISSING

There were missing shingle(s) present on the roof surface. Repairs are recommended to be conducted as needed by a roofing contractor or other qualified person.

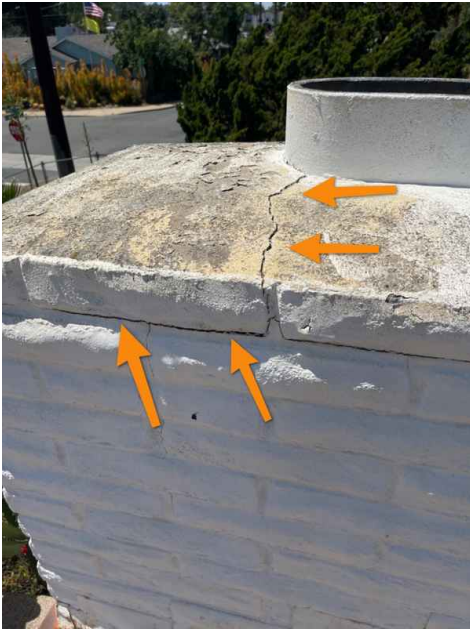
4.7.1 Chimney

CROWN - CRACKING

The chimney crown had some degree of cracking present. This can allow for rainwater infiltration into the masonry, and in freezing temperatures this infiltrated rainwater can freeze and expand allowing for damage to the masonry. Evaluation and repairs or replacement of the crown as needed is recommended to be conducted by a chimney sweep or other qualified person.

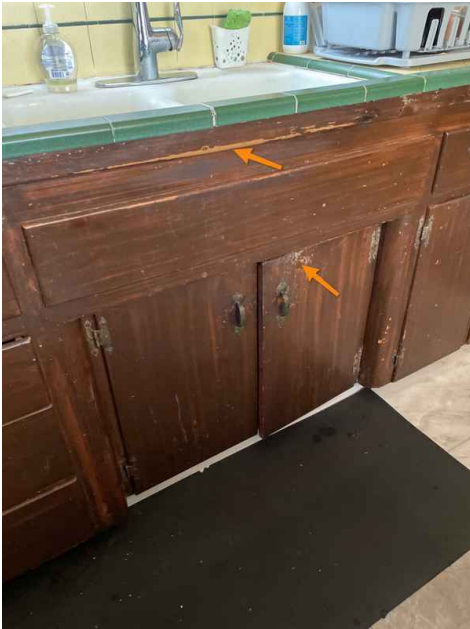
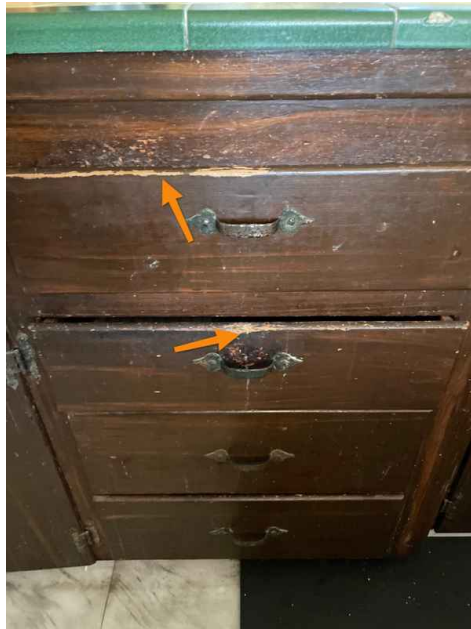
MINOR DAMAGE ON KITCHEN CABINET FINISH

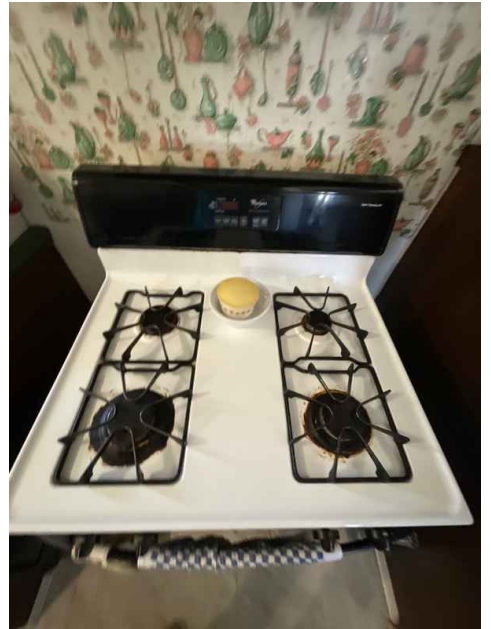
BURNER(S) - WOULD NOT IGNITE

The gas burners did not ignite for the cooktop. Repairs are recommended as needed for proper operation by an appliance repair company or other qualified person.

Contact a qualified professional.

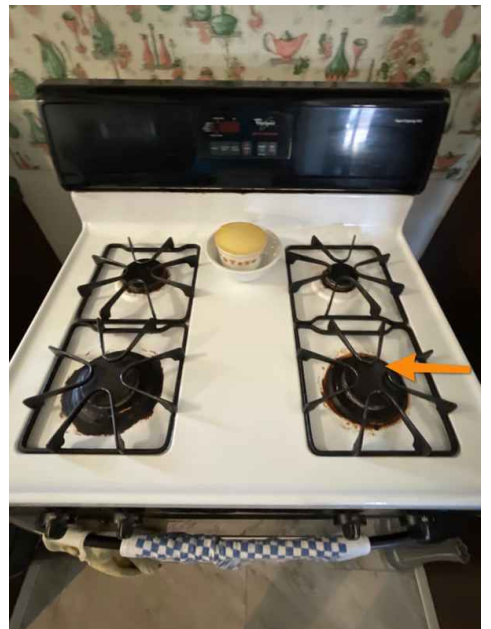
5.9.2 Cooktop

NOT ALL BURNERS WORK PROPERLY

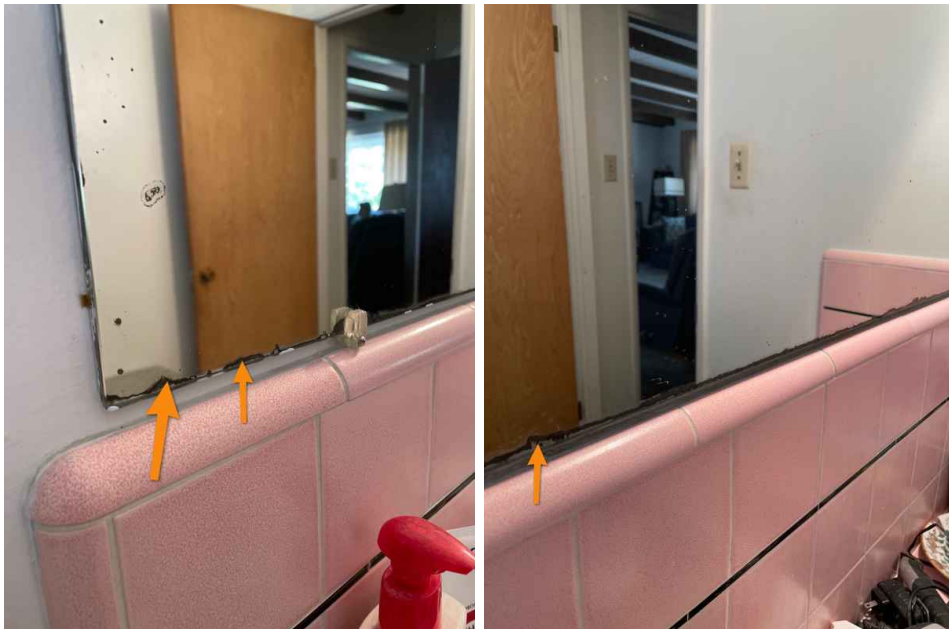
6.3.1 Mirror(s)

MAJOR MIRROR EDGE DAMAGE

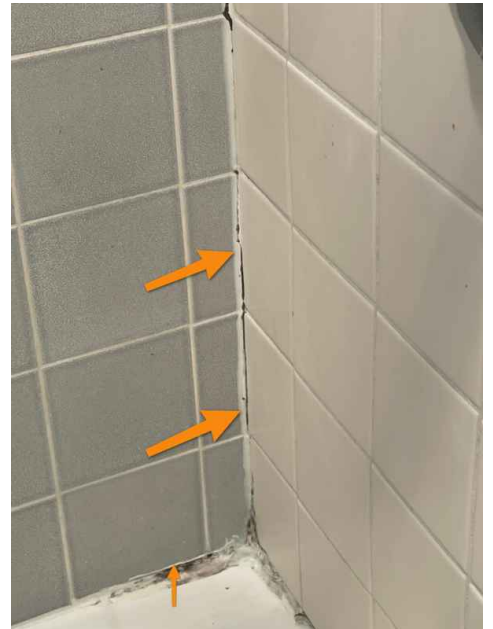
6.9.1 Shower Walls

SHOWER GROUT/SEALANT - IN NEED OF MAINTENANCE

Cracks and/or gaps was present on areas of the sealant on the shower walls. Re-sealing these areas as needed to prevent water infiltration is recommended to be conducted by a qualified person.

Contact a qualified professional.

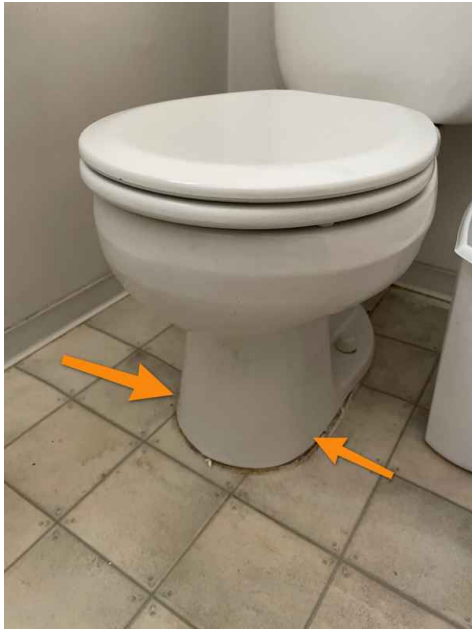
6.11.1 Toilet(s)

TOILET - LOOSE AT FLOOR

The toilet was loose at the floor anchor bolts. This can hinder a proper connection between the wax ring and toilet flange, which could allow for leaking. Evaluation of the toilet and wax ring, and re-securing as needed to ensure no leaking will occur is recommended to be conducted by a licensed plumber.

Contact a qualified plumbing contractor.

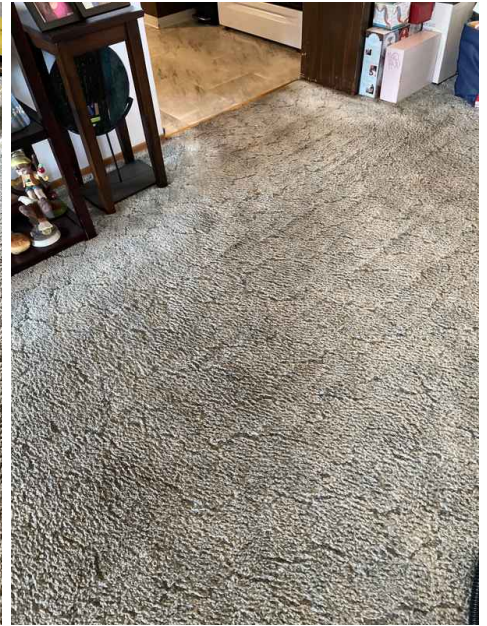
Floor Condition: Carpet Stains

Stains were present on the carpet in areas.

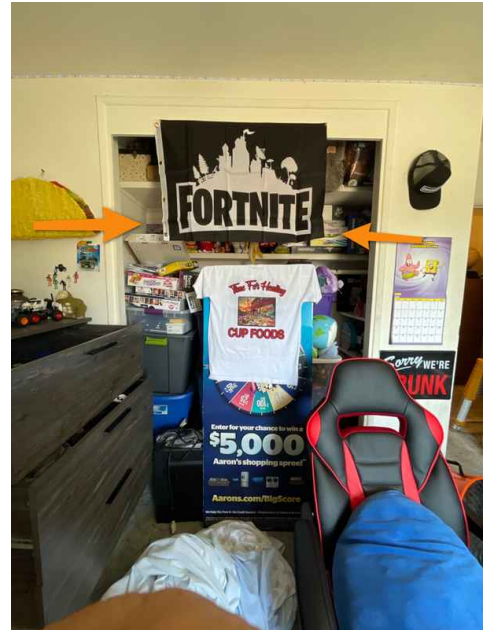
CLOSET DOOR MISSING

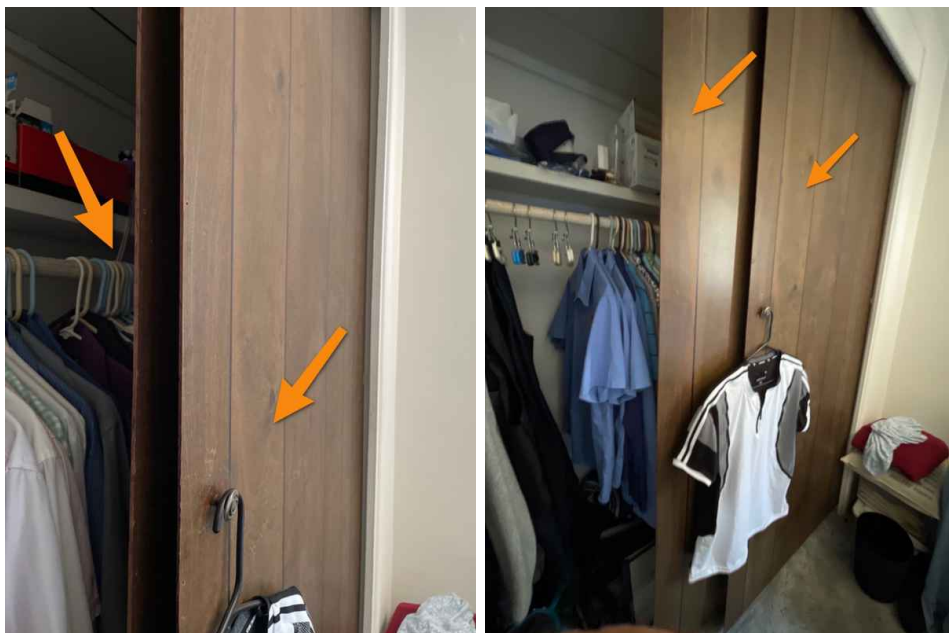
7.3.2 Closets

PANELING DOORS

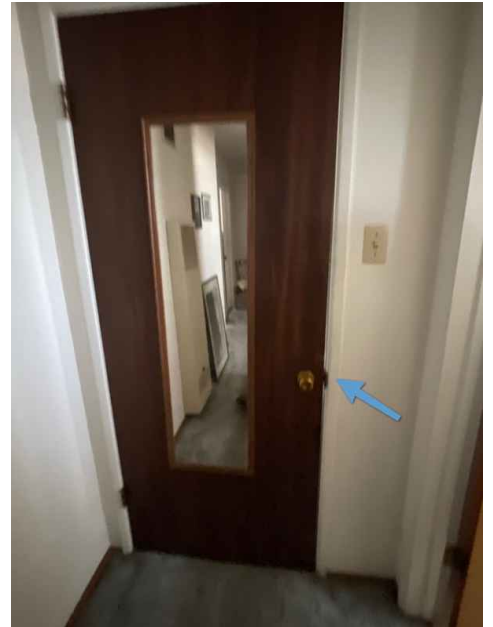
7.4.1 Interior Doors

The door was not latching properly. Adjustments or modifications as needed for proper operation is recommended to be conducted by a qualified person.

Contact a qualified handyman.

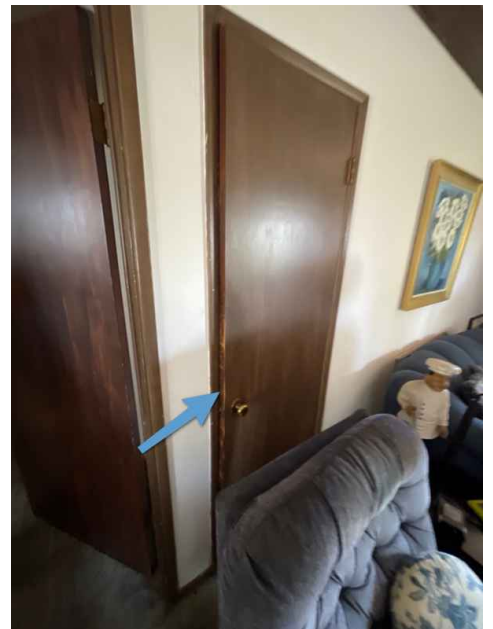
7.4.2 Interior Doors

There were door(s) that were binding / rubbing on an adjacent surface. Adjustments or modifications are recommended to be conducted by a qualified person as needed for proper operation.

Contact a qualified handyman.

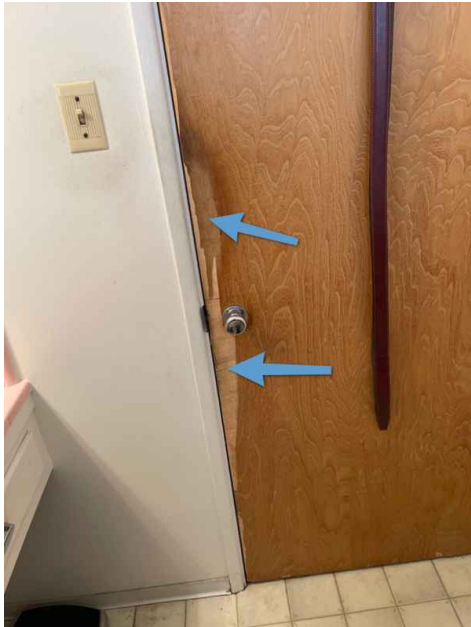
7.4.3 Interior Doors

**INTERIOR DOOR -
DAMAGED**

The referenced door(s) contained some degree of damage. Repairs or replacement of the doors as needed is recommended to be conducted by a qualified person.

Contact a qualified handyman.

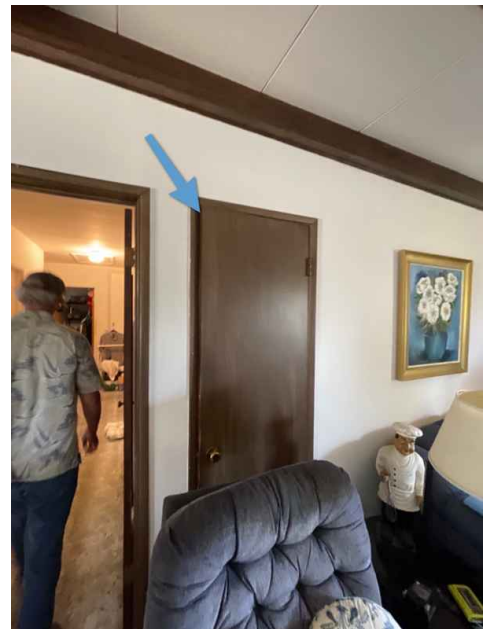
7.4.4 Interior Doors

The door was not functioning properly; this could be due to it not latching, binding or rubbing on a jamb or the floor, or another functional deficiency. These are typically easy modifications or repairs that are recommended to be conducted by a qualified person to achieve proper operation.

Contact a qualified professional.

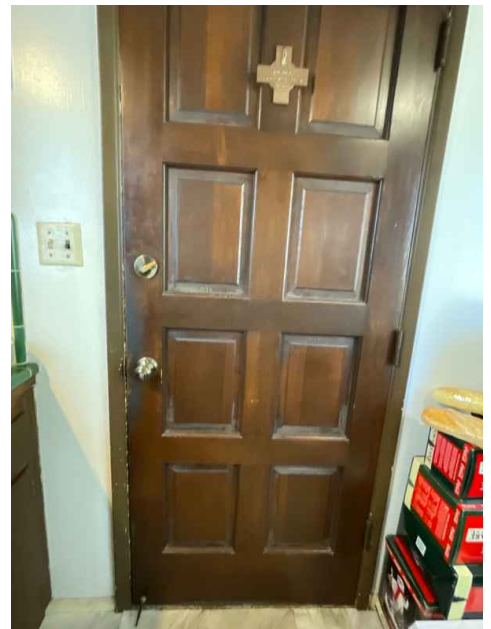
7.4.6 Interior Doors

DOOR WORN AND AGED

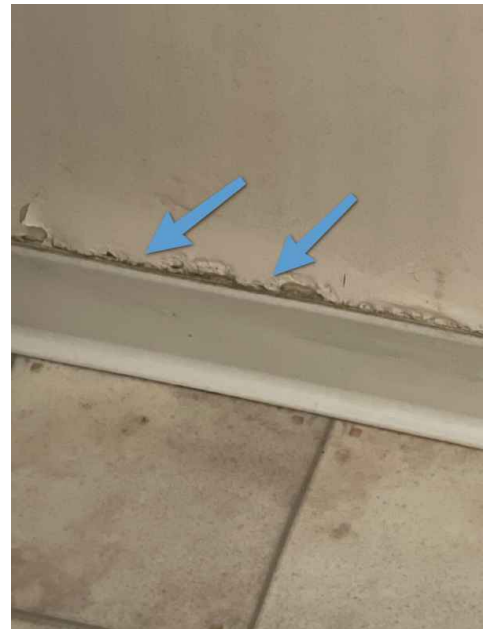
7.6.1 Wall Condition

**DRYWALL -
COSMETIC DAMAGE**

Cosmetic damage was on the drywall in areas. Repairs recommended as needed by a drywall contractor.

Contact a qualified professional.

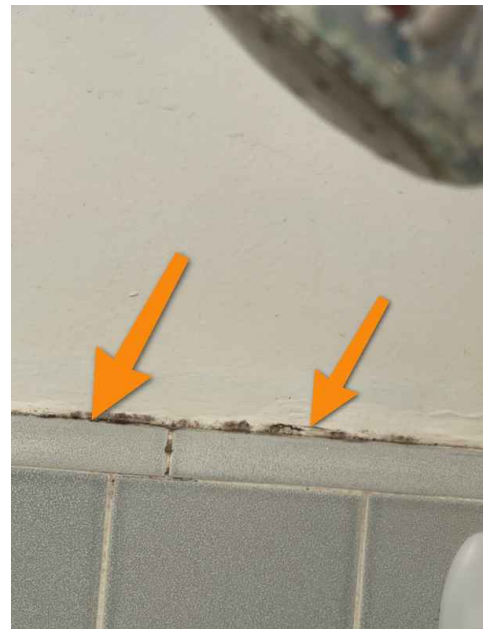
7.6.2 Wall Condition

MOLD POSSIBLE ON WALL

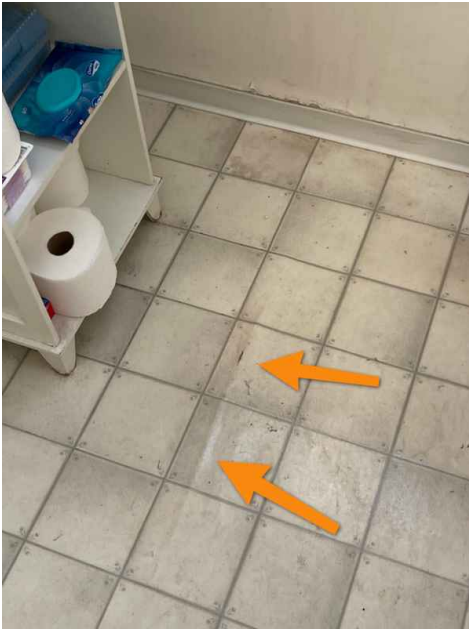
7.8.1 Floor Condition

VINYL FLOORING - BUCKLED

The vinyl flooring was not properly adhered to the subfloor and was buckled. Repairs are recommended as needed by a flooring contractor.

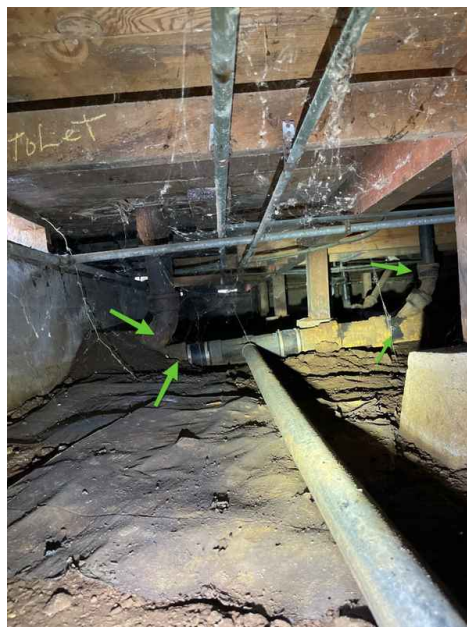
Some of the drain lines had been replaced with new ABS pipe

The remaining original cast iron drain lines looked to be in good condition

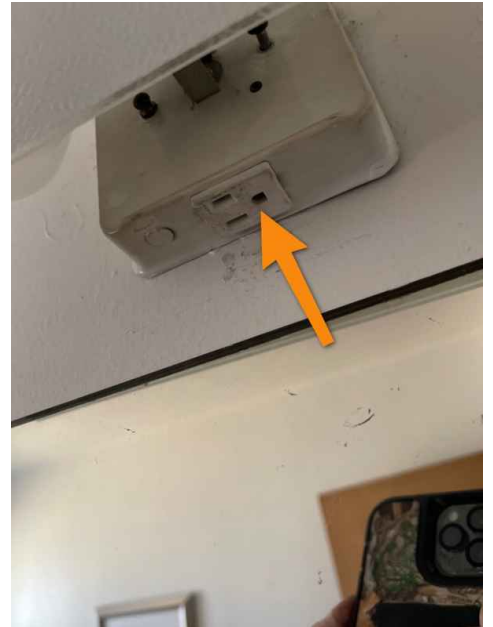
13.7.2 GFCI Protection

GFCI - NOT PRESENT ON ALL BATHROOM RECEPTACLES (UPGRADE)

Contact a qualified electrical contractor.
