# PACIFIC CREST HOME INSPECTIONS

## INSPECTION REPORT BY PACIFIC CREST INSPECTIONS

937 Westport Ln  
Vista, CA 92084

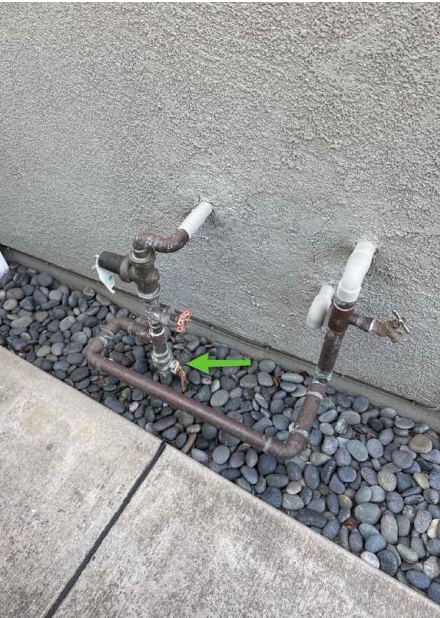
**Main Water Shut-Off Device  
(Describe Location): Main Water  
Shut off Location**  
Left Side of the Building

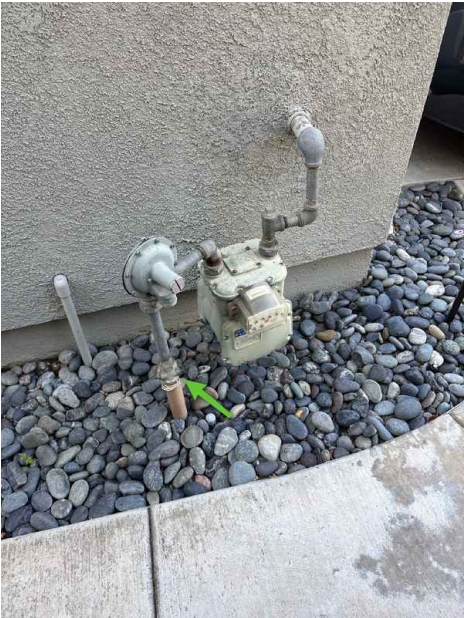
**Main Gas Shut Off Valve  
(Describe Location): Main Gas  
Shut Off Valve Location**  
Left Side of the Building

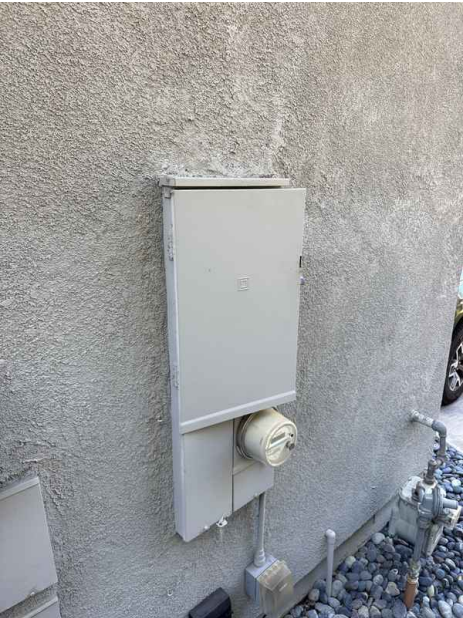
**Main and Distribution Panels  
(Describe Location): Main Panel  
Location**  
Left Exterior

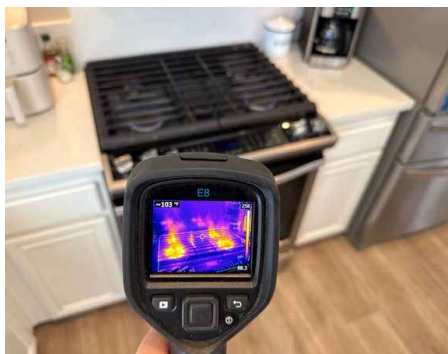
#### Ranges and Cooktops: Thermal Image Showing Operation

Infrared picture of range/cooktop in operation. This image shows function of the operable range burners.

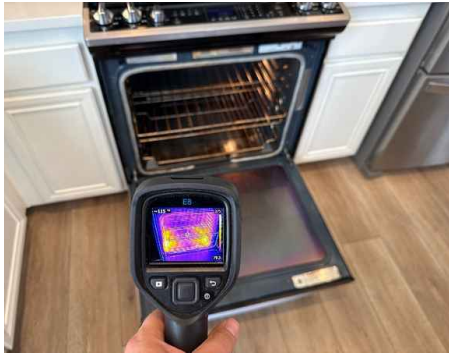
## Wall Oven: Thermal Image Showing Operation

Infrared picture of oven in operation. This image shows function of the operable oven heat source.

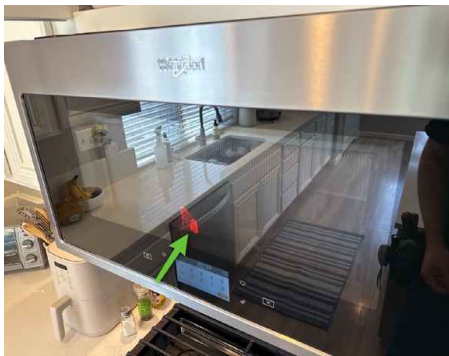
## Built-In Microwave : Picture of Microwave During Operation

The operation of the microwave was tested using a microwave tester. This unit appeared functional at the time of inspection.

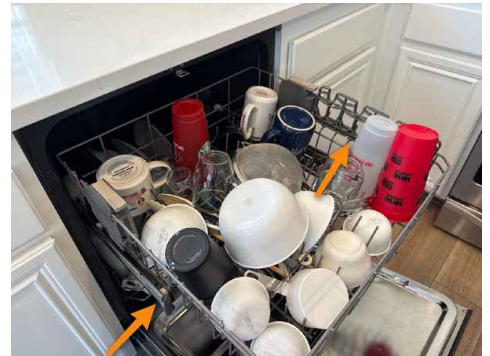
#### ROLLERS MISSING

The dishwasher trays were noted missing rollers. Advise correction to allow for proper operation.

Recommendation

Contact a qualified appliance repair professional.

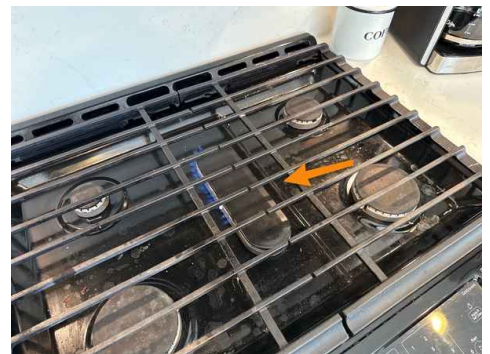
### 3.2.1 Ranges and Cooktops

#### BURNER INOPERABLE

Recommendation

Contact a qualified appliance repair professional.

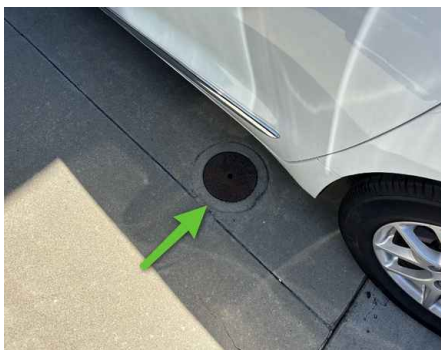
Driveway

#### Plumbing Drain, Waste and Vent Systems: Cleanout Location

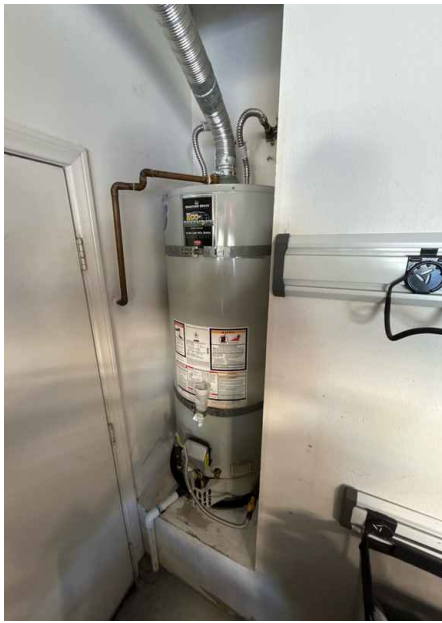
## Water Heaters, Controls, Flues and Vents: Picture of Water Heater

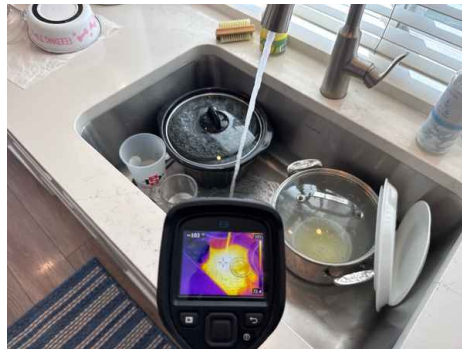
## Water Heaters, Controls, Flues and Vents: Thermal Image Showing Operation

Thermal image showing production of hot water at the sink location.

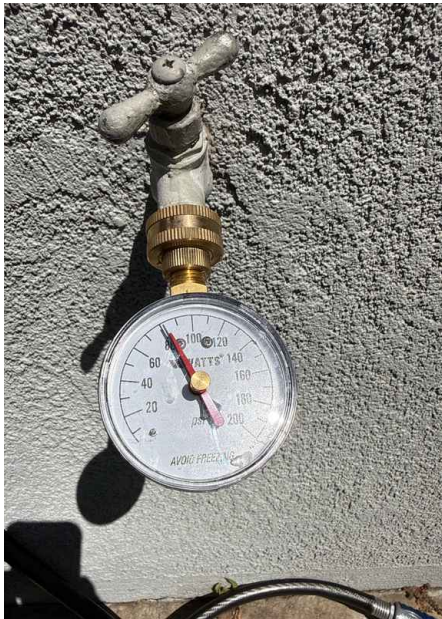
## Water Pressure: Water Pressure Normal

Water pressure was noted within normal operation parameters.

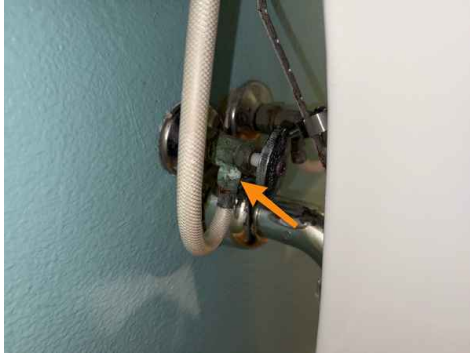
#### ANGLE STOP CORRODED

#### Recommendation

Contact a qualified plumbing contractor.

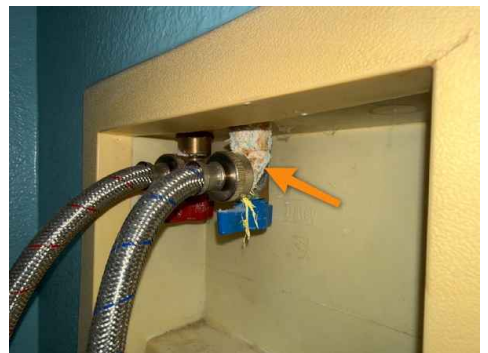
- ⚠️ 4.3.2 Plumbing System - Fixtures and Connected Devices : Laundry Valves Rusted
- ⚠️ 4.3.3 Plumbing System - Fixtures and Connected Devices : Sink Stopper Defect

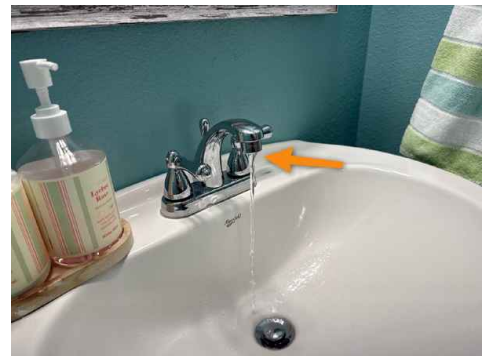
Half Bathroom

- ⚠️ 4.3.4 Plumbing System - Fixtures and Connected Devices : Low Flow
- ⚠️ 4.4.1 Plumbing System - Tub/Shower Fixtures: Tub Diverter Servicing
- ⚠️ 4.4.2 Plumbing System - Tub/Shower Fixtures: Tub Stop Missing

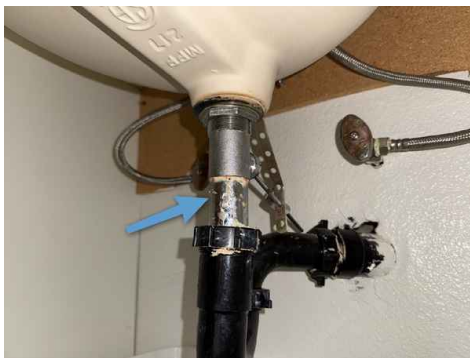
Hall Bathroom

- 🔧 4.5.1 Plumbing System - Plumbing Drain, Waste and Vent Systems: Previous Leak
- ⚠️ 4.5.2 Plumbing System - Plumbing Drain, Waste and Vent Systems: Leak-Sink

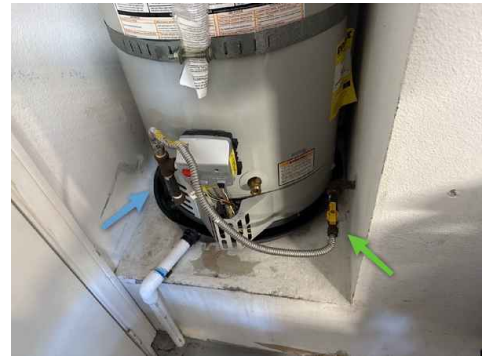
**SEDIMENT TRAP IMPROPER**

Observation Item

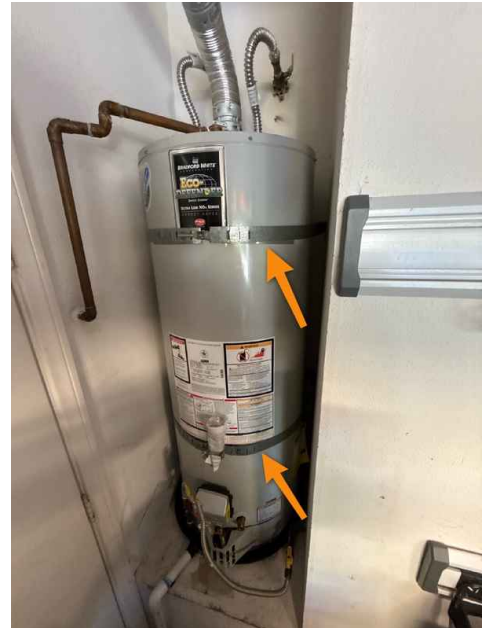
## 4.8.1 Water Heater Strapping/Bracing

**STRAPPING SHOULD ENCIRCLE TANK**

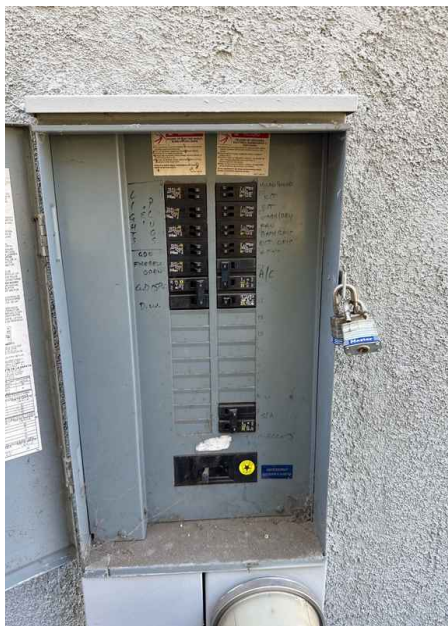
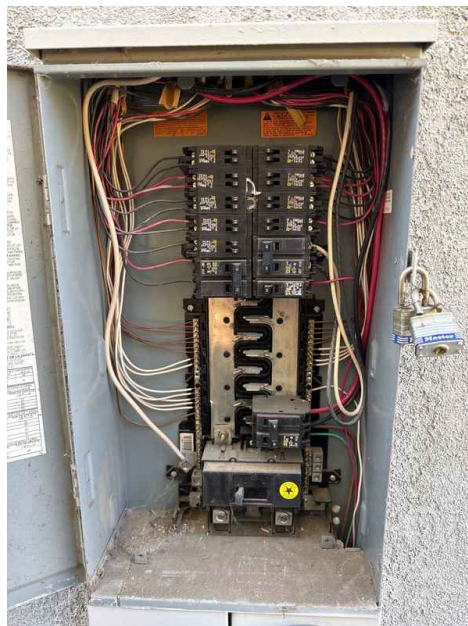
#### Main and Distribution Panels: Picture of Panels

Pictures of electrical panel(s).

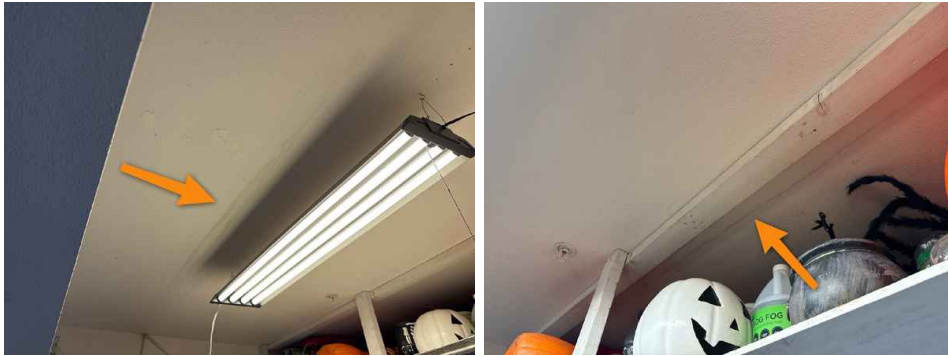
#### 7.2.2 Garage Ceiling/Roof Framing

##### WATER STAINS

Recommendation

Contact a qualified professional.

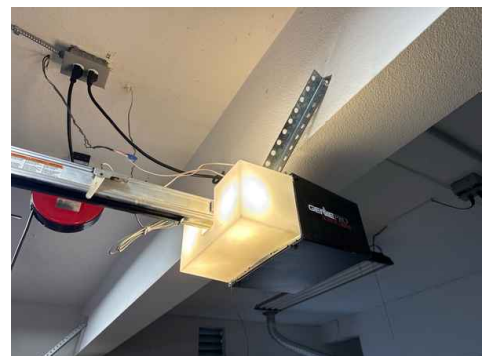
#### 7.7.1 Garage Door Operators

The garage door opener does not appear to be equipped with a back up battery. This is a modern building requirement and is a recommended upgrade for safety. Advise consulting a licensed garage door contractor to determine cost of necessary correction.

##### Recommendation

Contact a qualified garage door contractor.

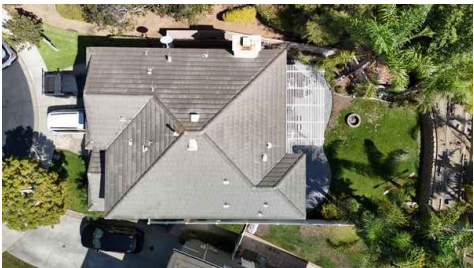
### INSPECTED FROM GROUND (UNSAFE MOUNTING CONDITIONS)

Portions of the roof covering was inspected from the ground and attic due to pitch or unsafe mounting conditions. This is in accordance with the CalNACHI standards of practice. The entire roof was not visible. I cannot guarantee that all of the roof materials, flashings, and roof penetrations are in good condition. I recommend that you have the roof inspected by a licensed roof contractor if you are concerned that there may be tiles that are broken or have slipped out of position.

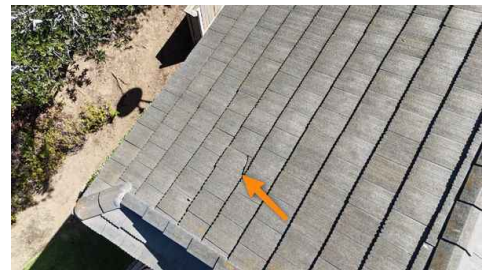
Attention Item

Slipped/cracked tiles noted. The roof covering was inspected from the ground and attic to avoid damaging the roof covering, and possibly voiding the warranty. This is in accordance with the NACHI standards of practice. The entire roof was not visible, and there may be additional defects. Advise maintenance review of the entire roof and necessary corrections by a licensed roofer.

Recommendation

Contact a qualified roofing professional.

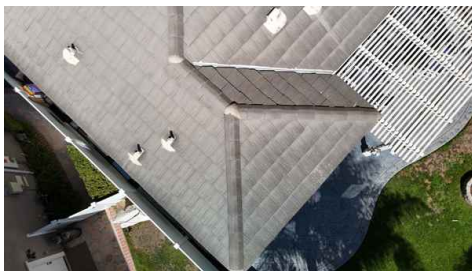
#### WEAR/DETERIORATION (GENERAL)

Wear and deterioration noted at roof covering due to age and sun exposure. This appears to be normal deterioration. However, prior to close of escrow we advise consulting with a licensed roofing contractor to review and give estimates of life remaining and necessary repairs to prevent leaks. This is also important because a home inspection is not a guarantee against roof leaks.

Recommendation

Contact a qualified roofing professional.

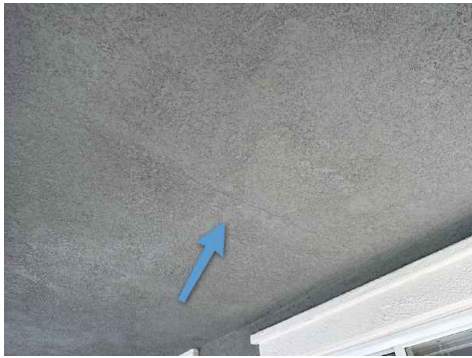
Entry Area

Stucco cracks and deterioration noted in areas. These cracks may be prone to moisture intrusion issues. You may wish to view them for yourself and have repaired by a licensed contractor.

Recommendation

Contact a stucco repair contractor

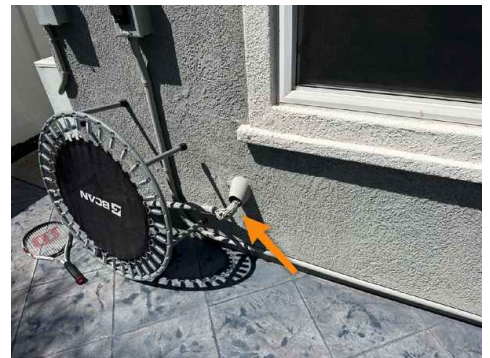
#### 10.2.2 Wall Cladding, Flashing and Trim

Gaps noted at the flashing around the a/c refrigerant lines, where the lines enter the home. I recommend sealing these gaps to prevent rodent intrusion.

Recommendation

Contact a qualified professional.

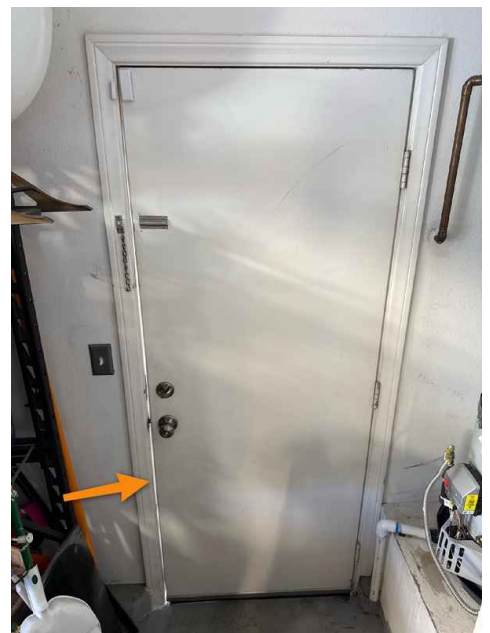
Garage

Missing or damaged weather stripping noted. This can cause drafts and lead to moisture intrusion. Advise repair by a qualified professional.

Recommendation

Contact a qualified professional.

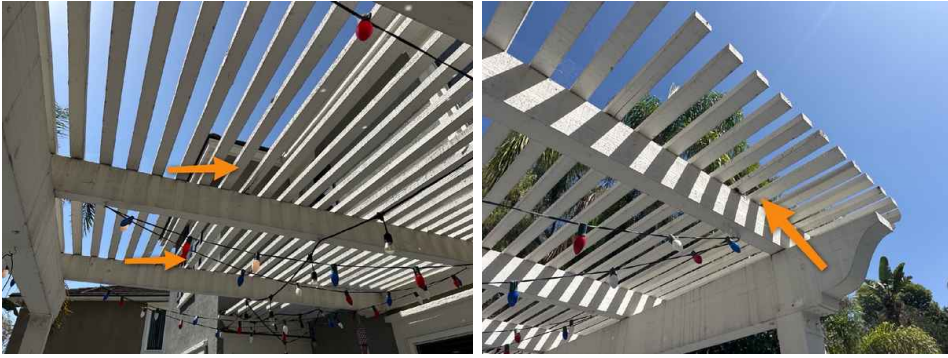
### WOOD DAMAGE

Wood damage/evidence of wood destroying organisms noted at the deck structure. Recommend consulting a licensed termite inspection company and/or decking contractor to determine corrections needed at this time.

Recommendation

Contact a qualified pest control specialist.

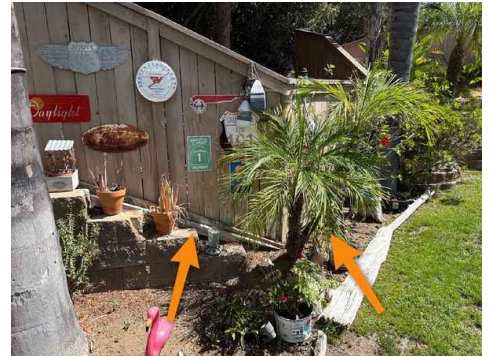
#### **WOOD DAMAGE**

Evidence of wood damage/wood destroying organisms was noted at the fencing in multiple locations. Recommend consulting a licensed fencing contractor to determine the scope of necessary repairs.

Recommendation

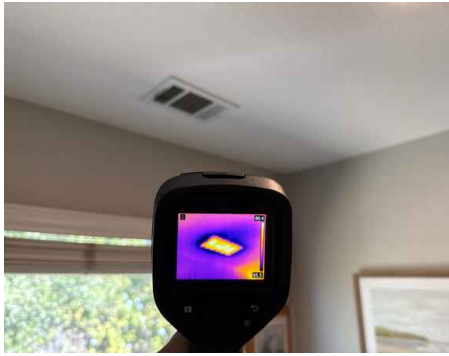
## Heating Equipment : Thermal Image Showing Operation

The furnace turned on and produced heat at the time of the inspection.
