# Cantor Property Inspection

## CONFIDENTIAL INSPECTION REPORT

7959 Caminito Dia Unit #4, San Diego, CA 92122

7/2/2026 9:00 am to 11:00 am

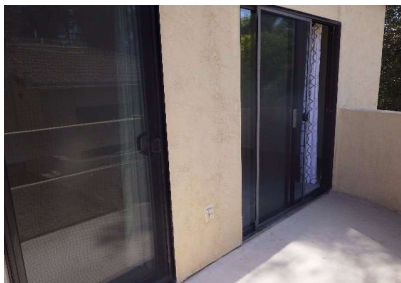
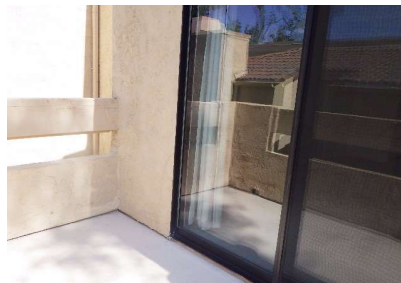
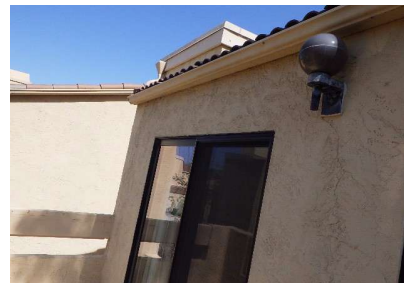
2.12 - Patching was noted in the stucco at various locations throughout the building. (Around the sliding glass door to the balcony) Further evaluation and repair by a licensed stucco contractor is advised.

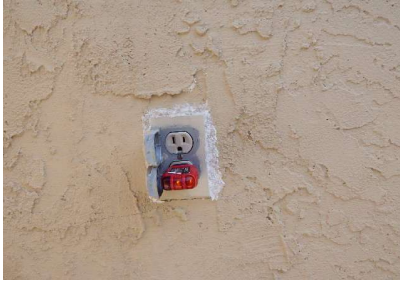
2.13 - Poor or incomplete patching was noted in the stucco around the electrical outlet on the balcony. Proper repair by a licensed contractor or qualified handyman is advised.

Poor or incomplete patching was noted in the stucco around the electrical outlet on the balcony - *Continued*

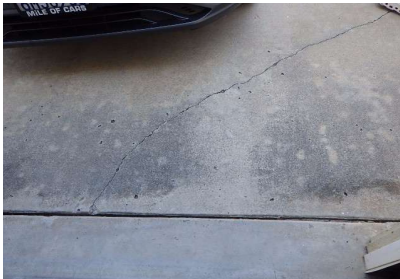
2.16 - There are cracks and offsets in the driveway that could prove to be trip-hazards, particularly for children or the elderly, which you may wish to evaluate for yourself.

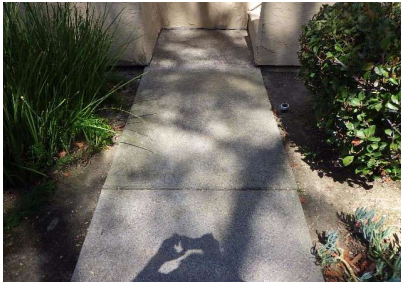
2.18 - There are several cracks and or offsets in the walkways that could prove to be trip-hazards.

There are several cracks and or offsets in the walkways that could prove to be trip-hazards - *Continued*

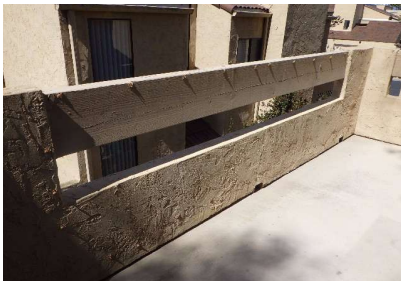
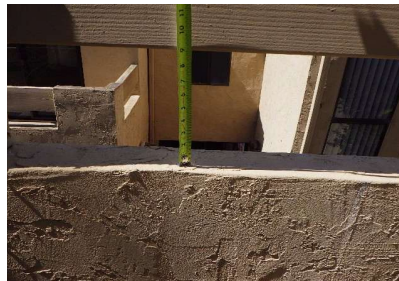
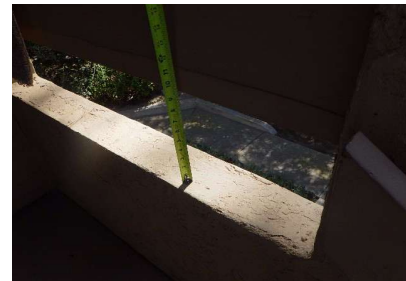
2.23 - The guardrails do not conform to current standards. They should be a minimum of forty-two inches high with pickets spaced no more than four inches for child safety, and you may wish to have them brought into compliance.

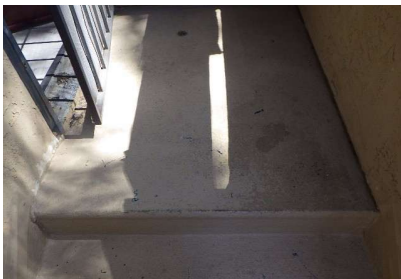
2.24 - There are cracks, damage, and or deterioration in the porch balcony surface. Further evaluation and repair by a licensed deck coating contractor is advised during the contingency period of the escrow.

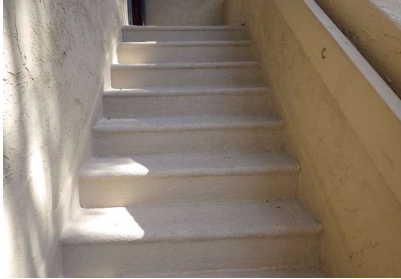
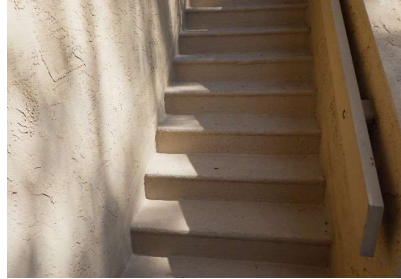
2.26 - There are cracks, damage, and or deterioration in the waterproof step surface. Further evaluation and repair by a licensed deck coating contractor is advised during the contingency period of the escrow.

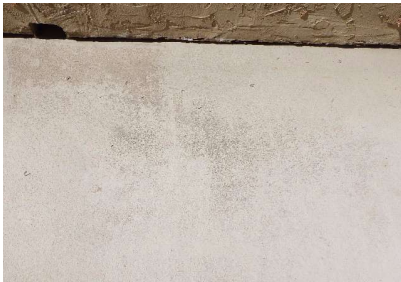
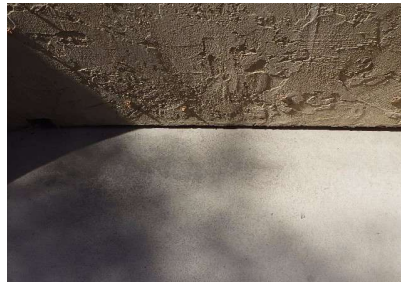
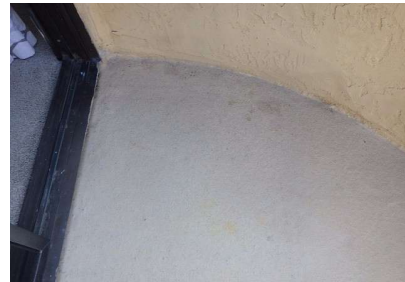
2.28 - There are cracks, damage, and or deterioration in the balcony surface. Further evaluation and repair by a licensed deck coating contractor is advised during the contingency period of the escrow.

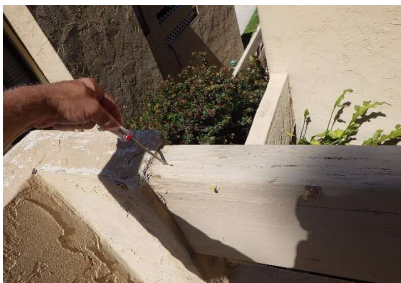
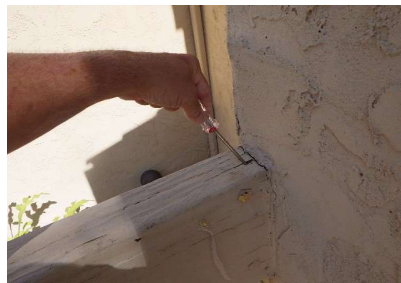
2.29 - There is signs of possible termite and or moisture damage to the balcony railings that should be further evaluated and repaired by a licensed Pest Control Operator.

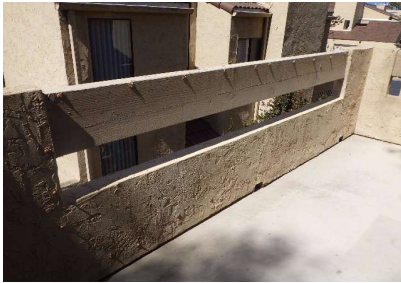
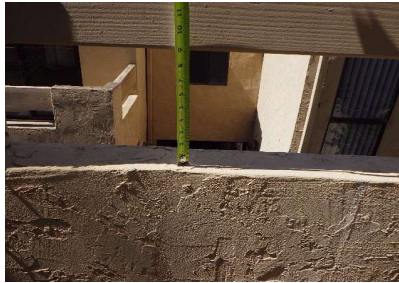
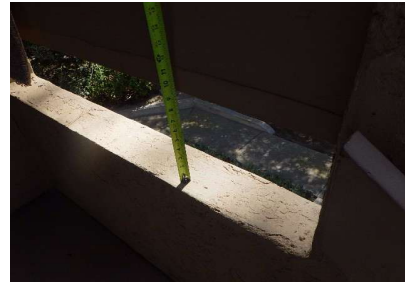
2.30 - The guardrails do not conform to current standards. They should be a minimum of forty-two inches high with pickets spaced no more than four inches for child safety, and you may wish to have them brought into compliance.

The guardrails do not conform to current standards - *Continued*

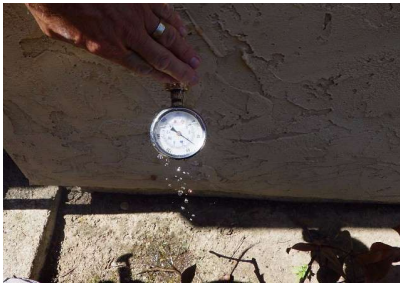
4.2 - A functional pressure regulator is in place on the plumbing system.

4.3 - The water pressure was 60 to 62 PSI when tested.

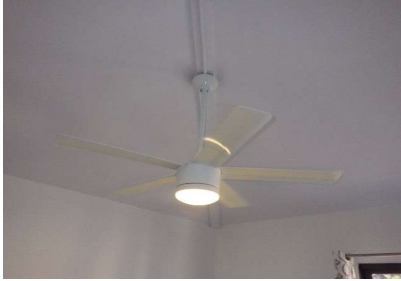
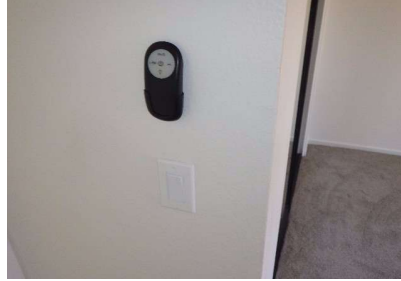
5.8 - The ceiling fan is improperly hard wired, without a required wall switch to power the fans off and on. (Guest bedroom #1) The only way to operate the fans is with a remote or by pulling the chains. Further evaluation and repair by a licensed electrician is advised.

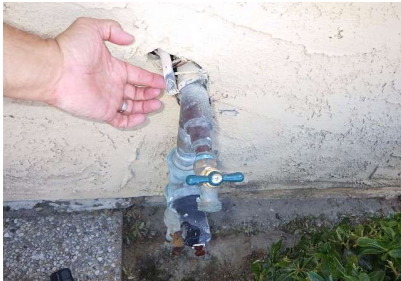
5.10 - The panel-ground to a water pipe, located at the front of the building, is detached, which should be reattached by a licensed electrician.

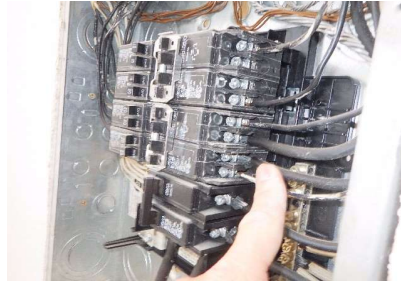
5.17 - There is no anti-oxidant grease on the aluminum wiring connections in the sub panel, which is required by current building standards, but may not have been, when the home was originally built. Installation of anti-oxidant grease, by a licensed electrician is advised.

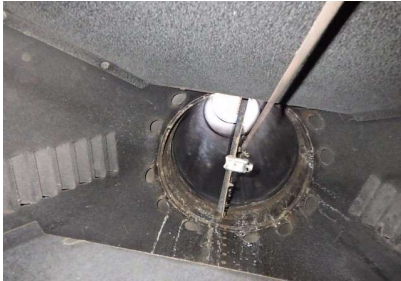
8.8 - There is minor rust, corrosion, and or stains noted on the bottom of the flue pipe inside the firebox, where the flue pipe attaches to the firebox, which may indicate a previous leak in the spark screen-weather cap, which should be monitored in the future.

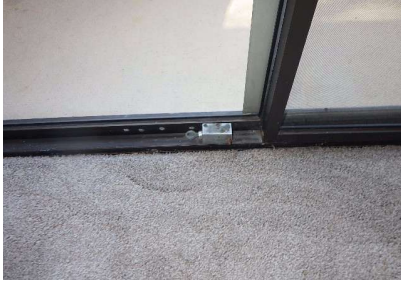
10.9 - The keyed lock on the exterior sliding glass door could prevent or impede an emergency exit, and should be replaced with a safer latch type.

The keyed lock on the exterior sliding glass door could prevent or impede an emergency exit - *Continued*

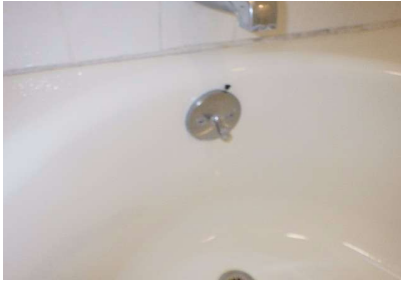
11.10 - There were chips, wear, and or deterioration noted in the bathtub finish.

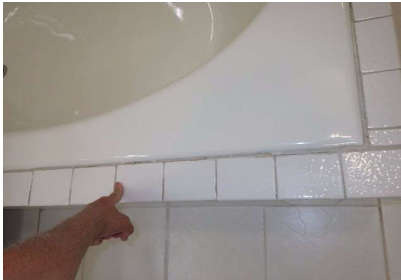
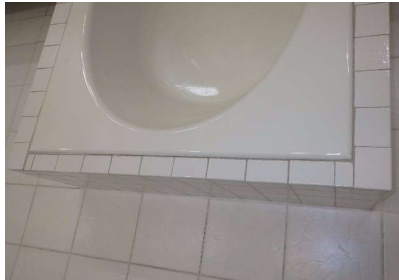
11.11 - There are cracks and or loose grout noted around the tub to tile intersection. Proper repair by a licensed contractor or qualified handyman is advised.

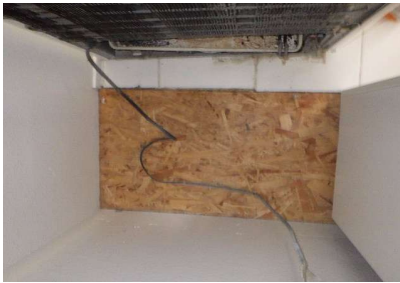
12.4 - The finished flooring is missing under the refrigerator, which you may wish to have replaced.

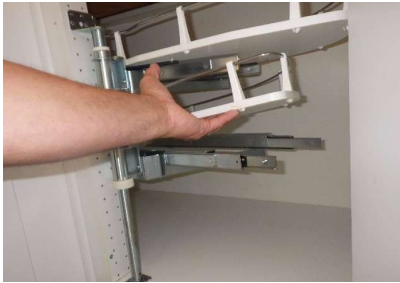
12.10 - The cabinets will need service to work well, such as replacing or adjusting drawer glides, pull latches, hinges, catches, etc. (Loose lower shelf in Lazy Susan cabinet)

The cabinets would need hardware service to work well - *Continued*

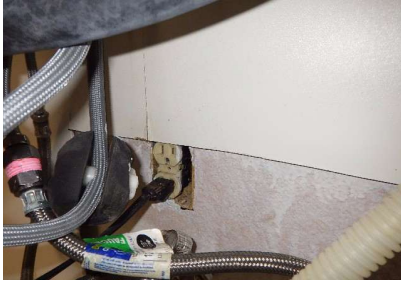
12.23 - One or more cover plates are missing at the kitchen outlets or switches. (Disposal outlet)

One or more cover plates are missing at the kitchen outlets - *Continued*

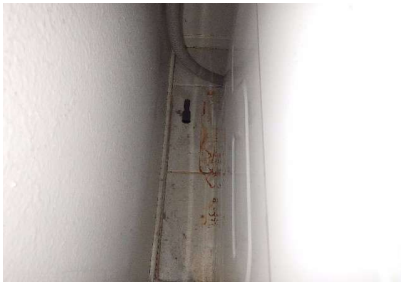
- 16.2 - The floor has no significant defects.
- 16.3 - The floor is stained and or cosmetically damaged, which you should view for yourself.

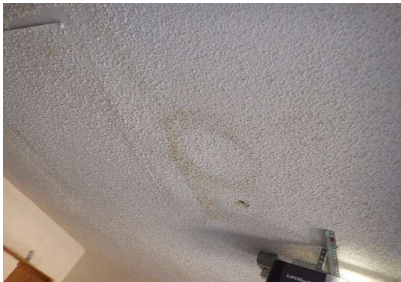
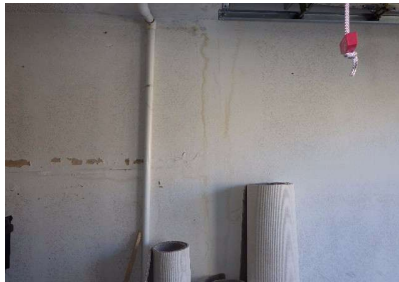
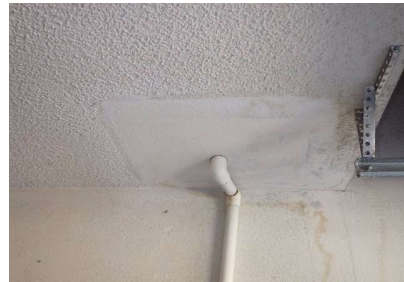
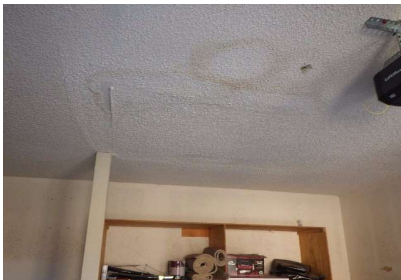
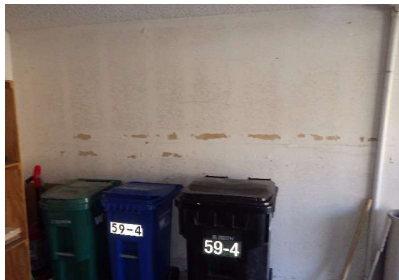
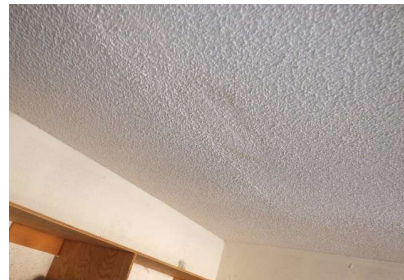
17.2 - There are moisture stains, damage, and or patching on the walls and or ceiling, the cause of which should be explained or explored further by a licensed contractor. (Reported to be from a previous repaired leak from the balcony above)

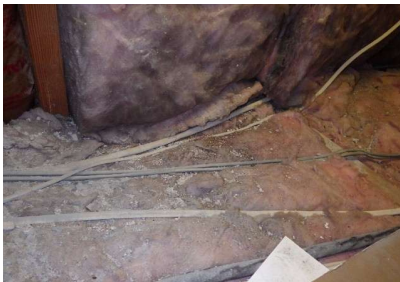
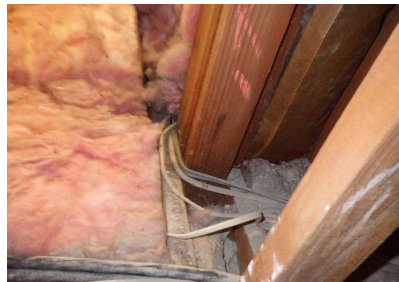
18.4 - There are signs of possible termite activity in the attic. Further evaluation and repair by a licensed Pest Control Operator is advised.

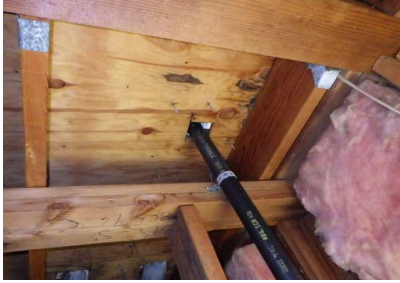
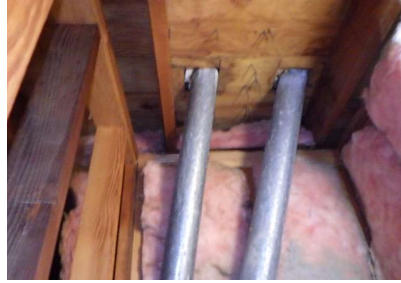
18.5 - There is evidence that the roof has leaked in various locations, which should be reasonably explained, or the roof should be further evaluated by a licensed roofer.

There is evidence that the roof has leaked in various locations - *Continued*

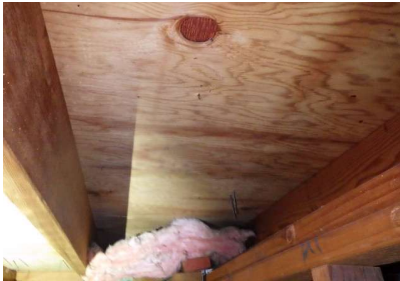
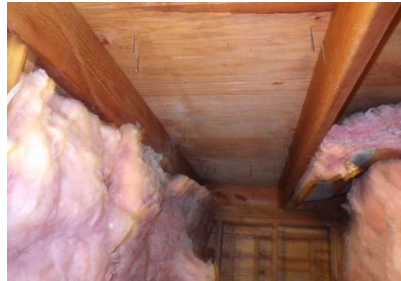
18.6 - There are exposed nails sticking through the roof sheathing, which may pose as a hazard.

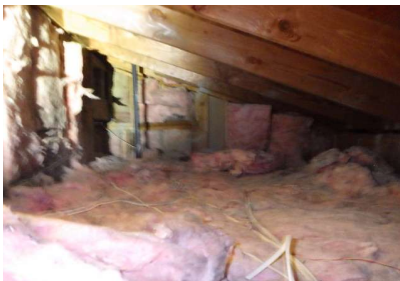
18.12 - Some of the insulation is displaced from when the home was remodeled. Reinstalling the insulation in its proper position is advised.
