## TRI RESIDENTIAL

5130 Roswell St  
San Diego, CA 92114

01/30/2026

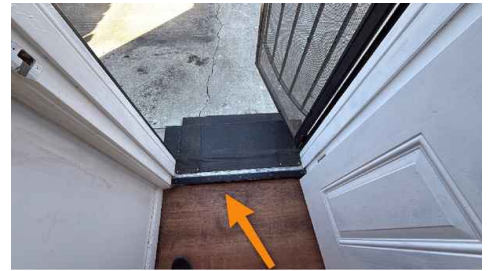
During the inspection, it was noted that the door sill or threshold is damaged, missing, or loose at one or more exterior doors. We recommend securing, repairing, or replacing the affected sills or thresholds as needed to ensure they function effectively and safely.

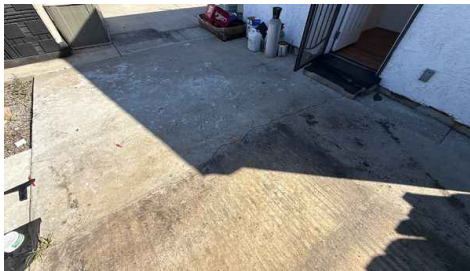
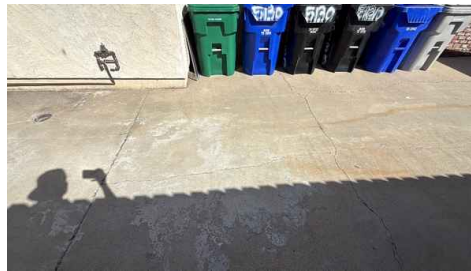
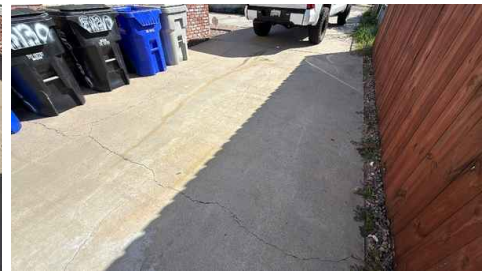
## 2.2.1 Driveway, Walkway(s), Patio

During the inspection, minor cracks were observed in the driveway and/or walkway(s). These cracks are generally a result of normal wear and tear due to the natural expansion and contraction of the materials with temperature changes and aging. While minor cracking is common and often not a cause for immediate concern, it is important to monitor these areas for any signs of worsening conditions, such as widening cracks or heaving. Routine maintenance can help to mitigate the progression of these cracks and prevent potential future issues. At this time, no significant structural impact from these minor cracks was noted. However, should you observe any changes or deterioration, further evaluation by a licensed professional may be necessary to ensure the continued safety and integrity of the surfaces.

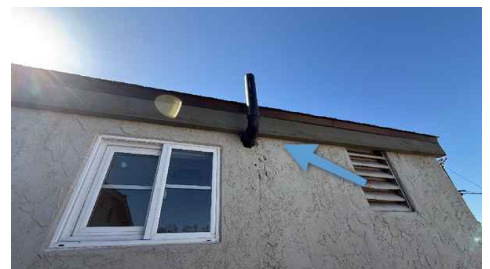
## 2.3.1 Sidings, Flashings, Trims

Caulking and sealing penetrations around the home as needed is recommended to prevent water intrusion, pest infestations, and intrusions. Properly sealing gaps and openings can help maintain the integrity of the wall components and protect against potential damage caused by pests and moisture.

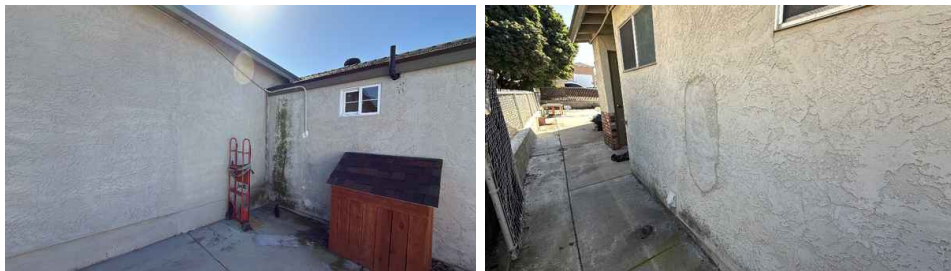
## 2.3.2 Sidings, Flashings, Trims

During the inspection, it was observed that the sidings and trim have undergone previous repairs. While these repairs may have addressed certain issues, their quality and scope are uncertain. Previous repairs can sometimes conceal underlying problems or may not have been performed to current standards. It is recommended to have a licensed professional evaluate the areas where repairs were made to ensure they were done correctly and to identify any potential underlying issues that may need further attention.

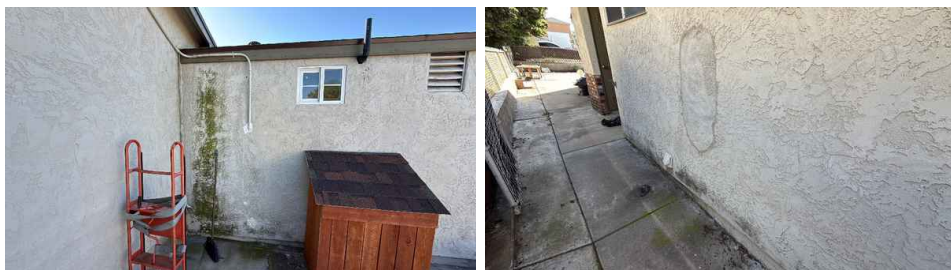
## STAINING/ALGAE/MILDEW

During the inspection, staining, algae, and/or mildew were observed on the sidings and trim. These conditions can result from moisture retention and can lead to further damage if not addressed. It is recommended to clean the affected areas to remove the staining, algae, and mildew. Additionally, addressing any underlying moisture issues will help prevent recurrence. Regular cleaning and maintenance can help preserve the appearance and integrity of the sidings and trim.

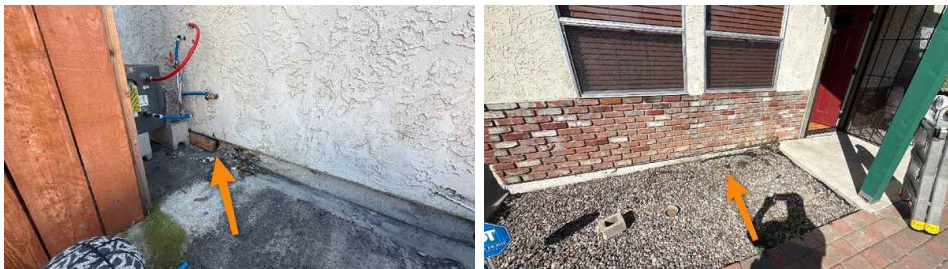
During the inspection, chips and other forms of damage were observed on the slab. These damages can result from impacts, heavy loads, or improper installation and can potentially lead to further deterioration if not addressed. It is recommended to repair the chipped and damaged areas of the slab to prevent further deterioration and maintain the slab's integrity. A licensed professional can provide appropriate repair solutions.

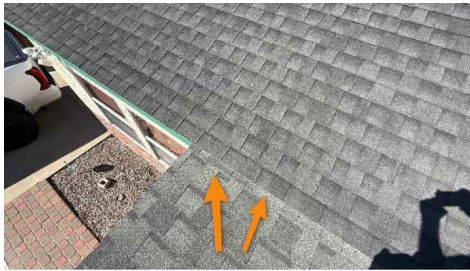
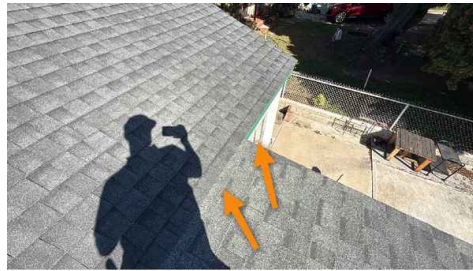
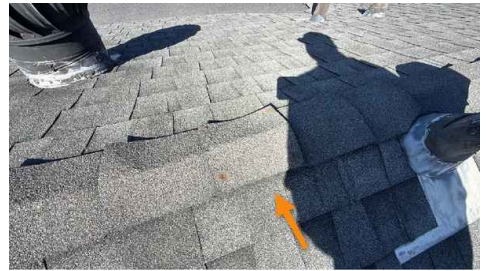
During the inspection, exposed nails or staples were noted on the shingles. Exposed fasteners can lead to water penetration and rust, compromising the roof's effectiveness. Recommend sealing or covering any exposed nails or staples to prevent potential water ingress and rust.

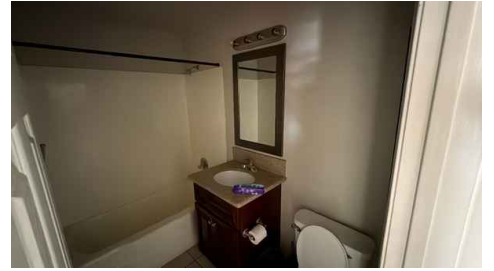
The bathroom in one or more areas did not have a outlet/receptacle. Recommend correction as needed by a licensed professional.

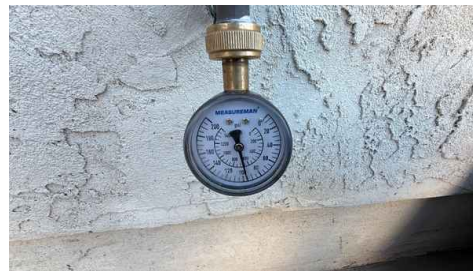
During the inspection, the water pressure was found to be too high. High water pressure can damage plumbing fixtures and appliances. Recommend installing or adjusting a pressure regulator to maintain proper water pressure levels 40-80psi.

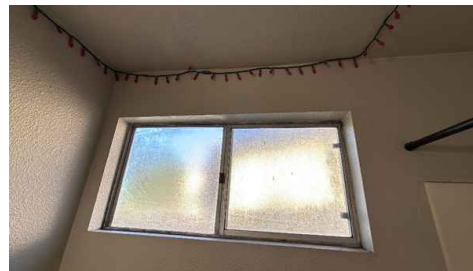
## 11.2.4 Windows

There are signs of possible dark growth around some windows. It is recommended to have a licensed professional conduct further evaluation and perform necessary corrections to address any potential mold or mildew issues and ensure a healthy environment.

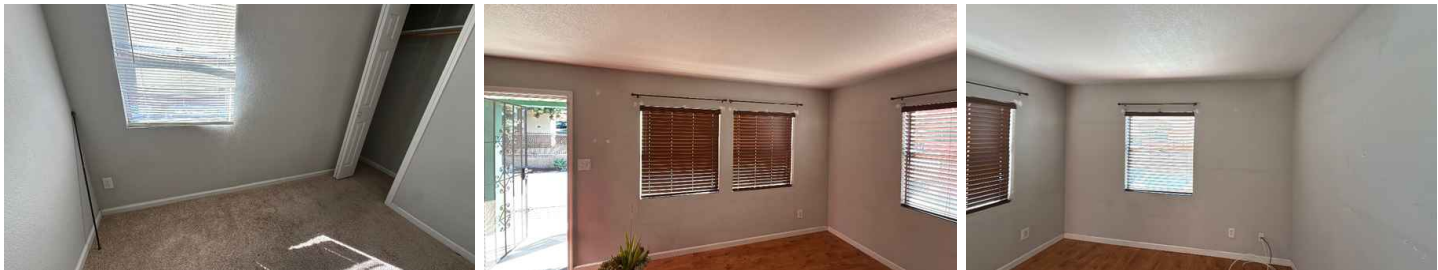
#### 11.4.2 Walls & Ceilings

Common cracks are visible on the walls and ceilings, likely due to settling or material shrinkage. It is recommended to repair the cracks as needed to maintain the integrity and appearance of the surfaces. Consider consulting a professional for proper assessment and correction.

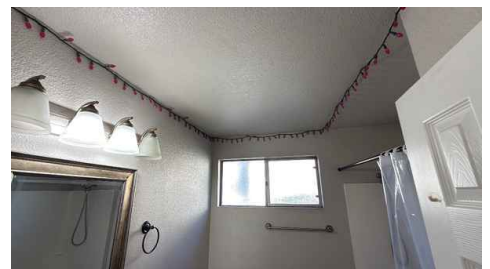
Ventilation fan(s) were not present in the bathroom(s), but rather a window was present for ventilation. While older standards may have allowed that a window could substitute for a fan, the installation of a fan is still recommended to be performed by a licensed electrician, as windows are not a feasible form of ventilation in winter months.

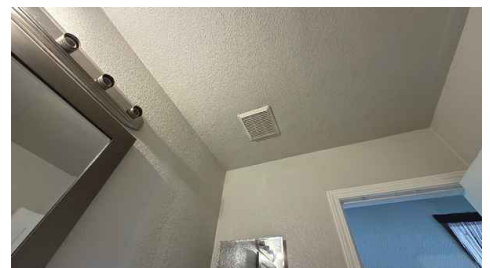
## 12.3.2 Ventilation

An irregular noise was produced from the exhaust fan. This may be from loose components, an object impeding the fan, or an indicator that the fan is nearing end of its useful life. An evaluation and repairs or replacement made as needed is recommended to be conducted by a licensed electrician.

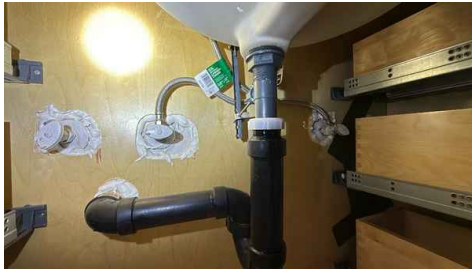
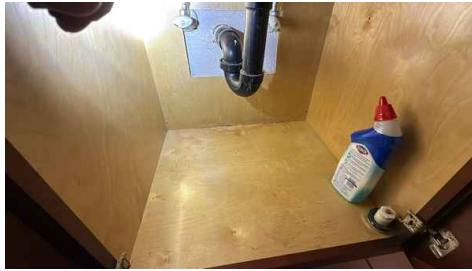
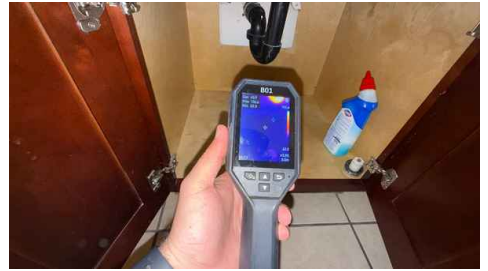
Corrosion was observed on the valves or connections beneath the bathroom sink. This could indicate age-related wear or exposure to moisture. Further evaluation and replacement of the corroded components are recommended to prevent leaks or failure.

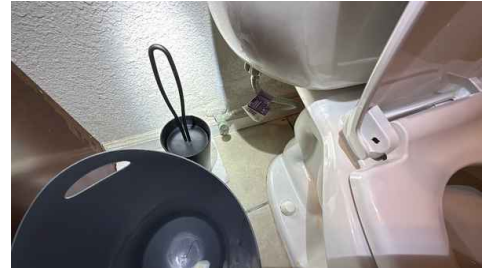
#### 12.6.1 Toilet

The shutoff valve shows signs of corrosion in one or more areas. Recommend replacing the valve to ensure proper function.

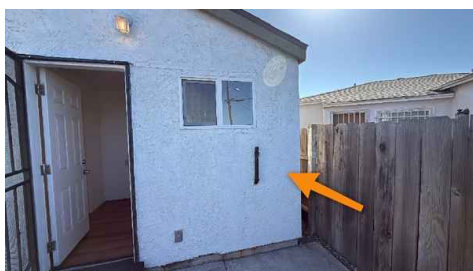
Improper termination noted to the exterior vent. Recommend further evaluation and correction as needed by a licensed professional.

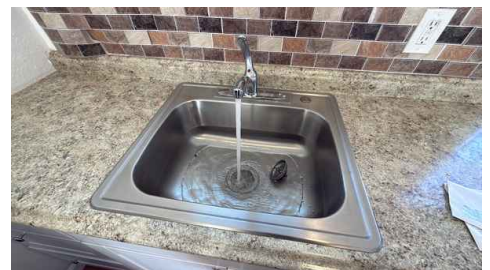
## 15.1.2 Kitchen Sink

The sink was observed to drain slowly, indicating a possible obstruction or partial clog. It is recommended that the drain be cleaned or cleared by a licensed plumbing professional to restore proper drainage.

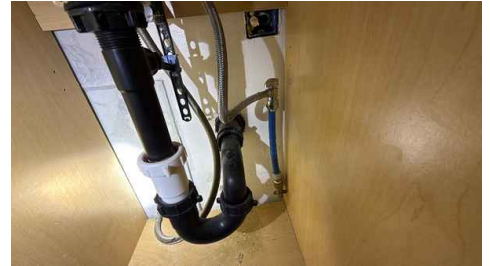
Open plumbing penetrations were noted under the bathroom sink. These openings can allow pests or moisture to enter. It is recommended to seal these penetrations to prevent potential issues.

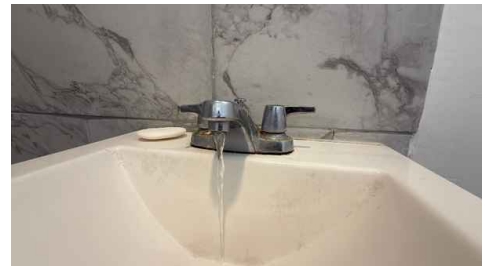
## 17.5.3 Bathroom Sink

The bathroom faucet shows signs of corrosion or damage, which could affect its performance and lifespan. Replacing or repairing the faucet is recommended to ensure it remains functional and visually appealing.

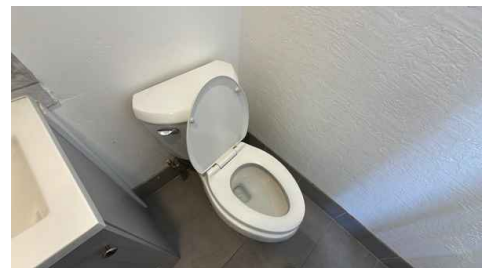
## 17.6.1 Toilet

The toilet is inoperable. It is recommended to have a licensed professional repair or replace the toilet as needed to restore functionality.

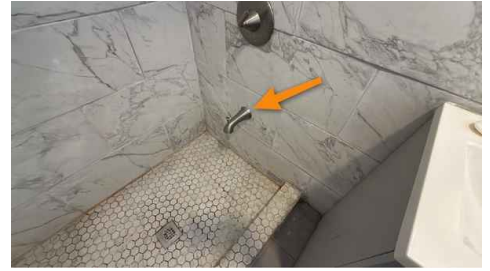
## 17.7.2 Bathtub &amp; Shower

The bathtub diverter is not engaging properly in one or more area(s). It is recommended to repair or replace the diverter to ensure proper functionality.

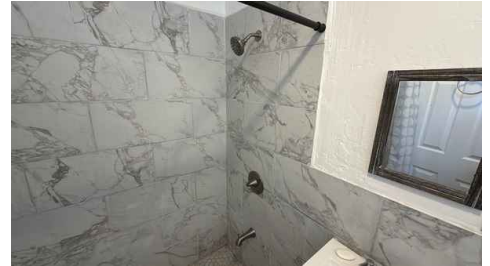
## 17.7.3 Bathtub &amp; Shower

The faucet/fixture is damaged, corroded, or rusted in one or more area(s). It is recommended to have a licensed professional repair or replace the affected component to ensure proper functionality and prevent further deterioration.
