# PROPERTY INSPECTION REPORT

**1036 Suncrest Court, Richmond, CA 94806**

DATE OF INSPECTION: 7/2/2026

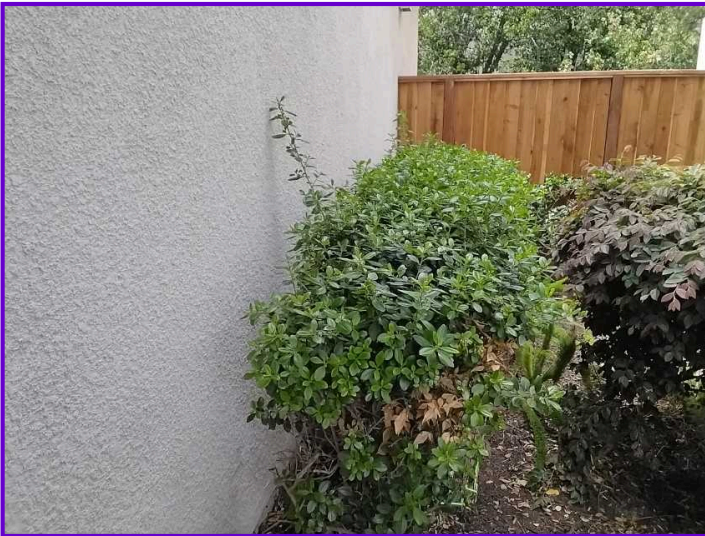
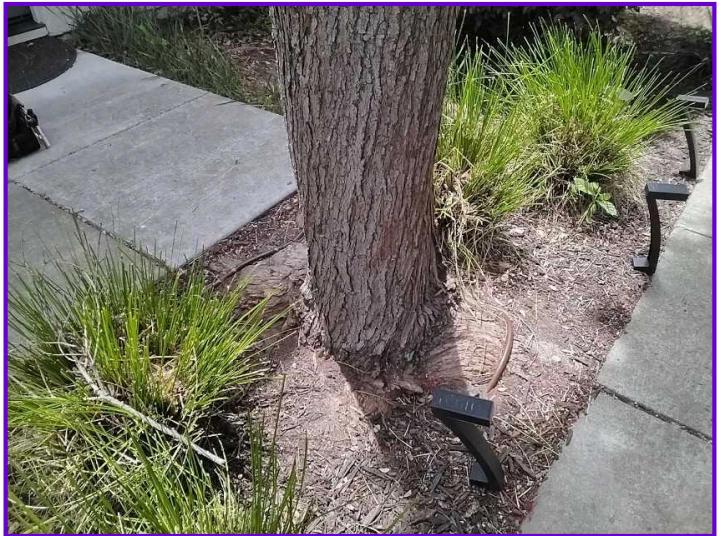
Site Features Vegetation

- **PREVENTIVE:** Mature trees were present on or near the property at the time of inspection. Tree roots can intrude into underground sewer lines and may contribute to blockages, damage, or pipe offsets over time. A sewer lateral camera inspection is recommended as a preventive due-diligence measure to evaluate the condition of the sewer line and identify potential root-related concerns. **Our office can schedule this service upon request.**

| Property Comments | | |
|---|---|---|
| Page 14 Item: 1 | Vegetation | <ul style="list-style-type: none"> <li>• <b>MAINTENANCE:</b> There is foliage growing at multiple locations around the property. Concerned parties may wish having the foliage removed or trimmed back to help prevent damage to the wall coverings.</li> <li>• <b>PREVENTIVE:</b> Mature trees were present on or near the property at the time of inspection. Tree roots can intrude into underground sewer lines and may contribute to blockages, damage, or pipe offsets over time. A sewer lateral camera inspection is recommended as a preventive due-diligence measure to evaluate the condition of the sewer line and identify potential root-related concerns. <b>Our office can schedule this service upon request.</b></li> </ul> |

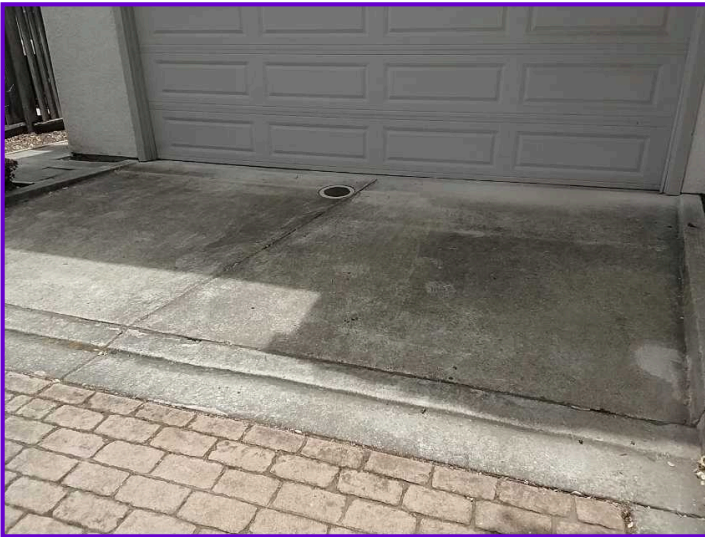
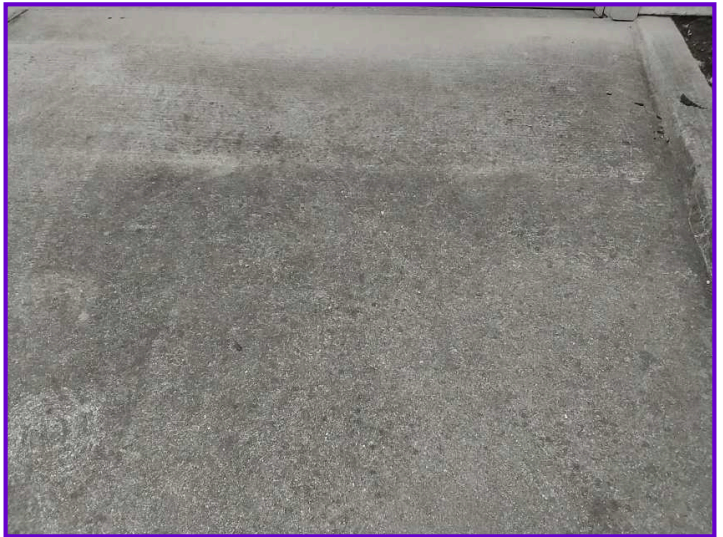
Hardscaping Driveway

- **COMMENTS:** The driveway is functional, indicating that it is in good condition and provides proper access. Regular maintenance, such as sealing any cracks and clearing debris, is recommended to ensure its longevity and continued usability.
- **COMMENTS:** The driveway is constructed using concrete. Concrete material is known for its durability and strength. Regular maintenance, such as sealing cracks and addressing any surface wear, can help preserve its condition and extend its lifespan.
- **CAUTION:** There are offsets in the concrete driveway. This condition could pose a trip hazard if not addressed. It is recommended to correct these issues to ensure safety and prevent any potential accidents. Regular maintenance and repairs will help maintain the driveway's integrity and usability.

| Property Comments | | |
|---|---|---|
| Page 18 Item: 1 | Driveway | <ul style="list-style-type: none"> <li>• <b>CAUTION:</b> There are offsets in the concrete driveway. This condition could pose a trip hazard if not addressed. It is recommended to correct these issues to ensure safety and prevent any potential accidents. Regular maintenance and repairs will help maintain the driveway's integrity and usability.</li> </ul> |

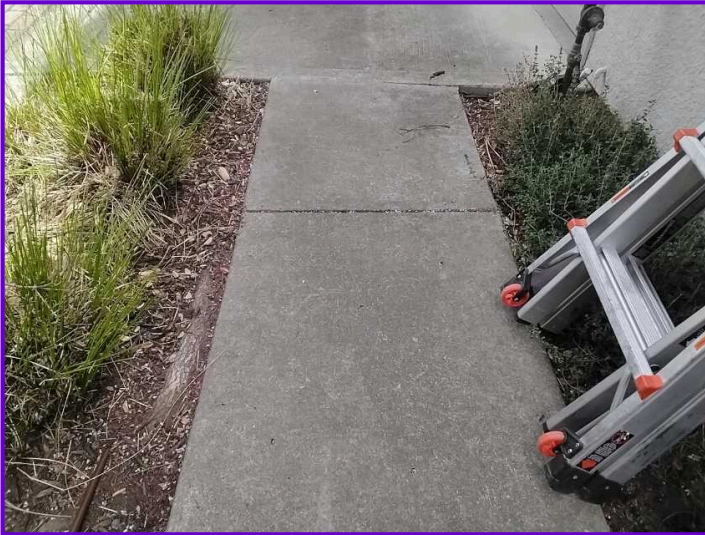
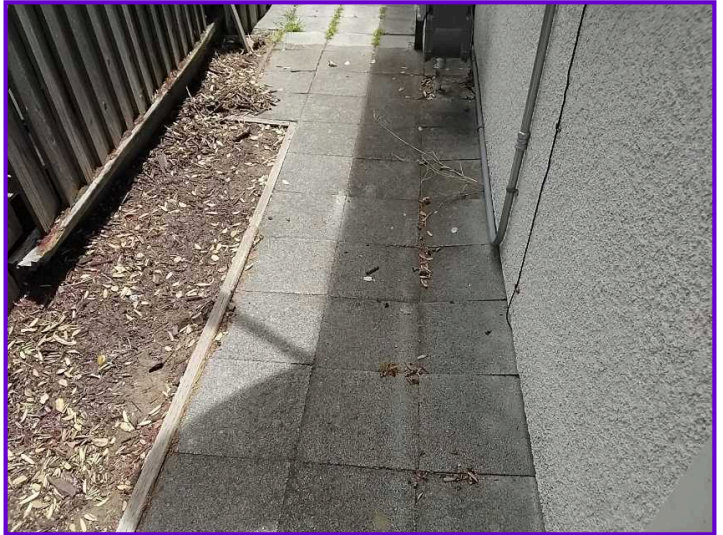
Hardscaping Walkways

- COMMENT: The walkways at various locations around the property appeared functional and in good condition at the time of inspection.
- COMMENTS: The walkways are constructed using concrete. Concrete material is known for its durability and strength. Regular maintenance, such as sealing cracks and addressing any surface wear, can help preserve their condition and extend their lifespan.
- COMMENTS: The walkways are constructed using paving stones. This type of paving provides an attractive and durable surface. Regular maintenance, such as cleaning and re-leveling any shifted stones, will help preserve their appearance and functionality over time.

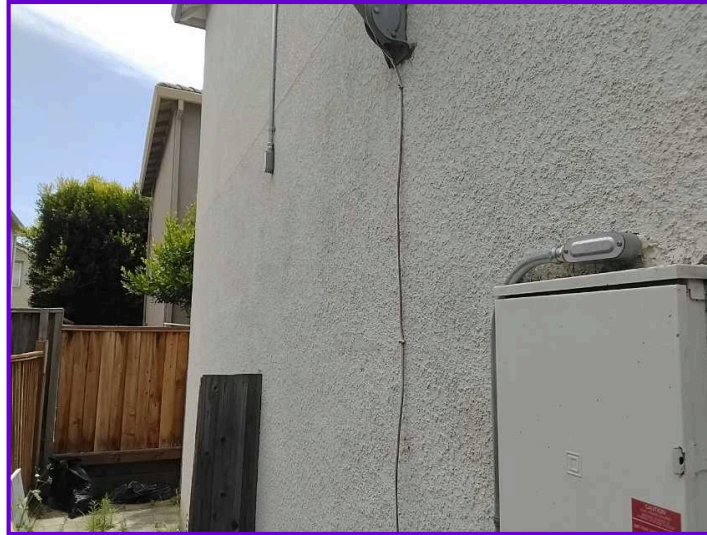
Building Features Wall Coverings

- **COMMENT:** The exterior wall coverings appeared functional and in good condition at the time of inspection.

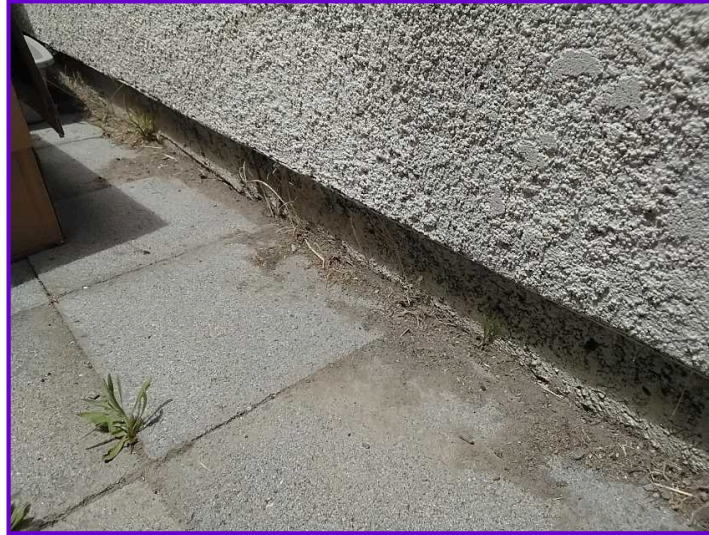
Slab Foundation Concrete Slab

- **COMMENTS:** The visible areas of the concrete floor structure appeared to be functional, demonstrating stability and integrity. There are no noticeable cracks, discoloration, or signs of damage that would suggest structural concerns at this time. This condition indicates that the concrete floor is providing adequate support and is well-maintained. Regular monitoring and maintenance are recommended to ensure that it remains in good condition, especially considering factors such as moisture exposure and loading conditions that could affect its long-term performance.

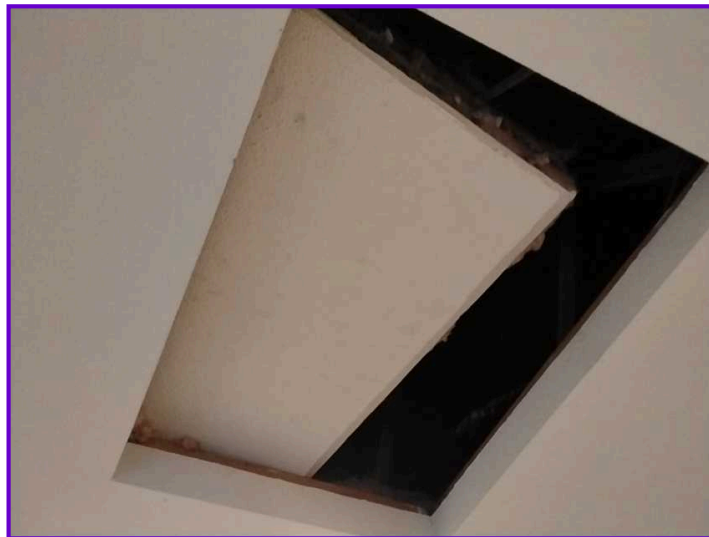
Attic Access

- COMMENTS: The attic access is located in the bedroom hallway.
- COMMENTS: There is clear access to the attic. The access allowed inspection of the attic areas and components.

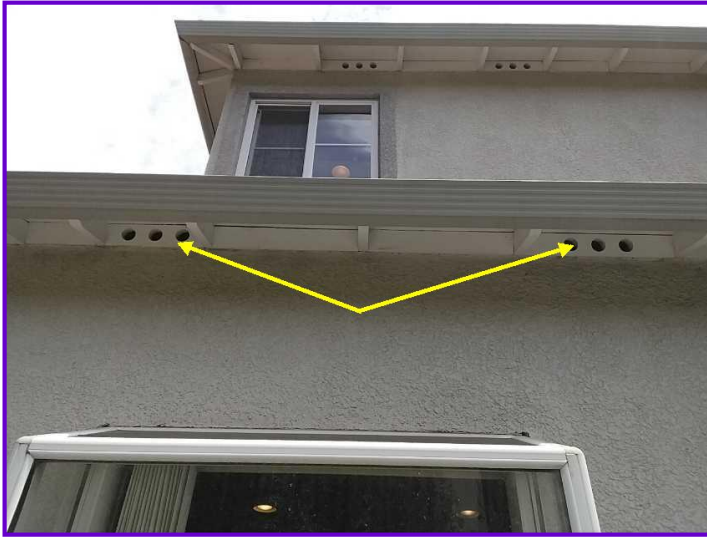
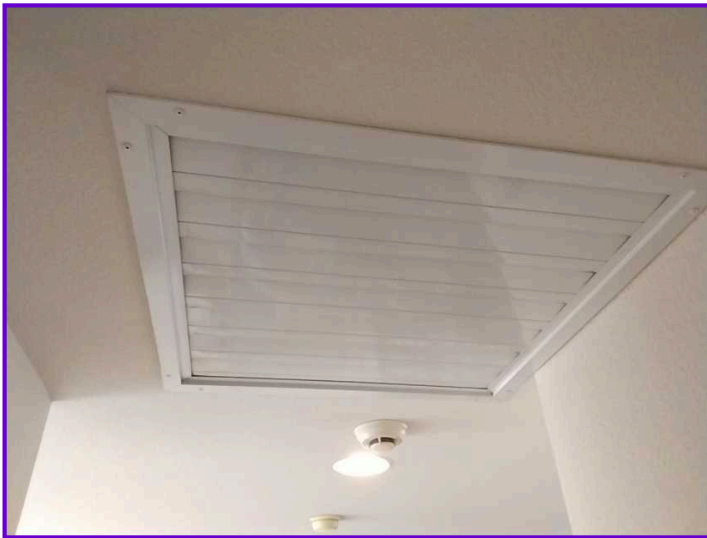
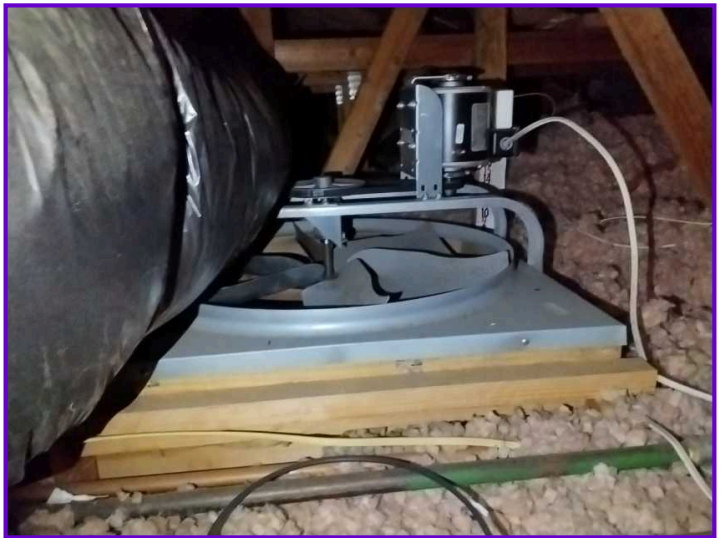
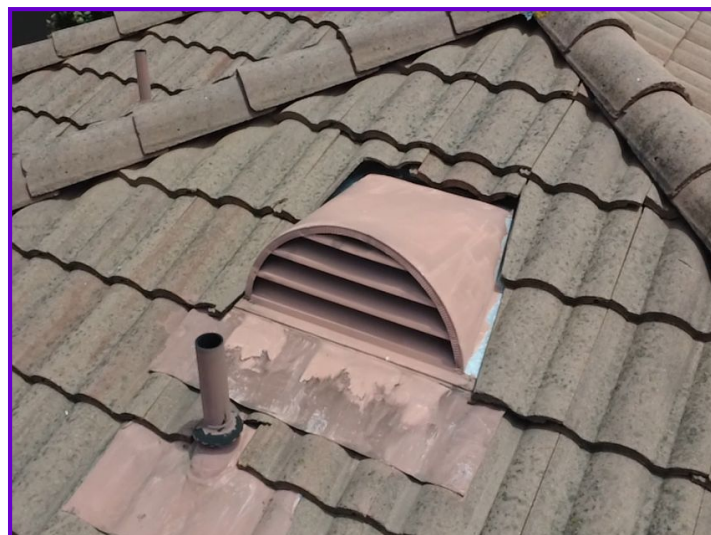
Attic Ventilation

- COMMENTS: Ventilation within the attic appears to be adequate.
- COMMENTS: The whole-house fan responded to normal user controls.

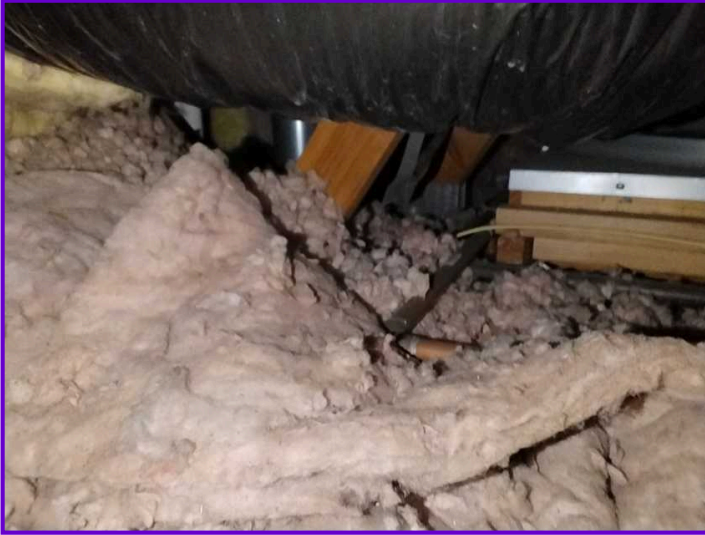
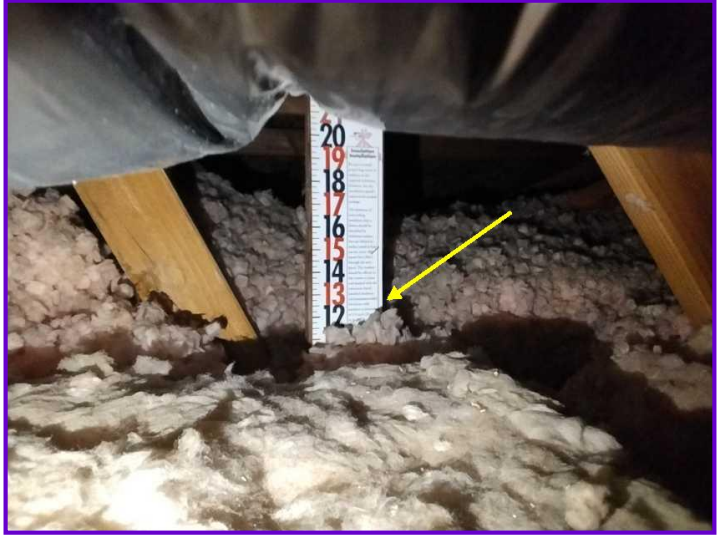
Attic Insulation

- **COMMENTS:** The attic floor is adequately insulated. A good insulation enhances energy efficiency and helps maintain a consistent temperature throughout the property. Regular checks are recommended to ensure the insulation remains in good condition and continues to provide optimal performance.

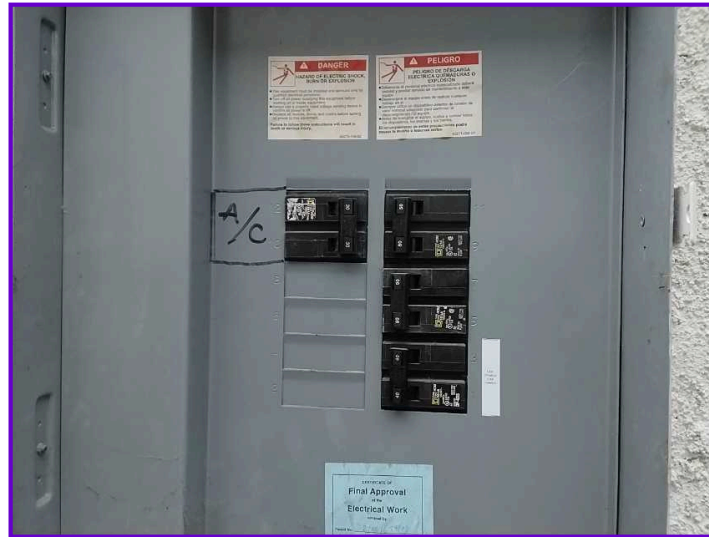
Main Panel Circuit Breakers

- COMMENTS: There were no visible deficiencies with the circuit breakers in the main electrical panel.

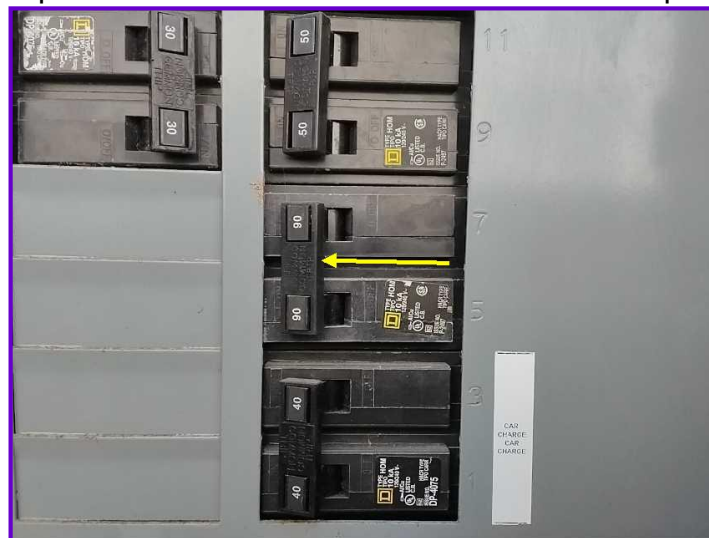
Main Panel Main Disconnect

- COMMENTS: The 90 ampmain disconnect is located inside the main panel.

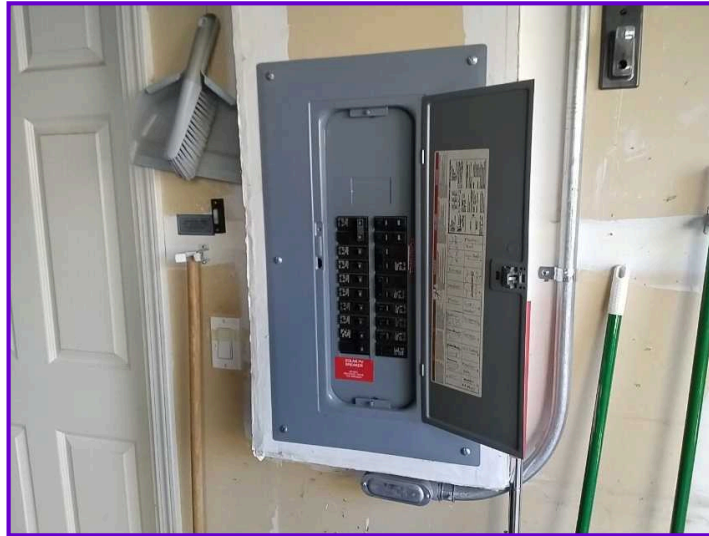
Sub Panel Sub Panel

- COMMENTS: The sub panel and its components have no visible deficiencies.
- COMMENTS: There is a sub panel located in the garage.
- DEFERRED: The sub electrical panel is not clearly labeled; however, it appears to be rated between 100 and 125 amps. Confirmation of the panel's exact amperage should be obtained by a qualified electrician to ensure accurate assessment and safety compliance.

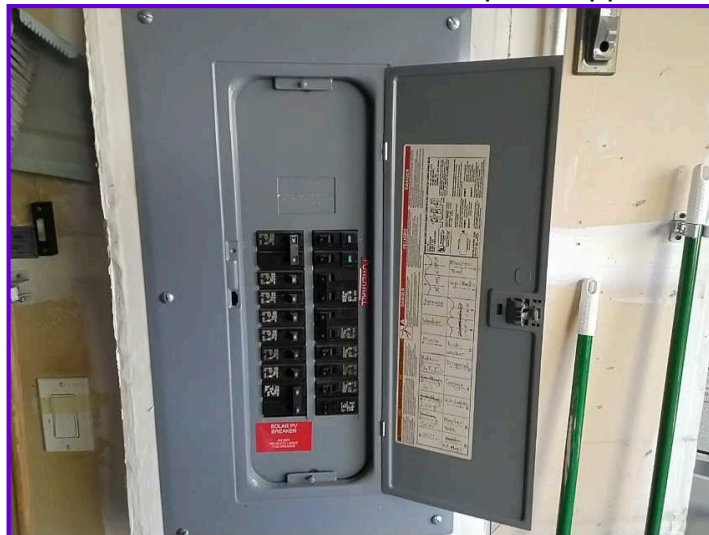
Sub Panel Panel Covers

- COMMENTS: The interior and exterior covers at the sub panel appeared functional.

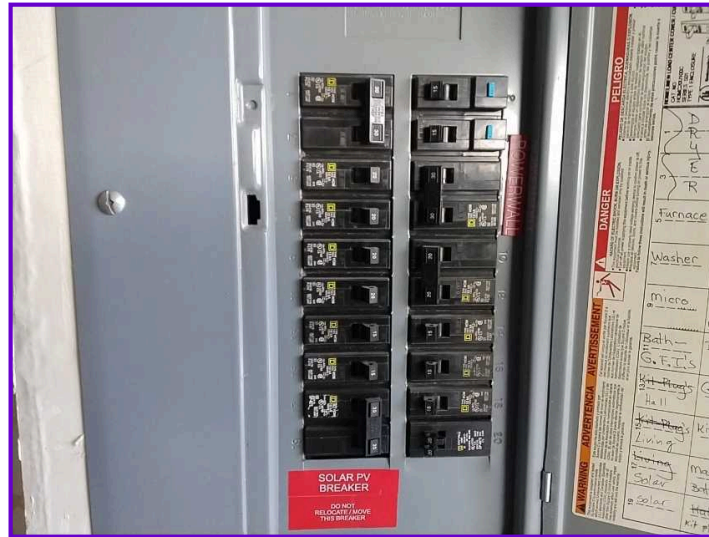
Sub Panel Circuit Breakers

- COMMENTS: There were no visible deficiencies with the circuit breakers in the sub panel.

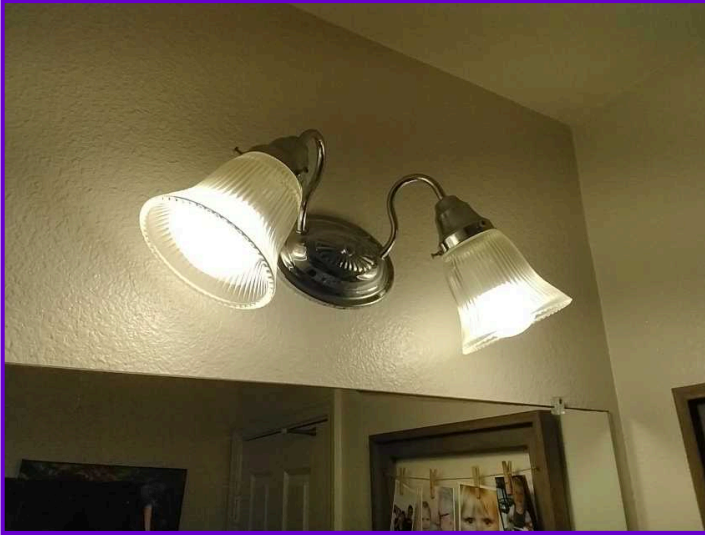
Lights and Switches Interior

- **COMMENTS:** The tested interior light fixtures were functional unless otherwise noted.
- **MAINTENANCE:** A light fixture did not fully respond during testing in the hall bathroom. It is recommended to install a new bulb and retest the fixture to ensure proper functioning. If problems persist, further inspection or repair by a qualified electrician may be necessary.

| Photovoltaic System | | |
|---|---|---|
| Page 39 Item: 1 | Interior | <ul style="list-style-type: none"> <li>• MAINTENANCE: A light fixture did not fully respond during testing in the hall bathroom. It is recommended to install a new bulb and retest the fixture to ensure proper functioning. If problems persist, further inspection or repair by a qualified electrician may be necessary.</li> </ul> |

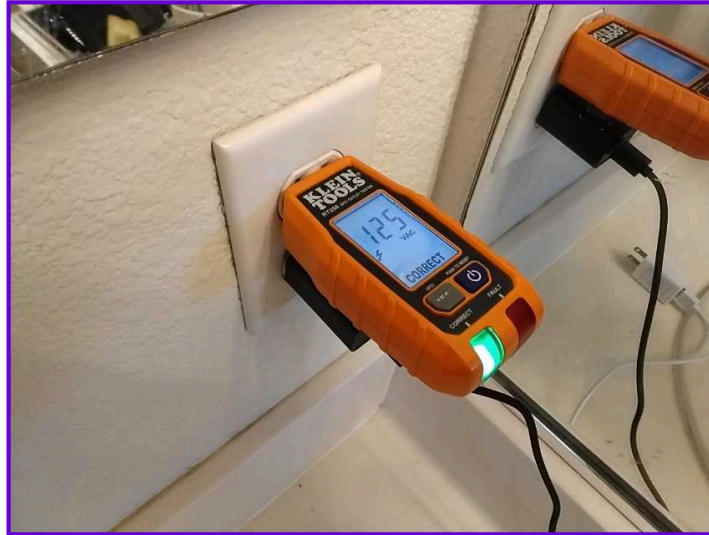
Receptacle Outlets Interior Outlets

- COMMENTS: The tested interior receptacle outlets were functional unless otherwise noted.

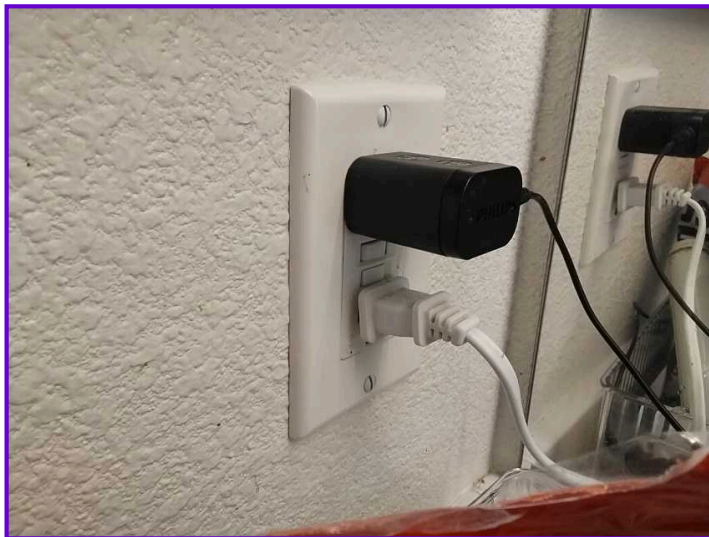
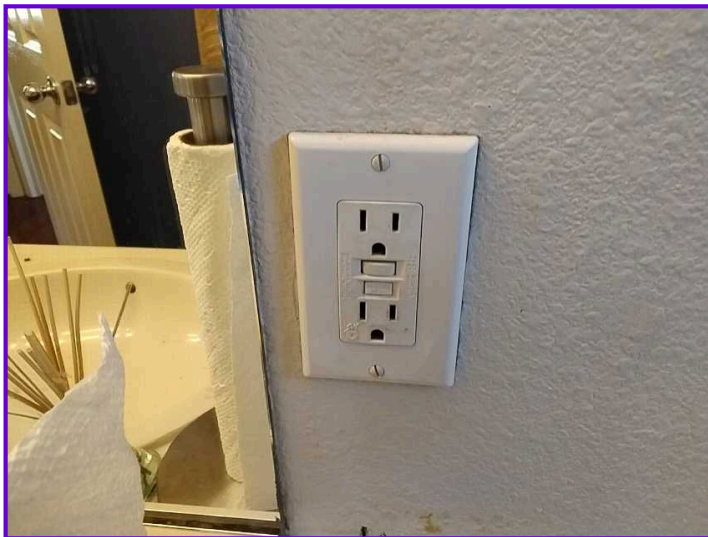
GFCI Protection GFCI Receptacle Outlets

- COMMENTS: The GFCI protected receptacle outlets at the home responded correctly when tested.

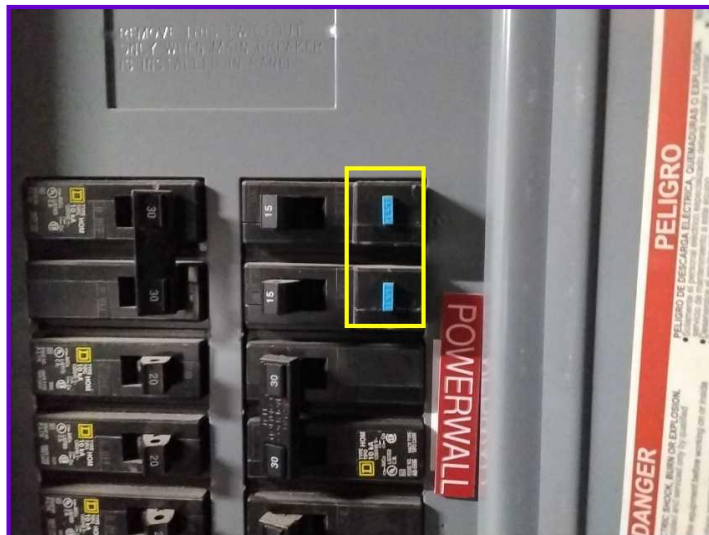
AFCI Protection AFCI Breakers

- **SAFETY:** The AFCI protected circuit breakers at the sub panel did not respond when using the built-in manufacturer's test button. The breakers will need to be evaluated or replaced by a qualified electrician for safety.

| Items of Concern | | |
|---|---|---|
| Page 42 Item: 1 | AFCI Breakers | <ul style="list-style-type: none"> <li>• <b>SAFETY:</b> The AFCI protected circuit breakers at the sub panel did not respond when using the built-in manufacturer's test button. The breakers will need to be evaluated or replaced by a qualified electrician for safety.</li> </ul> |

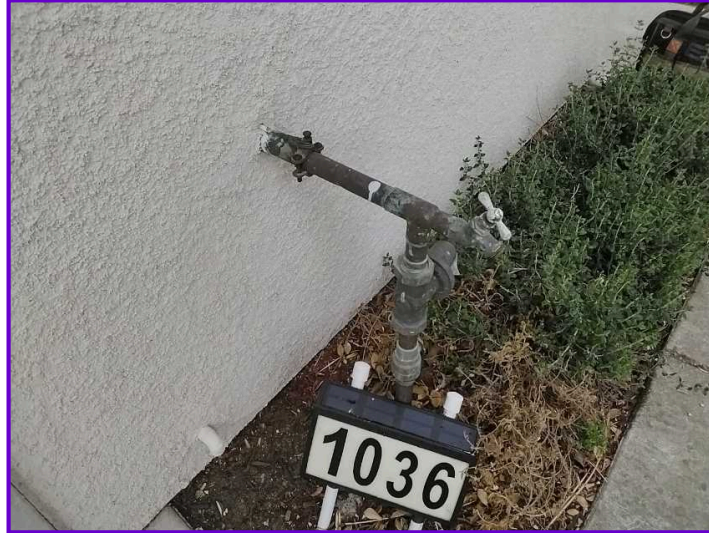
Water Supply System Water Main

- COMMENTS: Where exposed to view, the water main entering the property is a 1" copper line. The supply line enters at the front of the property.

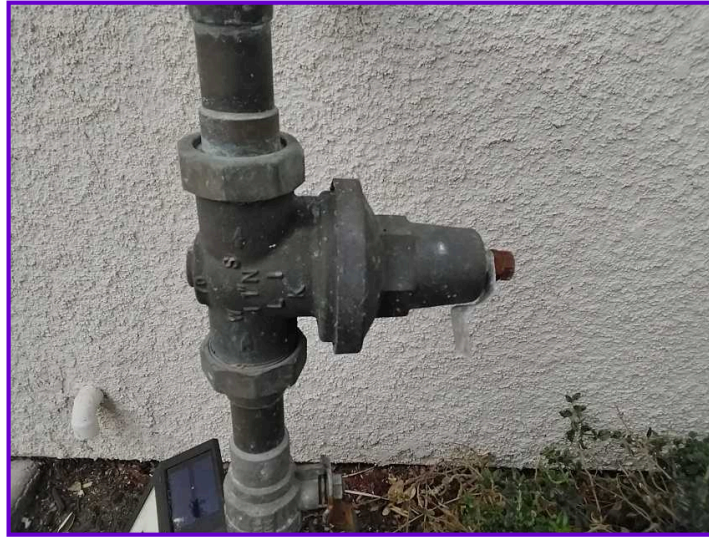
Water Supply System Pressure Regulator

- COMMENTS: A functional water pressure regulator was in place on the main water line.

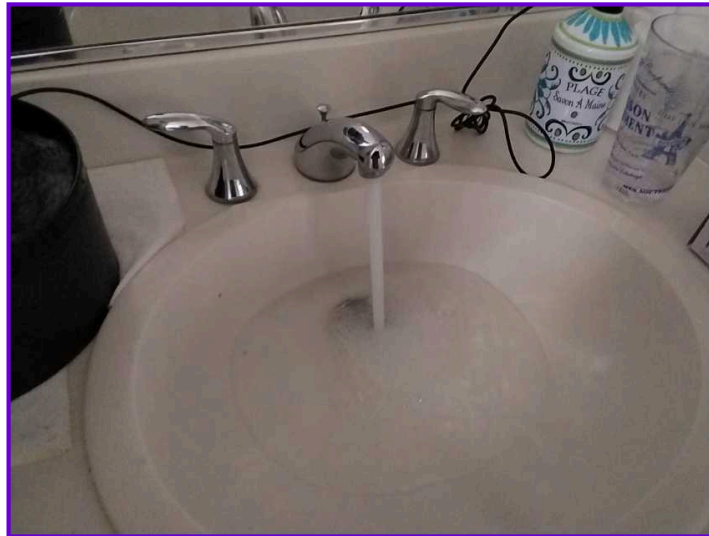
Water Supply System Functional Flow

- COMMENTS: The water flow at the plumbing fixtures appeared functional.

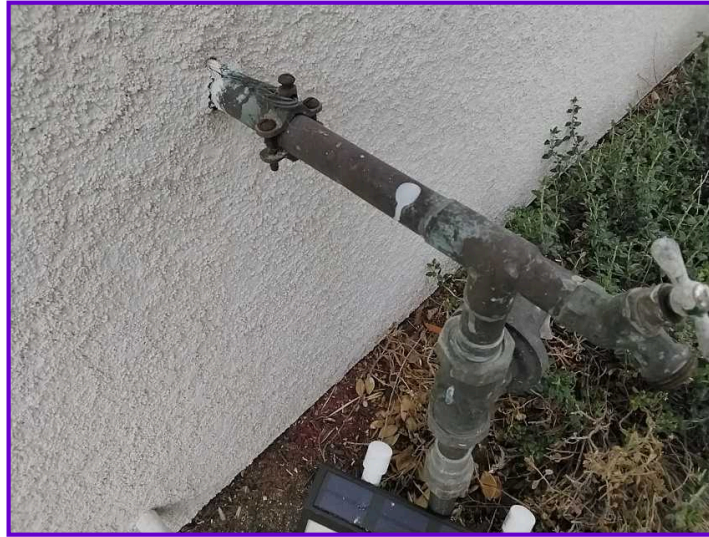
Water Supply System Supply Pipes and Connectors

- COMMENTS: The potable water pipes, where visible, are copper and appeared to be in satisfactory condition.

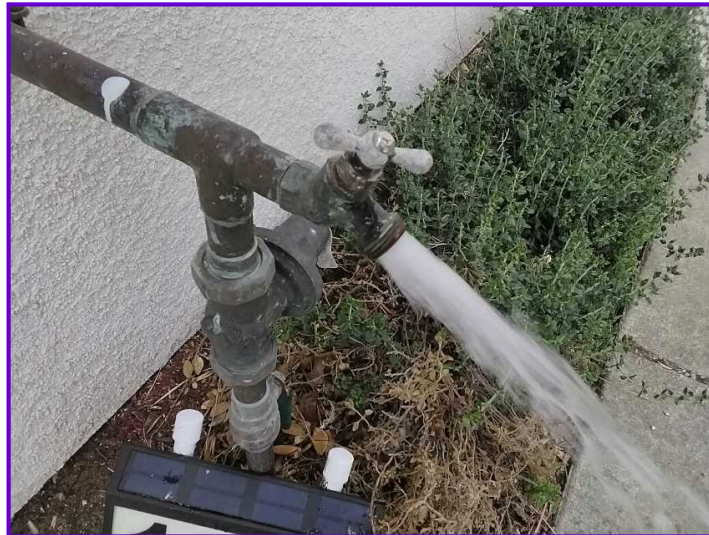
Water Supply System Hose Bibs

- **COMMENTS:** The hose bibs appeared functional at the time of inspection. No adverse conditions were observed.

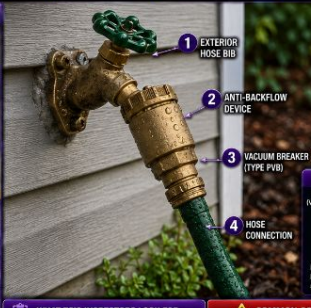
- EXTERIOR HOSE BIB**  
Standard hose bib connection at the exterior wall.
- ANTI-BACKFLOW DEVICE**  
Prevents contaminated water from flowing back into the potable water system.
- VACUUM BREAKER (TYPE PVB)**  
Built-in atmospheric vent blocks backflow when water is shut off.
- HOSE CONNECTION**  
Connects standard hose or watering equipment.
- SECURE MOUNTING**  
Device must be firmly attached and leak free to the hose bib.
- WEATHER PROTECTION**  
Cover or insulation recommended in cold climates to prevent freezing damage.

An anti-backflow device with a vacuum breaker prevents water that may contain contaminants (such as fertilizers, chemicals, or stagnant water) from flowing backward into your home's drinking water system.

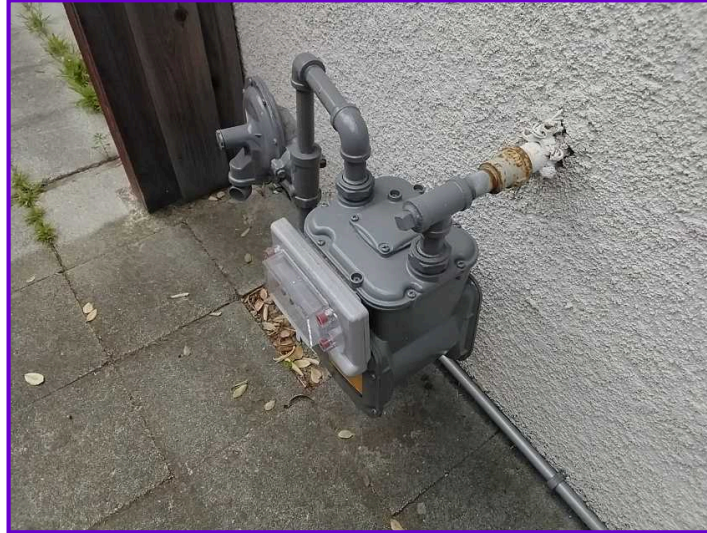
Gas Supply System Meter and Main

- **COMMENTS:** The gas meter appeared to be in satisfactory condition. The meter is located towards the front of the property.

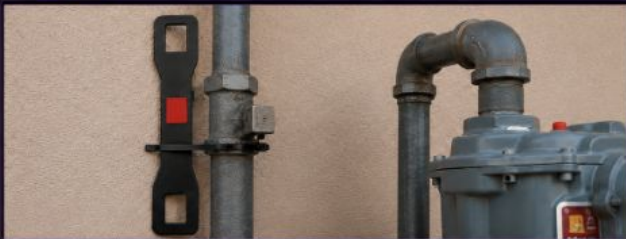
GAS SHUT OFF WRENCH NOT READILY AVAILABLE

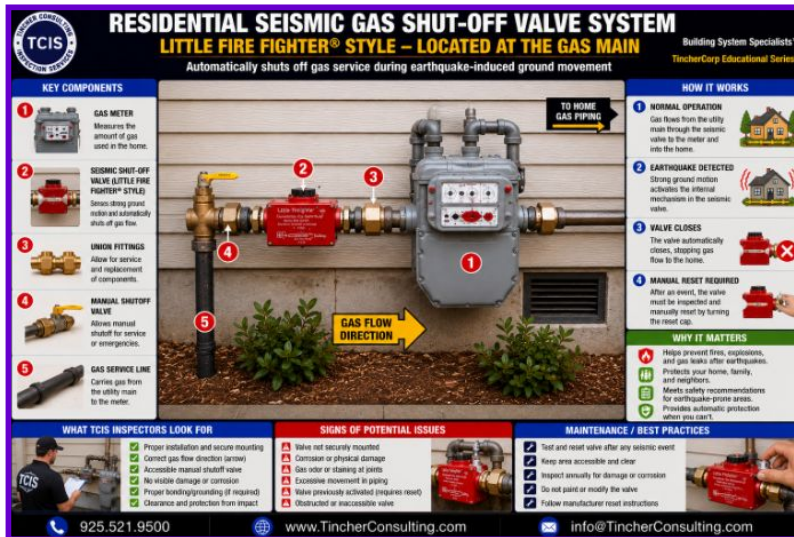
## Gas Supply System Seismic

- **PREVENTIVE:** The gas supply system did not have a seismic shut-off valve at the time of inspection. Although this safety device may not have been required when the property was originally constructed, it can help automatically shut off the gas supply during a significant seismic event. Concerned parties may wish to install a seismic shut-off valve as a safety upgrade.

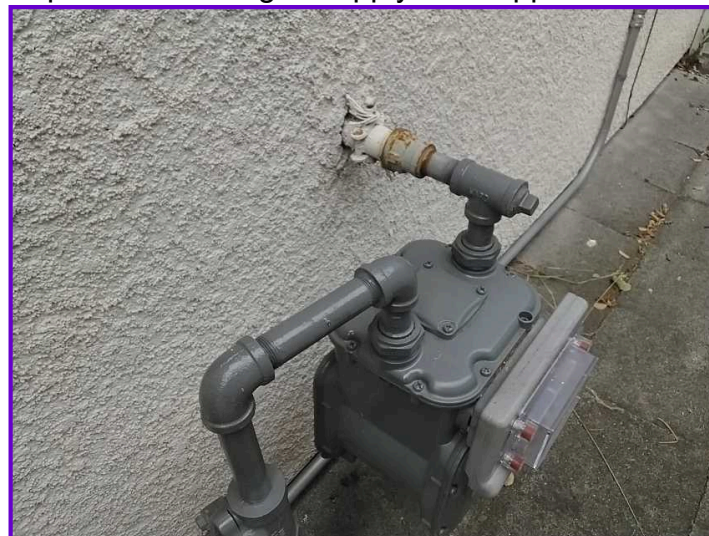
Gas Supply System Lines and Valves

- **COMMENTS:** The visible portions of the gas supply lines appear to be in satisfactory condition.

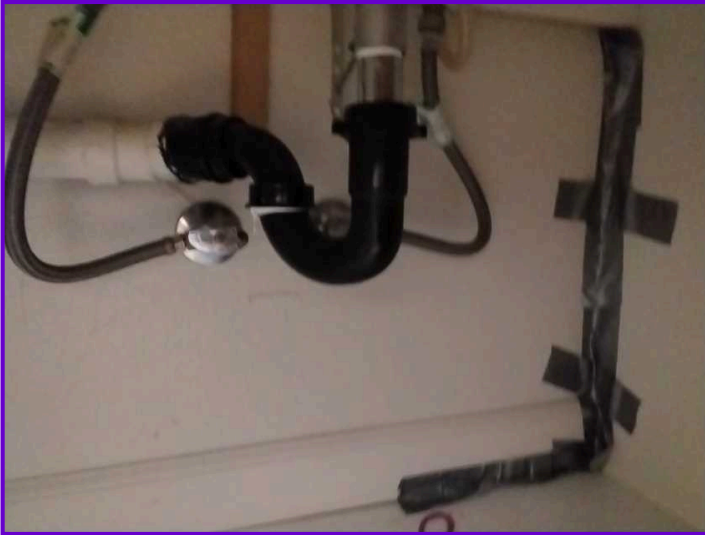
Drainage and Venting System Drain and Vent Pipes

- **DEFICIENT:** There is visible leakage under the right upper hall bathroom sink. Concerned parties may wish to have the drain line repaired or replaced to prevent further water damage and ensure proper drainage. Consulting a professional specialist for assessment and repair is recommended.

| Items of Concern | | |
|---|---|---|
| Page 50 Item: 1 | Drain and Vent Pipes | <ul style="list-style-type: none"> <li>• <b>DEFICIENT:</b> There is visible leakage under the right upper hall bathroom sink. Concerned parties may wish to have the drain line repaired or replaced to prevent further water damage and ensure proper drainage. Consulting a professional specialist for assessment and repair is recommended.</li> </ul> |

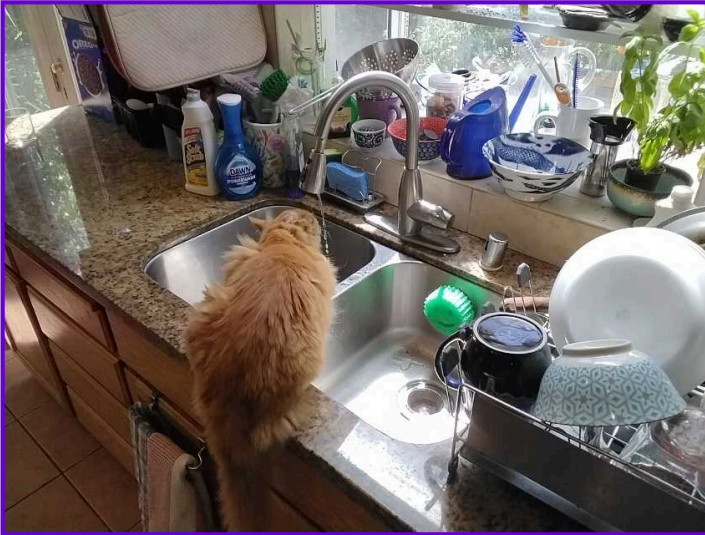
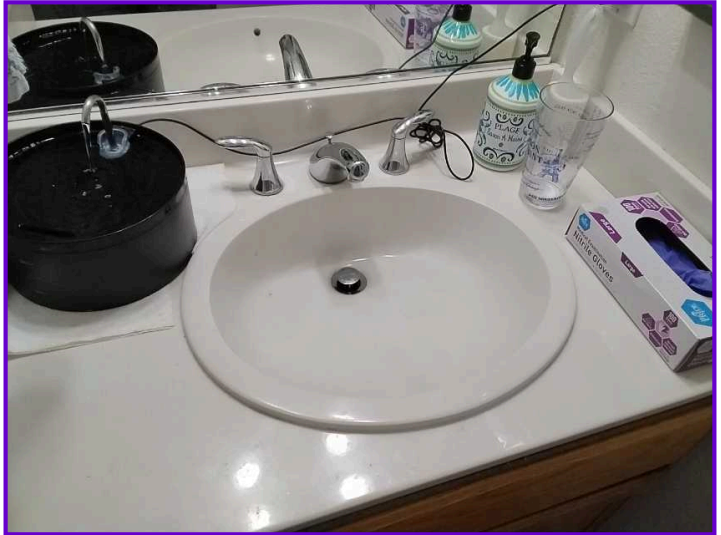
Plumbing Fixtures Sinks

- **COMMENTS:** All sinks and related components are functional.

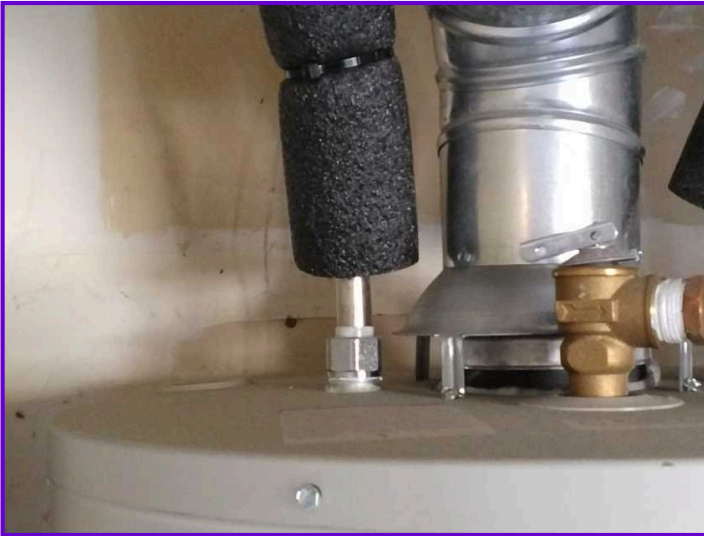
Water Heater Water Line Connectors

- COMMENTS: The water supply lines and connectors appeared to be in satisfactory condition.
- COMMENTS: The supply lines at the water heater are properly bonded. The bonding wire can redirect a small electrical current that passes through the copper piping to the steel fittings of the water heater. This process is thought to prevent electrolysis and corrosion, which can extend the service life of the water heater and prevent leaking.

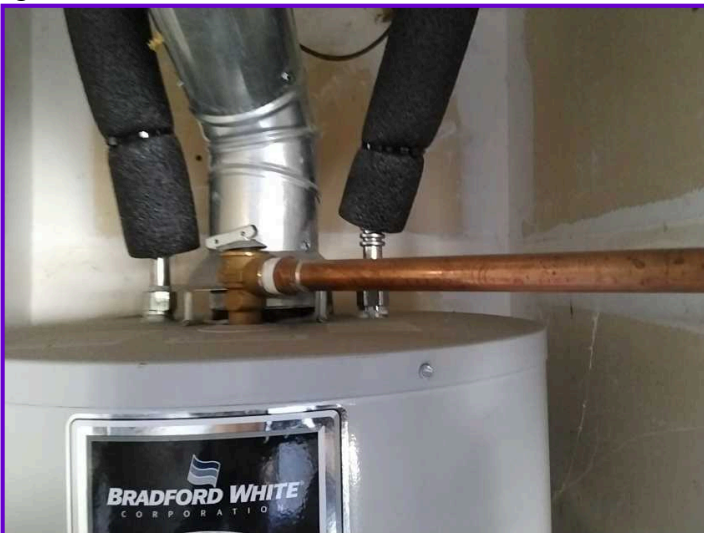
Water Heater TPR Valve

- COMMENTS: A temperature and pressure relief (TPR) valve was installed at the water heater as required. The TPR valve includes a discharge pipe that discharges to within six inches of the ground at a visible and accessible exterior location as needed.

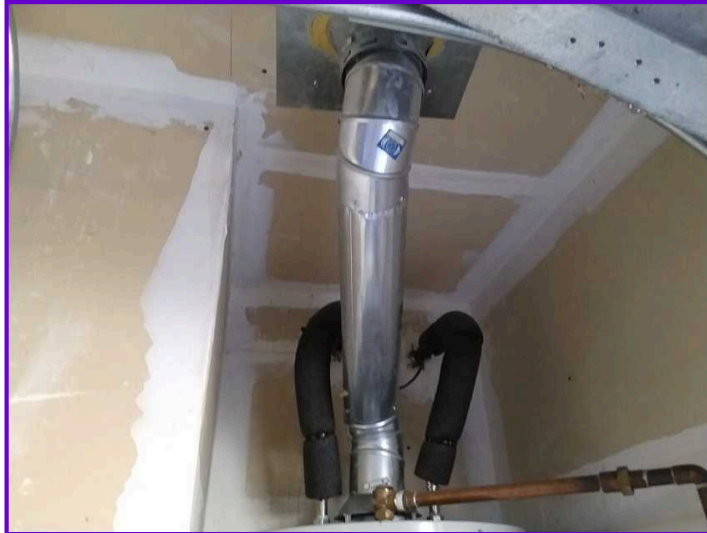
Water Heater Venting Provisions

- **COMMENTS:** The vent pipe and cap on the gas water heater appeared to be functional.

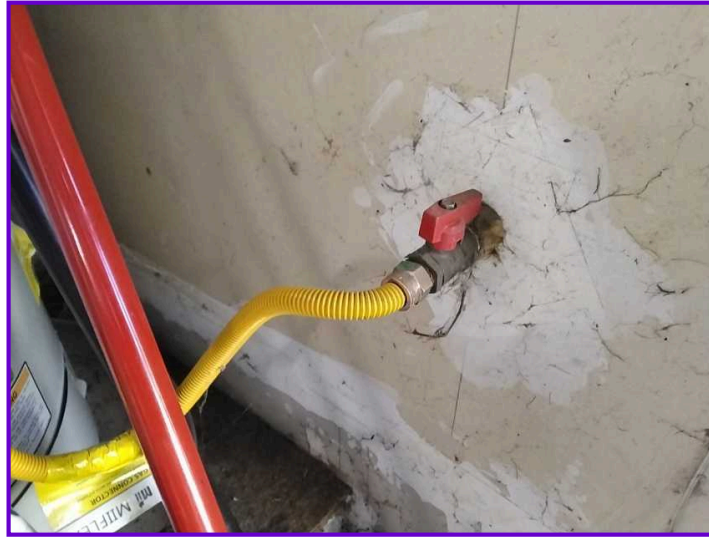
Water Heater Gas Shut-Off Valve

- **COMMENTS:** The gas control valve and connector appeared to be functional.

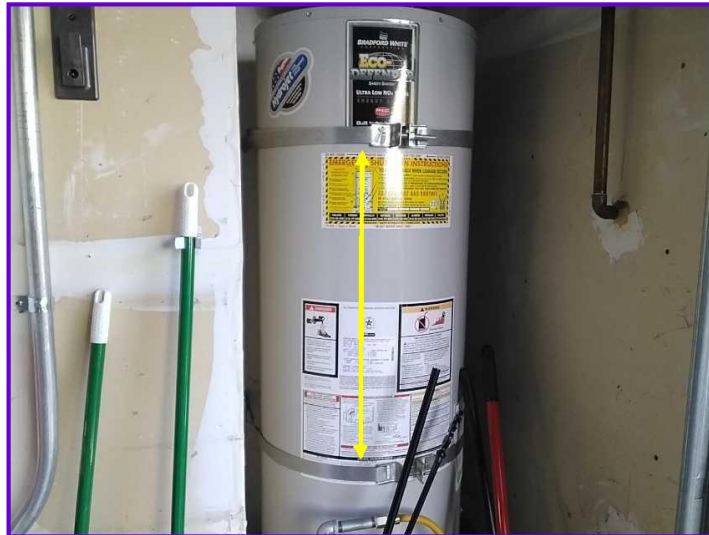
Water Heater Seismic Bracing

- COMMENTS: The water heater is properly strapped. The straps on the water heater help prevent falling or moving during an earthquake.

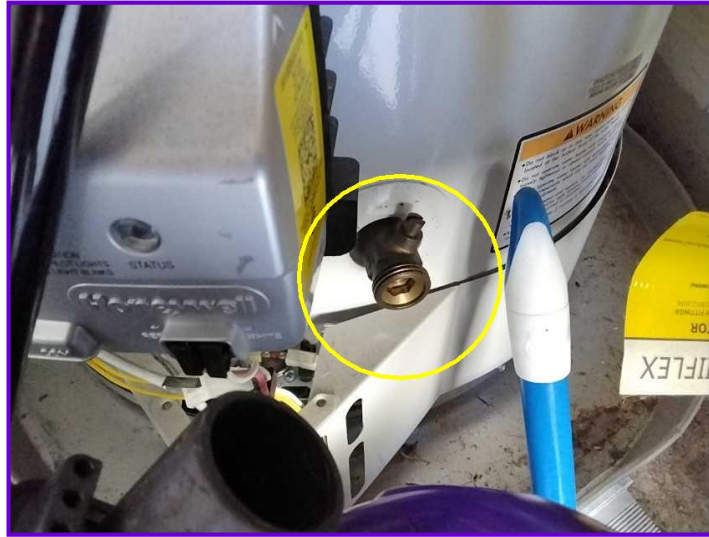
Water Heater Drain Valve

- COMMENTS: A drain valve was installed on the water heater. No leakage was noted. However, our evaluation did not include turning or testing of the drain valve.

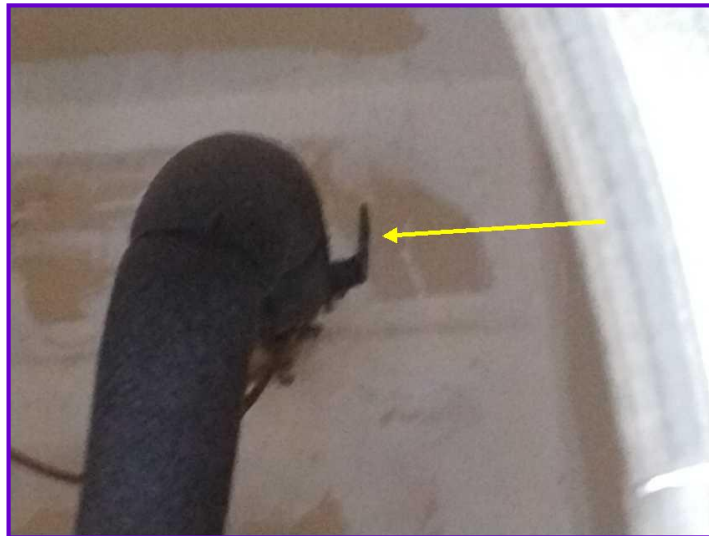
Water Heater Water Shut-Off Valve

- COMMENTS: The shut-off valve and water line connectors on the water heater appeared functional. To avoid possible leakage, our evaluation does not include turning or testing of the shut-off valve.

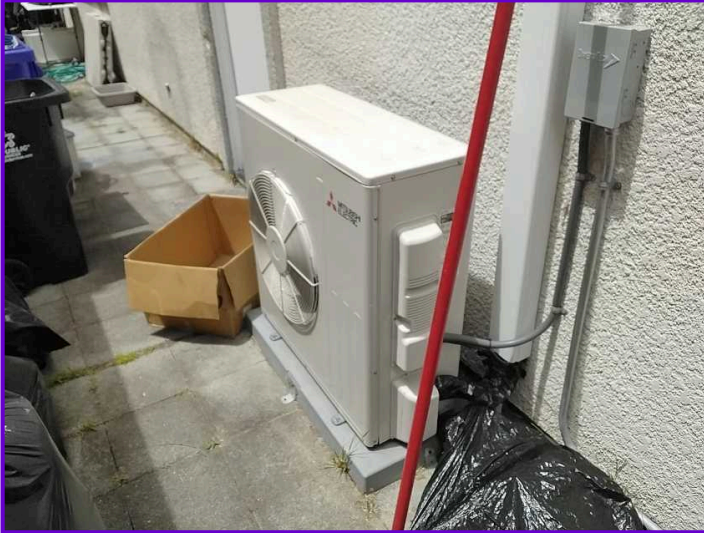
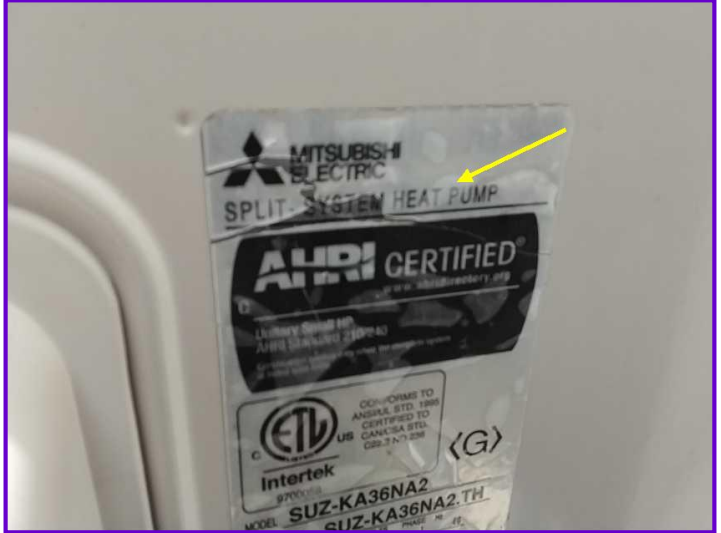
Heat Pump General Comments

• **COMMENTS:** Heating and cooling in this home is provided by a heat pump. A heat pump is essentially a reversible air conditioner, but contains additional equipment not found in normal air conditioning systems. The outdoor unit contains an accumulator and a reversing valve, and the indoor component (referred to as the air handler) is often accompanied by 'emergency' electric strip heaters. The reversing valve is the key component that determines the mode of operation (heating or cooling). In the heating mode, heat is extracted from the outdoor environment to heat the interior, and in the cooling mode, heat is extracted from the indoor environment and transferred to the exterior.
