# PROPERTY INSPECTION REPORT

**1036 Suncrest Court, Richmond, CA 94806**

DATE OF INSPECTION: 7/2/2026

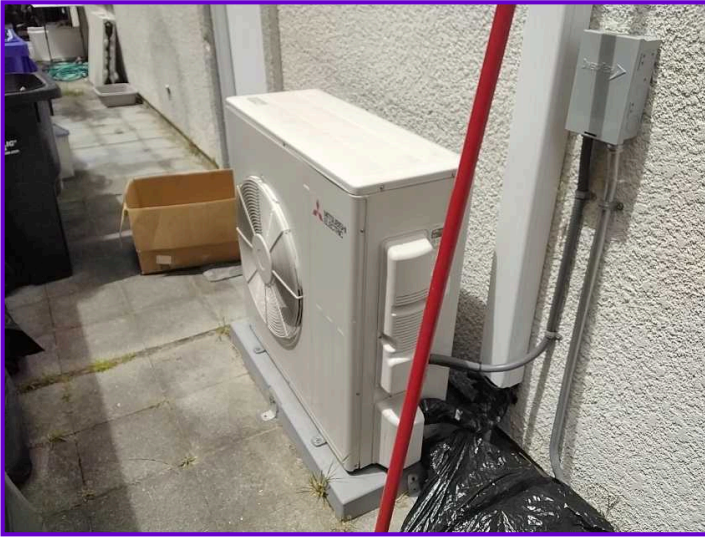
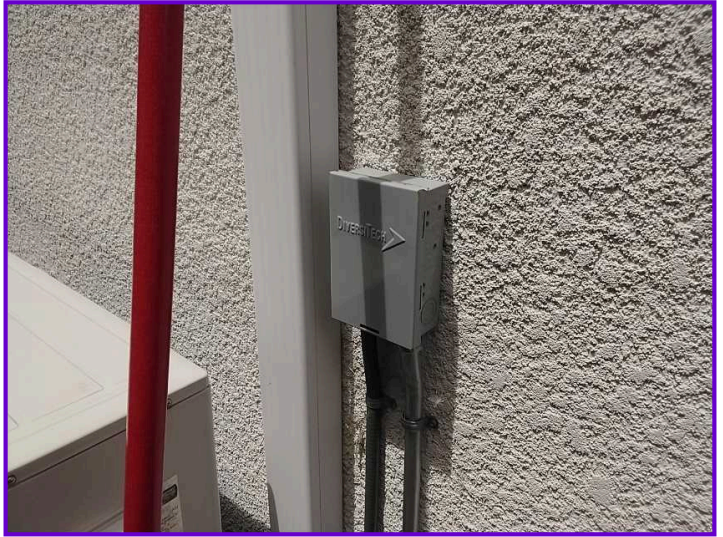
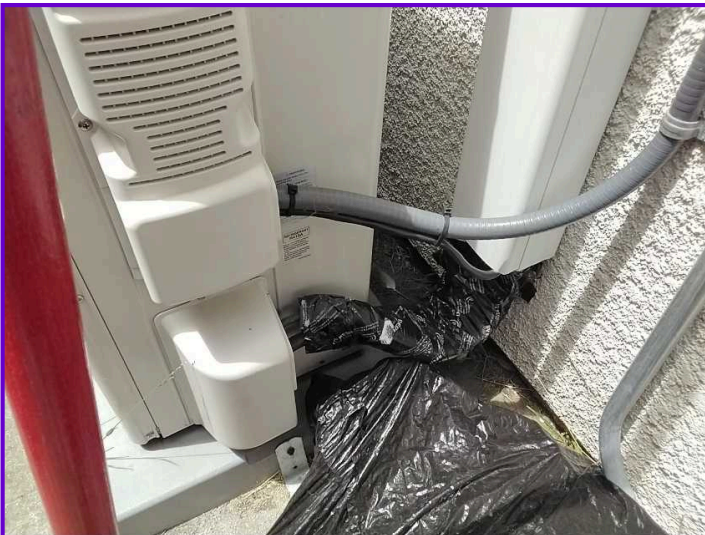
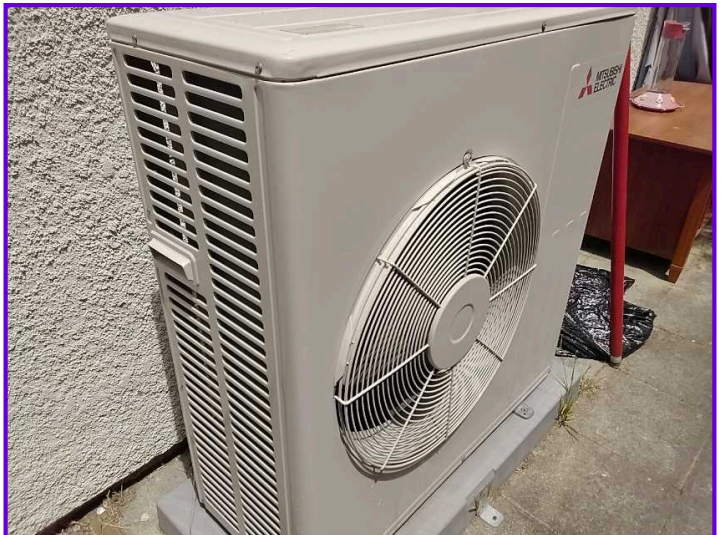
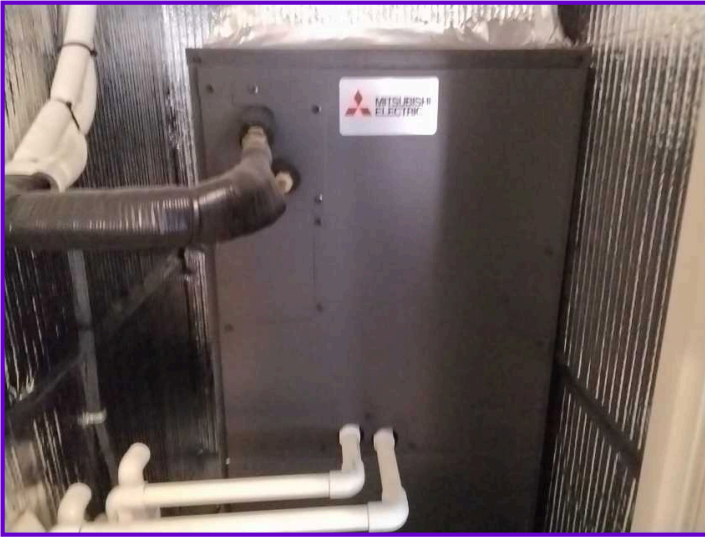
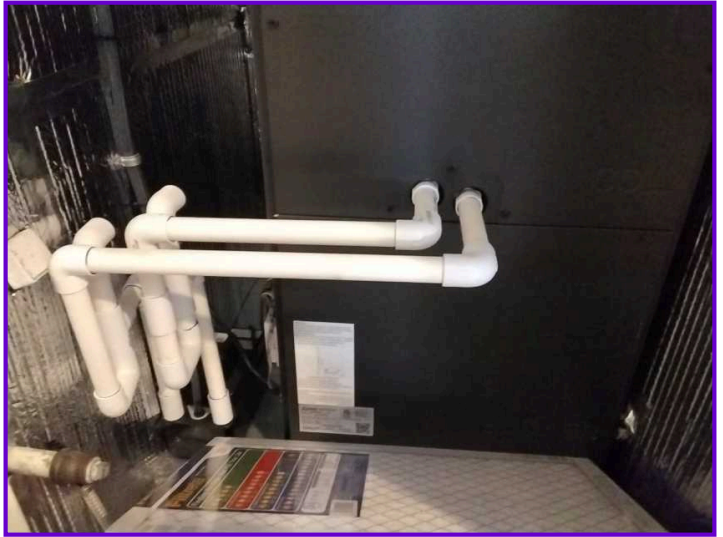
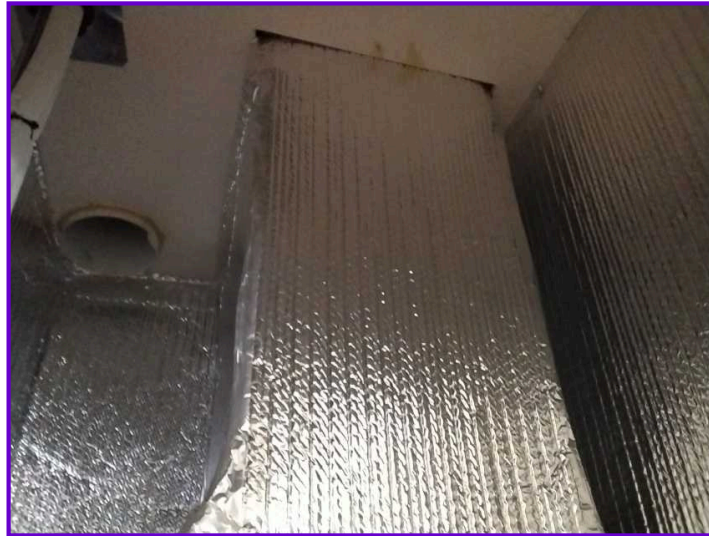
Heat Pump Heat and AC

- COMMENTS: All secondary system components appeared to be functional and in satisfactory condition. The system includes the controls, evaporator coil, condensate drain lines, drip pan, refrigerant lines and electrical disconnect.
- COMMENTS: The heat pump responded to normal users controls on the heating and cooling mode.
- COMMENTS: The differential temperature split between the air entering the system return and that coming out of the registers is satisfactory. The average differential temperature split is approximately between 10 and 15 degree Fahrenheit, indicating efficient heating and cooling system performance. Regular maintenance is recommended to ensure continued effectiveness.

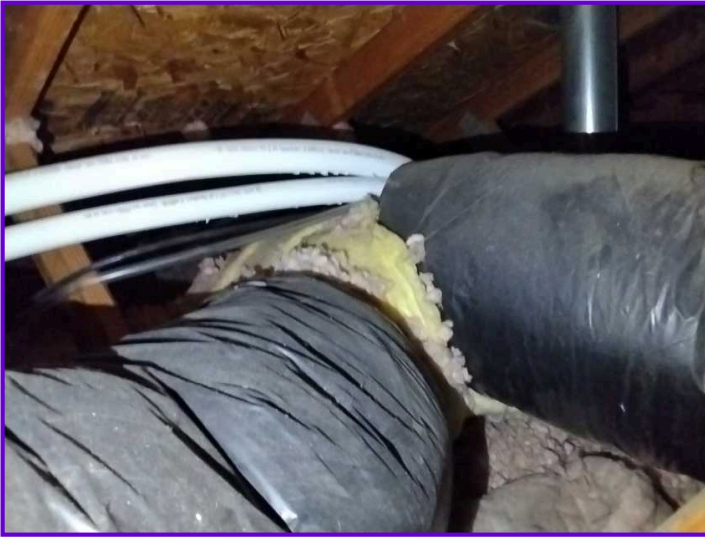
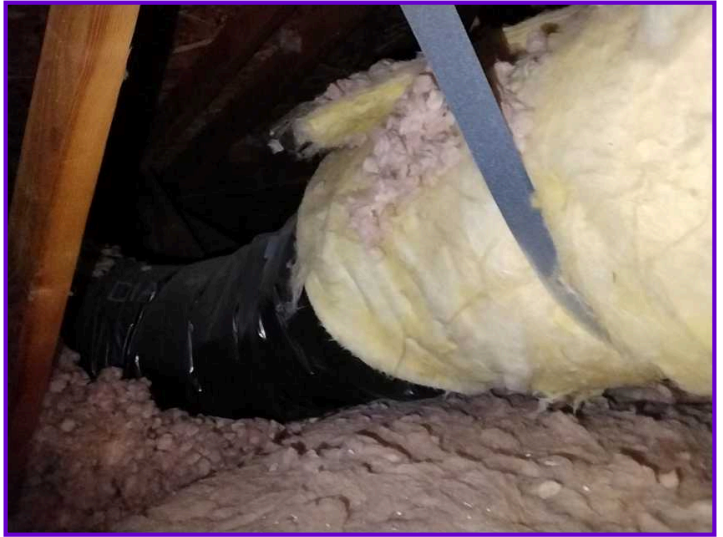
Heat Pump Distribution System

- **COMMENTS:** Where visible and accessible, the supply and distribution ducts were in satisfactory condition.

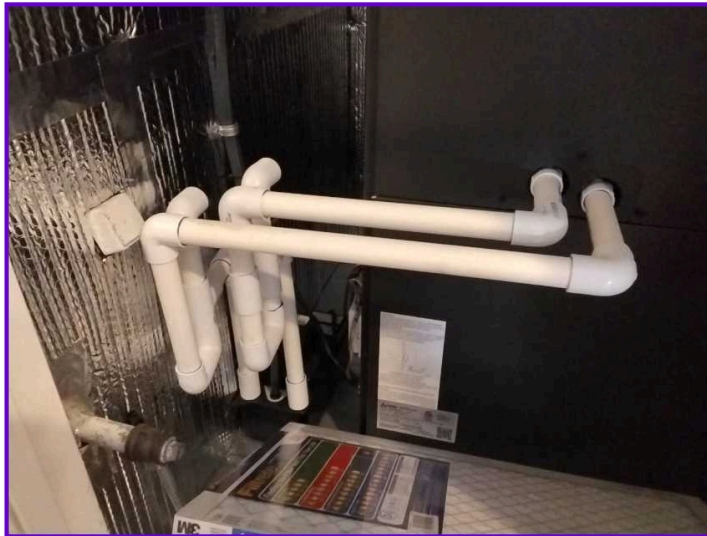
Heat Pump Condensate Drainage

- COMMENTS: The primary and secondary condensate discharge pipes appear to be functional.

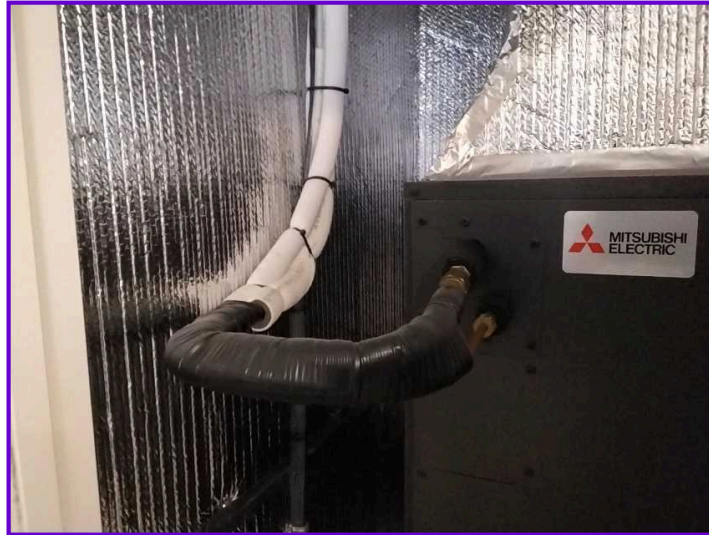
Heat Pump Refrigerant Lines

- COMMENTS: Where visible, the refrigerant lines appear to be in satisfactory condition.

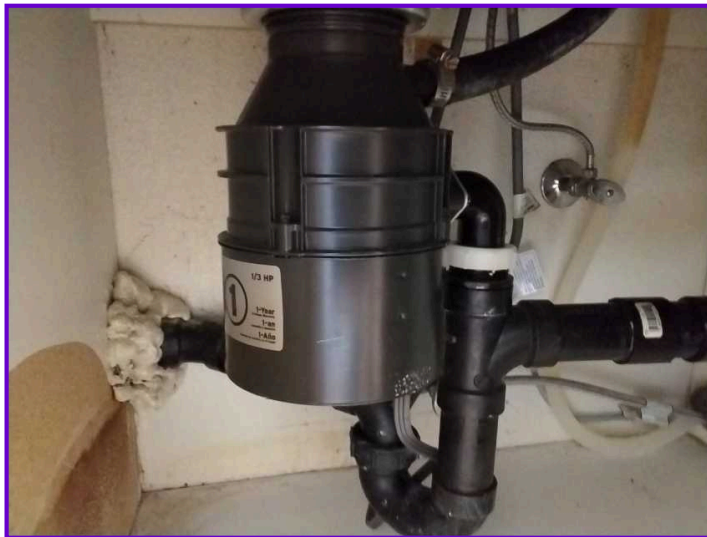
Built-In Appliances Garbage Disposal

- **MONITOR:** The garbage disposal is functional but noisy and may have a limited service life. Concerned parties may want to consider replacing it for a quieter one.

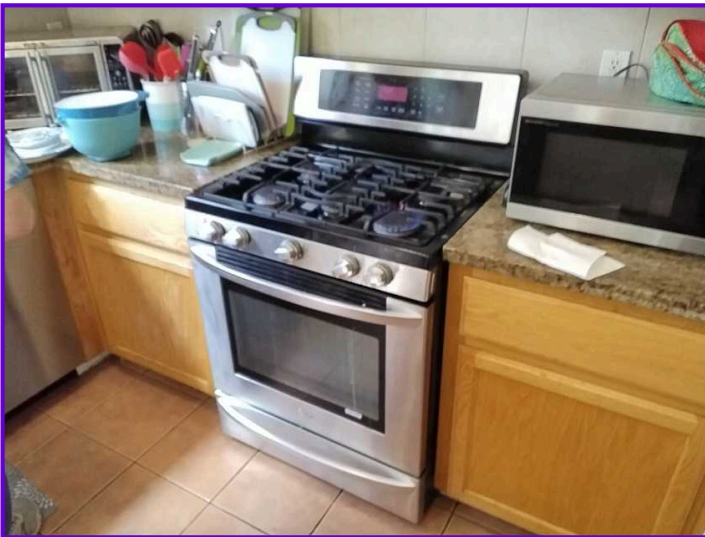
Built-In Appliances Gas Range

- **COMMENTS:** The gas range responded to normal user controls. This includes the stove burners, oven components, and primary controls. It appeared to be operating correctly at the time of inspection. Regular testing and maintenance are recommended to ensure continued safe and proper functioning.
- **SAFETY:** The gas range is currently lacking an anti-tip device. This is an important safety feature designed to prevent potential tipping hazards, especially in households with young children. This simple yet effective solution will provide added security and peace of mind for users, ensuring a safer kitchen environment. Steps to enhance safety and mitigate the risk of the range tipping over if a child attempts to climb on it or steps on the open door should be taken. It is strongly recommended that an anti-tip bracket be installed.

| Items of Concern | | |
|---|---|---|
| Page 73 Item: 3 | Gas Range | <ul style="list-style-type: none"> <li>• <b>SAFETY:</b> The gas range is currently lacking an anti-tip device. This is an important safety feature designed to prevent potential tipping hazards, especially in households with young children. This simple yet effective solution will provide added security and peace of mind for users, ensuring a safer kitchen environment. Steps to enhance safety and mitigate the risk of the range tipping over if a child attempts to climb on it or steps on the open door should be taken. It is strongly recommended that an anti-tip bracket be installed.</li> </ul> |

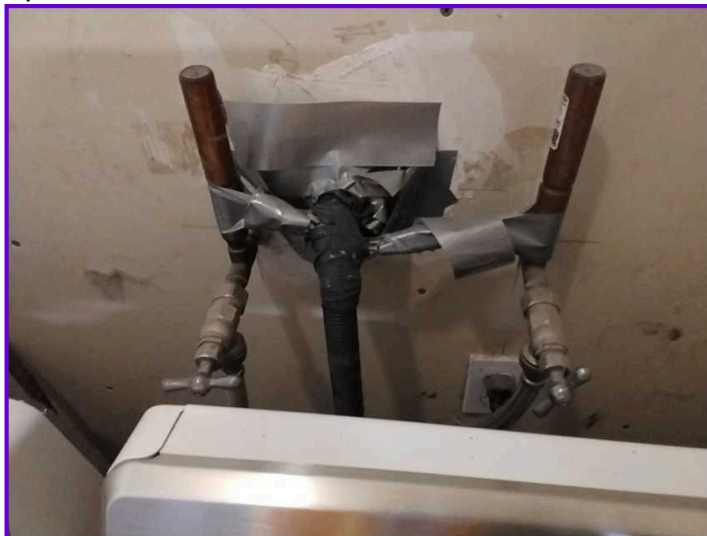
Laundry Provisions Washer Water Supply

- COMMENTS: The washer water supply valves were free of leakage. The valves were not turned or tested at the time of inspection.

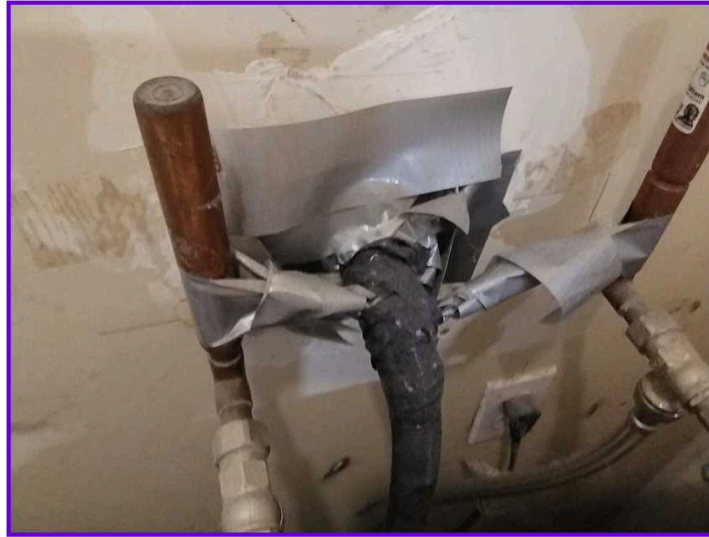
Laundry Provisions Washer Drainage

- COMMENTS: There is a washer drain line present.

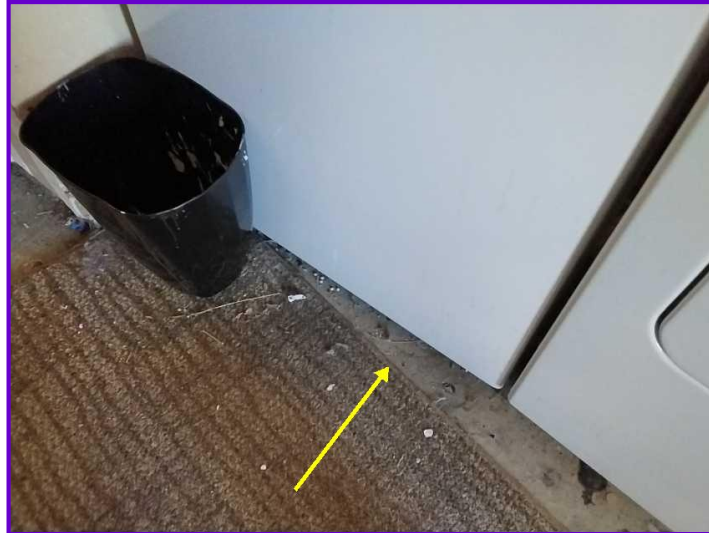
Laundry Provisions Washer Drain Pan

- **PREVENTIVE:** There is no drain pan beneath where the laundry washing machine is placed. As a discretionary upgrade, you may wish to have a drain pan installed, with a drain line routed to an exterior discharge location or approved drain. This will help prevent water damage in the event of leakage.

| Plumbing Fixtures | | |
|---|---|---|
| Page 75 Item: 4 | Washer Drain Pan | <ul style="list-style-type: none"> <li>• <b>PREVENTIVE:</b> There is no drain pan beneath where the laundry washing machine is placed. As a discretionary upgrade, you may wish to have a drain pan installed, with a drain line routed to an exterior discharge location or approved drain. This will help prevent water damage in the event of leakage.</li> </ul> |

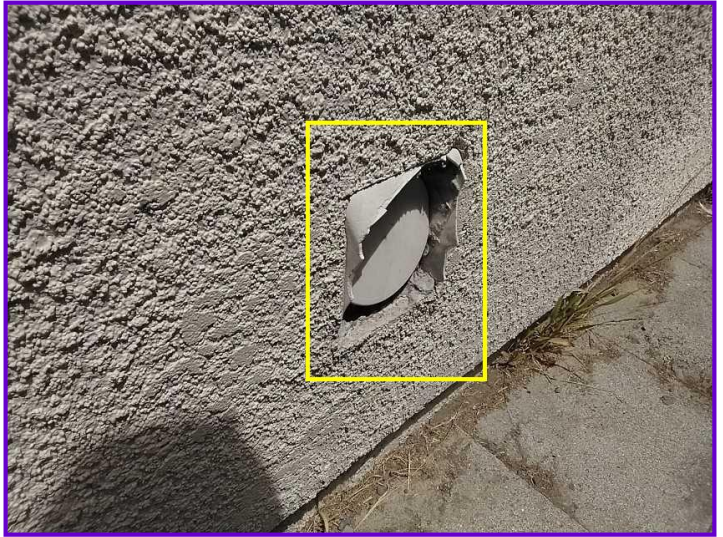
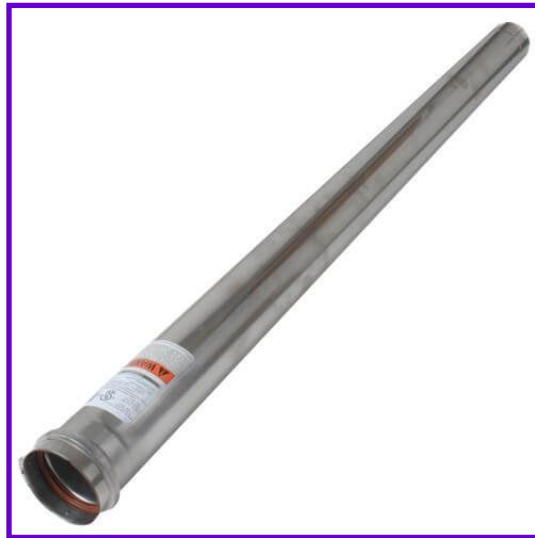
Laundry Provisions Dryer Venting

- **PREVENTIVE:** The flexible dryer duct connector extends more than six feet in length and therefore should be replaced or supplemented with a smooth-walled metal type for safety.
- **DEFICIENT:** The back-draft damper is damaged and needs to be repaired or replaced

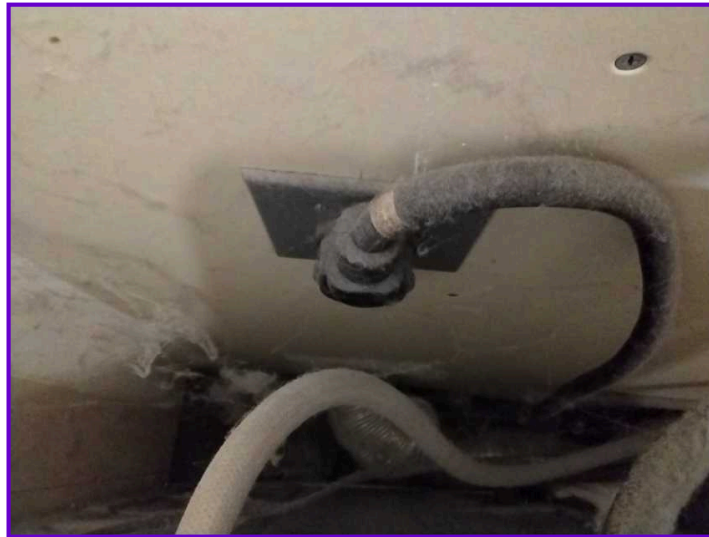
Laundry Provisions Electrical Supply

- **COMMENTS:** A 220-volt outlet was provided.

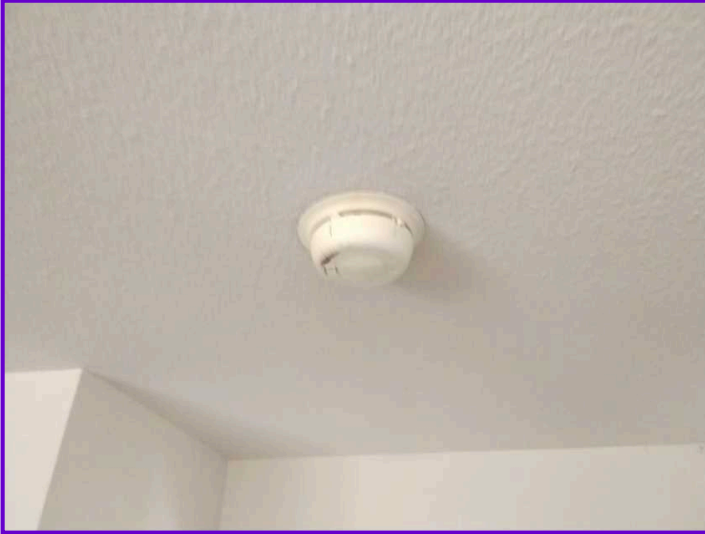
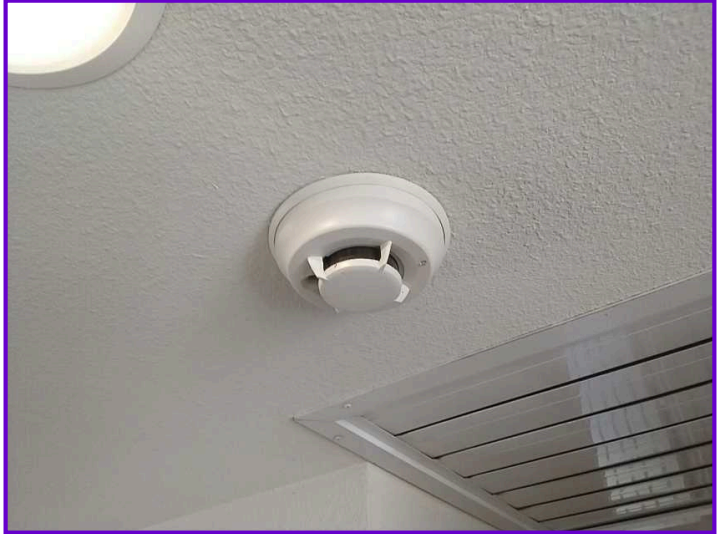
Smoke Alarms Placement

- COMMENTS: There are smoke detectors in the bedrooms. As required by current building and safety codes smoke detectors should be placed in every bedroom.
- COMMENTS: There is a smoke detector in the bedroom hallway. As required by current building and safety codes smoke detectors should be placed in every bedroom hallways.

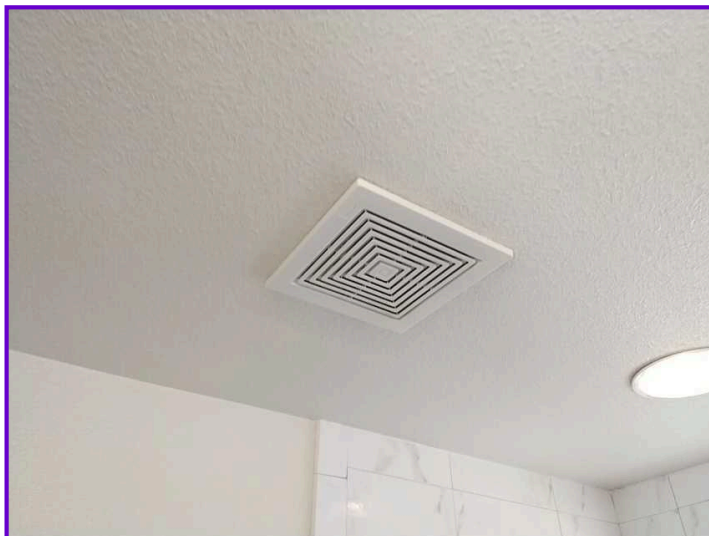
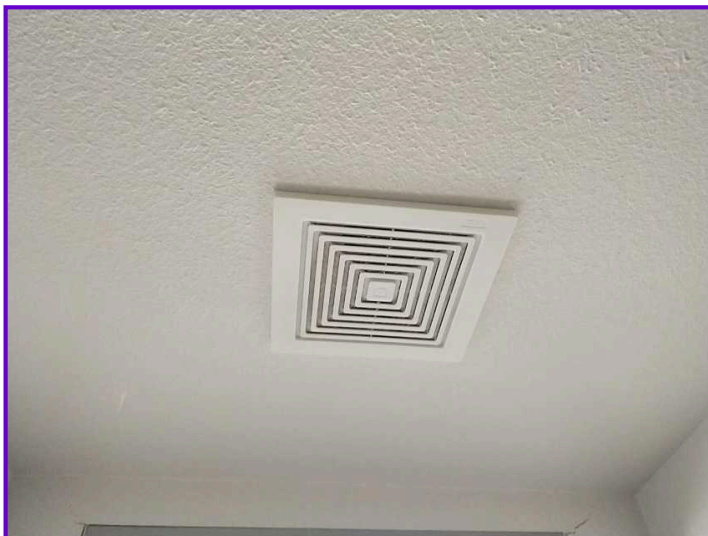
Ventilation and Exhaust Bathroom

- COMMENTS: The bathroom exhaust fans are functional.

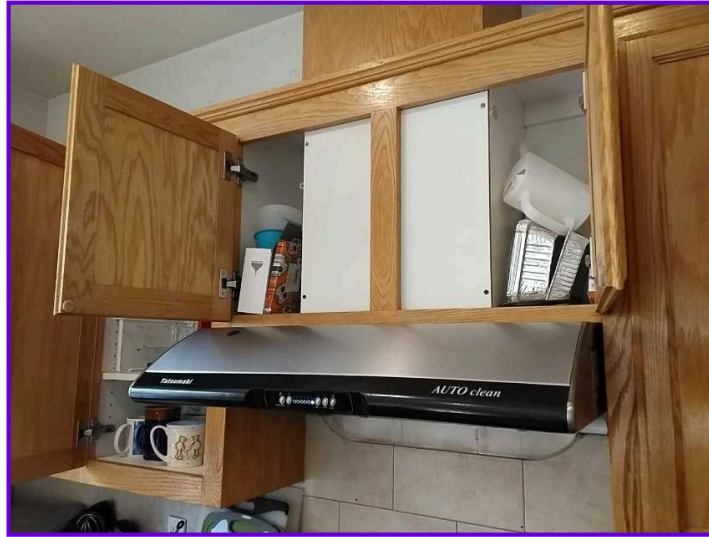
Ventilation and Exhaust Kitchen

- COMMENTS: The kitchen exhaust fan vents externally.

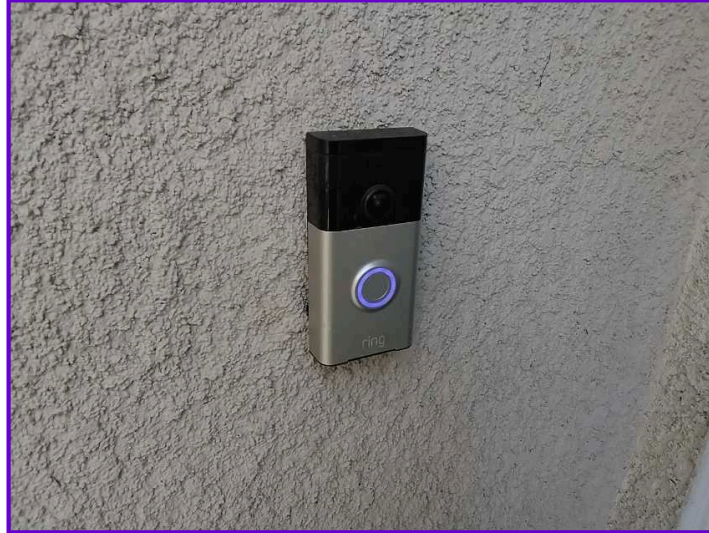
Additional Components Doorbells

- COMMENTS: The doorbell responded audibly when the button was pushed.

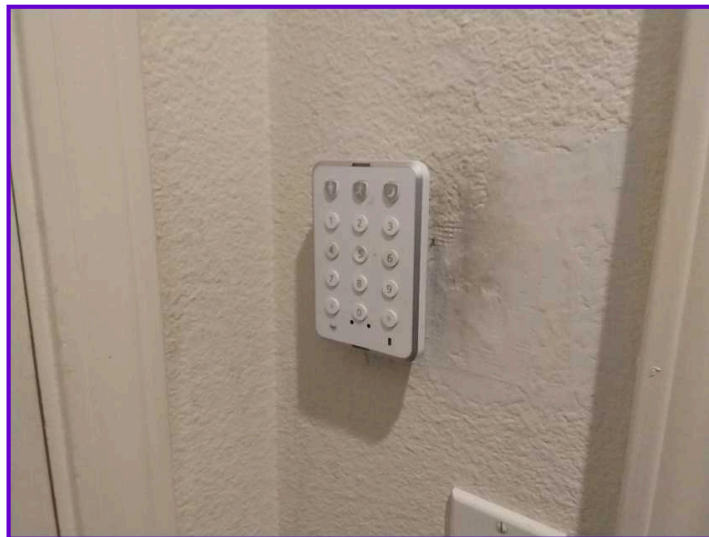
Additional Components Security System

- DEFERRED: The residence is equipped with a camera/security system. You may wish to employ the services of a residential security system specialist to evaluate the system for proper function and explain its strengths and weaknesses. Evaluation of security systems falls outside the scope of a home inspection.

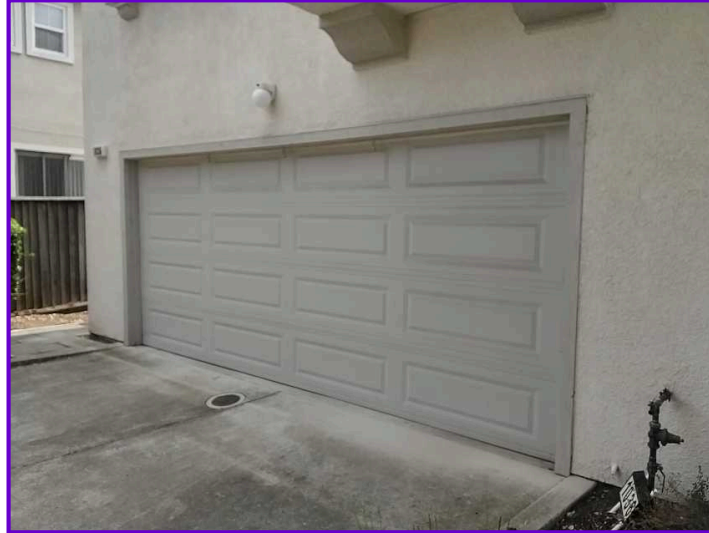
Vehicle Doors Vehicle Doors

- COMMENTS: The sectional garage vehicle door functioned satisfactorily when tested using the automatic opener.

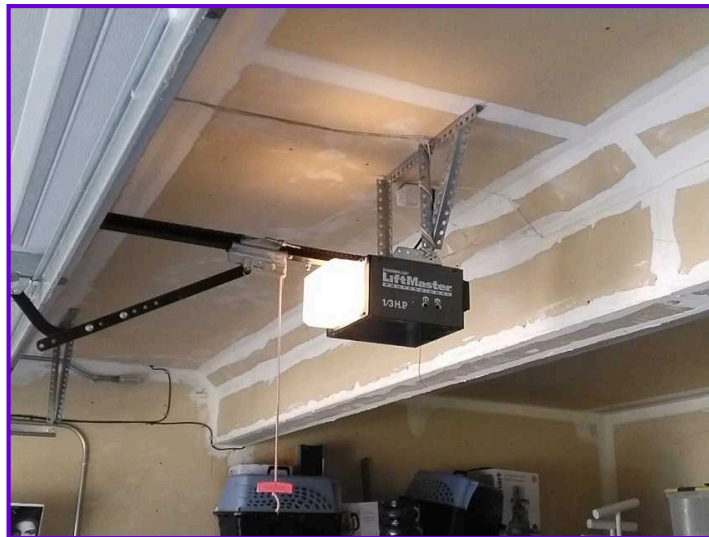
Vehicle Doors Automatic Opener

- COMMENTS: The automatic garage vehicle door opener and auto reversing feature functioned satisfactorily when tested.

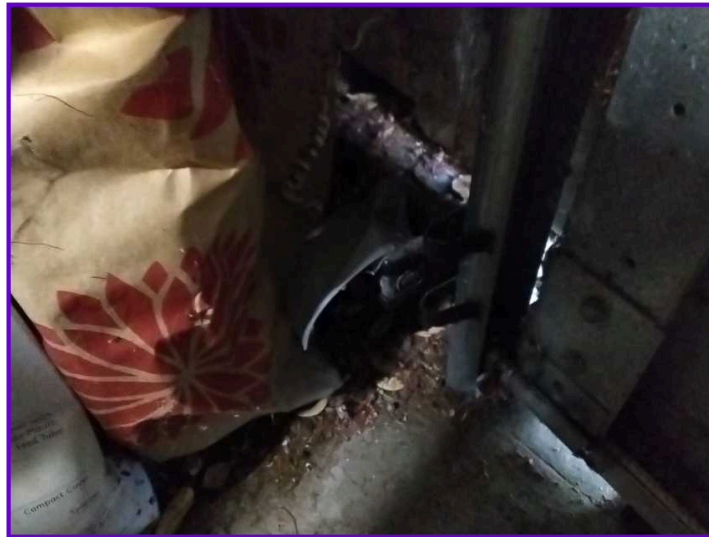
Vehicle Doors Safety Sensors

- COMMENTS: The safety sensors at the garage vehicle door functioned satisfactorily.

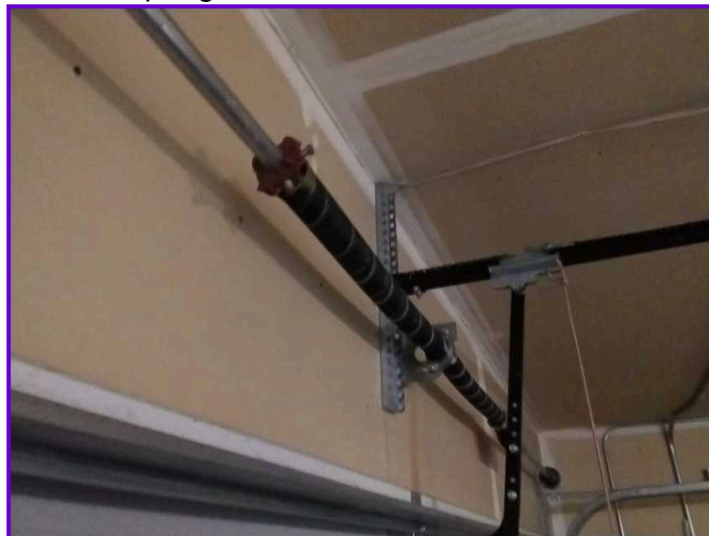
Vehicle Doors Springs and Torsion Bars

- COMMENTS: The vehicle door spring and torsion bar are functional.

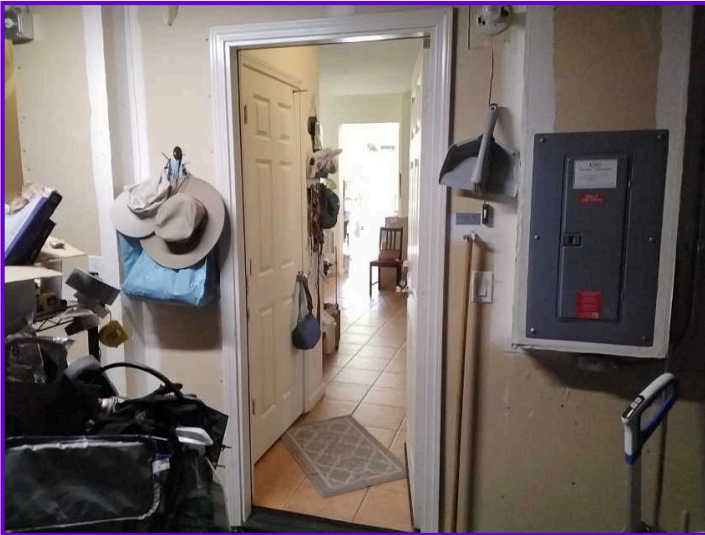
Garage Interior Fire Door

- **SAFETY:** The entry door from the garage into the house is not self-closing or latched. To maintain the necessary firewall separation between the garage and living areas, this door should be equipped with a self-closing hinge to help ensure safety and compliance with fire separation requirements. Installing a self-closing hinge at the middle of the door is a simple remedy.

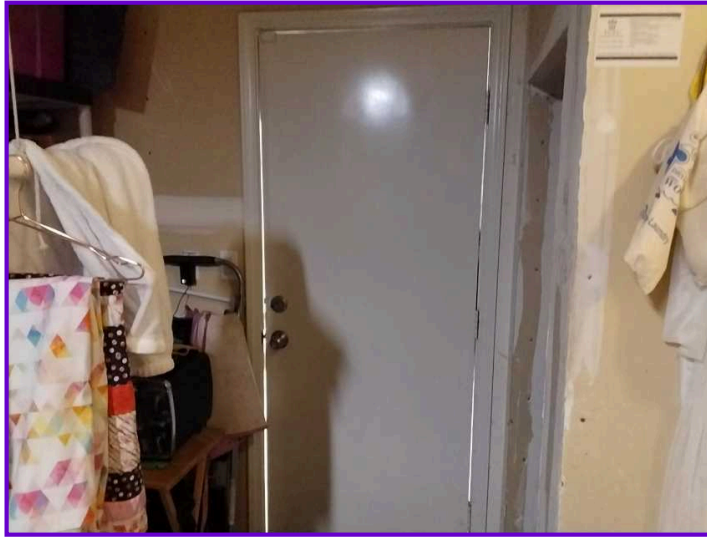
Garage Interior Doors

- **COMMENTS:** The garage side door is functional but may have minor wear and/or damage.

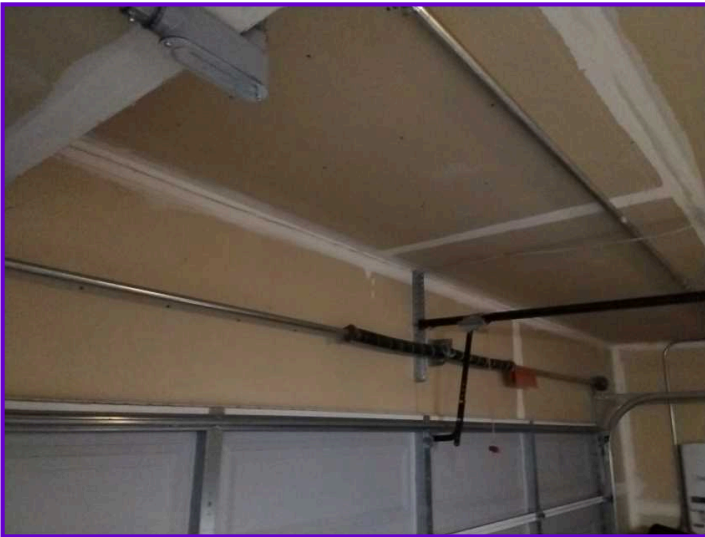
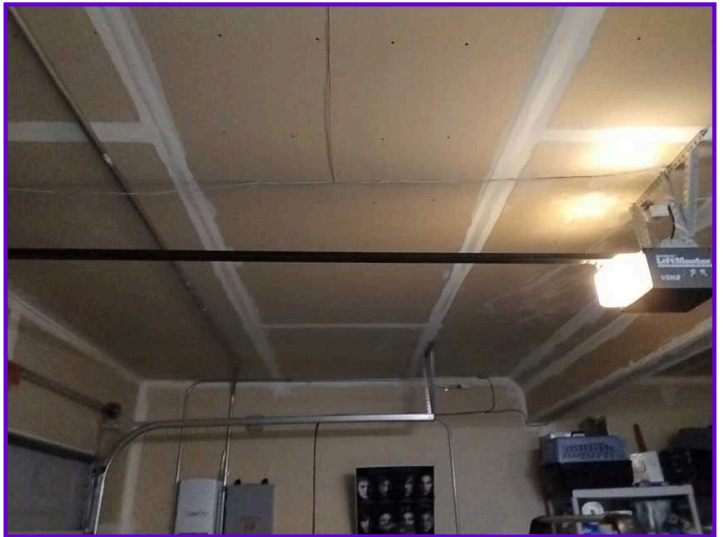
Garage Interior Walls and Ceiling

- COMMENTS: The wall covering is functional.
- COMMENTS: The wall coverings may have typical wear or cosmetic damage commensurate with their age.
- COMMENTS: The ceiling covering is functional.
- COMMENTS: The ceiling covering may have typical wear or cosmetic damage commensurate with its age.

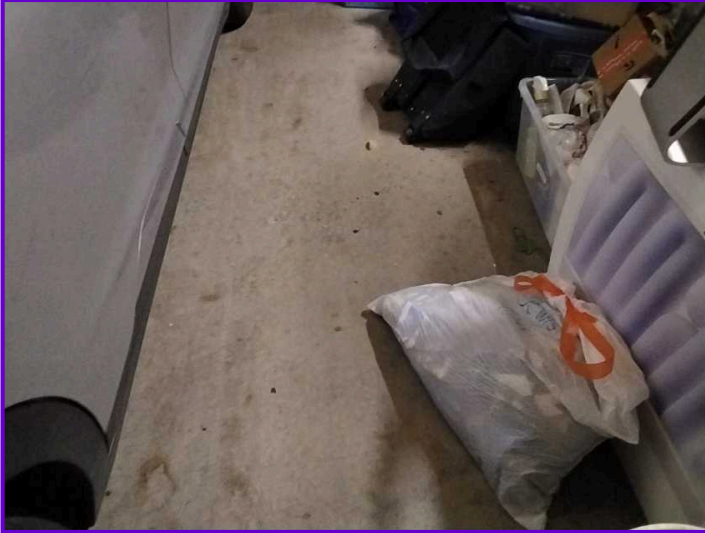
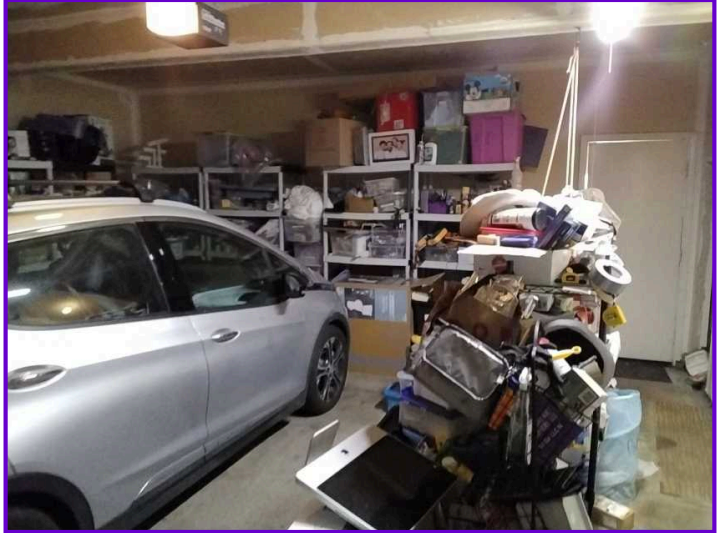
Garage Foundation Concrete Slab

- **DEFERRED:** Where visible, the garage concrete slab foundation appeared to be in satisfactory condition. However, the garage was filled with stored items, preventing a clear view of the slab and perimeter stem walls and for this reason we cannot fully endorse it. Concerned parties may wish to have the slab and perimeter stem walls reinspected once all stored items and belongings are removed.
