# RELIANCE HOME INSPECTION SAN DIEGO

## RESIDENTIAL REPORT

7701 Garboso Pl  
Carlsbad, CA 92009

09/10/2026

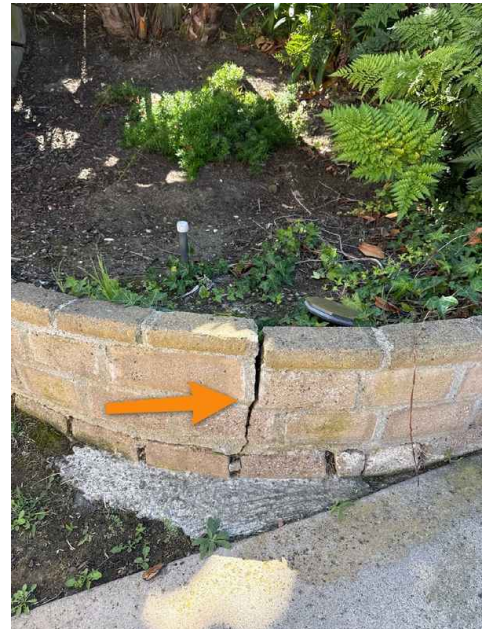
Example Noted At Rear Side Of Home

11.8.2 Vegetation, Grading,  
Drainage & Retaining Walls

Contact a qualified professional.
