## **San Diego's Premier Home Inspection Company**

# **CONFIDENTIAL INSPECTION REPORT**

11683 Via Ranch San Diego, El Cajon, CA 92019

8/4/2025 1:00 pm to 3:30 pm

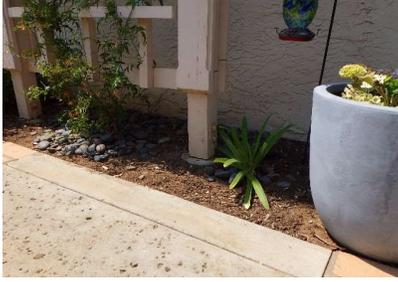
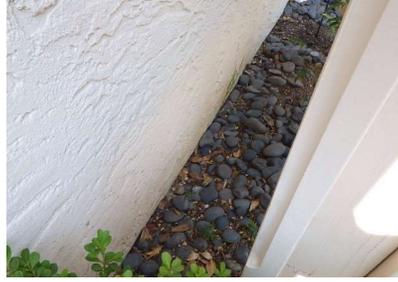
2.6 - The soil and or hard surface height are too high at the various locations around the perimeter of the home (Right side of the home). This is due to added landscaping elements that were improperly installed. It is recommended that the soil and or concrete heights be lowered to allow for proper drainage and to avoid possible moisture intrusion.

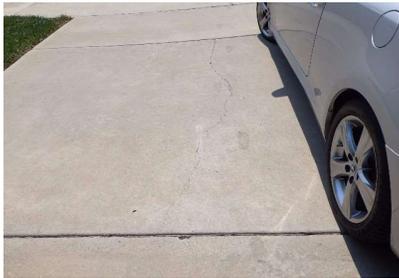
2.18 - There are cracks and or offsets in the driveway that could prove to be trip-hazards, particularly for children or the elderly, which you may wish to evaluate for yourself.

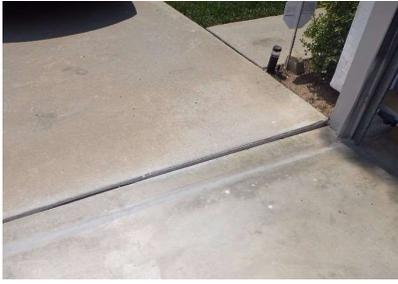
2.19 - There is an offset at the intersection of the driveway and garage slab, which may pose as a trip hazard and may indicate movement has occurred. Further evaluation and repair by a licensed foundation contractor is advised.

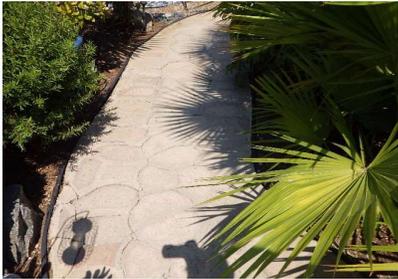
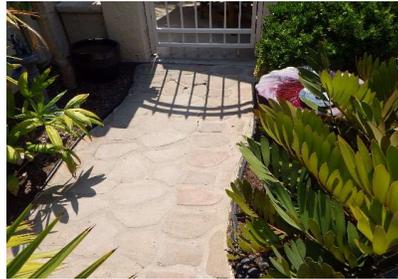
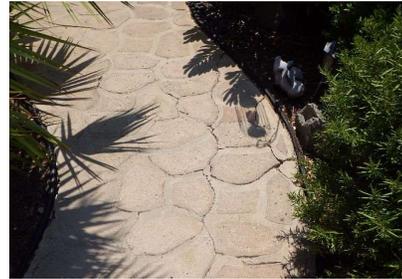
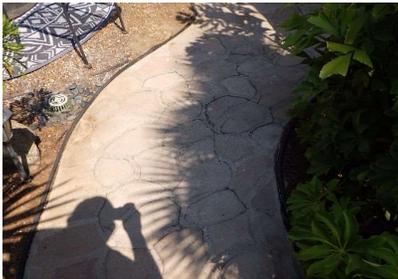
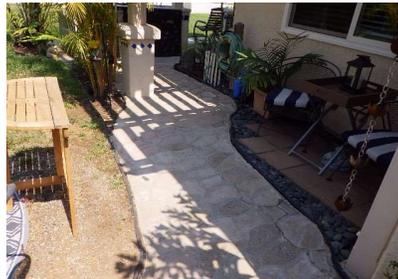
2.21 - There are cracks and or offsets in the walkways that could prove to be trip-hazards.

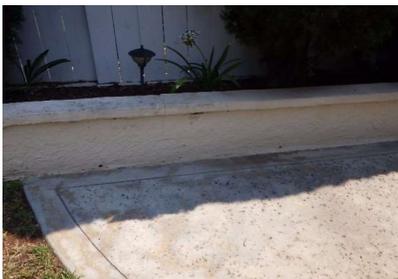
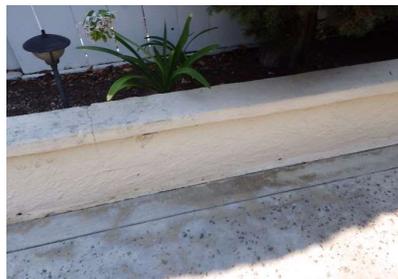
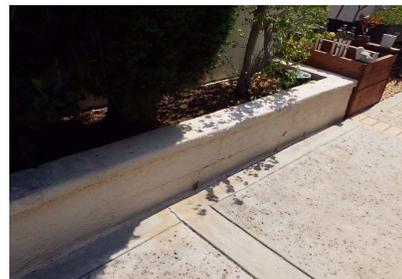
2.22 - The yard walls may have some cosmetic damage and cracking, but appear to be functional.

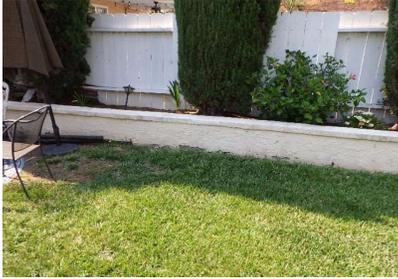
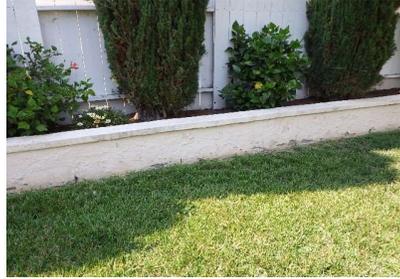
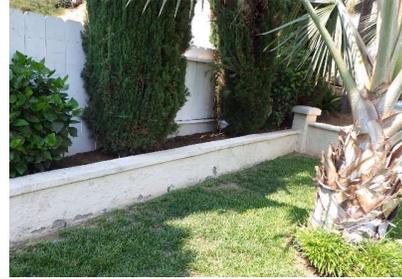
2.23 - There is efflorescence, or salt-crystal formations at various points on the yard walls. Such efflorescence is relatively common and is activated by moisture, but has only a cosmetic significance.

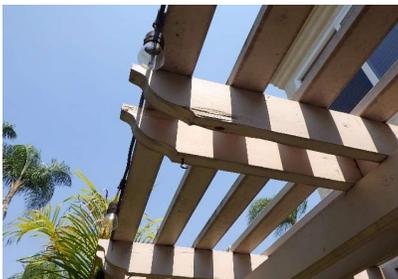
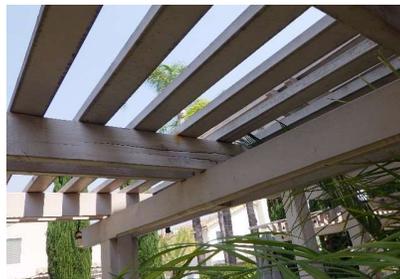
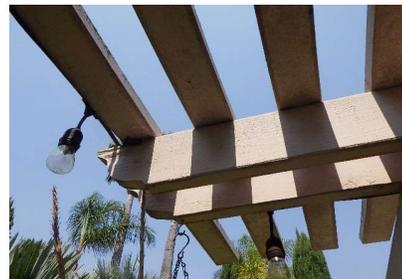
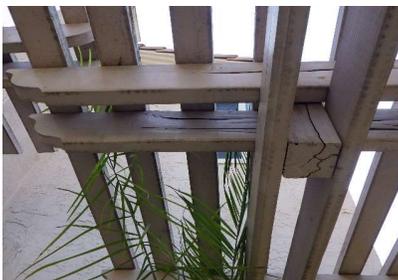
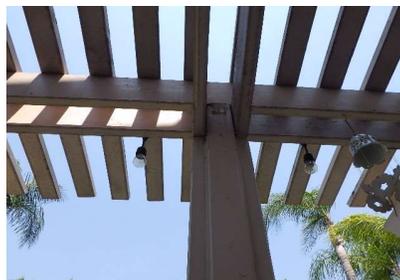
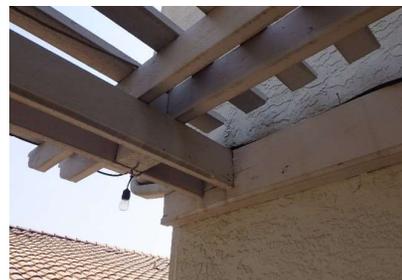
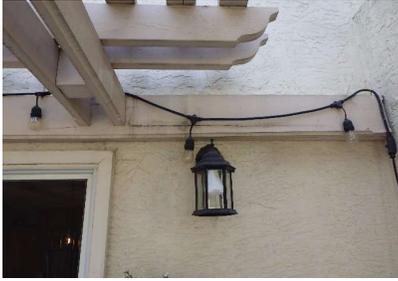
2.30 - There is possible termite and or moisture damage to the rear patio cover, that should be further evaluated and repaired by a licensed Pest Control Operator.

There is possible termite and or moisture damage to the rear patio cover - *Continued*

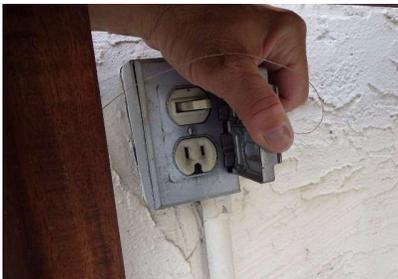
2.37 - One or more of the rear exterior outlets were damaged. Further evaluation and repair by a licensed electrician is advised.

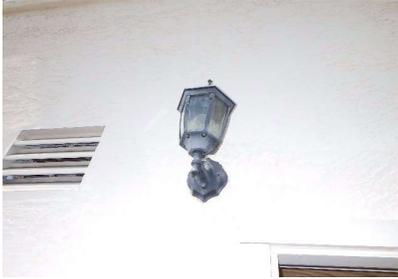
2.39 - One or more of the exterior lights appear to be on timers or sensors, which did not allow me to operate them. Confirming all exterior lights are functional with the seller is advised.

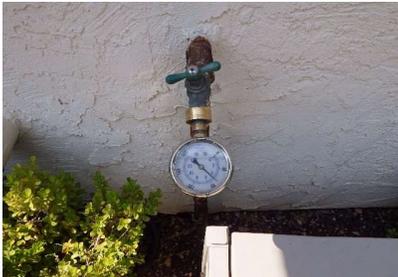
- 3.2 - A functional pressure regulator is in place on the plumbing system.
- 3.3 - The water pressure was 65 to 70 PSI when tested.

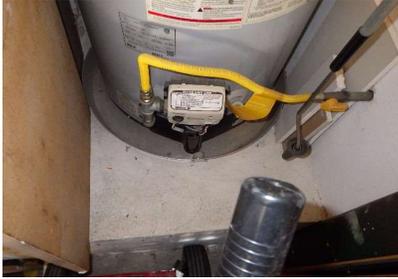
3.16 - The water heater is equipped with a drain pan, which is designed to minimize water damage from a leak, but does not have a visible drain pipe to the exterior. Therefore, it should be monitored periodically for signs of a leak.

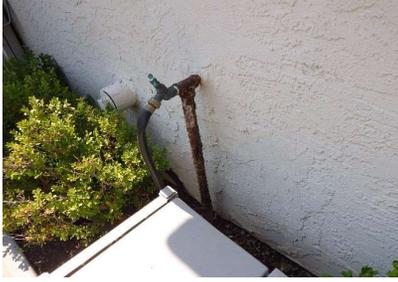
3.23 - One or more hose bibs are corroded and leaking (Right side hose bib) and should be repaired by a licensed plumber.

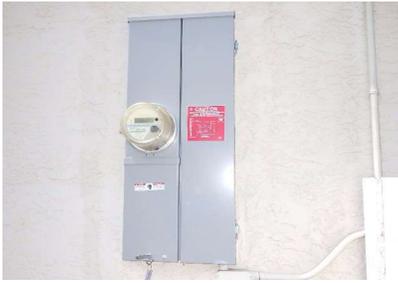
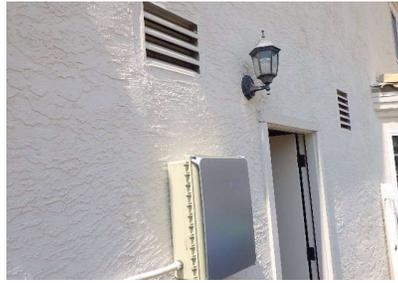
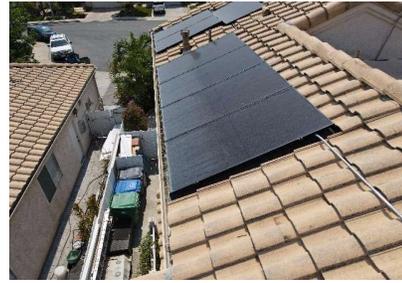
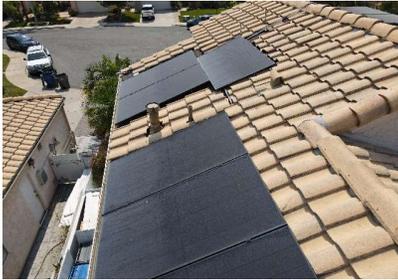
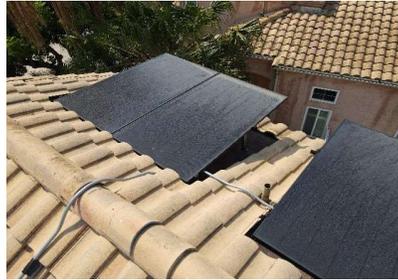
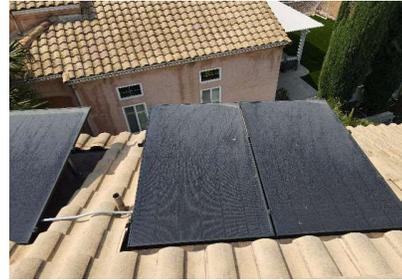
4.17 - The home is equipped with a Solar system which is located on the roof. We do not evaluate these systems as part of our services.

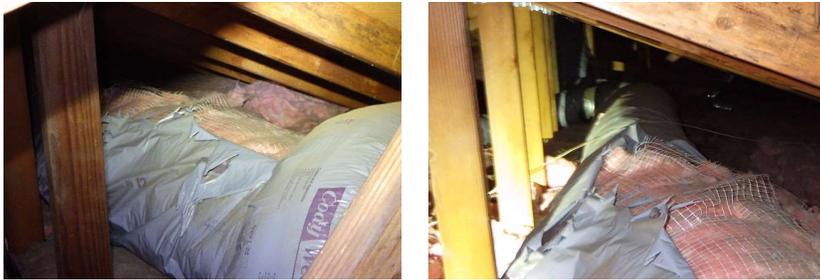
6.20 - The ducts are a modern flexible type that are comprised of an outer plastic sleeve and a clear inner liner that contains fiberglass insulation. However, portions of the outer sleeve are U-V contaminated and should be replaced by a licensed HVAC contractor.

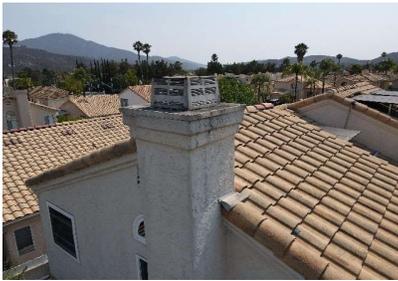
7.4 - The chimney weather cap-spark arrestor is dirty, which should be serviced by a certified chimney sweep.

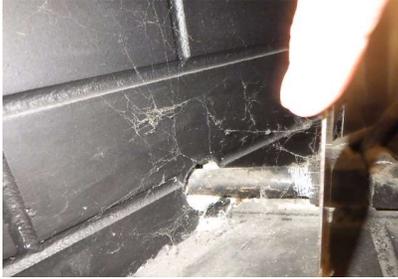
7.12 - The void around the gas pipe in the sidewall of the fireplace should be sealed with refractory caulk to prevent any possibility of back-drafting a flame beyond the combustion chamber, where it could come into contact with combustible material.

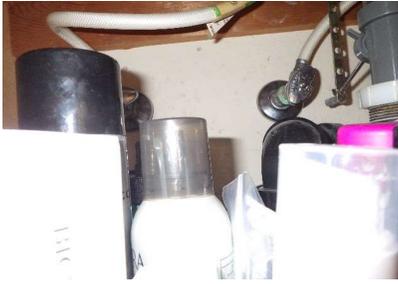
10.12 - Corrosion was noted on the water lines and or connectors below the sink, which should be serviced.

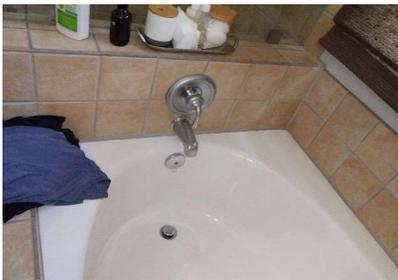
10.14 - The hot and cold is reversed on the tub valve. Proper repairs by a licensed plumber is advised.

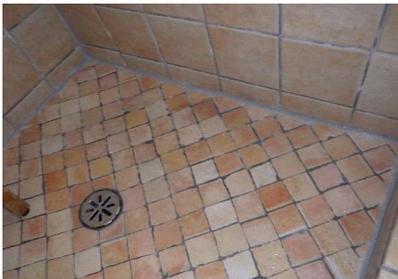
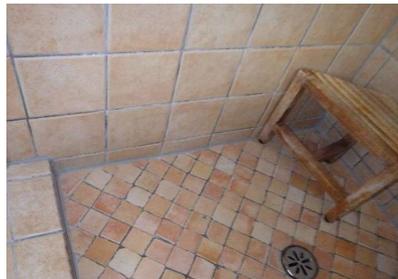
10.16 - Caulking was noted around the tiled shower pan and walls, which you may wish to view for yourself.

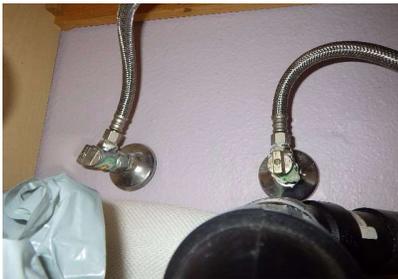
10.31 - Corrosion was noted on the water lines and or connectors below the sink, which should be serviced.

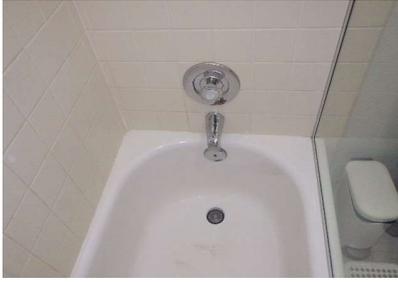
10.33 - The tub stopper is missing or incomplete and should be repaired or replaced.

10.34 - The hot and cold is reversed on the tub and shower valve, which should be repaired by a licensed plumber.

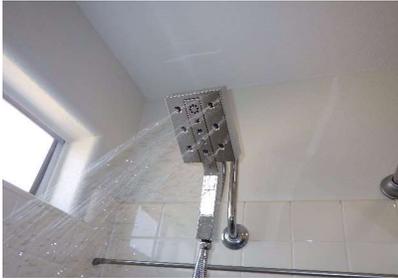
10.35 - The shower head is occluded by minerals, and does not spray uniformly.

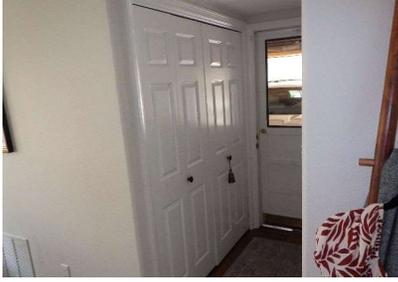
14.6 - There is no exhaust fan, louvered doors, or window, which would typically be required by building standards, and which you may want to install for better ventilation of the room.

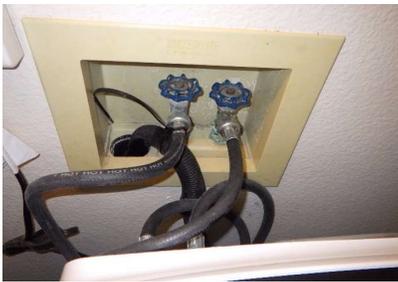
14.10 - Rust and or corrosion was noted on the hose faucet hook-ups for the washer, which should be serviced.

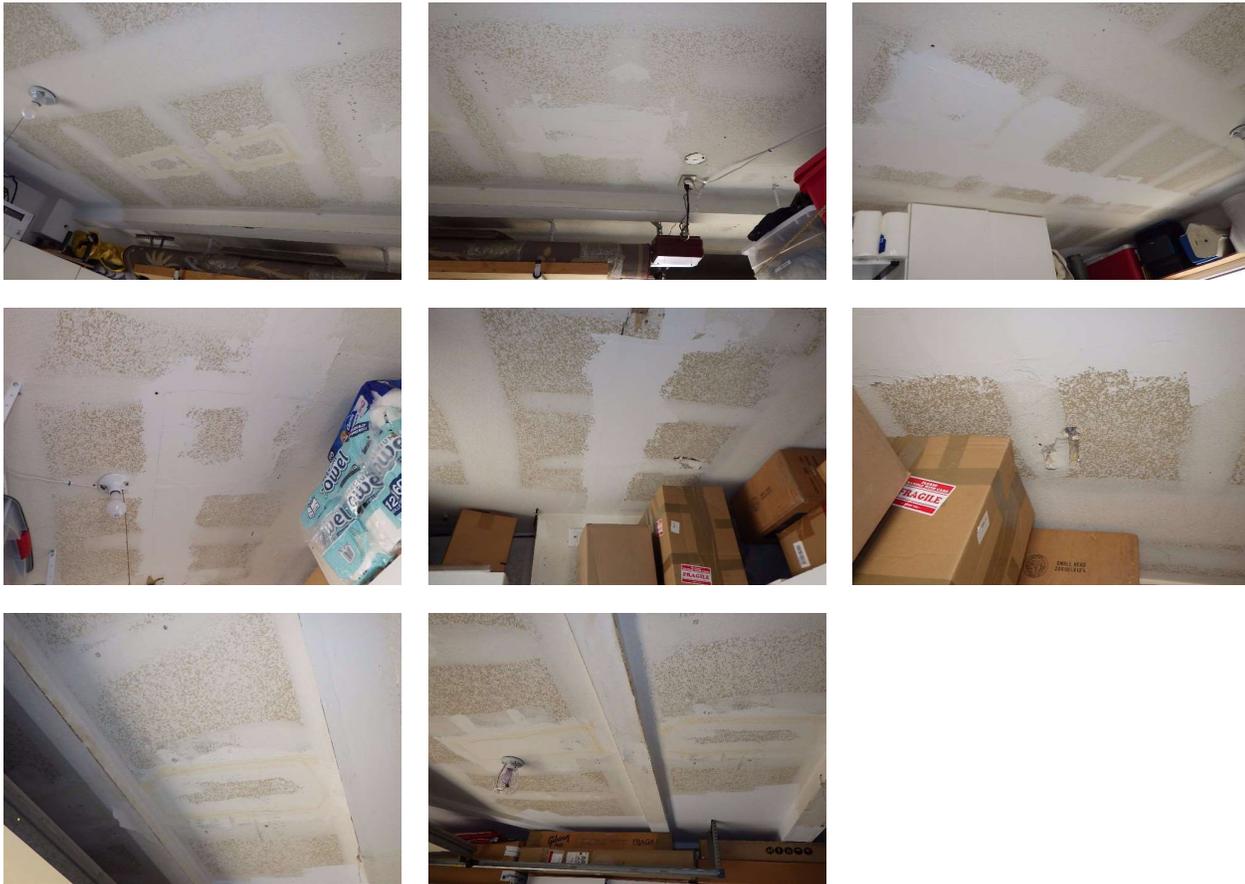
15.5 - There is cosmetic damage and or patching to the walls and or ceiling in the garage, which you should question the sellers about.

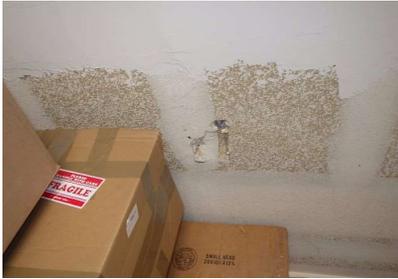
15.9 - The voids, holes, and or damaged areas in the garage firewall must be repaired, in order to maintain the necessary firewall separation between the garage and the residence.

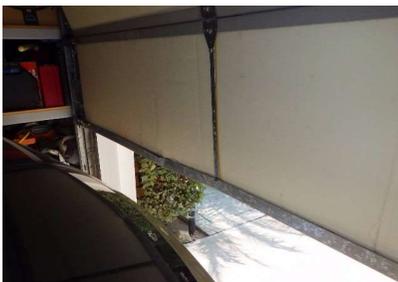
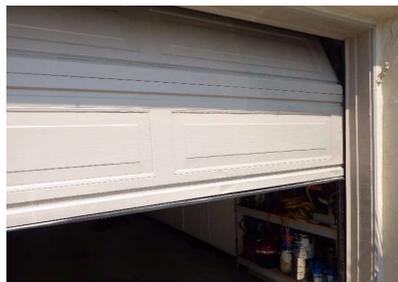
15.13 - There are one or more panels of the roll-up garage door that are bent, cracked, and or damaged. Proper repairs are recommended by a licensed garage door specialty contractor.

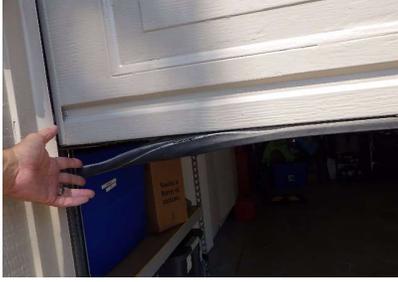
15.14 - The weather stripping is damaged and or missing on the bottom of the door, which should be repaired or replaced.

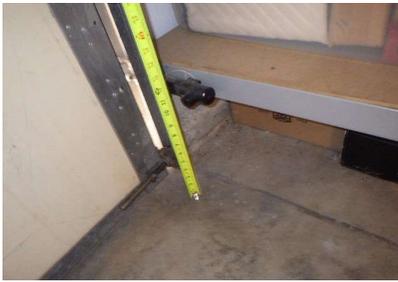
15.16 - The infra red auto-reversing sensor mechanism is functional, but located higher than the recommend six inches above grade.

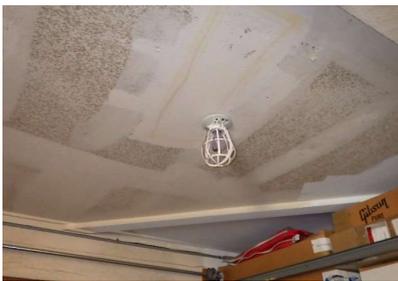
15.18 - One or more lights do not respond and should be serviced.

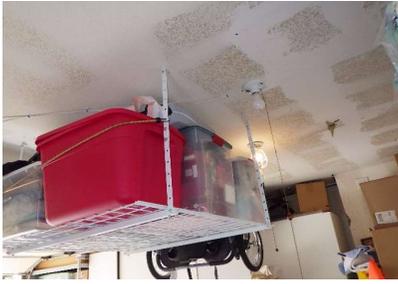
15.19 - Shop lights were added that are not permanently wired. Further evaluation and repair by a licensed electrician is advised.

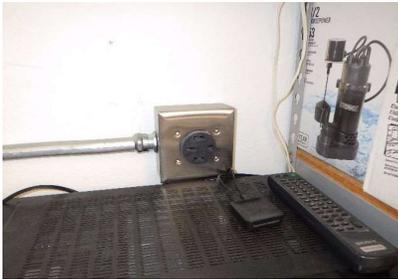
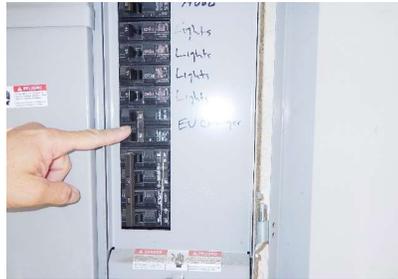
15.21 - The 220 volt outlet in the garage is not functional (The circuit breaker was turned off in the main panel). Further evaluation and repair by a licensed electrician is advised.

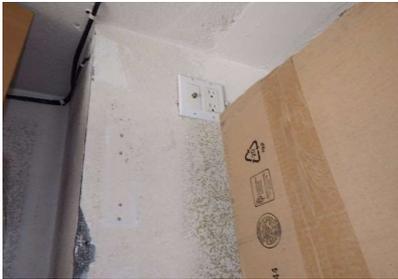
15.22 - One or more of the outlets that were tested are functional, however, are not ground fault protected. Installation of ground fault protected outlets is advised by a licensed electrician.

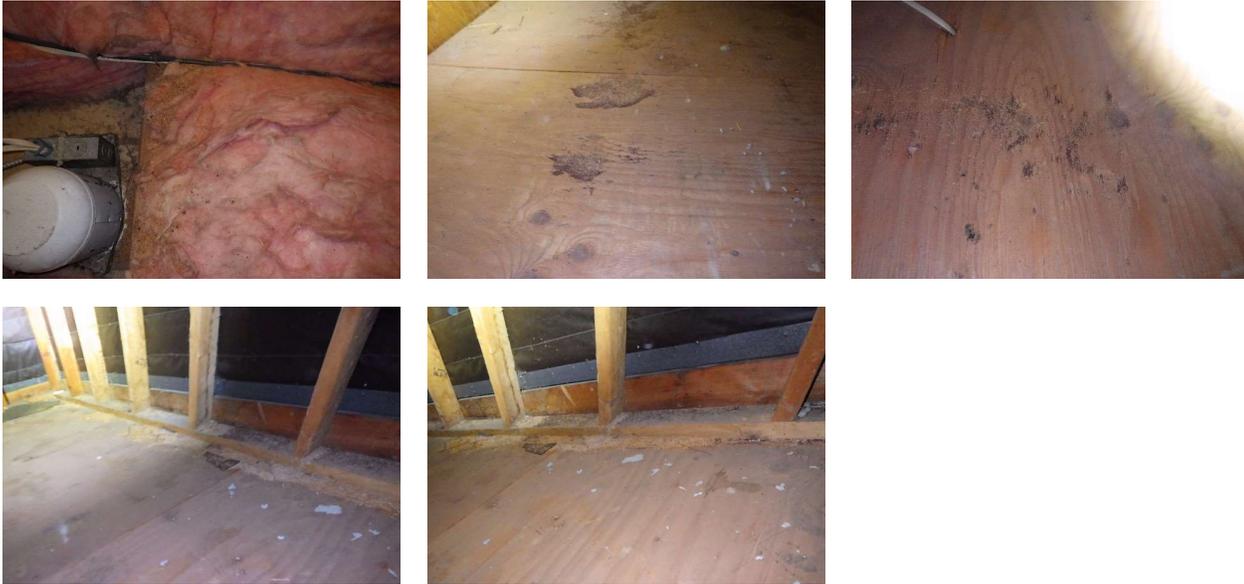
16.4 - There are signs of possible termite activity in the attic. Further evaluation and repair by a licensed Pest Control Operator is advised.

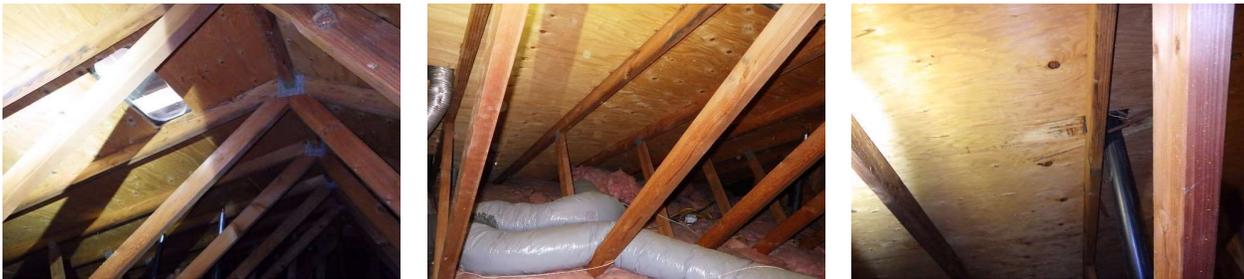
16.5 - There is evidence that the roof has leaked in several locations, which should be reasonably explained, or the roof should be further evaluated by a licensed roofer.

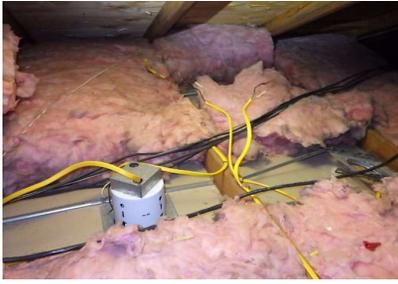
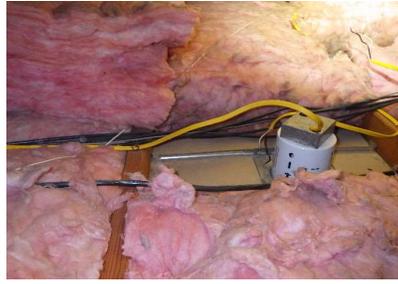
16.8 - There appear to be exposed abandoned Romex wires noted in the front portion of the attic. Proper removal of the wires is advised by a licensed electrician.

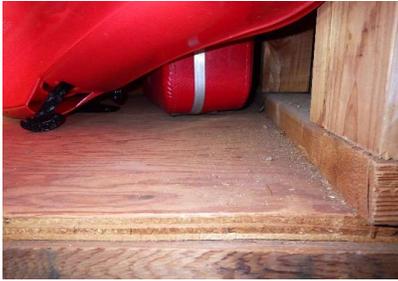
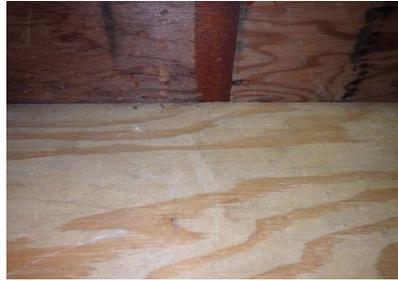
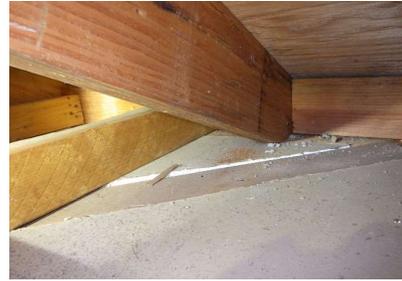
16.17 - There is signs of possible termite activity in the attic. Further evaluation and repair by a licensed termite inspector is advised.
