# WOOD DESTROYING PESTS AND ORGANISMS INSPECTION REPORT

Building No.	Street	City	Zip	Date of Inspection	Number of Pages
2144	Country Pl	Escondido	92026-1336	05/01/2024	1 of 6

General Description: One story Du-Plex Furnished- Occupied	Inspection Tag Posted: Garage
	Other Tags Posted: Major League Pest- (I) 08/24/2021

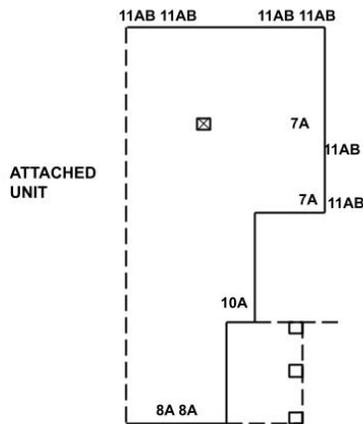
Diagram not to scale

Finding: 7A Evidence of drywood termites noted in area(s) marked on diagram.  
Recommendation: Locally treat area(s) at the rafter & attic wood members around vent for the control of drywood termites. Cover or remove accessible termite pellets. Areas treated are warranted for one (1) year.

Finding: 8A Evidence of drywood termites noted in area(s) marked on diagram.  
Recommendation: Locally treat area(s) at the top plates and stud for the control of drywood termites. Cover or remove accessible termite pellets. Areas treated are warranted for one (1) year.

Finding: 11A Evidence of drywood termites noted in area(s) marked on diagram.  
Recommendation: Locally treat area(s) at the 2x4 rafter ends, 2x4 blocks and 2x4 outriggers. for the control of drywood termites. Cover or remove accessible termite pellets. Areas treated are warranted for one (1) year.

Finding: 11B Termite damaged wood noted at area(s) marked on diagram.  
Recommendation: Repair termite damage at the 2x4 rafter ends, 2x4 blocks and 2x4 outriggers. .

Finding: 10A Water stains and/or damage noted in area(s) marked on diagram.  
Recommendation: Repair water damage area at the baseboard at slider.
