INSPECTION REPORT
1090 S Sagebrush
Palm Springs CA 92264

INSPECTED BY
Hank Myll
HSH Inspections
Inc. DBA Home
Sweet Home
Inspections

INSPECTION DATE
📅 4/24/2023
🕒 12:00 PM

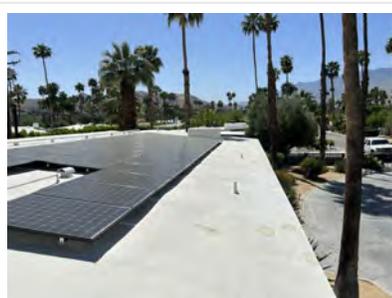
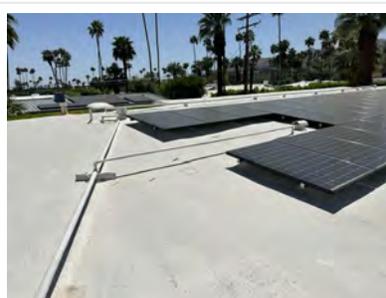
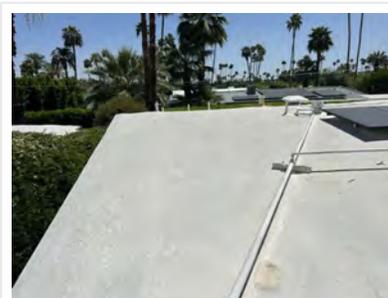
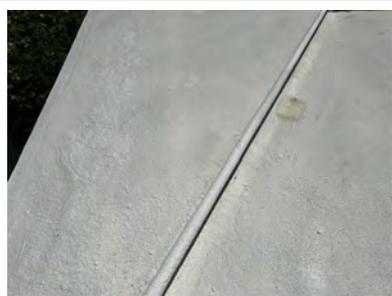
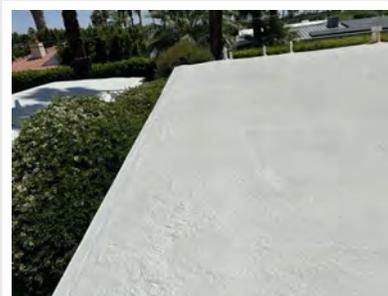
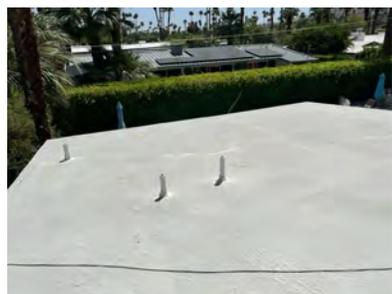
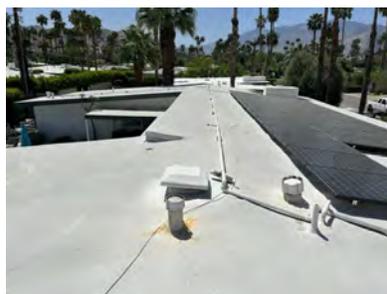
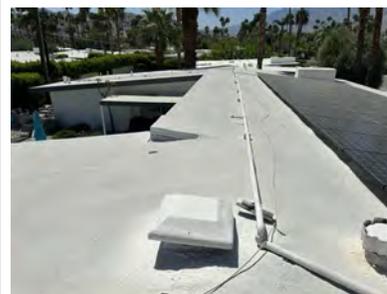
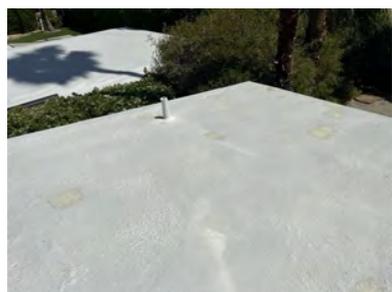
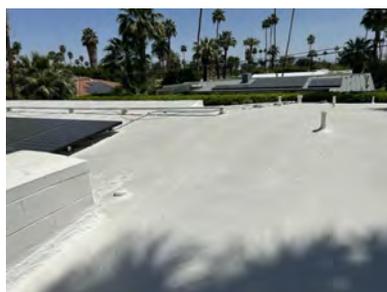
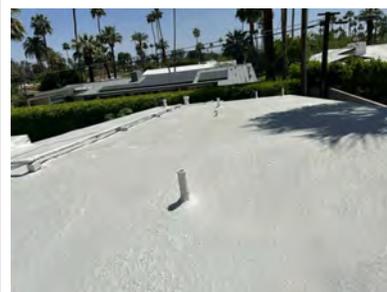
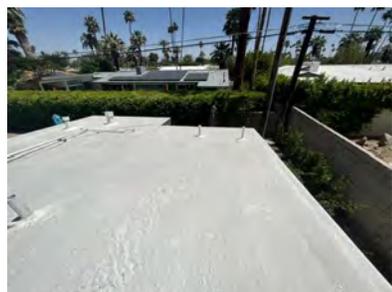
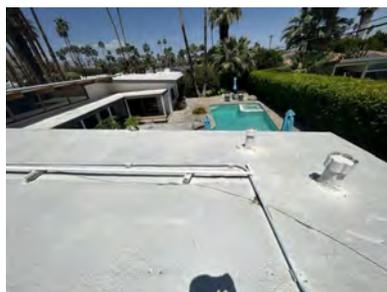
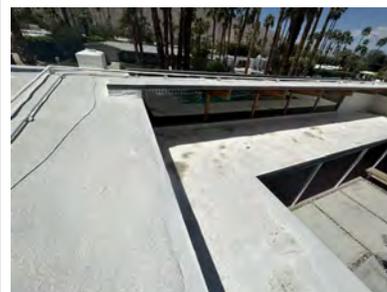
(1) The inspection of all roof and attic components are NOT inspected for vermin or bird intrusion. Recommend separate inspection be performed by specialist.

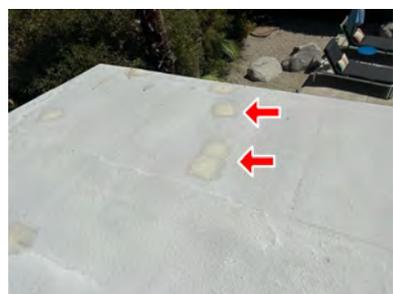
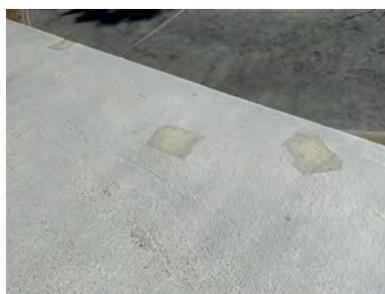
1.0 Item 17 (Picture)

(2) **Noted past roof repair. Roof appeared functional at time of inspection and is rated fair due to past repair. Recommend further evaluation as desired.**

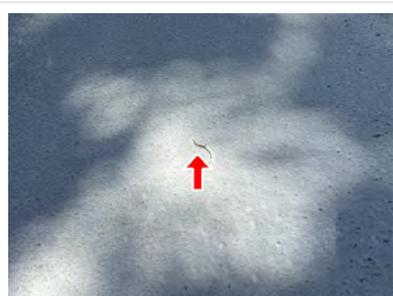
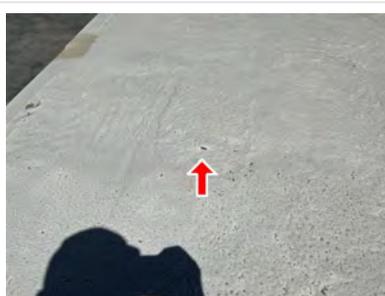
1.0 Item 19 (Picture)

(3) **Noted cracking / damage / deterioration on flat roof. Recommend evaluation/repair by roofing contractor.**

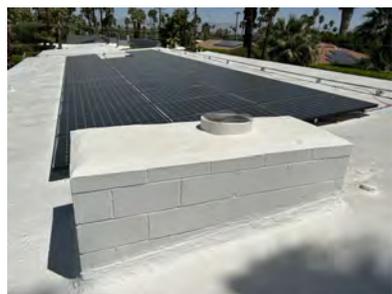
1.4 Item 1 (Picture)

SATISFACTORY

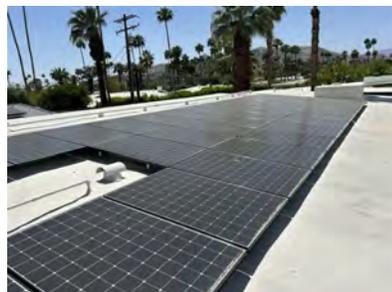
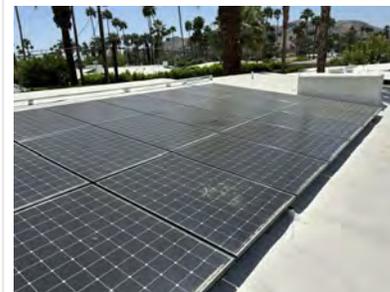
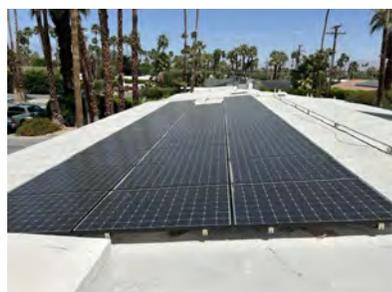
1.5 Item 1 (Picture)

Solar panel(s) / system / hot water system not inspected. Recommend evaluation by specialist as desired.

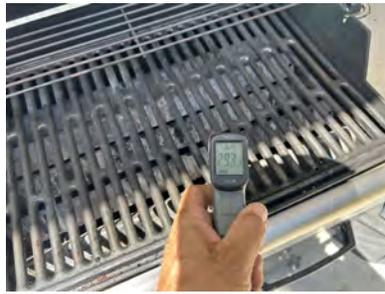
2.7 Item 2 (Picture)

(1) **Fire pit, fireplace and barbecue gas lines below ground level are not inspected, internal connections and fitting / gas line sizing not inspected. Recommend further evaluation confirmation of proper sizing by contractor. Nearly all of the gas lines to fireplaces / fire pits / barbecues are buried and therefore not**

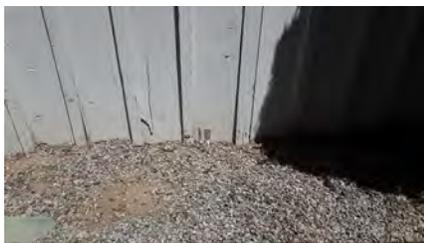
2.8 Item 1 (Picture)

- (1) Wood components are prone to decay and insect damage. Advise a check of these elements for current conditions and assurance of personal acceptability.**
- (2) Wood fence damage/past repair noted. Recommend repair/replacement as desired.**

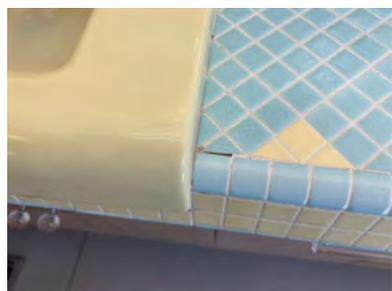
5.2 Item 1 (Picture)

- (1) Older cabinets noted, typical conditions for age. Repair or replace as desired.
- (2) Noted countertop grout cracking. Recommend grout repair as desired.

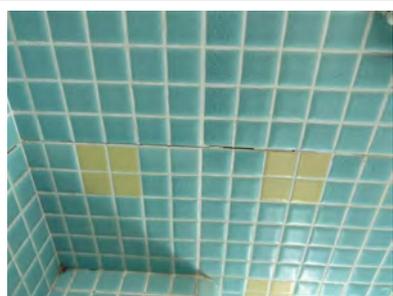
5.5 Item 1 (Picture)

Noted tile grout cracking and/or deterioration. Recommend repair to avoid possible moisture intrusion behind surround.

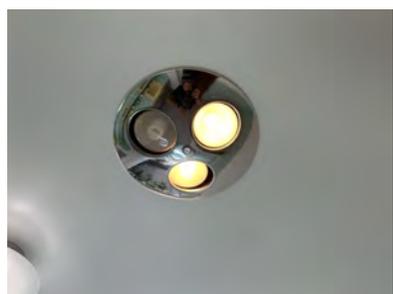
5.6 Item 1 (Picture)

Noted inoperative fixture. Recommend bulb replacement and further evaluation if necessary.

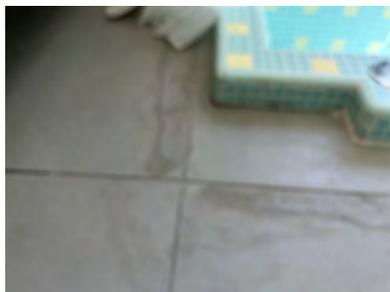
5.8 Item 1 (Picture)

(2) **Noted floor staining/deterioration. Recommend evaluation/repair as desired.**

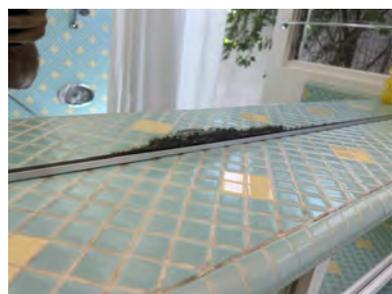
5.12 Item 1 (Picture)

Mirror damage/deterioration noted. Recommend evaluation/replace as desired.

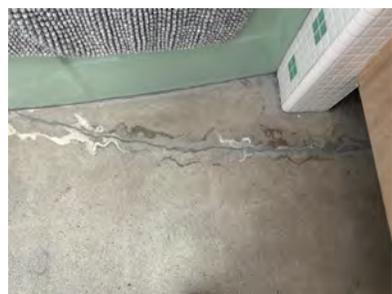
5.21 Item 1 (Picture)

Noted cracked/stained slab. Recommend evaluation/repair as desired.

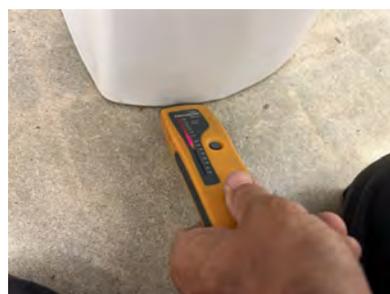
5.28 Item 1 (Picture)

Moisture noted at base of toilet. Recommend evaluation/repair by plumbing contractor.

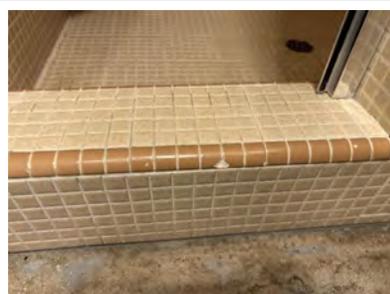
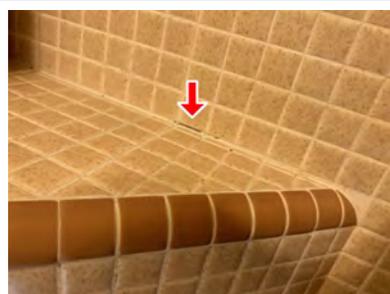
5.30 Item 1 (Picture)

(2) **The tile and/or grouting in the shower is cracked/missing. Recommend grout/tile repair to avoid possible moisture intrusion behind surround.**

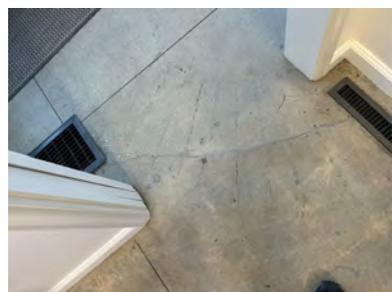
5.33 Item 1 (Picture)

Noted cracking/stained slab. Recommend evaluation/repair as desired.

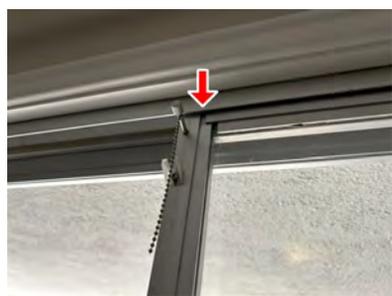
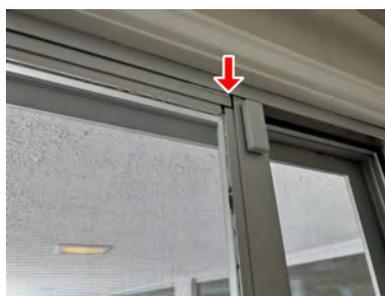
7.9 Item 1 (Picture)

Sliding door casing loose / damaged. Recommend evaluation / repair by specialist.

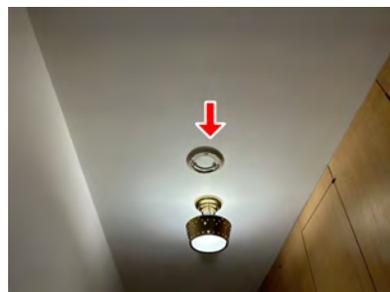
7.17 Item 1 (Picture)

- (1) **This home inspection does not include the placement of smoke/or any other detectors. An independent assessment should be made of the need for and/or replacement of detectors. All detectors should be tested on a regular basis.**
- (2) Smoke and carbon monoxide detector test features operational at time of inspection.
- (3) **Smoke detector in hallway not installed or inoperative. Recommend evaluation/repair by contractor.**

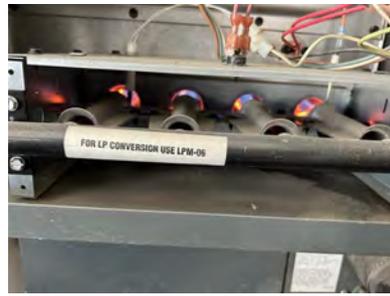
10.2 Item 1 (Picture)

☑ SATISFACTORY

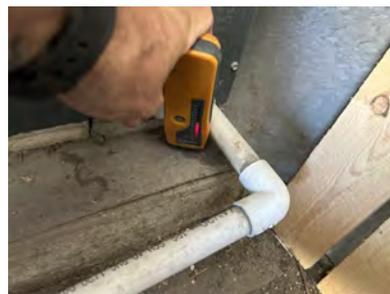
10.4 Item 1 (Picture)

Main or secondary condensation line(s) are leaking, moisture noted. Recommend evaluation/repair as necessary by HVAC contractor prior to close.

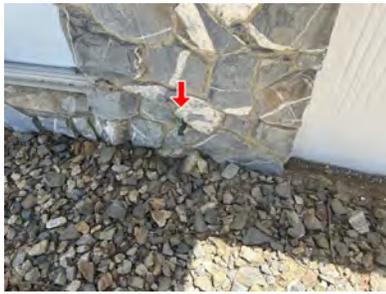
11.6 Item 1 (Picture)

Noted exterior faucet was inoperative. Recommend evaluation/repair by plumbing contractor.

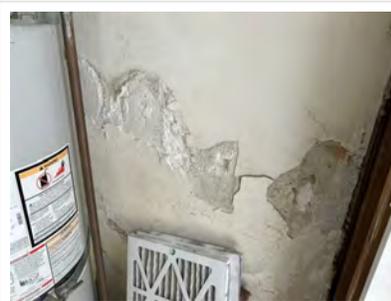
12.14 Item 1 (Picture)

Noted wall damage in heater cabinet that are not on a fire rated wall. Recommend repair as desired.

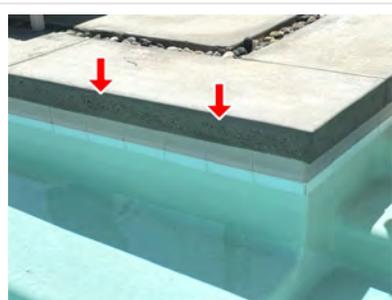
13.1 Item 1 (Picture)

(2) **Noted coping deterioration. Recommend further evaluation/repair by pool contractor as desired.**

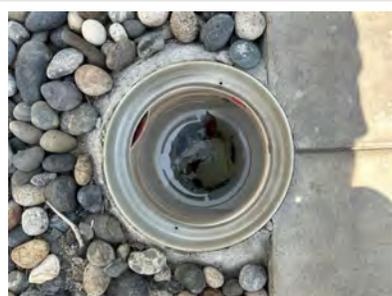
13.2 Item 1 (Picture)

☑ SATISFACTORY

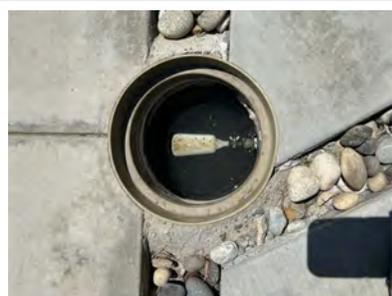
13.3 Item 1 (Picture)

☑ SATISFACTORY

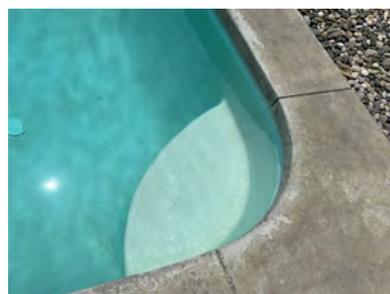
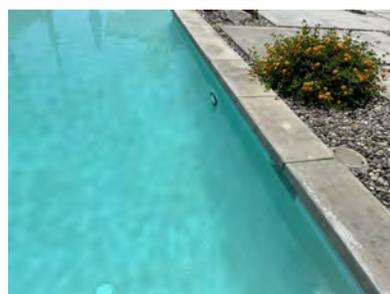
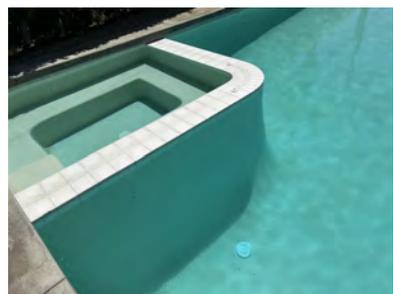
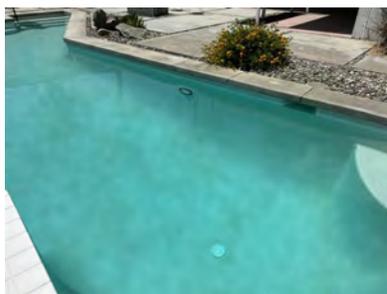
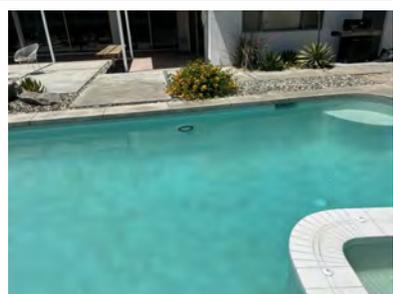
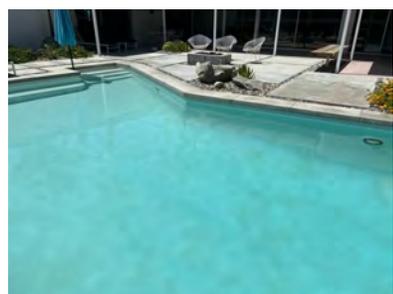
13.5 Item 1 (Picture)

(1) *In many cases, finishing surface defects are cosmetic in nature and do not affect pool function or physical condition. Refinishing may eventually be required due to the concerns with appearances or damage to the underlying surfaces. Any existing damage should be attended to as needed.*

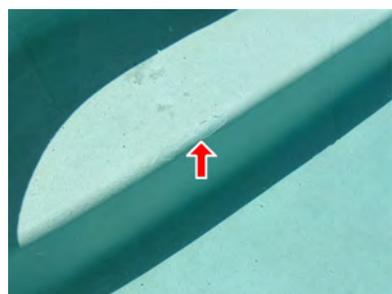
13.5 Item 11 (Picture)

(2) **Liner cracking/deterioration noted. Recommend liner be evaluated/repaired by pool contractor.**

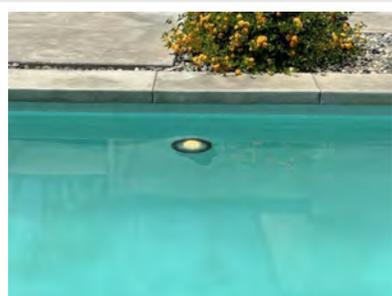
13.6 Item 1 (Picture)

☑ SATISFACTORY

All pool/spa electric components should be checked at least annually by a qualified electrician or pool service company to determine condition and repair needs.

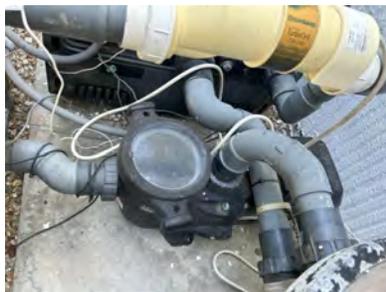
13.12 Item 1 (Picture)

☐ FAIR

Pump motor(s) operational at time of inspection. Rated fair due to indeterminate age.

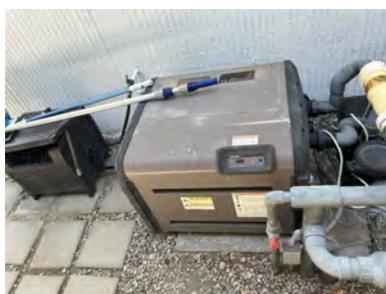
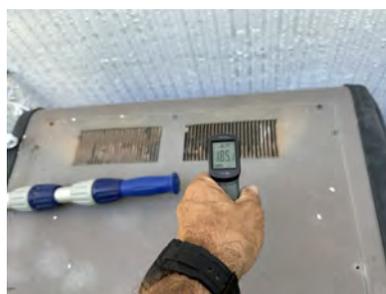
13.14 Item 1 (Picture)

☐ FAIR

(1) Determination of the operation and the ability of a heater to supply adequate/desired water temperatures is not within the scope of this inspection. Pool/spa heaters generally have relatively short-service lives. Any gas supply and venting concerns should be addressed promptly.

(2) **Heating unit functional at time of inspection and rated fair due to indeterminate age.**

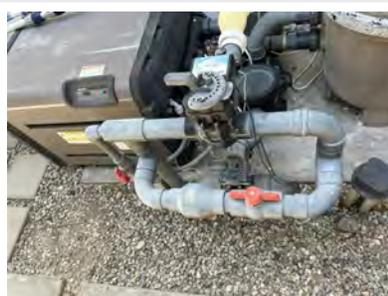
13.16 Item 1 (Picture)

(1) The condition of buried or concealed piping cannot be determined. Recommend a pressure test by a qualified pool service company to confirm there is no leakage.

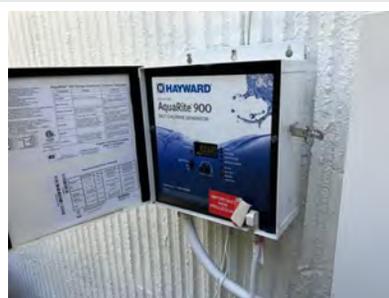
13.19 Item 1 (Picture)

Salt cell/chlorinator system not inspected. Recommend salt cell/chlorinator system be inspected by pool contractor.

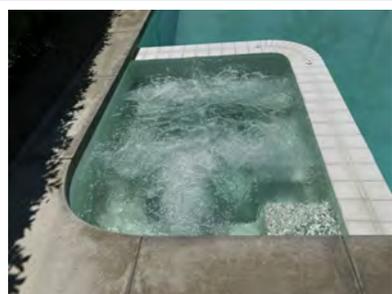
14.6 Item 1 (Picture)

No assessment was made as to the efficiency or adequacy of any jet or circulating system. Periodic maintenance/adjustment will be required.
