## Monday, June 17<sup>th</sup> update to Inspection report

## RESIDENTIAL / COMMERCIAL INSPECTION

118 California St D  
Arcadia, CA 91006

JUNE 13, 2024

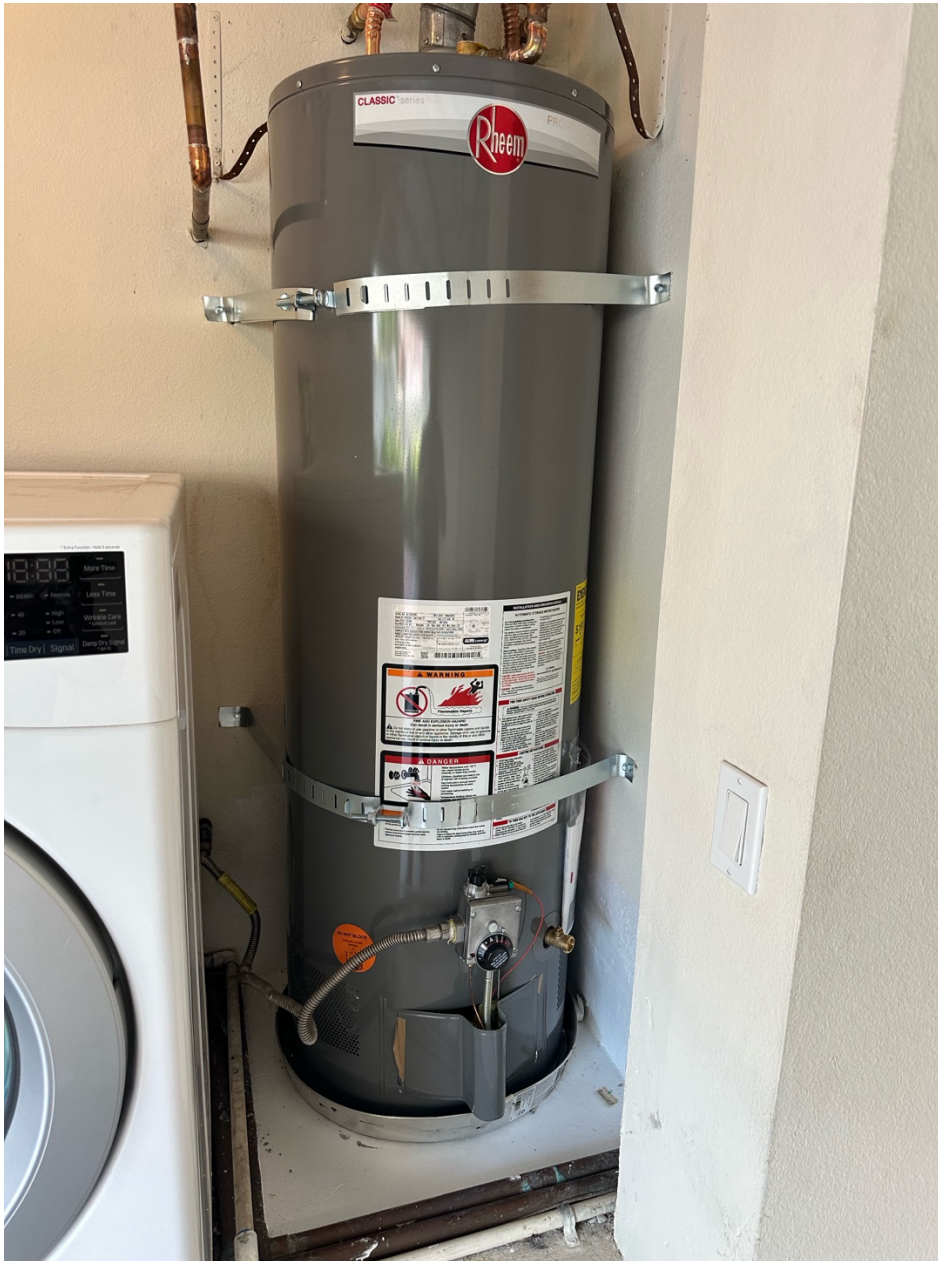
1. Inspector noted water heater, though installed in 2021, was leaking. Water heater was replaced with Rheem water heater on June 15<sup>th</sup>, plywood around water heater was removed, remaining area scrutinized for mold (none found) and new plywood installed under water heater, and water heater was strapped.

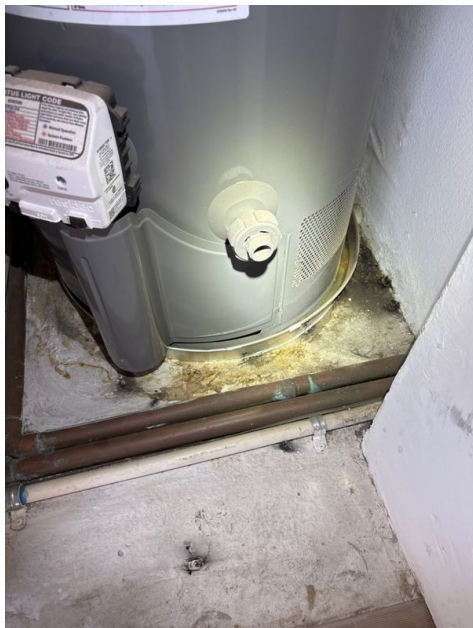
Garage

Microbial like growths and/or a musty odor were found at one or more locations. It is beyond the scope of this inspection to identify what substance or organism this staining is. However such staining is normally caused by excessively moist conditions, which in turn can be caused by plumbing or building envelope leaks and/or substandard ventilation. These conducive conditions should be corrected before making any attempts to remove or correct the staining. For evaluation and possible mitigation, consult with a qualified industrial hygienist or mold/moisture mitigation specialist.

Contact a qualified mold inspection professional.

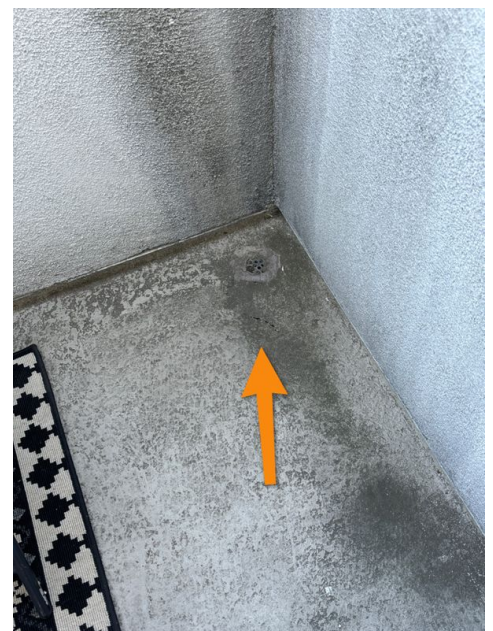
The waterproof membrane at one or more decks, porches and/or balconies was damaged, deteriorated and/or substandard. Recommend further evaluation and repair by a qualified professional.

Contact a qualified professional.

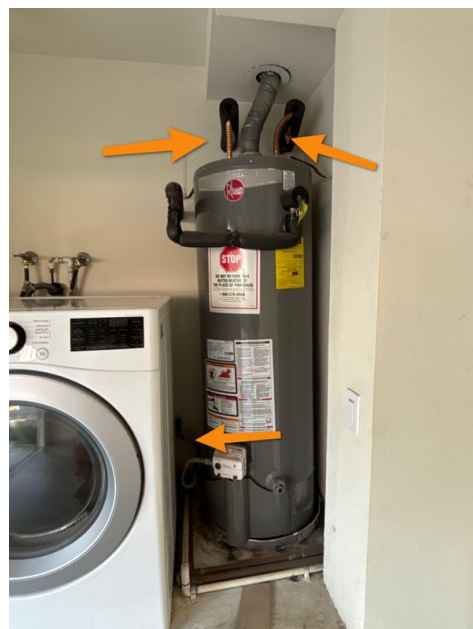
9.5.2 Water Heater

Improper / missing sediment trap installation was observed. Sediment traps help to prevent debris from entering the pilot / burner portions of the system.

Contact a qualified plumbing contractor.

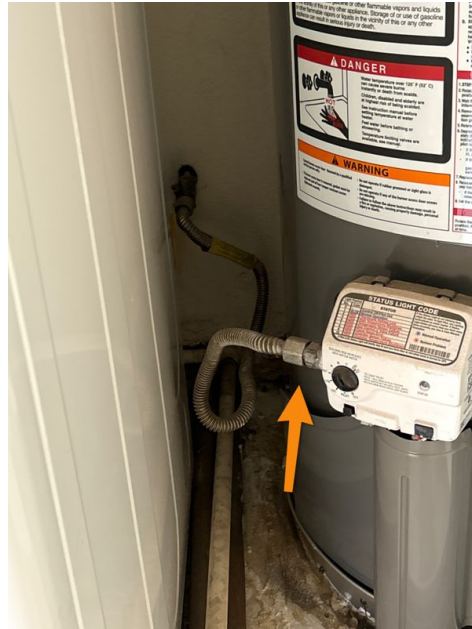
9.5.3 Water Heater

The water temperature tested was too hot. This can cause scalding and is a safety hazard. Recommend further evaluation by a qualified professional.

Contact a qualified professional.

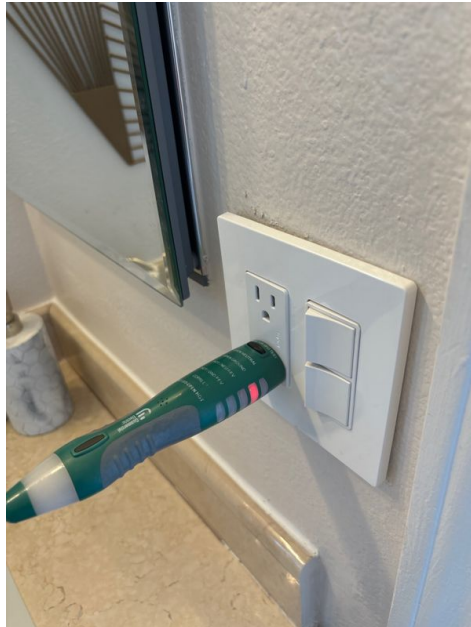
Primary Bathroom

One or more locations at this property were noted as not having GFCI protection or the inspector was unable to verify if GFCI protection existed at these locations. Adoption of GFCI outlets was generally phased in over numerous years/decades. Recommend client evaluate upgrading these areas to GFCI protection at their discretion.

Contact a qualified electrical contractor.

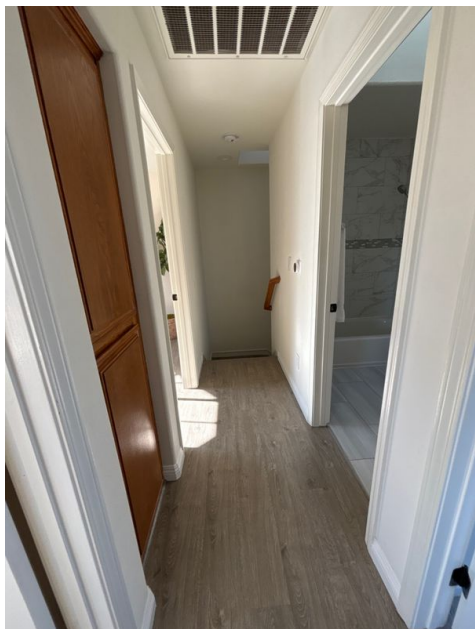
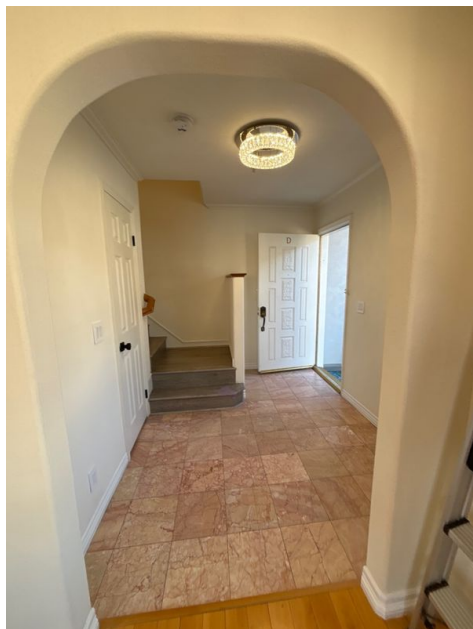
No permanently installed carbon monoxide alarms were found. This is a potential safety hazard. Recommend further evaluation and repair by a qualified professional.

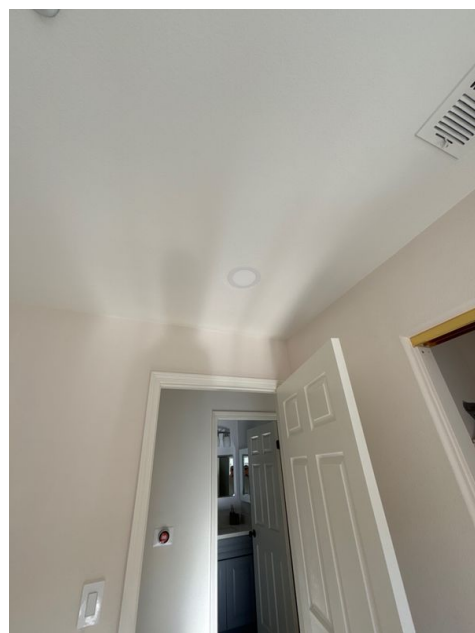
**SMOKE DETECTOR MISSING**

Smoke alarms were missing and/or not installed in one or more locations. Smoke alarms should be replaced as necessary and installed per standard building practices (e.g. in hallways leading to bedrooms, in each bedroom, on each floor). We recommend installing photoelectric type smoke detectors / alarms.

Contact a handyman or DIY project

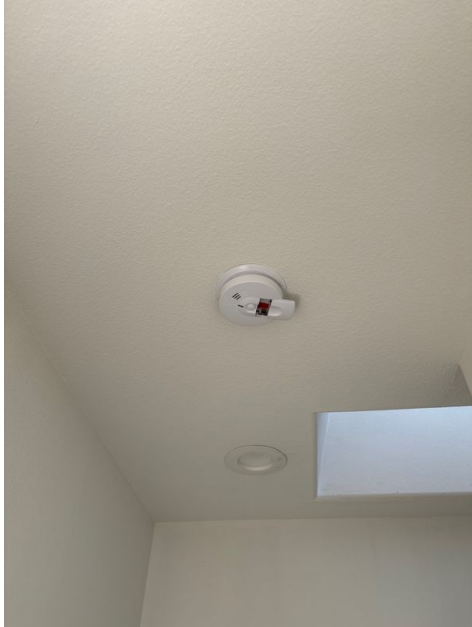
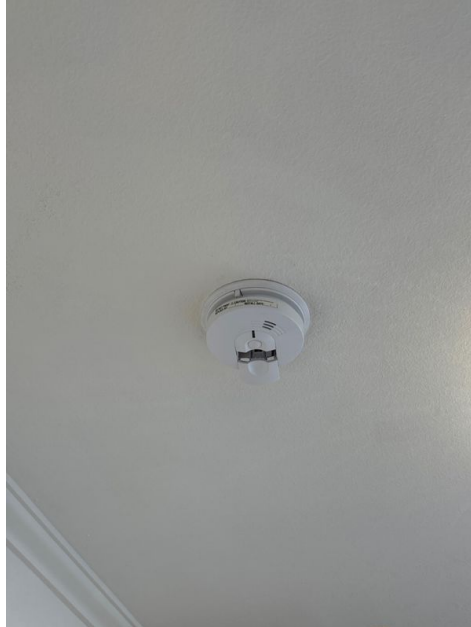
**SMOKE DETECTOR DAMAGED AND/OR INOPERABLE**

Smoke alarms were damaged and/or inoperable at one or more locations. Smoke alarms should be replaced as necessary and installed per standard building practices (e.g. in hallways leading to bedrooms, in each bedroom, on each floor). We recommend installing photoelectric type smoke detectors / alarms.

Contact a handyman or DIY project

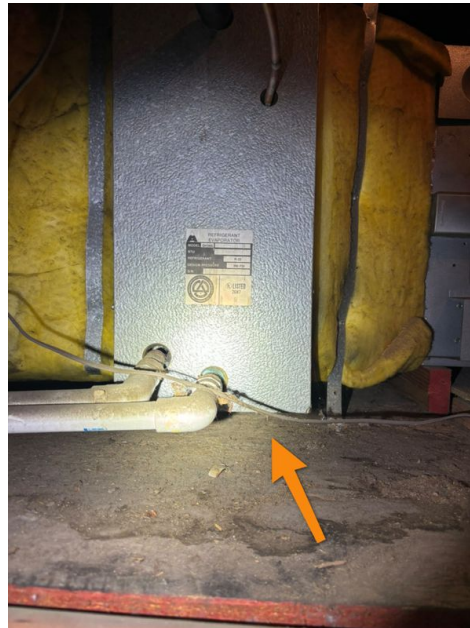
No condensation catch pan installed under the evaporative case. In the event the condensate drain line becomes clogged water from the condensate line will overflow onto whatever is below/around the unit, potentially causing water damage. Recommend a qualified licensed HVAC contractor evaluate the unit and add if allowed.

Contact a qualified HVAC professional.

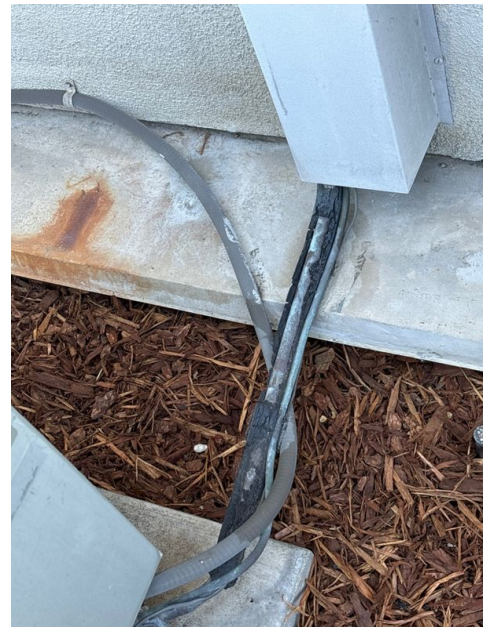
Insulation on the air conditioning refrigerant lines was deteriorated or missing in some areas. This may result in reduced efficiency and increased energy costs. Recommend further evaluation and repair by a qualified professional.

Contact a handyman or DIY project

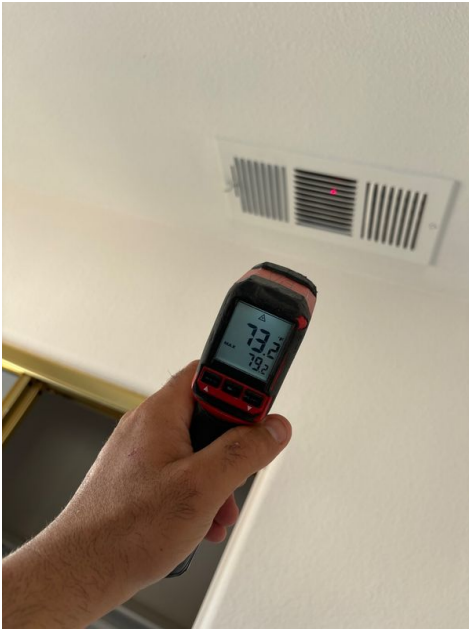
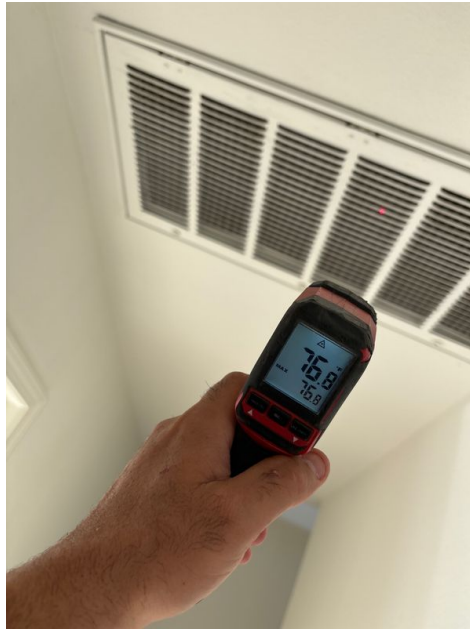
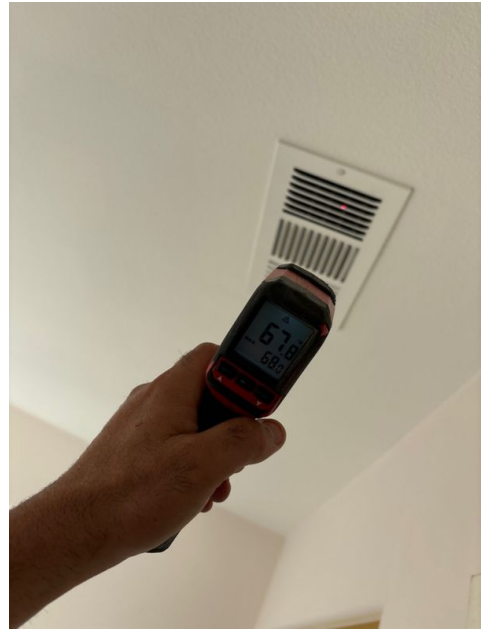
#### **AIR CONDITIONER NOT COOLING**

Supply air from the air conditioning or heat pump cooling system was not cool enough. It should be 14-22 degrees Fahrenheit cooler than at the return duct(s). Recommend further evaluation and repair by a qualified professional.

Contact a qualified HVAC professional.

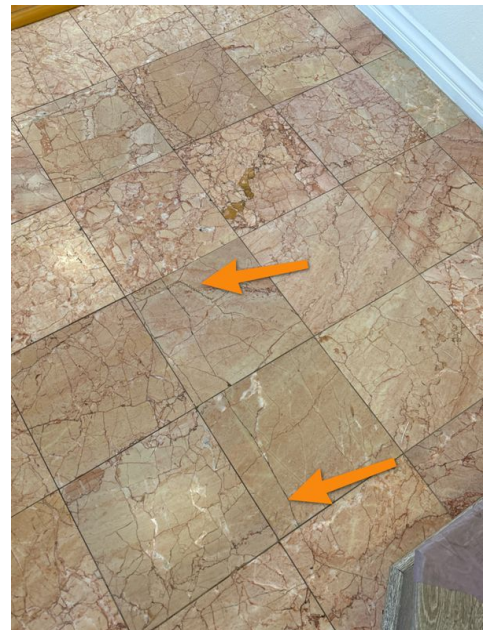
Hallway

#### **TILES CRACKED**

Cracked tiles were observed in one or more locations. Recommend further evaluation and repair by qualified professional.

Contact a qualified professional.

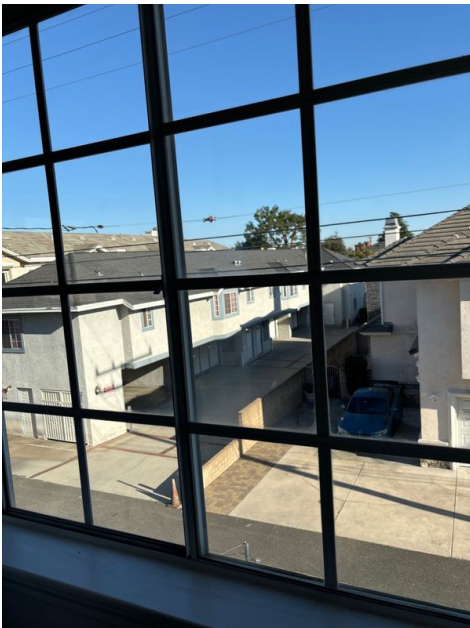
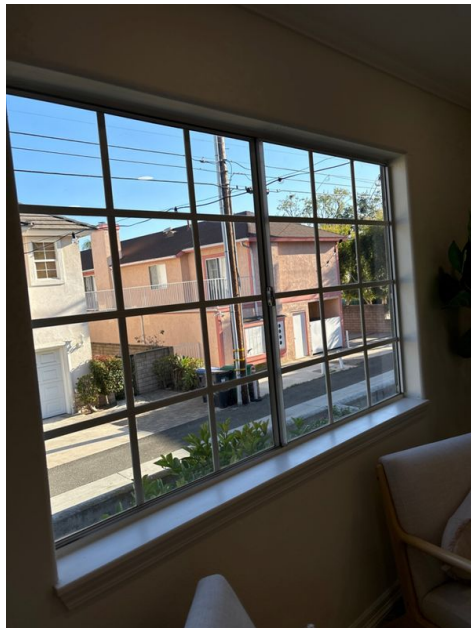
**MISSING SCREEN**

Window missing screen. Recommend replacement.

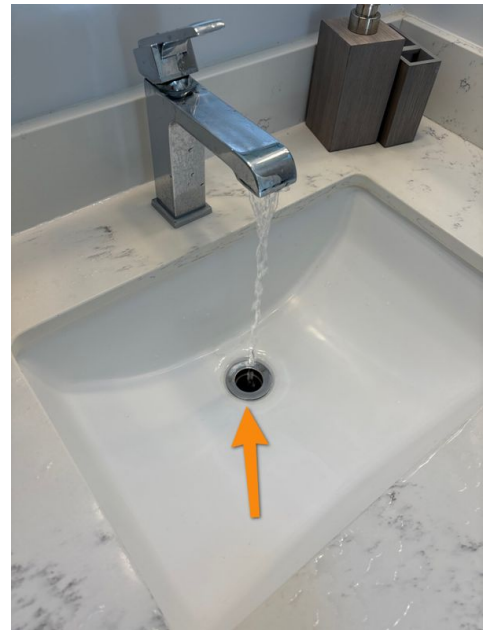
2nd Floor Hallway Bathroom

**STOPPER MISSING / BROKEN**

The drain stopper was missing / broken. Recommend replacement.

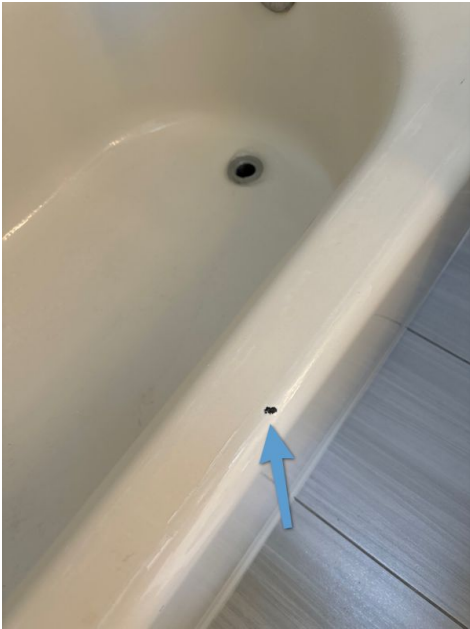
2nd Floor Hallway Bathroom

**TUB - SHOWER WORN / BLEMISHED - MINOR**

The bathtub / shower was worn or blemished.

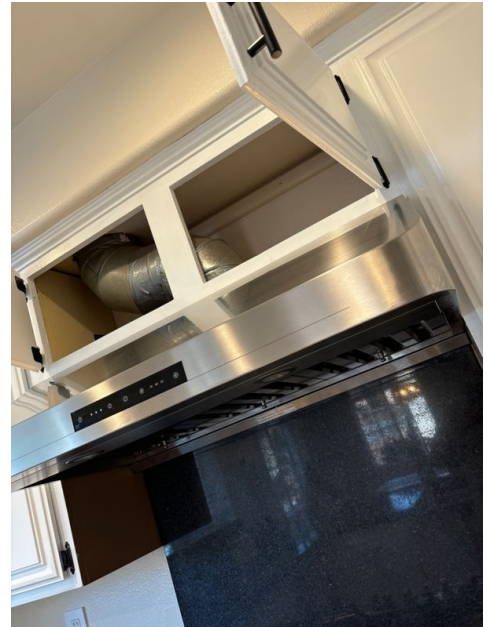
Exhaust fan was inoperable or slow. Recommend a qualified appliance repair person evaluate & repair.

Contact a qualified appliance repair professional.

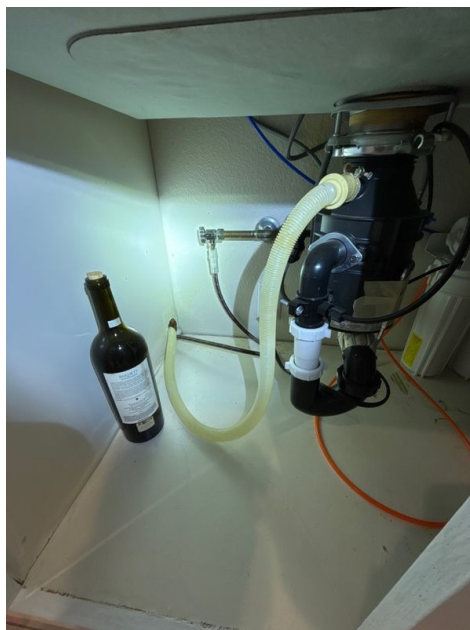
**AIR GAP / HIGH LOOP NOT INSTALLED**

No air gap or high loop was visible for the dishwasher drain. An air gap is a device that makes the drain line non-continuous or the drain line is looped high up under the countertop, and prevents waste-water backflow from entering the dishwasher, and possibly flooding out of the dishwasher if/when a siphon occurs. Some newer dishwashers have this device built in. Recommend determining if an air gap device is built in to this brand and model of dishwasher (e.g. review installation instructions). If not, or if this cannot be determined, then recommend that a qualified contractor install an air gap or a high loop per standard building practices.

Contact a qualified appliance repair professional.

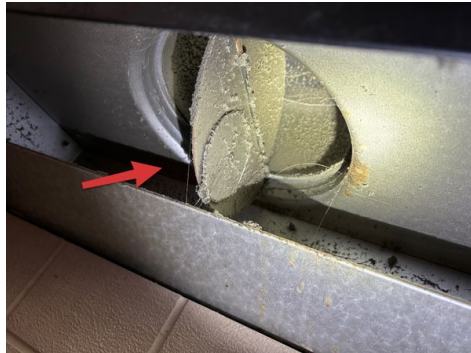
The chimney damper clamp was missing. This is a safety hazard. Recommend repair by a qualified professional.

Contact a qualified professional.

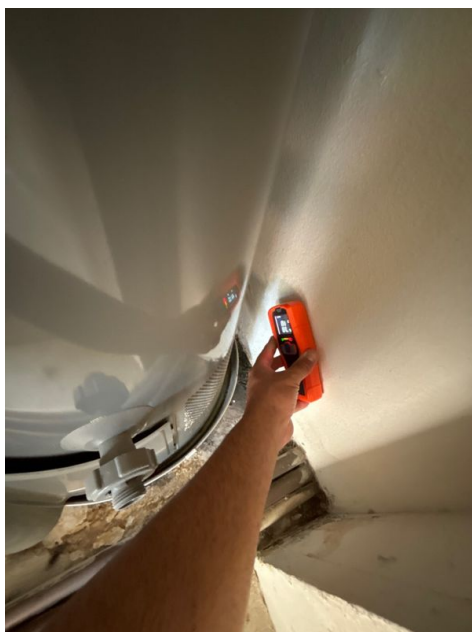
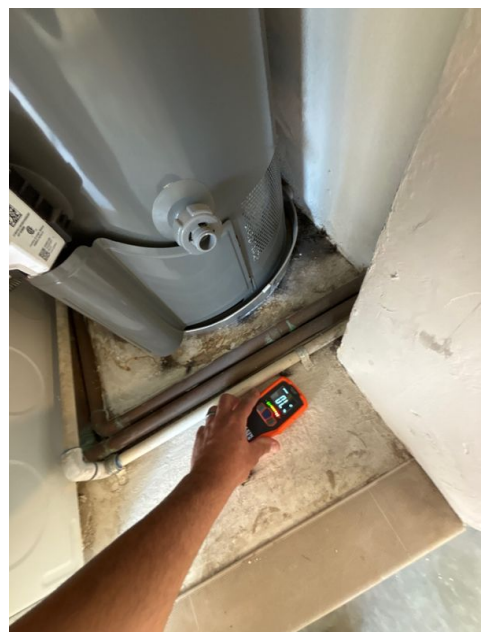
Garage

The moisture meter showed elevated levels of moisture in one or more areas. Recommend further evaluation and repair by a qualified professional.

Contact a qualified professional.
