## RESIDENTIAL INSPECTION

2864 W Canyon Ave.  
San Diego, CA 92123

APRIL 7, 2023

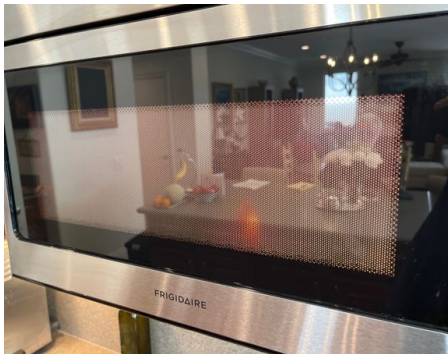
Example Noted at Kitchen

**BUILT-IN MICROWAVE: Picture Showing Microwave Working**

The operation of the microwave was tested using a microwave tester. This unit appeared to be functional at the time of the inspection.

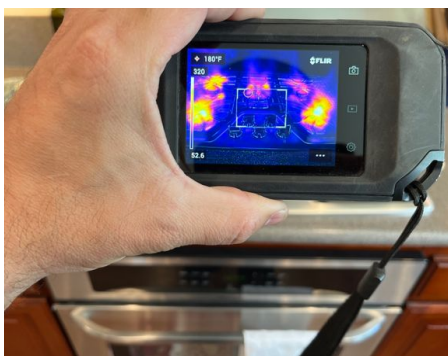
Example Noted at Kitchen

**RANGES AND COOKTOPS: Thermal Image Showing Range Working**

Infrared picture of range/cooktop in operation. This unit appeared to be functional at the time of the inspection.

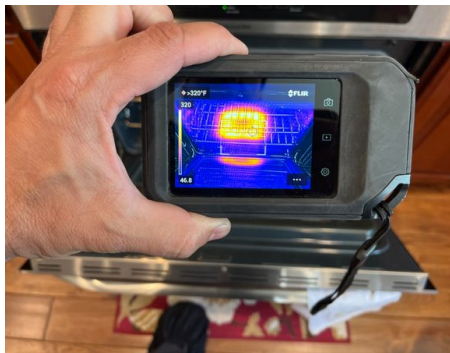
Example Noted at Kitchen

## OVEN: Thermal Image Showing Oven Working

Infrared picture of the oven(s) in operation. The unit(s) appeared to be functional at the time of the inspection.

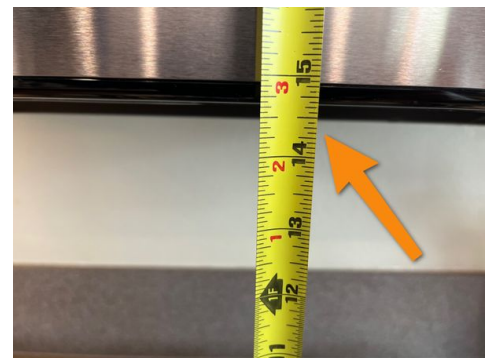
Example Noted at Kitchen

The microwave appeared to have been installed at a non-standard height, allowing the bottom of the microwave to be placed too close to the burners. This condition can cause damage to the microwave over time. The microwave may have been installed below a cabinet that originally did not have a microwave under it. We recommend further evaluation by a licensed appliance contractor before the removal of contingencies to determine what repairs are needed at this time and to determine if any latent defects exist.

Contact a qualified appliance repair professional.

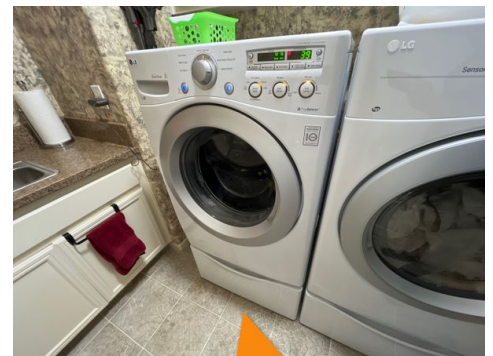
Example Noted at Laundry Room

A leak pan was noted as missing in the laundry area. We recommend further evaluation by a licensed appliance contractor before the removal of contingencies to determine what repairs are needed at this time and to determine if any latent defects exist.

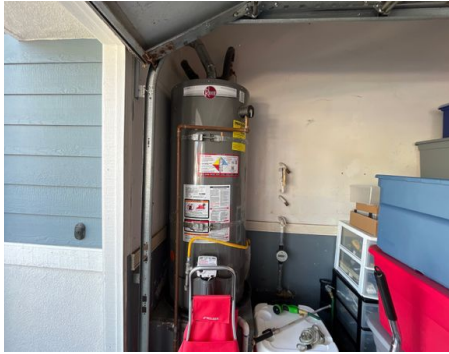
Example Noted at Water Heater

### WATER HEATERS, CONTROLS, FLUES AND VENTS: Picture of Water Heater(s)

Picture of water heater(s).

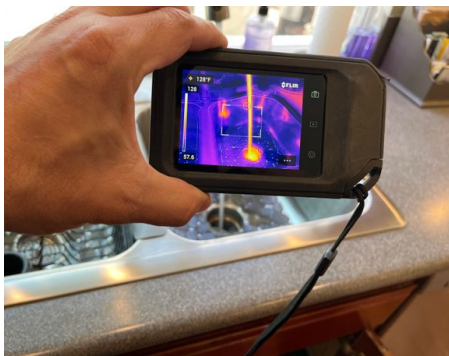
### WATER HEATERS, CONTROLS, FLUES AND VENTS: Thermal Image of Hot Water

Infrared image(s) showing the water heater(s) producing hot water at the time of the inspection.

128°F

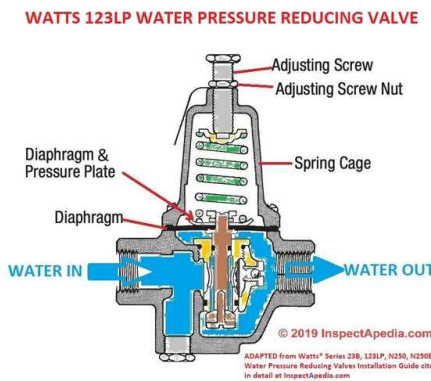
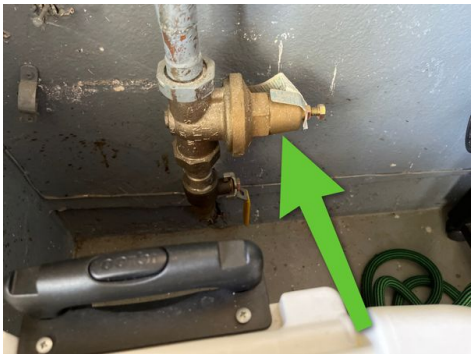
Example Noted at Garage

### PRESSURE REGULATOR: Picture of Pressure Regulator

Picture of the water pressure regulator. Adjustments to your water pressure can be made here. Recommend water pressure for residential properties is 40-80 PSI.

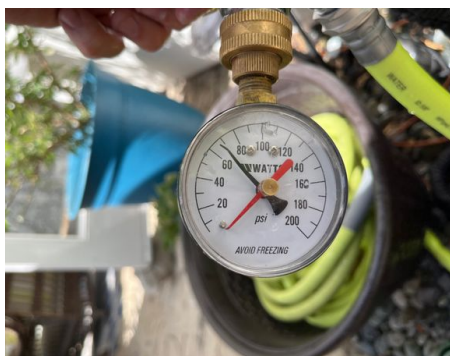
## PRESSURE REGULATOR: Picture of Water Pressure

Picture of water pressure taken at the time of inspection. Recommend water pressure for residential properties is 40-80 PSI. Water pressure is tested at an exterior hose bib and may not always be reflective of the internal water pressure due to the placement of the water pressure regulator, especially if the home is on a well.

70 psi

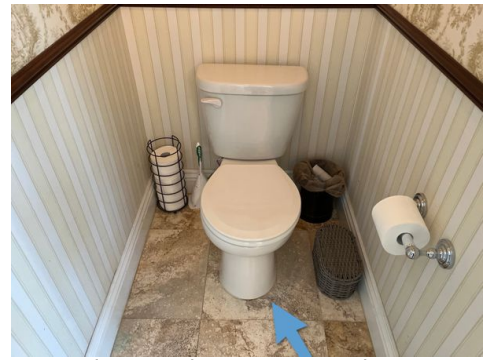
Example Noted at Master Bathroom

One or more toilets were noted fully caulked or grouted to the floor. This is standard, however, this condition prevents early detection of failed wax rings and leaks at the base. Caulking the base of the toilet is cosmetic only and prevents the inspector from observing any leaks associated with the wax ring at the time of inspection. While no active leaks were observed, and no evidence of prior leaks could be found at the time of inspection, we cannot make any determination for the condition concealed beneath the toilet. We recommend that you continue to monitor this area for any evidence of leaks, and if you have any concerns, we recommend further evaluation by licensed plumbing contractor before the removal of contingencies to determine if any latent defects exist.

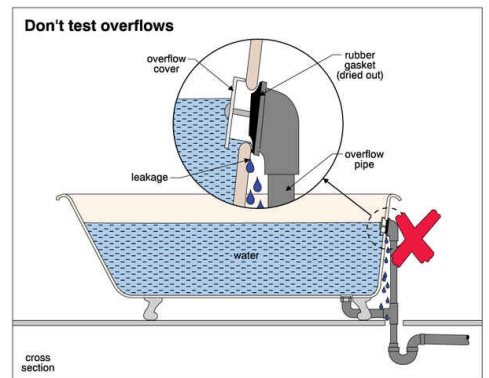
The drain overflow cover appeared to be installed properly at the bathtub(s). However, determining if the drain line is properly connected behind these covers is beyond the scope of this inspection. To ensure that this line is properly attached to the back of the bathtub, we recommend further evaluation by a licensed plumber before the end of your contingency period to determine if latent defects exist.

Contact a qualified plumbing contractor.

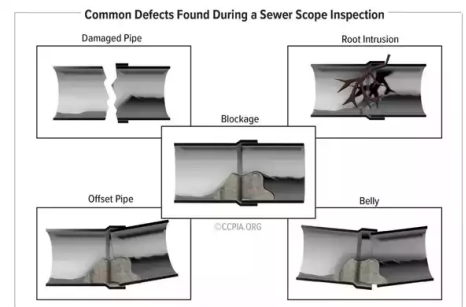
Our inspection of the drain waste lines is limited to running water down each sink, tub, and shower drain to look for slow or clogged drains. This test is very limited and does not ensure that the main drain line is not blocked or clogged and is truly functional. New construction homes are not exempt from drain line issues, latent defects and construction debris may be present and undetectable at the time of inspection. Only a sewer line video camera scope can provide an accurate and detailed inspection of the main sewer line. Problems with the main sewer line can be very expensive to repair and should be identified during your contingency period. Because of this, we highly recommend contacting a qualified sewer line video inspection company and have the main drain line video camera scoped before the removal of contingencies.

Contact a qualified plumbing contractor.

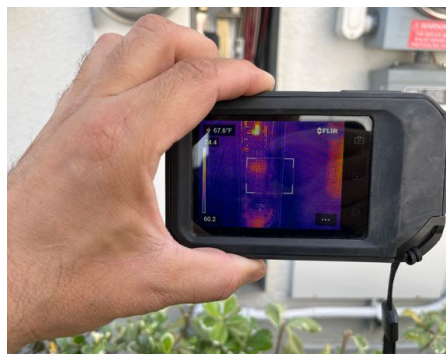
Example Noted at Main Panel

**MAIN AND DISTRIBUTION PANELS: Thermal Image Of Electrical Panels**

Provided is an infrared image of your electrical panels. Infrared technology can be useful for identifying certain defects such as loose connections on electrical circuits.

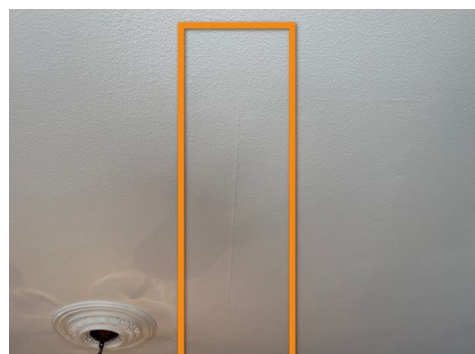
Example Noted at Family Room

The ceilings appear to have cracks in one or more areas. The cause can vary from typical to major structural settlement, impact damage, and possibly water intrusion. Determining if this is a recent or past settlement crack is not part of this standard inspection. We recommend further evaluation by a licensed drywall contractor before the removal of contingencies to determine what repairs are needed at this time and to determine if any latent defects exist.

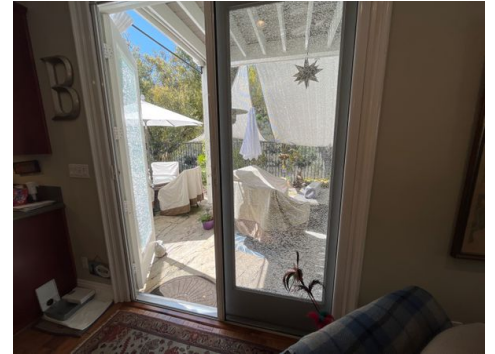
Example Noted at Kitchen

The glass at one or more doors or required windows does not appear to have safety tempered glass. Unable to locate any stamps or markings on the glass which would confirm this safety feature. Having standard plate glass could cause serious injury if the glass breaks. Recommend further evaluation by a licensed window contractor and upgrading for safety as necessary at this time.

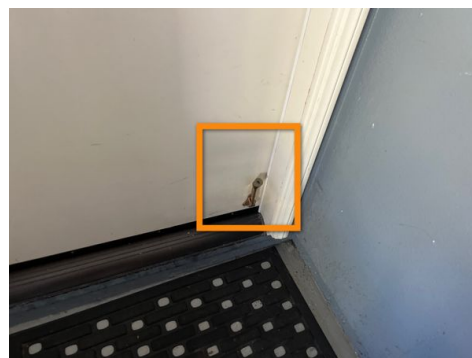
Example Noted at Garage

The fire door, from the garage to inside the home, should not be equipped with devices that allow the door to remain open (door-stoppers), such devices should be removed for safety. Propping the door open can allow unconditioned air, and possibly dangerous carbon monoxide gases into the home. We recommend further evaluation by a licensed door contractor before the removal of contingencies to determine what repairs are needed at this time and to determine if any latent defects exist.

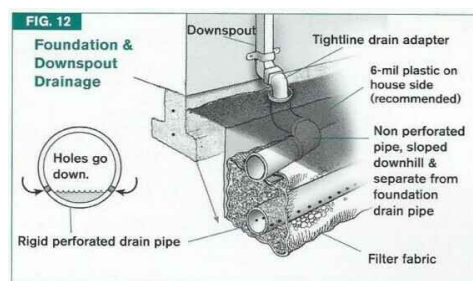
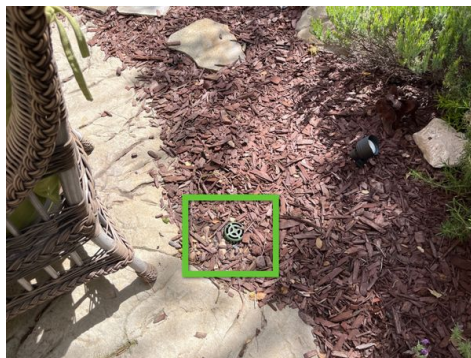
Example Noted at Rear

Subsurface drainage noted at the exterior in one or more locations. We are unable to determine the condition and drainage quality. This inspection is limited to the visible portions accessible at the time of inspection, we cannot view the inside of the pipe. We recommend further evaluation by a licensed landscape contractor to ensure these drains function properly.

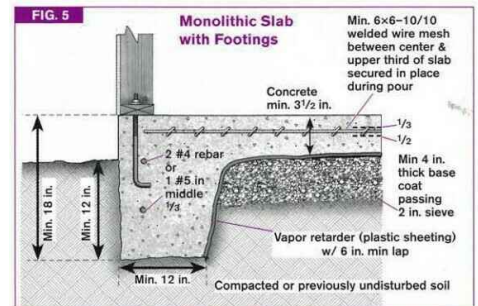
Due to floor coverings, vegetation, siding or other obstructions, not all areas of the foundation were visible. Our review of the home's foundation is limited. You may wish to have this further explored by a licensed foundation contractor and/or a licensed structural engineer to determine if any latent defects exist.

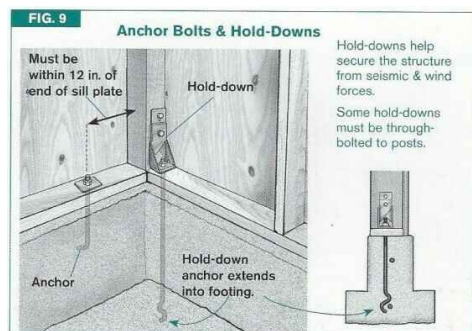
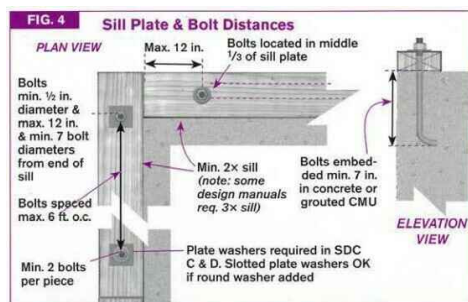
The home is likely bolted to the foundation. However, drywall was in place at the time of the inspection. Bolts could not be seen because of this. We recommend further evaluation by a licensed foundation contractor to confirm the presence of foundation bolts.

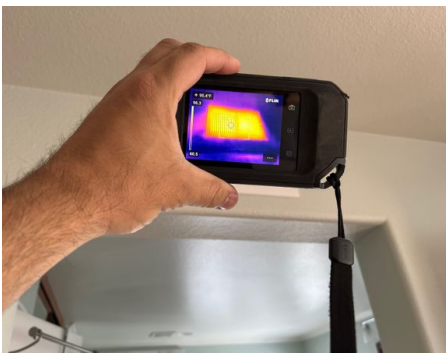
Example Noted at Master Bedroom

**HEATING EQUIPMENT: Thermal Image Showing Furnace Turned On**

Attached is an infrared picture confirming the furnace(s) turned on at the time of inspection. The unit(s) appeared to turn on and produce heat at time of inspection. However, due to the many components that are not visible (like the heat exchanger and the entire length of the flue pipe), our inspection of the system(s) is limited. If you have any concerns, we recommend further evaluation/safety check be performed by a licensed HVAC contractor or the local gas company before the removal of contingencies.

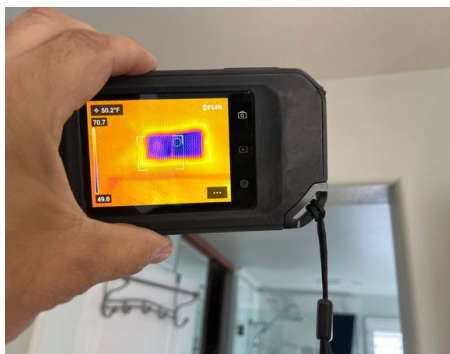
Example Noted at Master Bedroom

## COOLING AND AIR HANDLER EQUIPMENT: Thermal Image Showing AC Turned On

Attached is an infrared picture confirming the air conditioning unit(s) turned on at the time of inspection. During the test of this home's air conditioning system a minimum split of 14 degrees was achieved between the ambient air temperature and the temperature of the air blowing out of the registers. Because of this, the unit(s) appeared to be functional. However, this is a limited review. If you have any concerns about the internal components or any latent defects, you should consider having the unit(s) further explored by a licensed HVAC contractor before the removal of contingencies.

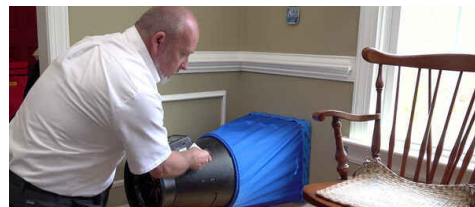
**DUCTWORK - LIMITED INSPECTION (LEAKS)**

Testing for ductwork leaks is done on a visual basis only, we do not use special equipment to check that the system is balanced and sealed tight. We can only comment on what appears to be the conditions at the time of inspection. On average heating and cooling ducts in a California home leak almost 30 percent. That is why when heating or cooling equipment is replaced, testing the system's ducts for leaks is now required by building officials in many parts of the state. The home you are preparing to buy may have had work performed after October 2005. We recommend you inquire with the sellers and ask to see the duct testing report, or for an explanation as to why such testing was not required. For more information, visit: [www.energy.ca.gov/title24/changeout/](http://www.energy.ca.gov/title24/changeout/)
