# PRP Inspections Inc.

### SUMMARY REPORT

**Client:** Wayne & Danielle Lehr  
**Inspection Address:** 12312 Sunbrite Lane, Lakeside, CA 92040  
**Inspection Date:** 6/15/2026 Start: 9:00 am End: 11:00 am  
**Inspected by:** Mike Durnell

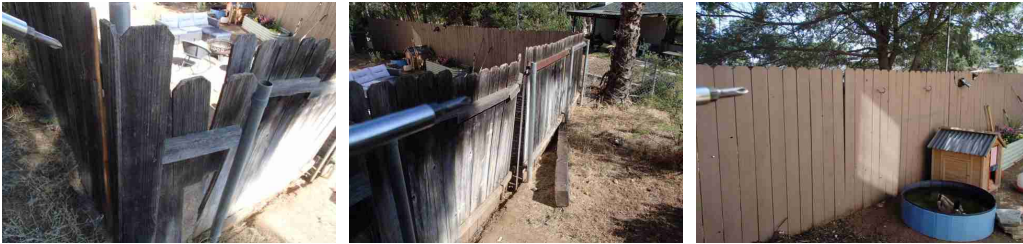
Sections of the fence or gates are leaning or damaged and should be repaired or replaced.

- Sections of the fence or gates are leaning or damaged and should be repaired or replaced

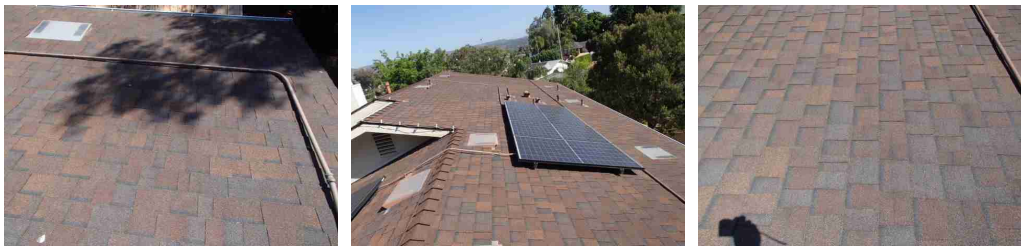
We evaluated the roof and its components by walking on its surface.

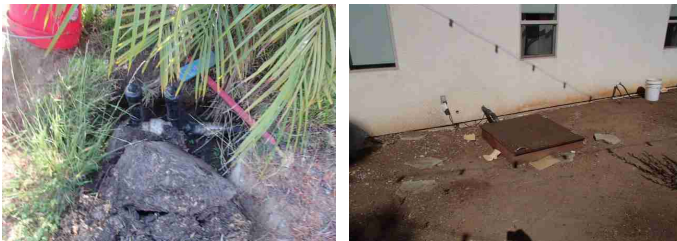
The entire home flows into a gray pump that appeared to be functional at the time of the inspection. This pump pumps the waste to street level and may need special maintenance that should be explained by the sellers. There is no high water alarm that one be installed that would warn you if the pump stops. Feminine products and sanitary wipes should not be flushed down toilets as they could damage or clog the system.

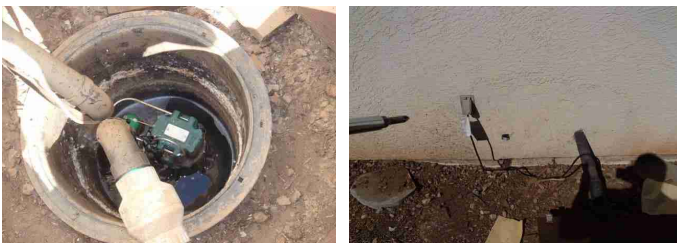
There is no high water alarm on the system which may not be required by is a sensible recommendation. This could prevent your home from a possible flood.

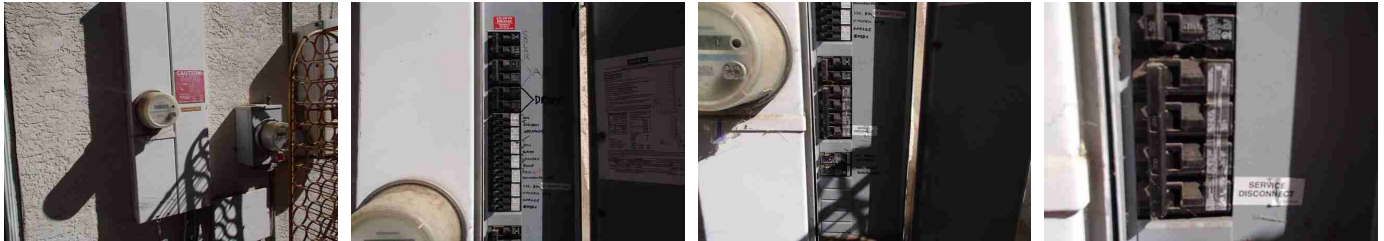
The main panel is located on the side of the residence. The residence is serviced by a 200 amp, 110-220 breaker.

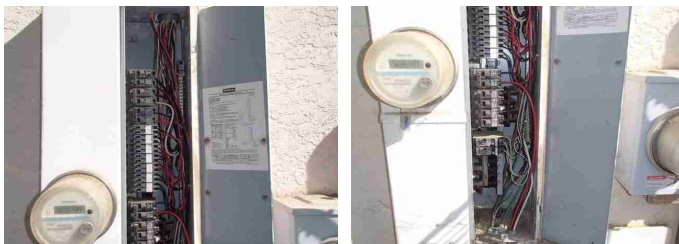
The panel and its components have no visible deficiencies.

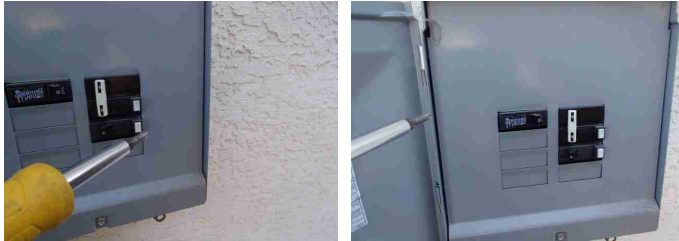
Various circuits within the sub-panel are not labeled, and should be serviced by an electrician so that the appropriate load calculations and breaker sizes could be determined.

- Various circuits within the sub-panel are not labeled and should be serviced by an electrician

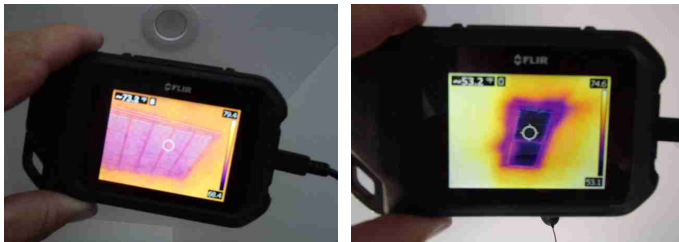
The air-conditioning responded and achieved an acceptable differential temperature split between the air entering the system and that coming out, of seventeen degrees or more.

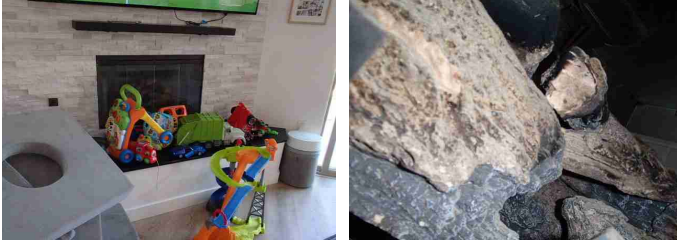
There are a wide variety of pre-fabricated chimneys, which are constructed on site with approved components. We perform a competent inspection of them, but we are not specialists, and our inspection of them is limited to those areas that can be viewed without dismantling any portion of them, and we cannot guarantee that any particular component is the one stipulated for use by the manufacturer. For instance, experience has taught us that many prefabricated chimneys have been fitted with architectural shrouds that are not approved by the manufacturer, and which can inhibit drafting and convectional cooling. However, we recommend a level-two inspection by a qualified specialist within the contingency period or before the close of escrow, as recommended by NAPA standards "upon the sale or transfer of a property."

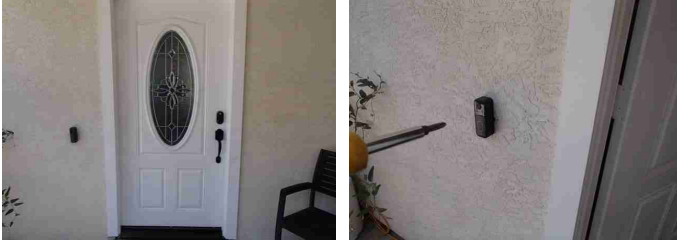
The inside doorbell does not work and should be serviced - *Continued*

- The inside doorbell does not work and should be serviced

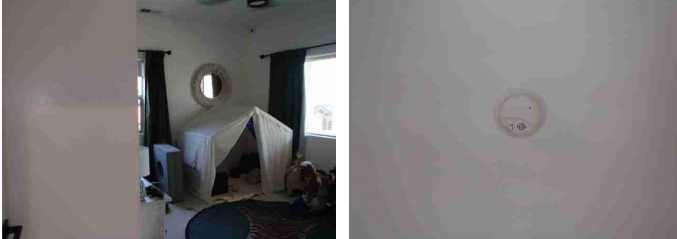
The smoke detector is present but should be checked periodically.

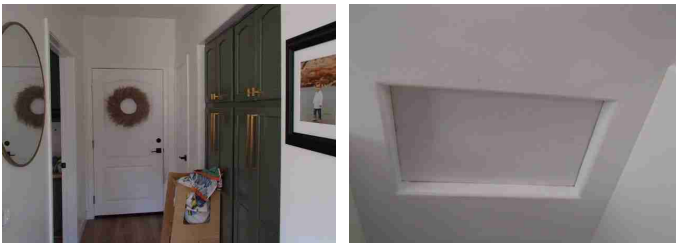
The attic can be accessed through a hatch in the hallway ceiling.

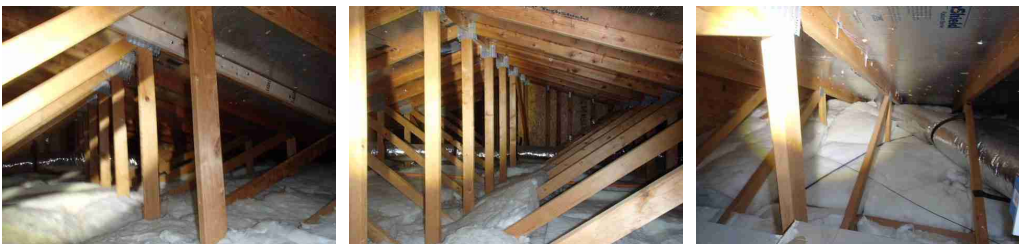
We evaluated the attic by direct access. Only 85% percent of the attic was able to be inspected due to limited accessibility of some areas.

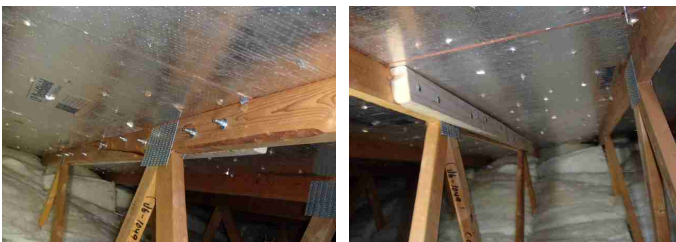
The top board of a truss has been repaired and we recommend any paperwork be provided on this repair to insure it was done by a licensed specialist.

- The top board of a truss has been repaired and we recommend any paperwork be provided on this repair
