WEST IVY INSPECTIONS

RESIDENTIAL INSPECTION

8715 Blue Lake Dr
San Diego, CA 92119

MARCH 11, 2025

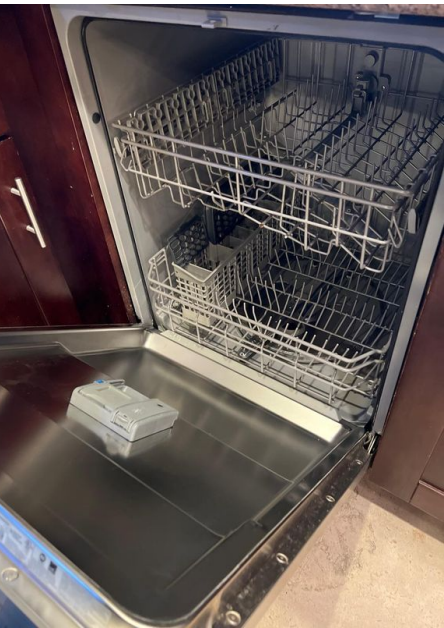
DISHWASHER: Dishwasher Turned On - Inspection Limited

The dishwasher turned on and appeared to complete a wash cycle at the time of the inspection. However, this is not a guarantee that this unit will not leak at some time in the future. We recommend purchasing a home warranty to cover the unit and any possible damages that may result from a leak.

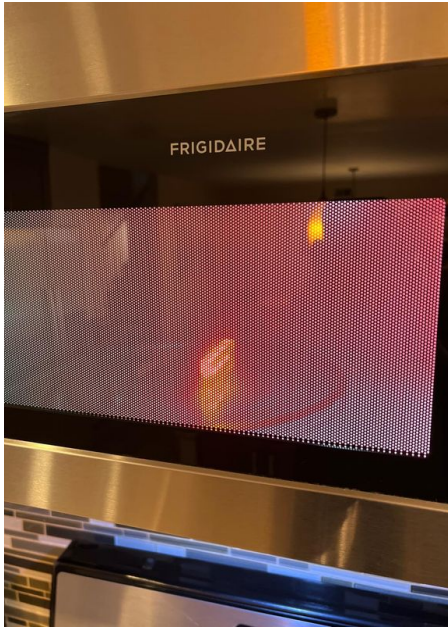
BUILT-IN MICROWAVE: Picture Showing Microwave Working

The operation of the microwave was tested using a microwave tester. This unit appeared to be functional at the time of the inspection.

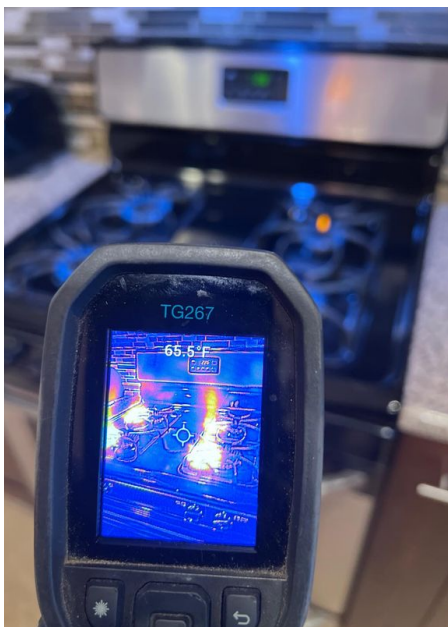
**RANGES AND COOKTOPS: Thermal Image Showing Range Working**

Infrared picture of range/cooktop in operation. This unit appeared to be functional at the time of the inspection.

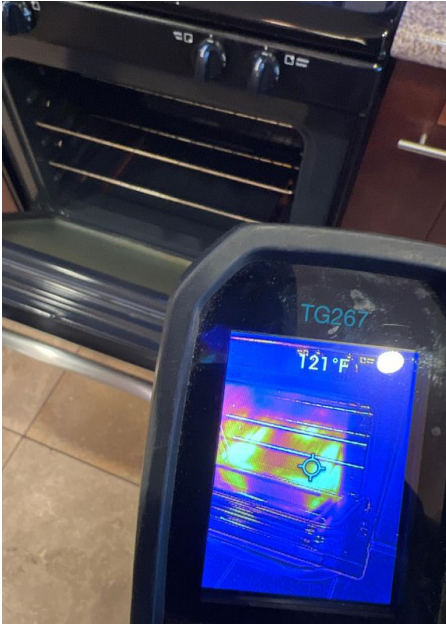
OVEN: Thermal Image Showing Oven Working

Infrared picture of oven(s) in operation. The unit(s) appeared to be functional at the time of the inspection.

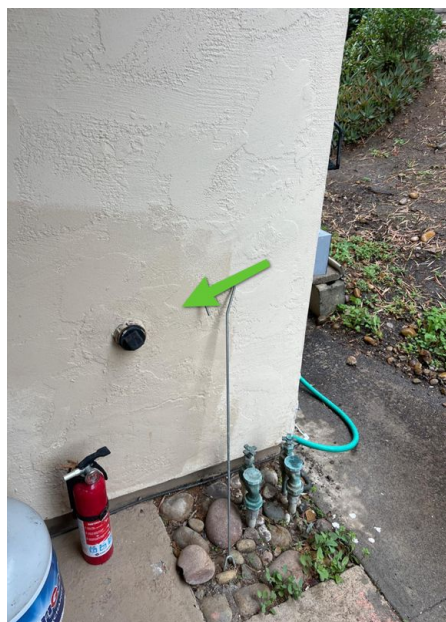
PLUMBING DRAIN, WASTE AND VENT SYSTEMS: Sewer Cleanout Location

The main sewer cleanout location was noted. This is for your information.

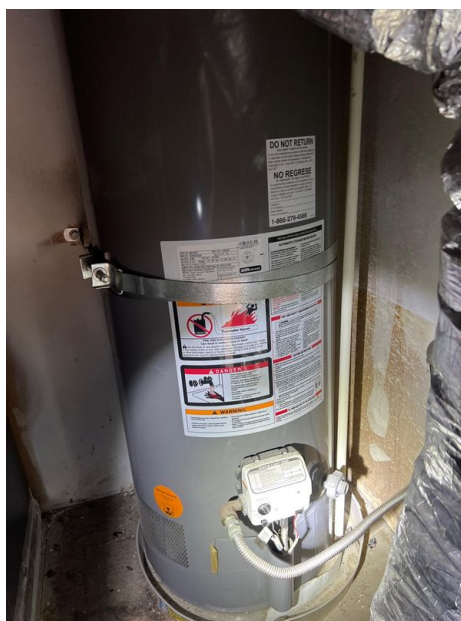
**WATER HEATERS: Picture of Water Heater**

Picture of water heater(s).

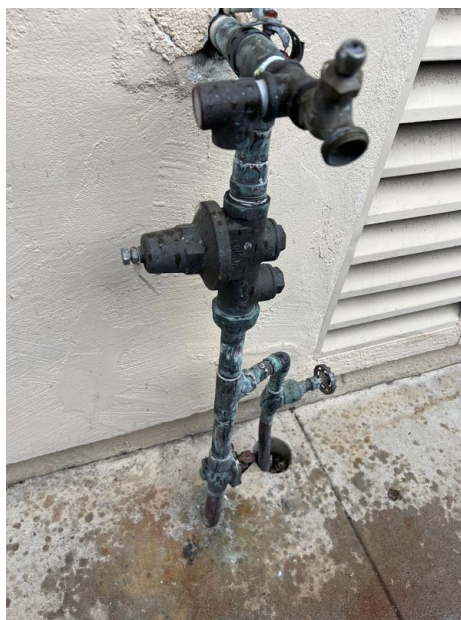
**PRESSURE REGULATOR: Pressure Regulator**

right of the home

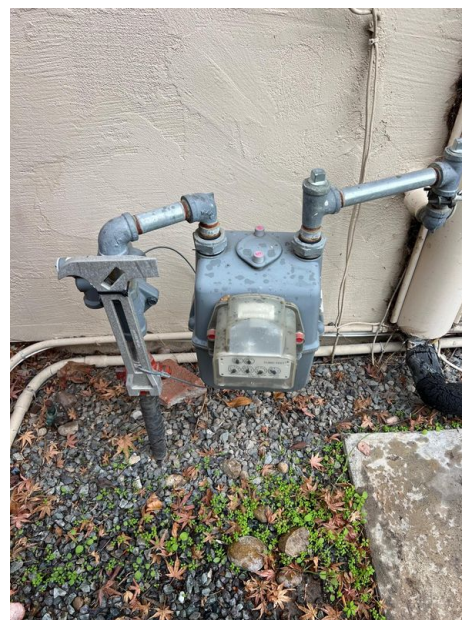
**MAIN GAS SHUT OFF VALVE (Describe Location): Main Gas Shut-Off Location**

Left side of building

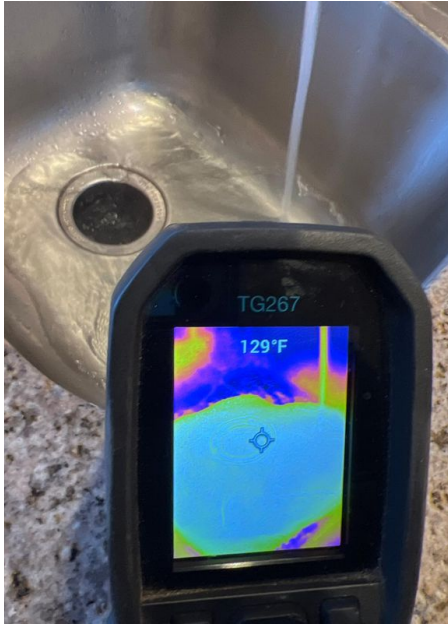
WATER HEATERS: Thermal Image of Hot Water

Thermal image(s) showing the water heater(s) producing hot water at the time of the inspection.

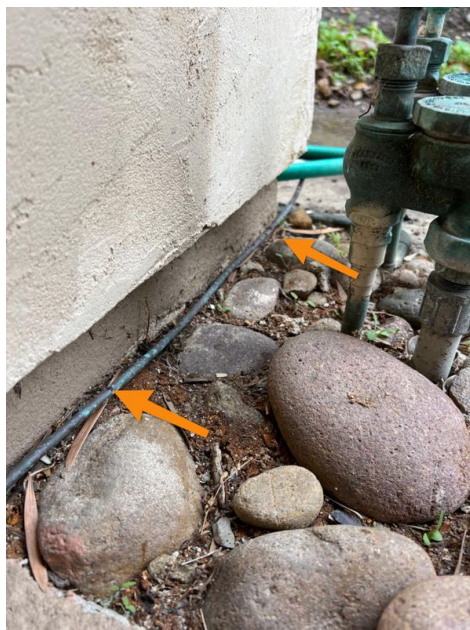
Example Rear of building

This has been addressed

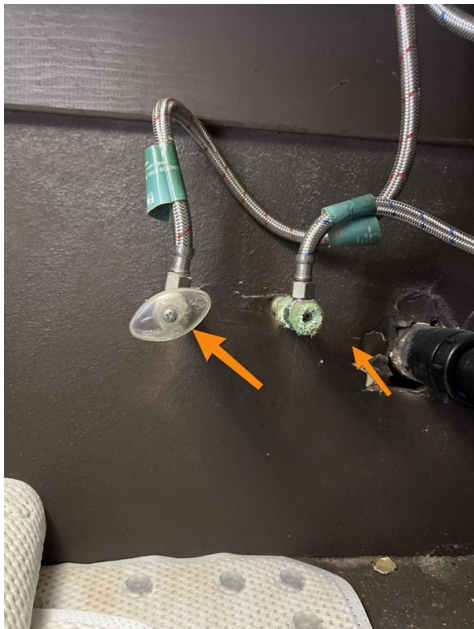
Master bathroom

This has been addressed

Contact a qualified plumbing contractor.

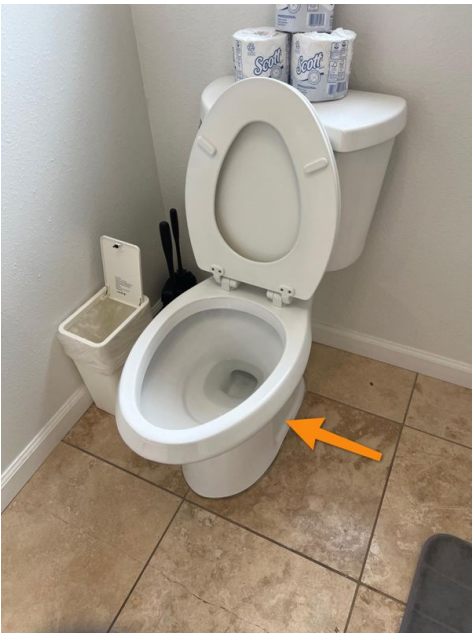
Master bathroom

This has been addressed

Contact a qualified plumbing contractor.

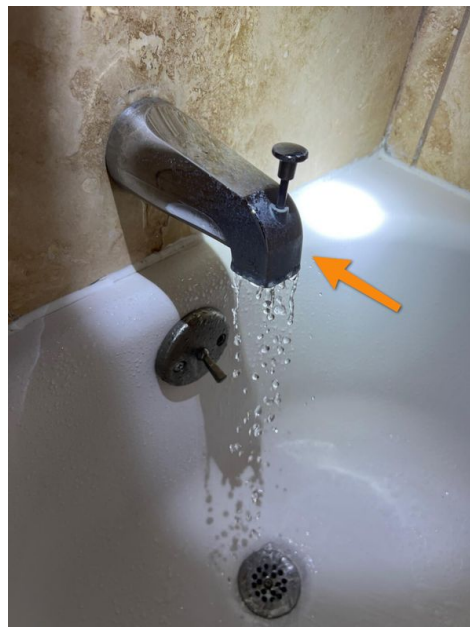
3.5.1 TUB/SHOWER FIXTURES

TUB DIVERTER - NOT FUNCTIONAL/DEFECTIVE

Example Master bathroom

Recommendation

Contact a qualified plumbing contractor.

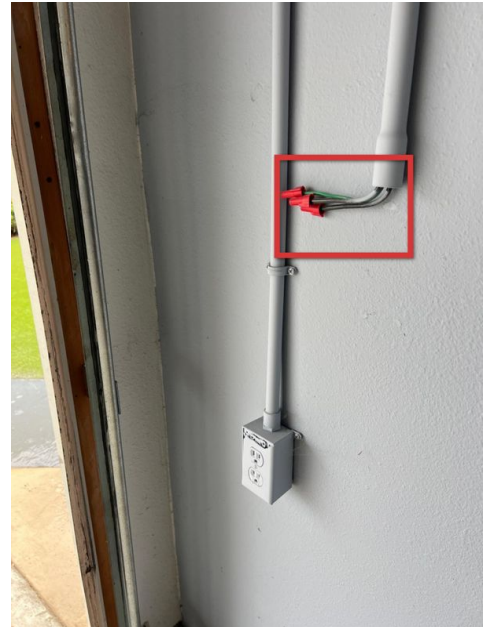
4.7.1 BRANCH CIRCUIT CONDUCTORS

IMPROPER TERMINATION

Recommendation

Contact a qualified electrical contractor.

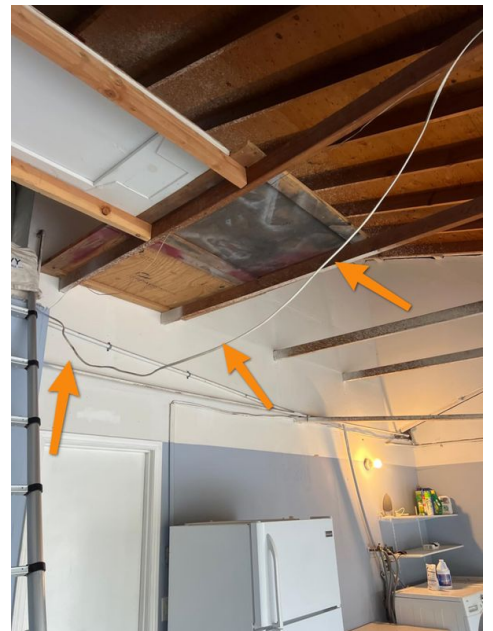
4.7.2 BRANCH CIRCUIT CONDUCTORS

WIRES - UNSECURED

Garage

Recommendation

Contact a qualified electrical contractor.

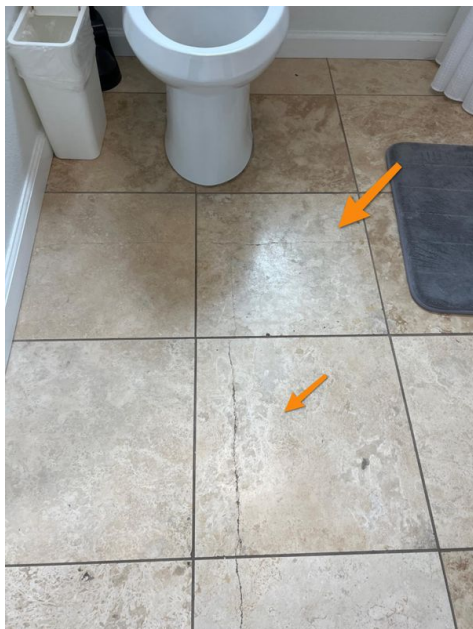
Cracked and/or chipped tile(s) noted. Recommend further evaluation by a licensed tile contractor to determine any repairs necessary at this time.

Master bathroom

Recommendation
Contact a qualified tile contractor

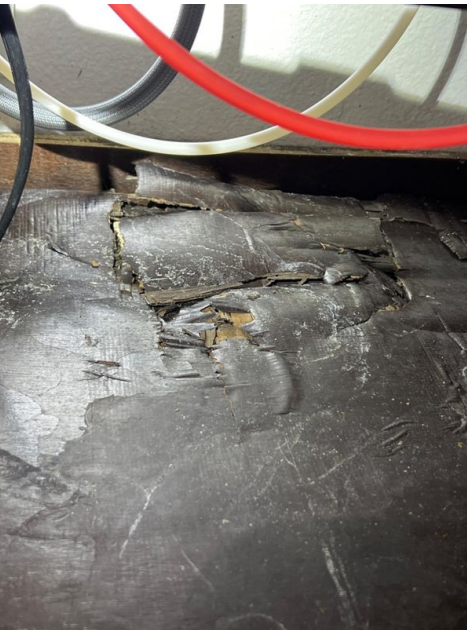
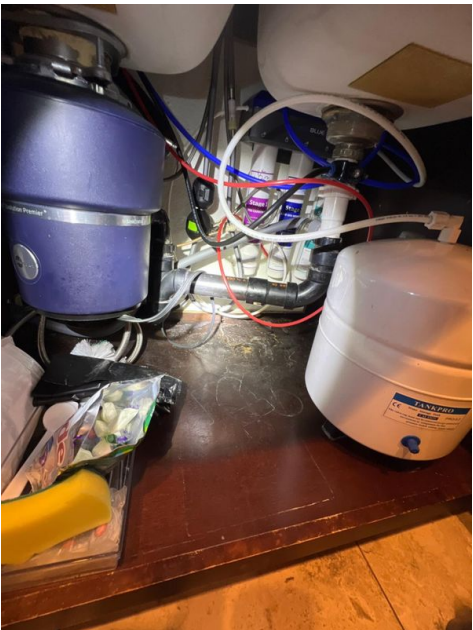
6.6.1 COUNTERS, CABINETS, DRAWERS, CLOSET

CABINET FLOOR - MOISTURE STAINS/DAMAGE

Moisture stain(s)/Damage noted at the floor of the cabinet below the sink(s). This appeared to be indicative of a previous leak. The area appeared to be dry at the time of the inspection. Recommend further evaluation by a licensed plumbing contractor to determine any repairs necessary at this time.

Close Up Photo Kitchen

Recommendation
Contact a qualified plumbing contractor.

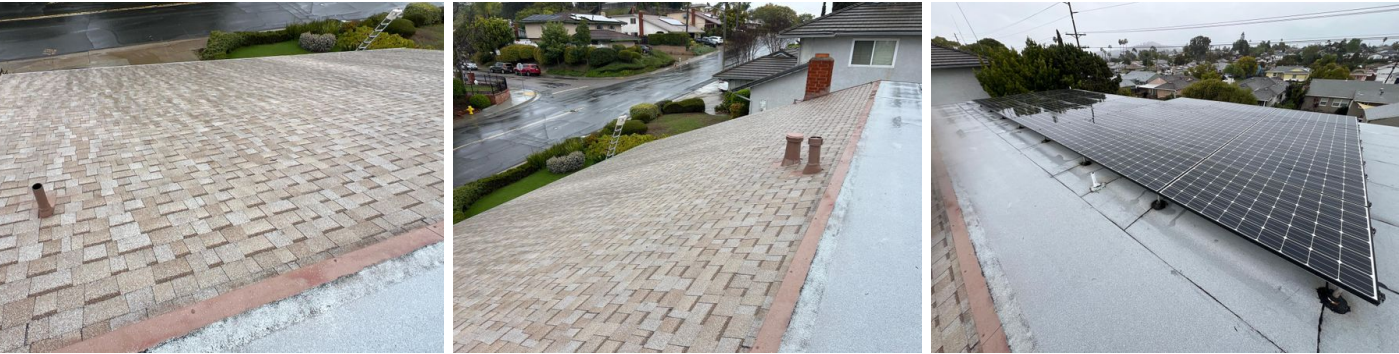
ROOF SHEATHING (As Observable From Attic): Flat Roof - No Attic

Homes with flat roofs are built with no attic access. This limits our inspection to only viewing the exterior roofing and the interior ceiling. If the sheathing is of concern we recommend contacting a licensed manufactured home contractor for more information.

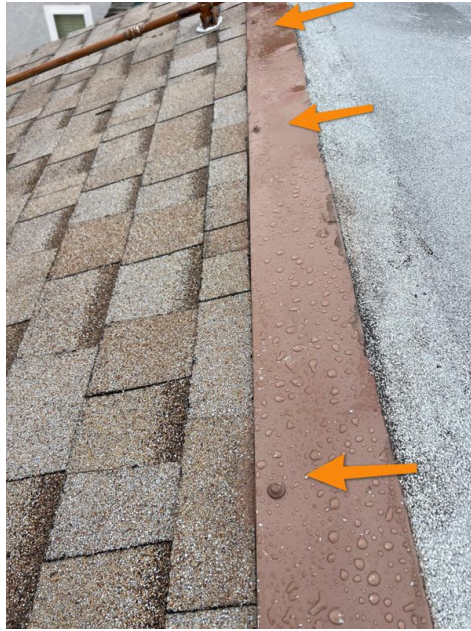
Exposed nails/fasteners noted at the flashings and/or roof penetrations in various locations. We recommend further evaluation and repair by a licensed roofing contractor as necessary at this time to prevent possible moisture intrusion issues.

Recommendation

Contact a qualified roofing professional.

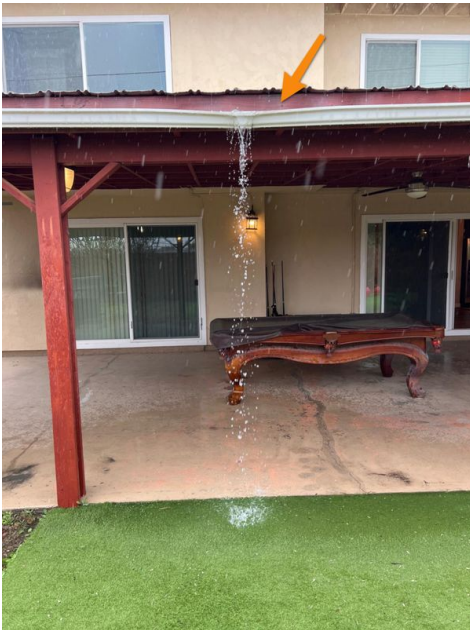
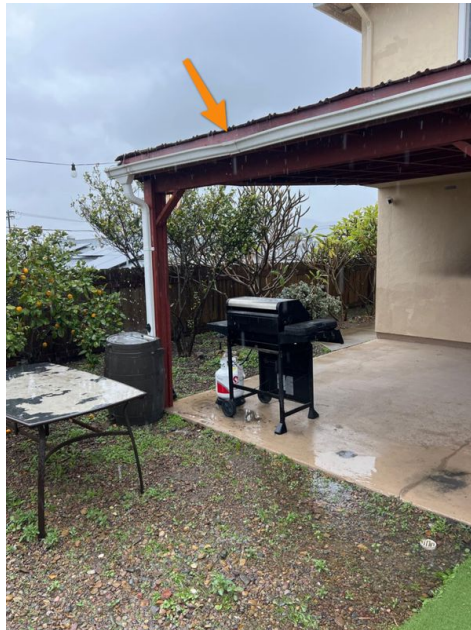
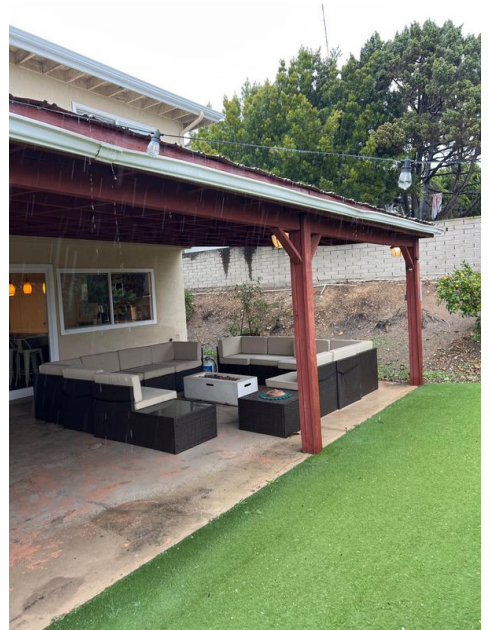
GUTTERS AND DOWNSPOUTS REQUIRE SERVICE

The gutters and downspouts appeared to require service to be fully functional. Recommend further evaluation by a licensed gutter contractor to determine corrections necessary at this time to ensure proper function.

Recommendation

Contact a qualified gutter contractor

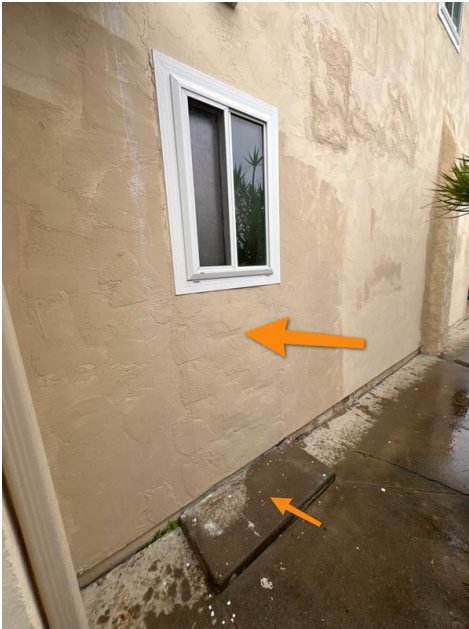
Example Right of building

Evidence of previous repairs noted in one or more areas of the exterior siding. Recommend asking the sellers for a detailed explanation regarding these repairs. You may wish to view this for yourself and/or have further explored by a licensed siding contractor to determine if additional repairs are necessary at this time.

Recommendation

Contact a qualified siding specialist.

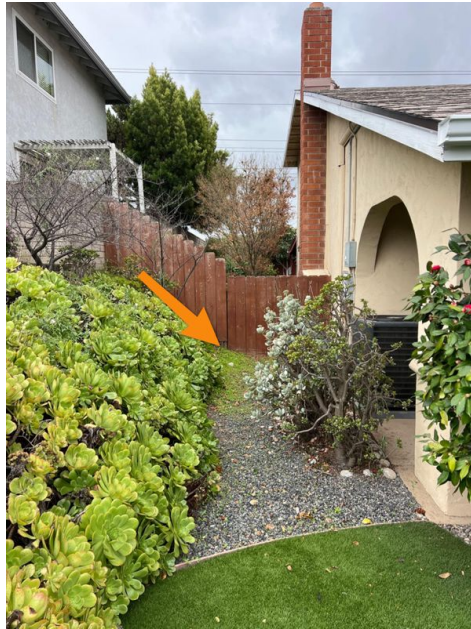
Example Left of building

There is a negative slope at one or more areas. This condition can cause or contribute to water pooling and intrusion which can have a negative effect on the overall stability and longevity of this home, to include but not limited to, its foundation. Recommend further evaluation by a licensed grading and drainage contractor before the removal of contingencies to determine repairs possible at this time.

Recommendation

Contact a qualified grading contractor.

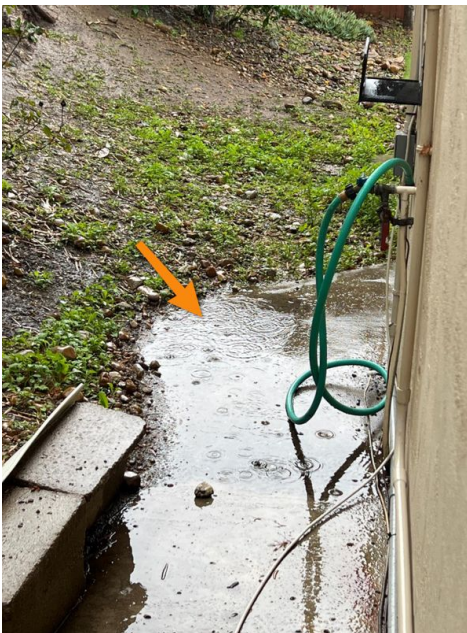
Example Left of building

The landscape require a trench or drainage due to water standing or puddling during or after heavy rain. Recommend further evaluation of the homes landscape by a licensed grading contractor to determine corrections necessary at this time to ensure proper drainage occurs.

Recommendation

Contact a qualified professional.

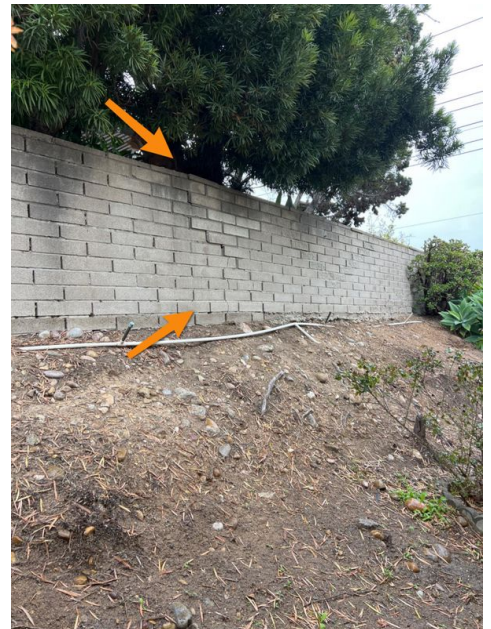
Example Left of building

Retaining wall(s) noted leaning and erosion signs appear to be present. This problem will continue to become worse and needs correcting. Recommend further evaluation by a licensed masonry contractor to determine repairs necessary at this time.

Recommendation

Contact a qualified masonry professional.

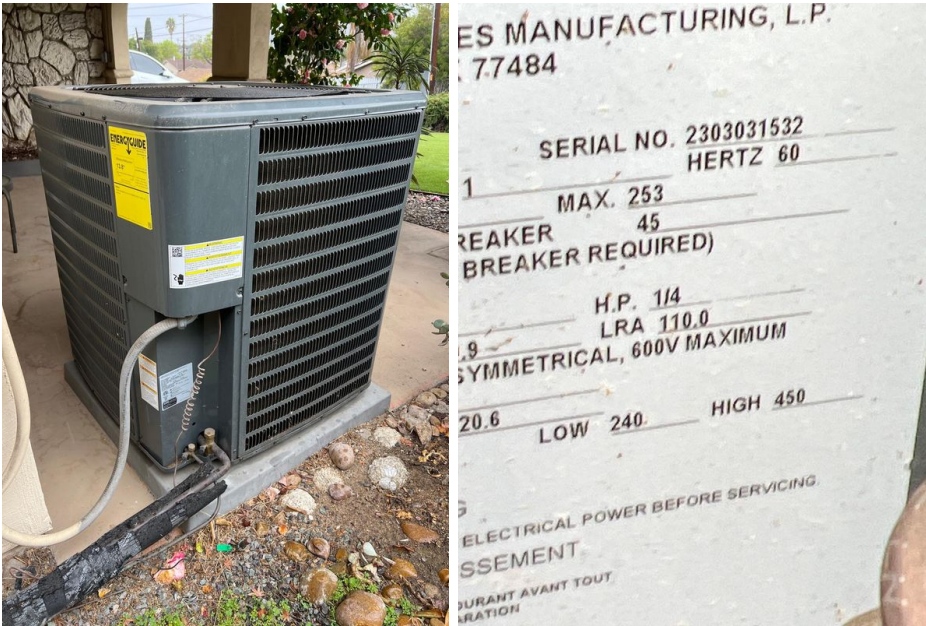
COOLING - EQUIPMENT: AC Condenser (Photo)

Photo of AC condenser

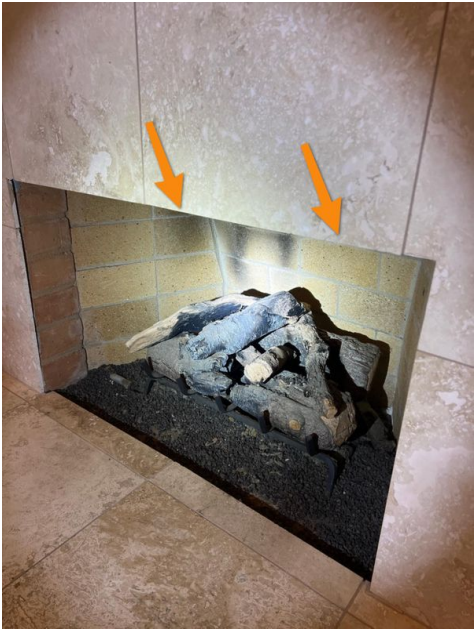
DOORS / SCREEN - NOT INSTALLED

Fireplaces doors/screen noted not installed or removed at the time of the inspection. Recommend repair or replacement by a licensed fireplace contractor.

Recommendation
Contact a qualified fireplace contractor.

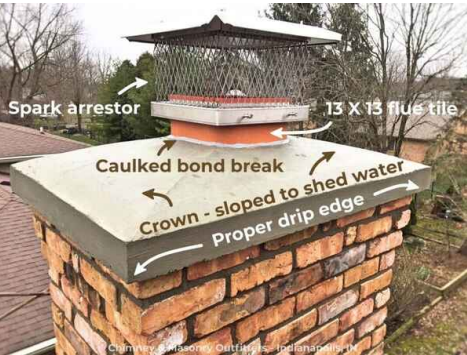
Example of Spark Arrestor

The fireplace chimney is not equipped with a rain cap and/or spark arrestor. Recommend installation by a licensed chimney contractor for safety.

Recommendation
Contact a qualified chimney contractor.
