SUBJECT PROPERTY:
777 6th Ave #409, San Diego, CA 92101

INSPECTION DATE:
3/10/2022

SUMMARY REPORT

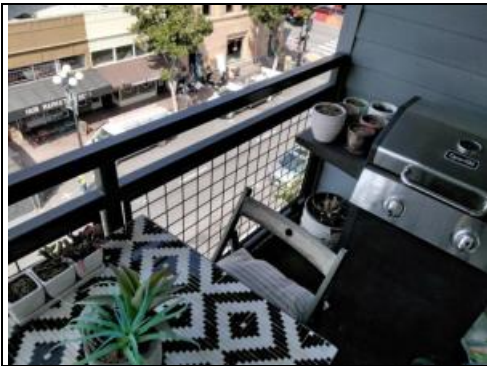
The safety railing around the balcony is made of tubular steel. It was in good condition and securely attached. Maintenance of the railing is believed to be the responsibility of the HOA.

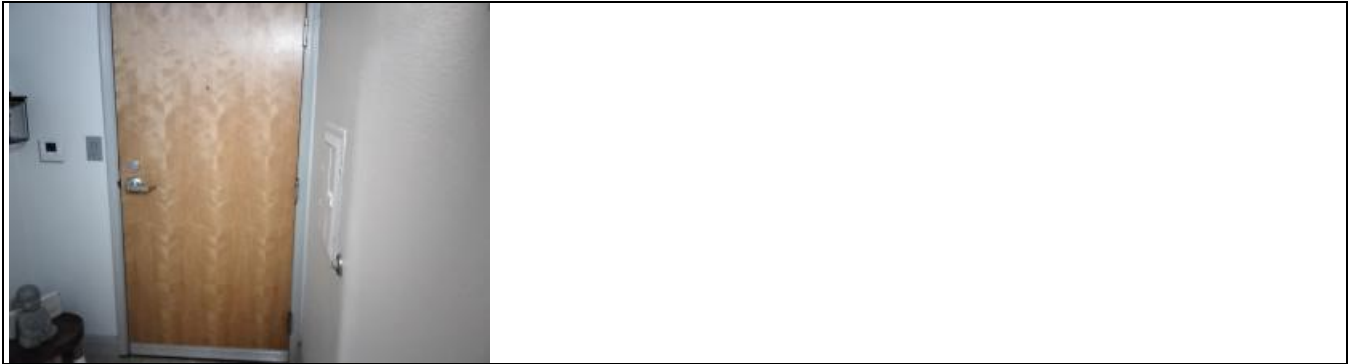
The front entry door appeared to be in good condition; and, the self closer functioned as required. Safety Glass was observed to be present in all required exterior door locations.

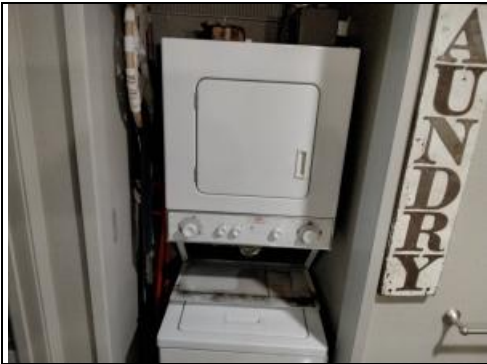
Laundry provisions were located at an interior laundry area. A 240 volt receptacle was present at the laundry area for an electric clothes dryer.

Advisory: Rubber Hoses are installed on the washing machine. Rubber laundry hoses are susceptible to fail without warning. Recommend installing braided metal hoses when the hoses are replaced.

Advisory: Rubber Hoses are installed on the washing machine. Rubber laundry hoses are susceptible to fail without warning. Recommend installing braided metal hoses when the hoses are replaced.

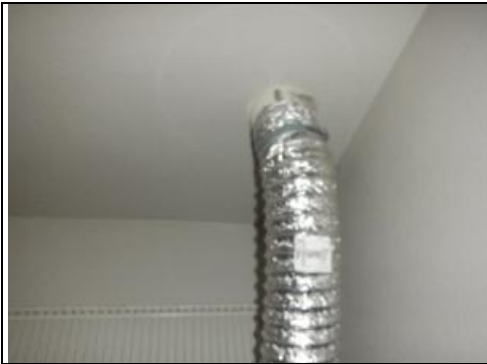
Advisory: The laundry vent discharge is above the vent on the dryer. This means that the lint must be blown uphill before it is discharged. Most dryer lint motors are too small to efficiently remove the lint from the hose. Recommend that the vent hose be cleaned annually to reduce the possibility of fire originating in the hose.

Advisory: The laundry vent discharge is above the vent on the dryer. This means that the lint must be blown uphill before it is discharged. Most dryer lint motors are too small to efficiently remove the lint from the hose. Recommend that the vent hose be cleaned annually to reduce the possibility of fire originating in the hose.

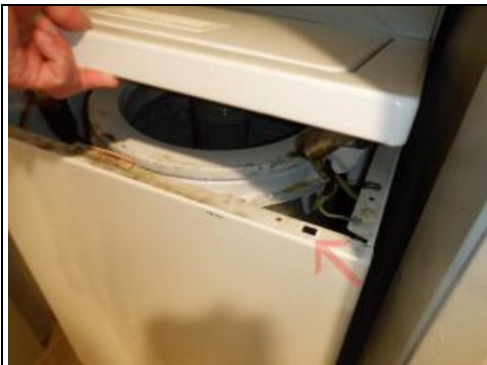
Maintenance: The top of the washing machine is missing its spring clips which hold the lid onto the base cabinet. We recommend that the clips be replaced.

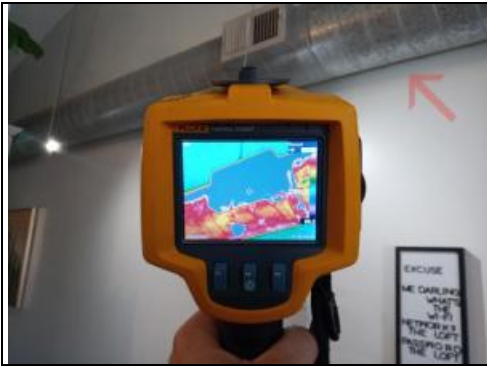
The observable distribution ductwork was hard metal 26-28 gauge type. Also, the ductwork where visible, was observed to be properly supported and in generally acceptable condition with no obvious separations or damage, unless otherwise noted below:

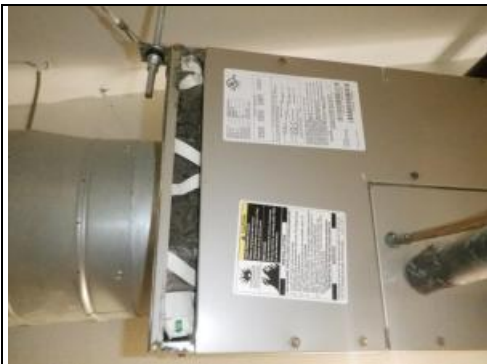
Maintenance: The air filter had accumulated debris which decreased its effectiveness and blocked air flow. This can dramatically decrease efficiency of the system. We recommend that the filter be cleaned or replaced as required.

Further Review: The air filter was the wrong size and/or not properly held down letting unfiltered air through the system. This will cause a buildup on the air conditioning coil which will in turn decrease the efficiency of the unit. The replacement of the air filter and further evaluation of the unit's coil and other components is highly recommended.

Maintenance: The air filter had accumulated debris which decreased its effectiveness and blocked air flow. This can dramatically decrease efficiency of the system. We recommend that the filter be cleaned or replaced as required.

Further Review: The air filter was the wrong size and/or not properly held down letting unfiltered air through the system. This will cause a buildup on the air conditioning coil which will in turn decrease the efficiency of the unit. The replacement of the air filter and further evaluation of the unit's coil and other components is highly recommended.

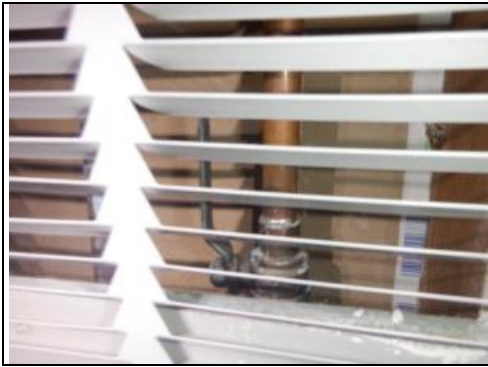
The water shut off is in a wall hatch located in the bedroom closet. The pipe and valve were clean of excessive corrosion.

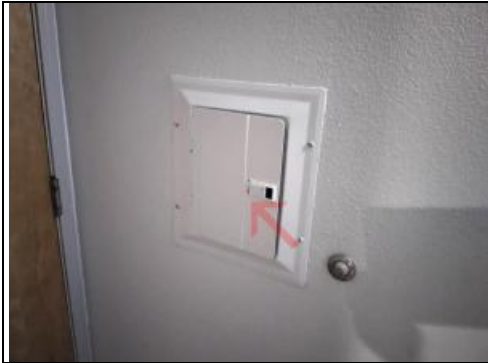
An additional distribution panel, or sub panel was located at the hallway area.

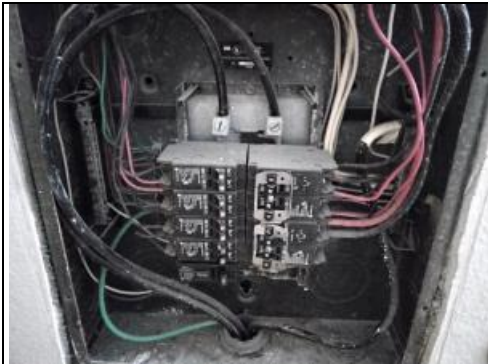
The electrical service system as described in the electrical inspection scope, including wire sizing, breakers, feed, meter, grounding and panel placement were observed to be correct for the panel being used and appeared to be in generally acceptable condition, unless otherwise noted below:

No deficiencies were observed.

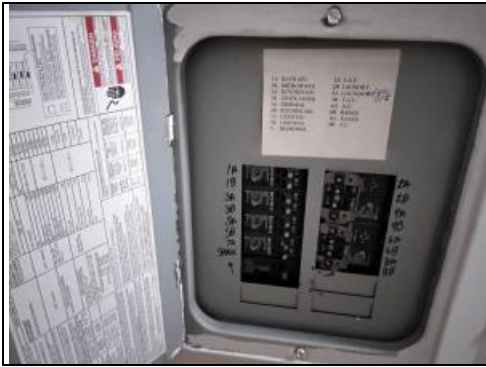
The circuitry in the main panel was labeled.

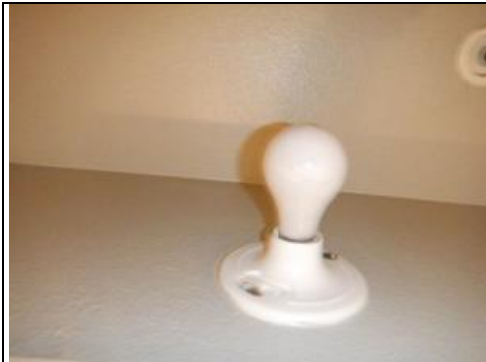
Repair: The light fixture at the laundry was not functioning using the normal operating controls. The bulb(s) in this fixture may be burned out. If the bulbs are not burned out, the condition of the fixture and wiring should be verified. We recommend repair as necessary to restore the function of this fixture.

Repair: The light fixture at the laundry was not functioning using the normal operating controls. The bulb(s) in this fixture may be burned out. If the bulbs are not burned out, the condition of the fixture and wiring should be verified. We recommend repair as necessary to restore the function of this fixture.

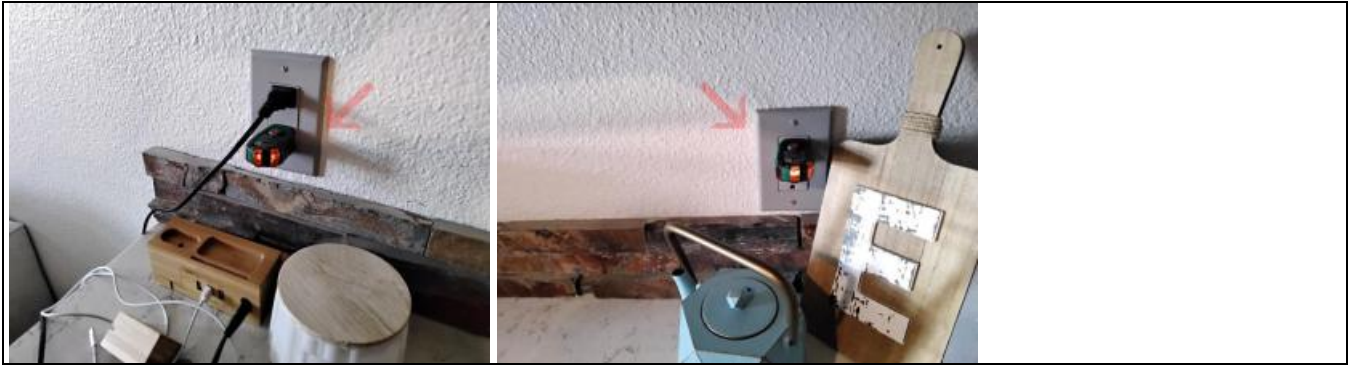
Safety Concern: Two kitchen ground fault circuit interrupter breaker (GFCI) receptacles did not function as intended. This could pose a serious safety condition and we recommend that these GFCI breakers be replaced as soon as possible.

Safety Concern: Two kitchen ground fault circuit interrupter breaker (GFCI) receptacles did not function as intended. These are located on both sides of the kitchen sink. This could pose a serious safety condition and we recommend that these GFCI breakers be replaced as soon as possible.

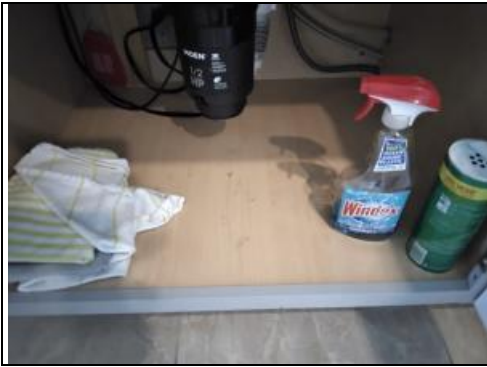
The kitchen sink drained properly with no leakage observed.

The kitchen faucet functioned properly.

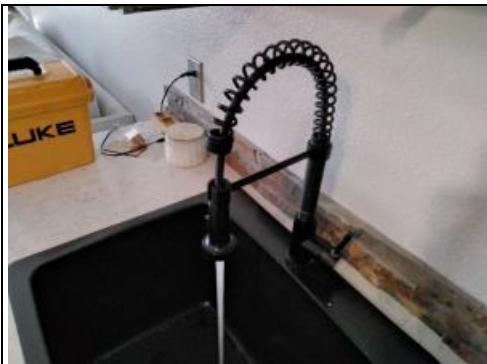
Repair: The caulking or grout for the backsplash behind the sink is in need of touch up. We recommend that caulking be installed and/or gaps filled to prevent possible water intrusion at the wall areas. The counters in the kitchen appeared to be in good condition.

Repair: The caulking or grout for the backsplash behind the sink is in need of touch up. We recommend that caulking be installed and/or gaps filled to prevent possible water intrusion at the wall areas. The counters in the kitchen appeared to be in good condition.

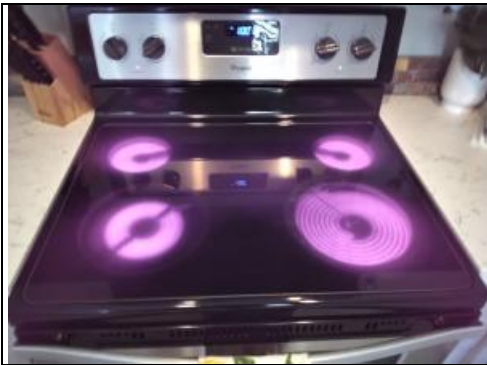
Functional. All of the burners ignited.

Safety Concern: The cooktop/range was not equipped with an anti tip hold down. This hold down prevents the tipping of the stove top when a small child attempts to step on the lowered oven door. We recommend that the anti tip device or hold down is installed for safety reasons.

Safety Concern: The cooktop/range was not equipped with an anti tip hold down. This hold down prevents the tipping of the stove top when a small child attempts to step on the lowered oven door. We recommend that the anti tip device or hold down is installed for safety reasons.

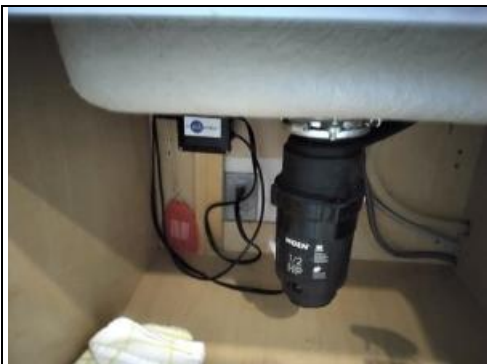
Monitor: The garbage disposal was found to be noisy during operation. This may indicate that the unit was nearing the end of useful service life and that replacement in the near future should be expected.

Monitor: The garbage disposal was found to be noisy during operation. This may indicate that the unit was nearing the end of useful service life and that replacement in the near future should be expected.

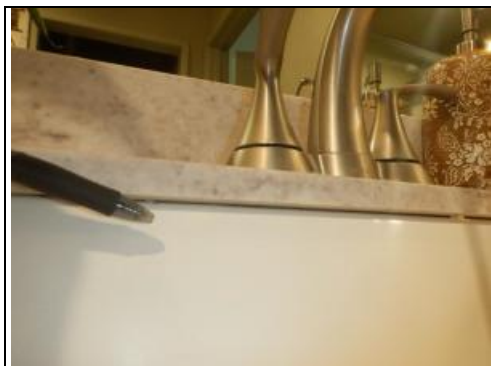
Repair: The under sink basin attachment to the countertop at the hall bath needs caulking or sealing. We recommend that this area be caulked to stop moisture from getting to the under cabinet surfaces.

Repair: The under sink basin attachment to the countertop at the hall bath needs caulking or sealing. We recommend that this area be caulked to stop moisture from getting to the under cabinet surfaces.

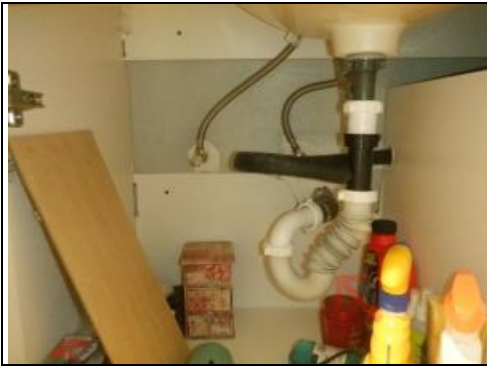
Replace: The sink drain line is a flexible, accordion type, plastic pipe. This type of pipe clogs easier than a smooth sided pipe; and, may be cut or dislodged if a plunger is used on them. We recommend replacement.

Replace: The sink drain line is a flexible, accordion type, plastic pipe. This type of pipe clogs easier than a smooth sided pipe; and, may be cut or dislodged if a plunger is used on them. We recommend replacement.

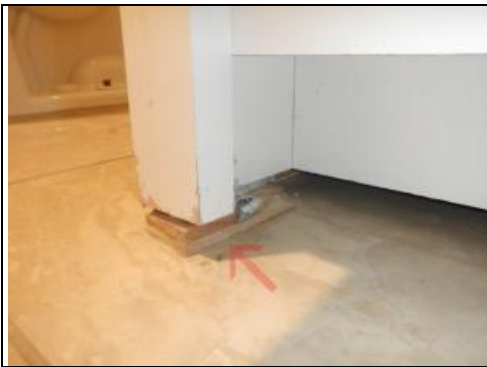
Monitor: The legs of the bathroom cabinet are propped up with shims. If they get wet often, they may deteriorate and fail to support the cabinet properly. We recommend monitoring the shims and to replace them with any signs of deterioration.

Repair: The bottom of the top drawer in the bathroom cabinet is not in the cabinet. We recommend that the drawer be repaired.

Monitor: The legs of the bathroom cabinet are propped up with shims. If they get wet often, they may deteriorate and fail to support the cabinet properly. We recommend monitoring the shims and to replace them with any signs of deterioration.

Repair: The bottom of the top drawer in the bathroom cabinet is not in the cabinet. We recommend that the drawer be repaired.

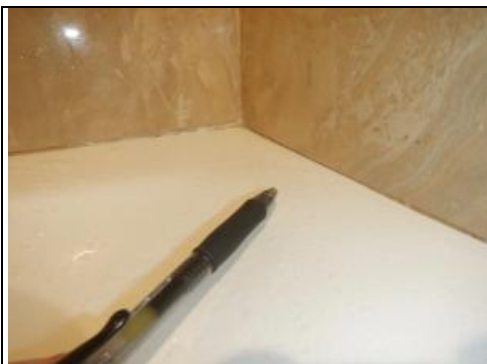
Repair: Missing or deteriorated grout was noted at the shower/tub wall area of the bathroom. The possibility of mold growth behind the wall is present. We recommend re-grouting to reduce water penetration and possible damage to the surrounding areas.

Repair: Missing or deteriorated grout was noted at the shower/tub wall area of the bathroom. The possibility of mold growth behind the wall is present. We recommend re-grouting to reduce water penetration and possible damage to the surrounding areas.

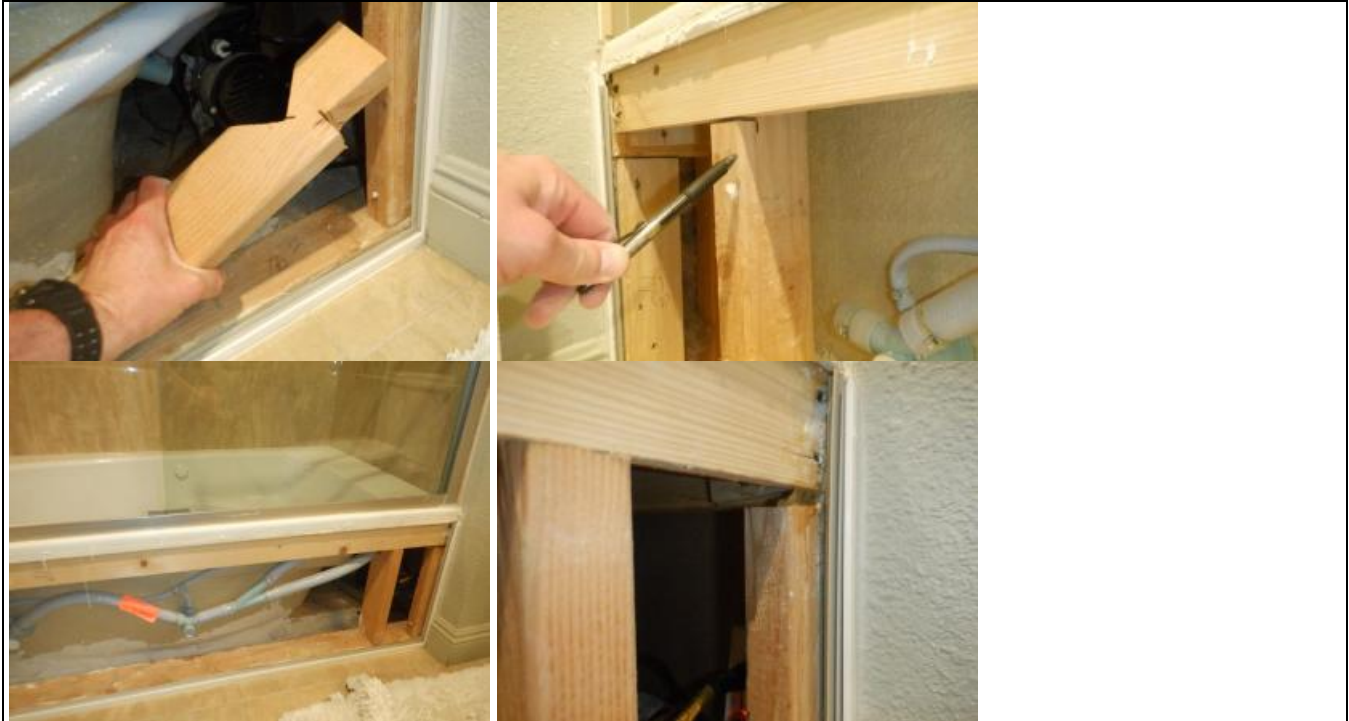
Upgrade: It appears that the bathtub may have been replaced with a spa tub. The framing to support the tub is, in our opinion, not properly constructed to securely support the tub. Some framing members are not nailed properly and could fail during a seismic event. We recommend that an appropriate tradesman repair and secure the framing properly.

Upgrade: It appears that the bathtub may have been replaced with a spa tub. The framing to support the tub is, in our opinion, not properly constructed to securely support the tub. Some framing members are not nailed properly and could fail during a seismic event. We recommend that an appropriate tradesman repair and secure the framing properly.

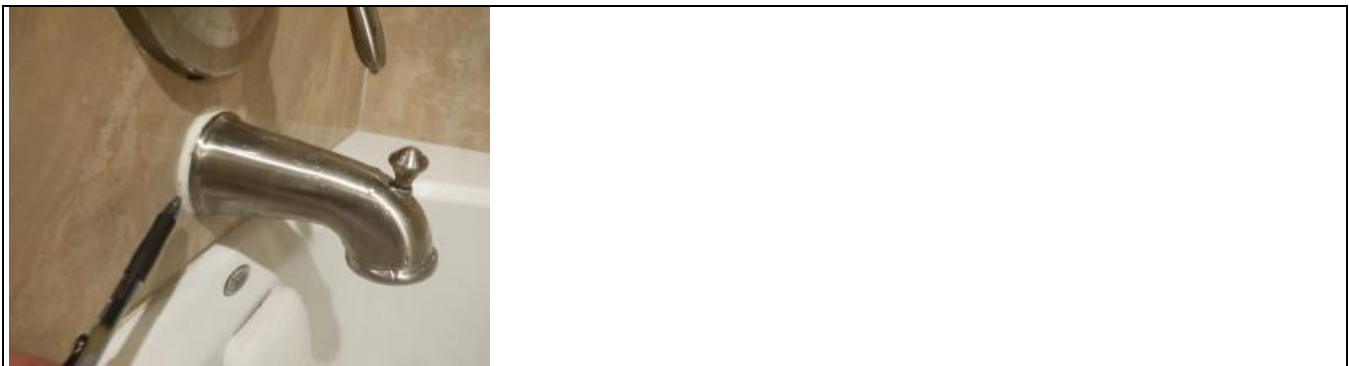
Repair: The spout for the bathtub had a large gap that has been caulked; but, could cause leaking in the future. We recommend the spout be tightened and/or joint sealed to prevent future leakage.

Repair: The spout for the bathtub had a large gap that has been caulked; but, could cause leaking in the future. We recommend the spout be tightened and/or joint sealed to prevent future leakage.

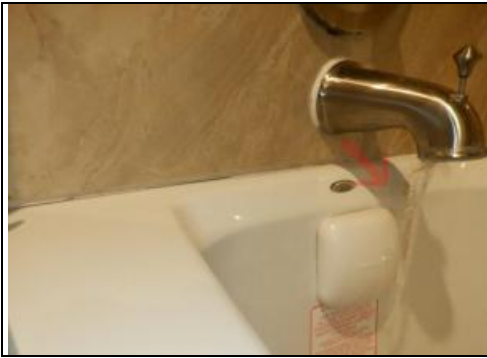
Repair: The tub/shower diverter was found to be difficult to operate or was not fully operative in the bath. We recommend repair or replacement of the diverter(s).

Repair: The tub/shower diverter was found to be difficult to operate or was not fully operative in the bath. We recommend repair or replacement of the diverter(s).

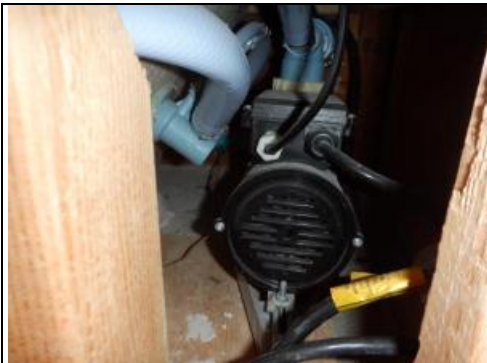
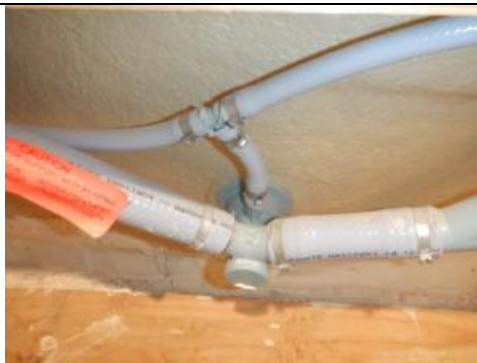
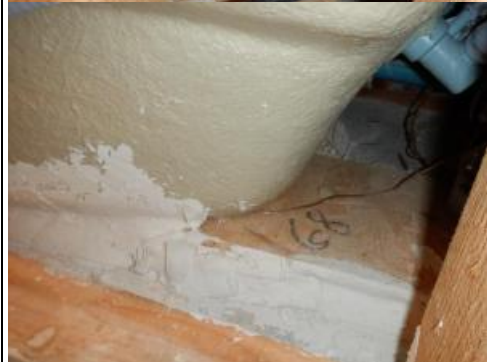
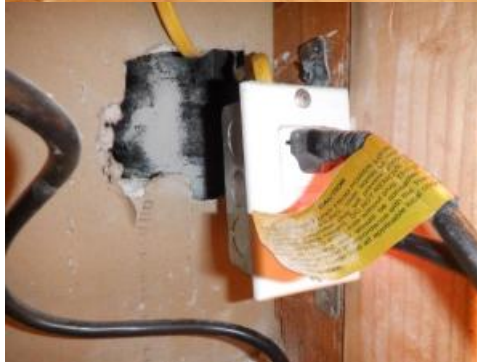
The mechanical access area for the spa tub was accessible. There is a functioning GFCI receptacle. There was no sign of any previous water leak. The pump appeared to be in good condition.

Advisory: The cover of the access opening fits loosely. Water from the shower could enter the space. We recommend that the cover be studied to determine a method to make it water tight.

Advisory: The cover of the access opening fits loosely. Water from the shower could enter the space. We recommend that the cover be studied to determine a method to make it water tight.
