# ASLAN HOME INSPECTION SERVICES

## INTER NACHI REPORT

4020 Gamma St  
San Diego, CA 92113

APRIL 23, 2023

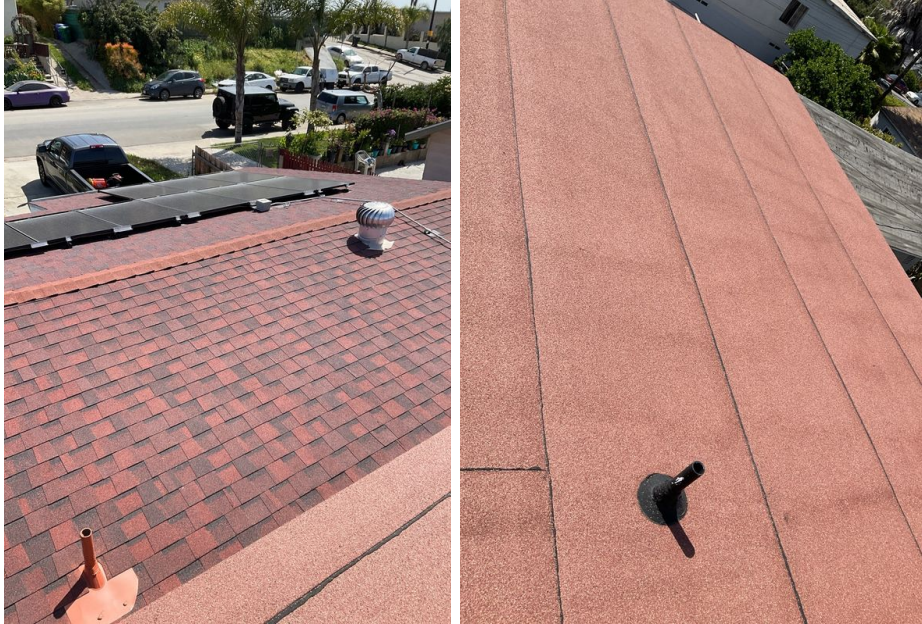
### Roof Covering: Front ridge of roof is older age than the remainder of the roofing.

Front ridge of roof is older age than the remainder of the roofing.

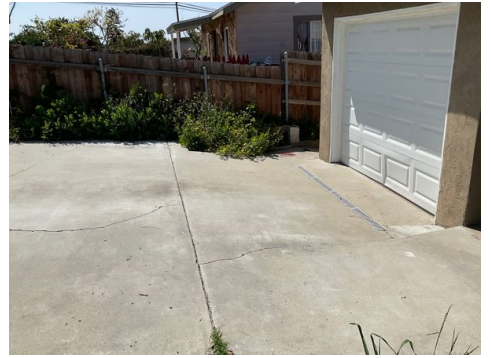
**IMPROPERLY SLOPED DRIVEWAY SURFACE**

I observed that the driveway has a negative slope and drains towards the house. This condition is prone to water penetration into the house structure.

Correction and further evaluation is recommended.

Contact a qualified driveway contractor.

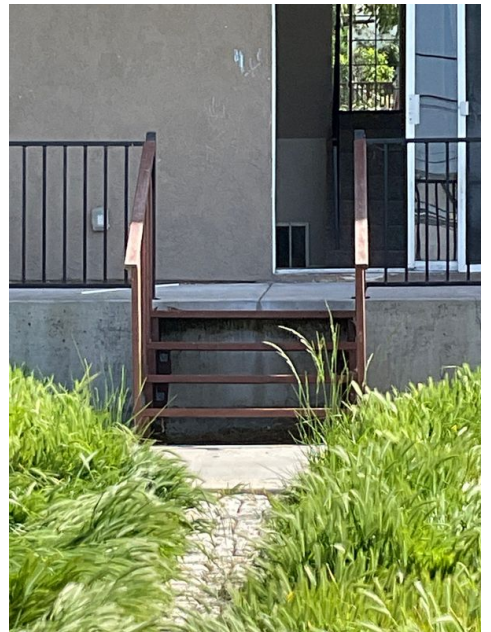
**LOOSE HANDRAIL**

I observed a loose handrail.

Contact a qualified professional.

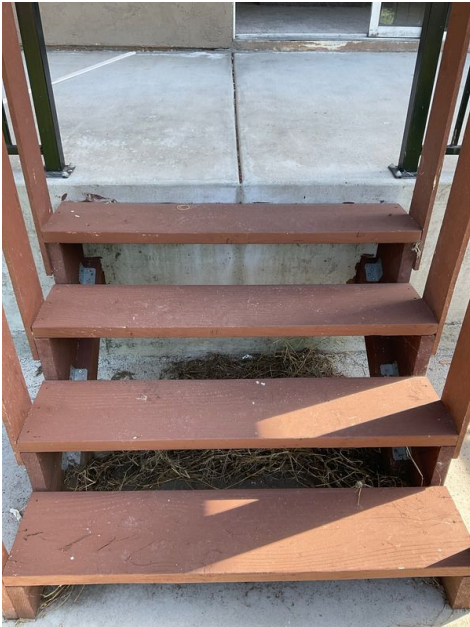
#### **LOOSE RAILING COMPONENT**

I observed a loose railing component. This condition is a safety hazard.

Correction and further evaluation is recommended.

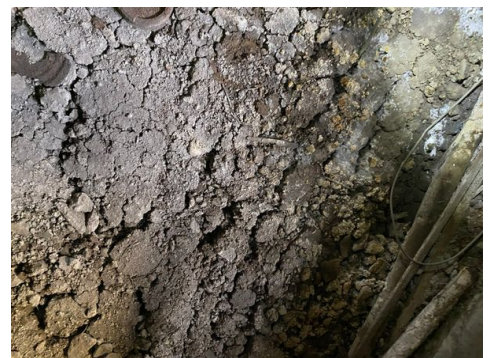
### PRIOR WATER PENETRATION OBSERVED

I observed indications that sometime in the past, there was water penetration or intrusion into the crawlspace.

Recommend monitoring.

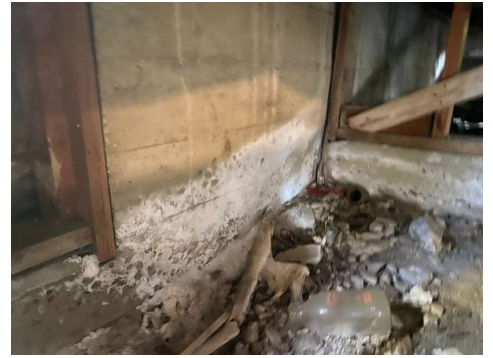
4.1.3 Under-Floor Crawlspace

### EFFLORESCENCE OBSERVED

I observed efflorescence from the crawlspace.

Efflorescence is the white chalky powder that you might find on the surface of a concrete or brick wall. It can be a cosmetic issue, or it can be an indication of moisture intrusion that could lead to major structural and indoor air quality issues.

I noted the presence of efflorescence in the inspection report because it generally occurs where there is excess moisture, a condition that also encourages the growth of mold.

Contact a qualified professional.

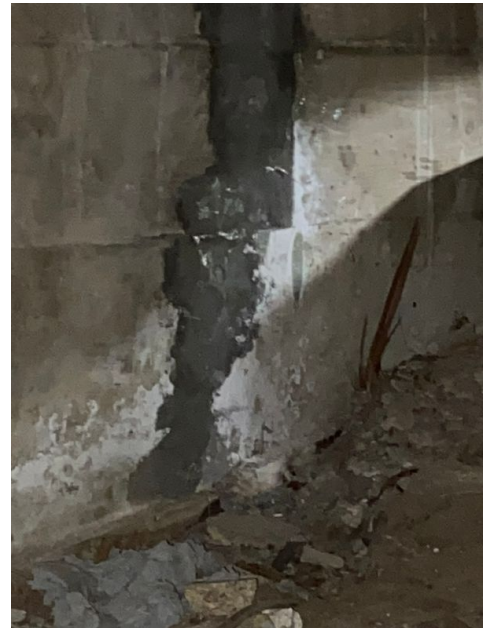
#### 4.1.4 Under-Floor Crawlspace

### **SIGNS OF PRIOR REPAIR TO STRUCTURAL WALL**

Signs of prior repair to structural wall are visible in crawl space. Recommend monitoring.

Contact a qualified professional.

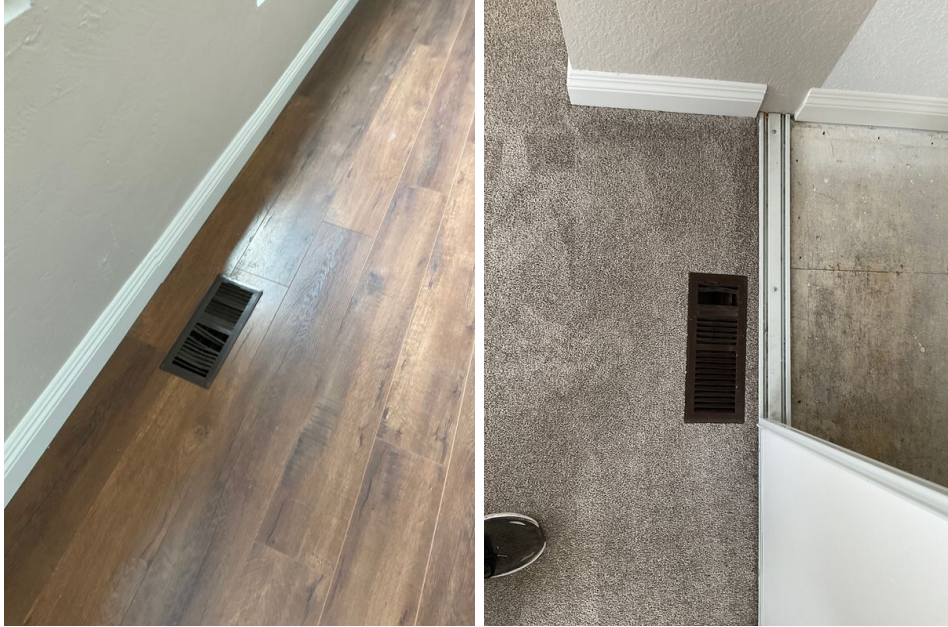
5.1.2 Heating System Information

**HVAC REGISTER DAMAGED**

HVAC register damagedL

Contact a qualified professional.

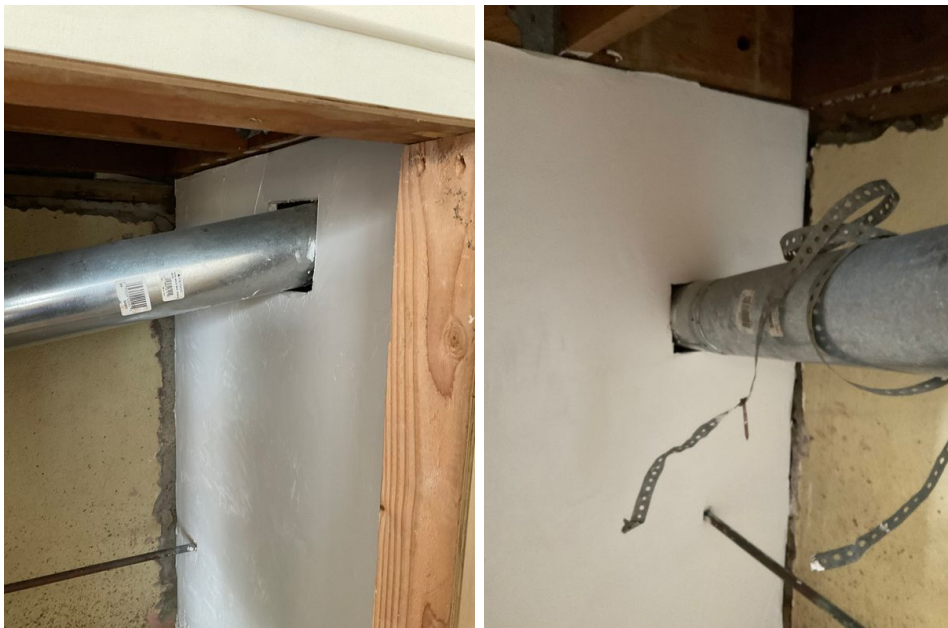
5.1.3 Heating System Information

**HVAC VENT LINE RUNS THROUGH DRYWALL WITHOUT INSULATOR RECOMMEND REPAIR**

HVAC vent line runs through drywall without insulator recommend repair.

Contact a qualified professional.

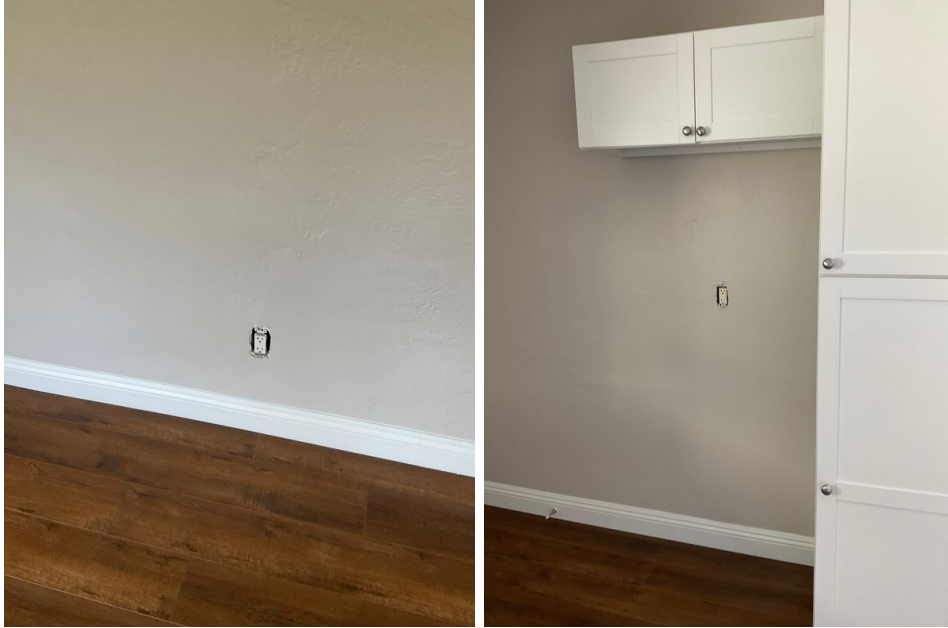
### 7.9.1 Electrical Defects

#### **ELECTRIC COVER PLATES MISSING IN MULTIPLE AREAS.**

Contact a qualified professional.
