# PROPERTY INSPECTION **REPORT**

**250 Enterprise Way, Palm Springs, 92262 CA**

DATE OF INSPECTION: 12/17/2025

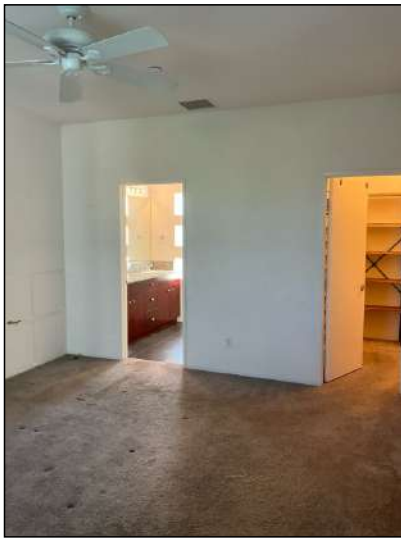
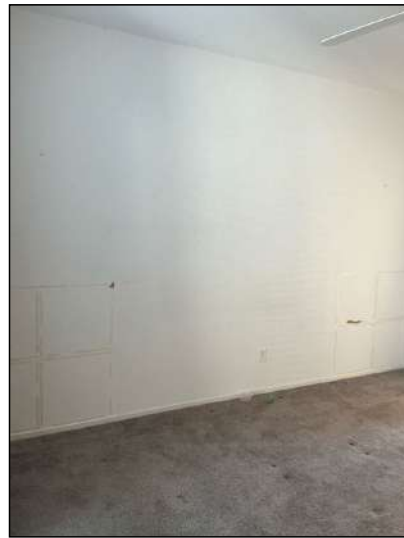
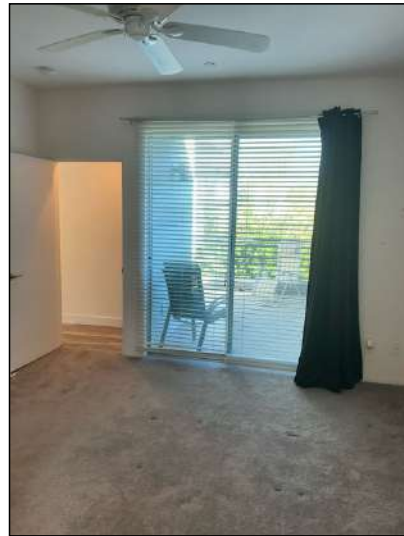
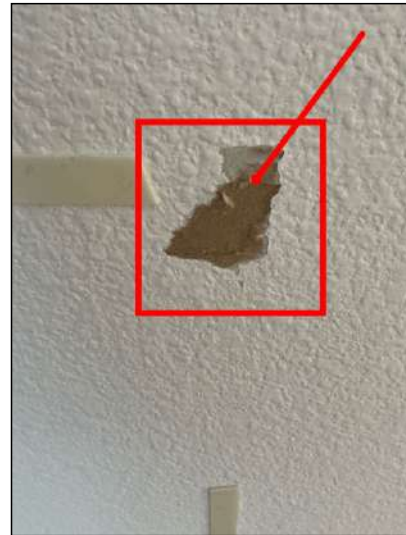
## 2. Wall Condition

• Visible damage on walls noted. Recommend licensed technician examine for further evaluation and repair.

Visible damage on walls noted. Recommend licensed technician examine for further evaluation and repair.

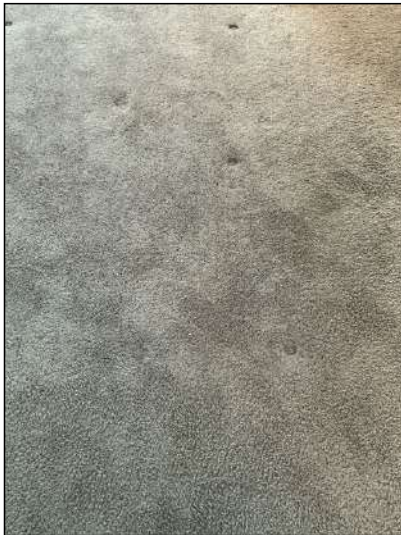
## 6. Floor Condition

- Visible stains on carpet noted. Recommend licensed technician Repair/Clean.

Visible stains on carpet noted. Recommend licensed technician Repair/Clean.

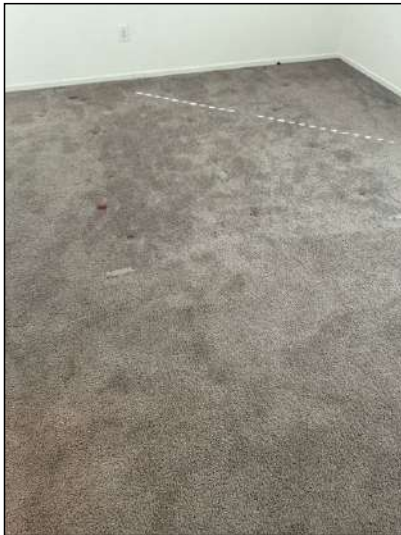
## 6. Floor Condition

- Visible stains on carpet noted. Recommend licensed technician Repair/Clean.

Visible stains on carpet noted. Recommend licensed technician Repair/Clean.

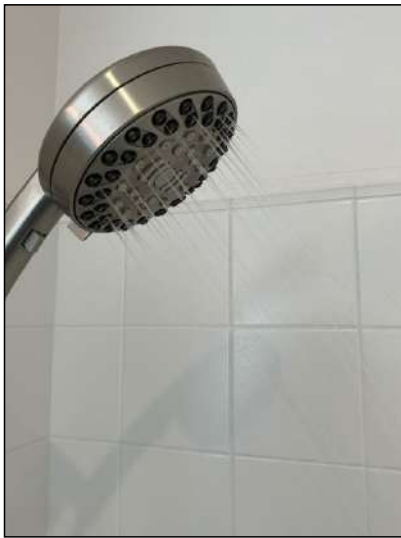
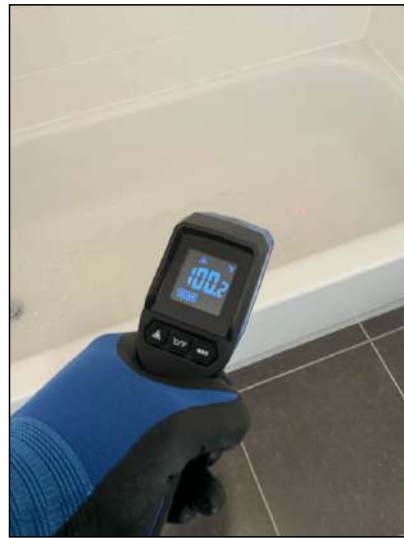
- Leaking faucet/shower diverter. Recommend licensed plumber examine/evaluate/repair. All of the water is not flowing to shower head.

Leaking faucet/shower diverter. Recommend licensed plumber examine/evaluate/repair. All of the water is not flowing to shower head.

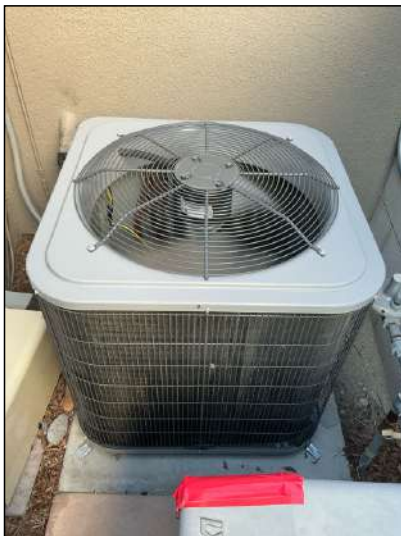
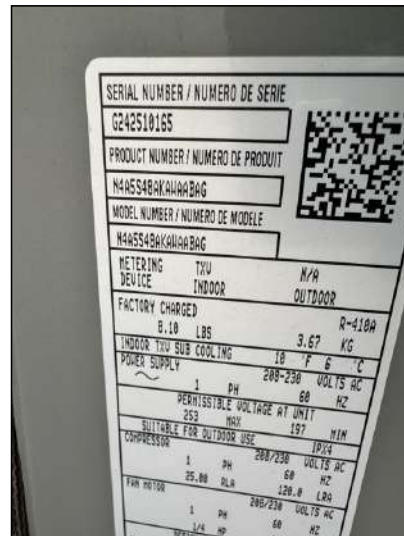
## 1. Heater Condition

Materials: The furnace is located in the garage  
Materials: Gas fired forced hot air.

Brand name: not visible  
Model number: N4A5S48AKAWAABAG (4 ton unit)

Serial number: G242510165  
Unit is approximately: 1 year old  
Manufacture date on label: June 2024

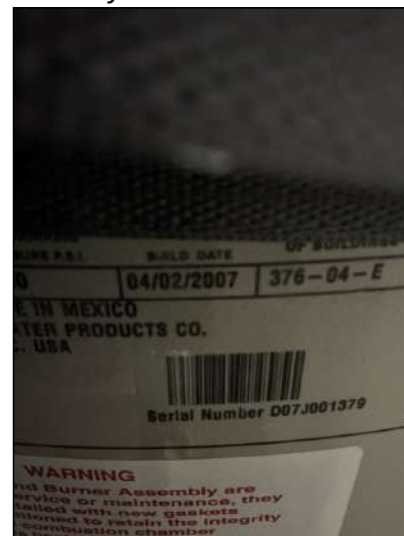
### 4. Water Heater Condition

- FYI: The normal life expectancy of a water heater is between 12-16 years old.
- Buyers Tip: Recommended water temperature should be set at 118-122 degrees F to prevent scalding, extend water heater life, and improve energy efficiency and conservation.

Brand: A.O. Smith  
Manufacture date on label: 04/02/2007  
Unit is approximately: 18 years old

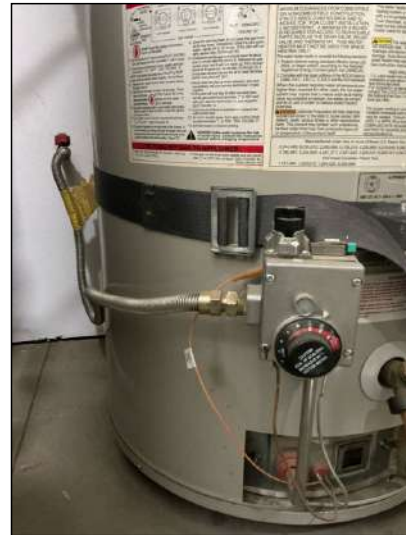
• What is a sediment trap? A sediment trap is used on fuel piping to prevent sediment, debris, and moisture from entering a gas appliance or fuel regulator. Sediment traps are required to be installed in a manner that meets or exceeds fuel piping codes and manufacture requirements for appliances and devices.
  - **Missing sediment trap. Recommend licensed plumber install.**

Missing sediment trap. Recommend licensed plumber install.

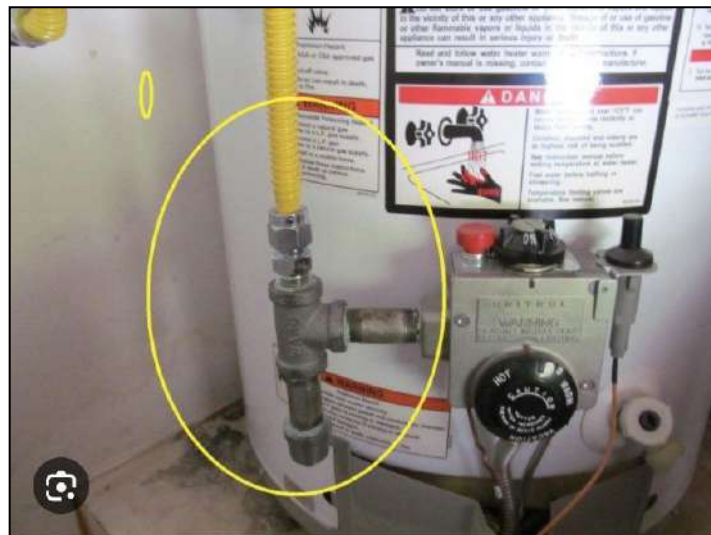
Pictured: sediment trap

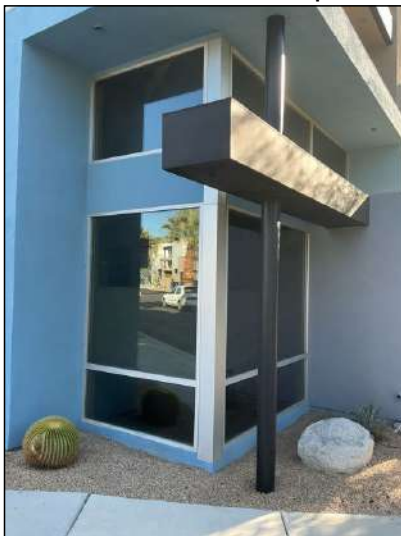
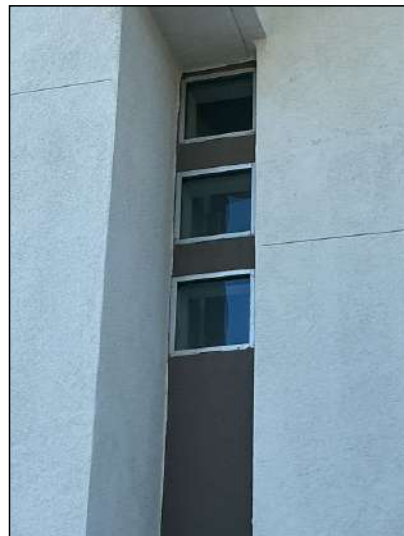
### 4. Window Condition

- Dirty windows and doors noted. Recommend licensed technician Service/Clean. Windows and doors were difficult to open and close when tested.

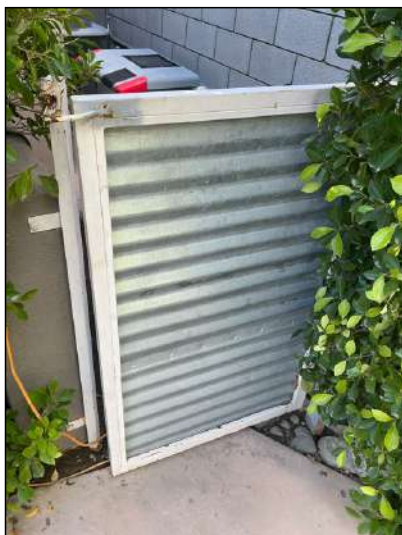
### 5. Gate Condition

- Visible rusting and damaged paint on gate(s) noted. Recommend licensed technician Repair/Repaint. Location: by pool equipment

Visible rusting and damaged paint on gate(s) noted. Recommend licensed technician Repair/Repaint. Location: by pool equipment

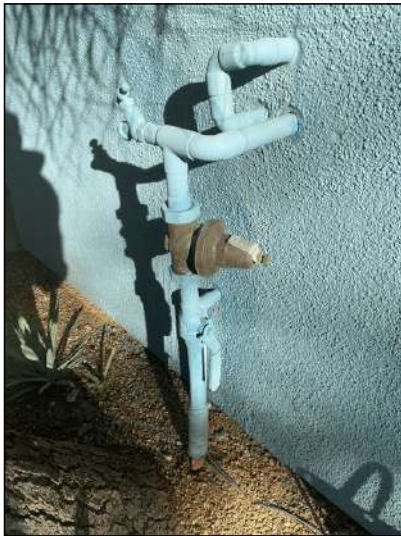
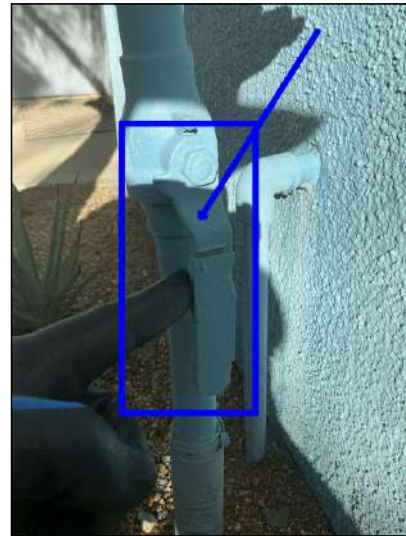
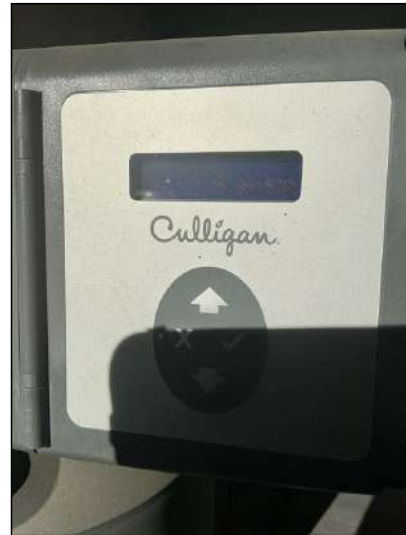
- ✓ Main water shut of valve. Location: south exterior garage wall
- Normal psi for a home pipe system is between 30 and 80 psi. While you don't want to be too low, you should aim for a psi that's between 60 and 70 psi.
- The home is equipped with a water softening/conditioning system. Please verify with the current owner on the operation of these components, as testing of their operation cannot be done during a normal home inspection and as such, is beyond the scope and limitations of this inspection.

Main water shut of valve. Location: south exterior garage wall

The home is equipped with a water softening/conditioning system. Please verify with the current owner on the operation of these components, as testing of their operation cannot be done during a normal home inspection and as such, is beyond the scope and limitations of this inspection.

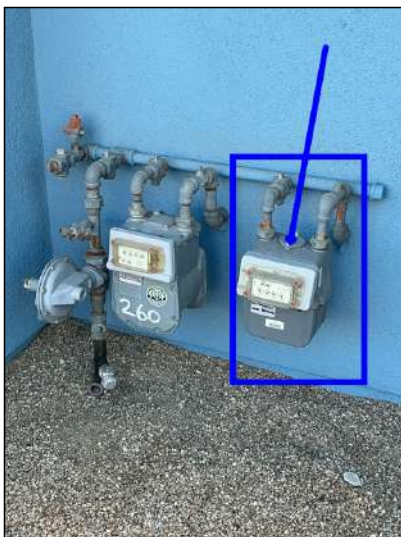
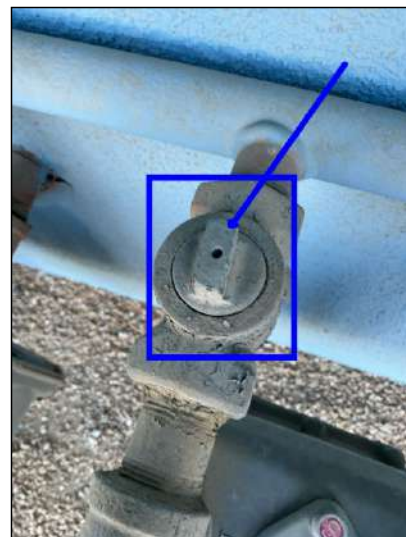
### 13. Main Gas Valve Condition

Materials: West side.

Main gas shut off valve. Location: west exterior wall

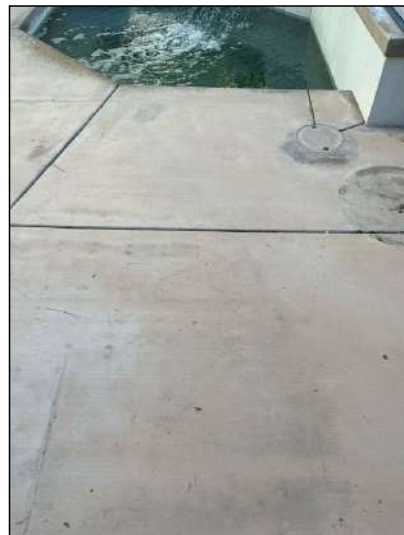
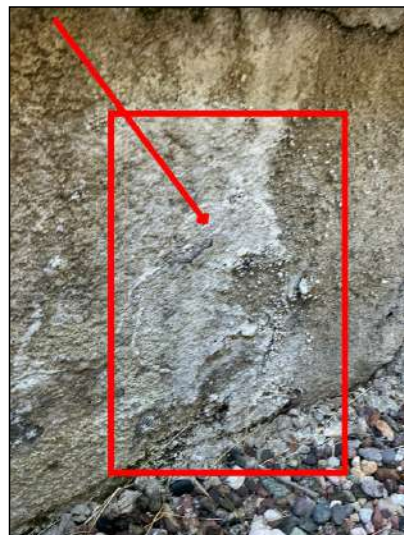
## 1. Deck Condition

- The objective of our limited visual pool and spa equipment is to determine if the equipment would benefit from inspection, repairs or improvements by a certified, licensed pool and spa contractor/specialist. The scope of our inspection includes a limited visual inspection of electrical system, circulation system, barriers, surfaces and decking. We do not dismantle pool and spa components. Water chemistry is not evaluated.
- A licensed pool contractor is recommended for further evaluation, repairs and estimates.
- **Visible chipped/damaged stucco noted around back of spa. Recommend licensed pool contractor examine/evaluate/repair.**

Visible chipped/damaged stucco noted around back of spa. Recommend licensed pool contractor examine/evaluate/repair.

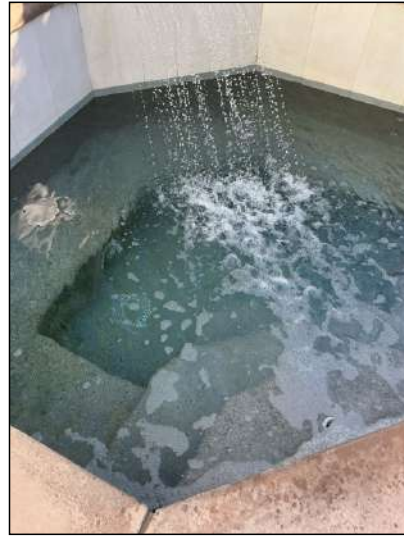
## 2. Structure Condition

- Dirty pool/spa tiles noted. Recommend licensed pool technician clean/service

Dirty pool/spa tiles noted. Recommend licensed pool technician clean/service

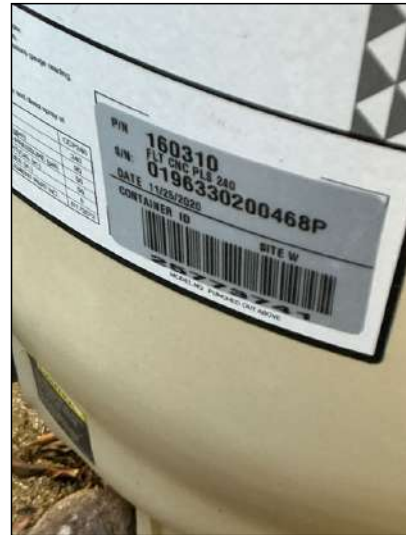
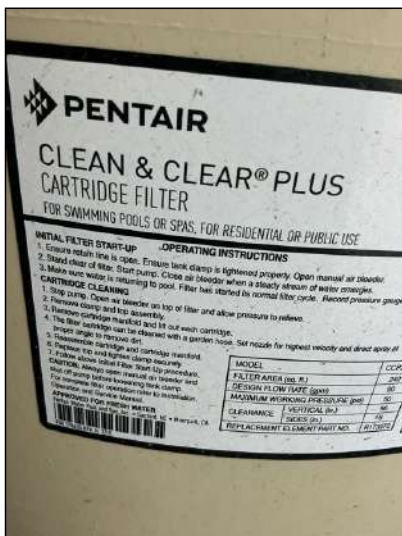
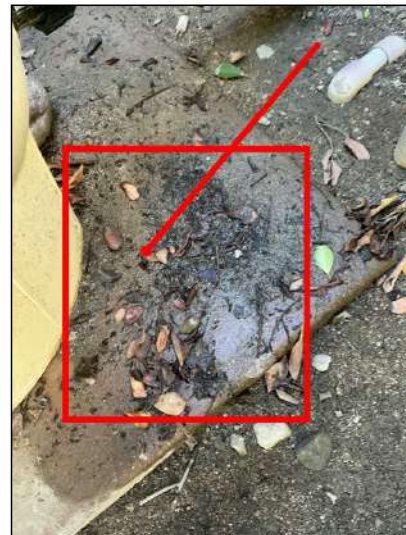
- Cartridge filter
- Visible moisture/water noted on/around filter. No visible leaks when pool/spa equipment was tested. May be water by nearby sprinklers. Recommend licensed pool technician examine/evaluate/repair.

Manufacture date on label: 11/25/2020  
Filter is approximately: 5 years old

Visible moisture/water noted on/around filter. No visible leaks when pool/spa equipment was tested. May be water by nearby sprinklers. Recommend licensed pool technician examine/evaluate/repair.
