## RESIDENTIAL INSPECTION

15615 Vista Vicente Dr 5  
Ramona, CA 92065

08/14/2026

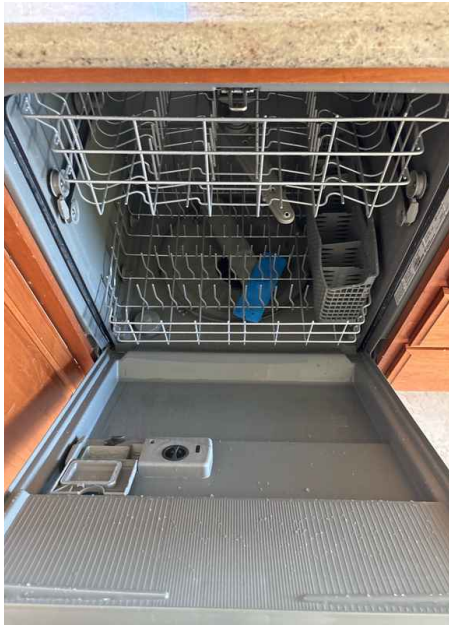
### **DISHWASHER: Dishwasher Turned On - Inspection Limited**

The dishwasher turned on and appeared to complete a wash cycle at the time of the inspection. However, this is not a guarantee that this unit will not leak at some time in the future. We recommend purchasing a home warranty to cover the unit and any possible damages that may result from a leak.

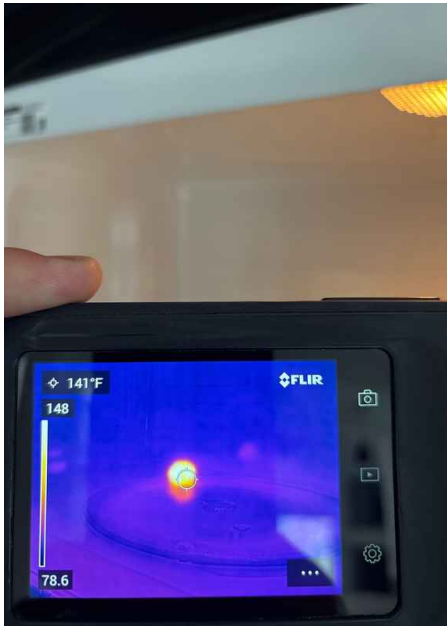
### **RANGES AND COOKTOPS: Thermal Image Showing Range Working**

Infrared picture of range/cooktop in operation. This unit appeared to be functional at the time of the inspection.

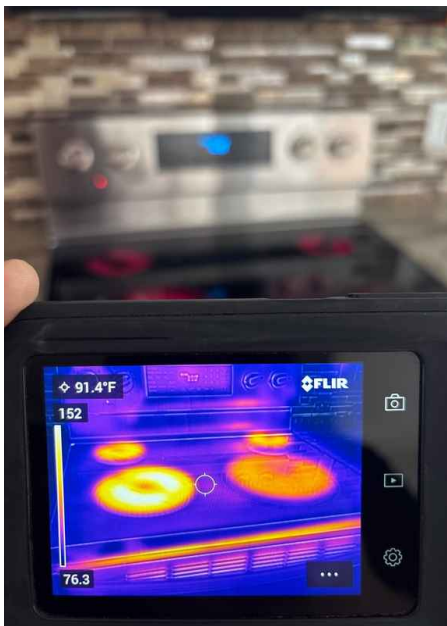
### OVEN: Thermal Image Showing Oven Working

Infrared picture of oven(s) in operation. The unit(s) appeared to be functional at the time of the inspection.

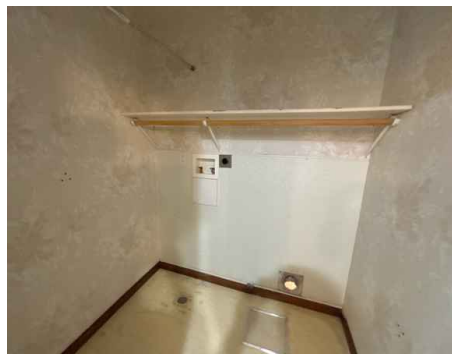
### WASHER/DRYER: Laundry Equipment - Not Inspected

The clothes washer and dryer were not tested nor inspected. Testing these units is outside the scope of a standard home inspection.

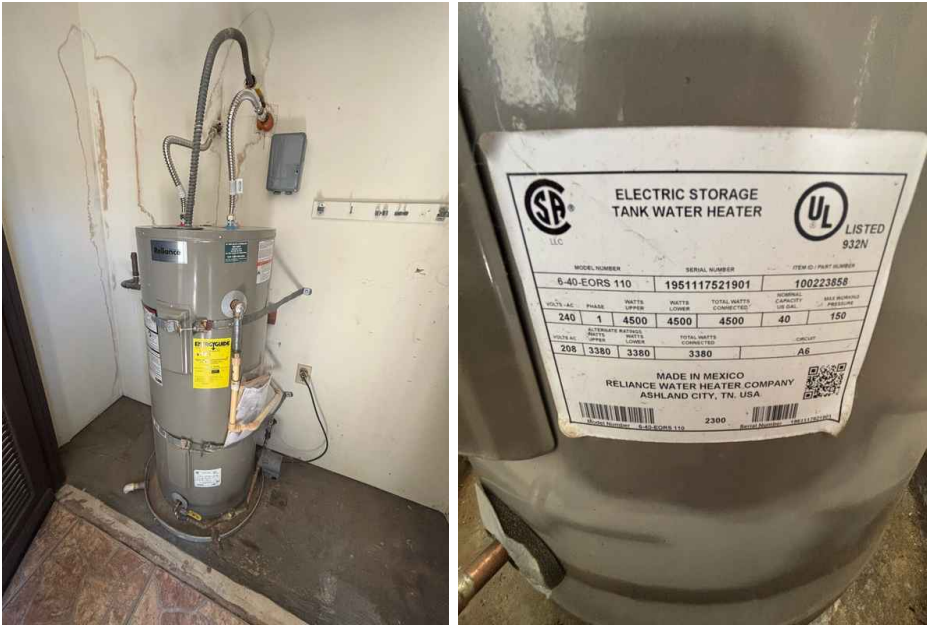
WATER HEATERS: Picture of Water Heater

Picture of water heater(s).

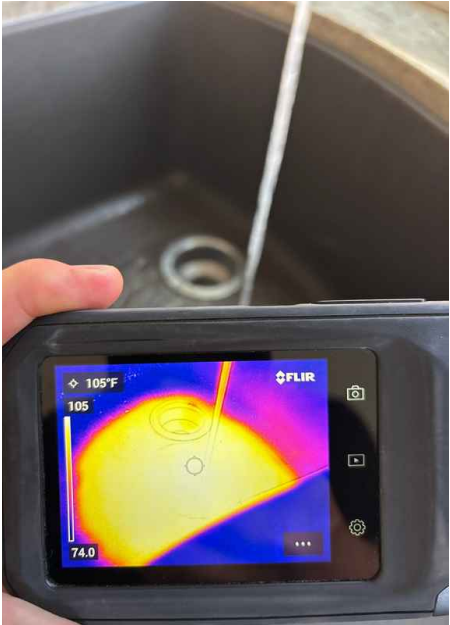
WATER HEATERS: Thermal Image of Hot Water

Thermal image(s) showing the water heater(s) producing hot water at the time of the inspection.

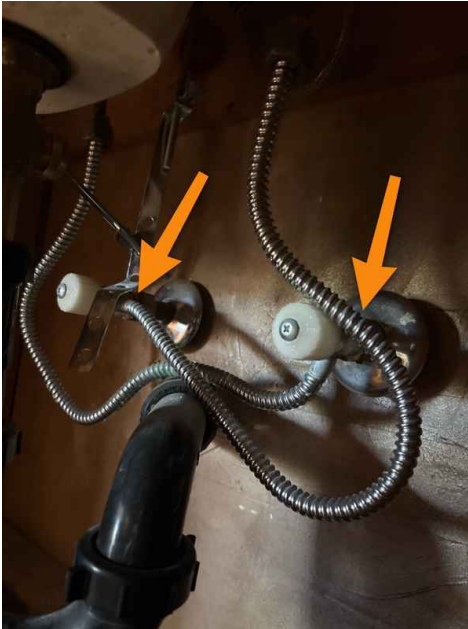
Example Primary Bathroom

ANGLE STOPS CORROSION

Recommendation

Contact a qualified plumbing contractor.

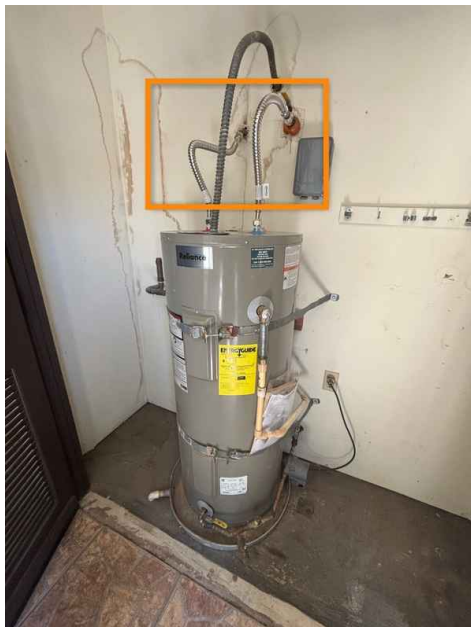
The water heater appears to be between 6-10 years old based on visual inspection. Water heaters typically have a useful lifespan of 10-15 years depending on maintenance, water quality, and usage patterns. Knowing the age helps establish when replacement or professional servicing may become necessary.

Contact a qualified professional.

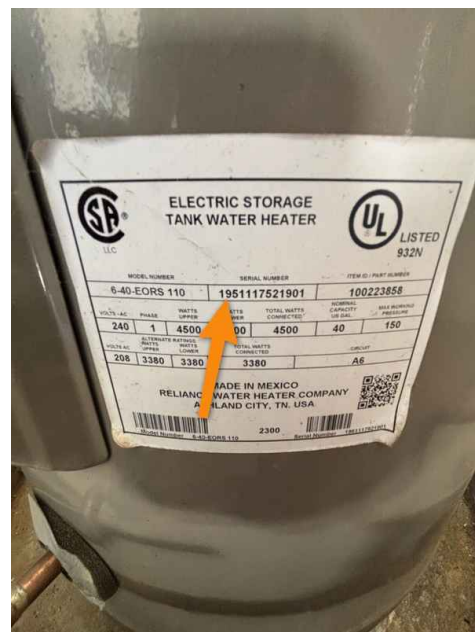
Attention Items

Manufactured 2019

Contact a qualified professional.

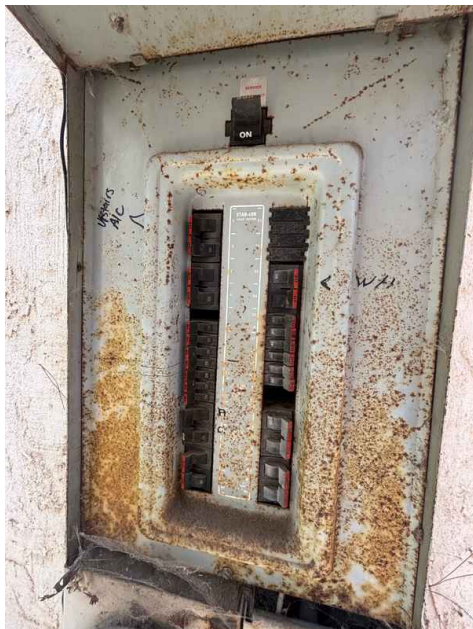
#### 4.2.2 MAIN AND DISTRIBUTION PANELS

##### **KNOCKOUT - MISSING**

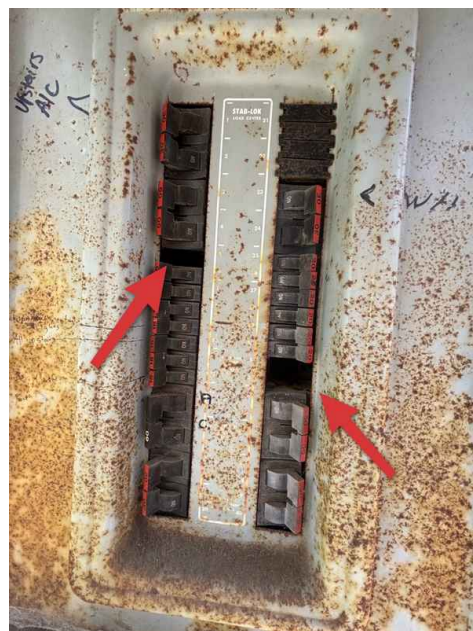
#### 4.2.3 MAIN AND DISTRIBUTION PANELS

##### **FPE / STAB-LOK**

Contact a qualified electrical contractor.

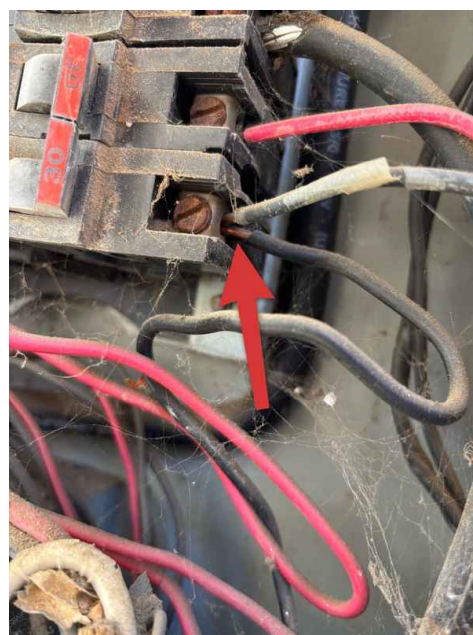
#### 4.7.1 FIXTURES AND CONNECTED DEVICES

(Observed from a representative number operation of ceiling fans, lighting fixtures, switches and receptacles located inside the house, garage, and on the dwelling's exterior walls)

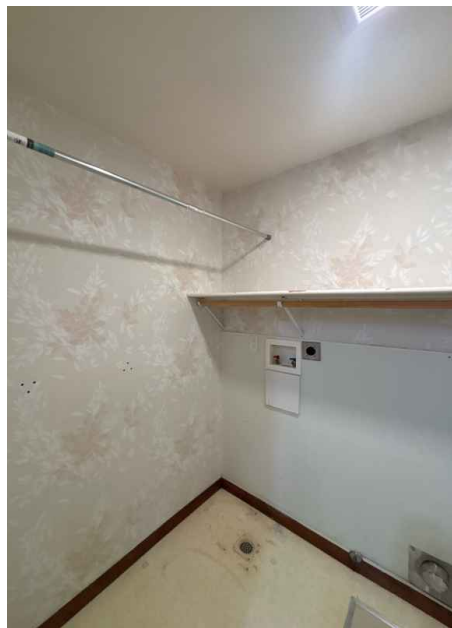
## WALLS: Wall Paper - Limited Inspection

One or more areas of this home have wall paper installed. This makes our wall inspections extremely limited due to the covering. Our company does not remove wall paper for inspections. Defects in the wall can be covered by this installation. Recommend having the walls further evaluated once wall paper has been removed.

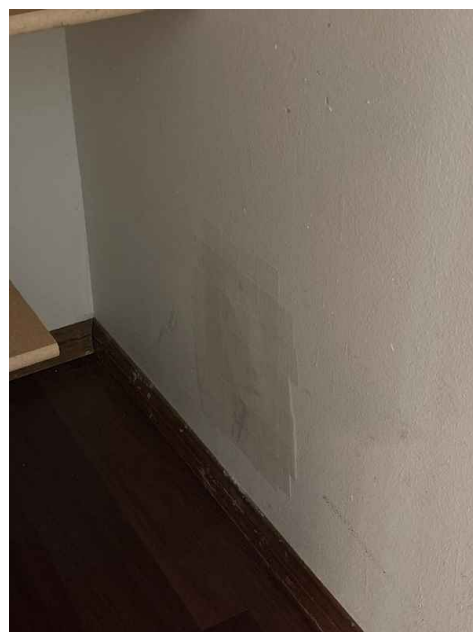
**PRIOR REPAIR**

Evidence of a prior repair noted. Uncertain of the cause for repair. You may wish to ask the sellers about any repairs you are concerned with.

Contact a qualified professional.

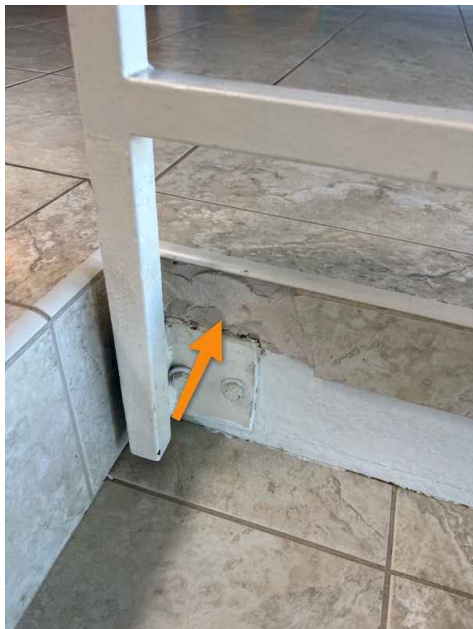
**TILE - CRACKED/CHIPPED**

Cracked and/or chipped tile(s) noted. Recommend further evaluation by a licensed tile contractor to determine any repairs necessary at this time.

Contact a qualified tile contractor

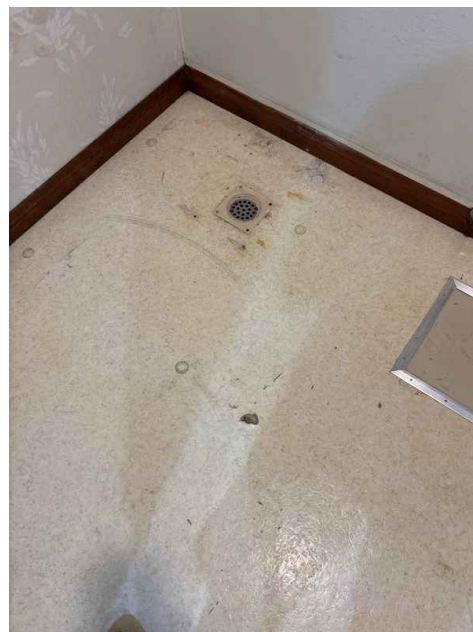
**FLOORING - DAMAGED**

Damaged flooring noted at one or more areas. You may wish to view this for yourself and have repaired by a licensed flooring contractor as necessary.

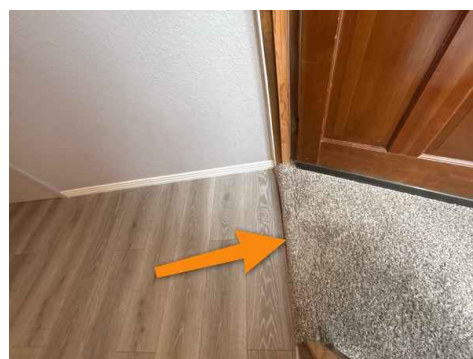
**FLOORING TRIP HAZARD**

Offsets noted in areas of the flooring that may prove to be a trip hazard. Recommend further evaluation by a licensed contractor as necessary at this time for safety.

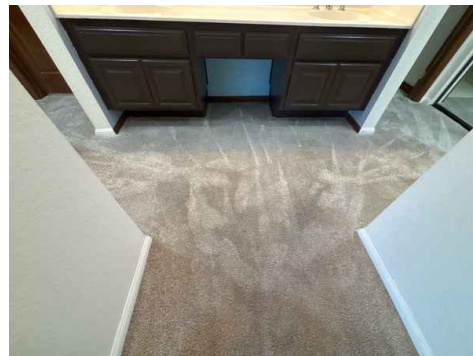
Carpet noted installed in the bathroom(s). This typically results in the presence of organic growth at the underside of the carpet and/or pad. These conditions cannot be identified within the scope of a standard home inspection. You may wish to have this further evaluated by a licensed flooring contractor and repair as necessary at this time.

Contact a qualified flooring contractor

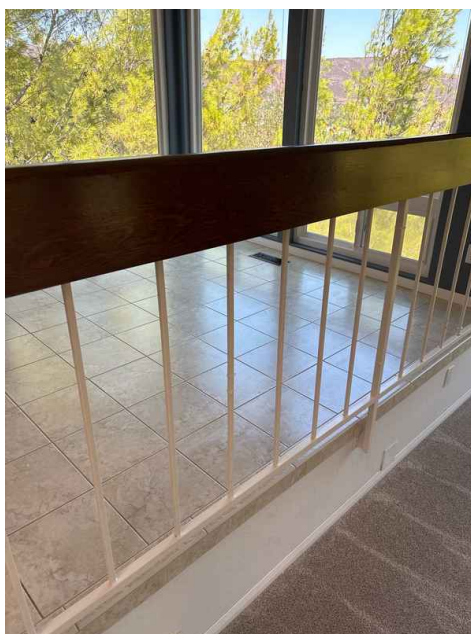
The balusters at the railing are spaced too far apart for today's safety standards. Balusters should not have more than a 4-inch gap between them. This relatively tight amount of spacing still allows for visibility between spindles, but also stands as a safety measure to prevent small children from becoming stuck between spindles or from slipping through the balusters. You are not required to retrofit older homes with current standards. However, recommend a qualified professional to further evaluate as needed.

Contact a qualified general contractor.

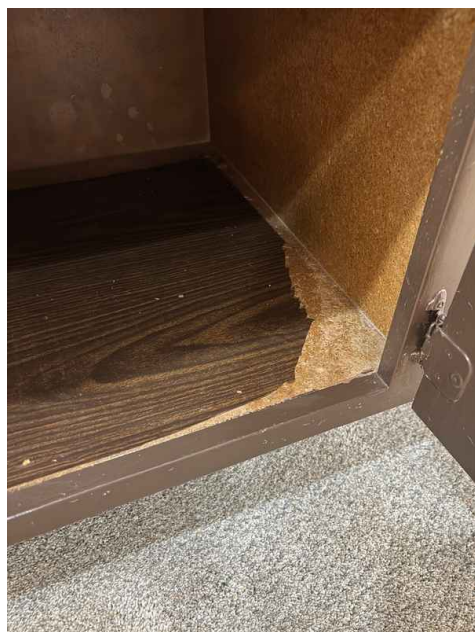
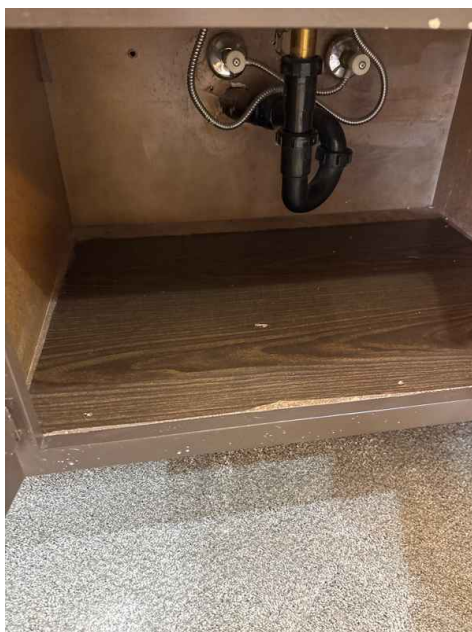
**COSMETIC DAMAGE**

Cosmetic damage noted in areas. This is for your information. You may wish to view this for yourself and have repaired as desired.

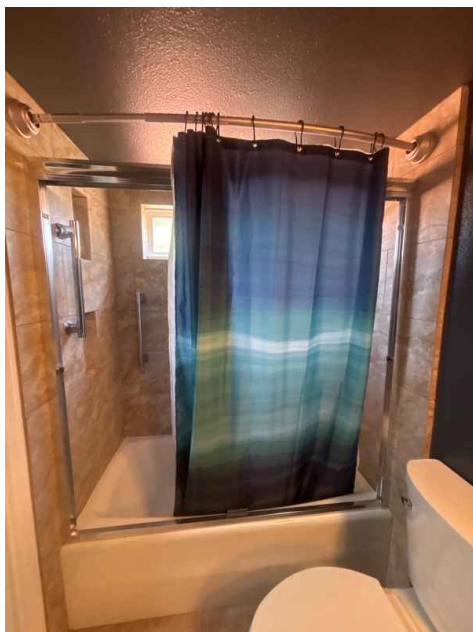
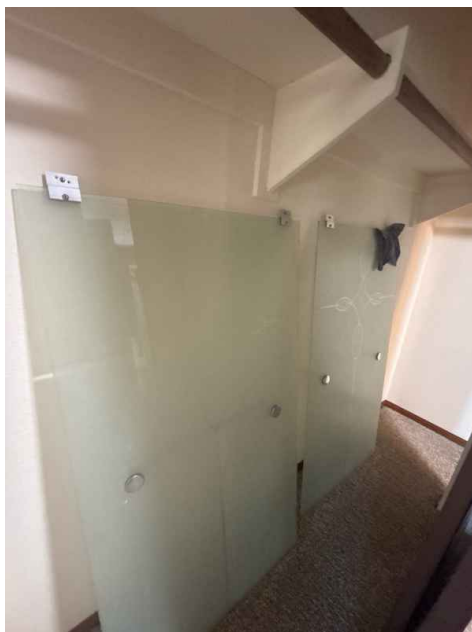
**SHOWER DOOR/ENCLOSURE - NOT INSTALLED**

Shower door not installed or inadequate. This may allow moisture outside of the shower enclosure. Recommend installation or repair as necessary at this time by a qualified professional to prevent moisture from escaping the enclosure.

Contact a qualified professional.

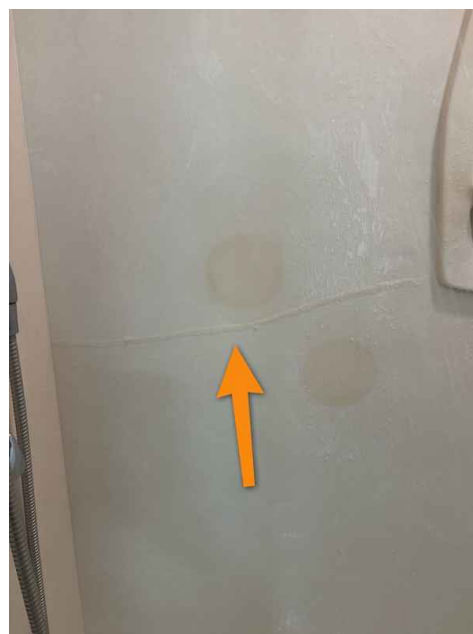
**SHOWER ENCLOSURE - BROKEN PANEL(S)**

The enclosure panels appear to be cracked. This could lead to moisture leaks outside of the shower enclosure. Recommend repair by a qualified contractor.

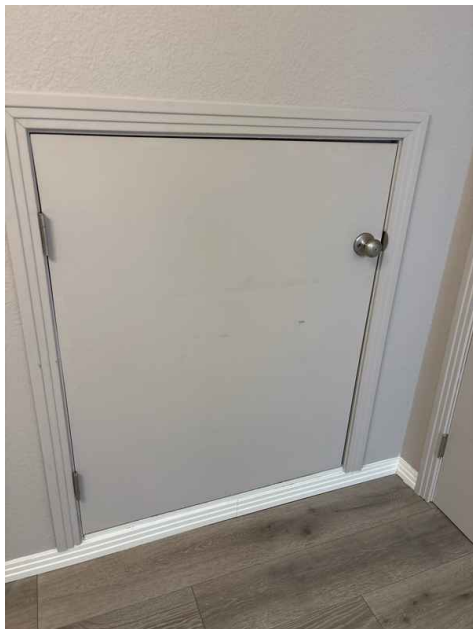
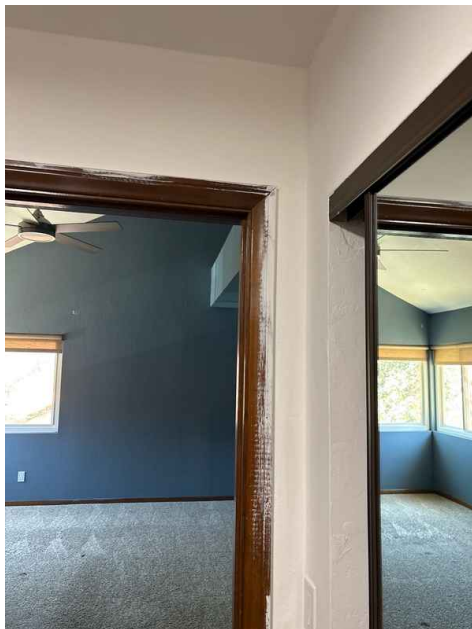
**DOOR - COSMETIC DAMAGE**

One or more doors shows signs of cosmetic damage. If this is of concern we recommend contacting a qualified handyman for repairs.

Contact a qualified door repair/installation contractor.

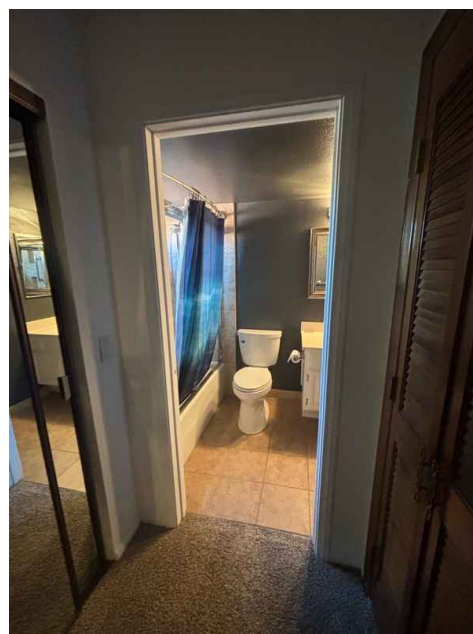
Door(s) noted removed at the time of the inspection. You may wish to view this for yourself and have replaced as necessary.

Contact a qualified door repair/installation contractor.

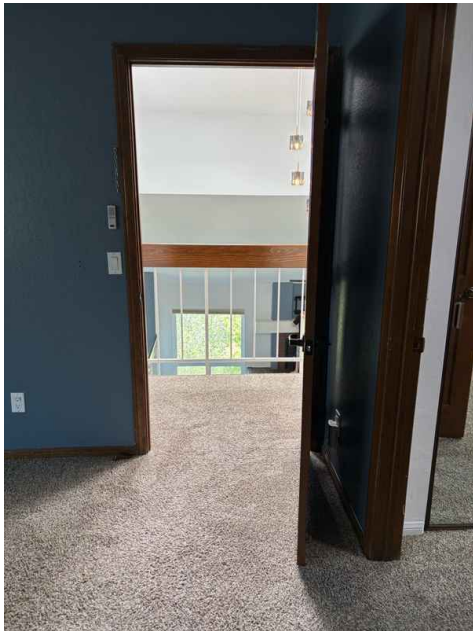
Door(s) noted closing on its own unless propped open. This condition can be indicative of poorly installed doors, however, this can also indicate movement in the structure. Recommend further evaluation by a licensed door contractor to determine the most likely cause and any corrections necessary at this time to ensure proper function.

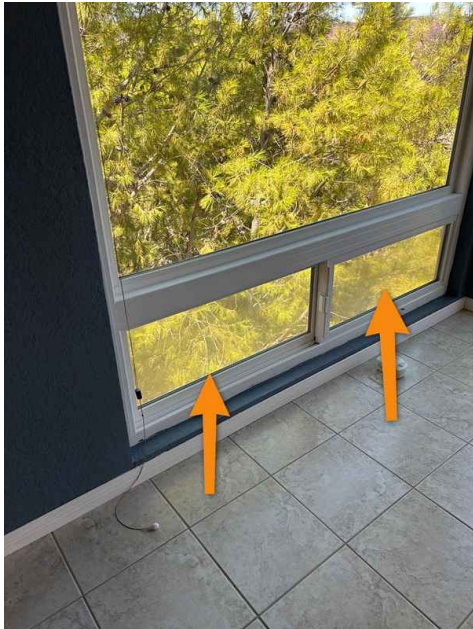
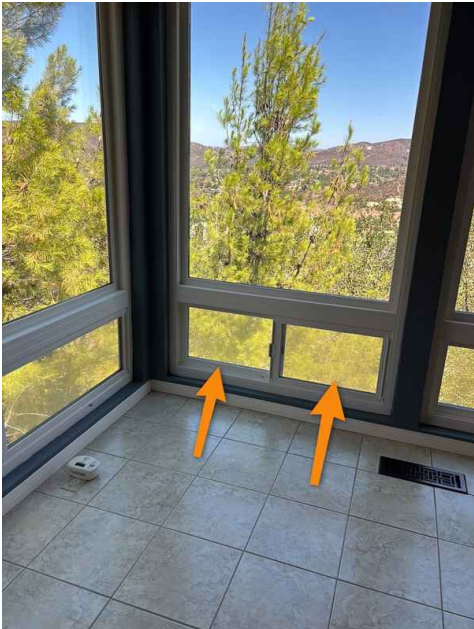
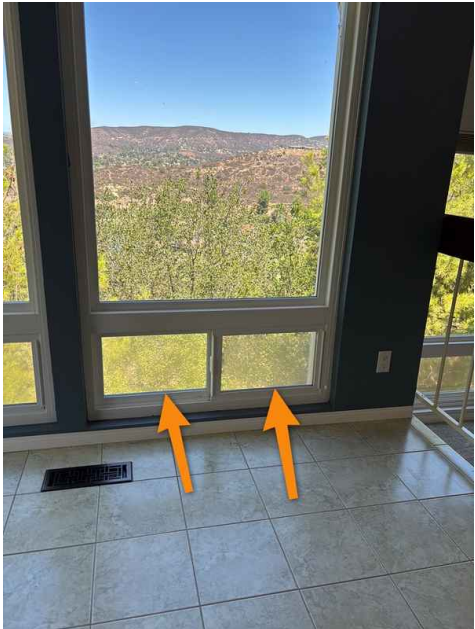
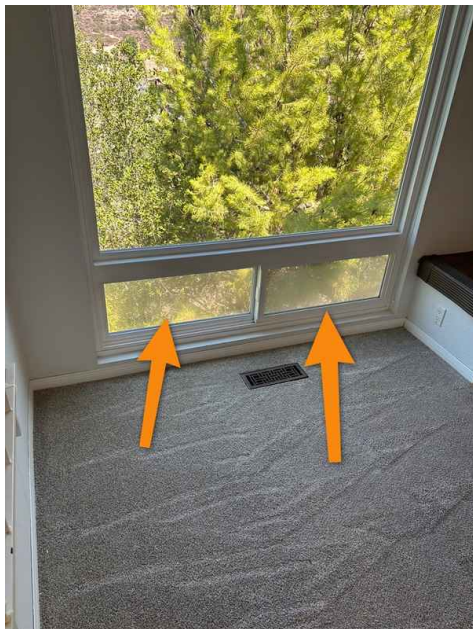
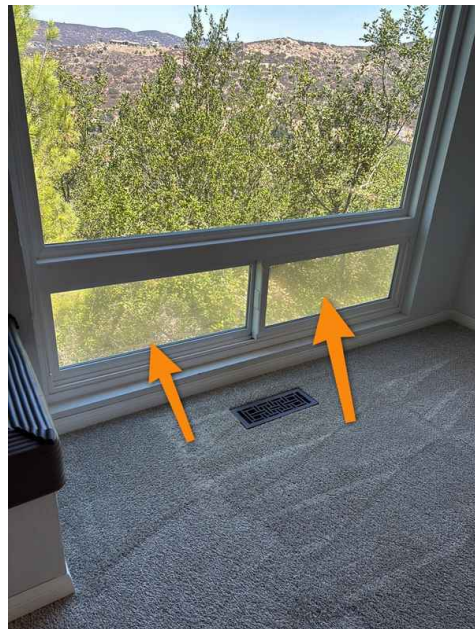
**FOGGED WINDOWS**

Fogged window(s) noted. This is indicative of failed hermetic seals. This condition will reduce the visibility and thermal efficiency of the affected windows. Recommend further evaluation of all windows by a licensed window contractor to determine corrections necessary at this time.

Contact a qualified window repair/installation contractor.

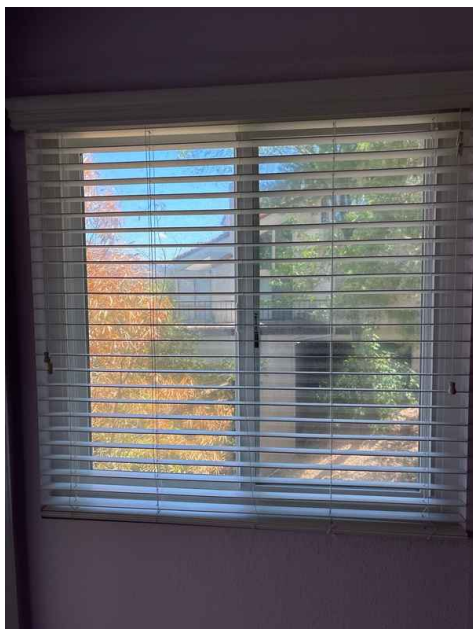
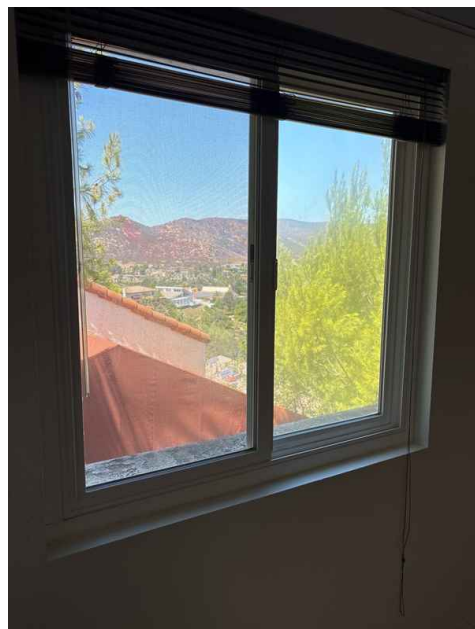
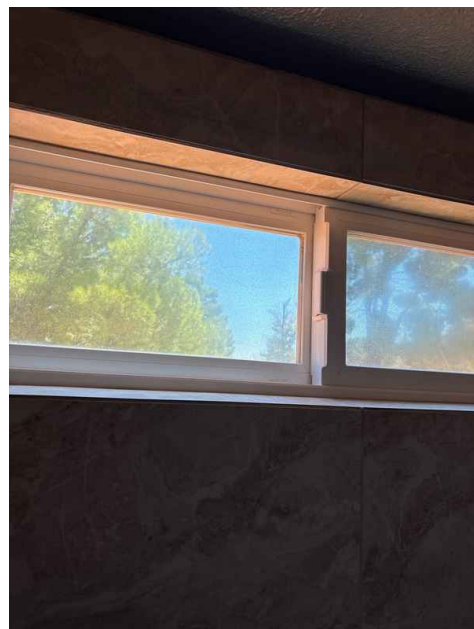
Several of the windows in the home appear to be equipped with a window tint or film. Aging, peeling or damaged tint/film noted in areas. This may be an indication of failing tint or of a possible issue with the window seal. You may wish to view this for yourself and/or have further evaluated and repaired by a licensed window contractor as necessary at this time.

Contact a qualified window repair/installation contractor.

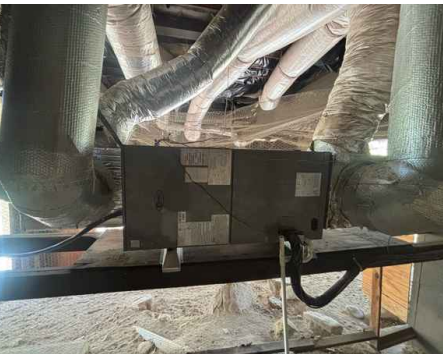
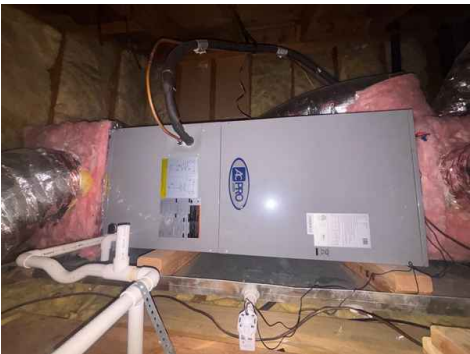
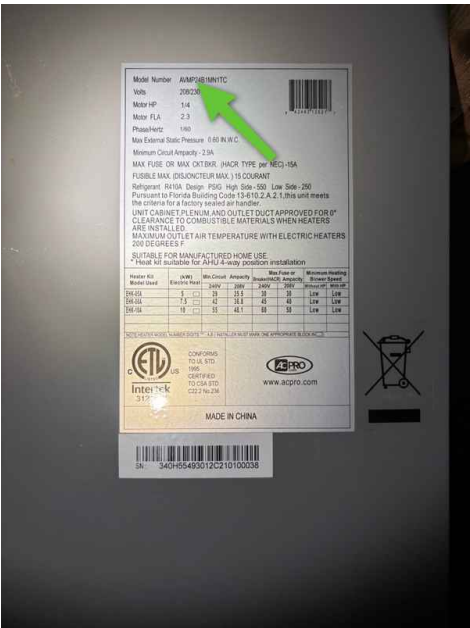
HEATING - EQUIPMENT: Heat Pump / HVAC - Picture

Photo of heat pump

Manufactured 2024

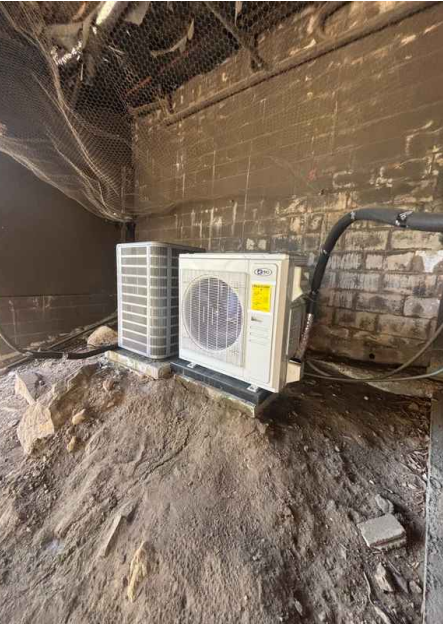
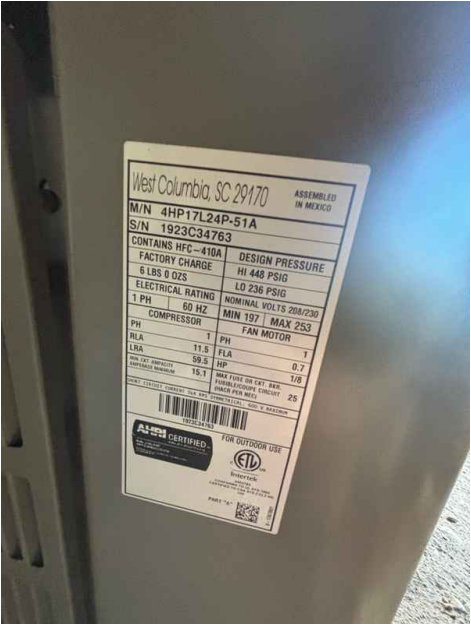
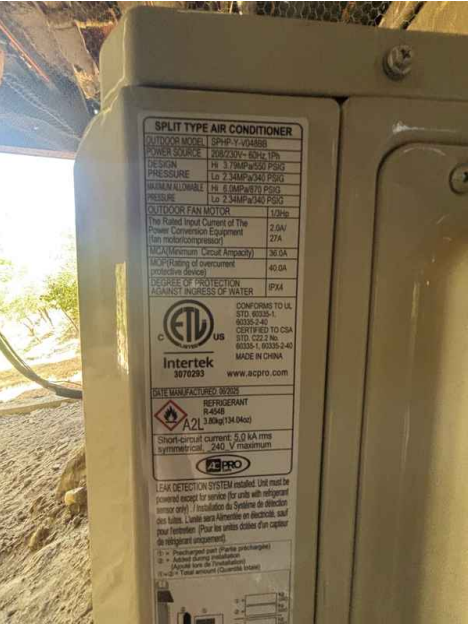
COOLING - EQUIPMENT: AC Condenser (Photo)

Photo of AC condenser
