CITY OF  
**VENTURA**  
CODE ENFORCEMENT

**NOTICE AND ORDER TO REPAIR OR ABATE**

**CASE NO.:** CE-26-1172

**SITE ADDRESS:** 2381 HYLAND AVE, Ventura, CA, 93001

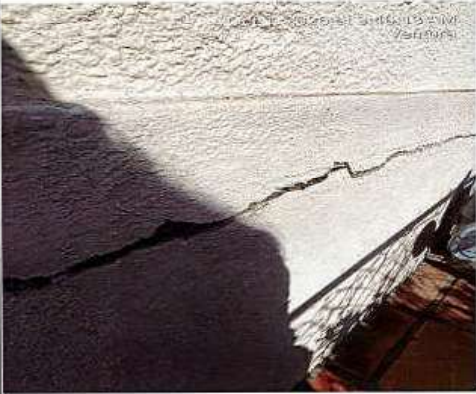
| Photo | Details |
|---|---|
| A close-up photograph of a light-colored stucco wall. A prominent, jagged crack runs diagonally from the upper left towards the center. A dark shadow is cast on the wall to the left of the crack. The photo has a timestamp 'Oct 1, 2026 at 9:40:40 AM' and 'Veritas' in the top right corner. | <p><b>Title:</b> 10/01/26</p> <p><b>Date:</b> Oct 01, 2026 14:19</p> |

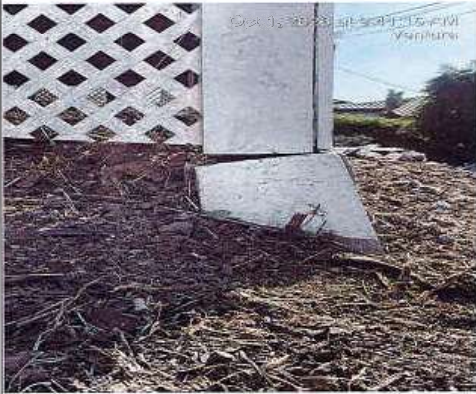
| Photo | Details |
|---|---|
| A photograph showing a concrete block wall and a white plastic lattice fence. The ground in the foreground is covered with dry, brown mulch or straw. The photo has a timestamp 'Oct 1, 2026 at 9:40:40 AM' and 'Veritas' in the top right corner. | <p><b>Title:</b> 10/01/26</p> <p><b>Date:</b> Oct 01, 2026 14:19</p> |

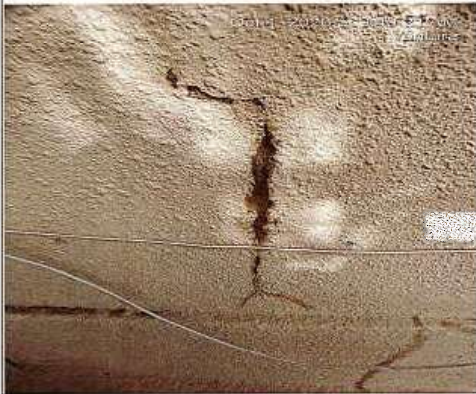
| Photo | Details |
|---|---|
| A close-up photograph of a light-colored stucco wall. A vertical crack runs down the center of the frame. The photo has a timestamp 'Oct 1, 2026 at 9:40:40 AM' and 'Veritas' in the top right corner. | <p><b>Title:</b> 10/01/26</p> <p><b>Date:</b> Oct 01, 2026 14:19</p> |

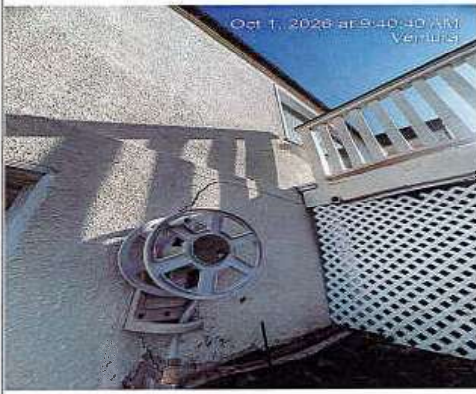
| Photo | Details |
|---|---|
| A photograph of an exterior wall with a white plastic lattice fence. A circular metal object, possibly a wheel or a vent cover, is visible on the wall. The photo has a timestamp 'Oct 1, 2026 at 9:40:40 AM' and 'Veritas' in the top right corner. | <p><b>Title:</b> 10/01/26</p> <p><b>Date:</b> Oct 01, 2026 14:19</p> |
