# JOHN ROBINSON'S INSPECTION GROUP

## RESIDENTIAL INSPECTION

1282 Highbluff Ave  
San Marcos, CA 92078

John Merritt  
APRIL 11, 2022

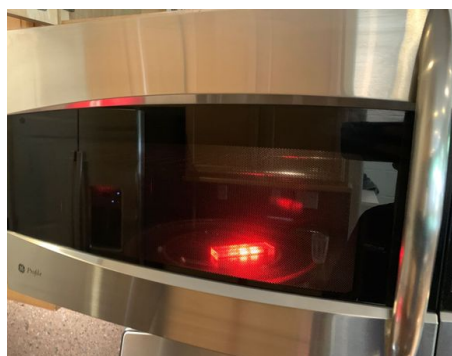
### BUILT-IN MICROWAVE: Picture Showing Microwave Working

The operation of the microwave was tested using a microwave tester. This unit appeared to be functional at the time of the inspection.

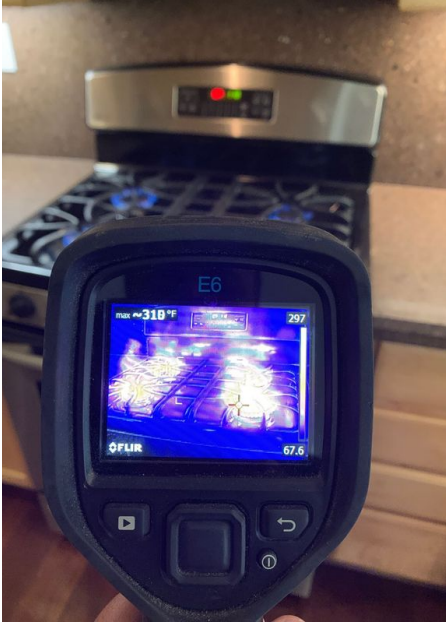
## RANGES AND COOKTOPS: Thermal Image Showing Range Working

Infrared picture of range/cooktop in operation. This unit appeared to be functional at the time of the inspection.

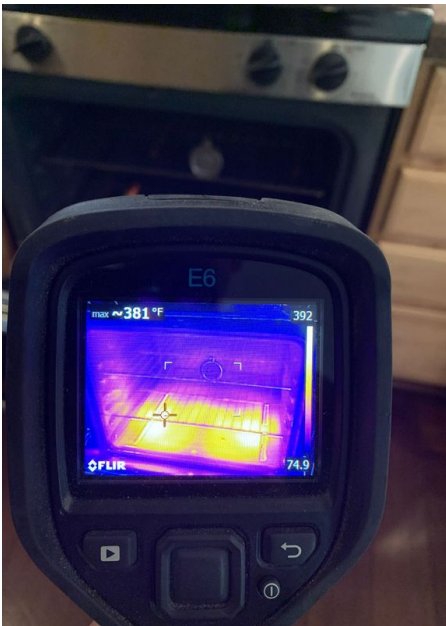
## OVEN: Thermal Image Showing Oven Working

Infrared picture of oven(s) in operation. The unit(s) appeared to be functional at the time of the inspection.

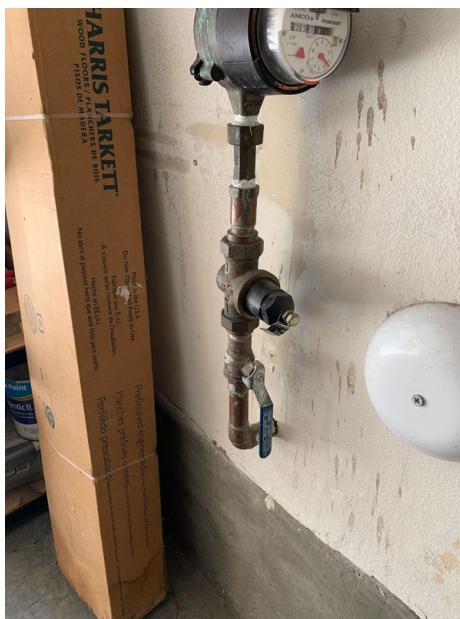
**MAIN WATER SHUT-OFF DEVICE (Describe Location): Main Water Shut-Off Location In the Garage**

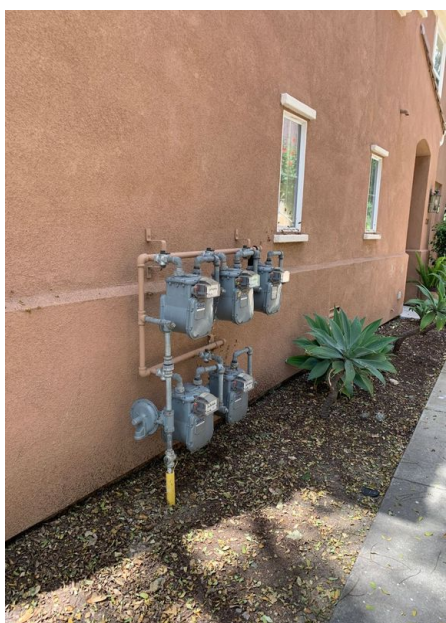
**MAIN GAS SHUT OFF VALVE (Describe Location): Main Gas Shut-Off Location Common area**

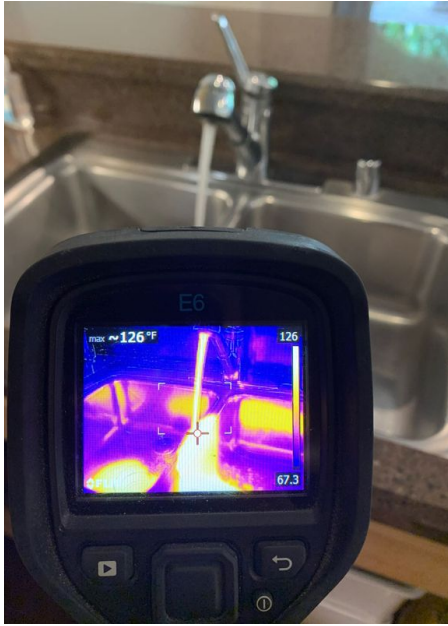
## WATER HEATERS, CONTROLS, FLUES AND VENTS: Thermal Image of Hot Water

Thermal image(s) showing the water heater(s) producing hot water at the time of the inspection.

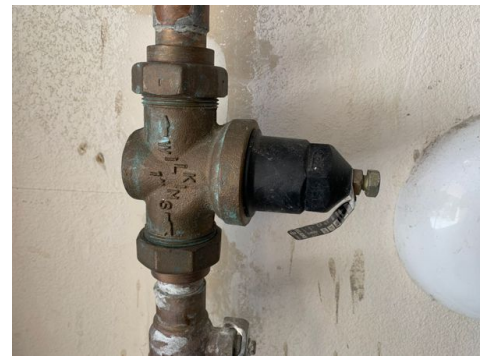
**PRESSURE REGULATOR: Picture of Pressure Regulator**

Picture of water pressure regulator. Adjustments to your water pressure can be made here. Recommend water pressure for residential properties is 40-80 PSI.

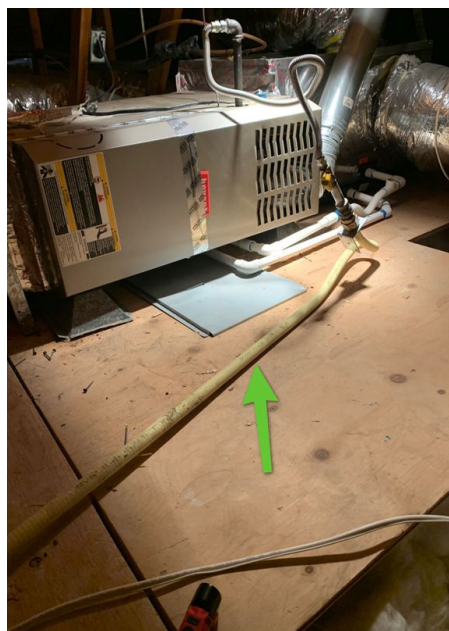
Example Noted at Attic

**GAS STORAGE AND DISTRIBUTION SYSTEMS (Interior Fuel Storage, Piping, Venting, Supports, Leaks): CSST Lines**

CSST gas lines were observed at one or more areas. This type of material has specific installation requirements that we are unable to fully verify due to framing members, insulation, wall/floor coverings, and/or other obstructions. Recommend inquiring with sellers for work receipts to verify if the work was done in accordance with today's plumbing standards by a licensed plumbing contractor.

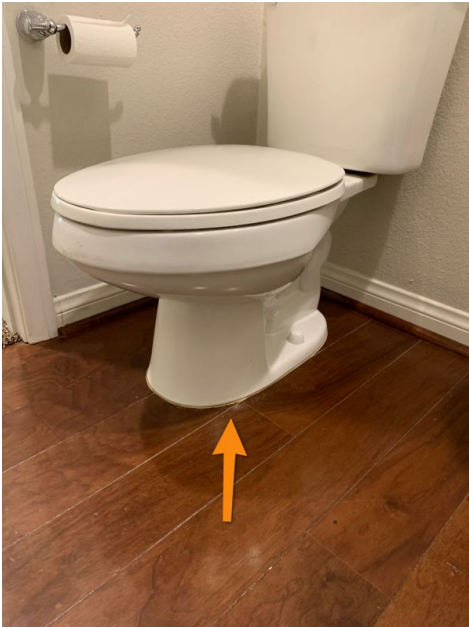
Example Noted at Half Bathroom

### **TOILET CAULKED TO FLOOR**

One or more toilets was noted fully caulked or grouted to the floor. This condition prevents early detection of failed wax rings and leaks at the base. Caulking the base of the toilet is cosmetic only. We recommend further evaluation by licensed plumbing contractor before the removal of contingencies to determine if any latent defects exist.

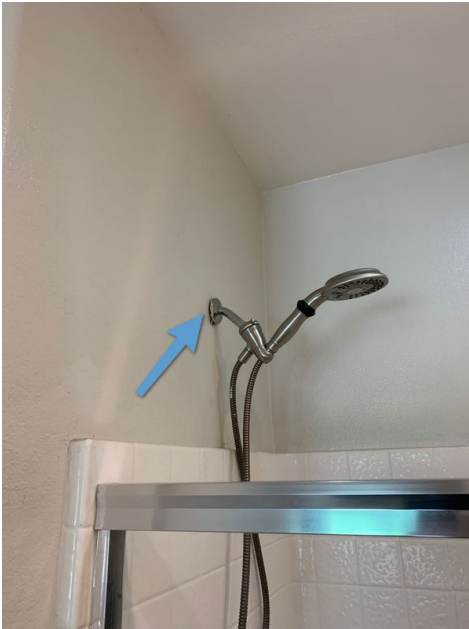
Example Noted at Master Bathroom

3.4.1 Plumbing System - TUB/SHOWER FIXTURES: Shower Head - Loose Backing Plate
-

3.4.1 TUB/SHOWER FIXTURES

Contact a qualified plumbing contractor.

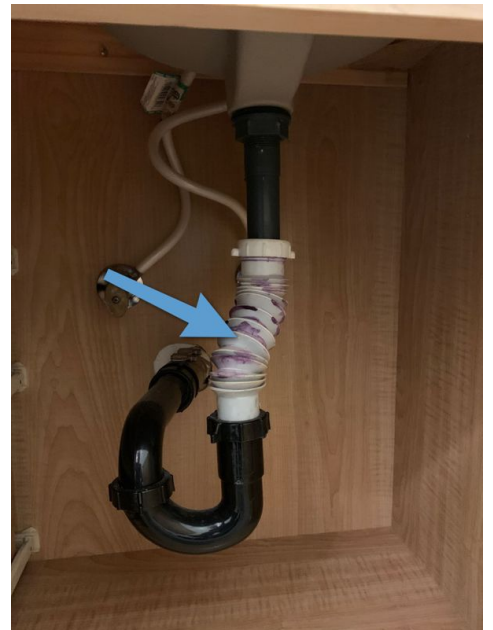
Example Noted at Master Bathroom

### 3.6.1 PLUMBING DRAIN, WASTE AND VENT SYSTEMS

Contact a qualified plumbing contractor.

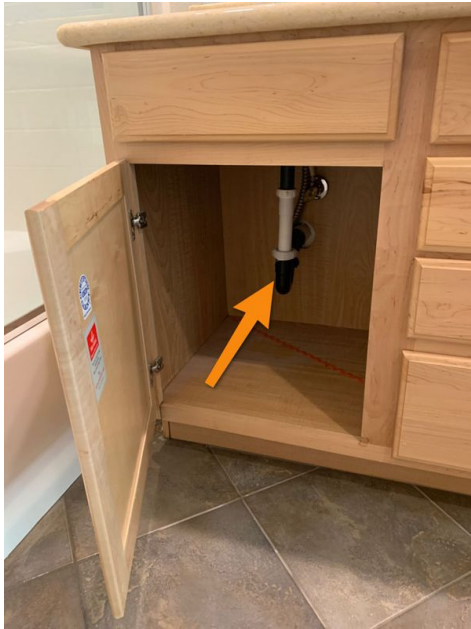
Example Noted at Master Bathroom

### 3.6.2 PLUMBING DRAIN, WASTE AND VENT SYSTEMS

Contact a qualified plumbing contractor.

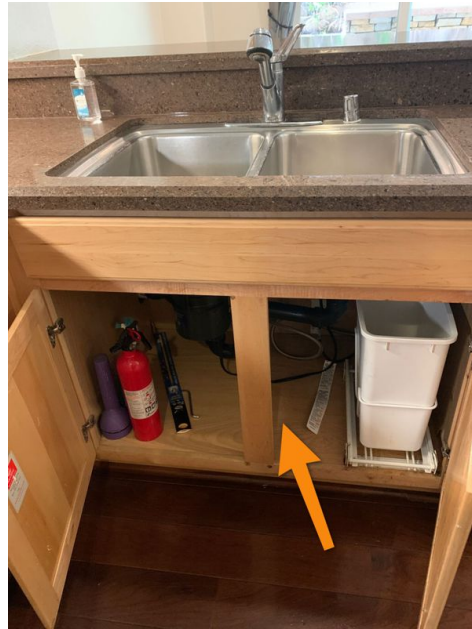
Example Noted at Kitchen

3.6.2 Plumbing System - PLUMBING DRAIN, WASTE AND VENT SYSTEMS: Active Leak - Sink Drain
-

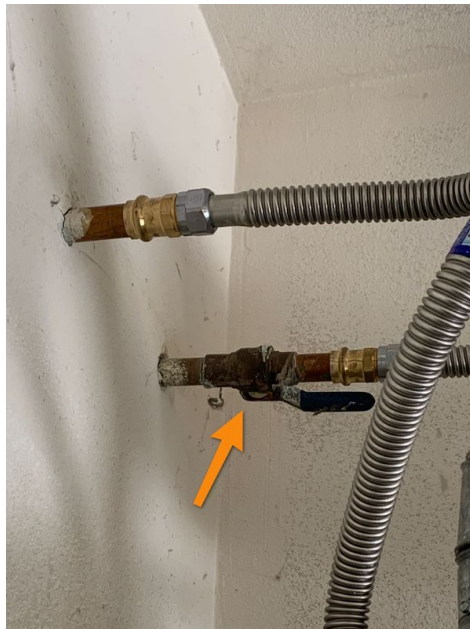
Example Noted at Water Heater

3.7.4 Plumbing System - WATER HEATERS, CONTROLS, FLUES AND VENTS: Plumbing - Shut-Off Corrosion
-

### 3.7.4 WATER HEATERS, CONTROLS, FLUES AND VENTS

Contact a qualified plumbing contractor.

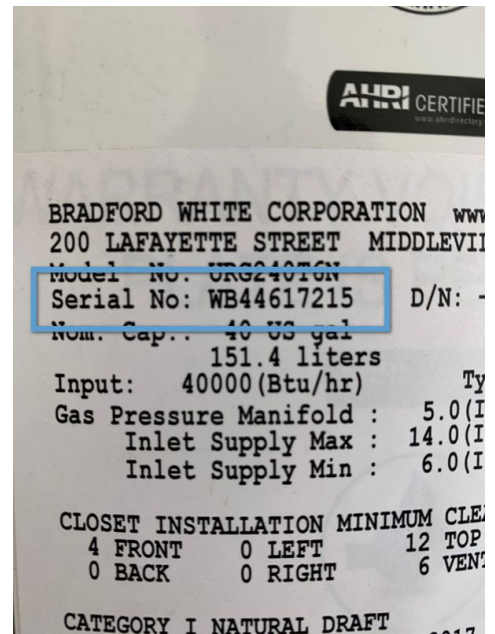
Example Noted at Water Heater

3.7.5 Plumbing System - WATER HEATERS, CONTROLS, FLUES AND VENTS: Water Heater - Replaced

3.7.5 WATER HEATERS, CONTROLS, FLUES AND VENTS

Contact a qualified plumbing contractor.

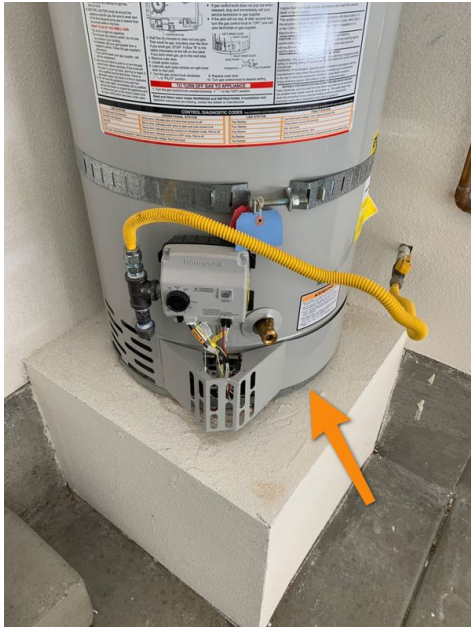
Example Noted at Water Heater

3.7.6 Plumbing System - WATER HEATERS, CONTROLS, FLUES AND VENTS: Leak Pan - Missing
-

3.7.6 WATER HEATERS, CONTROLS, FLUES AND VENTS

Contact a qualified plumbing contractor.

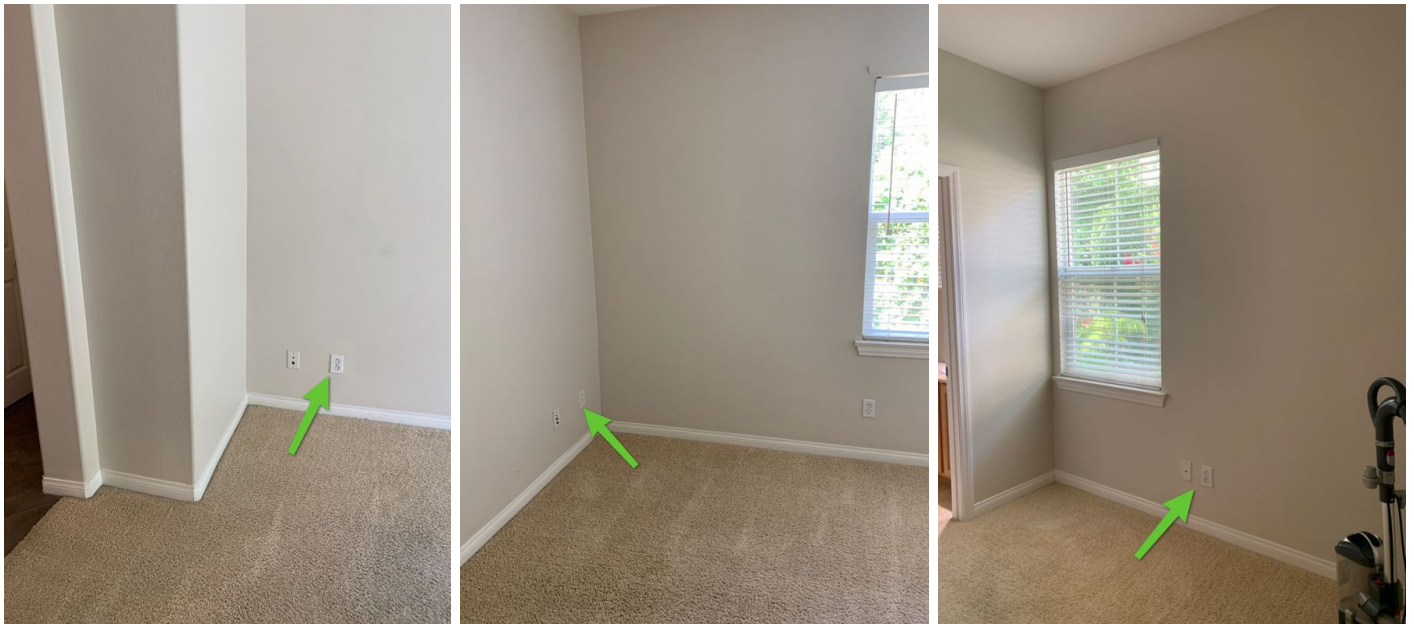
Example Noted at Master Bedroom

**FIXTURES AND CONNECTED DEVICES (Observed from a representative number operation of ceiling fans, lighting fixtures, switches and receptacles located inside the house, garage, and on the dwelling's exterior walls): Split Circuit/Half Hot Noted**

For your convenience, we have noted the location of the split circuit/half hot used for lighting in one or more rooms.

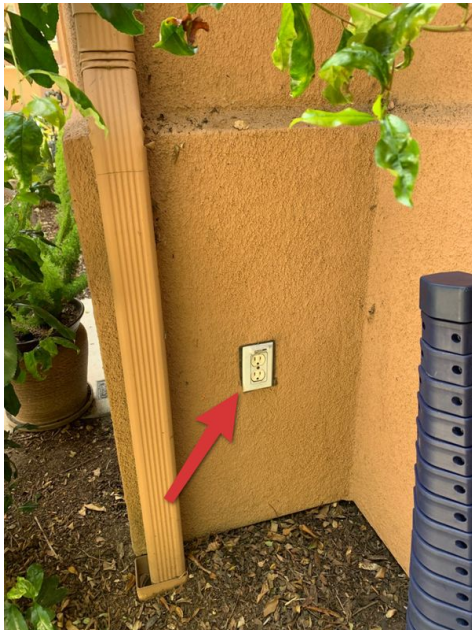
Example Noted at front door

4.8.2 Electrical System - FIXTURES AND CONNECTED DEVICES (Observed from a representative number operation of ceiling fans, lighting fixtures, switches and receptacles located inside the house, garage, and on the dwelling's exterior walls): Weatherproof Cover - Missing/Inadequate

4.8.2 FIXTURES AND CONNECTED DEVICES (Observed from a representative number of operation of ceiling fans, lighting fixtures, switches and receptacles located inside the house, garage, and on the dwelling's exterior walls)

Contact a handyman or DIY project

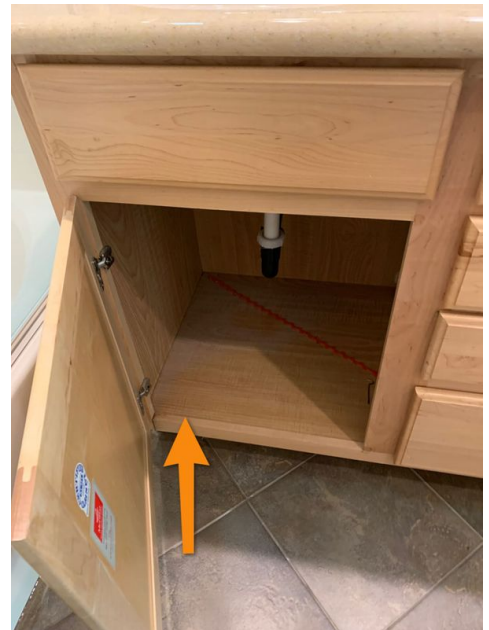
Example Noted at Master Bathroom

5.6.1 Interiors - COUNTERS AND A REPRESENTATIVE NUMBER OF CABINETS: Cabinet - Moisture Damage Below Sink

5.6.1 COUNTERTOPS AND A REPRESENTATIVE NUMBER OF CABINETS

Contact a qualified professional.

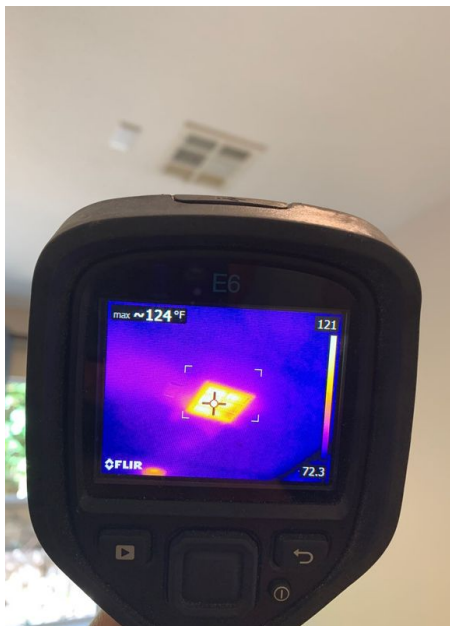
### HEATING EQUIPMENT: Thermal Image Showing Furnace Working

Infrared picture of the furnace(s) in operation. The unit(s) appeared to turn on and produce heat at time of inspection. For your reference, we have attached a thermal image to confirm operation. However, due to the many components that are not visible (like the heat exchanger and the entire length of the flue pipe), our inspection of the system(s) is limited. If you have any concerns, we recommend further evaluation/safety check be performed by a licensed HVAC contractor or the local gas company before the removal of contingencies.

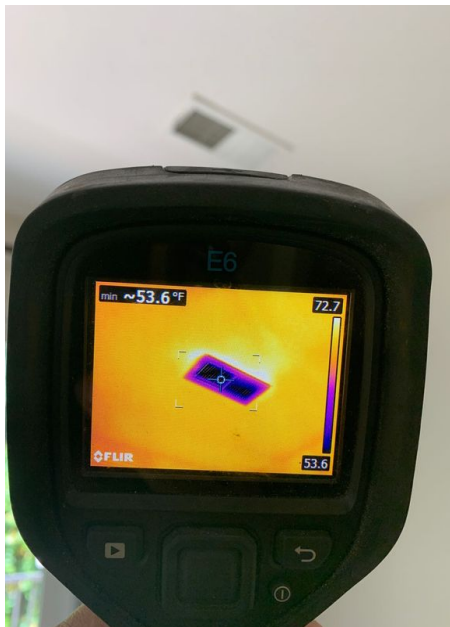
### COOLING AND AIR HANDLER EQUIPMENT: Thermal Image Showing AC Working

Infrared picture of air conditioning unit(s) in operation. During the test of this homes air conditioning system a minimum split of 14 degrees was achieved between the ambient air temperature and the temperature of the air blowing out of the registers. Because of this, the unit(s) appeared to be functional. However, this is a limited review. If you have any concerns about the internal components or any latent defects, you should consider having the unit(s) further explored by a licensed HVAC contractor.
