CARLSBAD PROPERTY INSPECTIONS REPORT

1345 Green Canyon Rd
Fallbrook, CA 92028

Heidi Nelson
06/03/2025

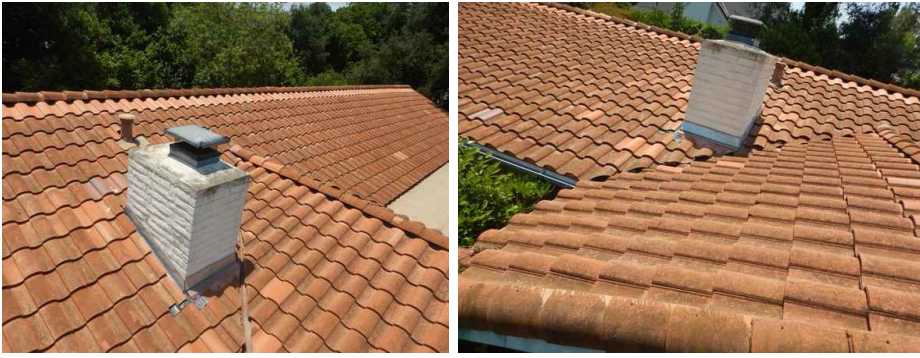
Roof - multiple locations

**Coverings: Evidence of repairs**

I observed evidence of repairs to roof coverings at one or more areas. Monitor this area (inside dwelling) to ensure repairs were adequately performed.

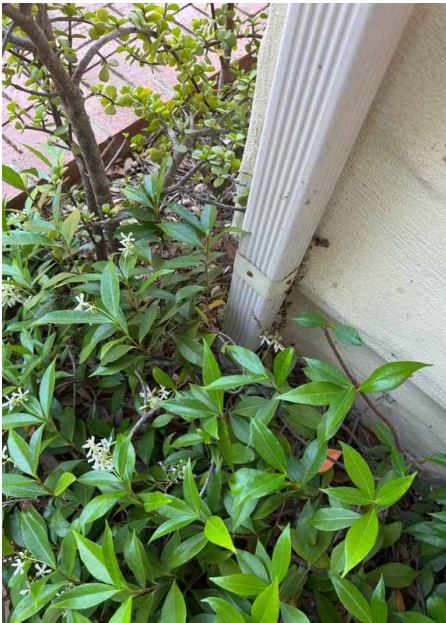
Northwest

One or more downspouts drain too close to the home's foundation. This can result in excessive moisture in the soil at the foundation, which can lead to foundation/structural movement. Recommend adjusting or adding downspout extensions to all downspouts so that water drains 3-6 feet from the foundation.

Recommendation
Contact a handyman or DIY project

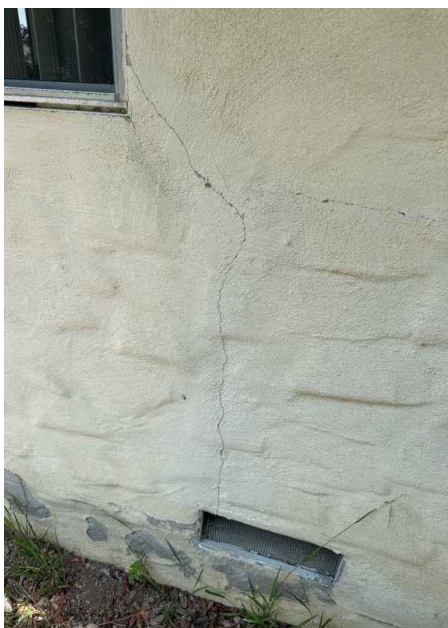
South

Stucco, Flashing, & Trim: Small cracks/chips/holes

Small cracks/chipped areas/holes were present in areas - These may be covered with stucco patch - recommend stucco service/maintenance

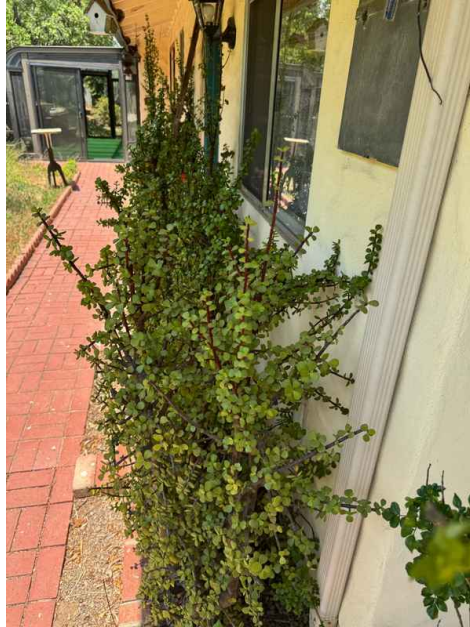
South

3.3.1 Stucco, Flashing, & Trim

The color coat (top-most layer of stucco) was deteriorated near the grade due to moisture - if gutters are not installed, the Inspector recommends adding gutters and drainage to help keep moisture away from the structure - all work should be performed by a qualified contractor

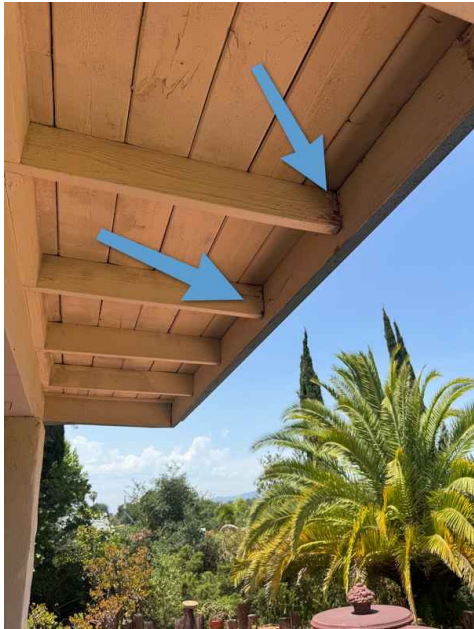
North

DETERIORATED WOOD

Deteriorated wood was observed in one or more locations, typical of that caused by moisture and/or wood-destroying insects. Identification of infestation by wood destroying insects lies beyond the scope of this inspection. The Inspector recommends an inspection and any necessary work be performed by a qualified pest control contractor

Recommendation

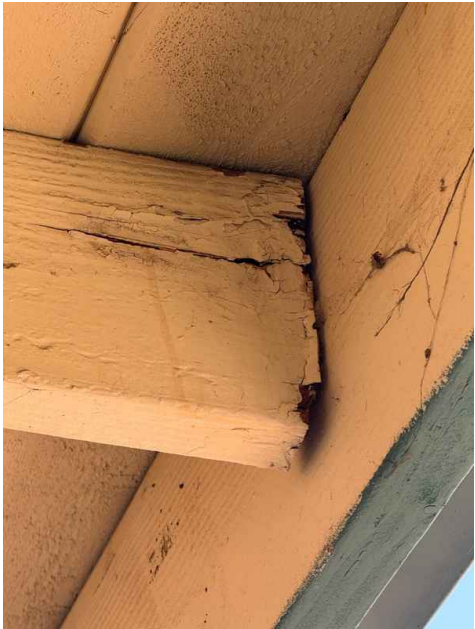
Zoomed

3.5.1 Eaves, Soffits,& Fascia

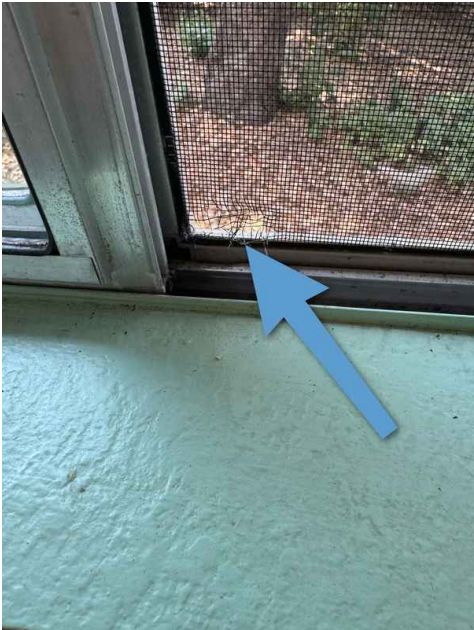
West

DAMAGED WINDOW SCREEN

I observed one or more damaged window screen(s). Recommend repair.

Recommendation

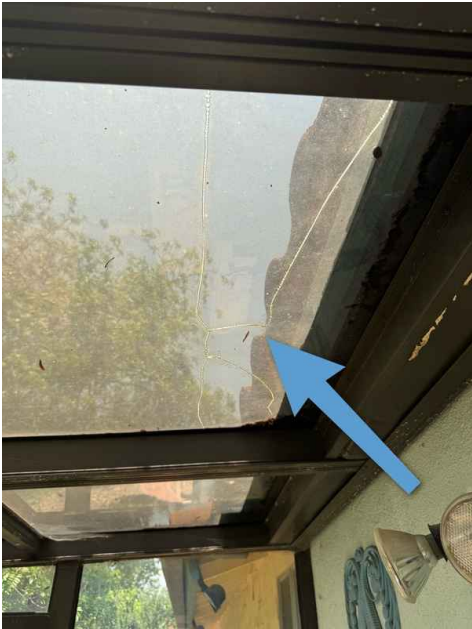
CRACKED GLASS

The glass or plexiglass was cracked in one or more locations at the sunroom. Recommend repair.

Recommendation

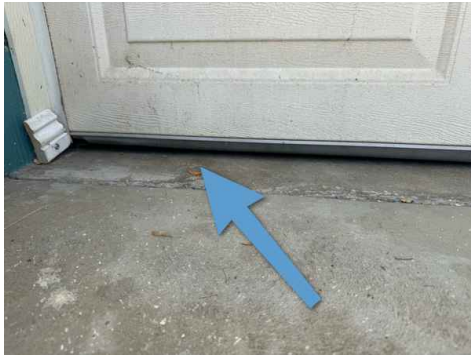
I observed gaps at the garage door and trim when garage door is closed. Recommend adjusting garage door travel and/or sealing to prevent moisture and pest intrusion.

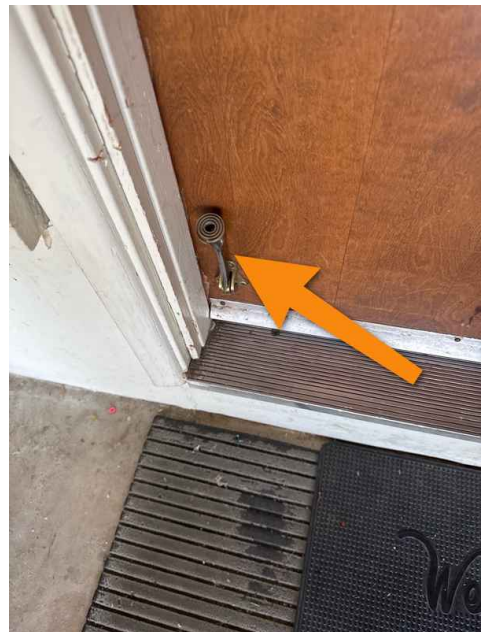
DOOR HOLDER

The fire door was equipped with a door holder - door holders are not allowed on fire doors, as they may prevent proper self-closure of the fire door - recommend removal of the door holder for improved safety

Recommendation

Contact a qualified professional.

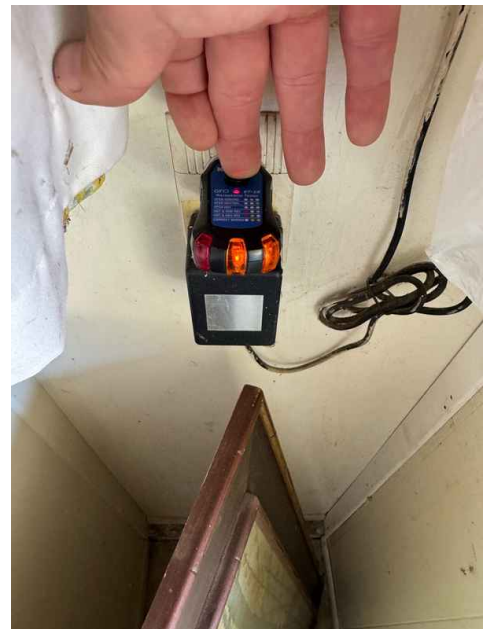
There were no GFCIs visible at the time of the inspection - recommend upgrade for increased safety - all work should be performed by a qualified electrical contractor

Recommendation

Contact a qualified electrical contractor.

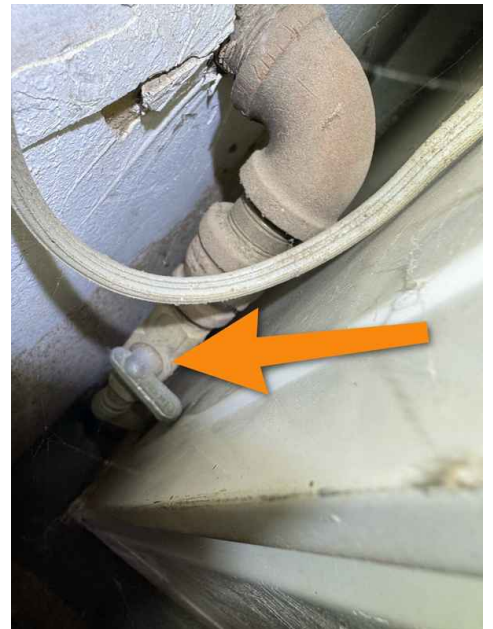
GAS NOT ON

Unable to test furnace at time of inspection. Gas to the furnace was not turned on preventing evaluation of the unit. Recommend a qualified professional evaluate furnace once gas is turned on.

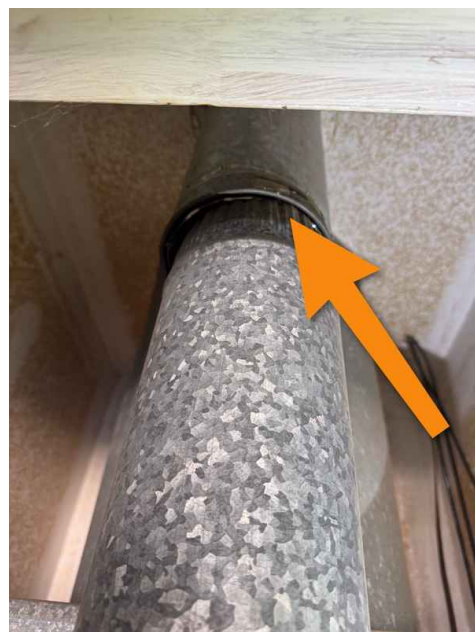
Loose connection

FLUE VENT CONNECTIONS LOOSE OR INADEQUATE

Contact a qualified professional.

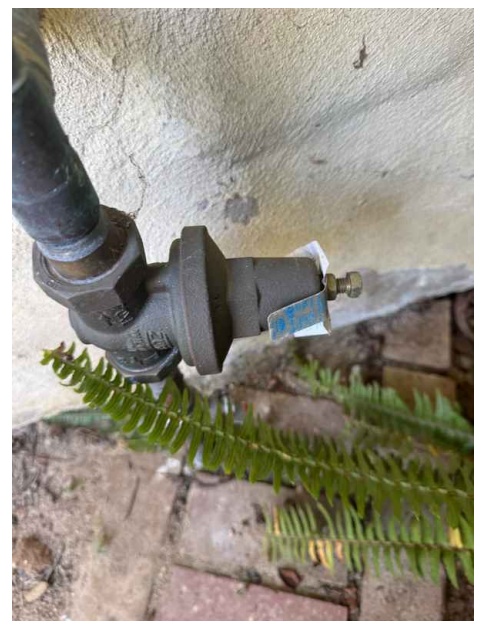
Main Valve

Water Pressure Regulator: Pressure Regulator Location

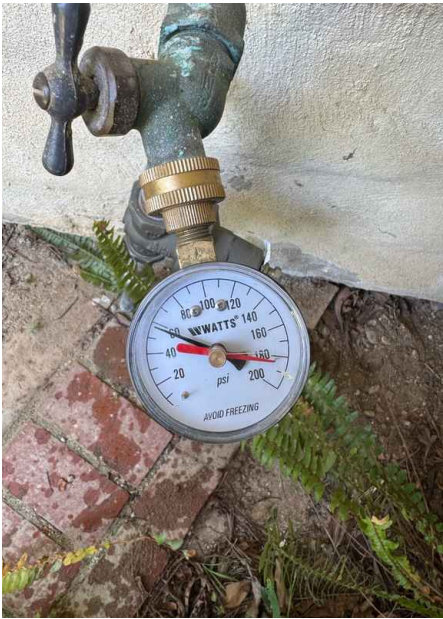
Water Pressure: Pounds per square inch:
58

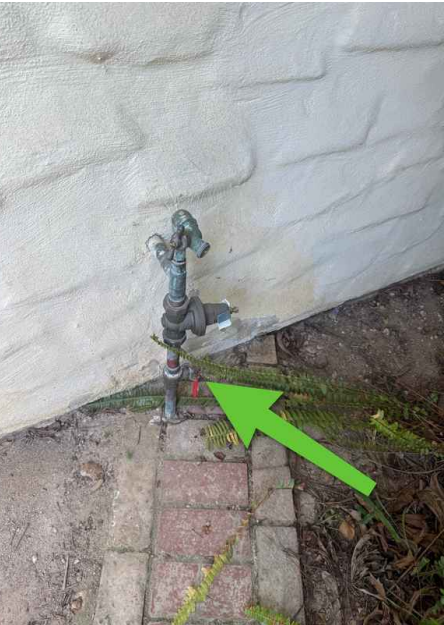
Northeast

Note: In addition to the main water shutoff at the residence, a water shutoff (valve) is frequently located at the water meter and can be used in the case of a water emergency/plumbing leak requiring water shutoff.

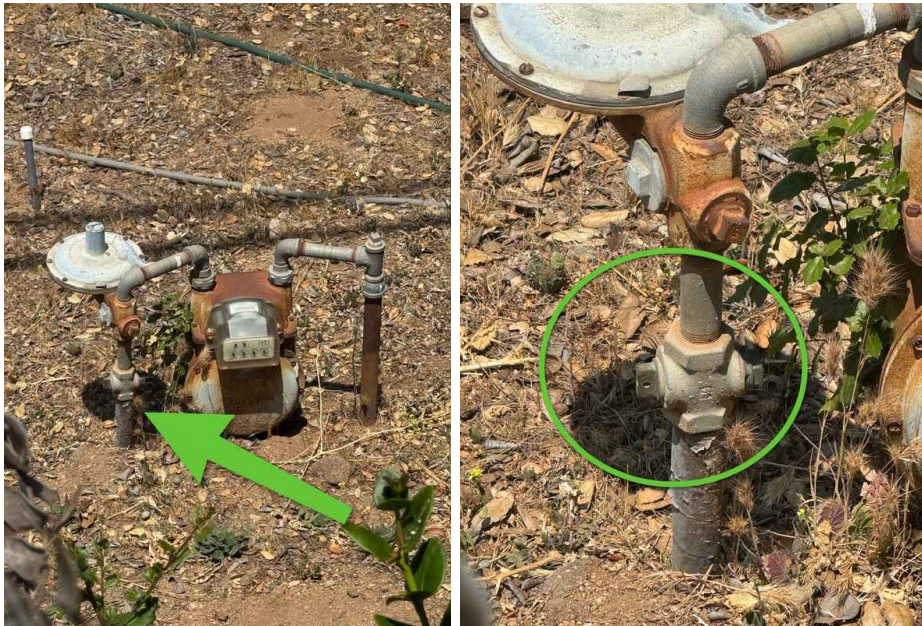
@ Gas Meter, North

Main Fuel Shutoff Location

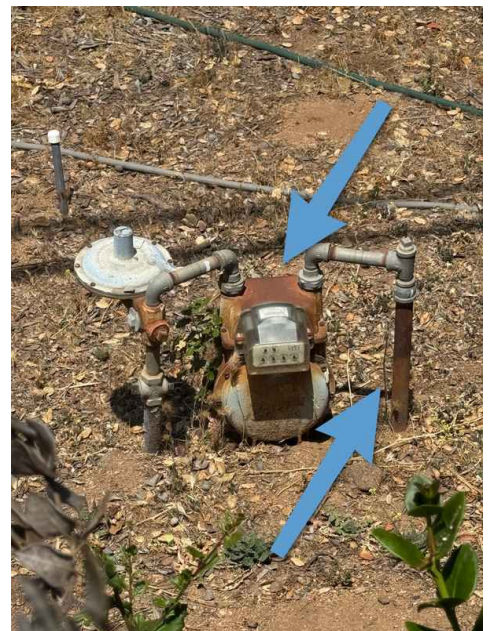
Gas meter North

GAS METER

Gas pipes were corroded at gas meter. This can lead to gas leaks. Recommend contacting local utility company for evaluation and/or repair.

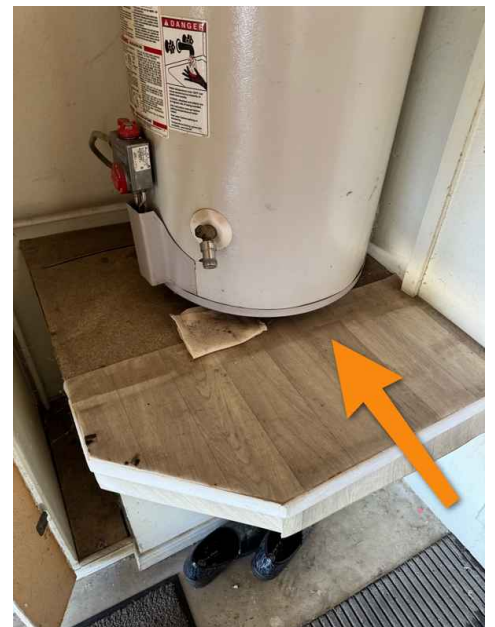
Recommendation/Major defect**NO DRIP PAN**

No drip pan was present. Recommend installation of drip pan and appropriate drain line by a qualified plumber.

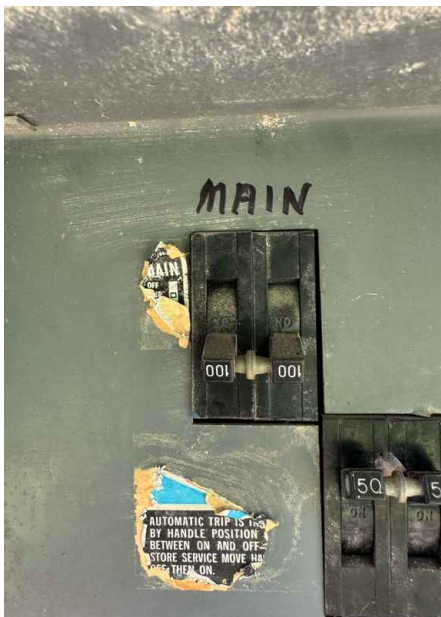
100 Amp

Electrical Service Disconnect:
Service Disconnect Amperage & Location

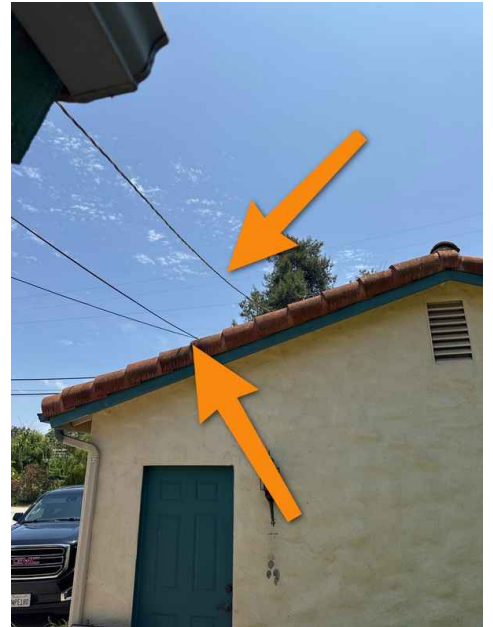
Wires resting on roof of detached garage

Recommendation

Contact your local utility company

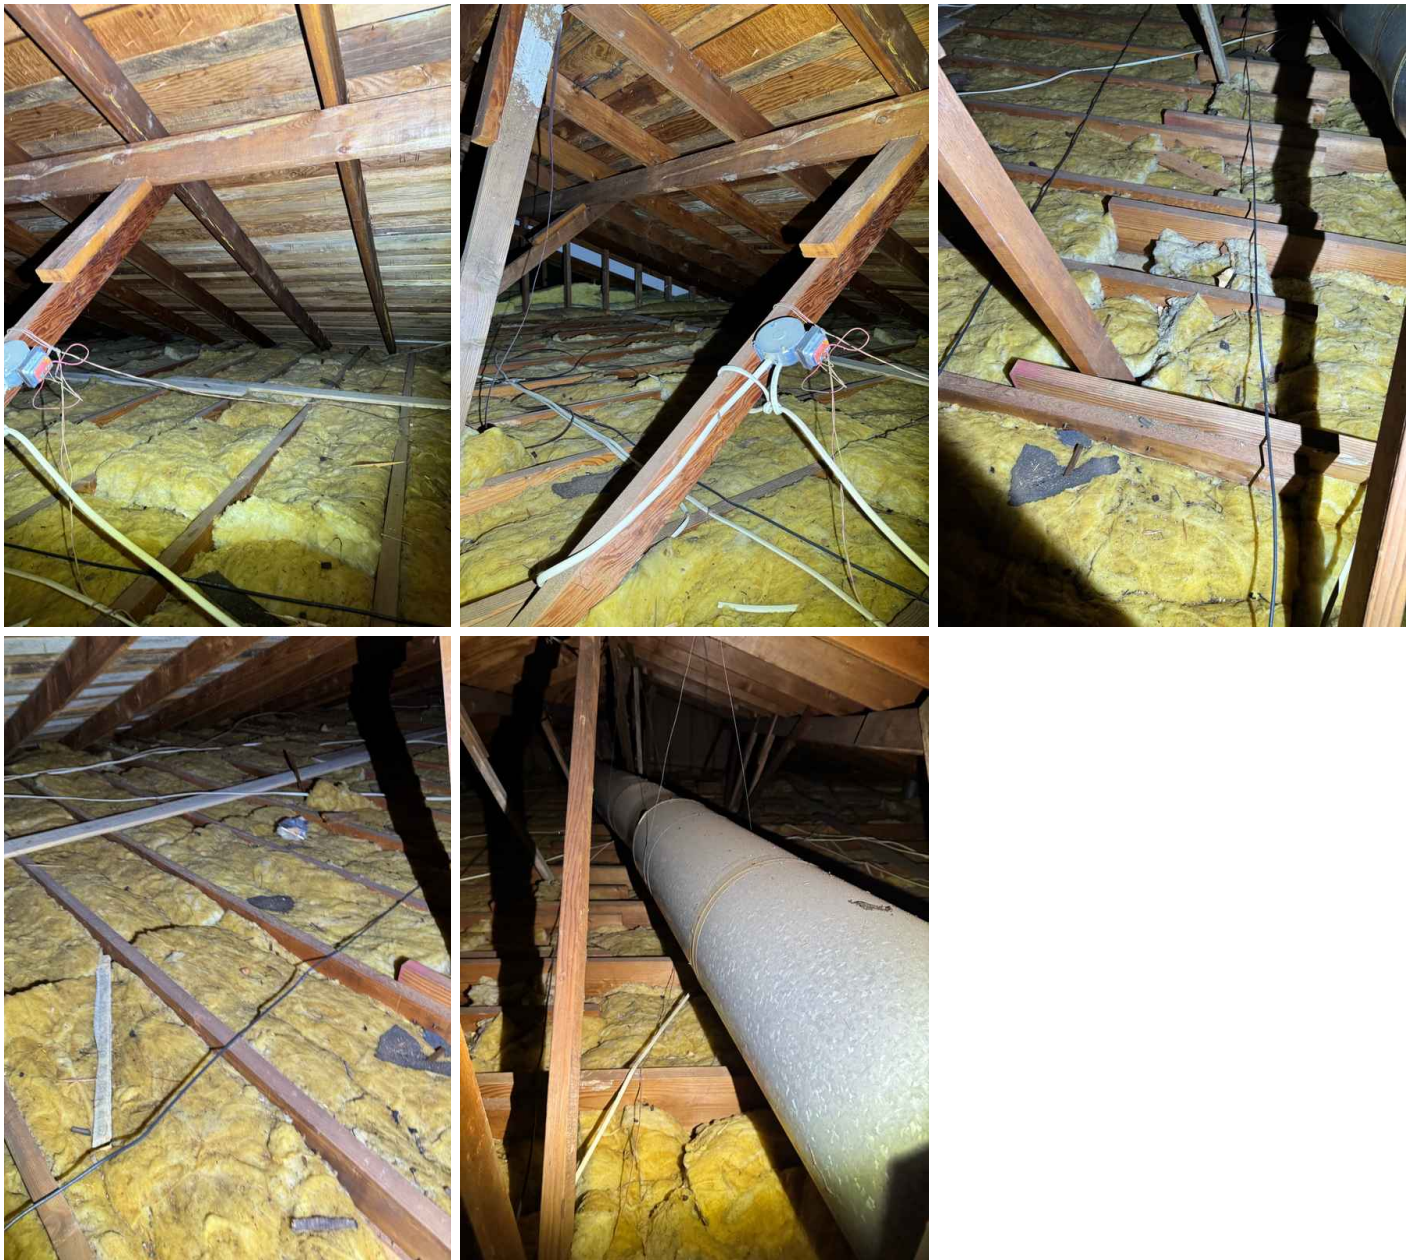
Attic Insulation: Avg Insulation 4 inches / R-Value 13

I observed the average insulation depth to be approximately 4 inches in the attic which gives an approximate R-value of 13. For reference, the recommended R-value for San Diego is 38

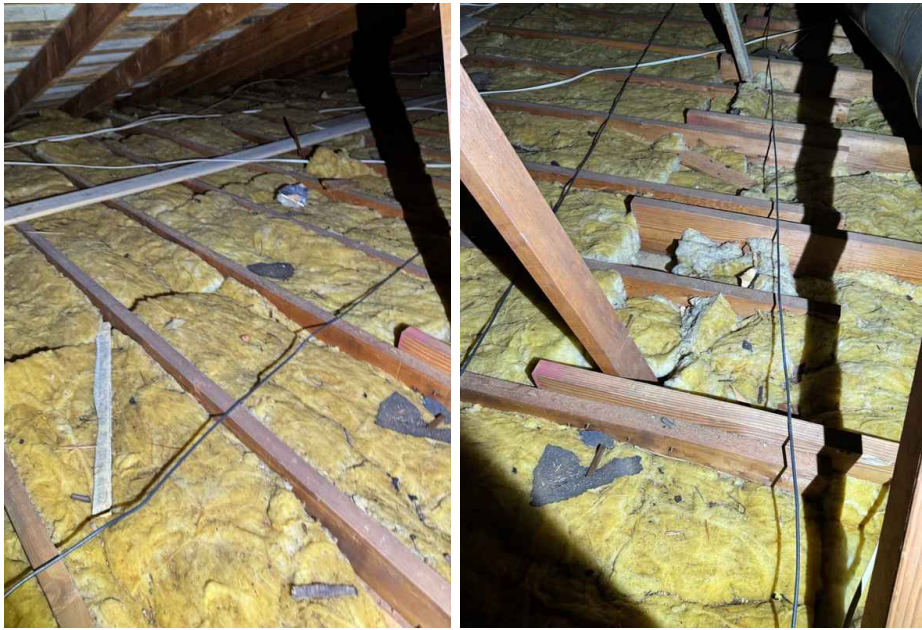
Attic

See pictures for examples of insulation levels in the attic observed

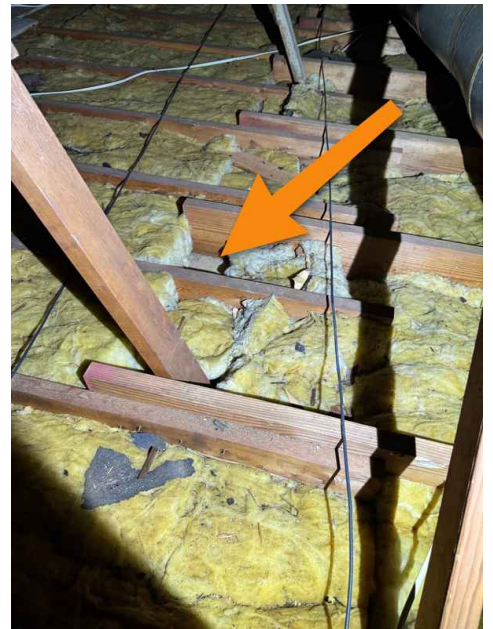
Insulation depth was inadequate and not evenly distributed. Current insulation has also settled below ceiling joists in areas. This allows heat to be transferred by conduction. Recommend adding insulation sufficient to cover ceiling joists to improve efficiency at home.

Contact a qualified insulation contractor.

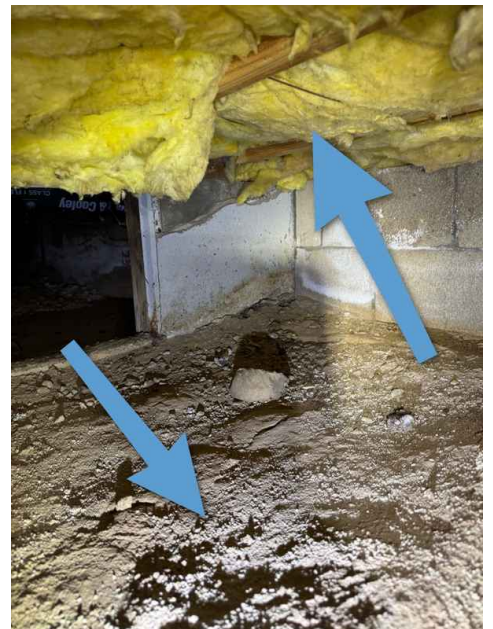
11.2.1 Vapor Retarders (Crawlspace or Basement)

There is no vapor barrier beneath the flooring or rodent barrier covering the underfloor insulation. This can result in unwanted moisture and deterioration of insulation. While many homes do not use vapor barriers in crawlspaces, I do recommend one be installed.

Contact a qualified professional.

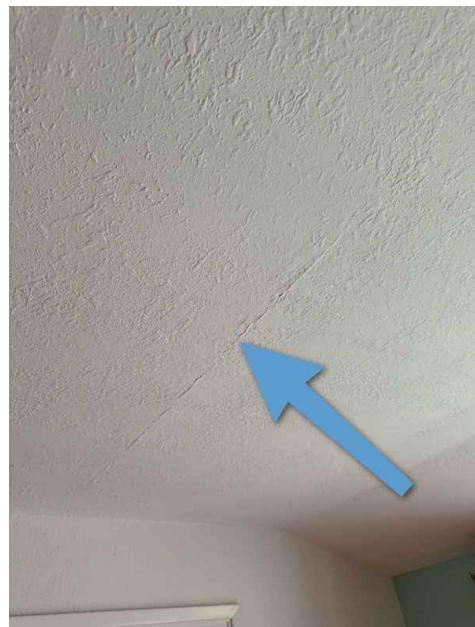
Middle bedroom

Minor cracks, damage or deterioration to the ceiling were visible at the time of the inspection. This appears to be from minor settling and/or expansion and contraction from humidity changes.

Recommend monitoring.

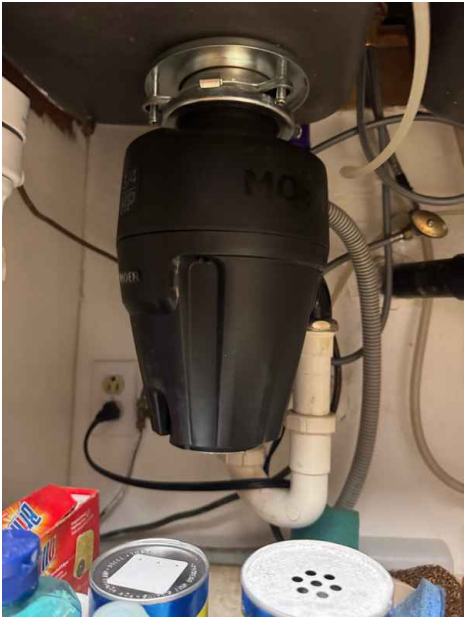
Garbage Disposal: Switch location
hidden
Left of sink

Garbage Disposal: Operated
The garbage disposal operated
at time of inspection

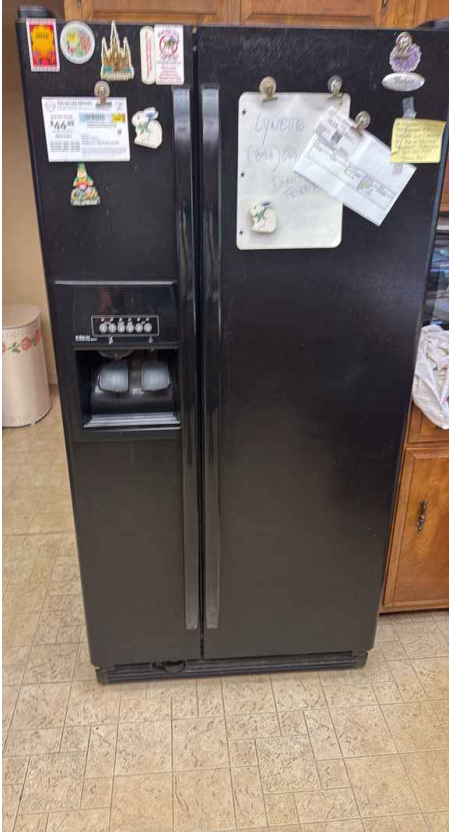
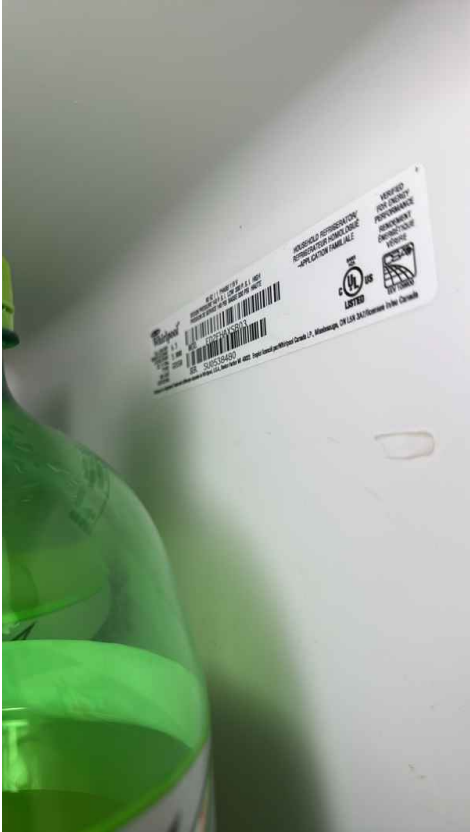
Refrigerator: Brand
Whirlpool

Refrigerator: Ice / Water dispenser present - not tested

An ice and water dispenser are present at the refrigerator. These were not tested as it is beyond the scope of the inspection.

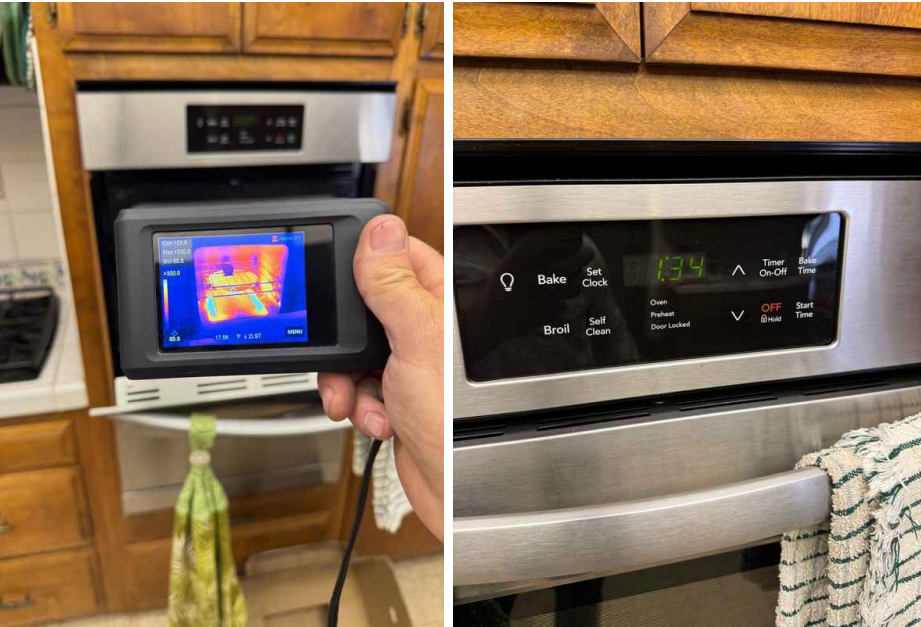
Ovens: Operated

The oven bake feature was tested via normal controls and found to be operational at the time of the inspection. The oven was turned off after inspection.

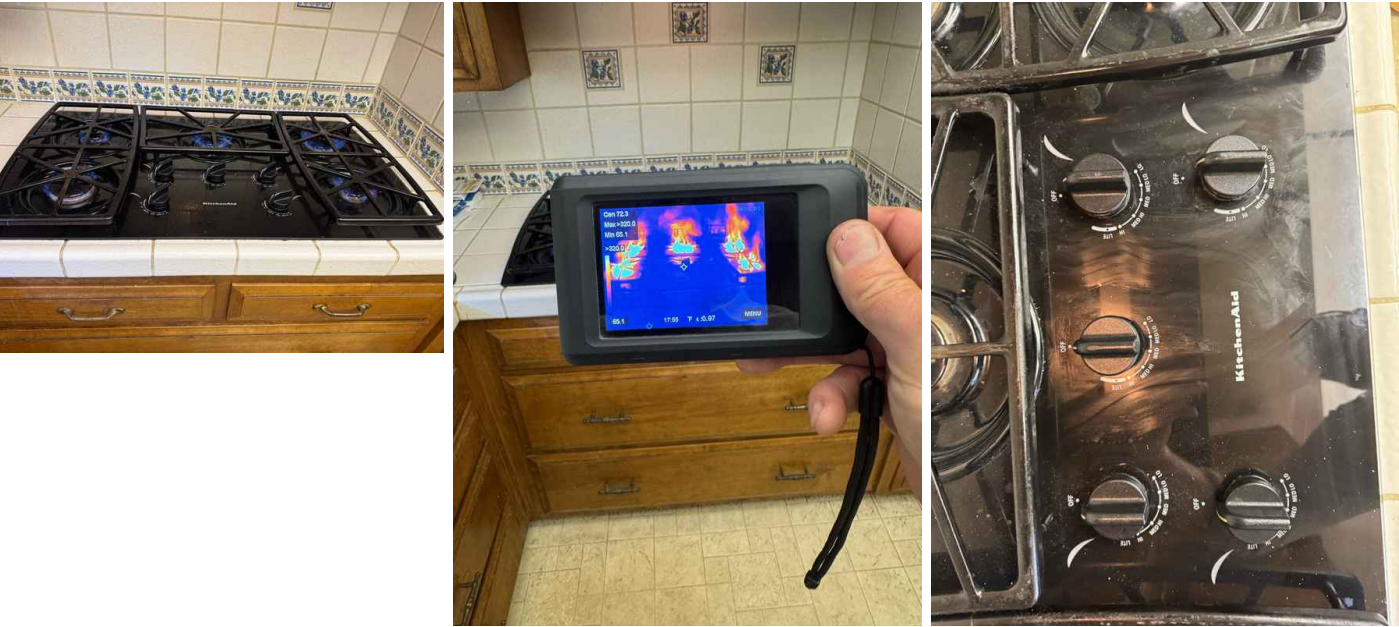
Cooktop: Operated

The cooktop was tested and was found to be operational at time of inspection via normal controls. The cooktop was turned off after inspection.
