INSPECTION REPORT 45330 Cielito Indian Wells CA 92210

INSPECTED BY Dan Williams HSH Inspections Inc. DBA Home Sweet Home Inspections

INSPECTION DATE 8/20/2022 08:00 AM

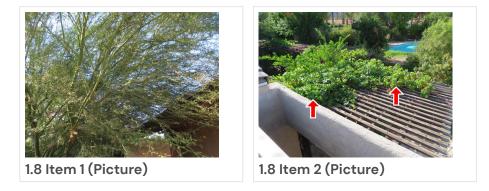
All trees and vegetation should be cut away from the roof line to prevent debris accumulation, roof damage and possible vermin access to roof.

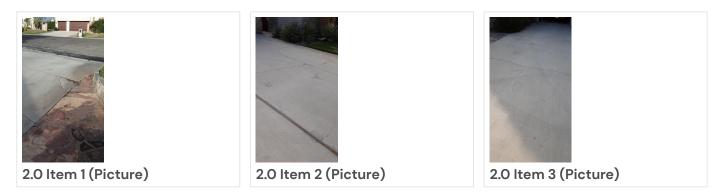
(1) Driveway cracking and staining noted. Recommend evaluation/repair as desired.

(2) Driveways that have settled or lifted more than one fourth of an inch may create a trip hazard and should be evaluated/repaired as necessary.

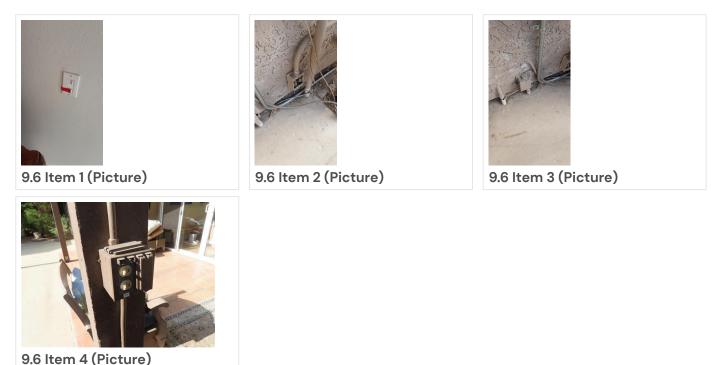
(1) Receptacles/switches are loose and/or missing covers. Recommend all loose or missing covers be repaired/replaced as necessary by electrician.
