## HOME INSPECTION REPORT (CONDO)

2909 Cowley Way Unit F  
San Diego, CA 92117

Emmet Gormican  
MAY 17, 2023

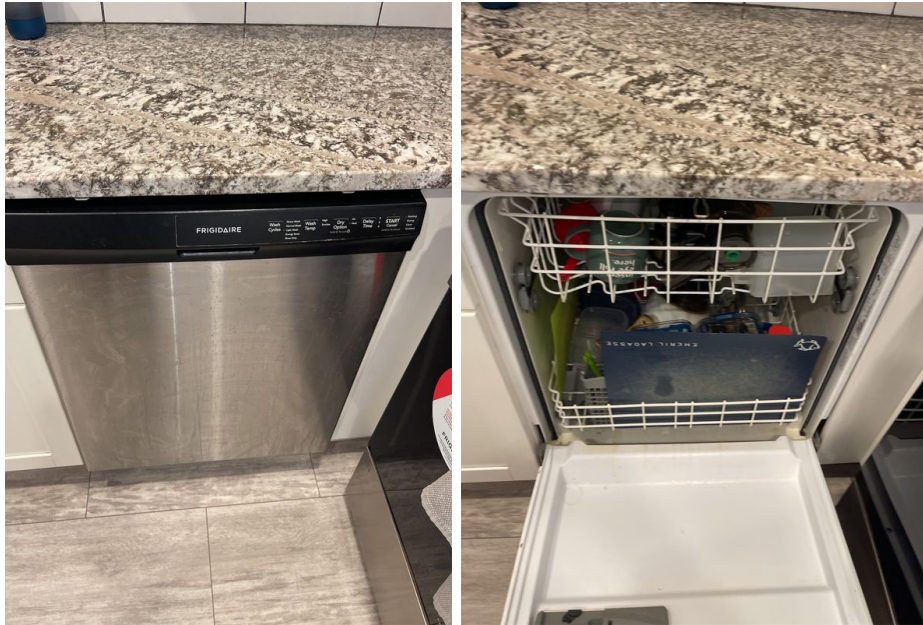
The dishwasher was tested and functioned properly at the time of the inspection. This is not an exhaustive test and does not verify the cleaning efficiency of the dishwasher. Notable exceptions will be listed below.

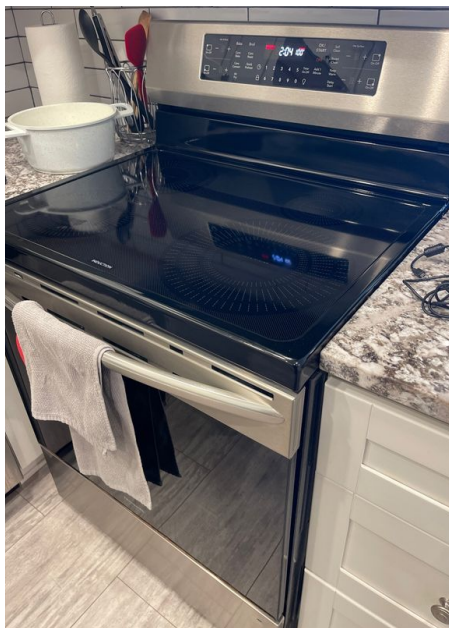
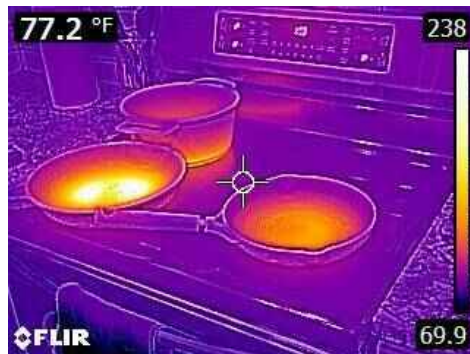
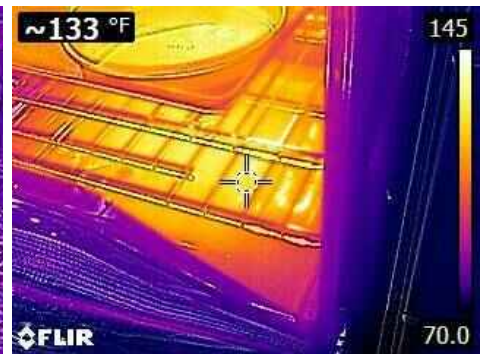
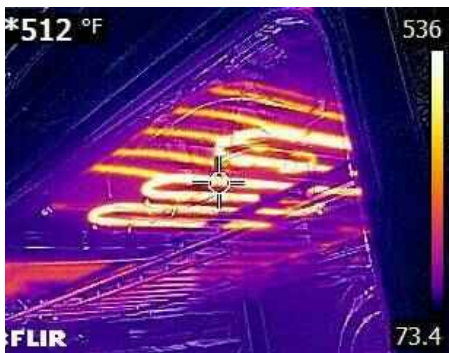
### RANGES/COOKTOP: Range - INSPECTED

The range was tested and was functional at time of the inspection. This test is not exhaustive and does not confirm the performance, accuracy, or effectiveness of the range.

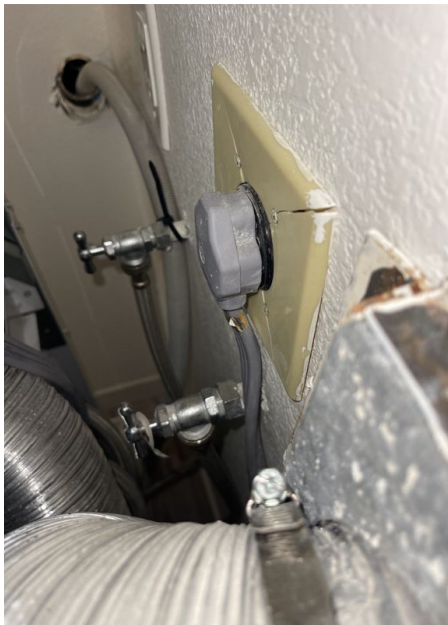
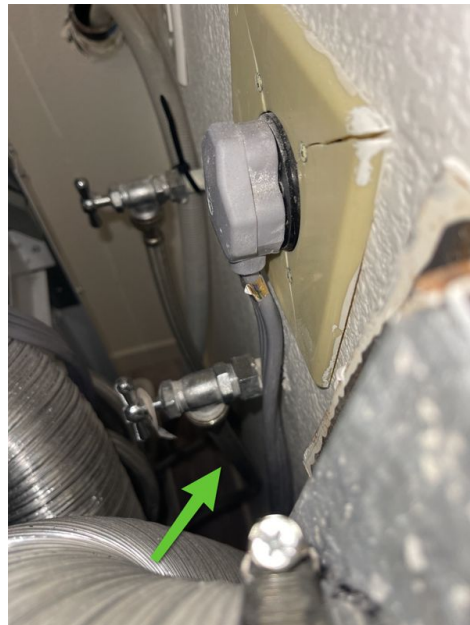
**WASHER/DRYER: Washer Hoses Replace**

Washer hoses are a common source of flooding in a home. We recommend installing new braided steel washer hoses to reduce the risk of leaks caused by burst hoses in the house. Any hoses left in the house or more than 5 years old should be replaced.

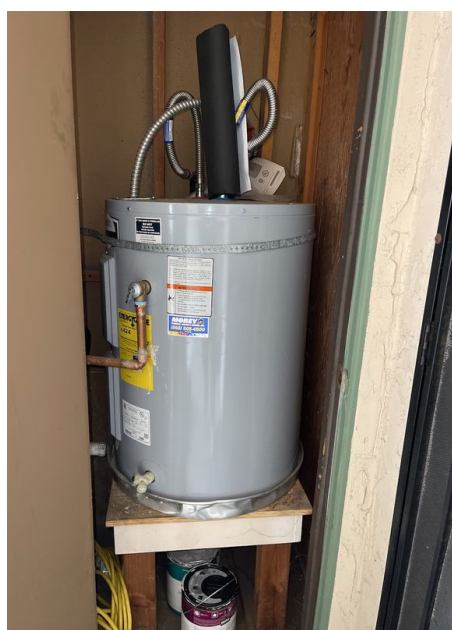
The water heater was inspected and was operational at the time of inspection. A home inspection does not evaluate the efficiency or recovery rate of water heaters. Notable exceptions will be listed below.

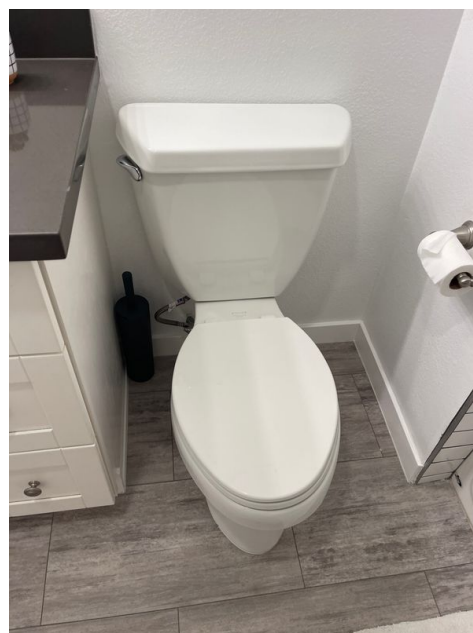
### TOILET - LOOSE - WOOD FLOOR

The toilet was loose on the wood subfloor. This can damage the wax ring under the toilet which can allow water to leak, and cause damage to the subfloor and framing members. We recommend having a licensed plumber install a new wax ring and check the flange for damage.

There may be additional damage to the subfloor which is concealed. We therefore cannot report on the presence of wood damage, if any, to the sub-floor under the toilet.

Contact a qualified plumbing contractor.

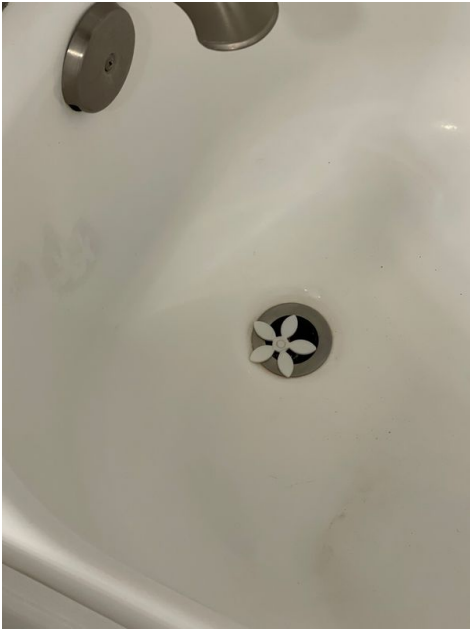
### TUB - STOPPER MISSING

The tub stopper is missing. We recommend replacement.

Contact a qualified professional.

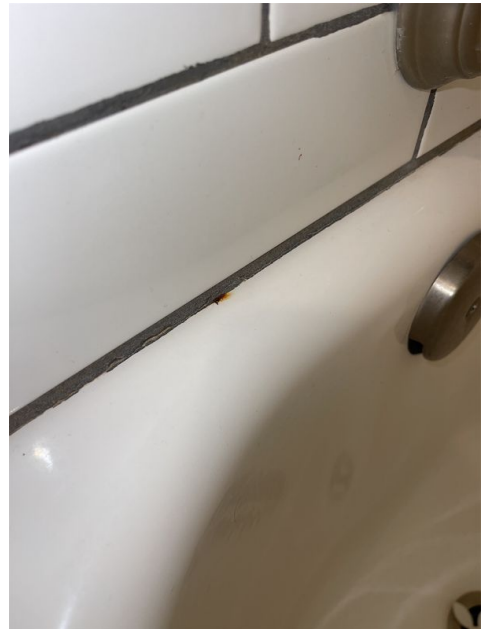
### 3.2.3 FAUCETS, VALVES AND CONNECTED FIXTURES

The tub has a small chip(s) in the enamel coating. We recommend patching the chip to prevent additional rusting.

Contact a qualified professional.

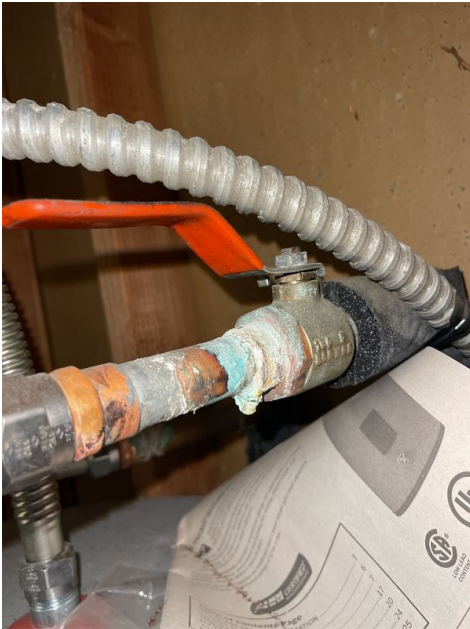
#### **WH SHUT OFF PIPING - CORRODED**

The cold water shut-off valve/pipe to the water heater is corroded. We advise replacing this valve to avoid future leaks.

Contact a qualified professional.

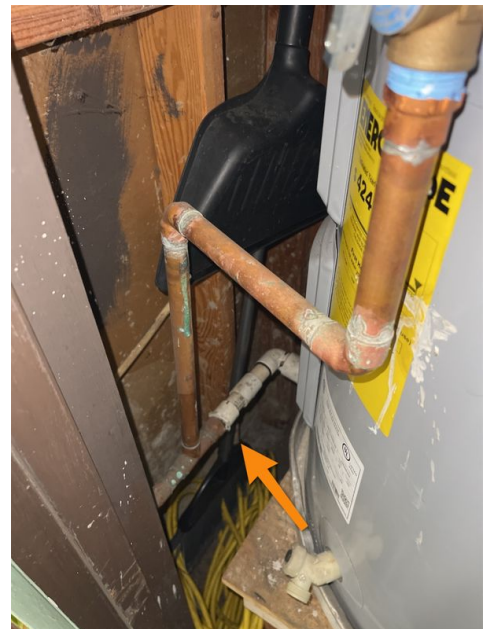
#### **T&P DISCHARGE - TERMINATES/CONNECTED W/LEAK PAN**

The discharge pipe at the T & P valve terminates into the water heater leak pan. This is an incorrect installation.

Contact a qualified plumbing contractor.

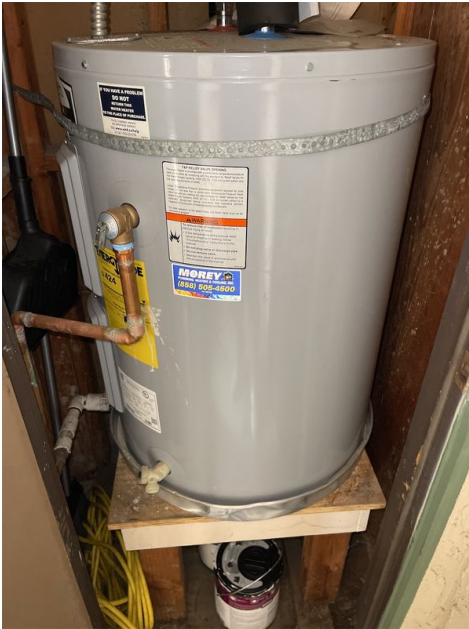
### 3.8.1 WATER HEATER STRAPPING, BRACING AND PLATFORM

The water heater is improperly strapped. Seismic strapping is required to be installed 4 inches above the controls, and at the top 1/3 of the water heater. We recommend installation of a seismic strap kit by a qualified person. Proper installation can be found by visiting [http://www.seismic.ca.gov/HOG/waterheaterbracing\\_08-11-04.pdf](http://www.seismic.ca.gov/HOG/waterheaterbracing_08-11-04.pdf)

Contact a qualified professional.

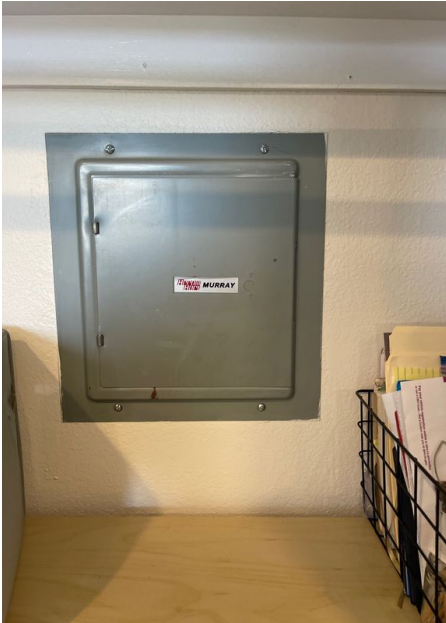
Electrical panels are visually inspected only; the inspector does not perform load calculations to determine service capacity or adequacy.

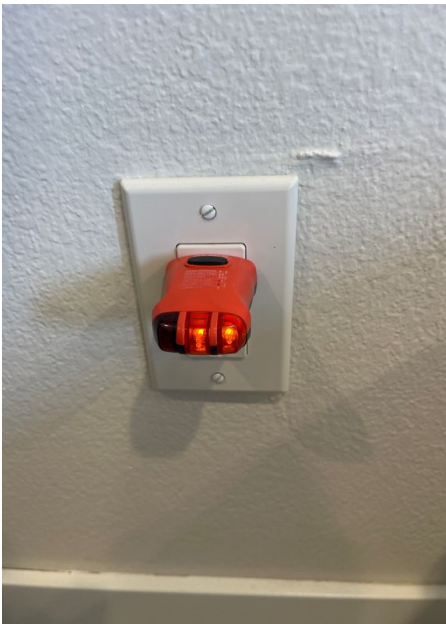
A representative number of receptacles were tested for power, polarity, and grounding according to standards of practice.

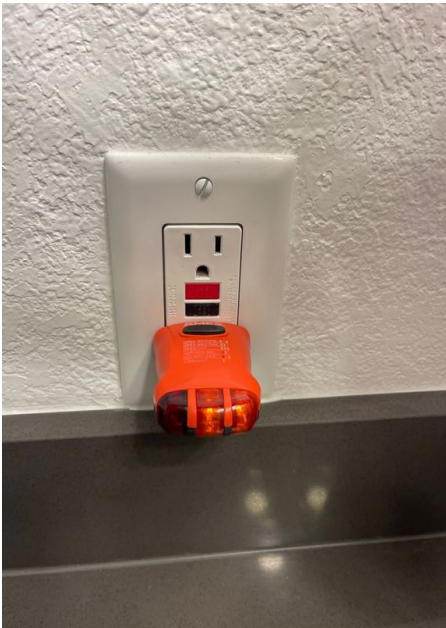
All accessible GFCI receptacles were tested and were functioning properly unless otherwise noted.

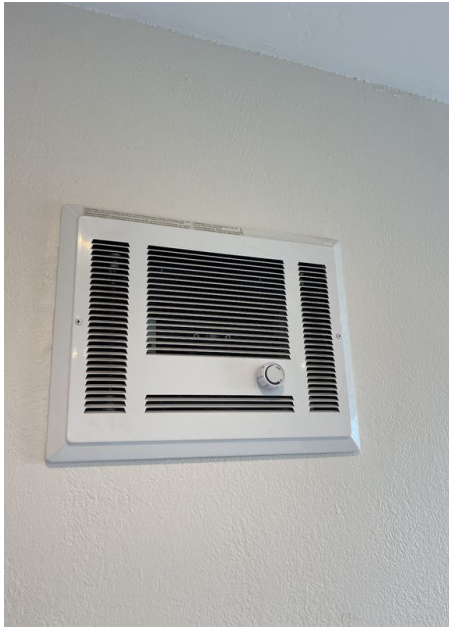
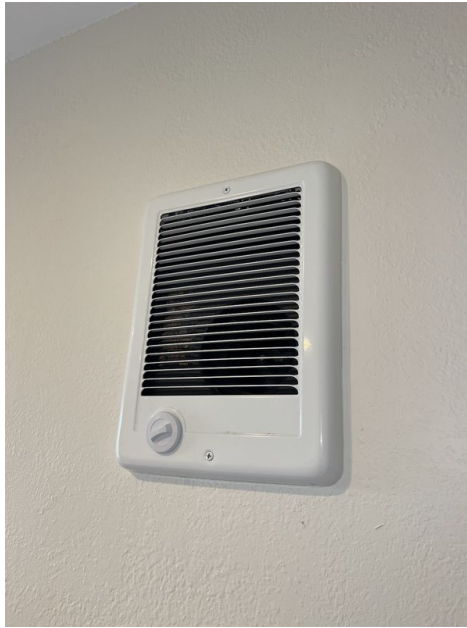
The wall heaters functioned when tested at the time of the inspection.

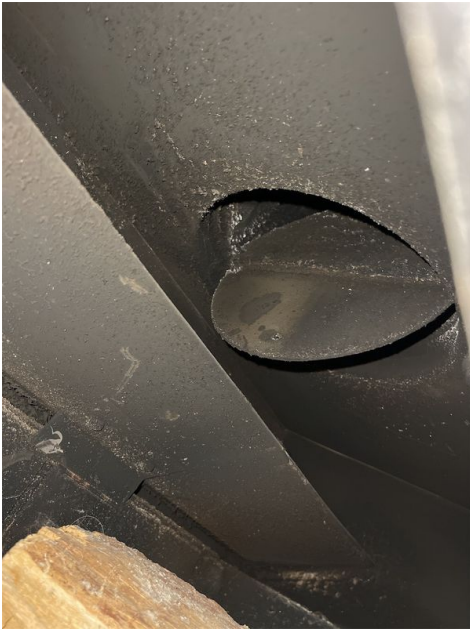
Creosote/soot build-up was noted at the chimney. We advise obtaining professional cleaning.

Contact a qualified chimney sweep.

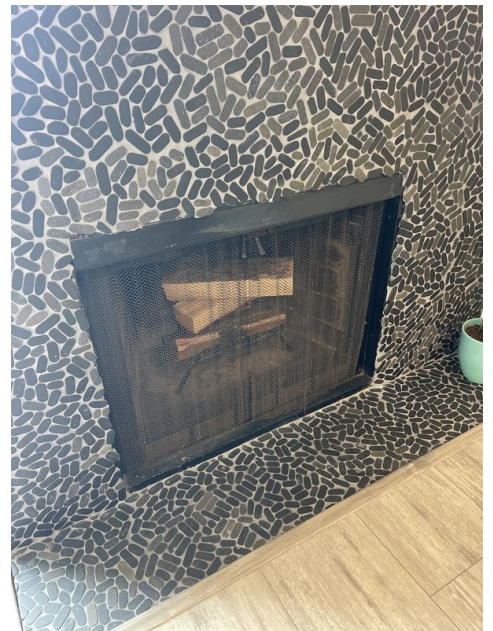
### **GLASS DOORS - MISSING**

Glass doors have been removed or are moss from the fireplace. We recommend replacement by a qualified fireplace service technician. Note: glass doors were NOT required on fireplaces built prior to 1988.

Contact a qualified professional.

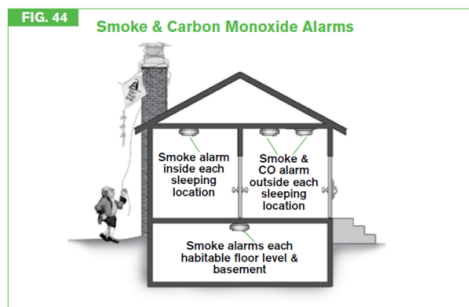
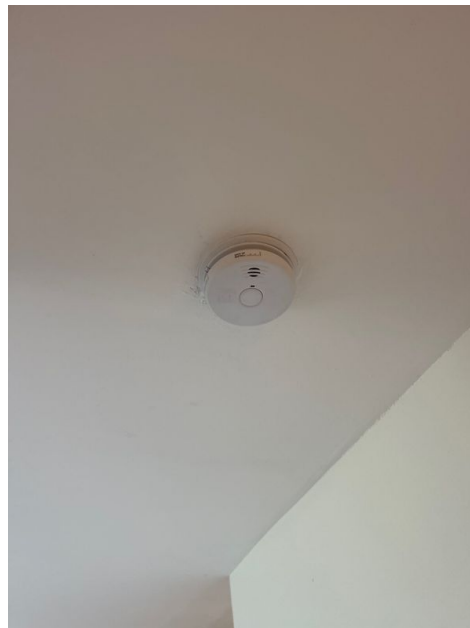
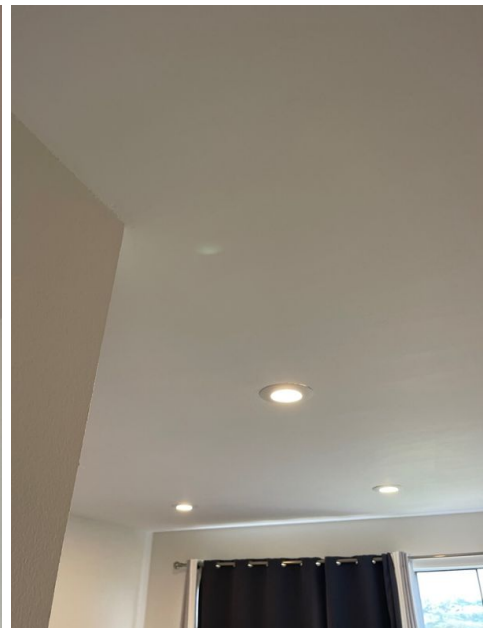
One smoke detector was present in the common hallway. California State Law SB 745 requires additional smoke detectors to be installed in all bedrooms and on each level in the common hallways in multi-story homes when modifications have been performed including alterations, repairs, or additions exceeding \$1,000 in value. Additional smoke detectors are also required in all dwellings intended to be used as rentals regardless of modifications.

Contact a qualified professional.

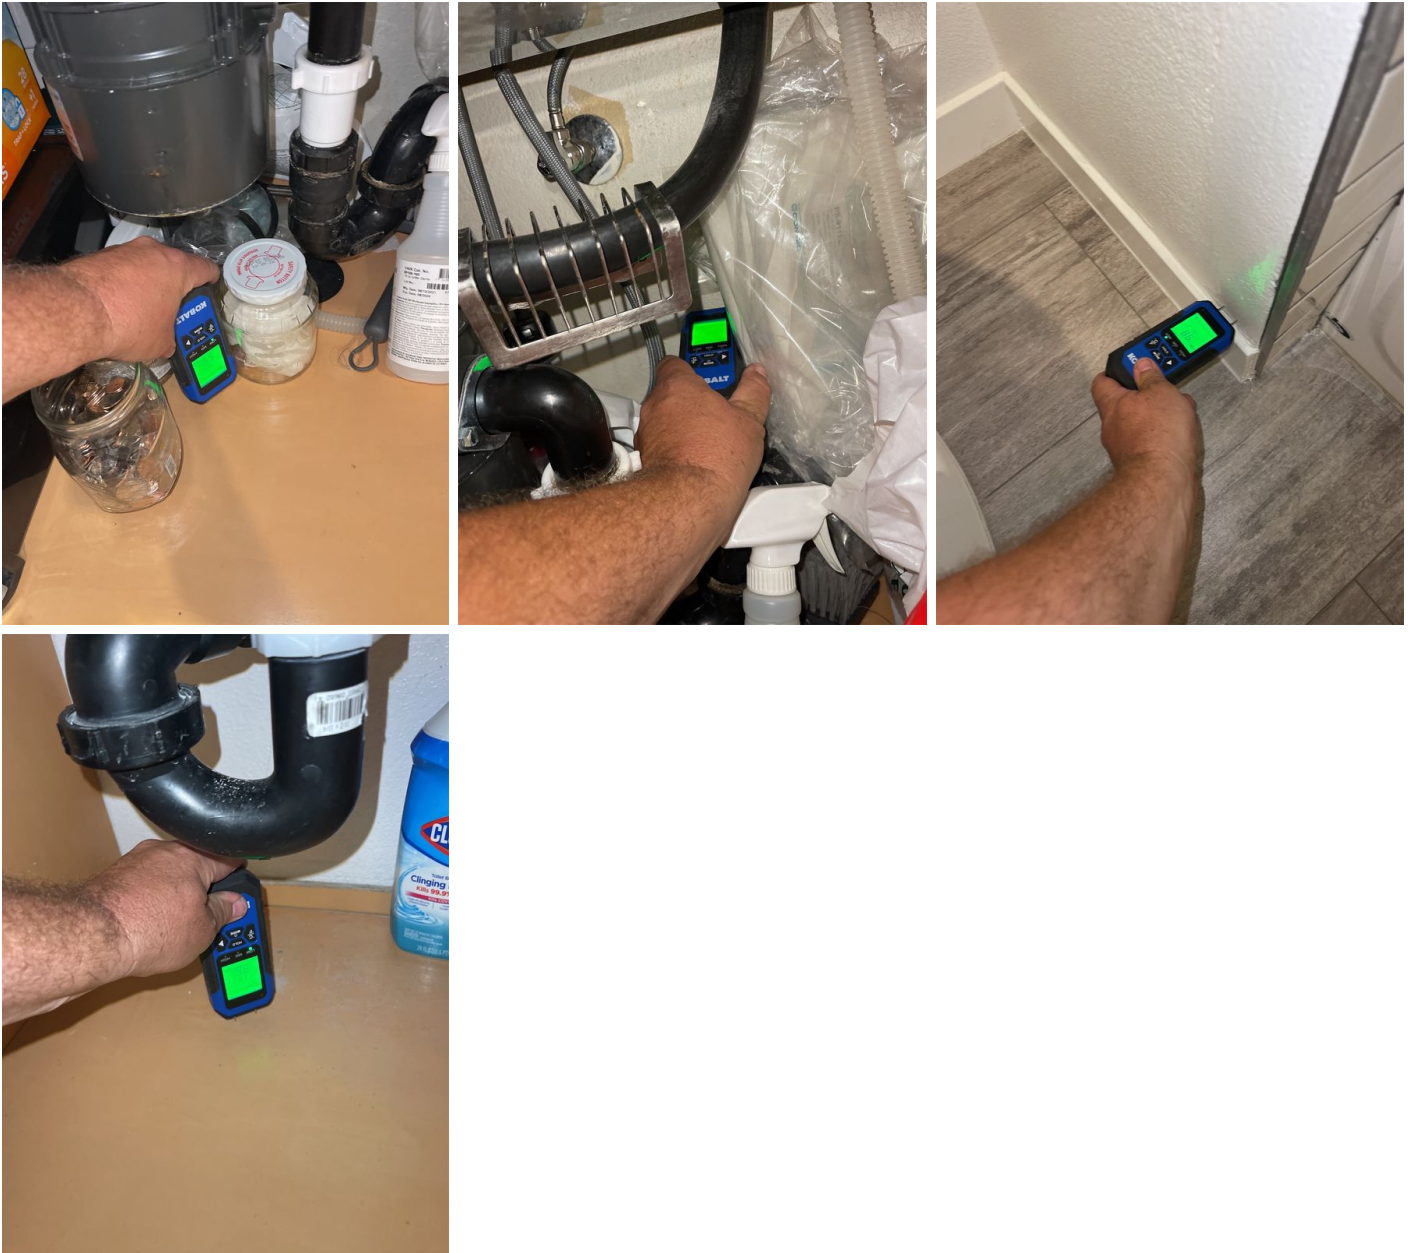
Note: A representative sampling for moisture was performed using a moisture meter at interior walls, ceilings, and cabinets in areas prone to moisture, such as kitchens, bathrooms, interior below-grade walls, or exterior walls with doors/windows. No elevated moisture was detected at the time of inspection. This is not an exhaustive test and only represents the conditions on the day of inspection.

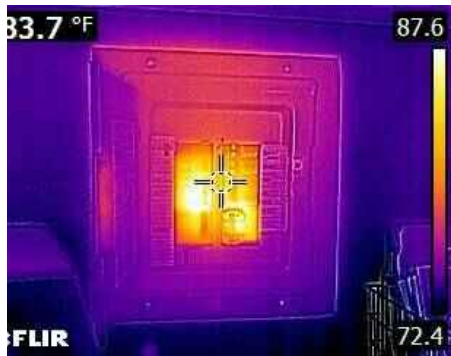
**INFRARED INSPECTION FINDINGS: Thermal Camera Scan - Breakers Normal**

A thermal scan was performed on the electrical panel(s). The panel, circuit breakers, and wiring were found to be operating within the normal temperature range which indicates the system was functioning as intended with the conditions present at the time of inspection.

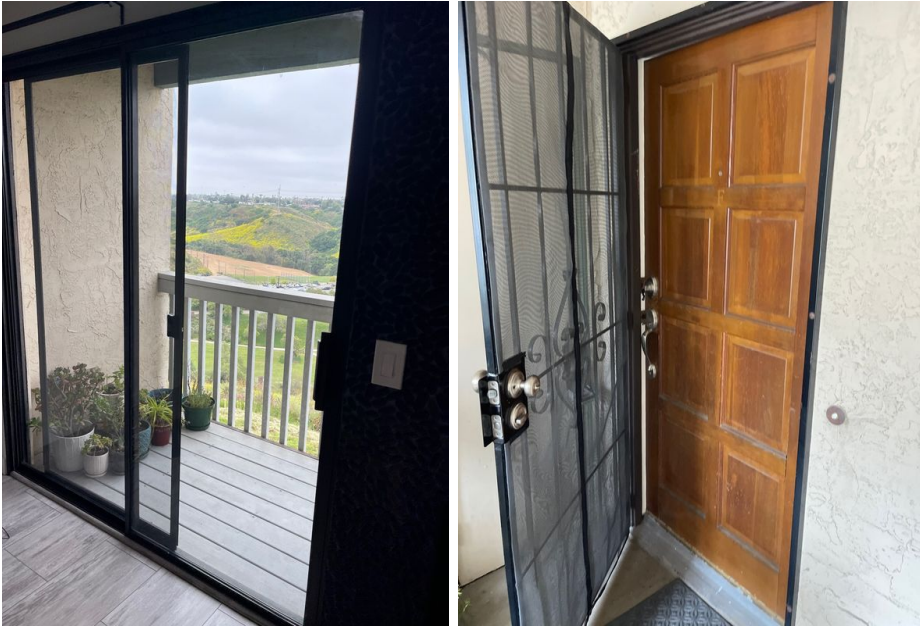
**DOORS (Exterior): Doors - Inspected - OK**

At the time of the inspection, the Inspector observed no deficiencies in the condition of exterior doors.

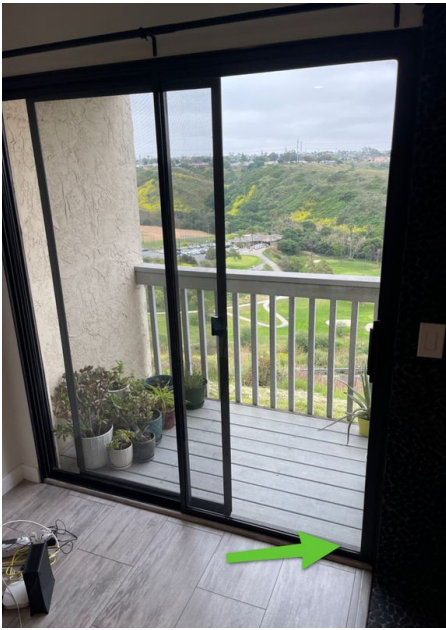
Rear Exterior

**BALCONIES (Railing, Decking Material): Balcony/Deck Coating- Inspected**

Note: The decking material/coating showed normal wear for its age and type. All decks require periodic maintenance to prolong the life of the deck and avoid leaks. No evidence of leaking was observed.

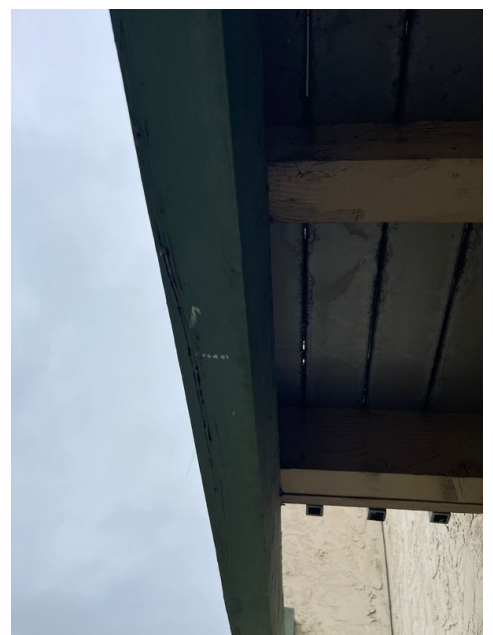
### DAMAGED WOOD TRIM

Some damaged wood was observed at the exterior. We recommend referring to the HOA regarding repairs at exterior walls/ trim.

Contact a qualified professional.

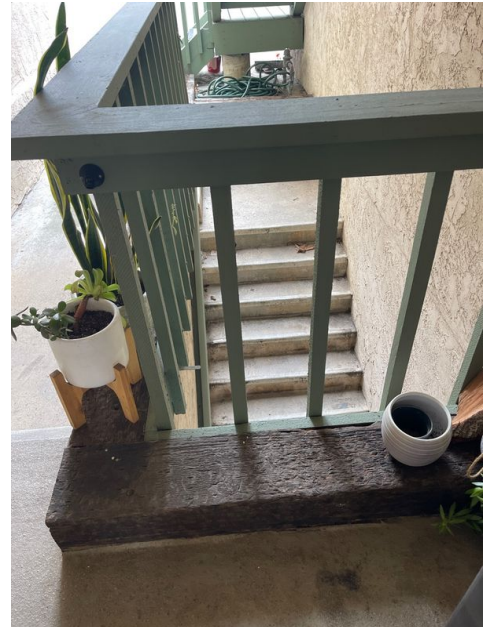
### 10.5.1 STOOPS, STEPS, PORCHES AND RAILINGS

#### **RAILING - SPACING**

While the railing/baluster spacing may have been standard at time of construction, it does not comply with current safety standards. The large openings can allow pets or children to fall through, or become entrapped. We recommend checking with HOA regarding installing additional balusters, or another form of barrier to prevent injuries.

Recommendation or Safety Upgrade

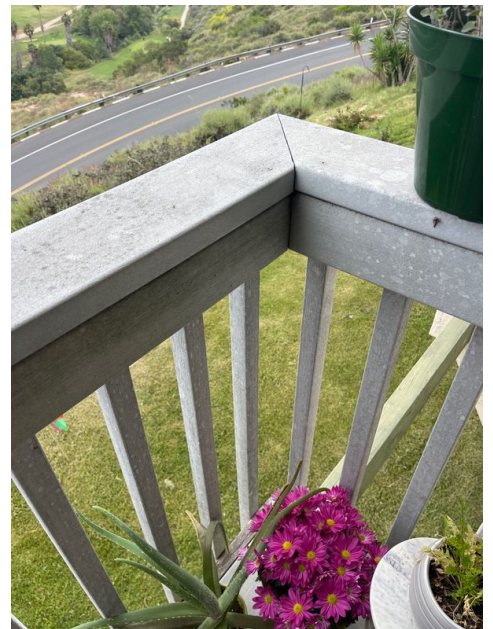
### 10.6.1 BALCONIES (Railing, Decking Material)

#### **LOOSE RAILING**

Loose railing noted. This is a safety hazard. We recommend checking with the HOA regarding repair by a qualified contractor.

Recommendation or Safety Upgrade

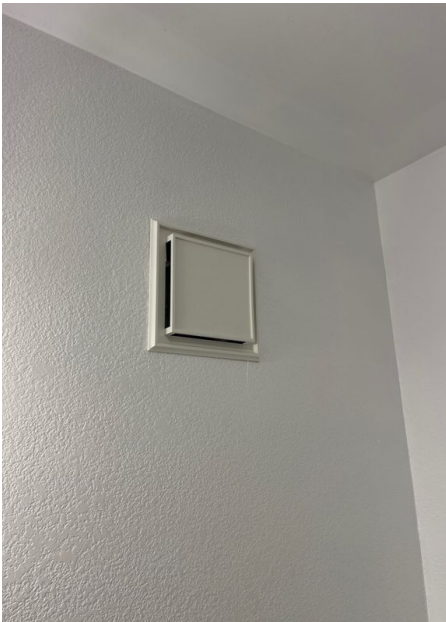
#### **BATHROOM VENTING: Exhaust Fans - OK**

The exhaust fan(s) were tested and were functional at the time of inspection. (This is not an exhaustive test, and does not evaluate the performance or effectiveness of the vent(s).)

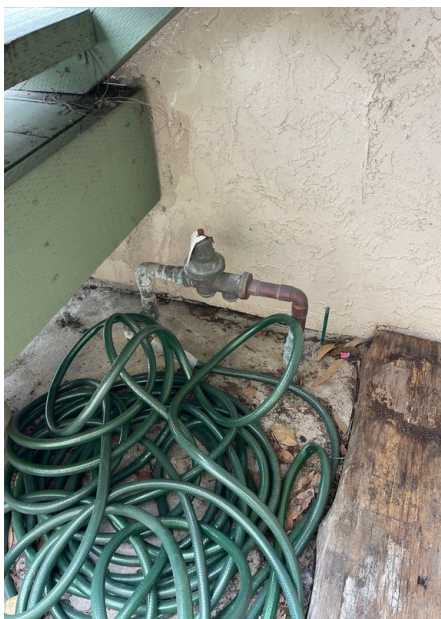
##### **Common Water Shut Off Found**

Water shut off for multiple units was found at front.
