## RESIDENTIAL INSPECTION

7060 Glenroy St, San Diego, CA, USA  
San Diego, CA 92120

07/23/2026

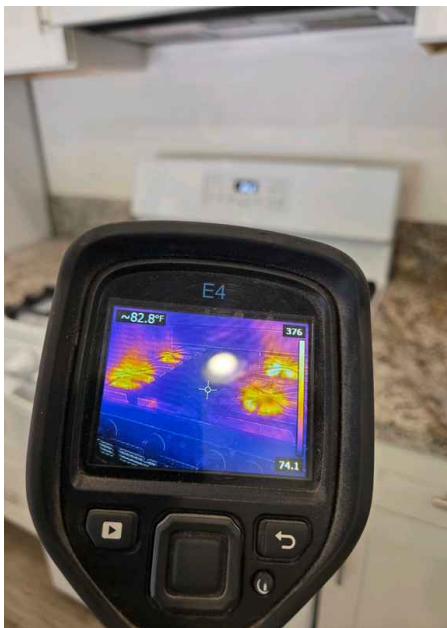
### **RANGES AND COOKTOPS: Thermal Image Showing Range Working**

Infrared picture of range/cooktop in operation. This unit appeared to be functional at the time of the inspection.

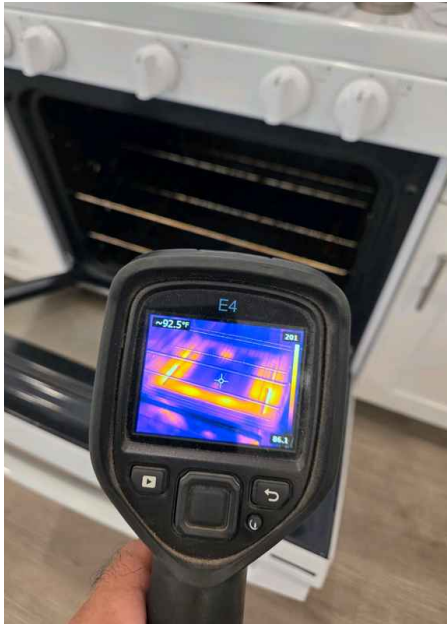
### OVEN: Thermal Image Showing Oven Working

Infrared picture of oven(s) in operation. The unit(s) appeared to be functional at the time of the inspection.

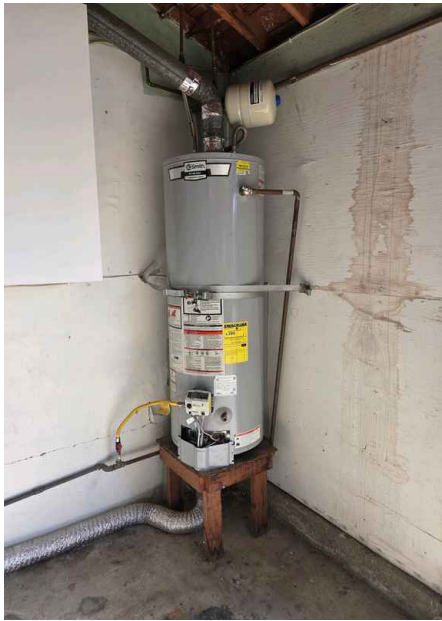
**WATER HEATERS: Picture of Water Heater**

Picture of water heater(s).

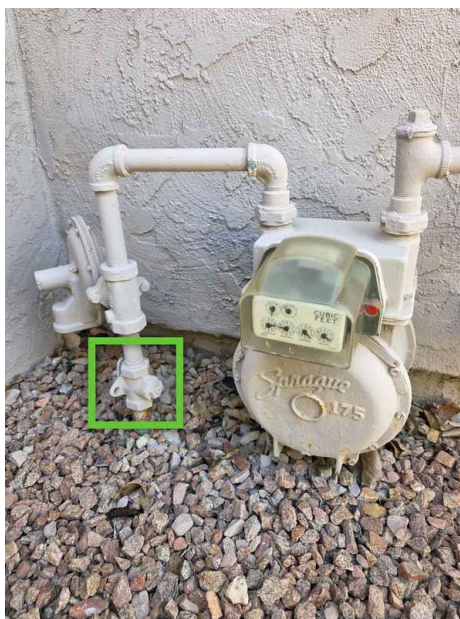
**MAIN GAS SHUT OFF VALVE (Describe Location): Main Gas Shut-Off Location**

Left side of building

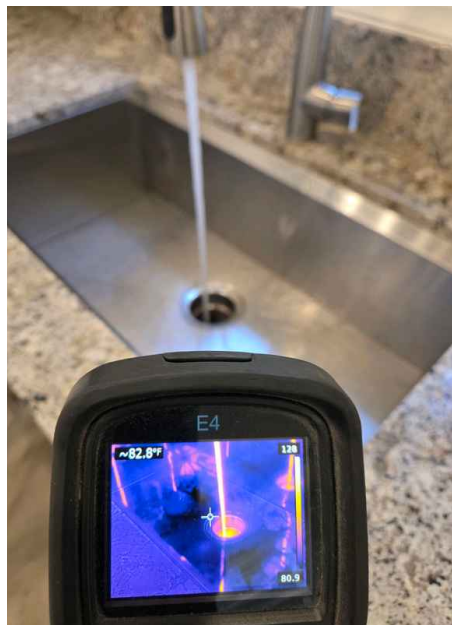
## WATER HEATERS: Thermal Image of Hot Water

Thermal image(s) showing the water heater(s) producing hot water at the time of the inspection.

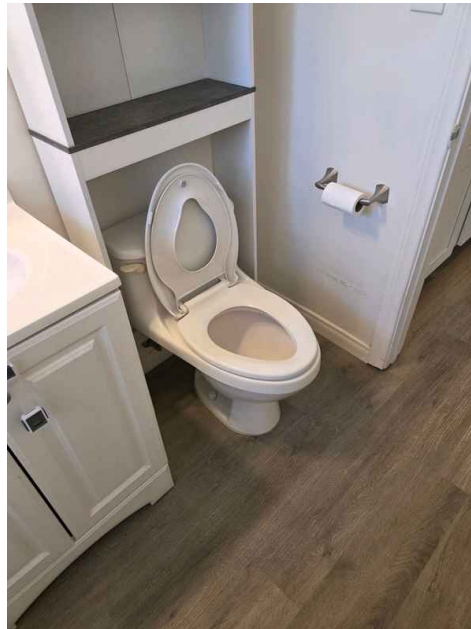
Hall Bath

#### TOILET LOOSE

#### Recommendation

Contact a qualified plumbing contractor.

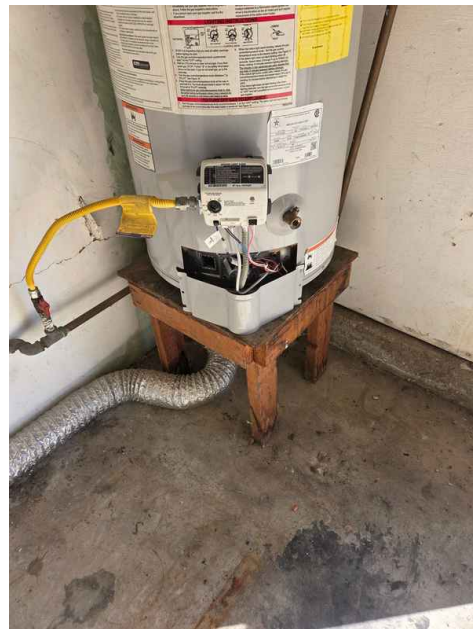
### 3.7.2 WATER HEATERS

#### **LEAK PAN - NOT INSTALLED**

#### Recommendation

Contact a qualified plumbing contractor.

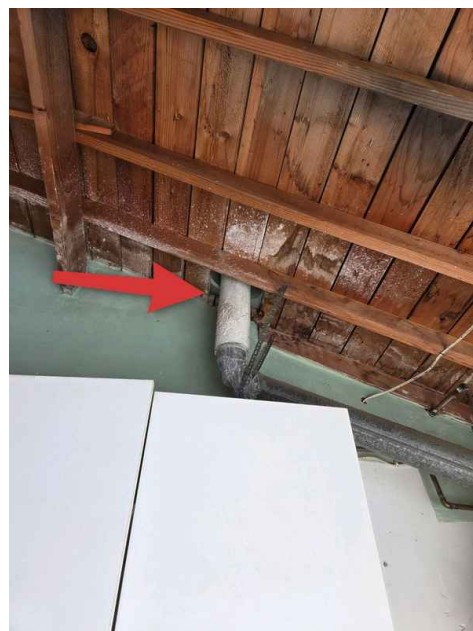
### 3.8.1 WATER HEATER FLUE

#### TRANSITE FLUE PIPE

#### Recommendation

Contact a qualified environmental contractor

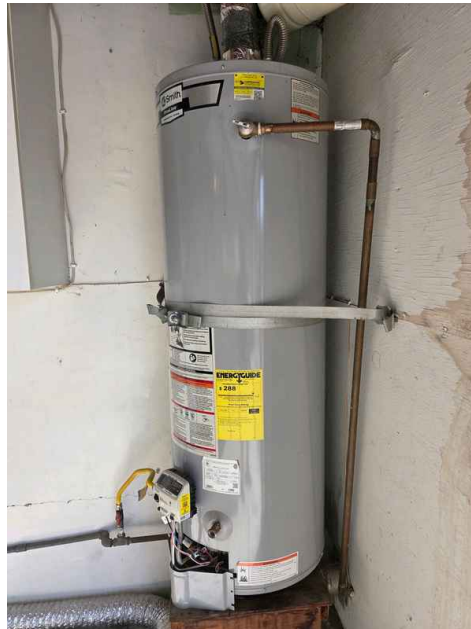
### Water Heater in Garage

### 3.10.1 WATER HEATER STRAPPING & BRACING

#### STRAPS- INADEQUATE OR NOT INSTALLED

Contact a qualified plumbing contractor.

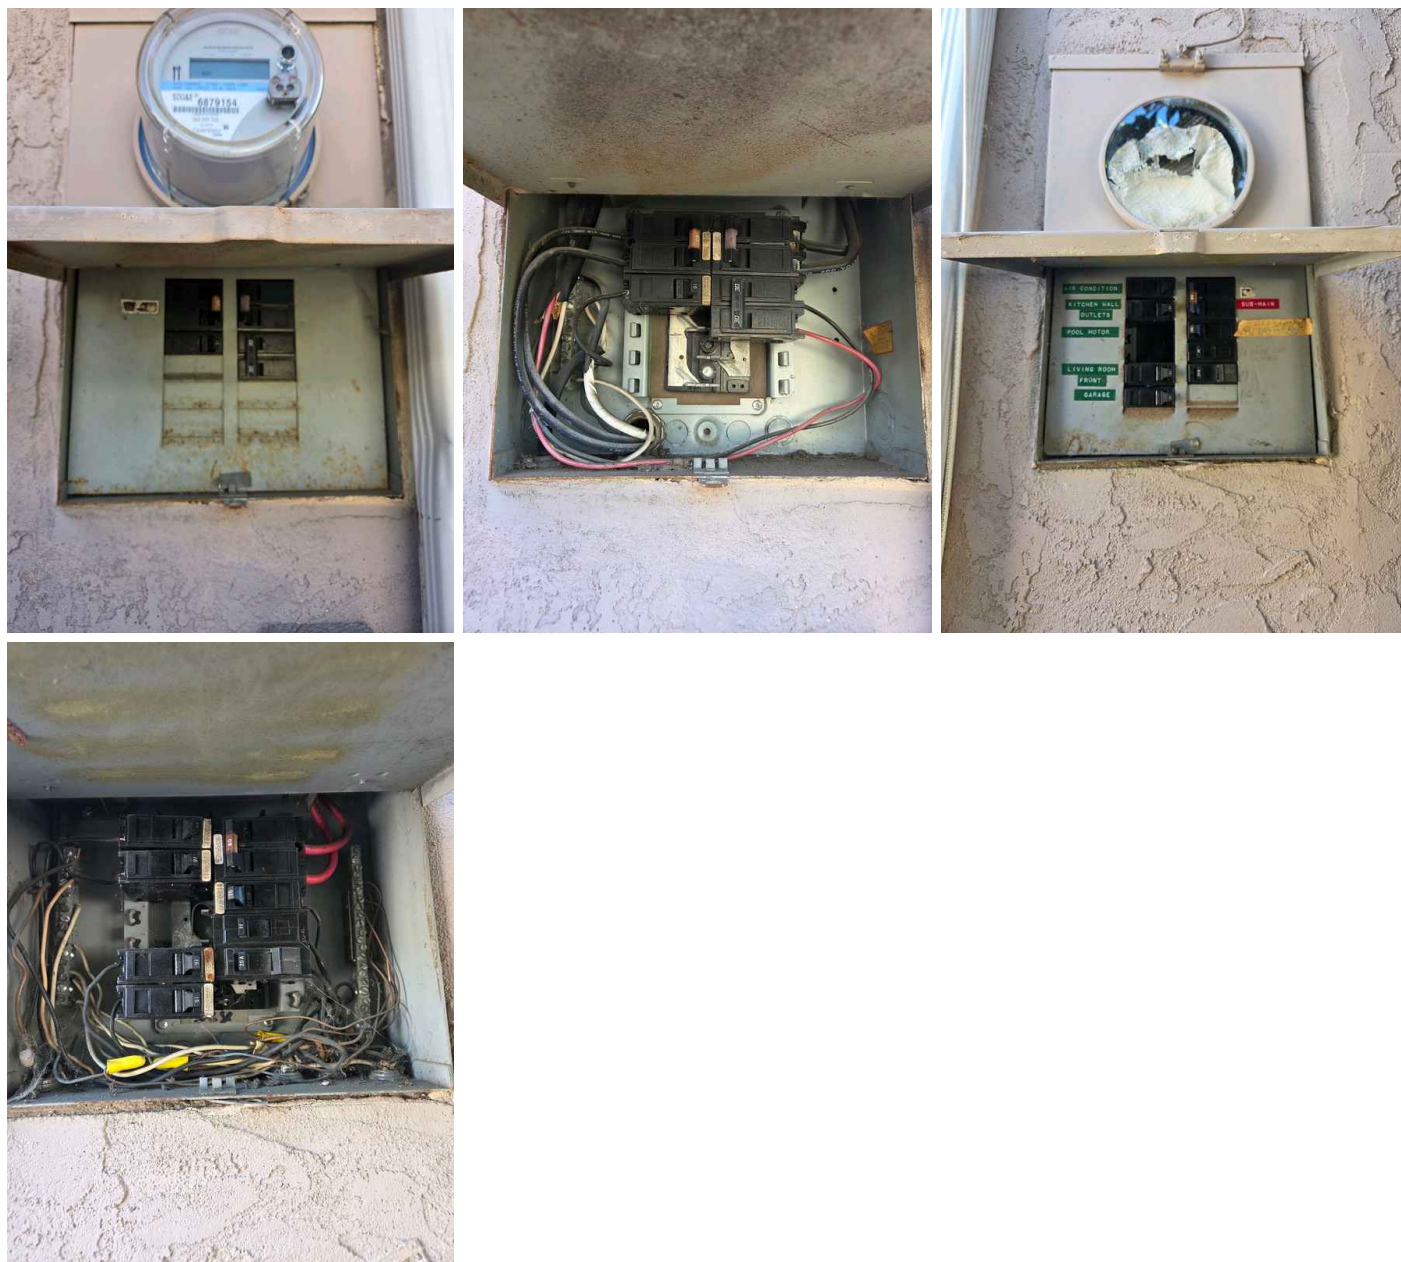
## MAIN AND DISTRIBUTION PANELS: Picture of Electrical Panel(s) / Type

Main Panel, Sub Panel(s)

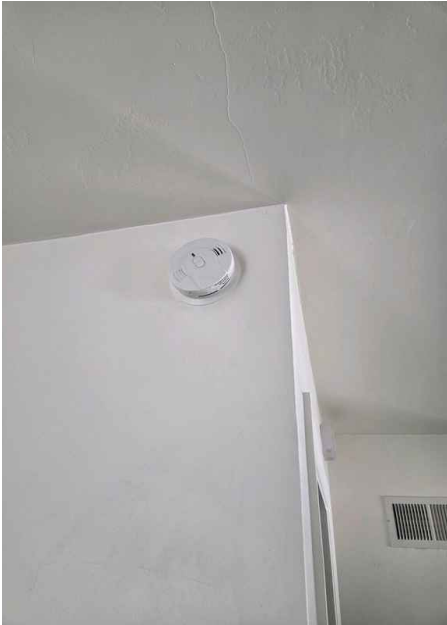
## SMOKE DETECTORS: Single Story - Smoke Detectors Present

Smoke detectors noted in the hallway and in each bedroom; units appeared functional at the time of the inspection.

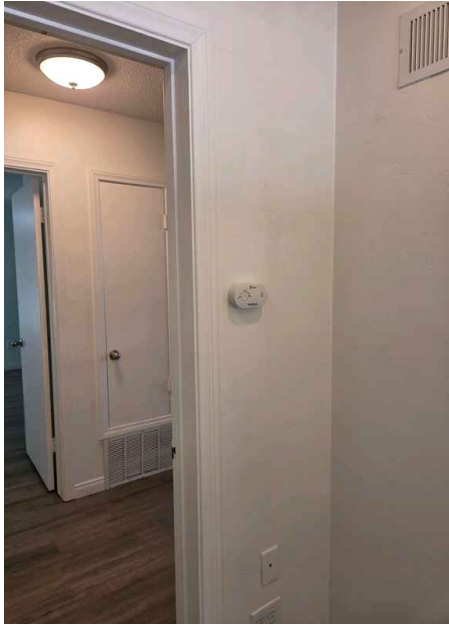
## CARBON MONOXIDE DETECTORS : Single Story - CO Detector Present

A CO detector is located in the common hallway as required. The unit appeared to be functional at the time of the inspection.

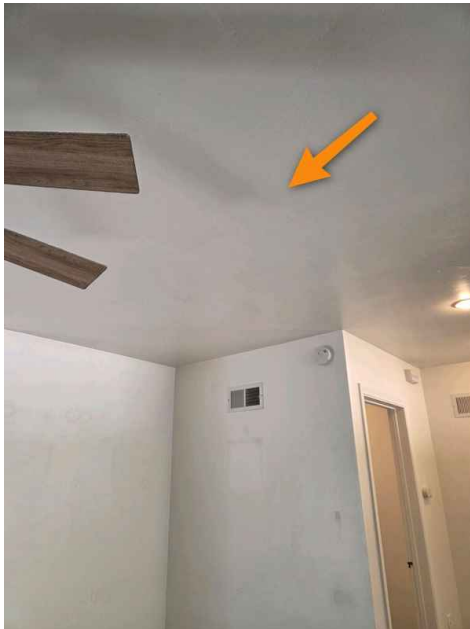
Living Room

### 6.2.1 CEILINGS

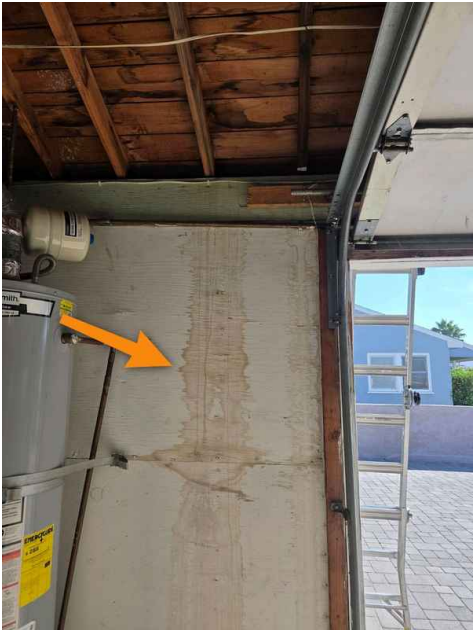
7.4.1 GARAGE WALLS (Including Firewall Separation)

WATER STAINS / DAMAGE

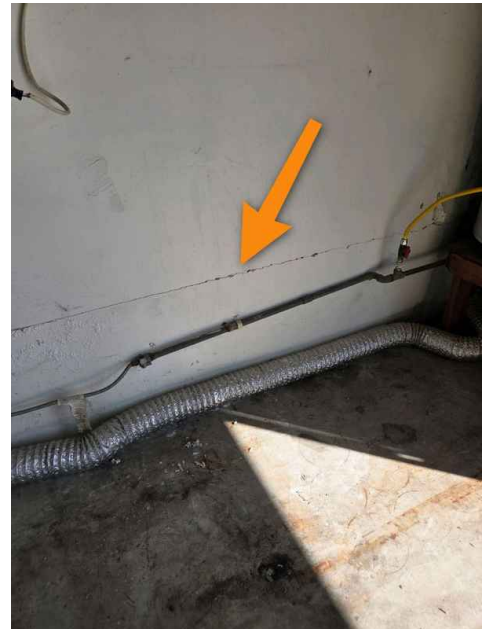
**SETTLEMENT CRACKS**

The wall(s) appear to have cracks in one or more areas. The cause can vary from typical settlement to major structural movement. Recommend further evaluation by a licensed general contractor to determine the most likely cause and have repaired as necessary at this time.

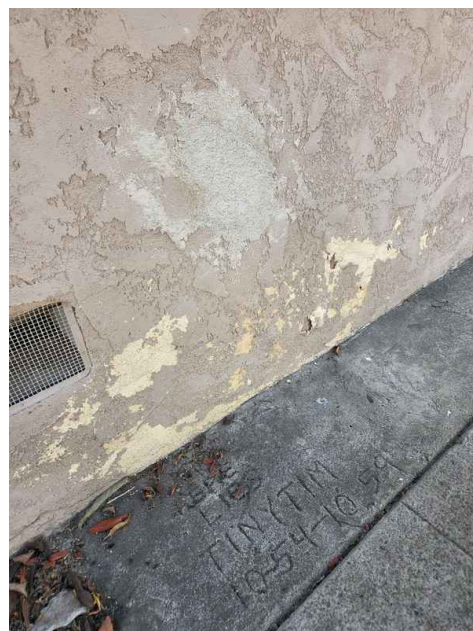
Left of building

### 9.2.2 WALL CLADDING, TRIM AND FLASHING

Contact a stucco repair contractor

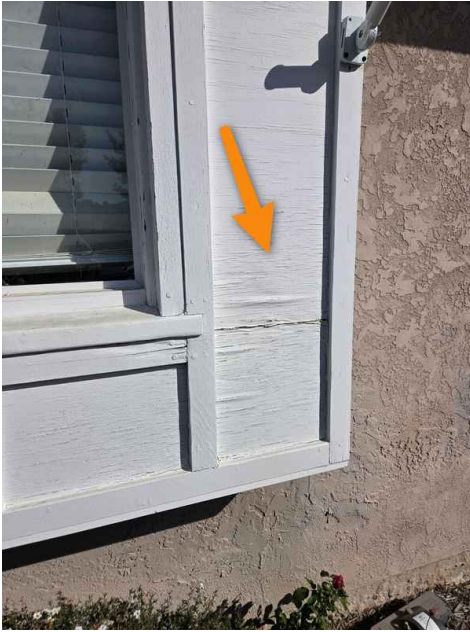
Front of building

### 9.2.3 WALL CLADDING, TRIM AND FLASHING

Contact a qualified siding specialist.

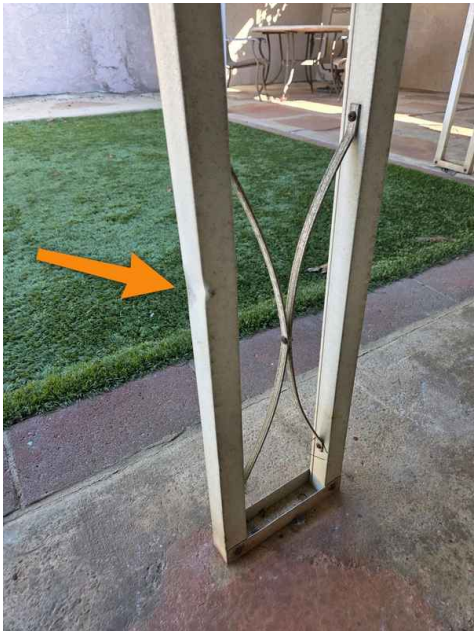
9.8.1 FENCING AND GATES

**LEANING/DAMAGED - FENCING/GATE(S)**

Sections of the fencing or gate(s) noted leaning and/or damaged. The fencing or gate is likely in need of repair or possible replacement. Recommend consulting a licensed fence contractor for any repairs necessary at this time.

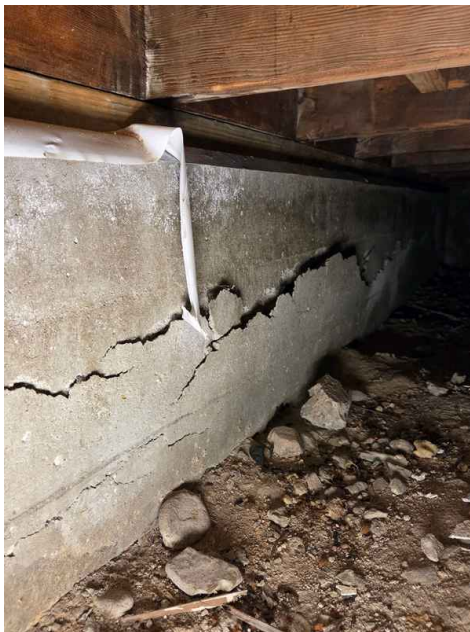
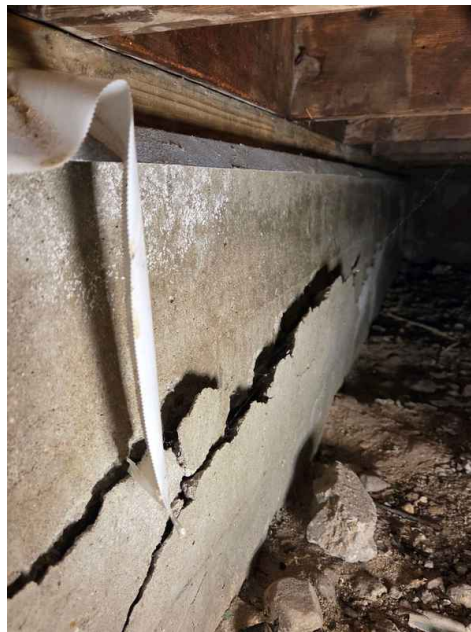
Rear of building

#### 10.2.2 FOUNDATIONS, CRAWL SPACES & BASEMENTS

##### **SLAB - STEMWALL CRACKS**

Recommendation

Contact a foundation contractor.

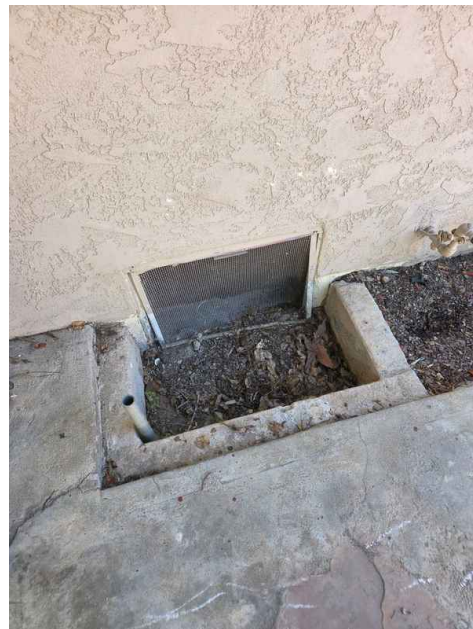
#### 10.2.3 FOUNDATIONS, CRAWL SPACES & BASEMENTS

##### **CRAWLSPACE ACCESS - DAMAGED/NOT INSTALLED DOOR**

Damaged or not installed crawlspace access door noted. This may allow pest and unwanted small animals. Recommend a qualified professional to repair as needed

Contact a qualified professional.

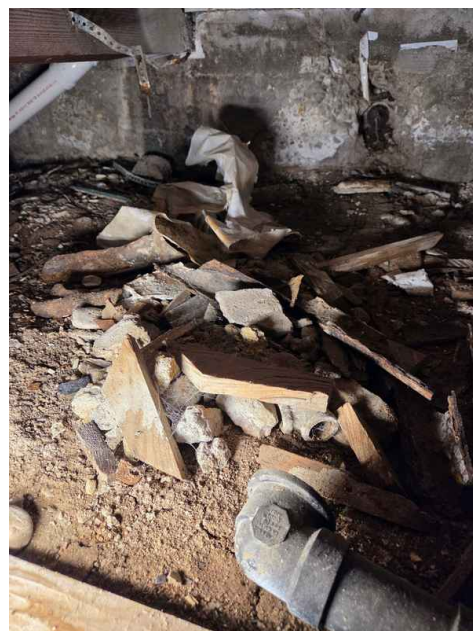
#### 10.2.4 FOUNDATIONS, CRAWL SPACES & BASEMENTS

Excessive construction debris, belongings and other materials was noted the crawlspace. This makes our inspection of the crawlspace limited to certain vantage points due to due to our safety. Recommend removal by a qualified professional. If further inspections are necessary we recommend either contacting a licensed professional or contacting us for a re-inspection.

Contact a qualified professional.

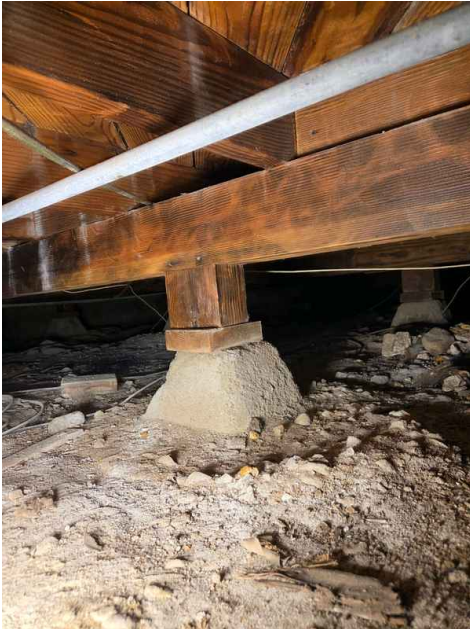
#### 10.3.1 POSTS, PIERS AND COLUMNS

The post and piers are not strapped/braced. Adding metal straps to the posts and piers may improve the overall stability and longevity of this home's foundation. This may have been common practice when the home was built. However, newer standards require additional support. The home was built properly and these supports may be considered an upgrade. Recommend further evaluation by a licensed foundation contractor to determine repairs or upgrades necessary at this time.

Contact a foundation contractor.

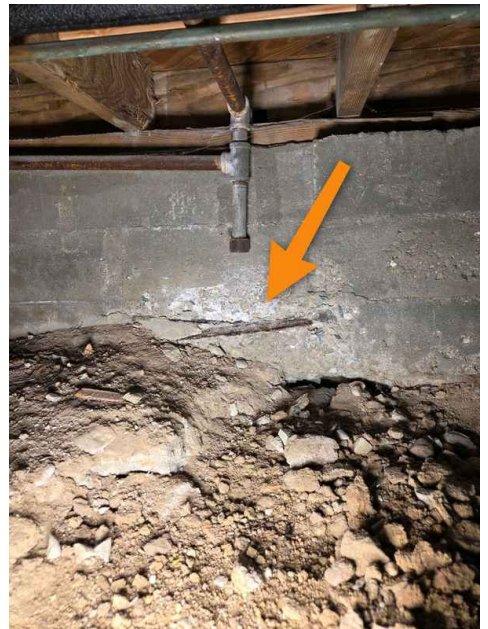
Front of building

#### 10.4.1 WALLS (Structural)

### FOUNDATION WALL - EXPOSED REBAR

#### Recommendation

Contact a foundation contractor.

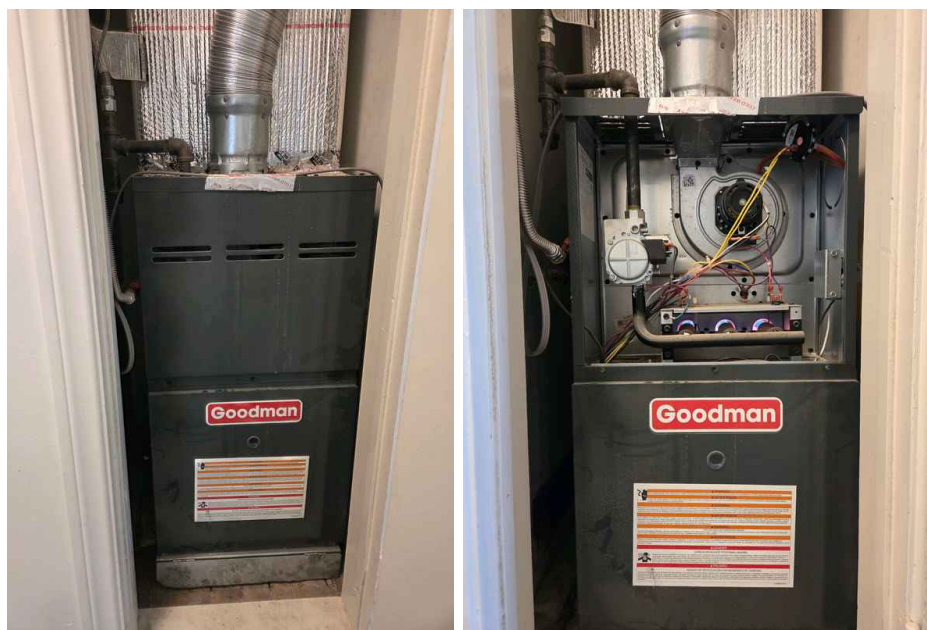
## HEATING - EQUIPMENT: Picture of Heater(s)

Photo of the heater

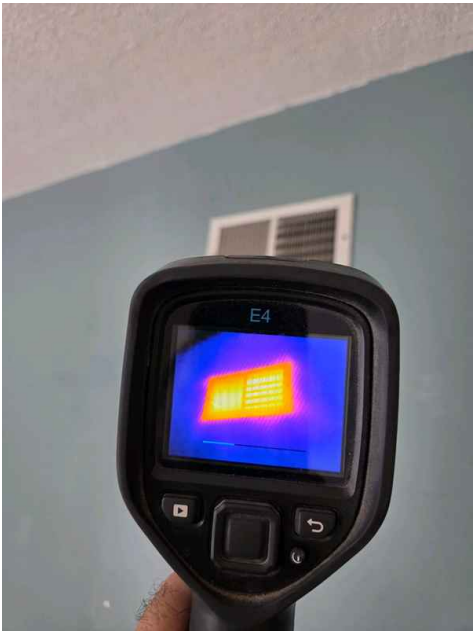
The furnace(s) appeared to turn on and produce heat at time of inspection. However, due to the many components that are not visible (like the heat exchanger and the entire length of the flue pipe), our inspection of the system(s) is limited. Because of this, we recommend further evaluation/safety check be performed by a licensed HVAC contractor or the local gas company before the removal of contingencies.

Contact a qualified heating and cooling contractor

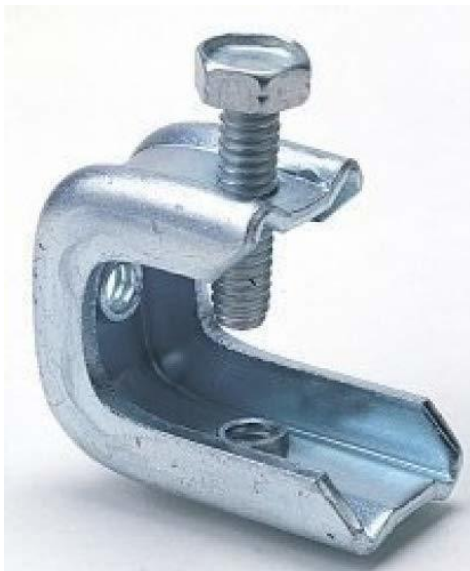
11.10.1 FIREPLACES - FIRE BOX

**DAMPER CLAMP - NOT INSTALLED**

Contact a qualified professional.
