**SUMMARY**  
 15139 Almond Orchard Ln, San  
 Diego, CA 92131  
 Victor Bianchini  
 May 30, 2024

John Bowley  
 20yrs of Experience as Certified  
 Commercial & Residential CRI, ACI, CRMI  
 BuildingSpecsPro's LLC  
 619-250-0517  
[john@buildingspecspro.com](mailto:john@buildingspecspro.com)

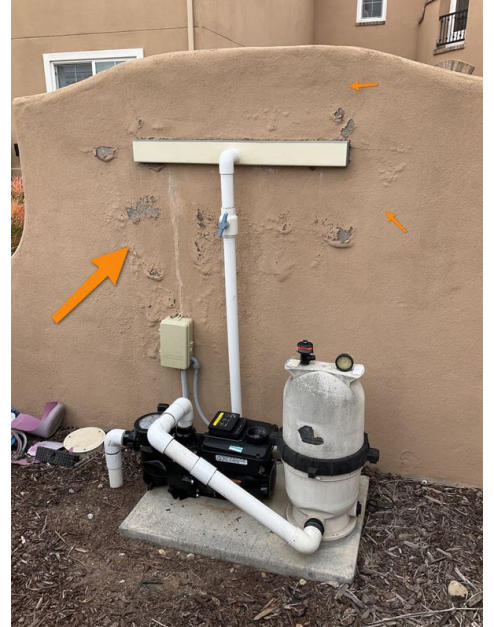
Exterior Side Yard

3.1.1 Misc. Concerns / Comments  
**STUCCO DETERORATION**

The side yard water feature rear wall stucco material is peeling and flaking. This appears consistent with the lack of maintenance and age. Refer to a licensed stucco contractor for further evaluations and repairs.

Recommendation  
 Contact a stucco repair contractor

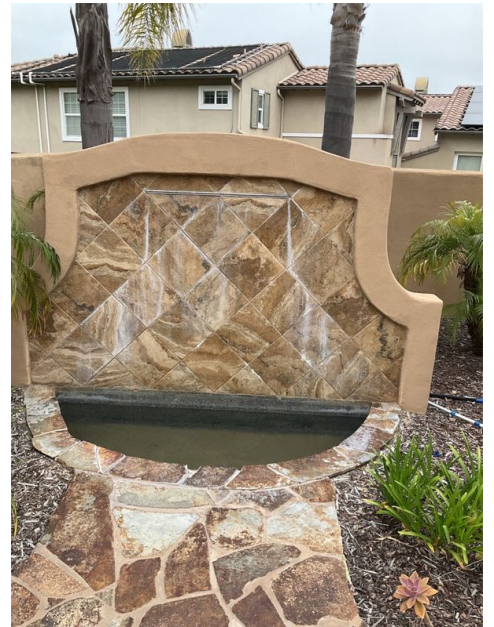
4.1.1 Grading  
**WATER FEATURE NOT TESTED / INSPECTED**

Water features such as fountains, ponds and/or water falls are not included in the inspection.

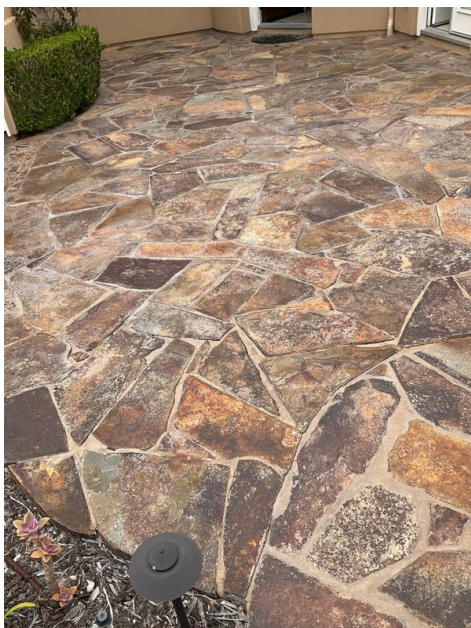
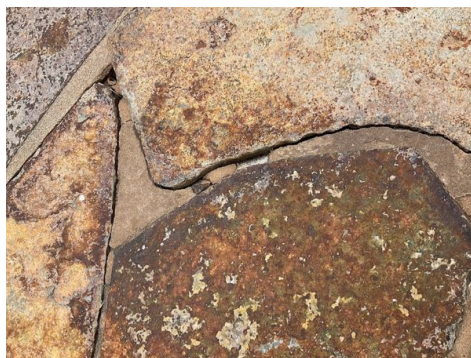
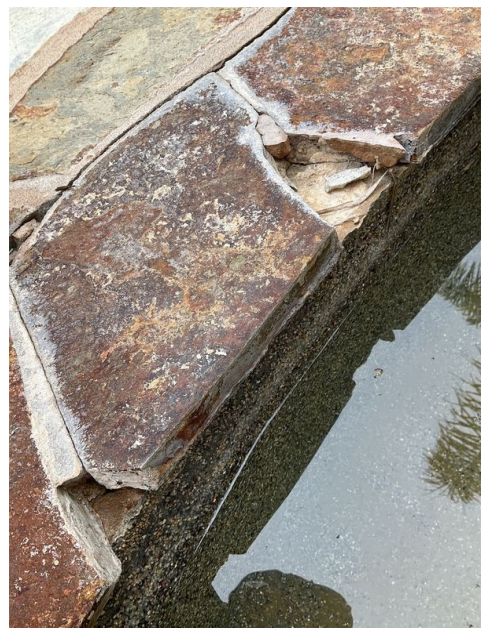
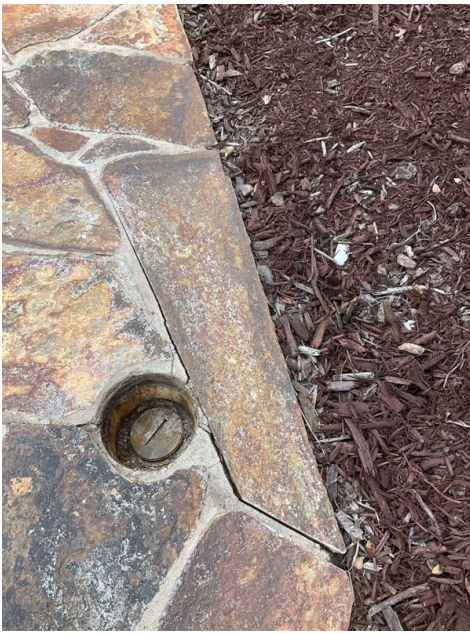
### STONE WALKWAYS CRACKED CHIPPED

The exterior stone walkways are missing, grout / sealants in various locations. There are chipped and cracked stones with sharp edges. Caution. The stone walkways are uneven and pose a potential trip concern. Refer to a licensed contractor for repairs.

Contact a qualified masonry professional.

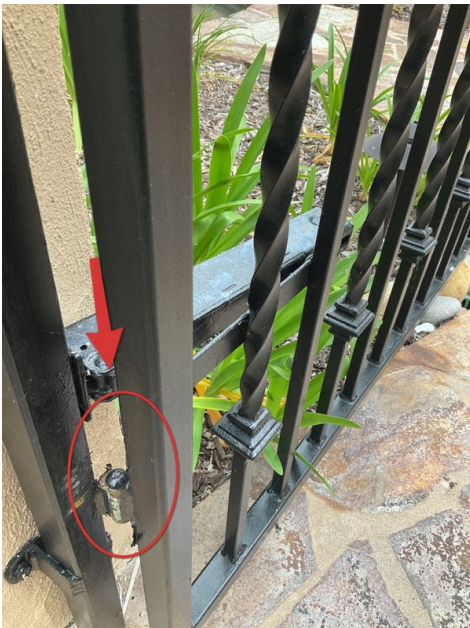
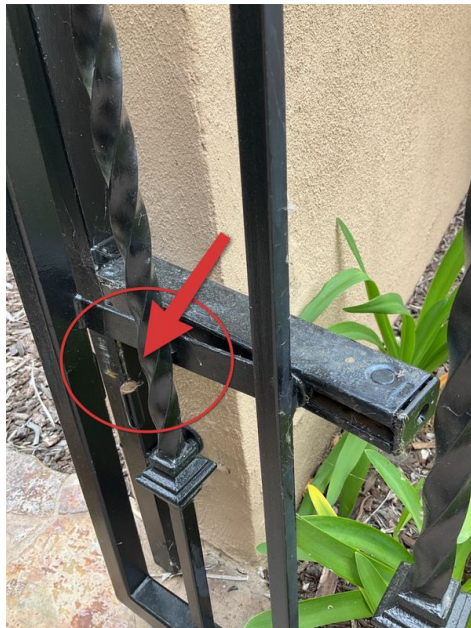
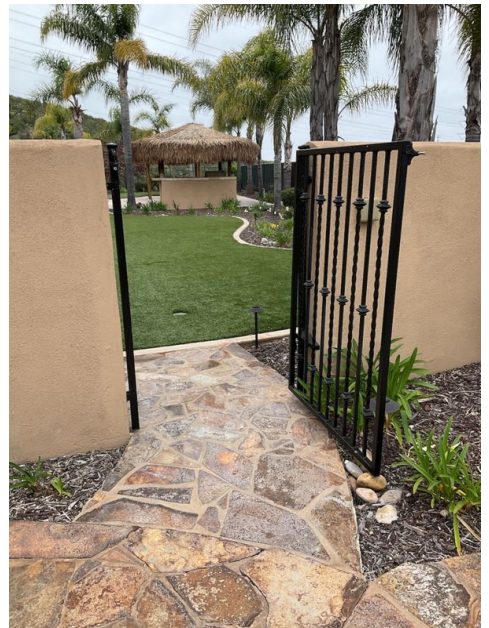
Exterior Gate

### POOL GATE SELF CLOSING HINGE DAMAGED

The exterior side yard metal gate self-closing hinge is not operational and/or connected. Caution safety hazard. The gate leads to the pool and spa area. Refer to a licensed gate contractor for immediate repairs.

Contact a qualified general contractor.

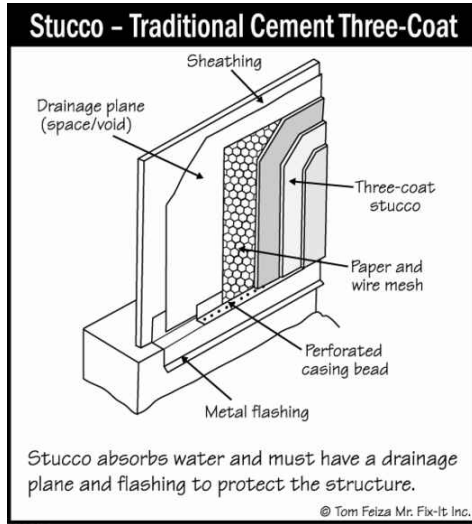
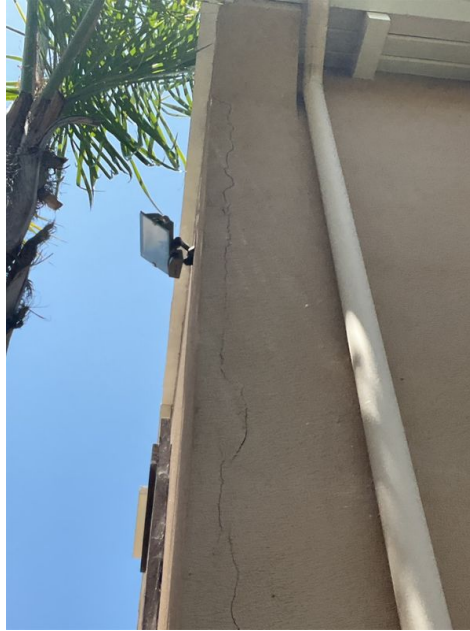
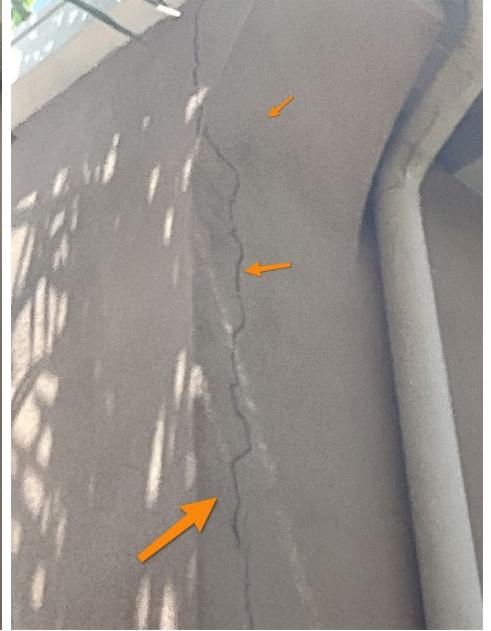
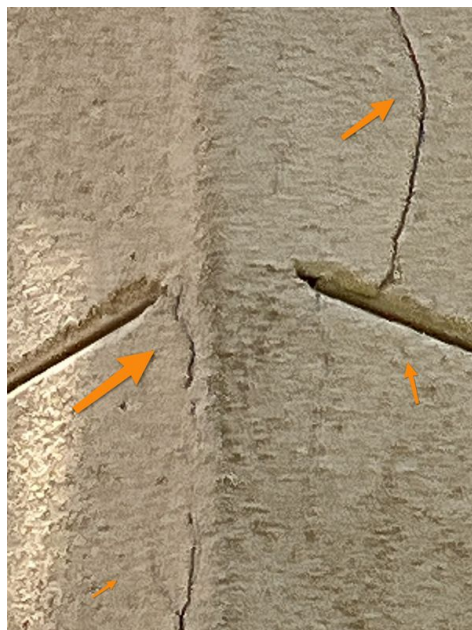
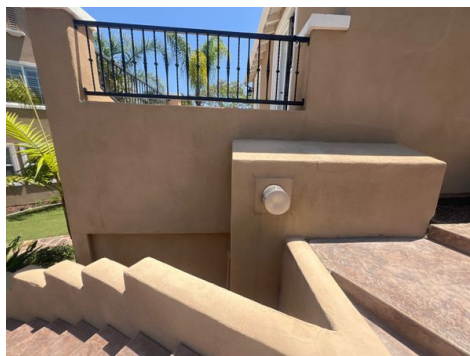
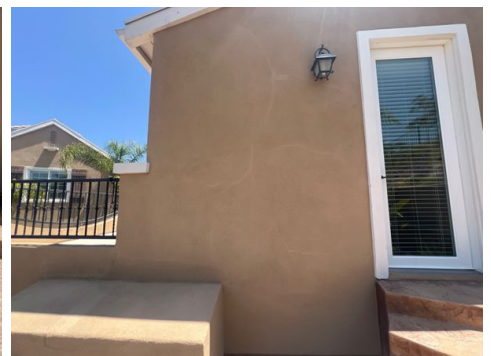
XO14

#### \*STUCCO STRESS CRACKS \*

There are small stress fractures and open voids in the stucco around the windows and doors that result from movement, and are quite common. Most people do not realize that structures move, but they do and sometimes more or less continuously. Therefore, stress fractures can reappear after they have been repaired, and particularly if they have not been repaired correctly. Caution conditions are prone to moisture intrusion and damages. Monitor conditions and/or stucco contractor for cost of repairs.

Contact a stucco repair contractor

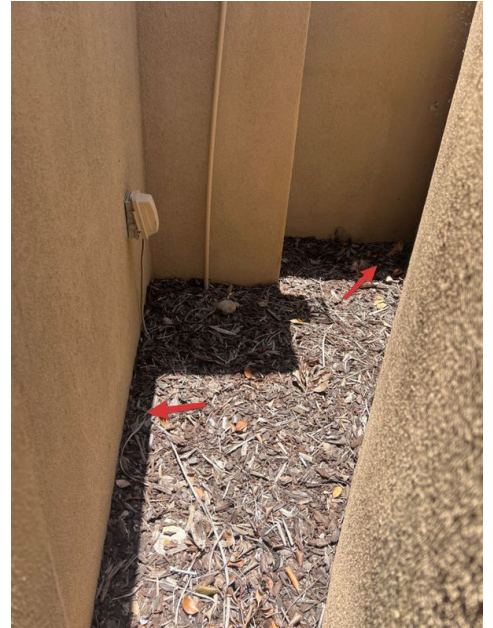
The stucco extends down to the soil without the benefit of a weep-screed. Weep screed is a horizontal strip of metal that isolates the stuccoed structural walls from the foundation and allows them to move independently of the foundation. This not only prevents horizontal cosmetic cracks that are commonly seen at the base of many stuccoed walls but also isolates the stucco from the soil and inhibits the wicking effect of moisture being drawn up into the stucco which in turn creates the flaking and peeling that is common on such surfaces.

Recommendation  
Contact a stucco repair contractor

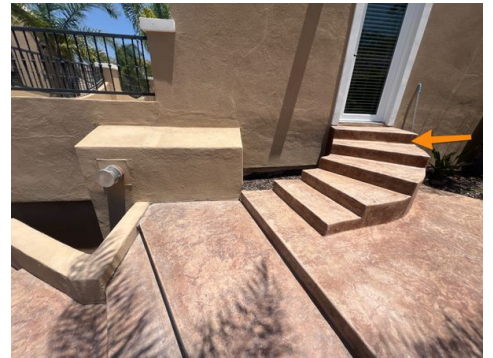
## ADU EXTERIOR STAIRCASE

ADU Exterior Staircase Handle is Missing. Please refer to a license contractor for further evaluation.

Recommendation  
Contact a qualified professional.

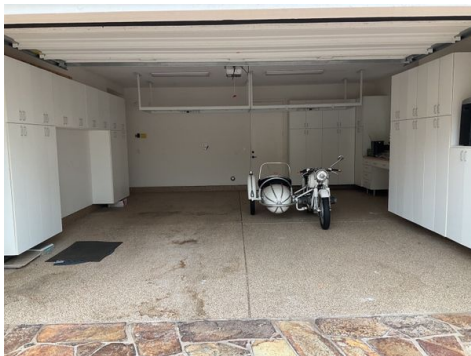
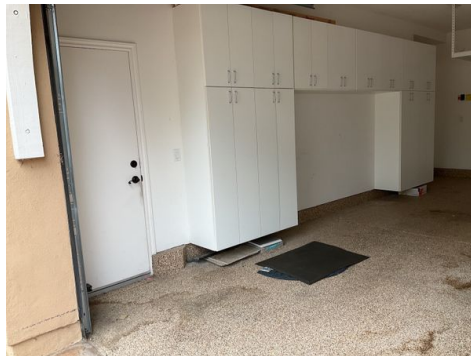
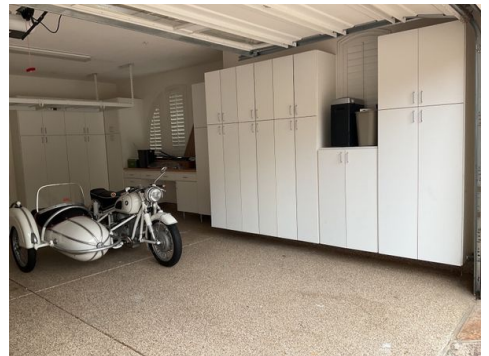
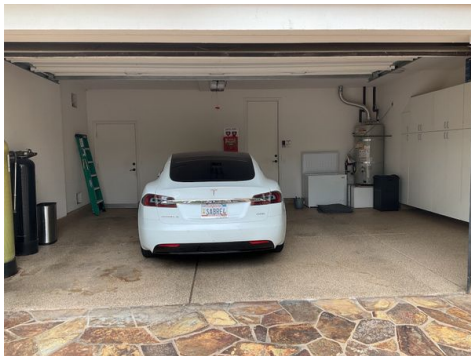
View of garage interior walls, floor and ceiling at the time of inspection. The \*garage walls, ceiling and floor have stored items which impede the inspector's full view. Remove stored items and re-inspect at later date.

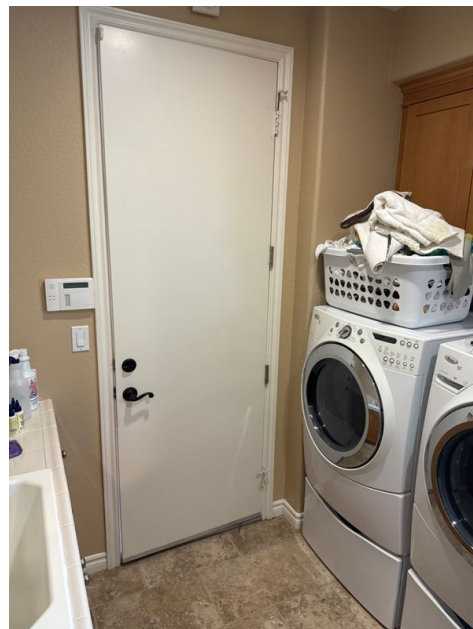
## SELF-CLOSING HINGES NEED MAINTENANCE

The garage entrance door to the residence is not self-closing. Caution safety hazard ⚠ the garage entry door is required to be on self-closing hinge(s). This compromises the fire separation between the garage and the living space. Refer to a licensed contractor for maintenance and repairs.

Recommendation  
Contact a qualified general contractor.

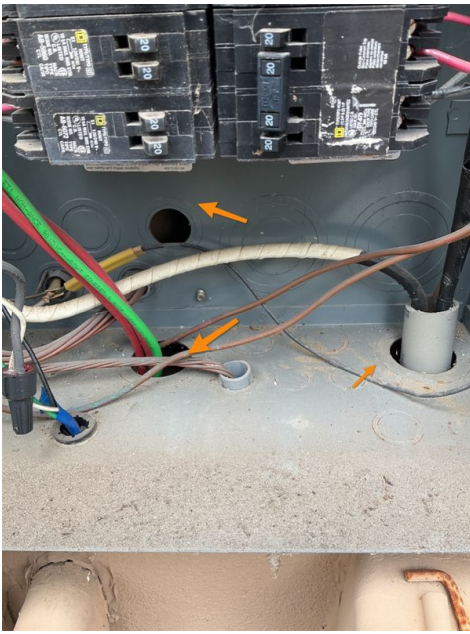
The electrical panel has open voids/slots. Caution area is prone to rodents nesting inside the electrical panel and wall cavity. Safety hazard Refer to licensed electrical contractor for repairs.

Recommendation  
Contact a qualified professional.

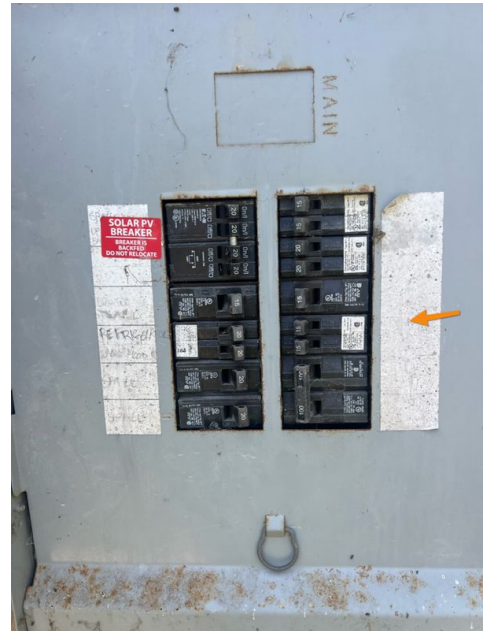
10.5.1 \*Electrical \*Sub \*Panel ADU  
**NOT LABELED**

The electrical sub-panel circuits are not clearly labeled with indelible marker. NEC standards require that all circuit breakers be clearly identified. Seek licensed electrical contractor for repairs. Sub-panels are often located inside residences, but they should not be located inside cloth closets, where they might be concealed and could impede an emergency disconnect. However, when they are located outside they are required to be weatherproof, unobstructed, and easily accessible, and their circuits should be clearly labeled. Refer to licensed electrical contractor for the cost to relocate sub-panel.

Recommendation  
Contact a qualified electrical contractor.

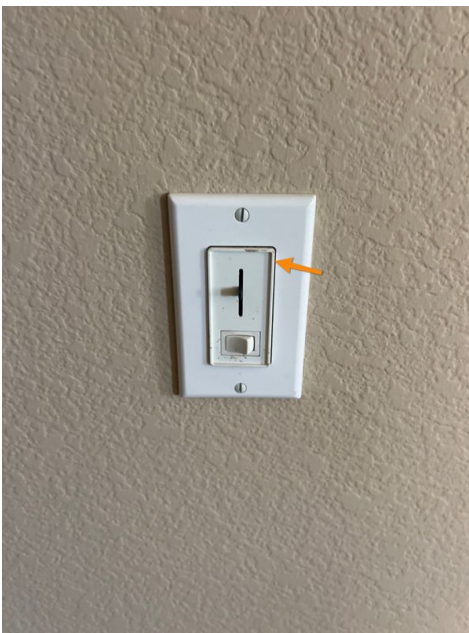
10.8.1 Switches / Receptacles  
**TOGGLE SWITCHES MISSING**

Toggle switches throughout the residence, appears to be missing. Please refer to a licensed electrician for further valuation and repairs.

Recommendation  
Contact a qualified professional.

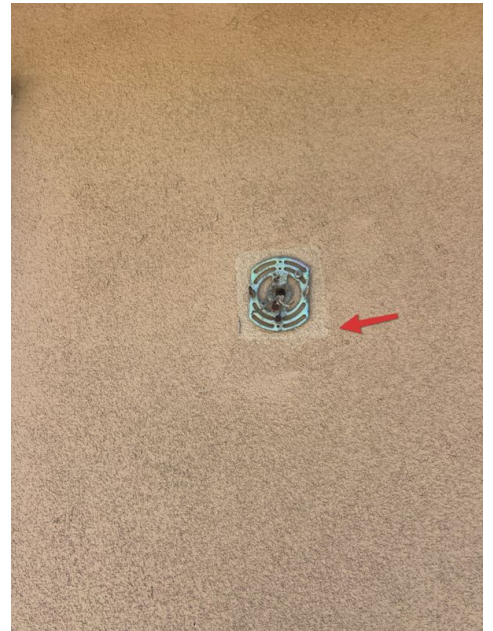
#### **EXTERIOR LIGHT FIXTURES MISSING / DAMAGED**

The building exterior light fixtures show adverse conditions. The light fixtures are intermittent, missing with exposed wires, rusted fixtures. Caution potential safety concern. Seek a licensed electrical contractor for further evaluations.

Contact a qualified electrical contractor.

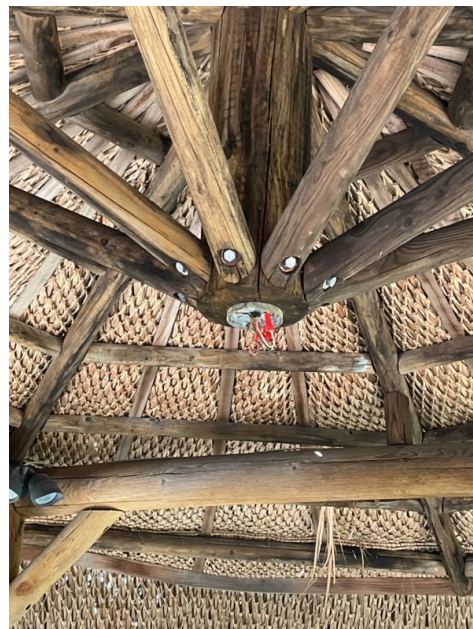
Outdoor patio barbecue area, ceiling, fan and or light not in place we have exposed electrical wiring missing junction box cover. Safety concern. Refer to a licensed electrician for repairs.

Recommendation  
Contact a qualified electrical contractor.

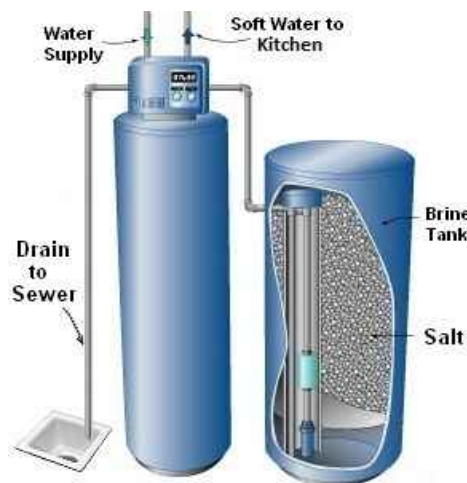
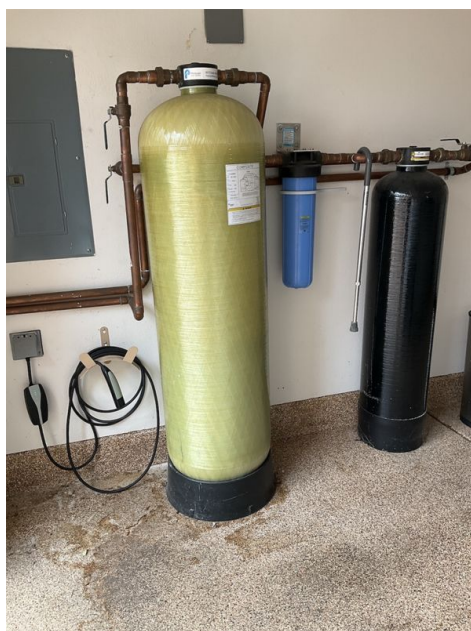
**Note:** A water softener system / water treatment device was installed on the premises. These are specialty systems and are excluded from this inspection. Comments in this report related to this system are made as a courtesy only and are not meant to be a substitute for a full evaluation by a qualified specialist. Water softeners typically work by removing unwanted minerals (e.g. calcium, magnesium) from the water supply. They prevent build-up of scale inside water supply pipes, improve lathering while washing, and prevent spots on dishes. Recommend consulting with the property owner about this system to determine its condition, required maintenance, age, expected remaining life, etc.

Recommendation  
Contact a qualified professional.

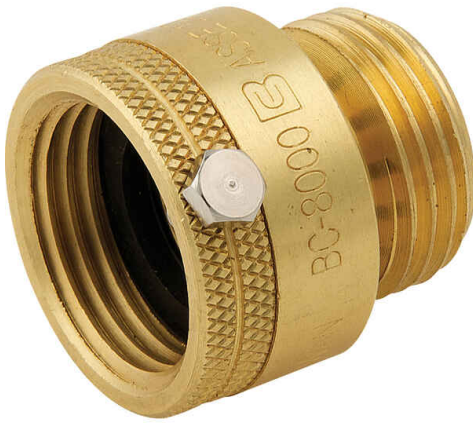
Hose Bib Backflow Preventer

## ANTI-SIPHON DEVICE MISSING

If the exterior wall hose bibs are missing, anti-siphoning devices. They are susceptible to cross-contamination into potable water supply. Refer to licensed contractor for repairs.

Contact a qualified plumbing contractor.

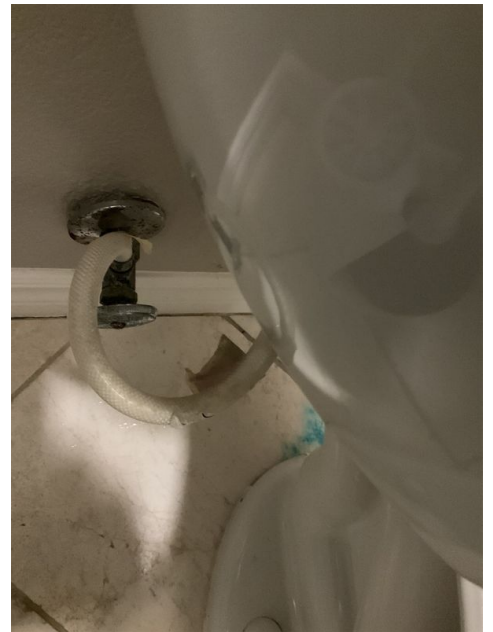
**WATER SUPPLY VALVE OXIDATION**

The water supply valves beneath the sinks, toilets, and laundry area shows oxidation and rust at valve stems and pipe connection which are conducive to water leakage if not replaced immediately. Seek licensed plumbing contractor for approved repairs and cost of replacement.

Recommendation  
Contact a qualified plumbing contractor.

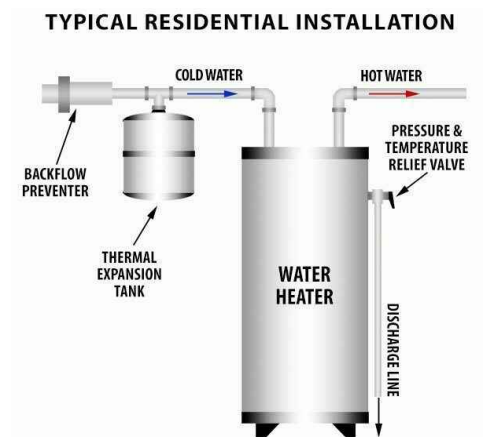
**\*NO EXPANSION TANK**

An expansion tank was not installed for the water heater. Current standards and manufacturers instructions recommend that expansion tanks be installed during water heater installations on closed loop systems. The presence of a pressure regulator where the water pipe enters the home, prevents back flow, and makes this a closed loop system. When water is heated, it expands, and can put pressure on the water heater or plumbing components, the expansion tank provides an area for this "expanded" water to enter. The installation of an expansion tank is recommended to be conducted by a licensed plumber.

Recommendation  
Contact a qualified plumbing contractor.

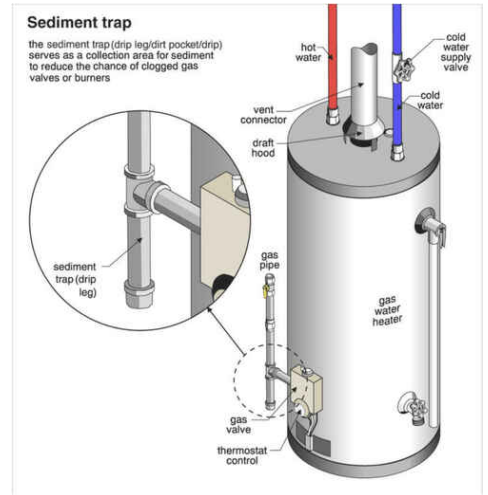
The gas supply pipe at the water heater did not contained a drip leg/ sediment trap. This may have been standard at the time of installation but now is highly recommended. The purpose of a drip leg is to prevent sediment/ debris from entering and clogging the water heater gas valve which could cause the water heater to shut down. Recommend having a drip leg installed by a qualified licensed plumber.

Recommendation  
Contact a qualified professional.

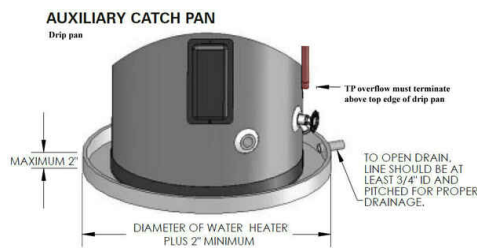
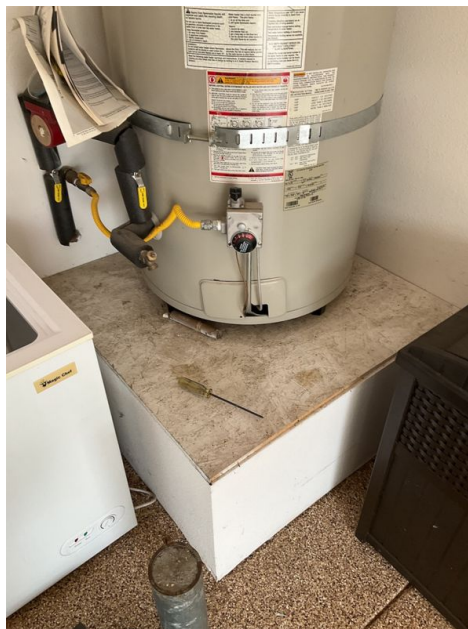
#### NO CATCH / SMITTY PAN INSTALLED

The water heater is not equipped with a leak pan. This is a recommended correction when the appliance is installed in a location where failure may pose a potential for water damage. Advise consulting a licensed plumbing contractor for correction.

Recommendation  
Contact a qualified plumbing contractor.

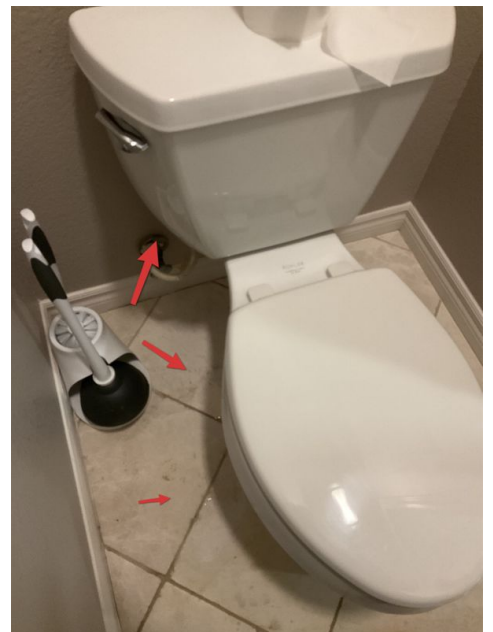
### TOILET TANK LEAKS

The toilet tank was leaking where it attached to the toilet. Flooring, the sub-floor or areas below may get damaged. Recommend that a qualified contractor remove the tank(s) and install a new rubber ring and tank(s) should be securely anchored to the toilet to prevent movement and leaking.

Contact a qualified plumbing contractor.

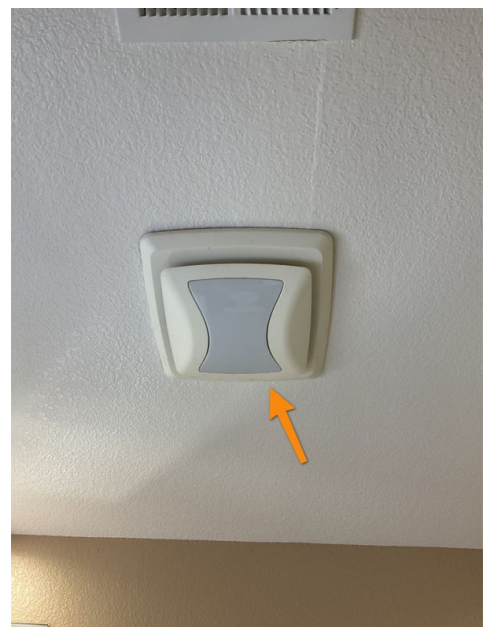
Light Bulb Need Replacement

### EXHUAUST FAN LIGHT NON FUNCTIONAL

The ceiling exhaust fan light not responding. Light bulb replacement recommended.

Contact a qualified professional.

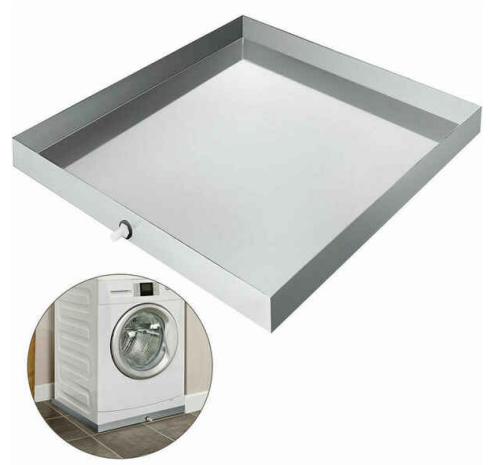
11.13.1 Laundry  
**NO CATCH PAN**

The laundry area washing machine does not have the approved drain pan or floor drain beneath the washing machine. Caution uniform standards of practice recommend that a drain pan be in place. The laundry area is susceptible to moisture intrusion and damages. Refer to a licensed contractor for repairs and maintenance.

Recommendation  
Contact a qualified appliance repair professional.

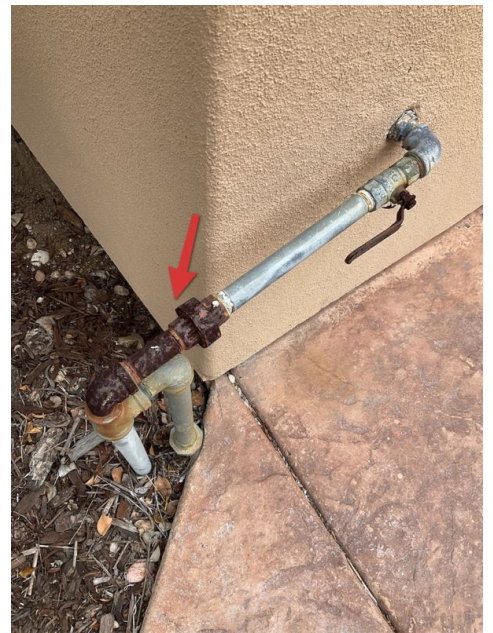
Exterior Rear Side Year

11.14.1 Fuel Systems  
**REAR YARD GAS PIPE EXCESSIVE RUST**

The rear side yard barbecue gas galvanized pipe show excessive rust and oxidation and prone to gas leakage. Caution potential safety hazard. Refer to a licensed plumbing contractor for repairs.

Recommendation  
Contact a qualified plumbing contractor.

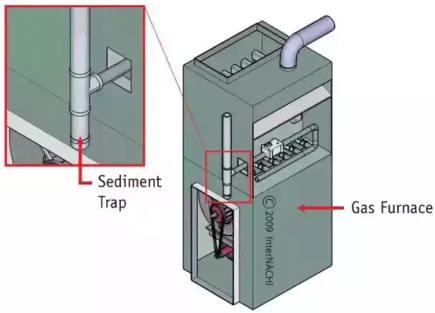
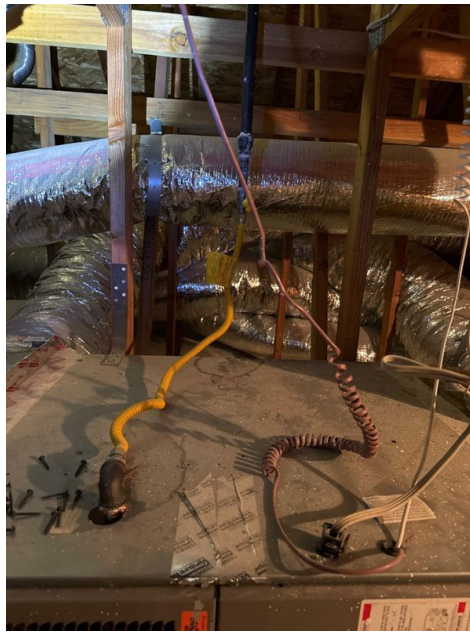
12.2.1 Heating / Forced Air  
**SEDIMENT TRAP (DRIP LEG)**

The furnace gas supply is missing condensation drip leg, and/or sediment trap at gas supply pipe connection. Seek a licensed HVAC contractor for approved repairs.

Recommendation  
Contact a qualified professional.

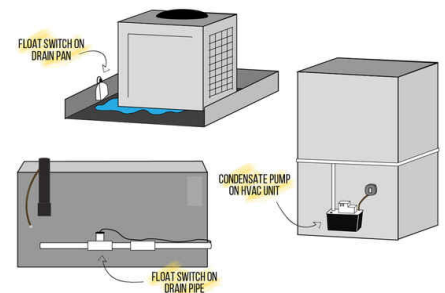
### 12.5.2 Air Conditioner NO SAFETY T- SWITCH

(Safety T Switch) No float switch for emergency shutoff was found on the "evaporator coil" to shut the system off in the event the condensate line becomes clogged this is known as "Safety T- Switch" without this mechanism, water from the condensate line will overflow onto whatever is below/around the unit, potentially causing excessive moisture damage. Refer to a licensed HVAC contractor for immediate repairs prior to sale.

Recommendation  
Contact a qualified HVAC professional.

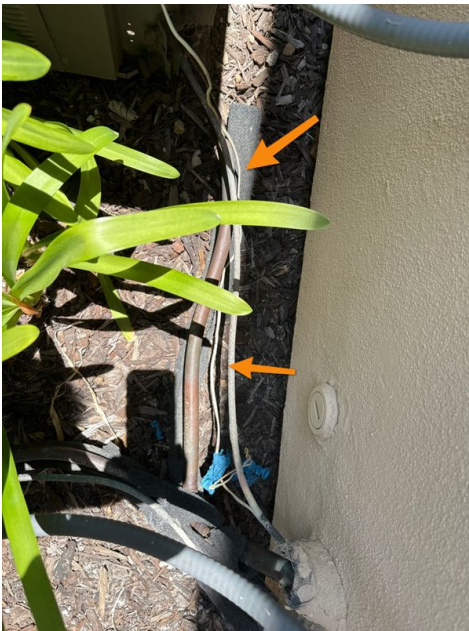
Exterior

### 12.5.3 Air Conditioner INSULATION MISSING / DETERIORATING

The insulation for the refrigerant line was in contact with the soil and deteriorating / missing. Caution  $\Delta$  this places premature wear on system components. Refer to licensed HVAC contractor for repairs.

Recommendation  
Contact a qualified HVAC professional.

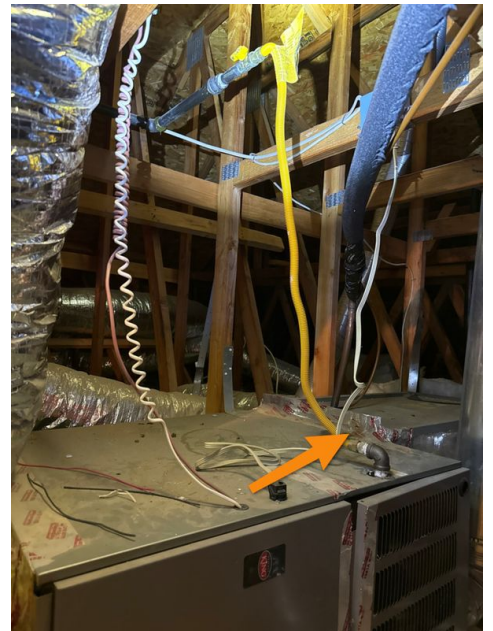
### 13.1.1 Heating / Gas Forced Air **SEDIMENT TRAP (DRIP LEG)**

The furnace gas supply is missing condensation drip leg, and/or sediment trap at gas supply pipe connection. Seek a licensed HVAC contractor for approved repairs.

Recommendation  
Contact a qualified professional.

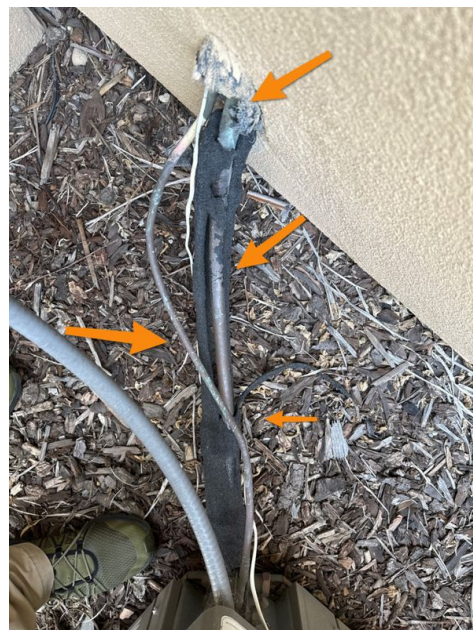
HVAC Refrigerant Pipes

### 14.2.1 Air Conditioner **REFRIGERANT LINE INSULATION TOUCHING SOIL**

The insulation for the refrigerant line was in contact with the soil and deteriorating / missing. Caution

this places premature wear on system components. Refer to licensed HVAC contractor for repairs.

Recommendation  
Contact a qualified heating and cooling contractor

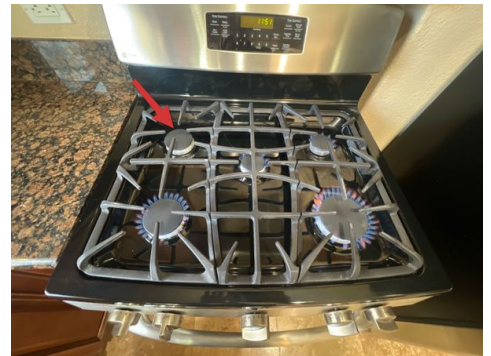
**OVEN BURNER(S) / ELEMENT(S) INOPERABLE**

Oven gas burner(s) and/or electric element(s) appear inoperable. Recommend a qualified appliance repair person evaluate & repair.

Recommendation  
Contact a qualified appliance repair professional.

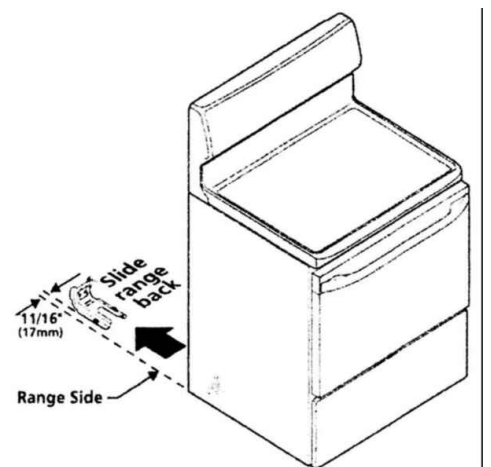
**\*ANTI TILT DEVICE / BRACKET MISSING**

An anti tilting device or bracket was not installed at the stove / range. This bracket prevents the range from tipping forward which could causing injuries to children and adults. Safety hazard. We recommend installation of an anti tip bracket by a licensed contractor for safety and to help prevent injury.

Recommendation  
Contact a handyman or DIY project

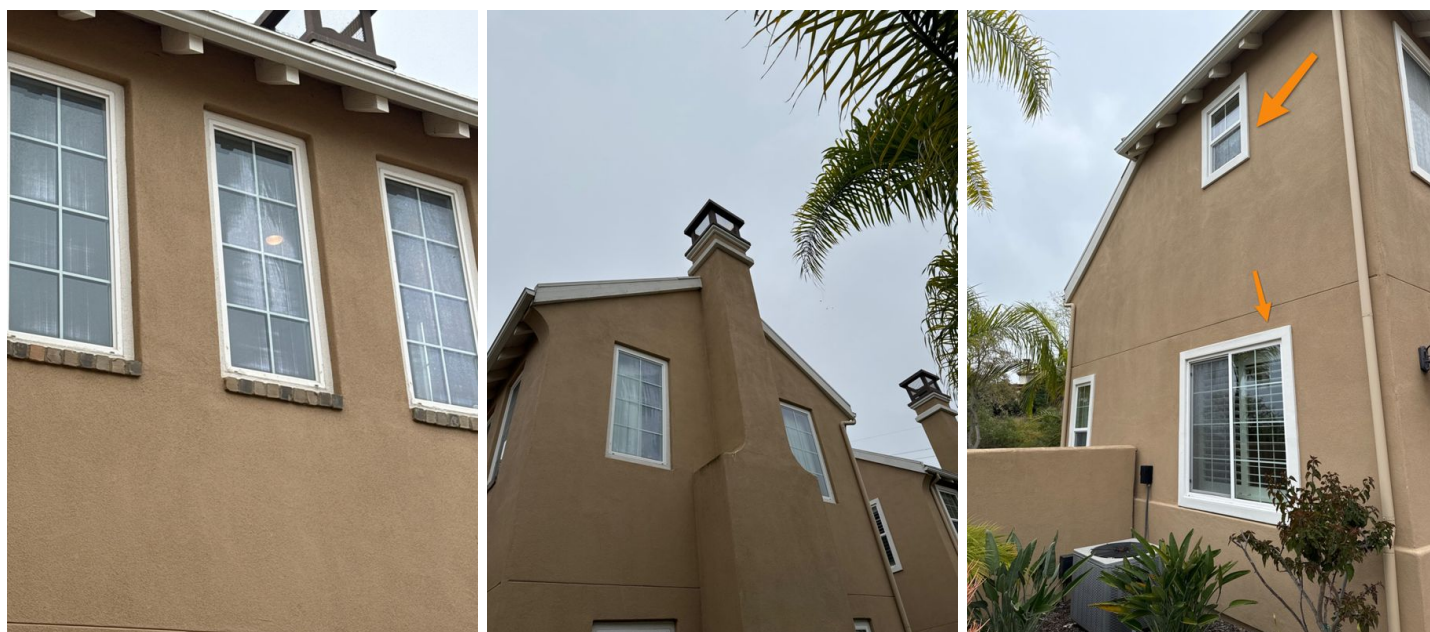
The exterior / interior \* windows and doors in various locations within the structure(s) appear to have dirty, cloudy/ fogging conditions. This appears to be prior window condensation. The window gaskets maybe compromised and/or starting to fail. Refer to a licensed window contractor for service and/or replacement glass panels.

Contact a qualified window repair/installation contractor.

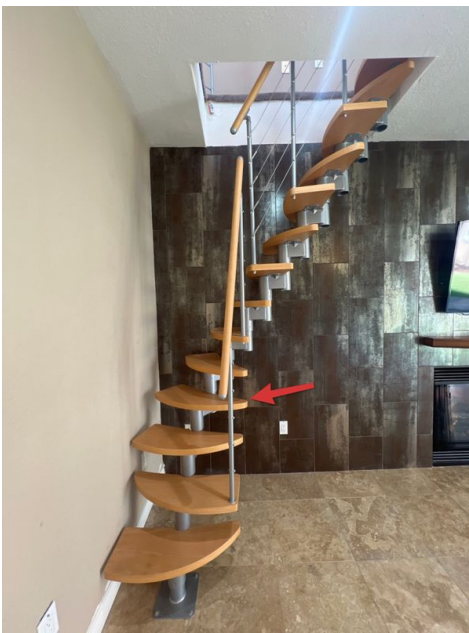
**STAIRCASE HAND RAILING**

The interior staircase hand railings does not meet uniform standards of practice. The height of the staircase railing is less than 34" inches. Caution ⚠ trip and fall hazard. Refer to licensed contractor for repair.

Contact a qualified general contractor.

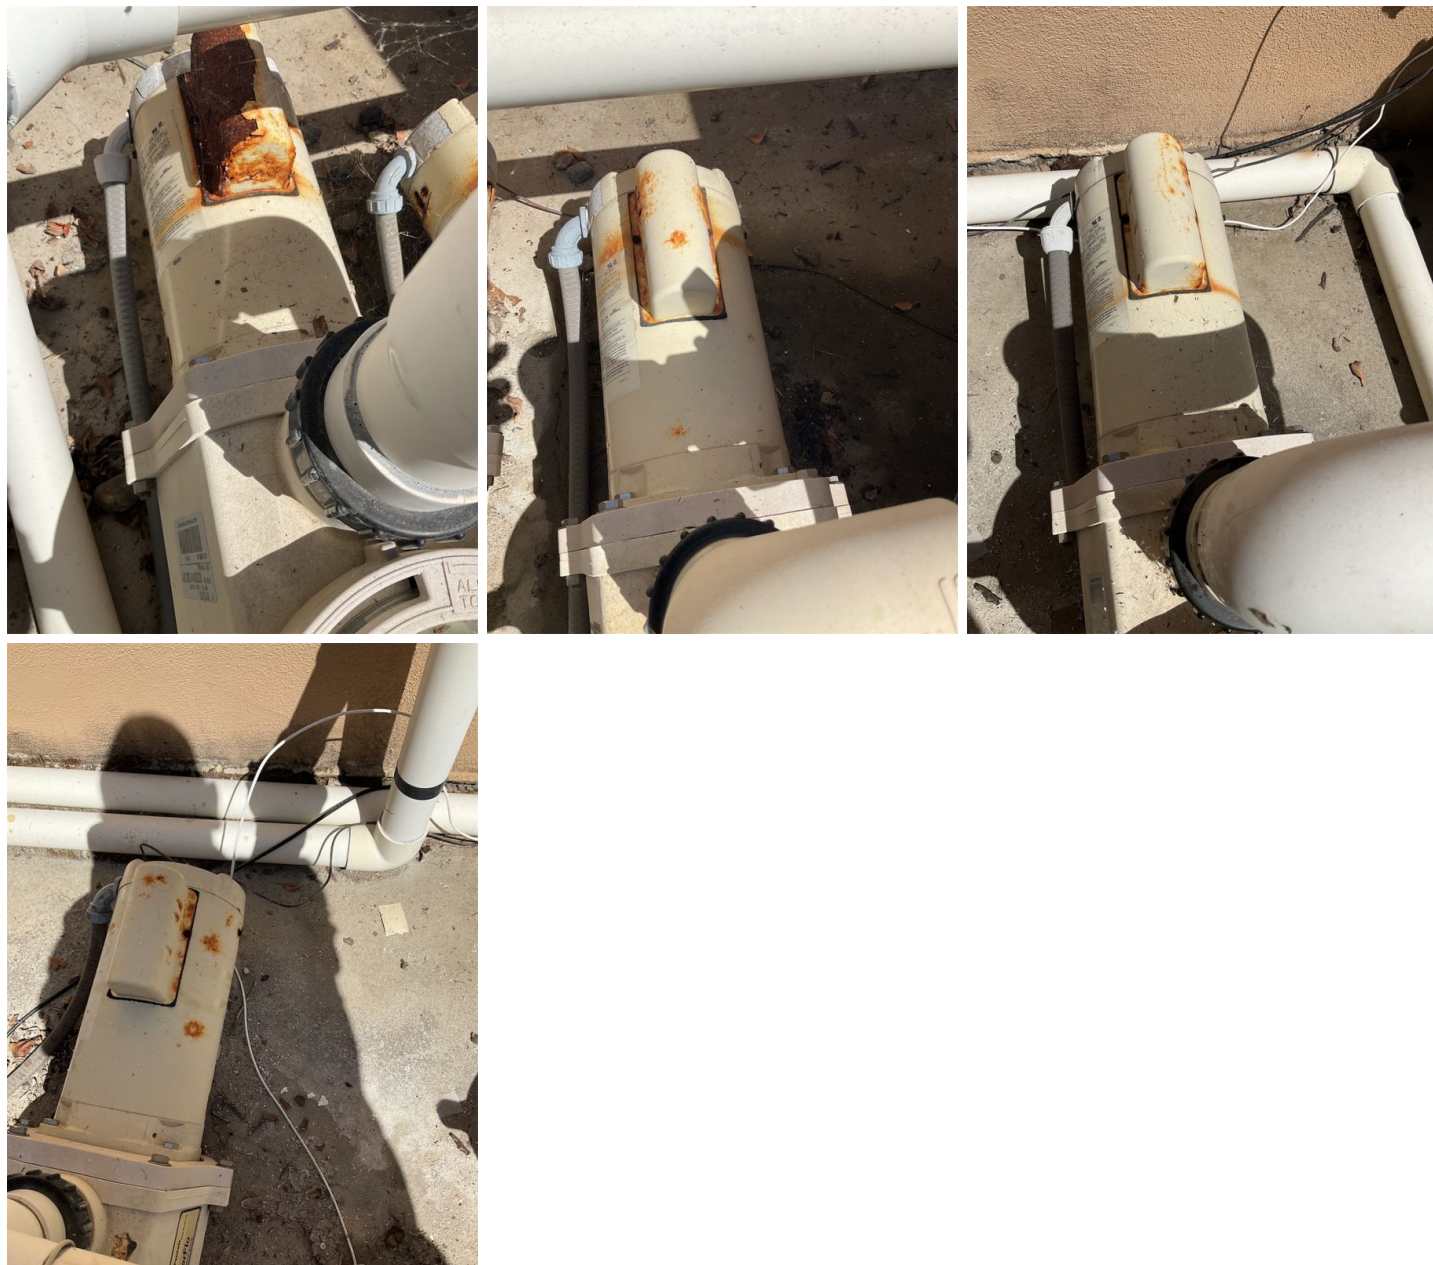
The swimming pool pumps, motors and equipment appear to lack general maintenance and service. The swimming pool and spa motors and pump show excessive rust, oxidation, and motor(s) are make loud noise and grinding sounds they appear at or nearing the end of useful lifespan and prone to failure.

Recommendation  
Contact a qualified swimming pool contractor

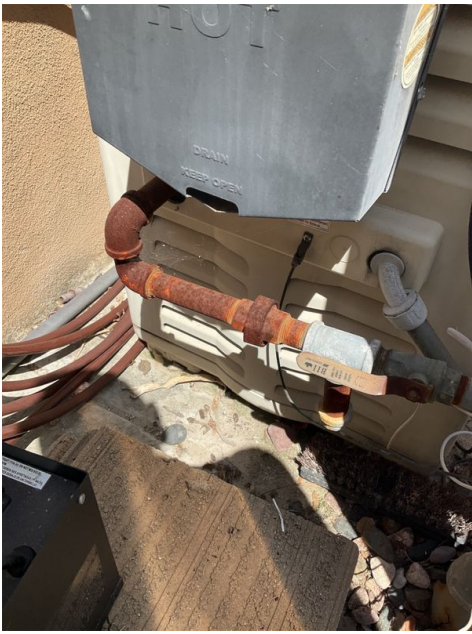
### POOL HEATER EXCESSIVE RUST

Contact a qualified swimming pool contractor
