## **Confidential Inspection Report**

**3232 Lanier**  
**Thousand Oaks, CA 91360**

**For Ellen Jirari**  
**3232 Lanier**  
**Thousand Oaks, California 91360**  
**Date 08/06/2026.**

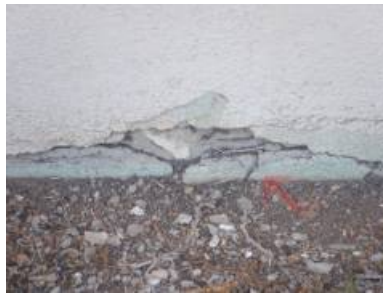
- 3.4 Visible Foundation Wall Cracks Noted From Exterior:** Yes - Cracking in the vertical foundation walls was noted from the exterior. **Action Necessary** - Cracks of 1/4" and wider were noted in the foundation walls. This condition warrants further investigation and analysis by a professional structural engineer and/or a licensed qualified foundation contractor to determine the cause and course of action.

- 3.5 Location of Wall Cracks and Description:** Horizontal cracks were noted in at least one exterior wall.

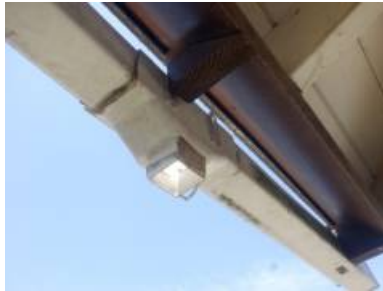
- 4.11 *Vents:* Satisfactory.
- 4.12 *Evidence of Leakage:* No -
- 4.13 *Roof Gutter System:* **Action Necessary** - The gutter system on the roof edge does not appear to be working. This is possibly due to open seams or parts missing.

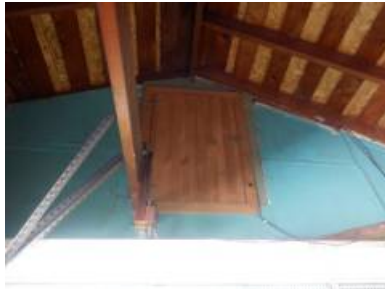
- 5.9 *Garage Walls Condition:* **Action Necessary** - For safety reasons, the dividing wall between the garage and the living space should be separated by a flame retardant material. . There is at least one opening in the firewall that creates an opening for fire travel. For safety reasons, this should be repaired.  
Door to attic is not fire rated -

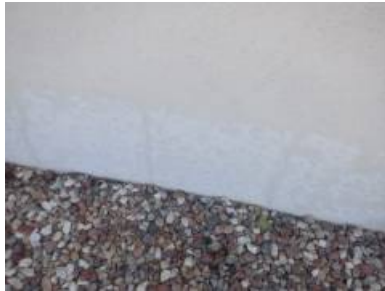
- 6.1 *Type of Construction:* Frame.
- 6.2 *Exterior Siding Materials:* Stucco.
- 6.3 *Siding Condition:* **Attention Needed** - The exterior siding material or finish is in a condition that requires minor repair to prevent further deterioration. Cracks observed monitor for further activity and seal as needed.

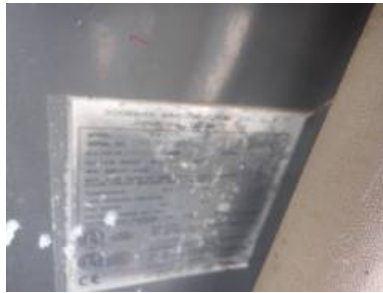
7.1 Model/ Serial Number/ Size: Brand - ; Model # ; Serial # ; This unit was manufactured about .

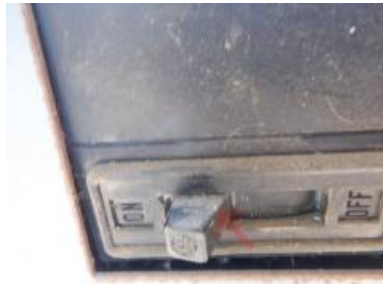
- 8.4 *Main Power Panel Size:* 100 amp - The amperage of the main power panel appears to be within the normal parameters for the structure's age. However, a load analysis is recommended if you anticipate adding more circuits or load to the system.

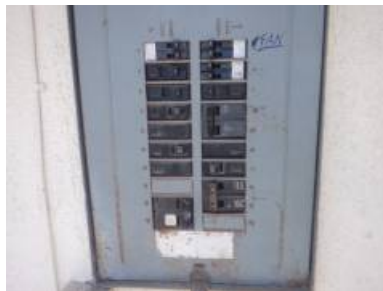
- 8.10 *Legend Available:* No - The breakers are not marked as to the rooms, areas, or appliances controlled. It is recommended that they be noted as soon as possible.

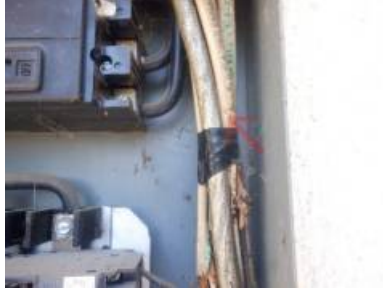
**8.13 Feeder and Circuit Wiring** **Attention**-Older cloth wiring observed- Contact electrician to verify condition.  
*Type:*

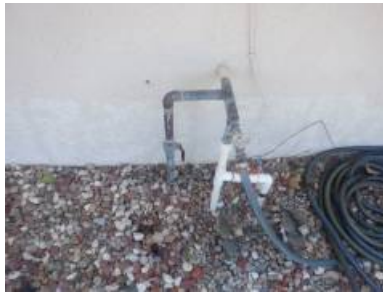
9.2 *Plumbing Service Piping Size* 3/4" water service line from the meter to the main cutoff.  
*to Structure:*

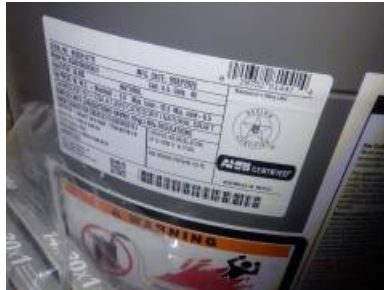
9.22 *Model & Serial Numbers:* Brand - Rheem ; Model # - ; Serial # - ; Manufactured **approximately** 2025 The average service life for a water heater is 10 - 12 years.

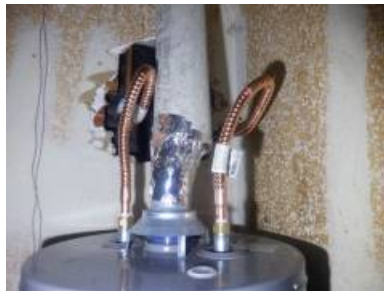
9.25 *Exposed Water Heater Condition:* **Action Necessary- Missing cold water bond.**  
**Action Necessary- Missing expansion tank.**

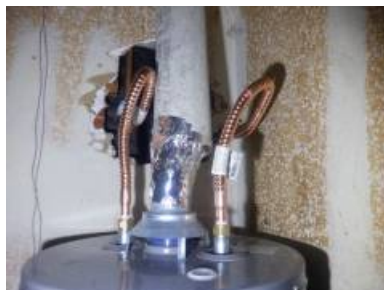
9.29 *Flue/Exhaust Pipe Condition:* The exhaust flue appears to be correctly installed. Note the metal pipe is connected to Transite pipe which is known to contain asbestos.
