A BETTER HOME INSPECTION BY FORSTERS, INC.

## PROPERTY INSPECTION REPORT

3425 Purer Rd  
Escondido, CA 92029

Tony Wang  
07/18/2026

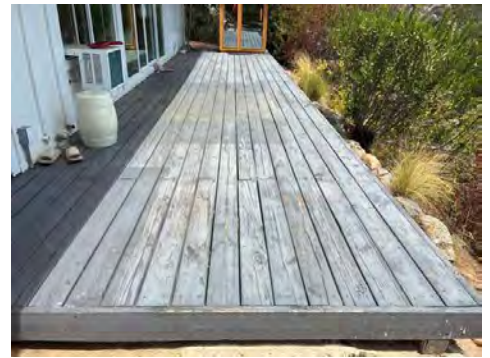
Rear of Property

### 3.4.5 Patio/Decks/Covers

- Structural deterioration: Weathering and water damage can weaken the materials, potentially compromising the deck or balcony's stability.
- Increased risk of rot: Prolonged exposure to moisture can lead to wood rot, further weakening the structure.
- Safety hazards: Damaged or deteriorated areas may pose a risk to occupants, especially if the deck or balcony is frequently used.

We recommend further evaluation and correction by a licensed professional to address the weathering and water damage, ensuring the safety and longevity of the deck or balcony.

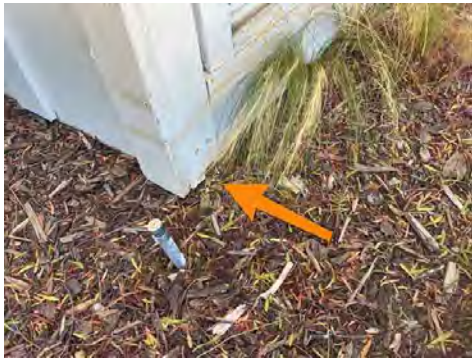
Rear of Property

#### **SIDING/TRIM - DETERIORATION/DAMAGE/MISSING**

Contact a qualified siding specialist.

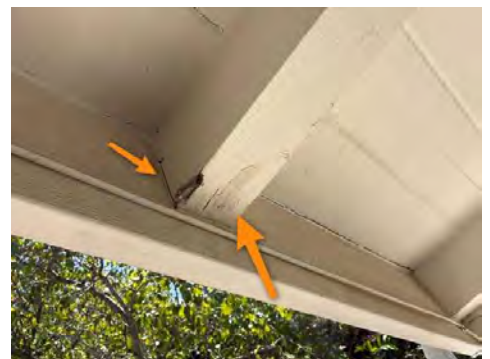
Rear of Property

**RAFTER TAILS - DAMAGE / DETERIORATION**

Damage was noted to the rafter tails in one or more areas around the home; not all areas may be shown. This condition can lead to:

- Damaged rafter tails can allow water to enter, potentially leading to rot, mold, or structural weakening.
- Prolonged damage may compromise the integrity of the roof structure.
- Refer to the termite report: For detailed findings regarding rot, fungus, or insect damage.

We recommend further evaluation and correction by a licensed professional to address the damage and ensure the rafter tails are properly repaired to prevent further deterioration.

Contact a qualified professional.

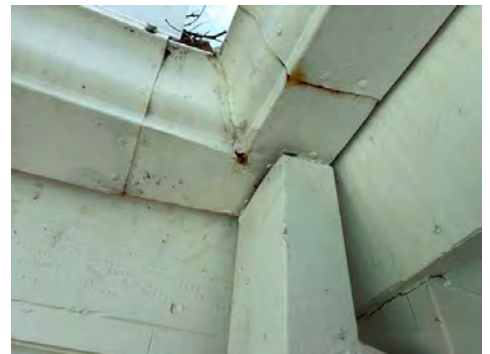
Rear of Property

- Water pooling: Leaking gutters may allow water to accumulate near the foundation, increasing the risk of moisture intrusion.
- Soil erosion: Continuous leakage can erode soil around the home, potentially impacting foundation stability.

Recommend further evaluation and correction as needed by a licensed gutter repair professional to address leaks and ensure effective water drainage away from the foundation.

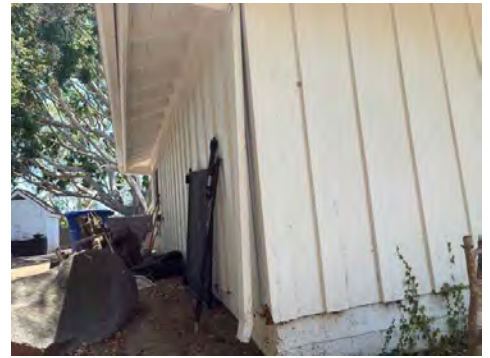
Rear of Property Garage

- Improper drainage: Loose gutters or downspouts may allow water to drain improperly, increasing the risk of moisture buildup near the foundation.
- Damage to gutters and structure: Unsecured components can cause wear or detachment, potentially damaging both the gutters and the building.

Recommend further evaluation and correction as needed by a licensed gutter repair professional to secure all loose gutters and downspouts, ensuring effective drainage.

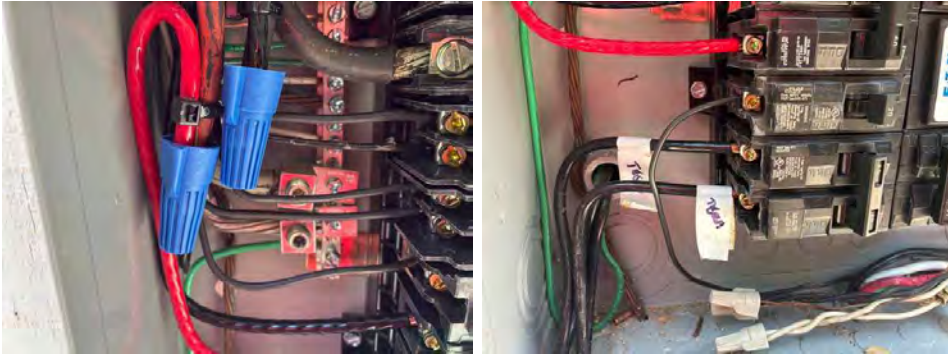
### 5.2.2 Main Panel

#### MAIN PANEL - SPLICED WIRES

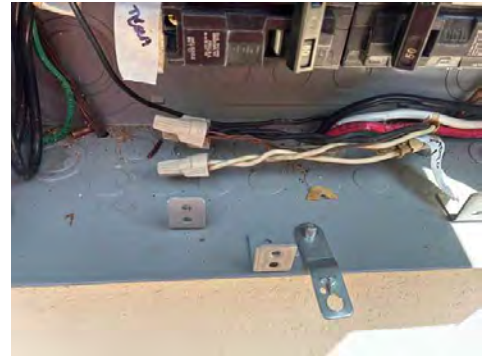
### 5.2.3 Main Panel

#### MAIN PANEL - UN-TERMINATED ROMEX

Contact a qualified professional.

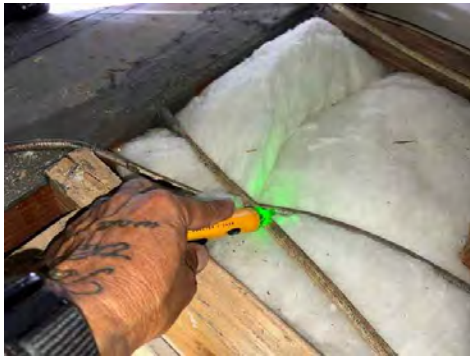
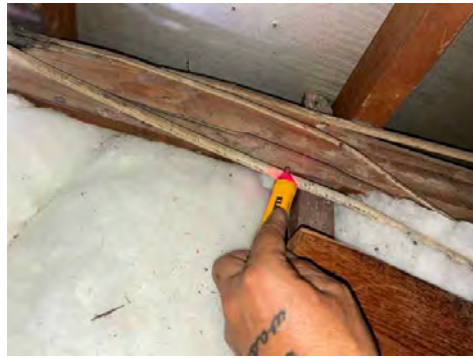
Attic

- Fire hazard: Cloth wiring is more prone to deterioration over time, increasing the risk of overheating and electrical fires.
- Non-compliance: Older wiring may not meet modern safety standards, potentially compromising the safety of the electrical system.

Recommend further evaluation and correction by a licensed electrician to assess the extent of cloth wiring, verify the condition of the electrical system, and make necessary updates to improve safety and compliance with current standards.

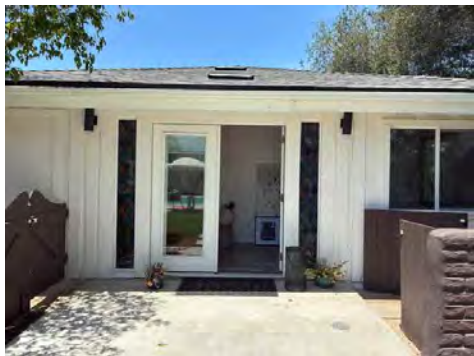
The garage appears to have been converted into bedroom(s), bathroom(s), office, or other living space. No permits or documentation were available at the time of inspection to verify whether the conversion was performed in compliance with local building codes. This condition can lead to:

Recommend further evaluation and correction as needed by a licensed contractor and verification with the local building department to confirm whether the conversion was permitted and completed to code.

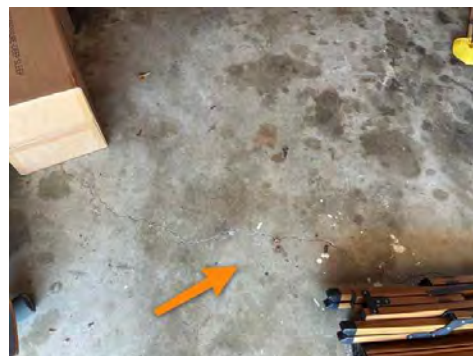
#### **GARAGE FLOOR - SETTLEMENT CRACK (-)**

One or more minor cracks were noted in the garage floor, appearing consistent with normal settling. This condition can lead to:

- Minor unevenness or cosmetic imperfections in the floor surface.
- Potential for cracks to expand over time, leading to trip hazards or moisture intrusion.

Recommend further evaluation and correction as needed by a licensed professional to ensure the cracks are not indicative of a larger issue and to maintain a safe, even surface.

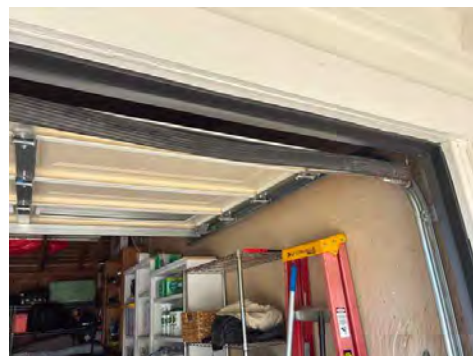
#### **GARAGE DOOR - WEATHER STRIPPING - DAMAGED / MISSING**

The garage door was observed to be missing and/or had damaged or loose weather-stripping at the time of inspection. Proper weather-stripping helps seal the door against the elements. This condition can lead to:

- Air, moisture, and pest intrusion, potentially affecting energy efficiency and interior comfort.
- Increased wear on door components due to exposure to environmental conditions.

Recommend further evaluation and correction as needed by a licensed garage door specialist or contractor to repair or replace the weather-stripping and ensure a proper seal.

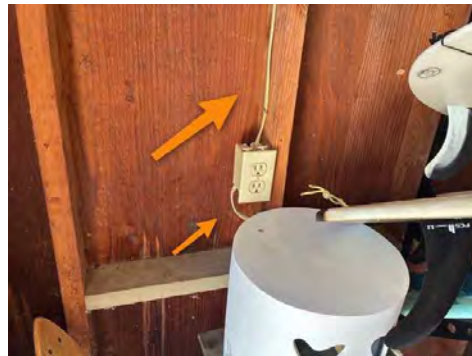
#### **WIRING - ROMEX BELOW 7FT**

Exposed Romex wiring was noted in one or more areas around the home. Electrical Romex below 7 feet should be properly protected by being placed in electrical conduit or behind drywall. This condition can lead to:

- Safety hazards: Exposed Romex is vulnerable to damage, which could result in electrical shock, short circuits, or fire.

We recommend further evaluation and correction as needed by a licensed professional to ensure proper protection and compliance with electrical safety standards.

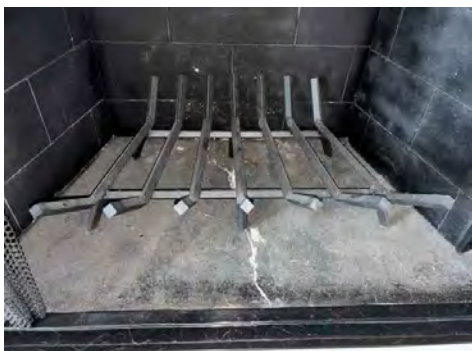
Master Bedroom

### FIREPLACE - CRACK(S)

It is noted that there is one or more cracks to the fireplace. Recommend repair as needed by qualified person

Contact a qualified professional.

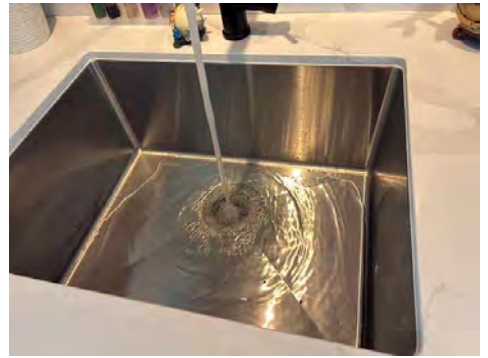
## 9.10.1 Wet Bar Sink

A slow drain was observed at the sink, indicating a potential blockage or plumbing issue. This condition can lead to:

- Reduced functionality of the sink, causing inconvenience during use.
- Further clogging or damage to the plumbing system if the issue is not addressed.

Recommend further evaluation and correction as needed by a licensed plumber to identify and resolve the cause of the slow drain and restore proper drainage.

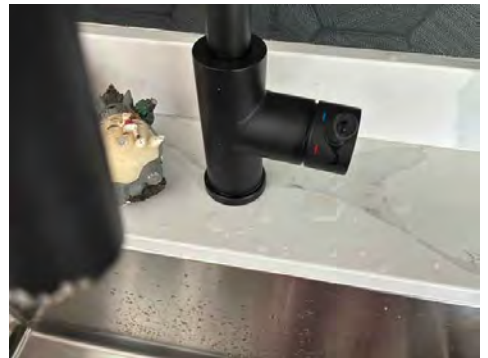
## 9.10.2 Wet Bar Sink

**SINK FAUCET - HOT & COLD REVERSED**

The hot and cold water supplies for the sink faucet are reversed, which does not comply with standard plumbing practices. This condition can lead to:

Recommend further evaluation and correction as needed by a licensed plumber to properly configure the water supply lines and ensure safe and functional operation.

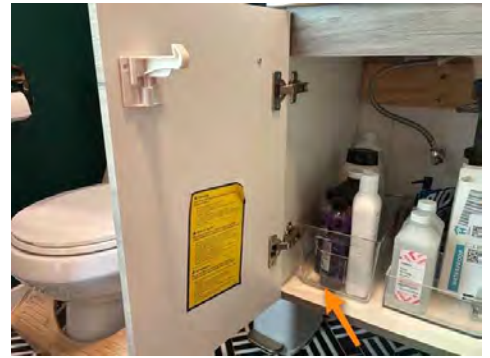
10.5.1 Countertops/Cabinets  
**CABINET - HINGE(S) LOOSE**

Cabinet hinge(s) were loose in one or more areas. Recommend further evaluation and correction as needed by licensed professional.

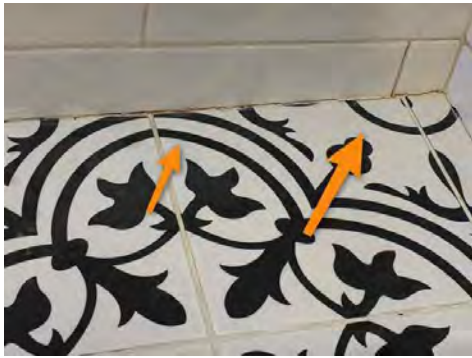
Bedroom Bathroom

### TUB/SHOWER - AREA CAULK / GROUT MISSING

Caulking or grout was missing, deteriorated, or in need of maintenance in the bathtub/shower area(s). All areas may not be shown. This condition can lead to:

- Water intrusion behind tiles or fixtures, potentially causing mold growth or structural damage.
- Reduced effectiveness of waterproofing, leading to leaks and long-term deterioration.

Recommend sealing the affected areas with proper caulking or grout to prevent water intrusion and maintain the integrity of the bathtub/shower enclosure. A qualified professional should perform the repair as needed.

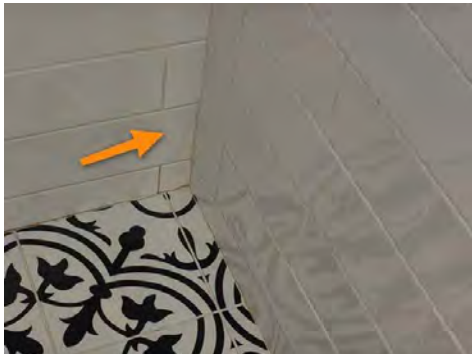
Bedroom Bathroom

### TUB/SHOWER - CRACK(S)

One or more cracks were observed in the bathtub or shower surfaces. Not all cracks may be shown, and some may not be fully visible without invasive inspection. This condition can lead to:

- Moisture intrusion into underlying materials, potentially resulting in mold growth or structural deterioration.
- Expansion of cracks over time, reducing the functionality and integrity of the fixture.

Recommend further evaluation and correction as needed by a licensed plumbing or bath repair professional to determine the extent of damage and perform necessary repairs to prevent water-related issues.

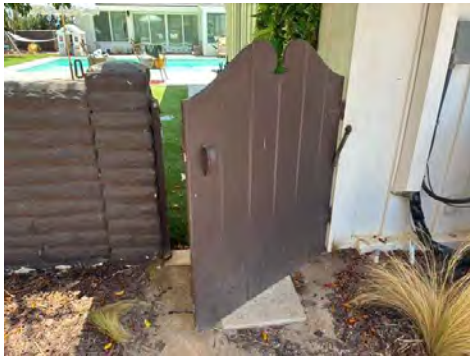
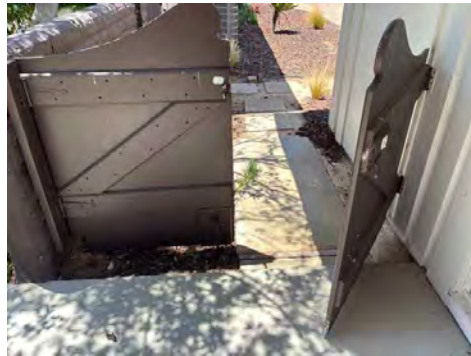
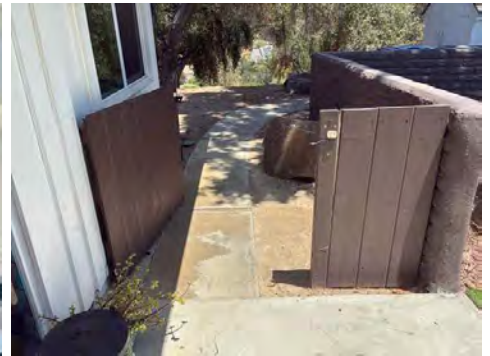
All Gates

#### SAFETY FEATURES - MISSING

One or more of the required safety features for the pool appear to be missing or non-compliant based on current safety standards.

Recommend further evaluation and correction as needed by a licensed pool safety specialist or contractor to ensure the pool meets all current safety requirements.
