Inspection Report

44359 Capri ct
Palm Desert Ca

Eagle Home Inspection Services

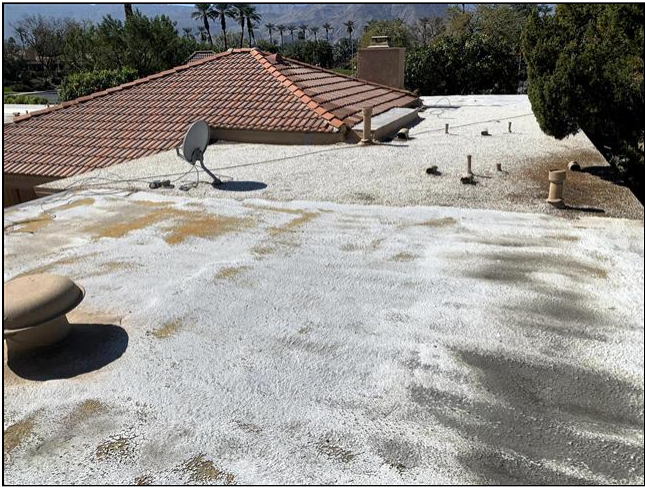
- Foam roofs are worn, need re-coating.
- Chips on a number of roof tiles.
- Recommend a roofing contractor to further evaluate roof and tile underlayment.

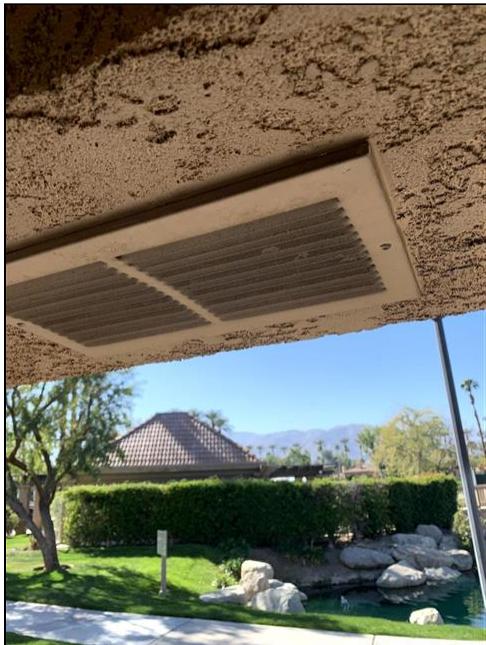
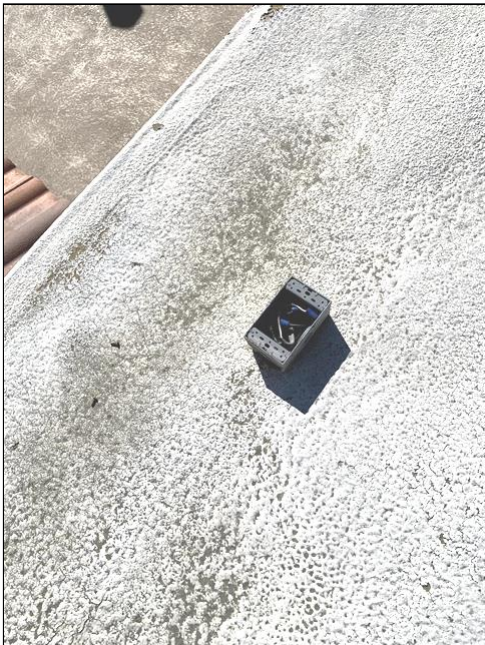
2.7 Outlets, Wiring (Exterior)

Exhaust fan over barbecue did not respond. Recommend repair/replace.

Open j-box on roof. Unknown use. Recommend further evaluation.

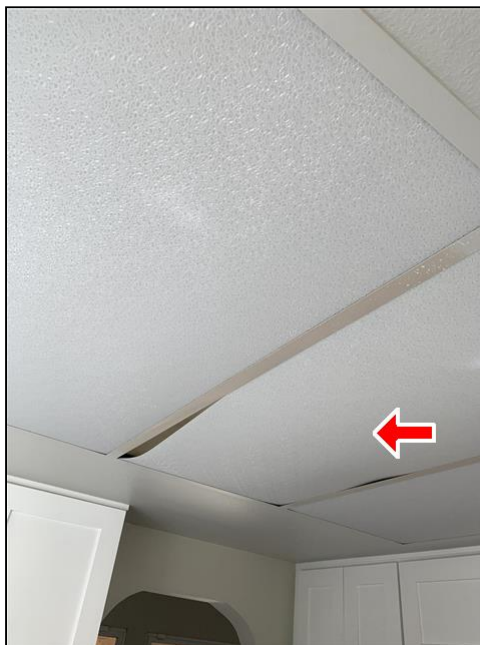
3.8 Item 1(Picture)

Note: light cover needs securing.

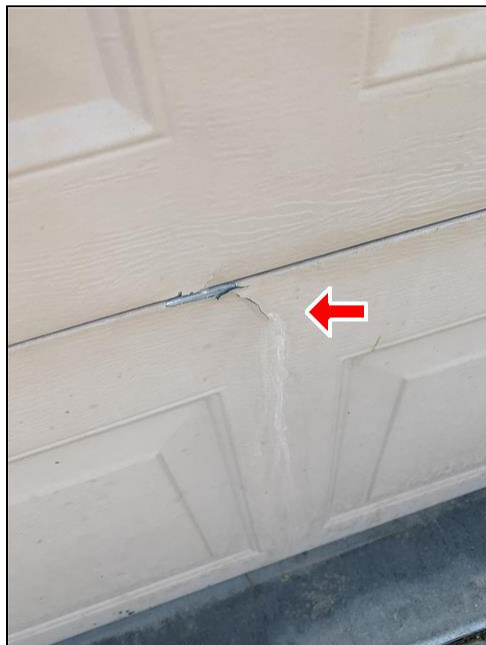
4.3 Garage Door (s)

Note: dent on garage door, paint chipped.

Separation from bug strip on right side.

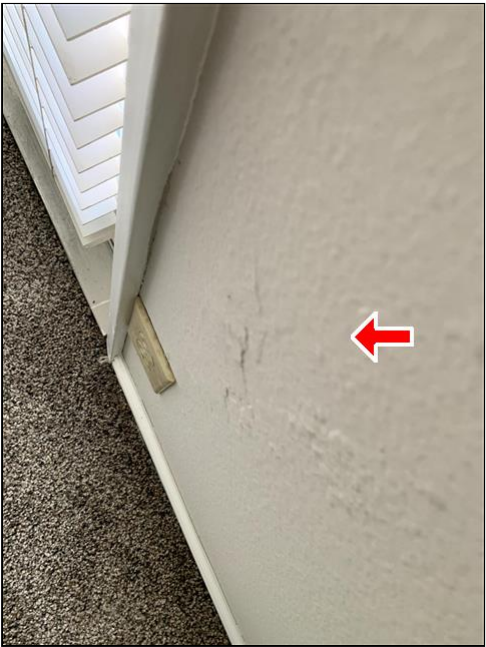
5.1 Item 1(Picture)

Note: some damage on wall by door in front bedroom.

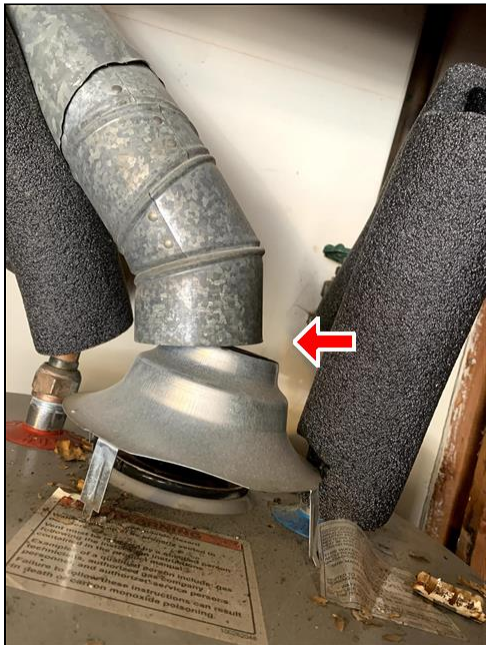
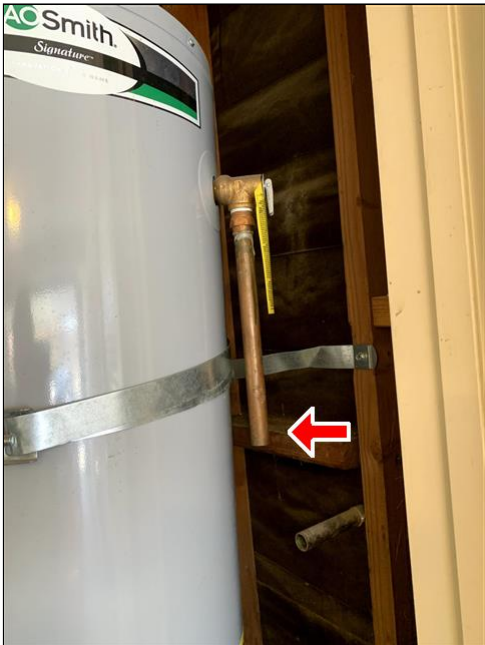
8.0 Hot Water Systems, Controls, Chimneys, Flues and Vents

Flue pipe is improper to even connect to the water heater. Needs a new flue pipe properly fitted.

TPR valve must be piped to the exterior with copper piping at a gravitational flow.

Recommend a plumbing contract to repair.

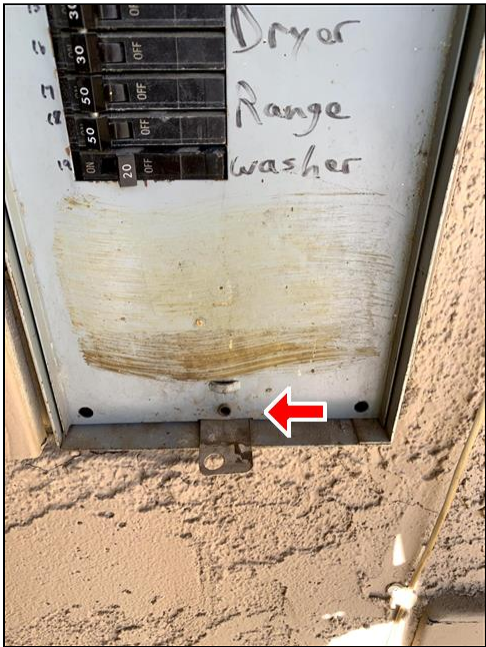
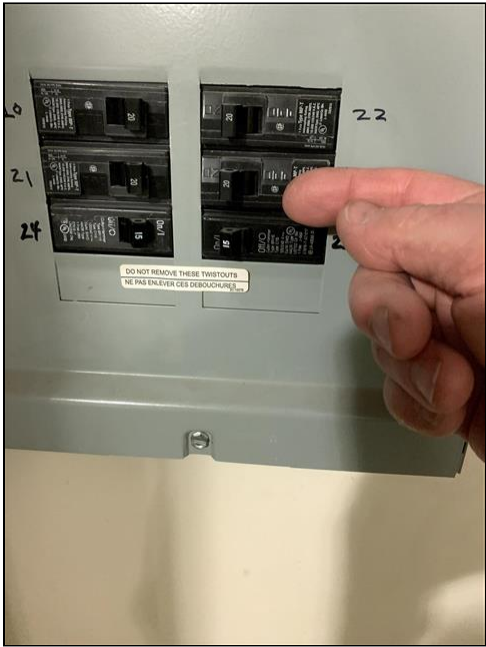
- Grounds connected to neutral bus bar. A separate bonded bus bar needed for these and both main ground/neutral must have a path back to the main panel.
- One breaker in sub panel tripped twice during inspection (third picture).
- Missing screw to secure main panel inner panel door.

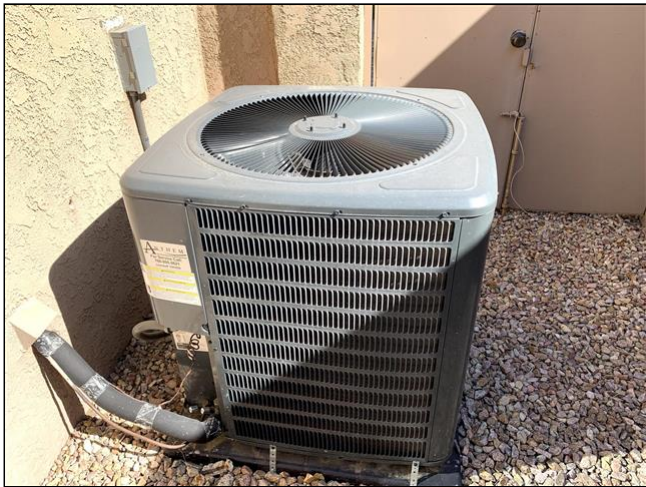
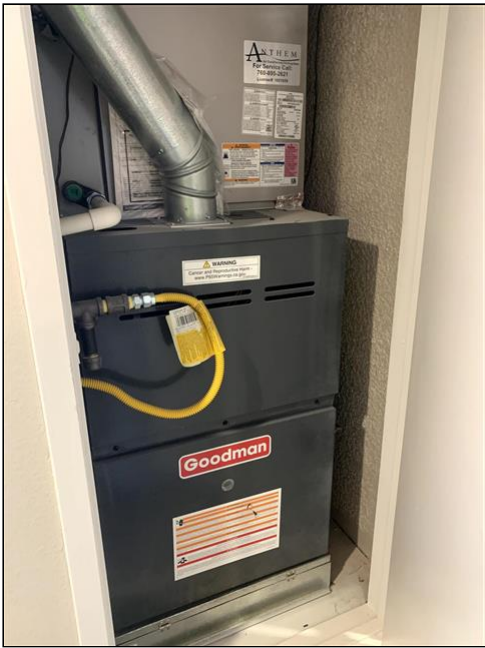
Heat Type: Forced Air	Energy Source: Gas	Number of Heat Systems (excluding wood): One
Heat System Brand: GOODMAN	Ductwork: Not Visible	Age of Furnace: 2015
Filter Type: Disposable	Cooling Equipment Type: Air conditioner unit	Cooling Equipment Energy Source: Electricity
Central Air Manufacturer: GOODMAN	Age of AC: 2018	Tons: 4 Tons
Seer Rating: 14 Seer

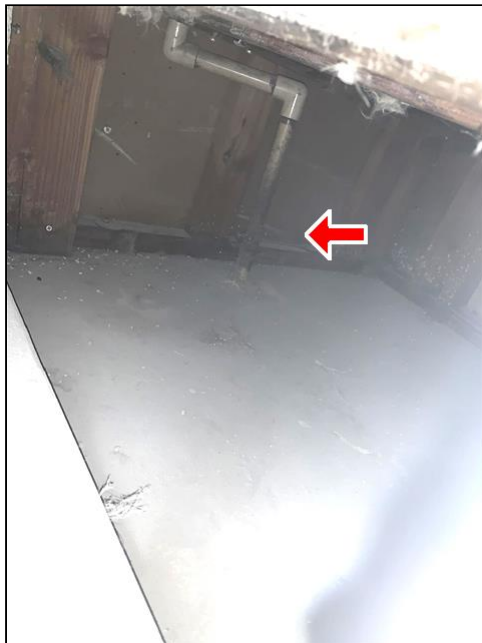
10.2 Item 1(Picture)

Condensate drain line enters foundation. Recommend extending outside instead.

Door to furnace needs weather stripping.

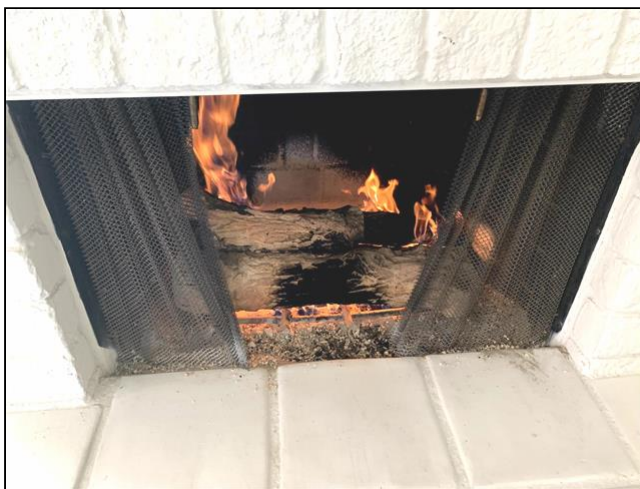
10.3 Item 1(Picture)

Operational.

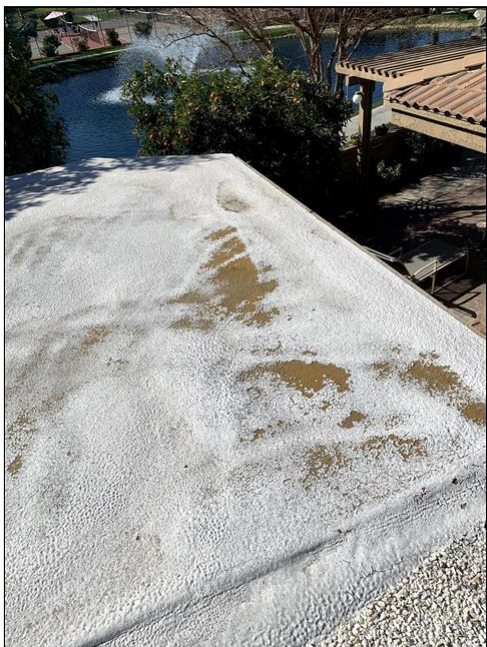
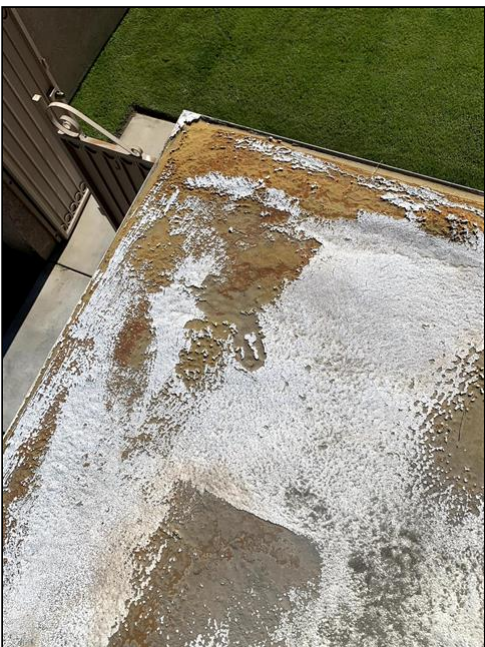
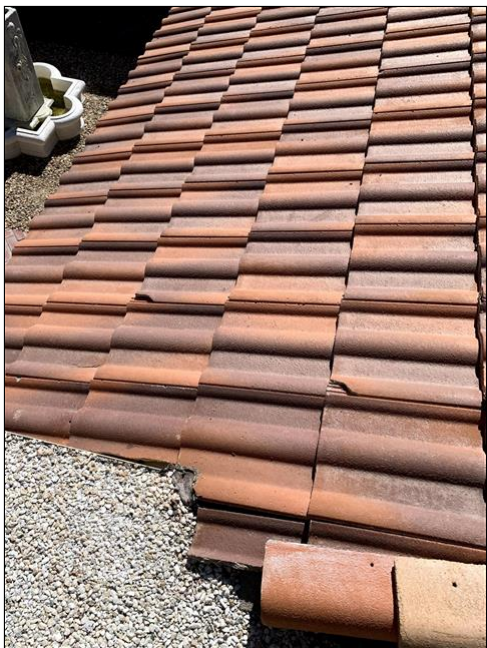
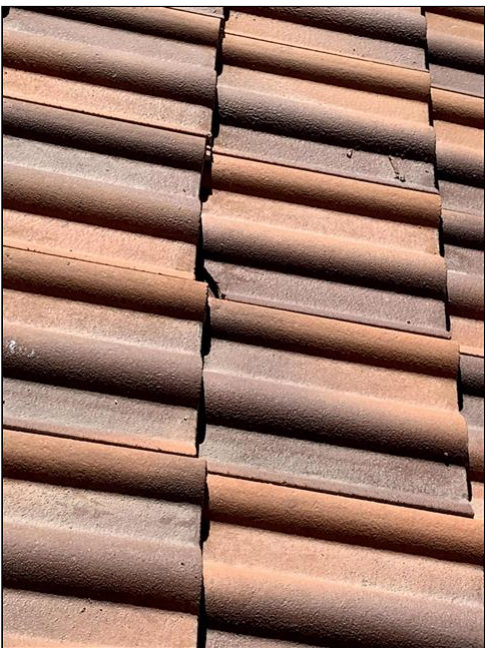
Foam roofs are worn, need re-coating.

Recommend a roofing contractor to further evaluate roof and tile underlayment.

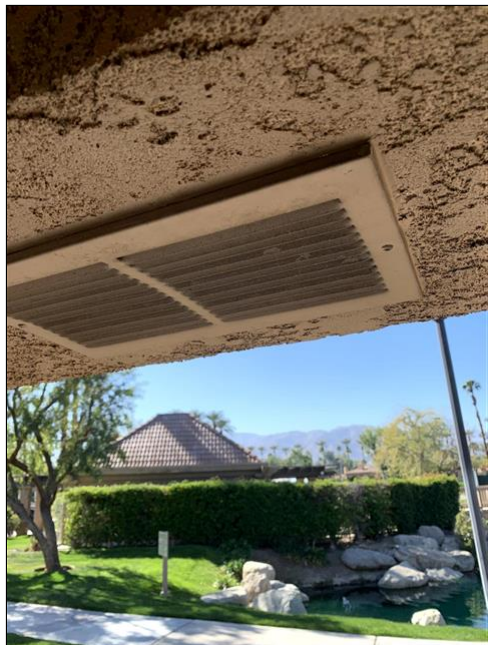
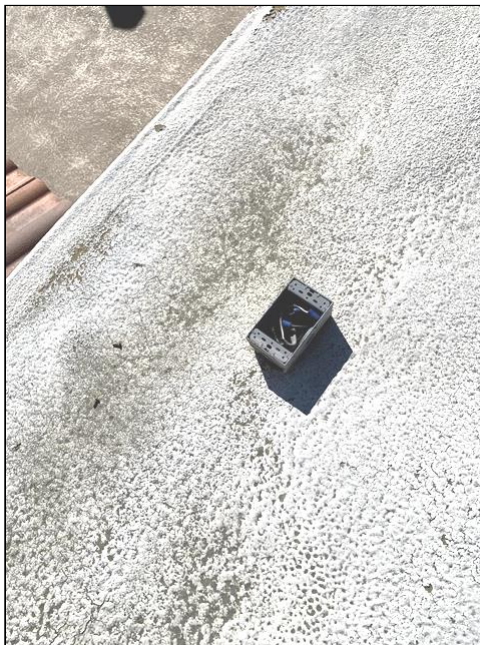
Exhaust fan over barbecue did not respond. Recommend repair/replace.

Open j-box on roof. Unknown use. Recommend further evaluation.

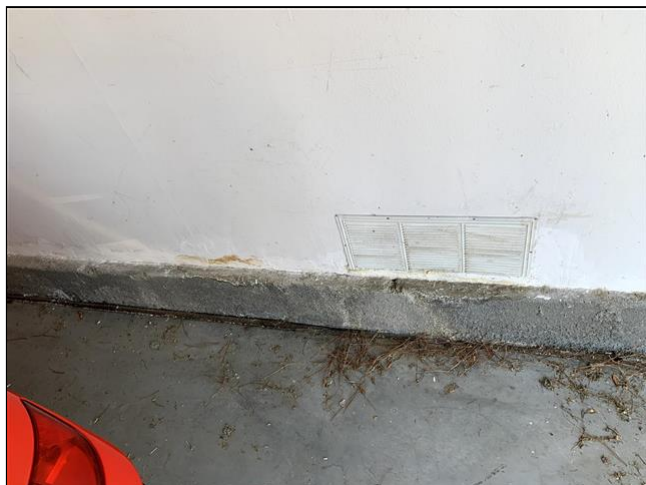
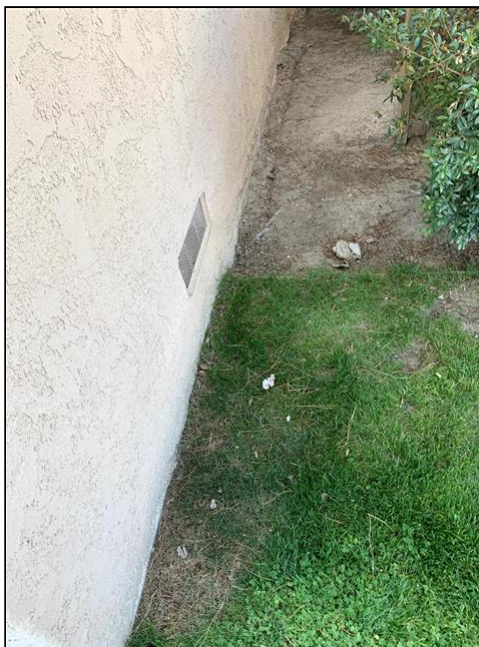
Water damage on lower garage right wall due to high soil and improper drainage on exterior of this wall.

Recommend repair of wall.

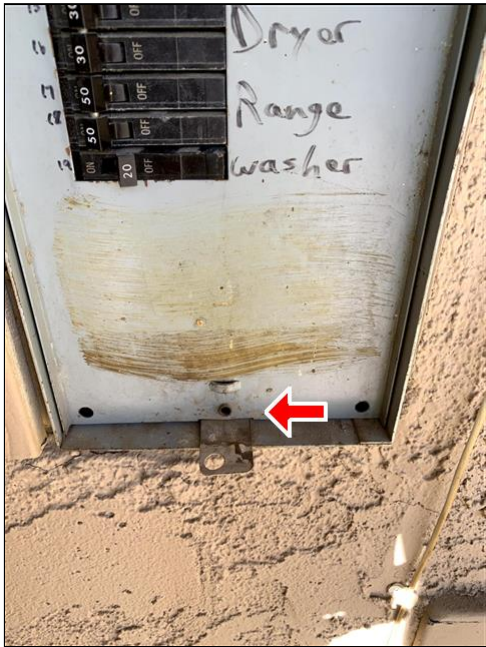
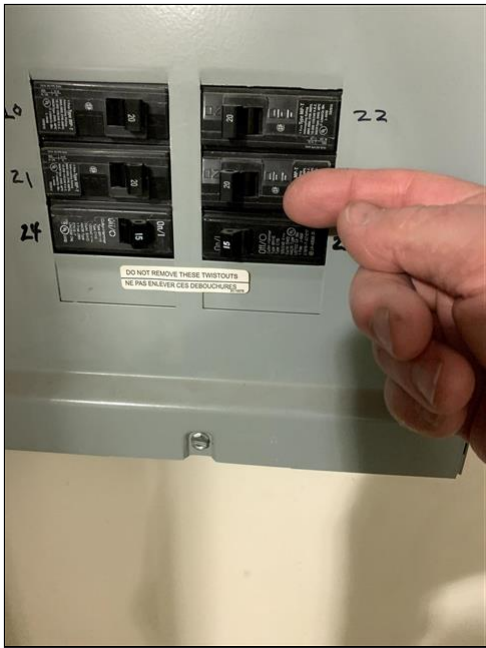
Missing screw to secure main panel inner panel door.

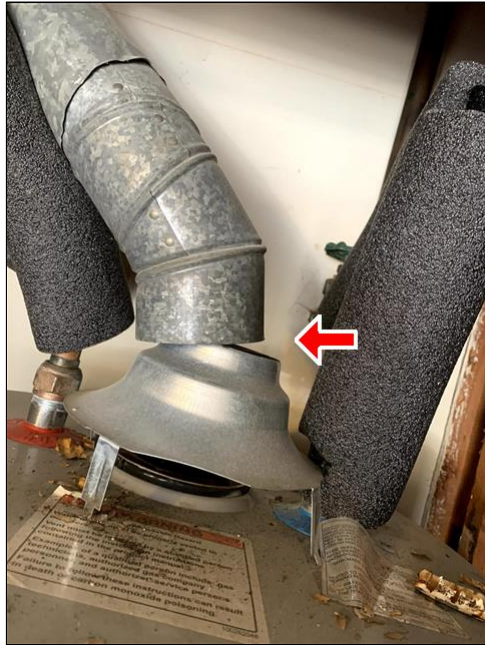
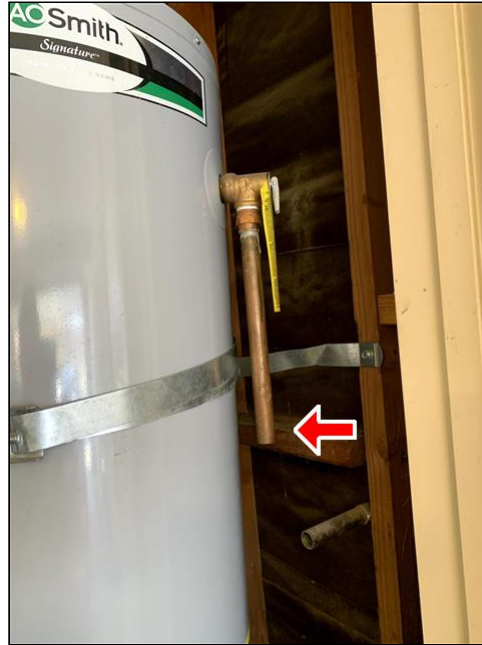
Flue pipe is improper to even connect to the water heater. Needs a new flue pipe properly fitted.

TPR valve must be piped to the exterior with copper piping at a gravitational flow.

Recommend a plumbing contract to repair.

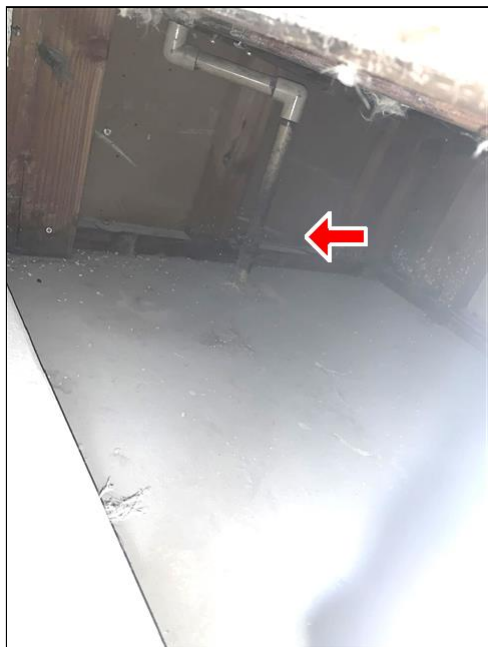
10.2 Item 1(Picture)

Condensate drain line enters foundation. Recommend extending outside instead.

Door to furnace needs weather stripping.
