## RESIDENTIAL REPORT

6370 Burnett Circle  
Ventura CA 93003

Thomas McNally  
AUGUST 14, 2019

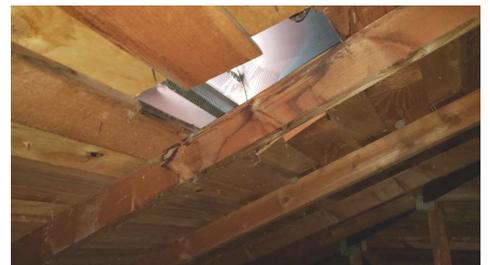
### OLD STAINS NO ACTION NEEDED

The stains appear to be from previous leakage. The stains appear to be from a long time ago and do not represent a current concern.

Recommendation

Recommend monitoring.

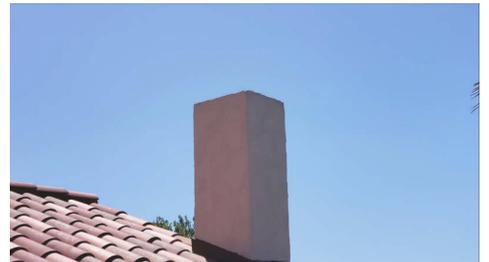
### MISSING SPARK ARRESTER/RAIN CAP

The missing chimney rain cap should be properly installed to reduce water and debris buildup and prevent sparks from escaping.

Recommendation

Contact a qualified chimney contractor.

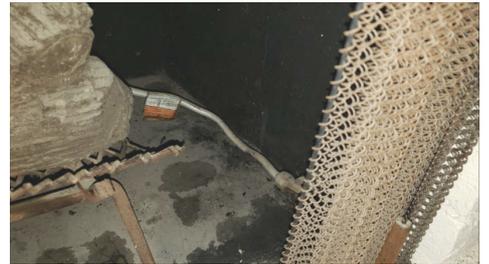
**RIGID ALUMINUM GAS PIPE IS KINKED**

The rigid aluminum gas pipe is kinked/restricted and should be replaced with a flexible gas pipe.

Recommendation

Contact a qualified professional.

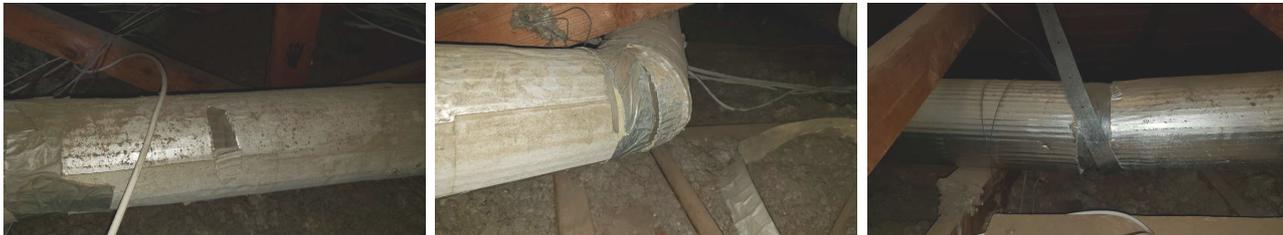
Air supply ducts were not properly sealed. Recommend a qualified HVAC contractor seal supply and return ducts for maximum efficiency.

Recommendation

Contact a qualified HVAC professional.

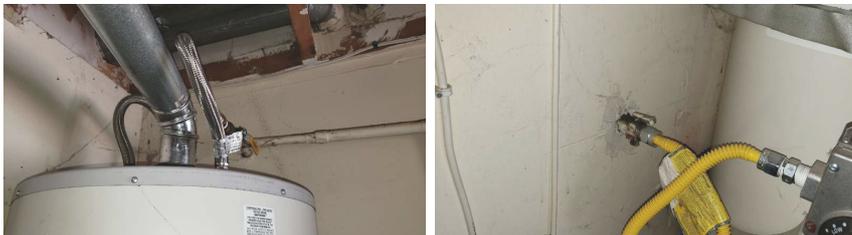
**NO EXPANSION TANK**

No expansion tank was present. Expansion tanks allow for the thermal expansion of water in the pipes. These are required in certain areas for new installs. Recommend a qualified contractor evaluate and upgrade if necessary.

Recommendation

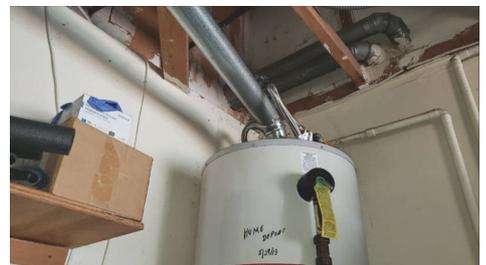
9.9.3 Water Heater Miscellaneous:

Sediment traps are recommended by most manufacturers to protect the gas valve and equipment.

Recommendation

Contact a qualified handyman.

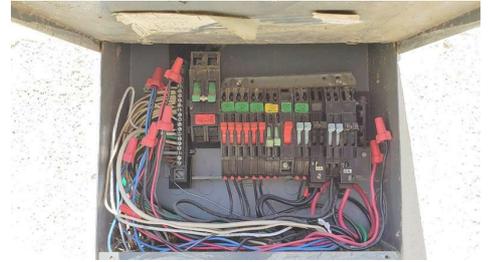
These panels are outdated and have been identified as more likely to cause issues as the breakers are not locked in place. We recommend having a qualified electrical contractor evaluate further to determine if repairs or replacement are indicated. Unless otherwise noted, no signs or overheating were visible.

Recommendation

Contact a qualified electrical contractor.

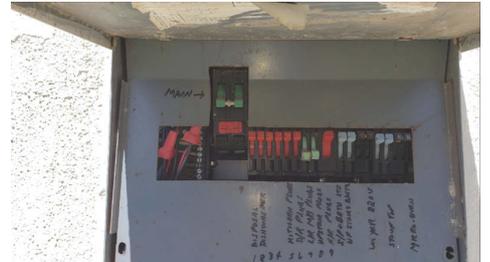
**KNOCKOUTS/FILLER PLATES MISSING**

"Knockouts" are missing on the electric panel. This poses a safety hazard and it is recommended that the opening in the panel caused by the missing knockout(s) be properly sealed by a licensed electrician.

Recommendation

Contact a qualified electrical contractor.

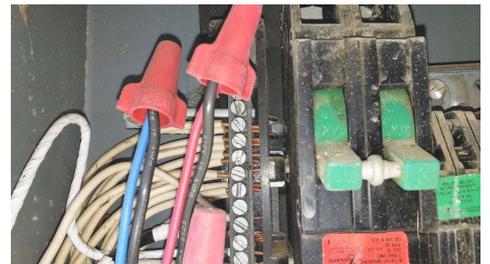
10.3.3 Main Electric & Sub-Panels, Main Overcurrent Device:

Double-tapping of the neutral/ground bus in the main panel used to be common, but is not longer done this way. No evidence of any problems were noted at this time. If you wish to upgrade the connections a qualified electrician should be consulted.

Recommendation

Contact a qualified electrical contractor.

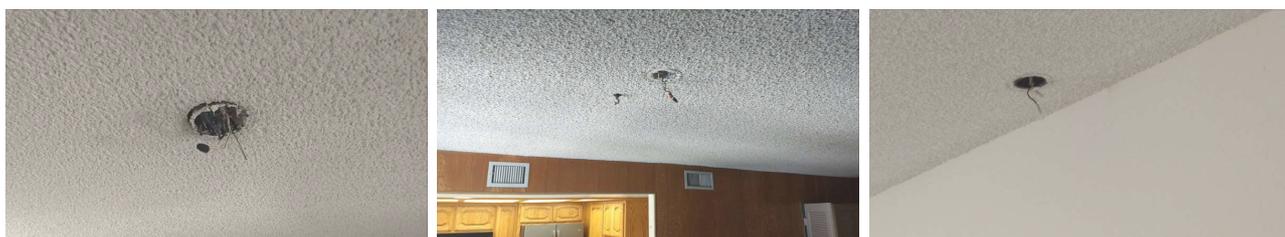
**EXPOSED INDIVIDUAL WIRES NOTED**

There are exposed to single conductor wires noted. All wiring that's exposed should be either enclosed in conduit or replaced with an approved wire method for safety

Recommendation

Contact a qualified electrical contractor.

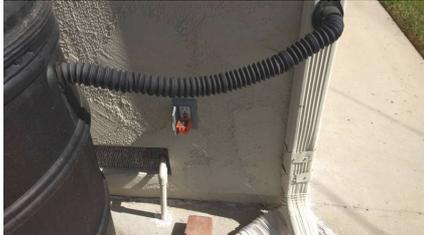
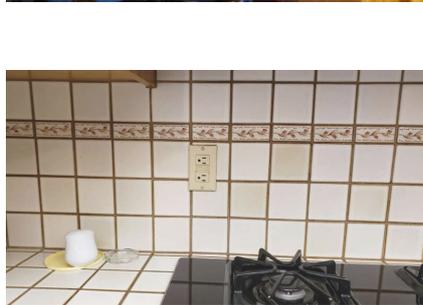
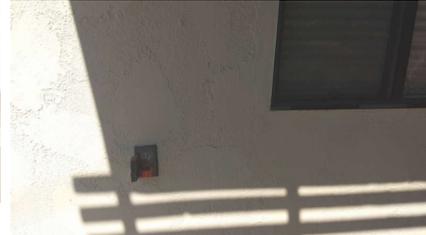
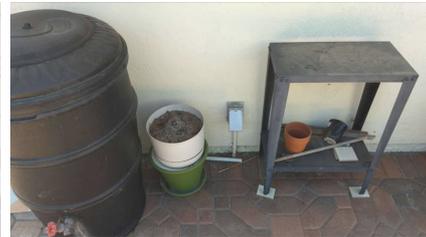
10.6.1 GFCI & AFCI:

GFCI appears to be defective and should be replaced for safety.

Recommendation

Contact a qualified electrical contractor.

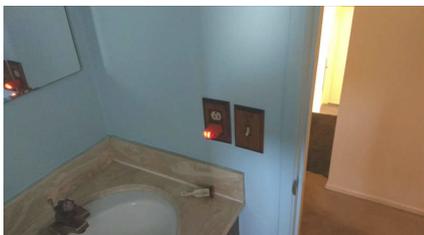
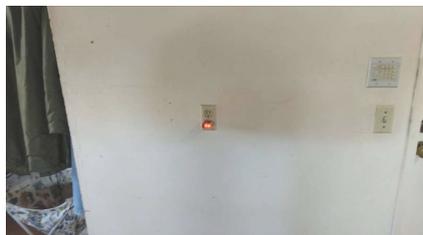
10.6.2 GFCI & AFCI:

We recommend installing GFCI protection as a safety upgrade. Although likely not required at the time of original construction, they are easily installed and add great safety enhancement.

Recommendation

Contact a qualified electrical contractor.

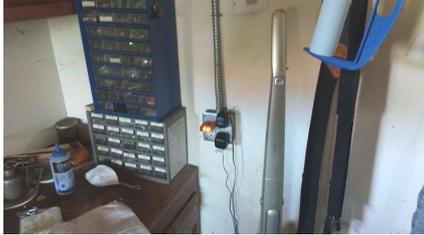
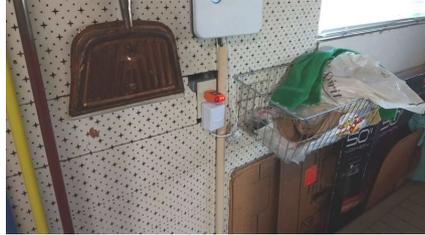
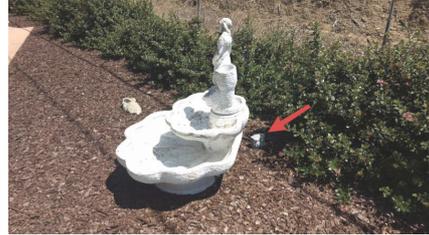
10.6.3 GFCI & AFCI:

Some receptacle(s) have been modified without GFCI protection installed. We recommend having a qualified electrical contractor install these for safety in all recommended locations.

Recommendation

Contact a qualified electrical contractor.

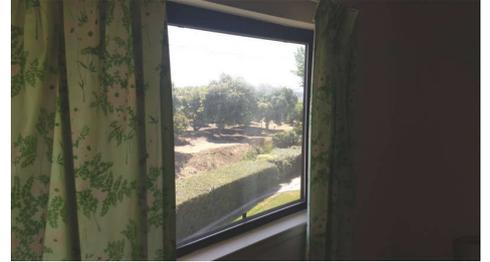
**FAILED THERMAL SEAL(S)**

Observed condensation between the window panes, which indicates a failed seal. Recommend qualified window contractor evaluate & replace as needed.

Recommendation

Contact a qualified window repair/installation contractor.

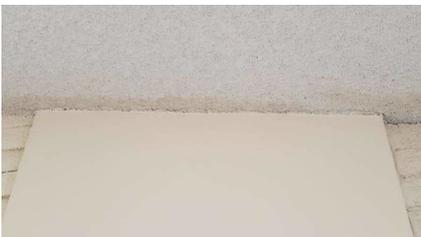
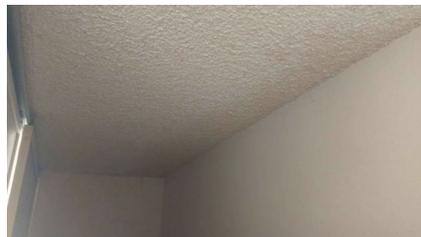
**STAIN(S) ON CEILING NOTED**

The stains in the ceilings were dry at the time of our inspection. We recommend asking the seller to verify that repair was made or have a contractor remove the damaged areas for further evaluation.

Recommendation

Recommend monitoring.
