## CONFIDENTIAL INSPECTION REPORT

41648 Comstock Ln., Big Bear Lake, CA. 92315

2/17/2024 7:30 am to 10:00 am

## GENERAL INFORMATION

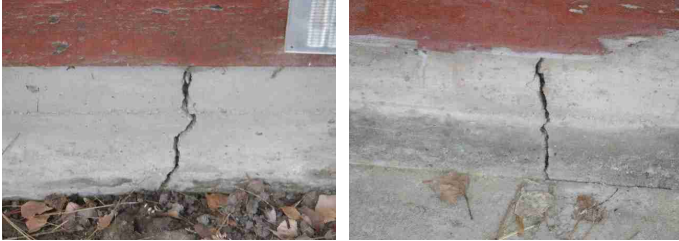
There are couple vertical cracks in the outer stem walls of the slab foundation, and although they are relatively small and there is no offset they are larger than shrinkage cracks, and it is likely that they extend beyond the stem wall and into the slab, which could permit moisture to intrusion. For this reason, one could consult an or be evaluated by a foundation contractor and be sealed or serviced as necessary.

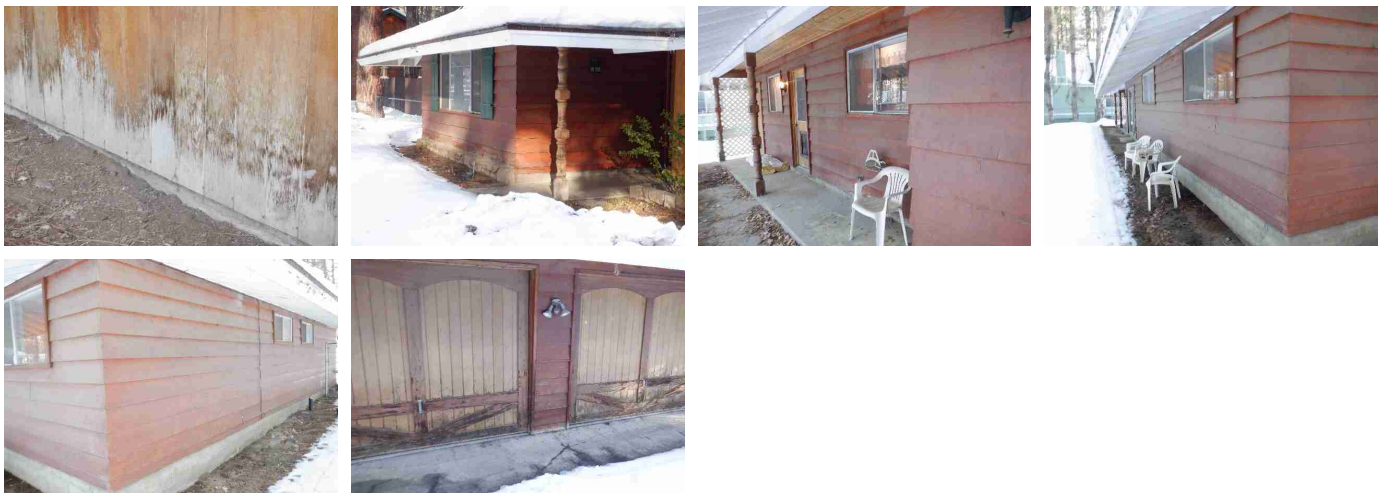
Sanding and repainting needed on the wood siding and trim around the house and garage doors.

One section of the wood siding on the side of the garage has a cut out that should be repaired

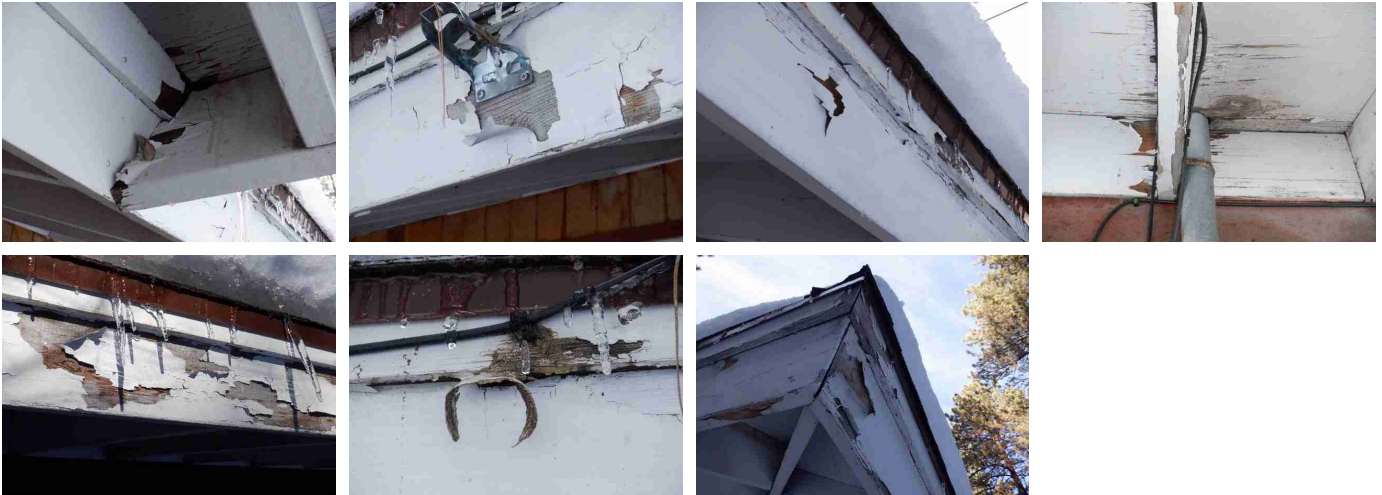
Sections of the fascia and trim need maintenance type service. Sanding and repainting to help prolong the life span of the wood.

The fascia and trim need typical maintenance-type service -see report for comments - *Continued*

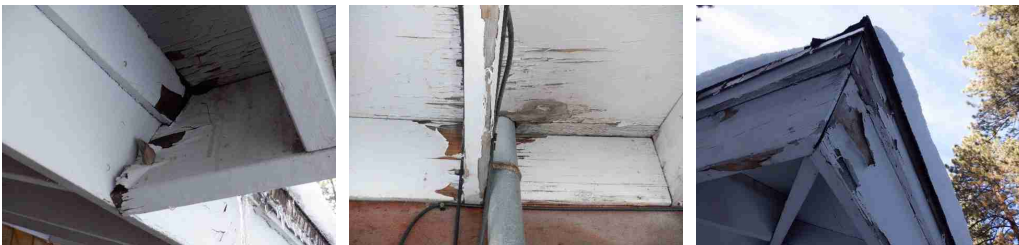
Wood damage noted at various locations of the eaves. Confirm with termite control co before the close of escrow.

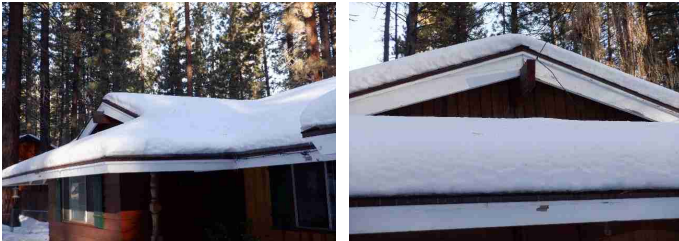
The composition shingle roof was not inspected or evaluated due to snow coverage. Therefore the roof was not inspected at time of inspection. Recommend having the entire roof inspected by a roofing expert once the snow has melted or been removed.

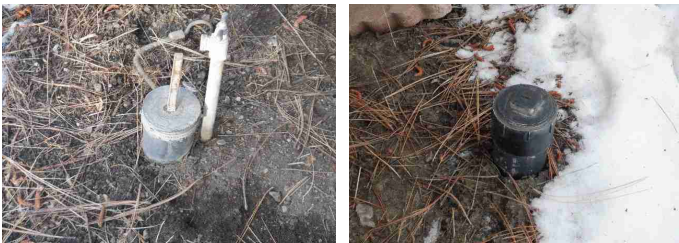
There are clean outs noted in the front and side yard.

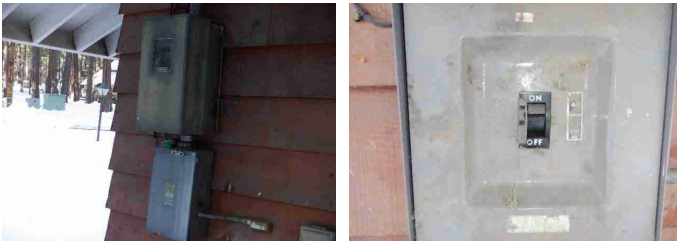
The residence is served by a 150 amp, 120 /240 volt panel, located in the garage side yard.

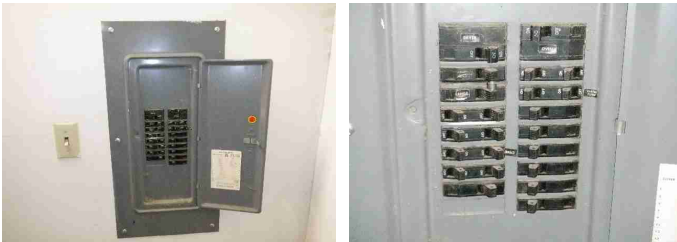
The residence is served by a 150 amp, 120 /240 volt sub panel, located inside the garage.

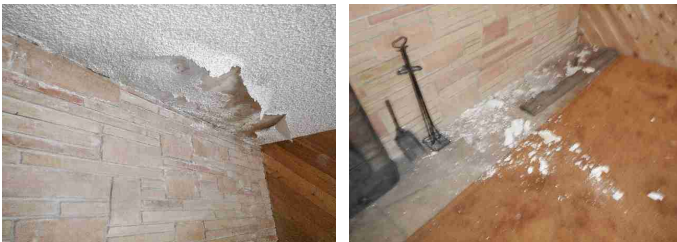
There is moisture damage on the living room ceiling, which you should ask the sellers to explain and have explored further. This area is adjacent to the chimney. This location indicates moisture has penetrated around the outer chimney wall. Stains noted on chimney wall in attic space. One snow has been removed. Roof and flashing needs to be further evaluated.

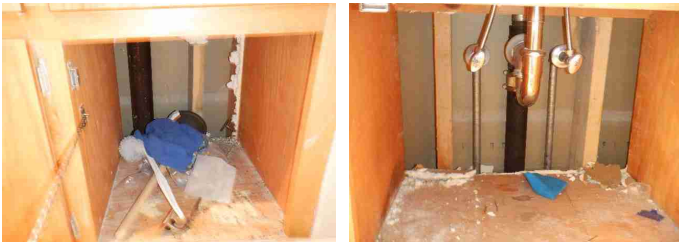
Section of walling have been removed beneath cabinetry. Replacements needed.

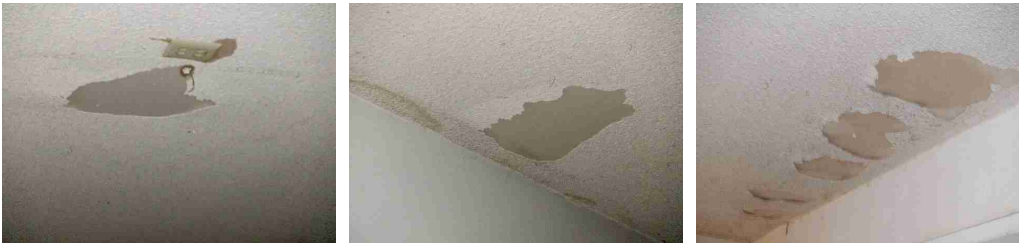
Old staining noted on some sections of the ceiling. No moisture was detected with meter. Ceiling damage noted. Sections of acoustic material has fallen down. No active moisture detected at time of inspection with meter. However this condition does not indicate any active leaking. Again recheck the roof when snow has melted and or removed.

Acoustic type ceiling noted. Ceiling may contain asbestos type material. Recommend consulting with an abatement contractor for further evaluation if desired.

Confirm with termite control co on any findings before the close of escrow.
