IM HOME INSPECTIONS

## IM HOME INSPECTIONS INC - RESIDENTIAL REPORT

2555 Northlake Cir  
Westlake Village, CA 91361

10/01/2026

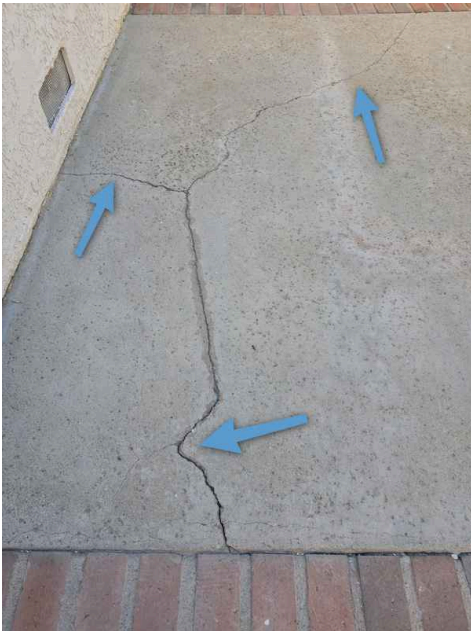
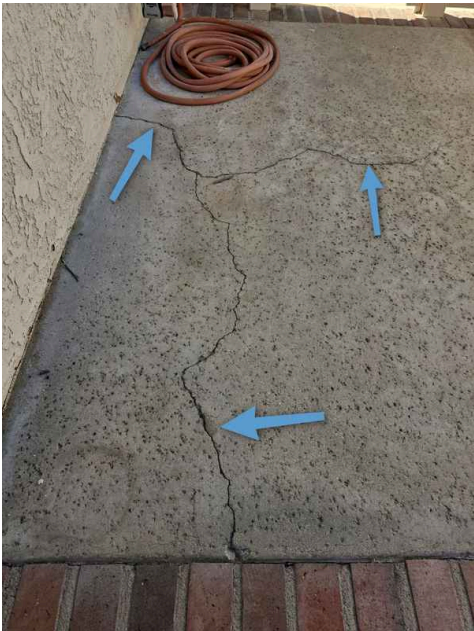
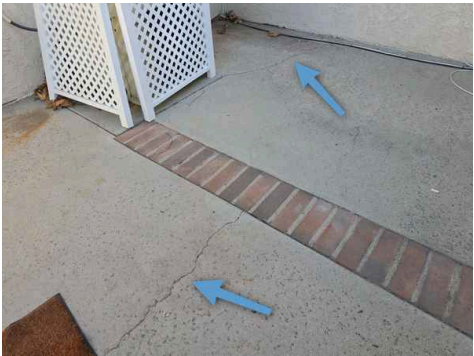
2.2.1 Driveway and Walkway Condition

Minor settlement or "hairline" cracks in walkways are normal for properties of any age. They should, however, be monitored for expansion and sealed as necessary. Client may wish to repair for cosmetic reasons.

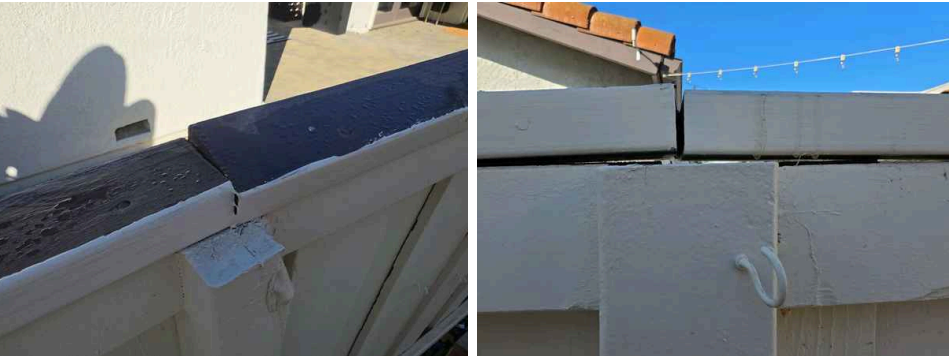
2.7.1 Fence Condition

FENCES HAVE SIGNS OF DETERIORATION AND AGE

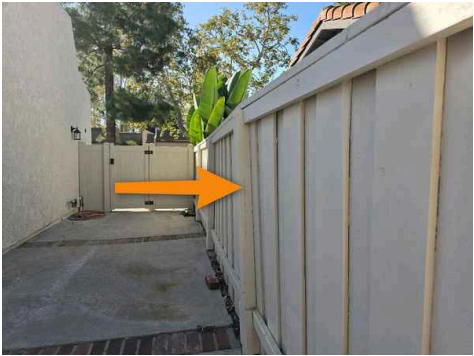
2.7.2 Fence Condition

LEANING

Fences are leaning. Recommend repair by a qualified person.

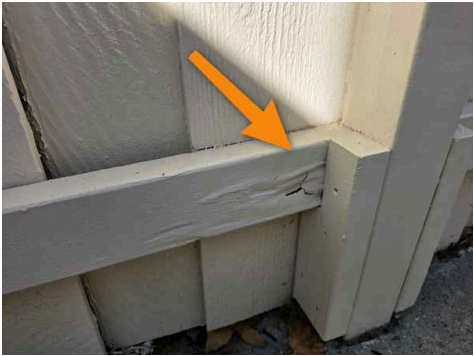
2.7.3 Fence Condition

DAMAGE NOTED

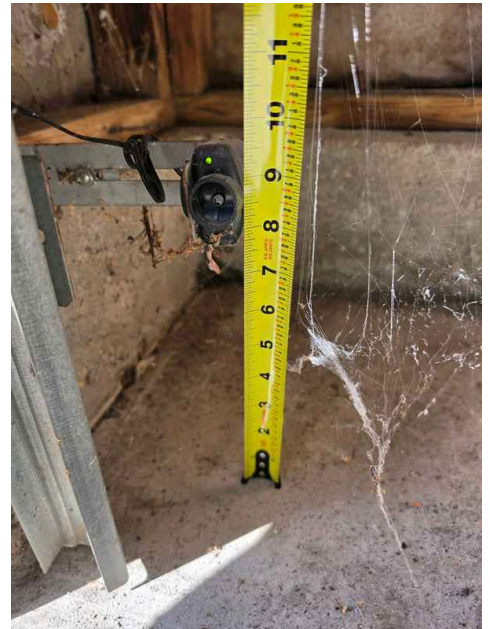
The photoelectric sensors were mounted more than 6 inches above the surface of the ground. It is recommended that photoelectric sensors be mounted between 4 and 6 inches above the surface. Babies and/or small animals may not be picked up by the photoelectric sensors and can be injured by the garage door. Recommend having a qualified person lower the photoelectric sensors to be between 4 and 6 inches.

Contact a qualified professional.

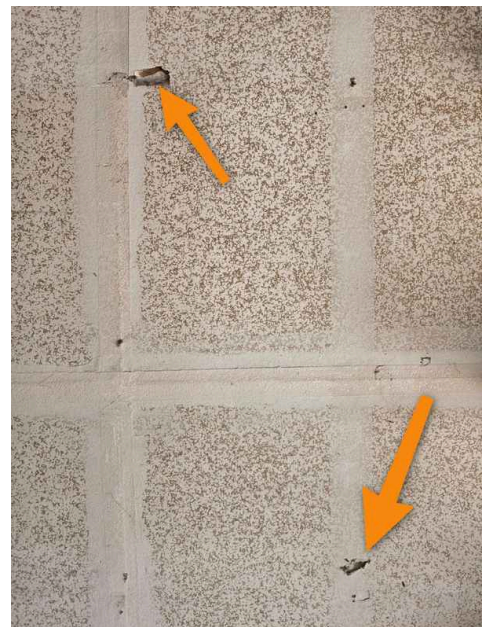
**DAMAGE NOTED**

Recommend repair by a qualified contractor.

Contact a qualified professional.

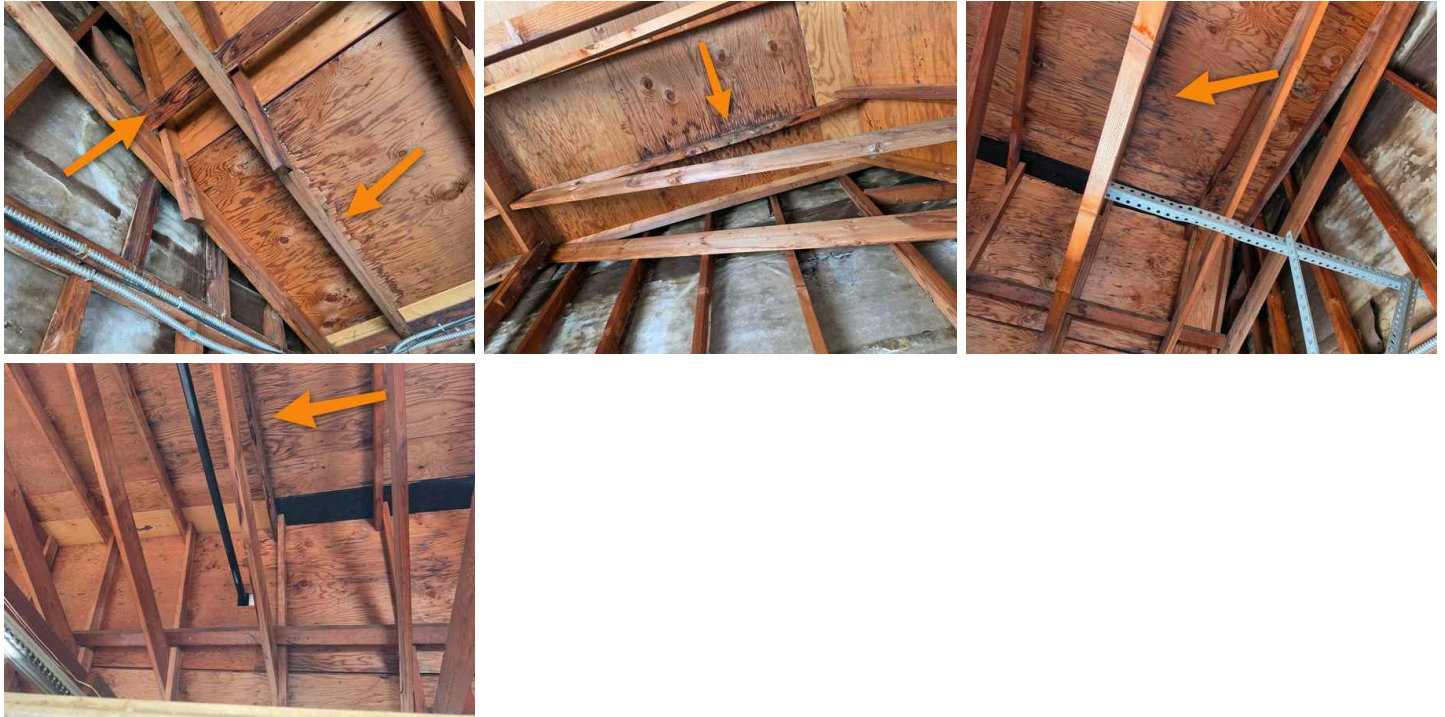
## 3.5.1 Rafters &amp; Ceiling

**MOISTURE STAINS THAT WERE NOW DRY NOTED**

Moisture stains that were now dry noted. Recommend repair by qualified contractor.

Contact a qualified professional.

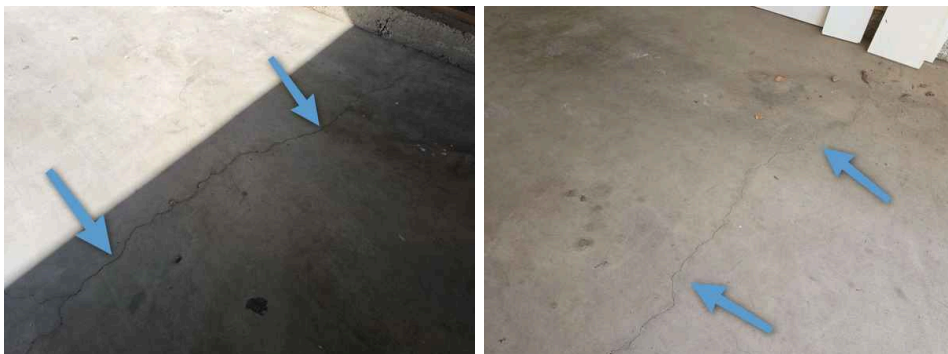
## 3.6.1 Floor Condition

**CRACKS - MINOR**

Minor or hairline cracks noted. Hairline cracks in garage floors are common due to the natural settling and curing process of concrete. They typically result from shrinkage and are not usually a structural concern. These cracks are generally thin and don't indicate significant damage or issues with the foundation. Routine maintenance and sealing can prevent them from widening, ensuring the longevity and integrity of the garage floor.

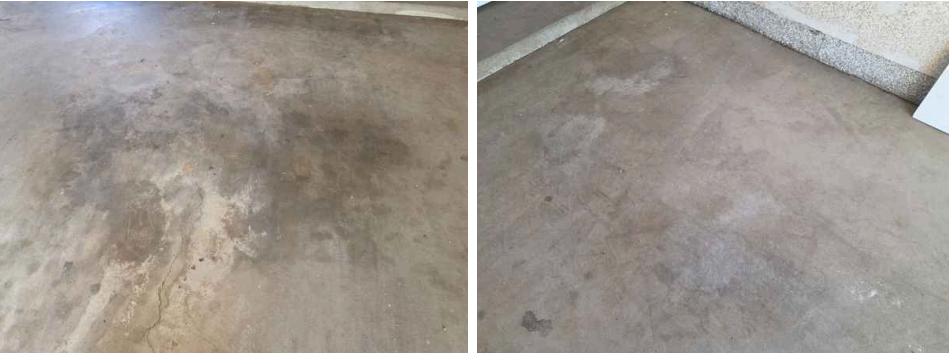
3.6.2 Floor Condition

**STAINS NOTED**

Stains noted.

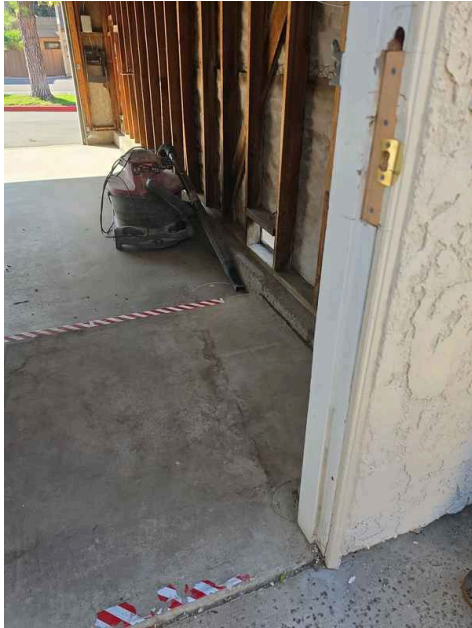
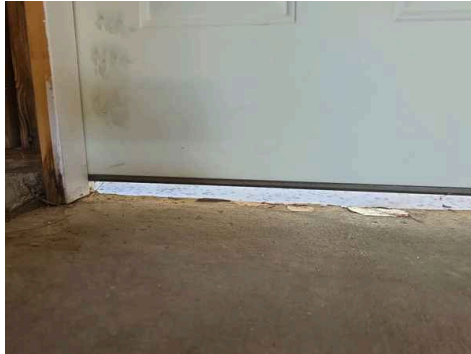
On the door from garage to exterior, the weatherstripping around exterior door was damaged or insufficient. Recommend that a qualified person repair or replace weatherstripping as necessary.

Contact a qualified professional.

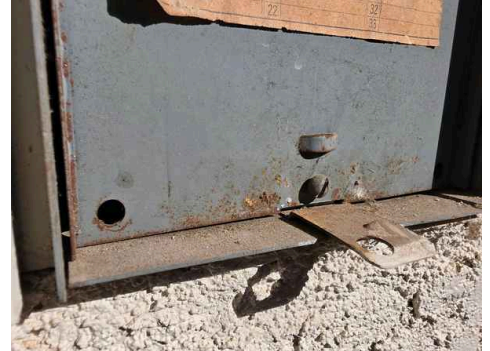
**RUST ON DEAD FRONT**

Rust noted on dead front cover. This may be a sign of moisture coming in contact with panel.

Contact a qualified professional.

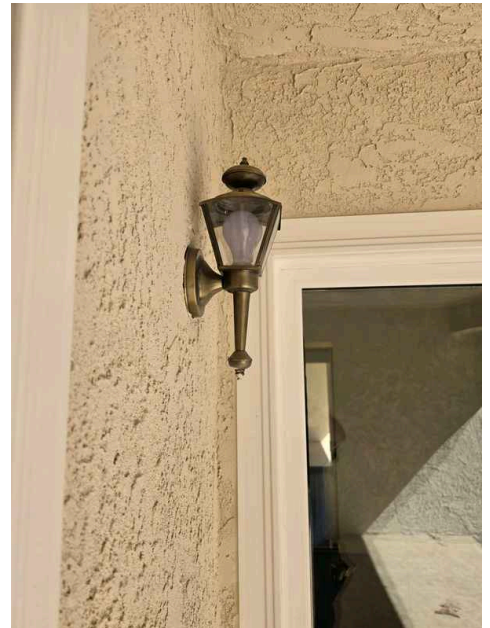
## 4.5.1 Lighting

**LIGHT FIXTURE NO RESPONSE/MISSING BULBS**

Light fixtures did not respond to the switch. While this may be an indication the bulbs need to be replaced, there may be a problem with the switch, wiring or light fixture. If after the bulb is replaced this light still fails to respond to the switch, this condition may represent a potential fire hazard and the Inspector recommends repair by a qualified electrician.

Contact a qualified professional.

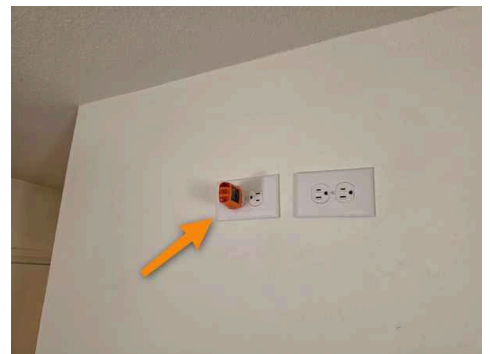
## 4.6.1 Receptacles

**NO POWER**

Electrical receptacle(s) had no power. Recommend further evaluation and repair by a qualified electrician.

Contact a qualified professional.

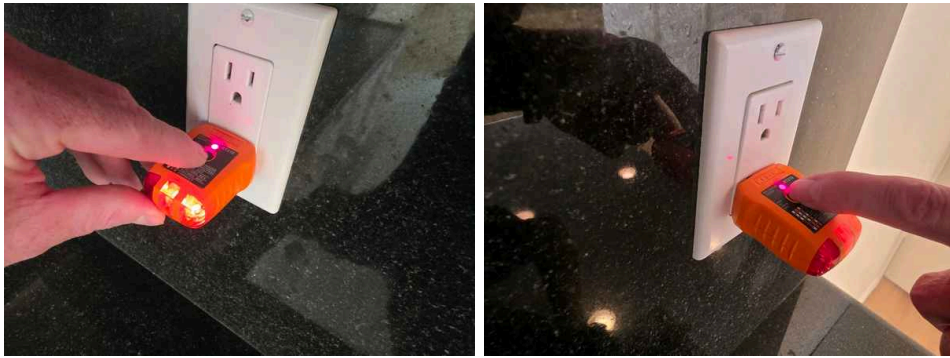
## 4.6.2 Receptacles

Recommended **upgrade**: GFCI outlets were not found in all areas of the kitchen counter. Lack of ground fault circuit interrupter receptacle protection in wet areas pose a shock hazard. Recommended that a qualified electrician install GFCI protection per standard building practices to meet modern safety standards. Read more [here](#)

Contact a qualified professional.

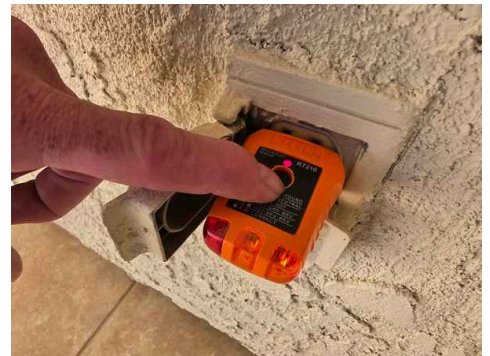
## 4.6.3 Receptacles

**NO GFCI AT EXTERIOR**

Lack of ground fault circuit interrupter receptacles in wet areas pose a shock hazard. GFCI outlets were not found on some or all of the exterior receptacles. Recommended that a qualified electrician install GFCI protection per standard building practices to meet modern safety standards. Read more [here](#)

Contact a qualified professional.

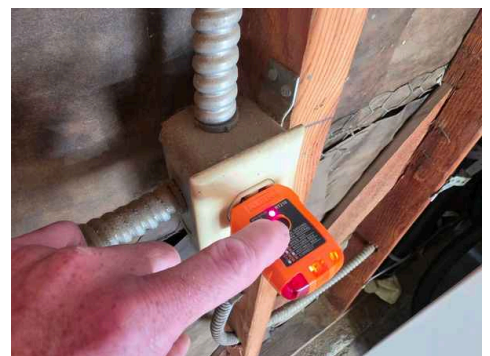
## 4.6.4 Receptacles

**NO GFCI AT GARAGE**

Lack of ground fault circuit interrupter receptacles in wet areas poses a shock hazard. GFCI outlets were not found at some or all of the outlets in the garage. Recommended that a qualified electrician install GFCI protection per standard building practices to meet modern safety standards. Read more [here](#)

Contact a qualified professional.

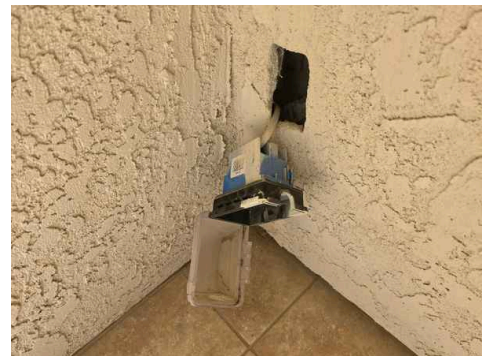
**LOOSE BOX**

Receptacle (outlet) box noted loose. This condition left energized electrical components exposed. This is a potential shock and fire hazard. Recommend repair by a qualified electrician.

Contact a qualified professional.

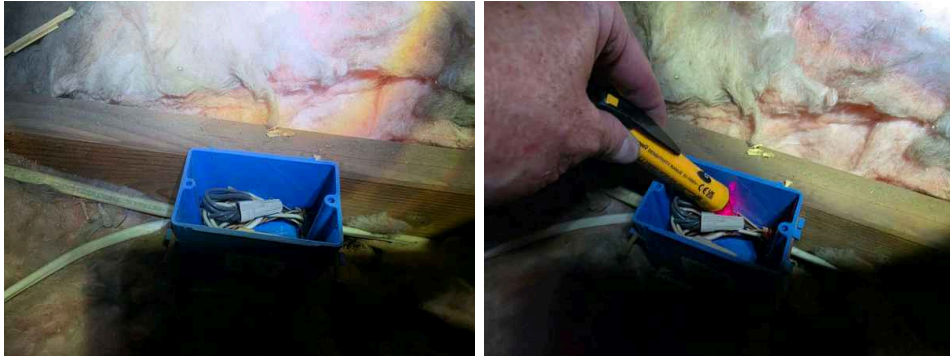
## 4.7.1 Wiring

**MISSING JUNCTION BOX COVERS**

Missing junction box covers were noted. Missing covers pose a hazard because they leave electrical components exposed, increasing the risk of electrical shocks, short circuits, and fires. These covers serve as a protective barrier, preventing contact with live wires and ensuring the integrity of the electrical connections. Recommend a qualified electrician install covers where missing.

Contact a qualified professional.

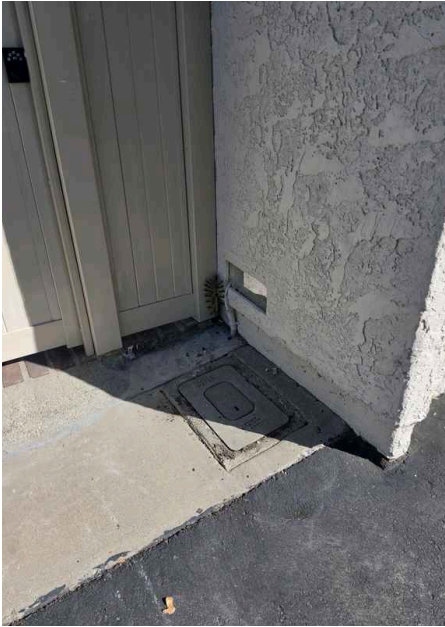
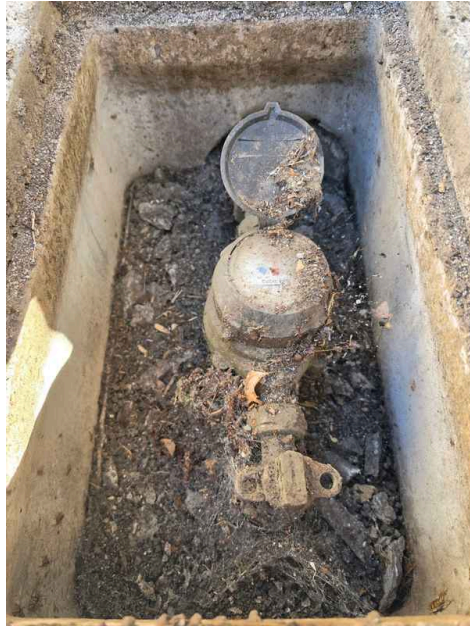
#### - Supply: Meter Partially Buried

Water meter is partially buried. Recommend qualified person remove soil so water meter is fully visible and accessible.

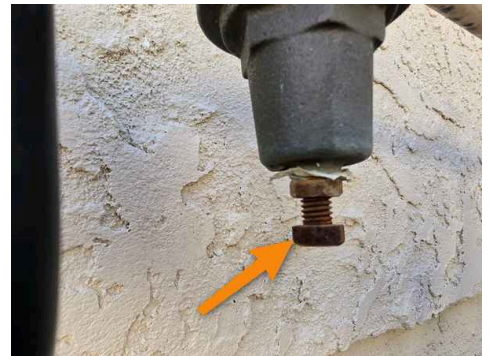
#### **RUST AT PRESSURE VALVE.**

Recommend a qualified plumber replace the pressure valve as necessary.

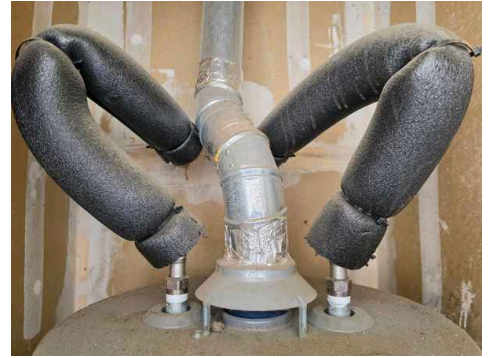
Recommend a qualified plumber install bonding wire and expansion tank to meet modern safety standards. CPC 608.3

Contact a qualified professional.

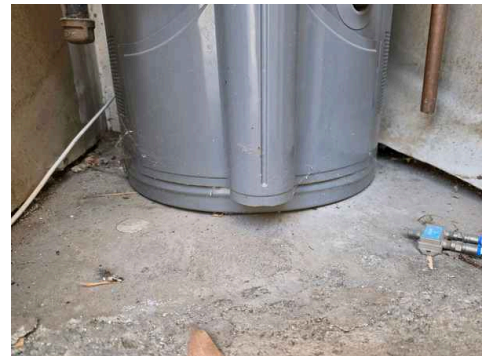
## 7.6.1 Strapping

**STRAPS LOOSE**

While the water had straps, the straps were not secured. This is a hazard. Recommend repair by a qualified person.

Contact a qualified professional.

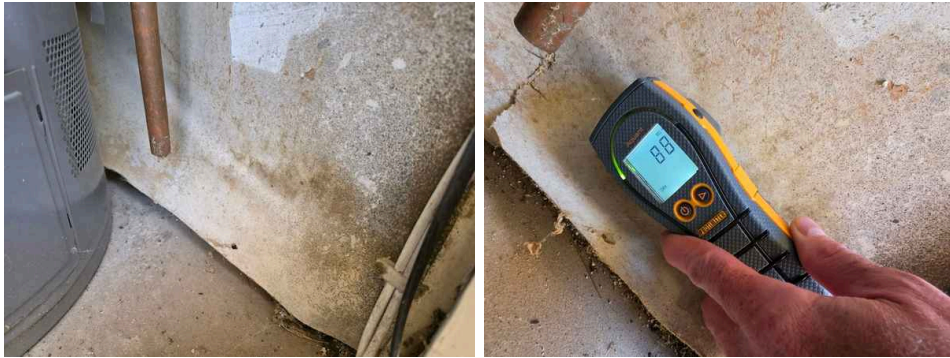
## 7.9.1 Water heater closet

**DAMAGE NOTED**

Contact a qualified professional.

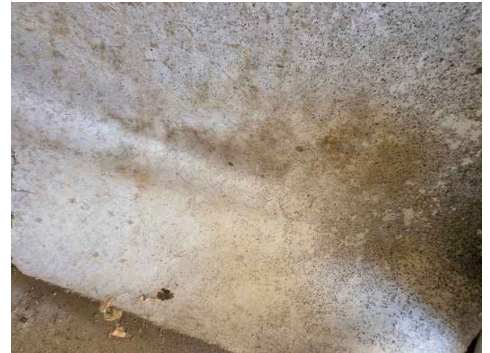
## 7.9.2 Water heater closet

**BIOLOGICAL GROWTH**

Contact a qualified professional.

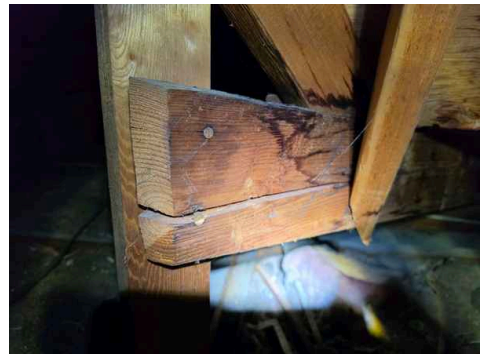
### 9.2.2 Structure

#### **CRACK IN FRAMING MEMBERS**

Contact a qualified professional.

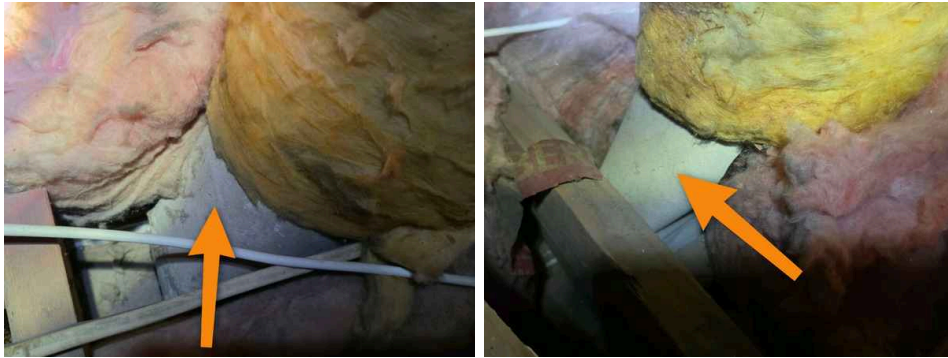
## 9.5.1 Ductwork

**POSSIBLE ASBESTOS MATERIALS -DUCT BOOT**

Contact a qualified professional.

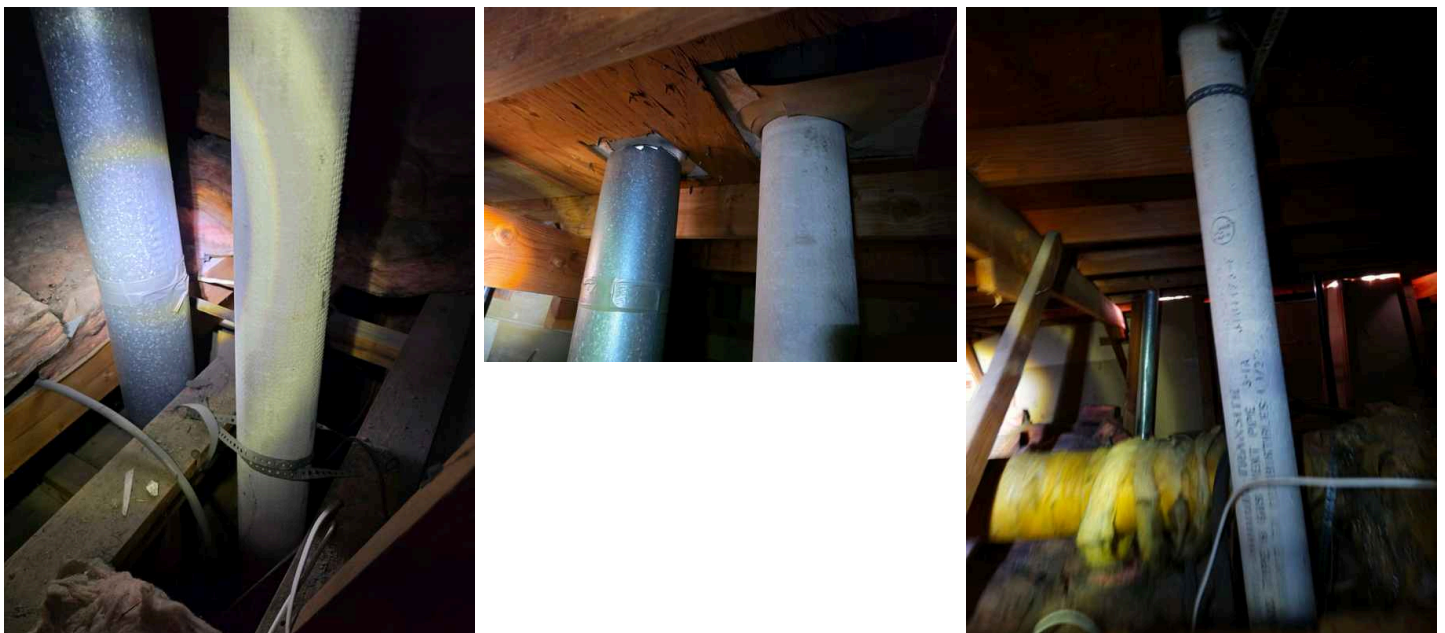
## 9.6.1 Exhaust &amp; Roof Penetrations

**POSSIBLE ASBESTOS PIPE**

Contact a qualified professional.

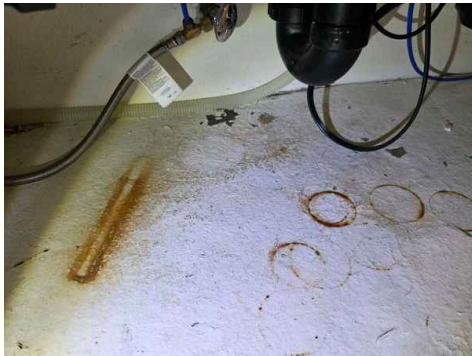
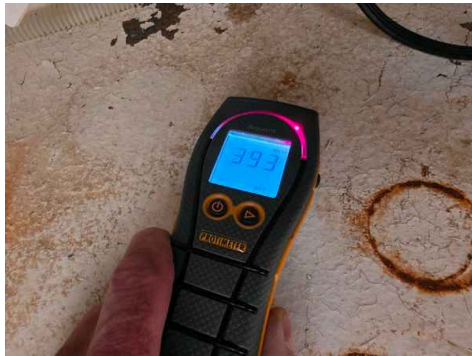
## 12.2.2 Sinks

**ELEVATED LEVEL OF MOISTURE UNDER SINK**
