RESIDENTIAL REPORT

2629 Lee St
Simi Valley, CA 93065

Darren Humphrey
04/23/2024

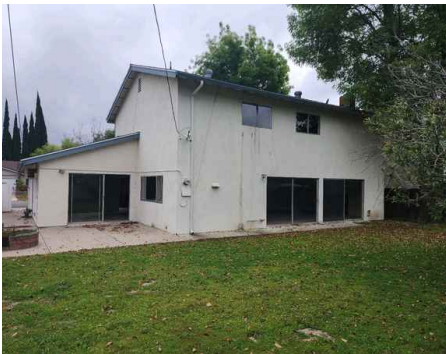
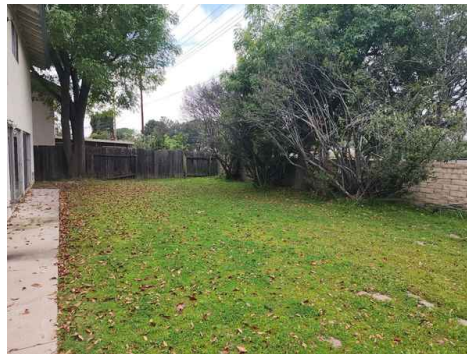
Additional Photos:

**Bad Shape:**

Note - Due to the numerous non-maintained items and lack of regular maintenance, there may be additional items that were not discovered as part of this report.

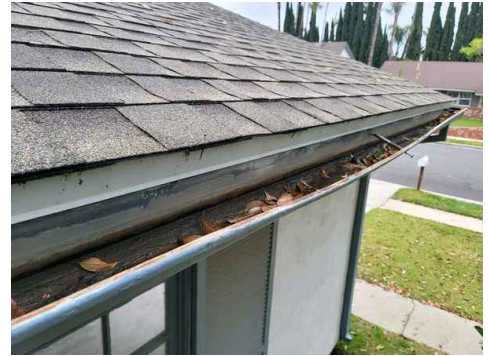
2.2.1 Siding, Flashing & Trim:

WOOD DAMAGE NOTED

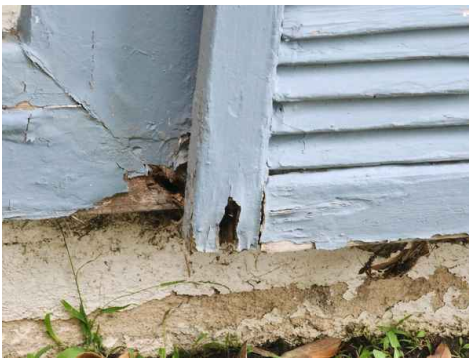
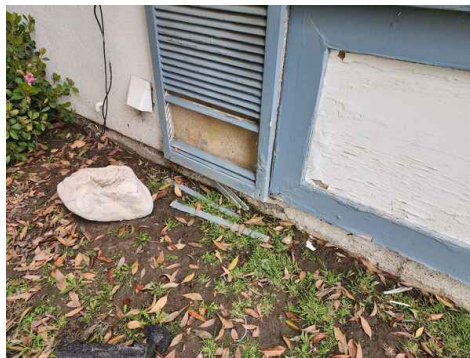
2.2.2 Siding, Flashing & Trim:

WEEP SCREED INADEQUATE CLEARANCE NOTED

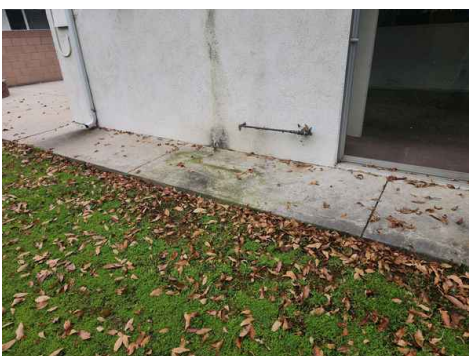
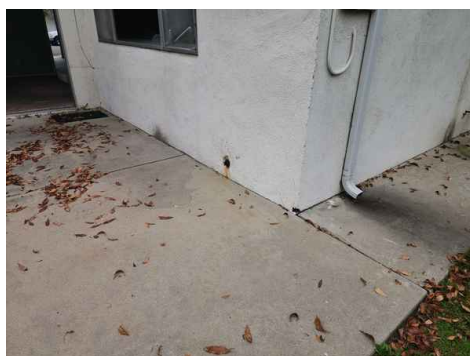
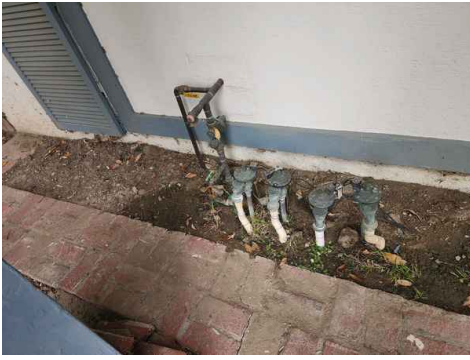
2.2.3 Siding, Flashing & Trim:

NEEDS PAINT OR STAIN

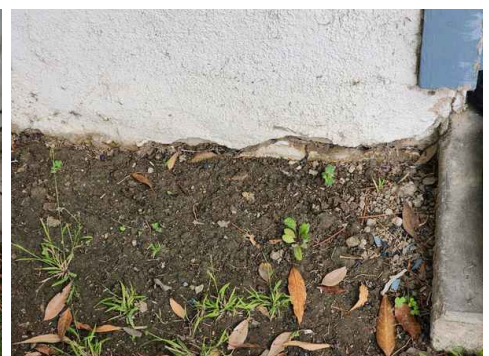
Wood damage noted on the trim/siding should be evaluated/repared by a qualified pest control company.

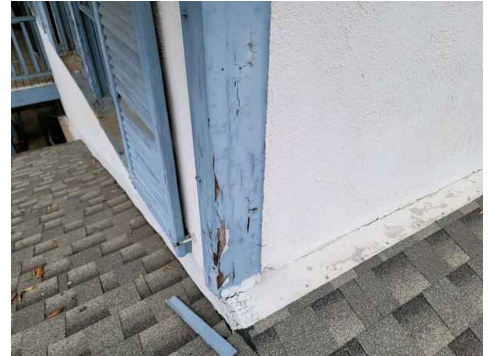
The exterior trim needs re-staining or re-painting to protect it from damage.

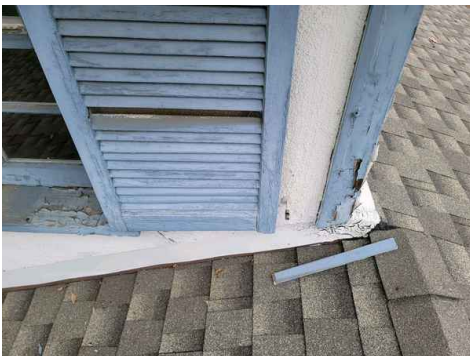
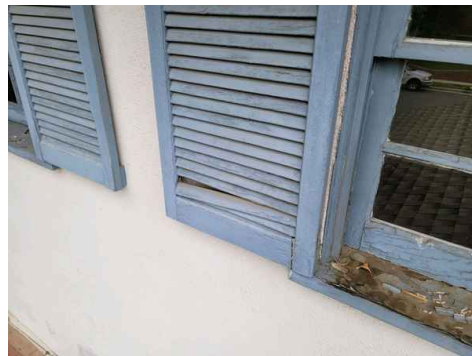
2.4.2 Exterior Window Trim:

PAINT NEEDED

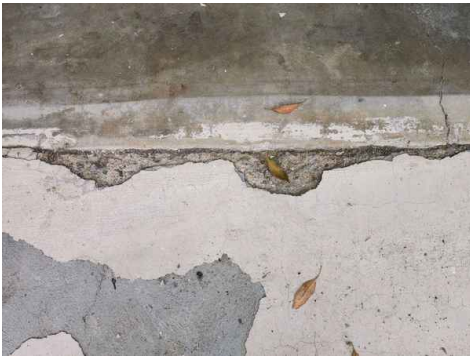
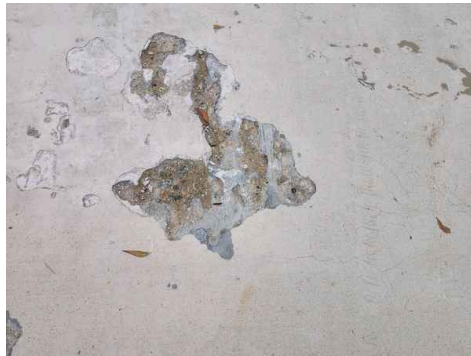
2.6.2 Driveways & Walkways:

WALKWAY UNEVEN/TRIP HAZARD

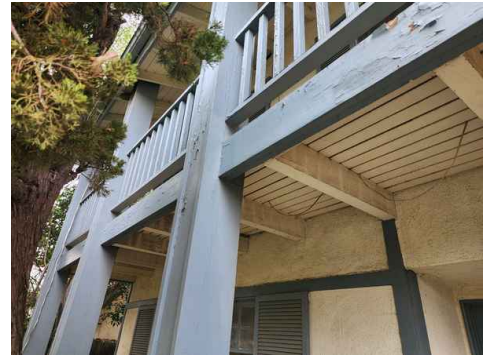
2.9.1 Decks & Balconies:

SURFACE RE-COAT NEEDED

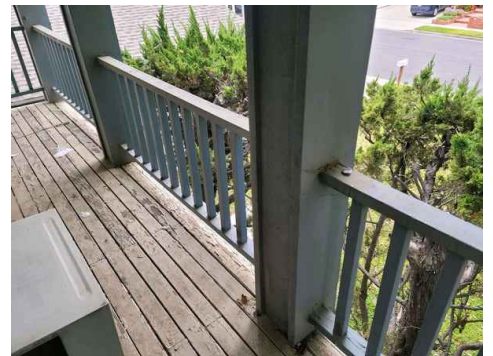
2.10.2 Stairs, Guardrails & Handrails:

PAINT OR STAIN NEEDED

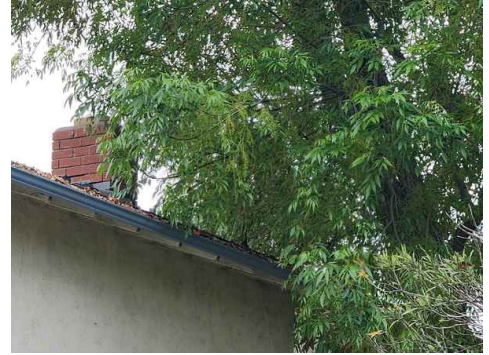
2.11.2 Trees & Shrubs:

TREE ROOTS CLOSE TO FOUNDATION

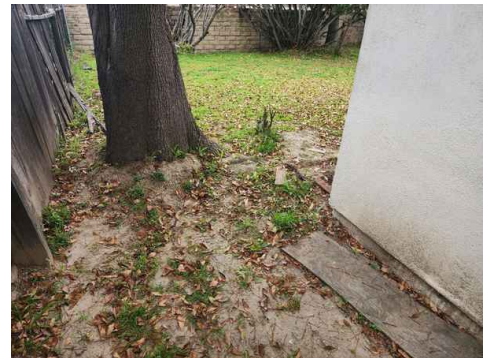
REAR LEFT EXTERIOR

The large tree is too close to the foundation and should be removed to prevent damage to the structure.

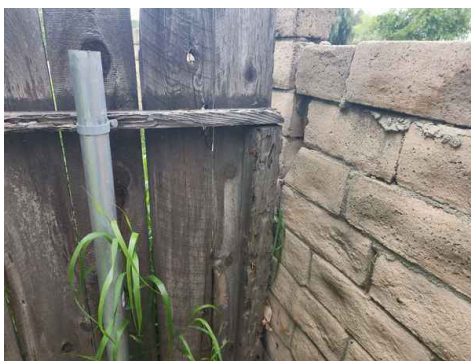
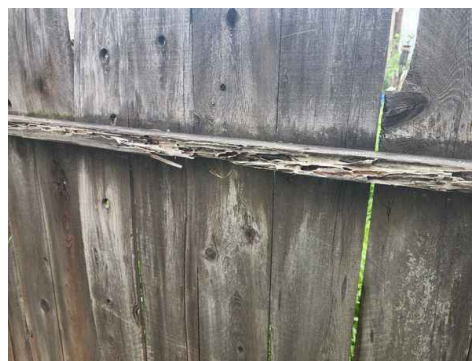
2.12.2 Fencing & Walls:

LEANING/DAMAGED/LOOSE BLOCK WALL NOTED

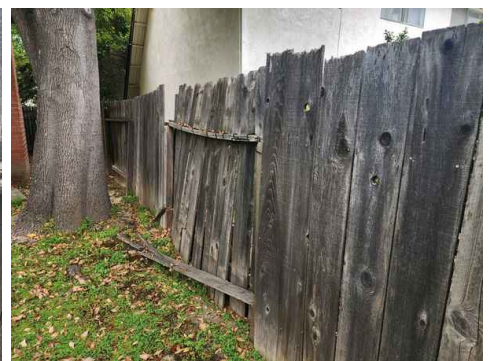
2.12.1 Fencing & Walls:

DAMAGED WOOD FENCING

Wood damage was noted on the fencing that should be repaired or replaced as needed.

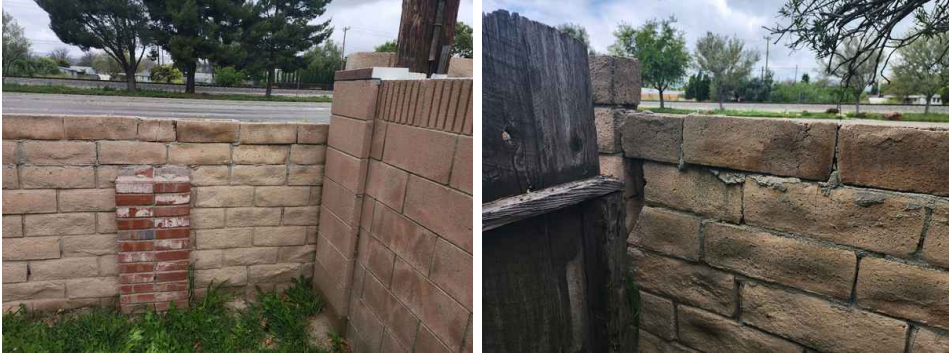
The leaning/loose/damaged sections of the block wall should be repaired as needed.

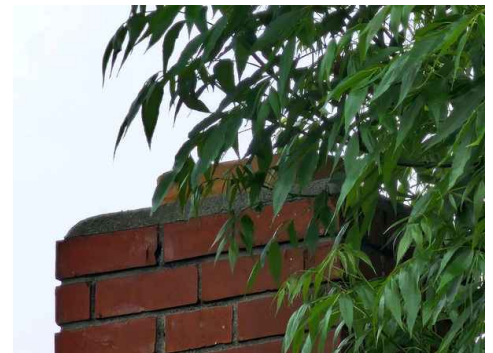
5.1.2 Chimney(s):

EXTERIOR

The flashing between the chimney and the wall/roof should be re-sealed with an exterior caulk to prevent water penetration.

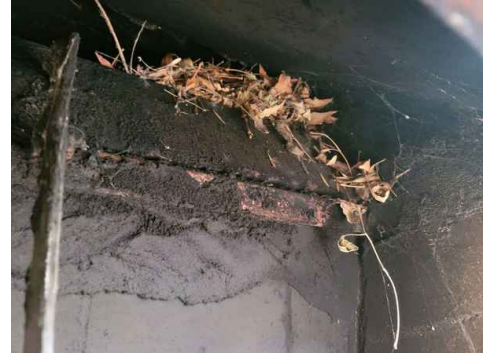
5.2.4 Fireplace(s):

DEBRIS NOTED IN CHIMNEY

The debris noted inside the chimney flue should be cleaned out before using for safe operation.

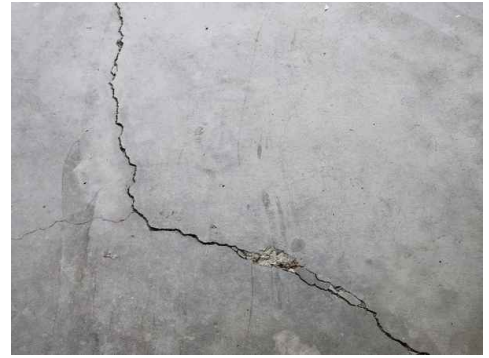
GARAGE

Typical cracks were noted that do not appear to pose a problem at this time.

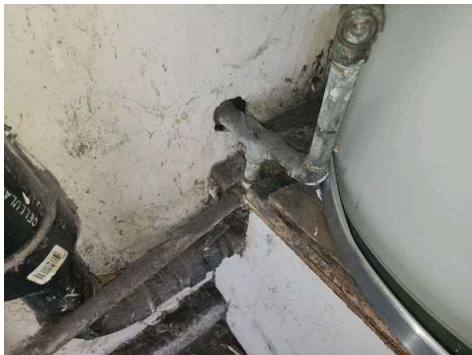
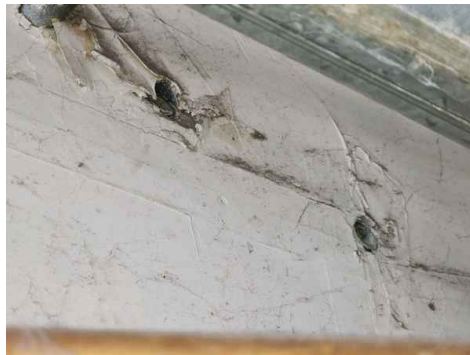
The hole(s) or gap(s) in the garage fire wall should be patched.

Large holes should be patched with fire-rated drywall. Small holes can be sealed with fire-rated expanding foam such as this product: [Fire Block Foam](#)

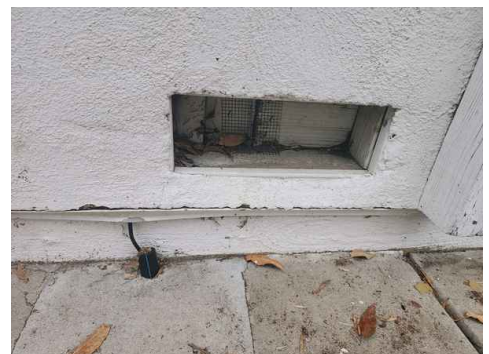
6.3.2 Walls & Fire Walls:

VENTS BLOCKED

Combustion air vents need to be reopened to allow air flow into garage area for proper combustion.

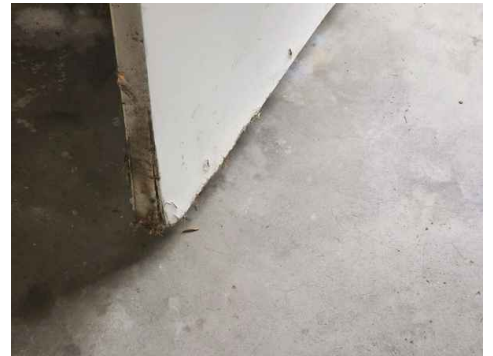
6.5.1 Garage Exterior Pedestrian Door(s):

Recommended Improvements**WATER DAMAGED DOOR NOTED**

Moisture damage was noted on the garage exterior pedestrian door. We recommend repairing the door or replacing as needed.

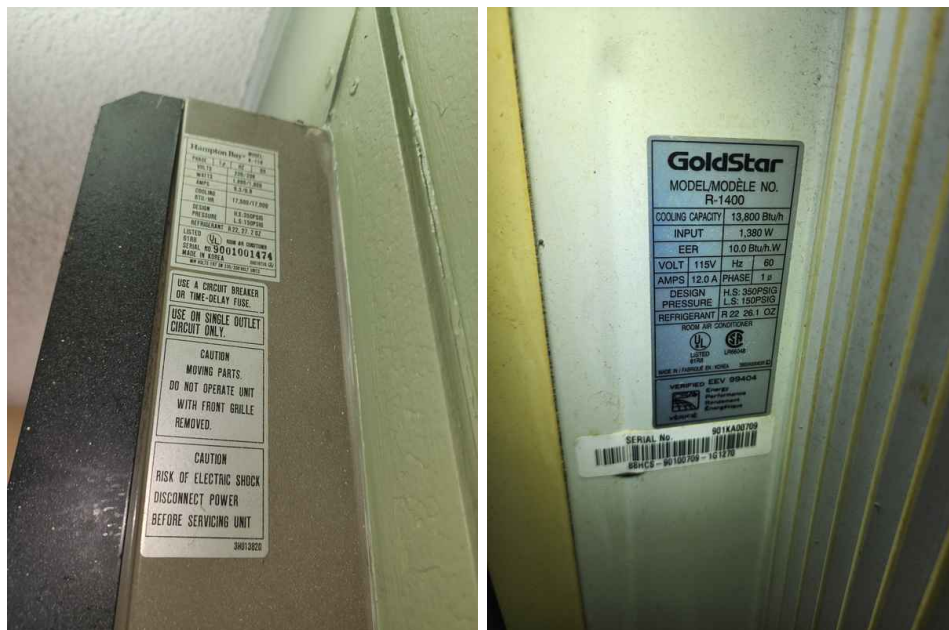
7.2.2 Cooling Equipment:

R-22 (Freon)

It should be noted that R-22 Freon is no longer approved for use in California and obtaining it for service may be difficult or expensive.

OLDER R-22 (FREON) NOTED

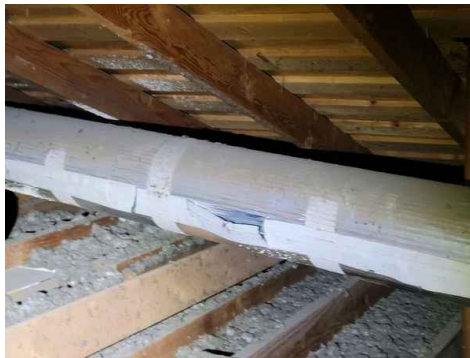
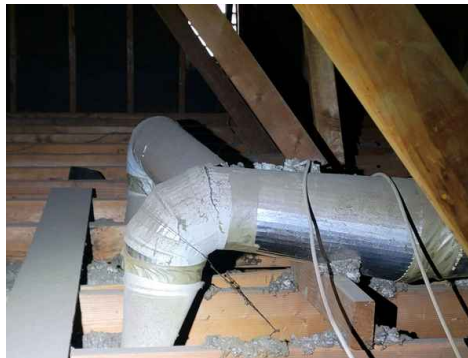
8.7.2 Distribution Systems:

ABANDONED MATERIALS - POSSIBLE ASBESTOS

There is abandoned duct material(s) in the attic that may contain asbestos and should be properly disposed of by a qualified contractor

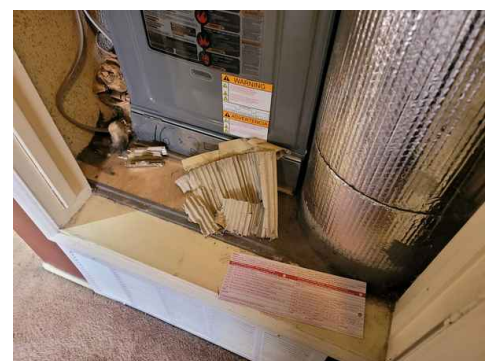
8.8.1 Vent Flue(s):

CLEARANCE INADEQUATE TO COMBUSTIBLE MATERIAL

The vent flue does not meet the minimum clearance to combustible material(s). This is typically 1 inch for double wall pipes and 6 inch for single wall pipes.

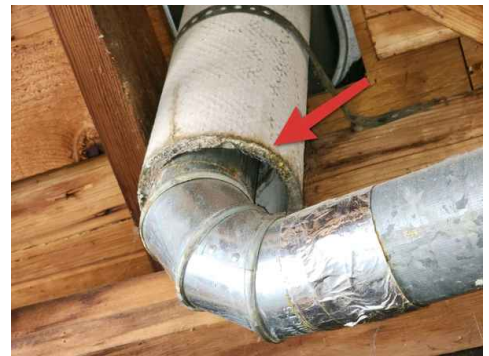
The vent pipe should have an adapter installed between the transite and the metal vent connectors as required by the gas company for safe operation.

Typically an Amerivent style Bell 3-4BTI (or similar depending on size). See photo shown.

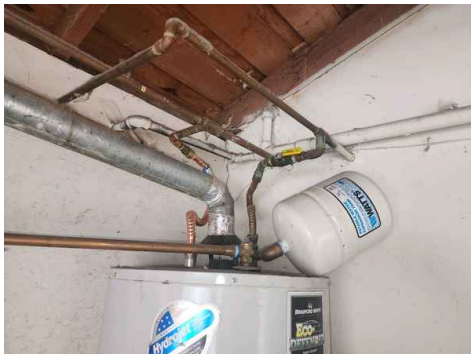
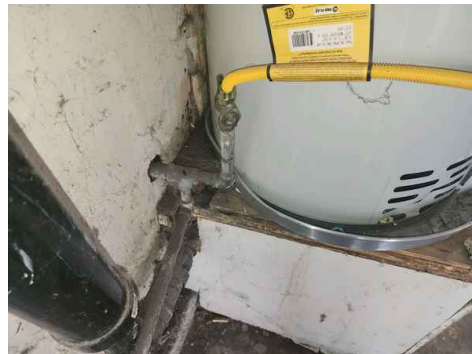
9.9.2 Water Heater Miscellaneous:

GARAGE

Sediment traps are recommended by most manufacturers to protect the gas valve and equipment.

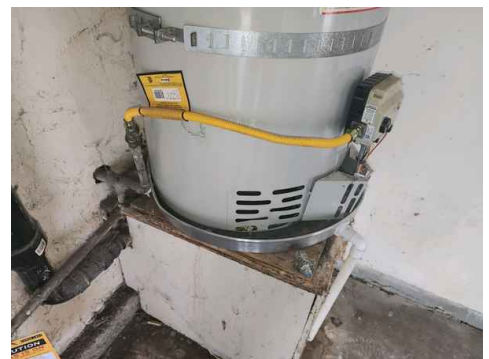
9.9.3 Water Heater Miscellaneous:

BLACK STAINS AND DAMAGE NOTED

The water heater platform or walls have damage and black stains likely due to previous leakage that should be repaired. The interior framing and insulation should be further evaluated and repaired and the drywall platform and/or wall should be replaced as it is also part of the firewall.

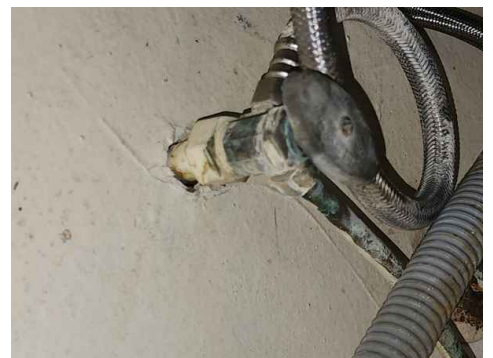
9.12.1 Angle Stops/Shut-off Valves:

The corroded angle stop valves should be replaced due to the risk of leakage.

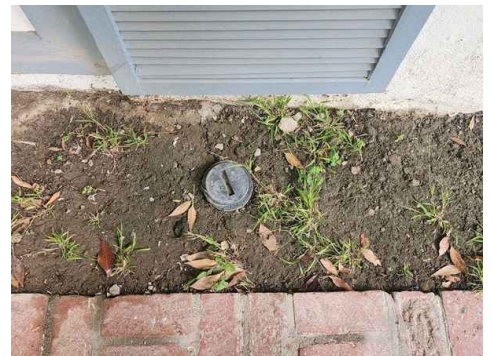
9.14.1 Drain, Waste, & Vent Systems:

We recommend verifying what, if any, repairs or replacement were made to the sewer line or have a professional sewer line video evaluation of the waste piping. An added clean out was noted for the system. Due to the age of the property and the large trees noted that may cause waste line impedance.

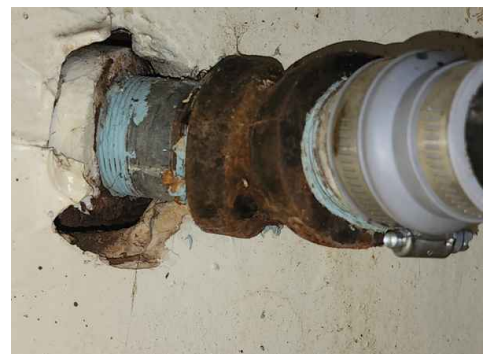
9.14.2 Drain, Waste, & Vent Systems:

The drain lines are showing corrosion and previous leakage and should be replaced.

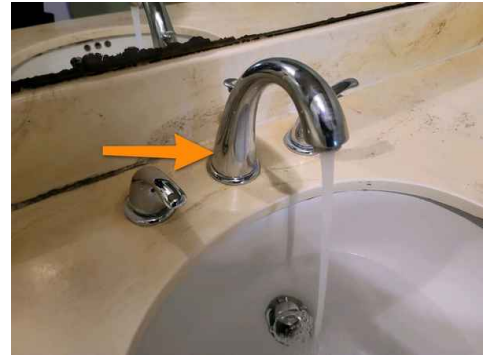
9.17.1 Sinks(s):

SLOW DRAIN NOTED

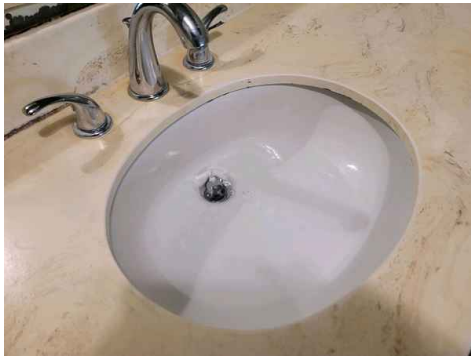
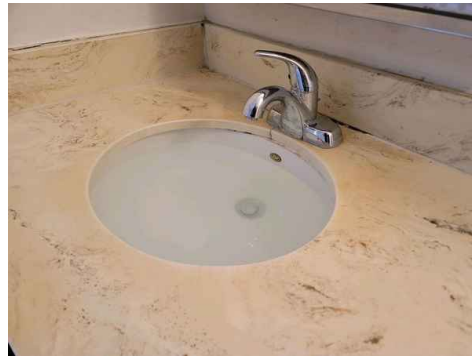
9.17.2 Sinks(s):

Master Bathroom

Upper Hallway Bathroom

SINK STOPPER NEEDS REPAIR

The sink drain stopper should be repaired or replaced as part of normal maintenance.

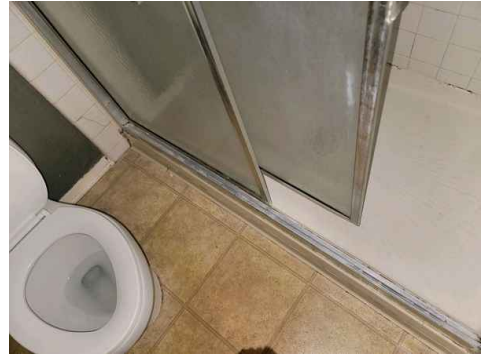
9.20.2 Shower(s):

DAMAGED/MISSING DOOR GUIDE

The shower door guide is damaged/missing and should be replaced or repaired. This prevents the door from coming off the track.

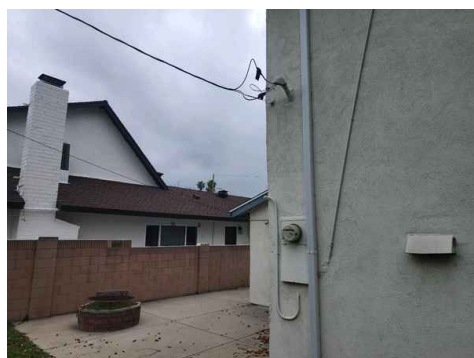
10.3.1 Main Electric & Main

The service wiring is lower than the required minimum for proper clearance.

Typical Service Drop Clearance Requirements.

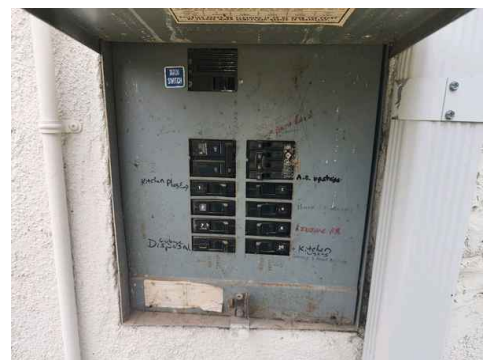
REAR EXTERIOR

The circuit breakers should be labeled as required for ease of use and in case of an emergency.

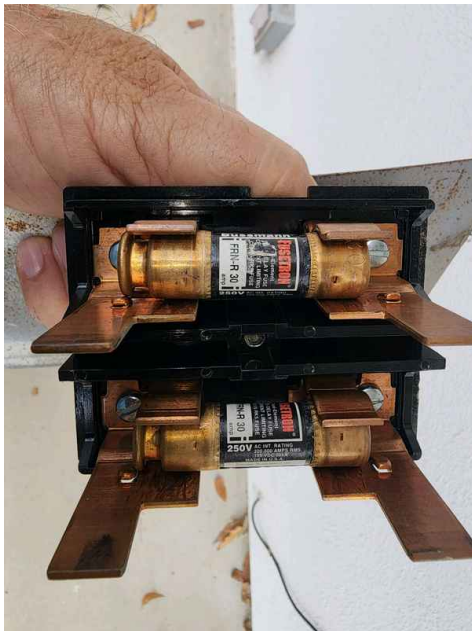
10.4.1 Sub-Panel(s)

FUSES TOO LARGE

The fuses are too large for the wire size(s) noted and should be replaced with the correct size.

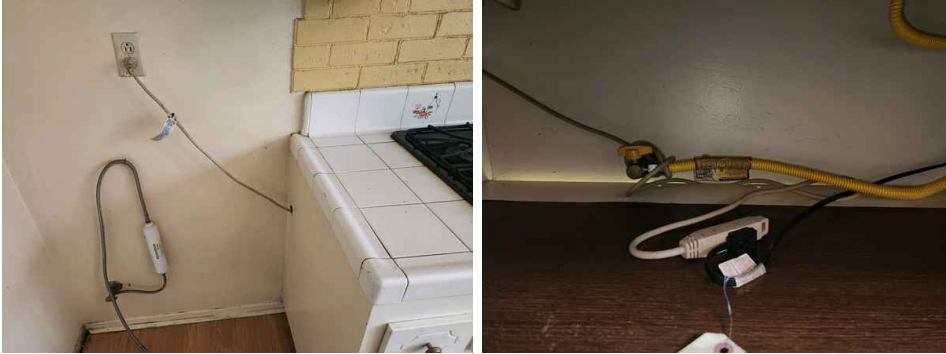
KITCHEN

EXTENSION CORD(S) OR POWER STRIPS WERE IMPROPERLY INSTALLED FOR USE AS PERMANENT WIRING

All extension cords and/or power strips are intended for temporary use only. Permanently installed receptacles are required for equipment that is permanent.

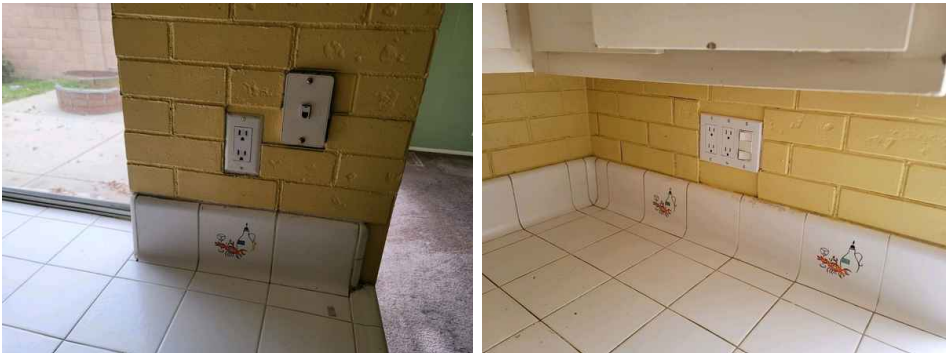
MODIFIED WITHOUT GFCI PROTECTION INSTALLED

Some receptacle(s) have been modified without GFCI protection installed. We recommend having a qualified electrical contractor install these for safety in all recommended locations.

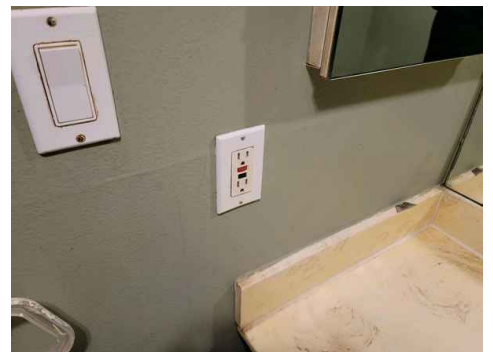
GFCI DOES NOT TRIP

GFCI appears to be defective and should be replaced for safety.

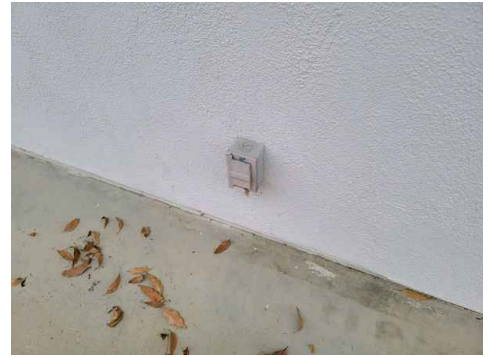
This condition will likely allow the receptacle to remain "live" when tripped and could cause injury.

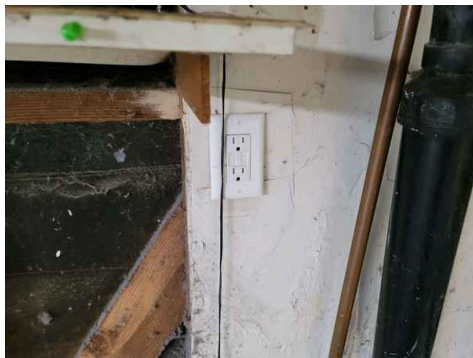
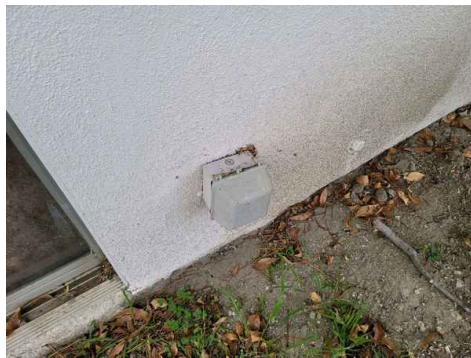
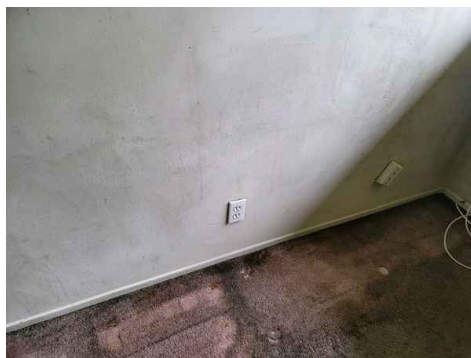
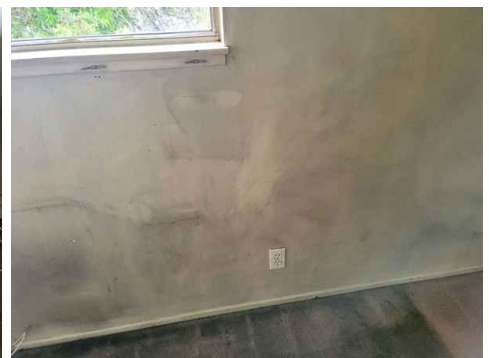
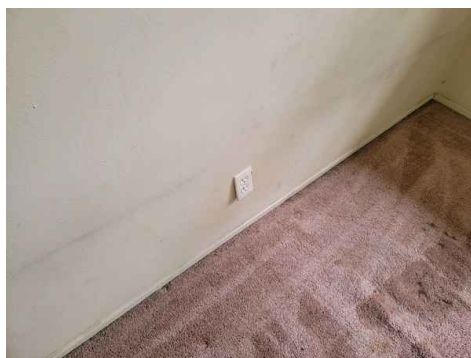
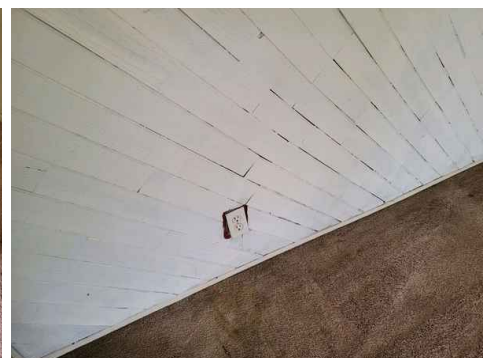
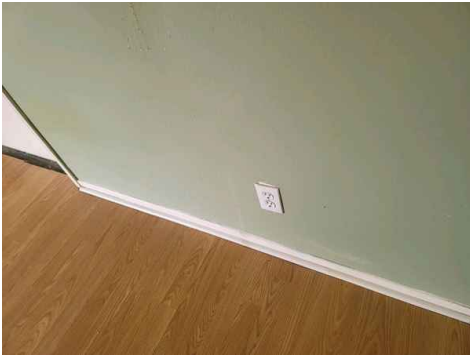
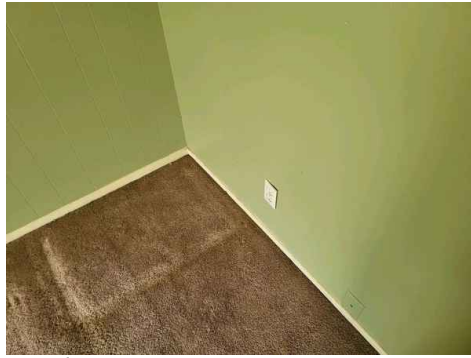
LOOSE RECEPTACLE(S) NOTED

The loose receptacle(s) or junction box(es) should be properly secured in place for safe operation.

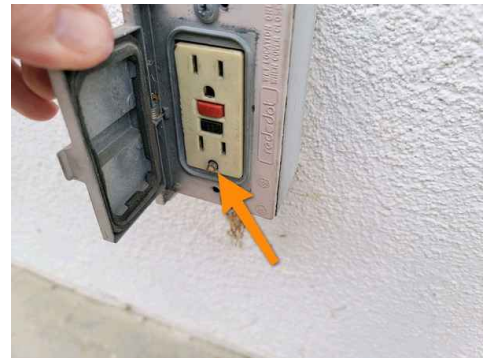
DAMAGED RECEPTACLE NOTED

The damaged receptacle should be properly repaired or replaced.

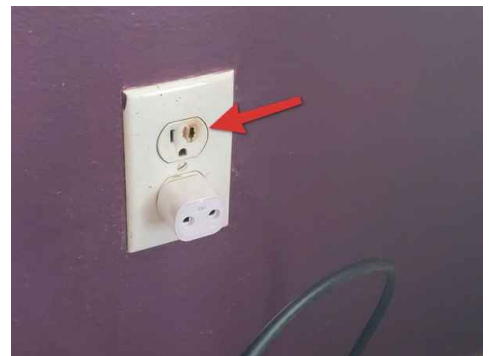
DISCOLORED RECEPTACLE NOTED

The discolored receptacle should be evaluated and repaired or replaced as needed by a qualified electrical contractor.

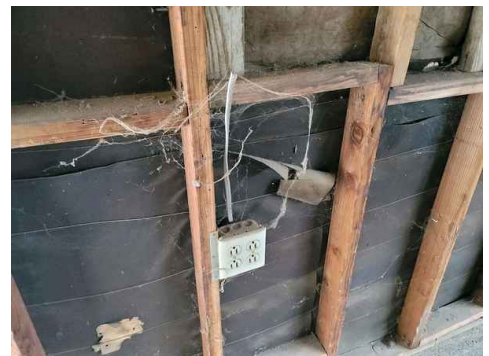
NON-OPERATIONAL RECEPTACLE(S) NOTED

The receptacle(s) in this area are not operational. Further evaluation by a qualified electrical contractor is recommended.

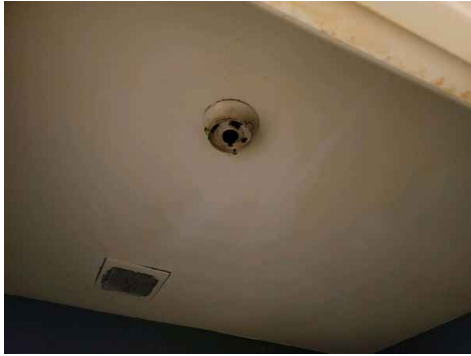
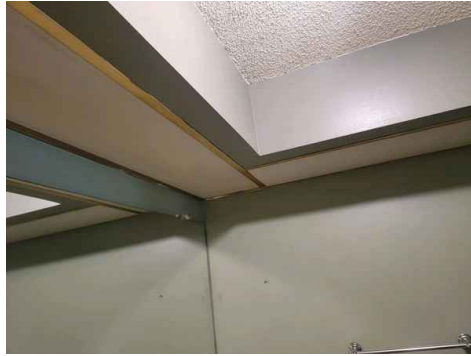
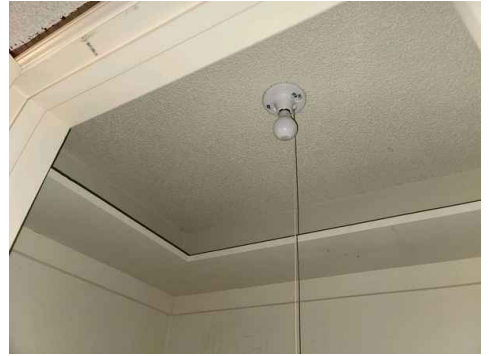
LIGHT(S) INOPERATIVE

One or more lights are not operating likely due to burned out or missing light bulb(s). Verify operation with seller by having the bulbs replaced.

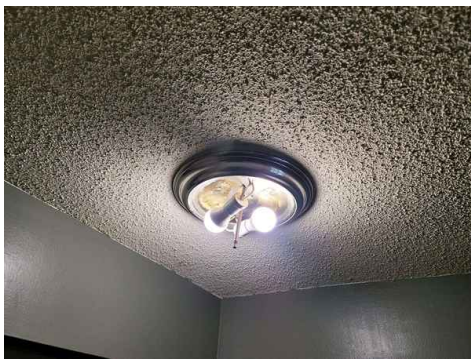
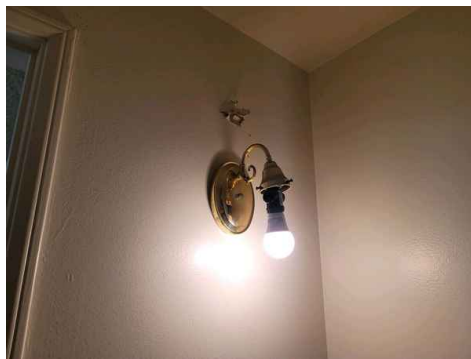
MISSING/LOOSE GLOBES OR EXPOSED BULBS

The light fixtures should have globes securely installed where possible or be upgraded to have fully enclosed light fixtures installed for increased safety.

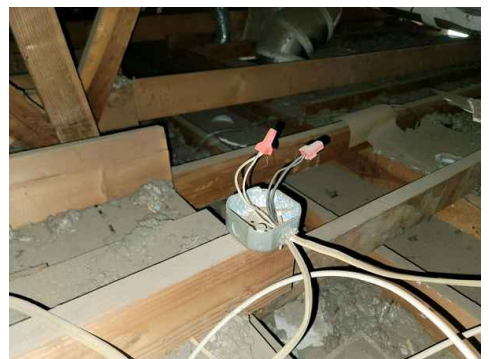
OPEN J-BOX(ES) NEEDS REPAIR

All junction boxes should be properly enclosed and covered for safety.

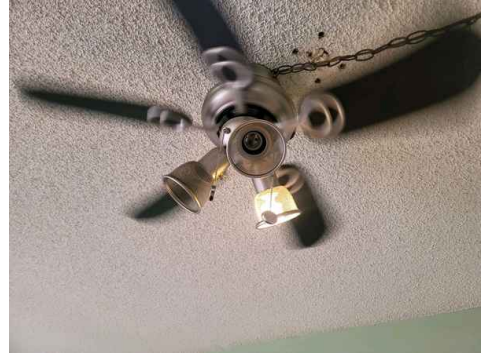
LIGHT(S) NOT OPERATIONAL

Usually due to the bulbs. We recommend having the seller replace to verify operation.

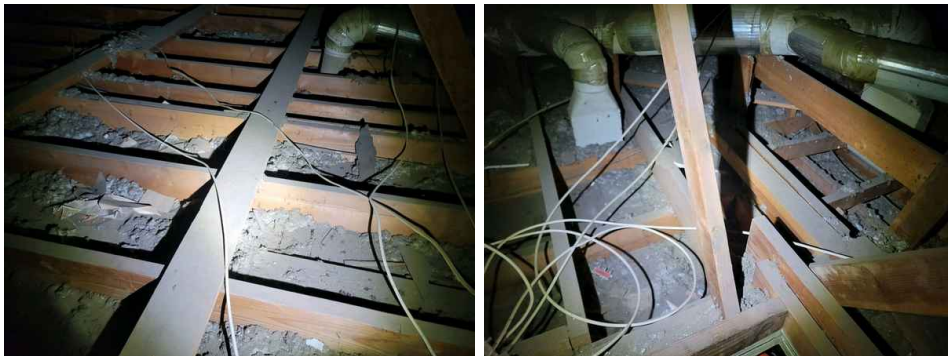
MISSING INSULATION NOTED

Insulation appears to have been pulled out and/or damaged by pests. Recommend a qualified insulation contractor evaluate and repair.

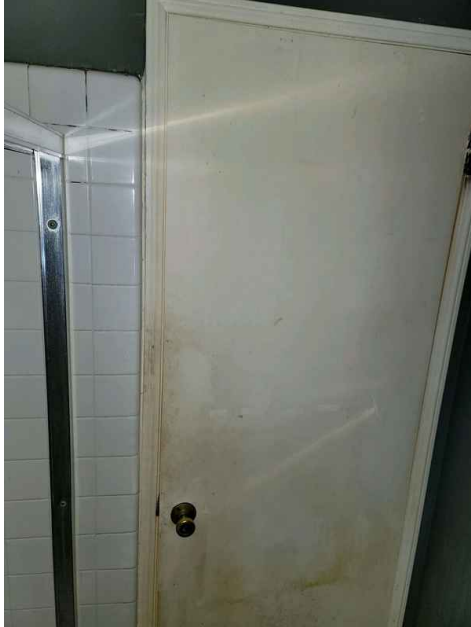
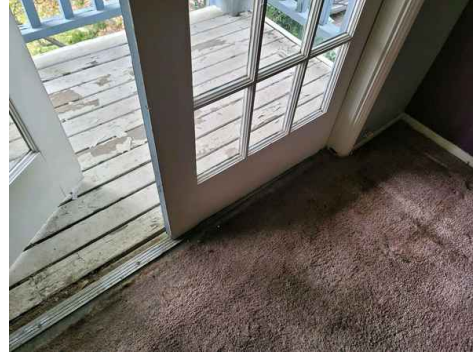
The door rubs and is difficult to operate. We recommend adjusting or planing the door for proper operation.

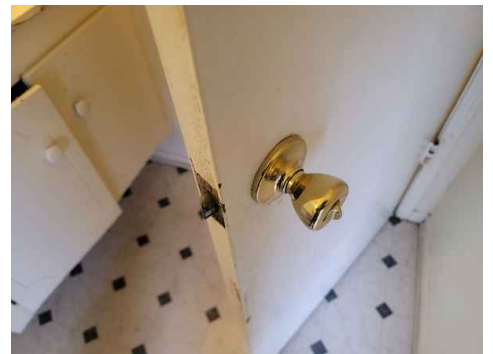
DOOR LOCK NEEDS REPAIR

The door lock(s) need repair to operate properly.

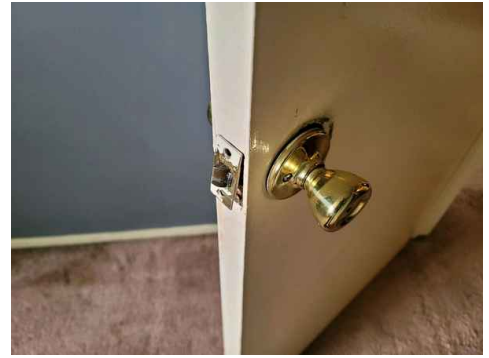
DOOR KNOB HARDWARE NEEDS REPAIR

The door knob hardware needs repair to operate properly.

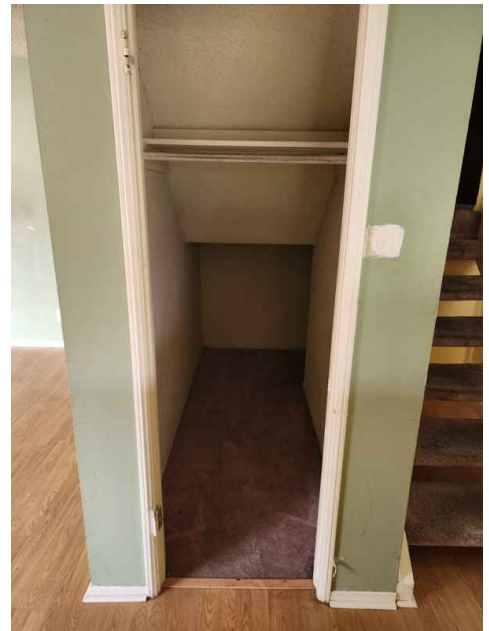
MISSING DOOR NOTED

The missing door(s) should be replaced as needed.

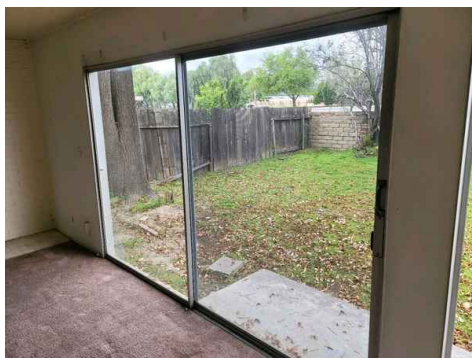
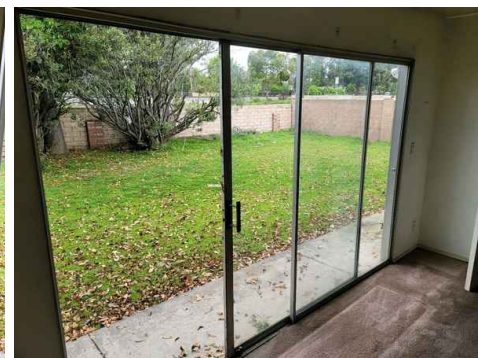
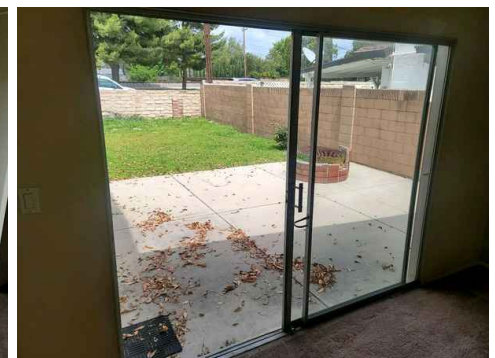
DOOR SAFETY GLASS NOT MARKED

The door glass was not clearly marked as being safety glass. We recommend installing a tint film for breakage protection if the tempered glass cannot be verified.

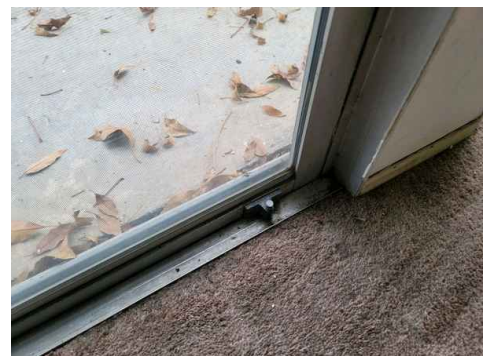
LIVING ROOM

Recommended Improvements**LOCK INTERFERENCE**

The added lock interferes with the operation of the sliding door and should be removed to allow proper operation of the door.

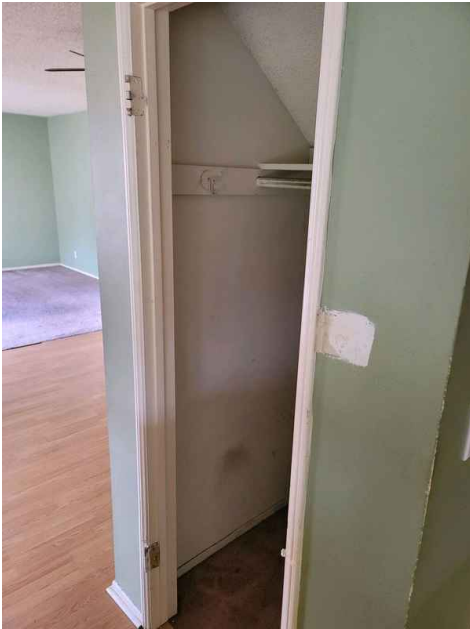
INTERIOR CLOSET

Upgrades/Maintenance Items**CLOSET DOOR(S) MISSING**

The missing closet door(s) should be replaced.

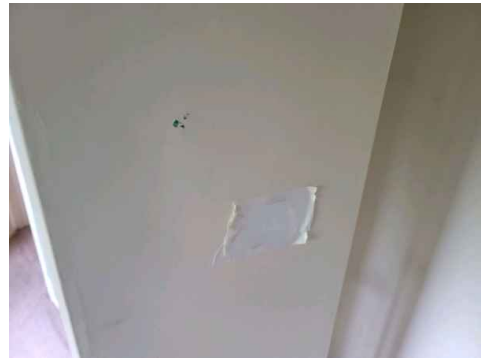
DAMAGED DOOR SKIN

The damaged closet door skin should be repaired.

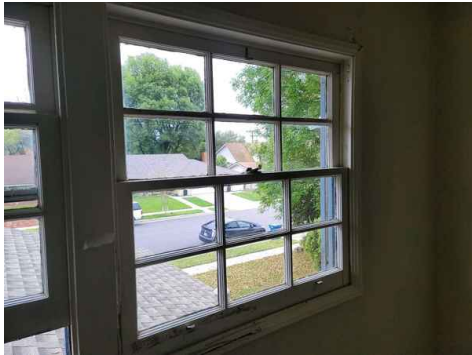
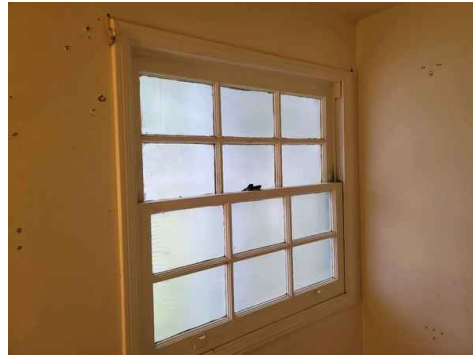
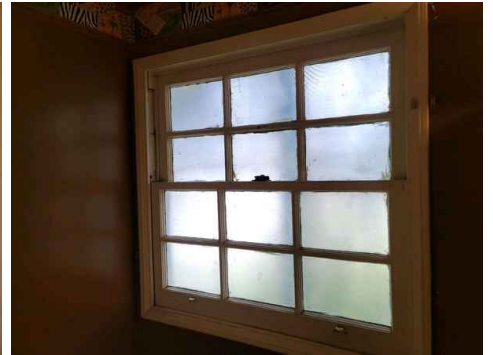
BROKEN SASH CORD/SPRING

The window won't open and close properly due to the broken sash cord/spring that should be repaired.

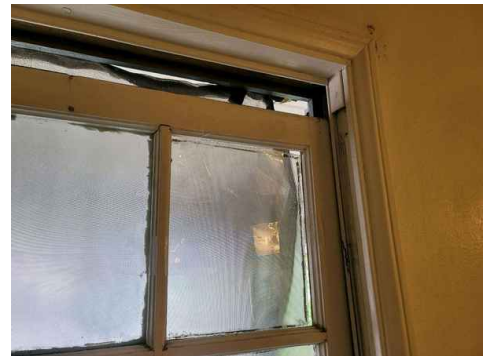
LOOSE WINDOW

The loose window should be repaired as needed.

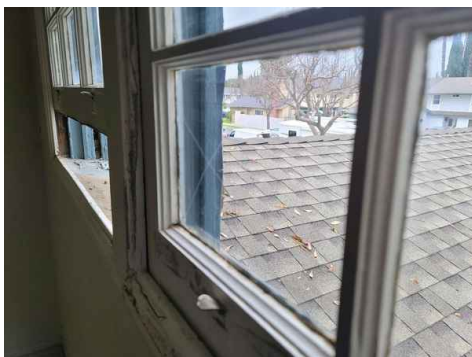
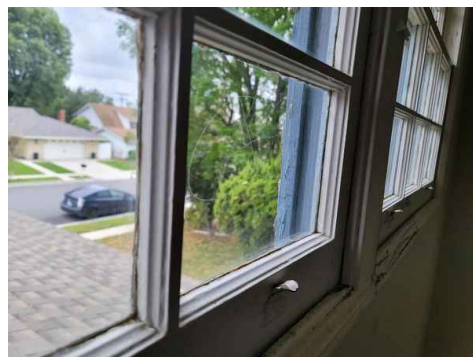
12.5.4 Windows:

GLASS SCORED/SCRATCHED

The window glass has been scored or scratched and needs replacement.

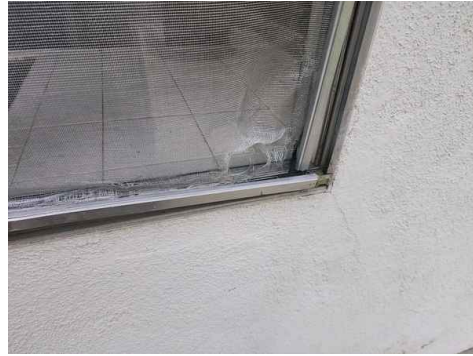
12.6.1 Window and Door Screens:

WORN/DAMAGED WINDOW SCREENS NOTED

The worn/damaged window screen(s) noted should be repaired or replaced to prevent insects from entering the property.

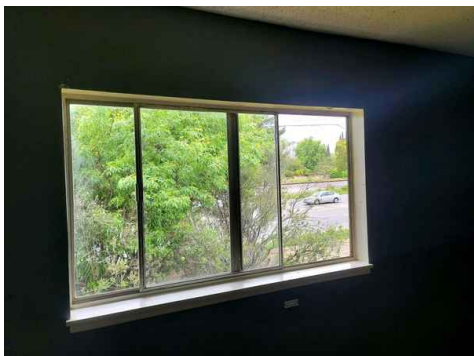
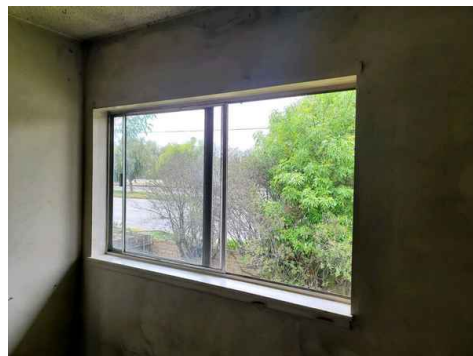
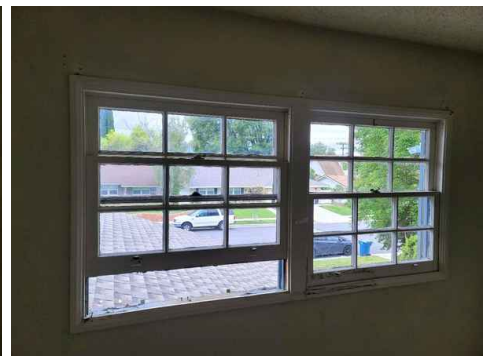
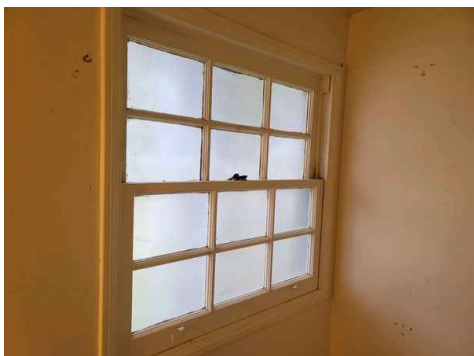
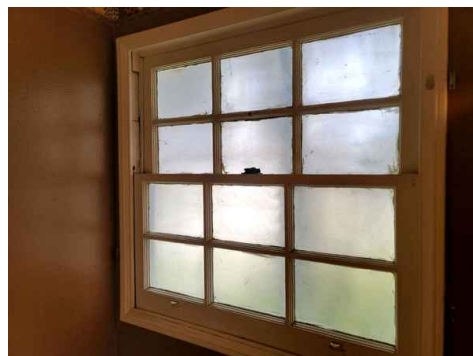
12.6.2 Window and Door Screens:

MISSING WINDOW SCREEN(S)

The missing window screens need replacement.

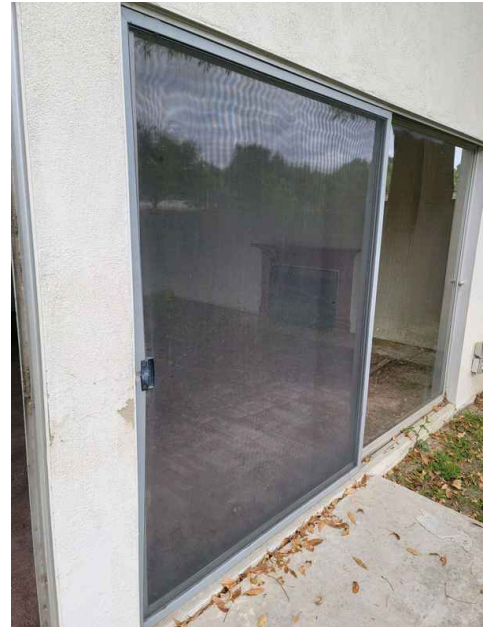
12.6.3 Window and Door Screens:

SCREEN DOOR IS WORN/DAMAGED

The worn/damaged screen door should be repaired or replaced as needed.

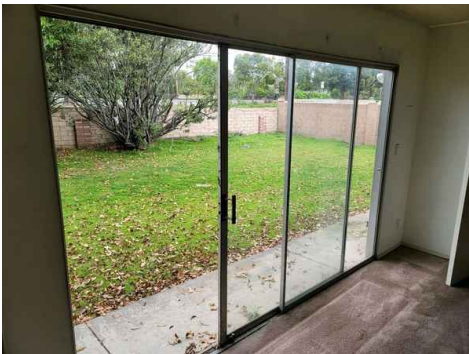
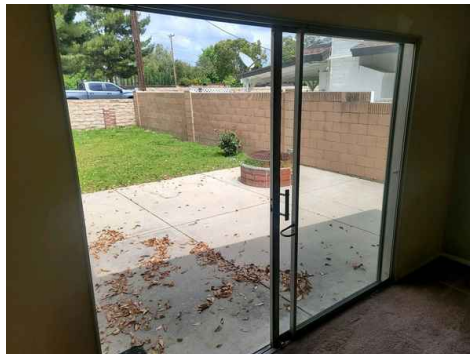
12.6.4 Window and Door Screens:

SCREEN DOOR IS MISSING

The missing screen door should be replaced.

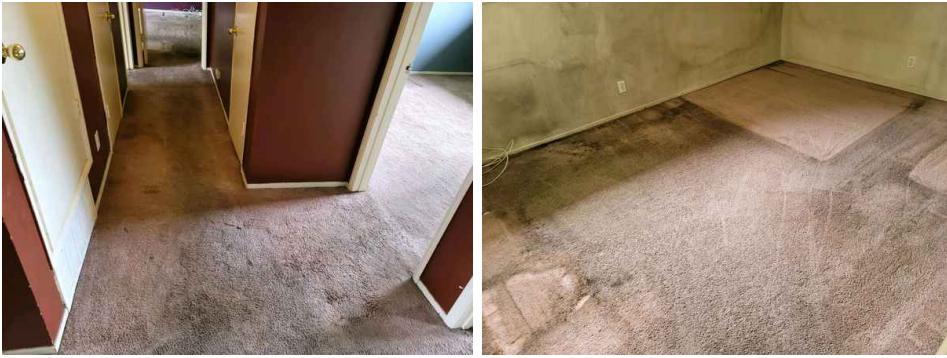
12.7.1 Floors:

CARPET STAINS

Carpet had areas of staining or discoloration. Recommend a thorough cleaning and stretching if possible by a qualified carpet cleaning company or replacement as desired.

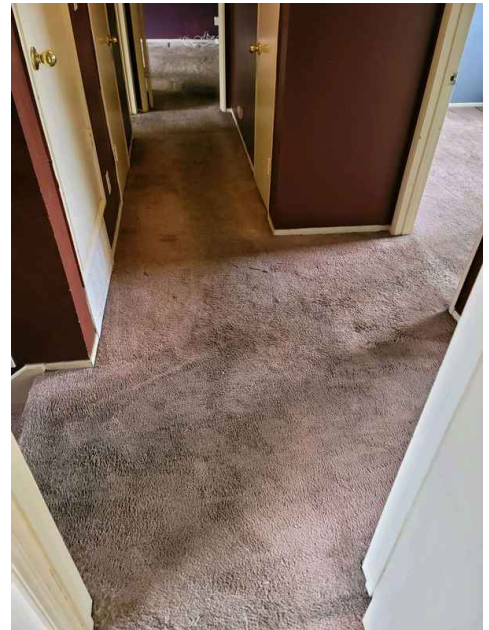
12.7.2 Floors:

SQUEAKING FLOOR(S)

Squeaking flooring were noted. This is usually caused by plywood rubbing and can be repaired by adding deck screws to the subflooring. For more information see: [No More Squeaks](#)

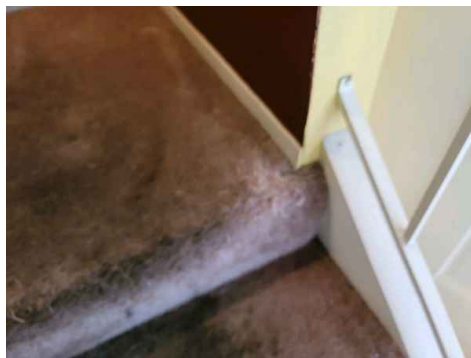
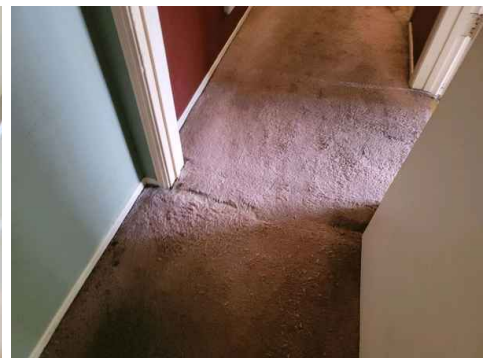
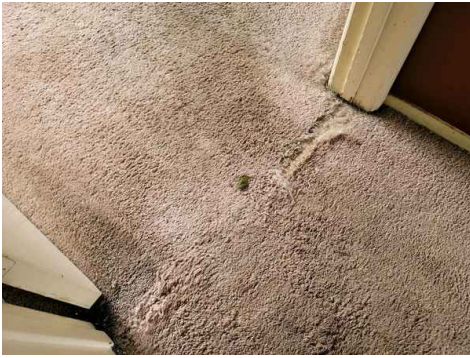
12.7.3 Floors:

CARPET DAMAGE NOTED

The property has carpet damage visible that needs repair or replacement as it may pose a trip hazard.

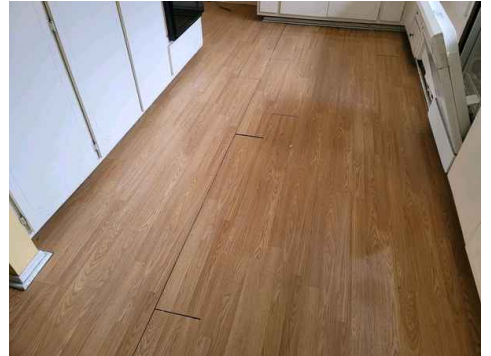
12.7.4 Floors:

FLOORING HAS OPEN SEAMS

The laminate flooring has open seams which may allow moisture penetration or premature wear and should be corrected.

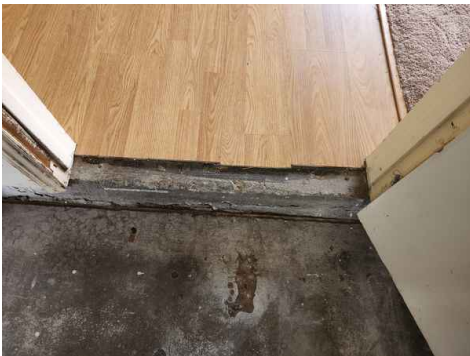
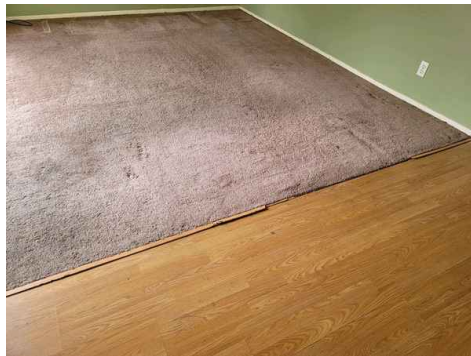
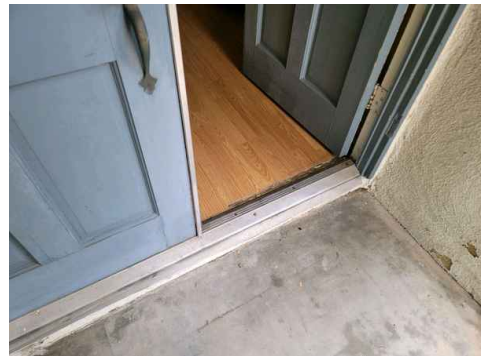
12.7.5 Floors:

LOOSE/MISSING THRESHOLD

The loose/mising floor theshold(s) should be installed or secured as needed.

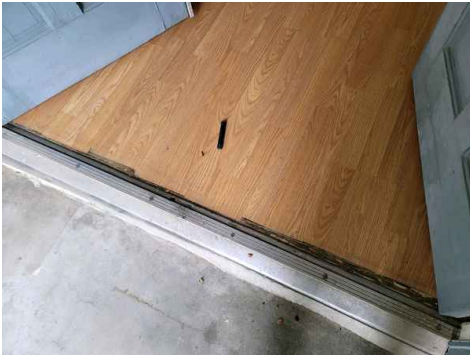
12.7.6 Floors:

The laminate flooring is loose and uneven in various areas. This is likely due to an unprofessional installation of the flooring materials. Recommend evaluation by a qualified flooring contractor.

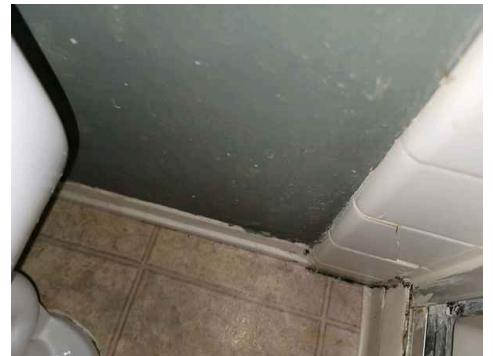
12.8.1 Walls:

WATER DAMAGE

The source of the water damage should be verified and repaired and the wall damage should be repaired as needed.
