RESIDENTIAL REPORT

2629 Lee St
Simi Valley, CA 93065

Darren Humphrey
04/23/2024

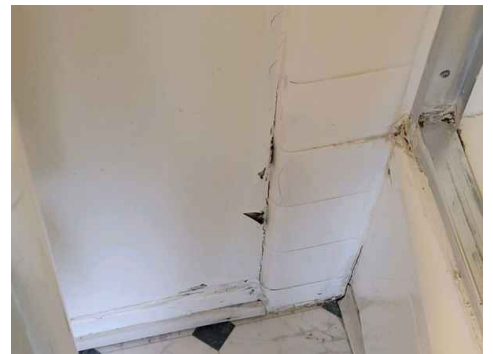
12.8.2 Walls:

MOISTURE STAINS AT WALL NOTED

The stains on the wall(s) visible at the time of the inspection appeared to be the result of previous moisture intrusion. We recommend verifying the source of leakage was repaired and then repairing the wall and repainting with primer as needed.

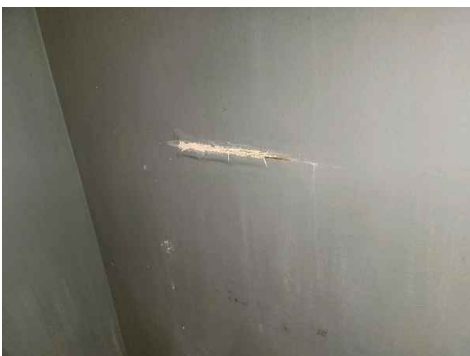
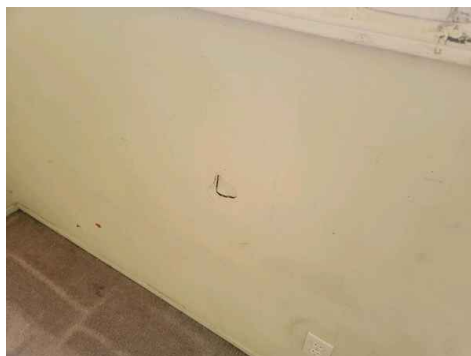
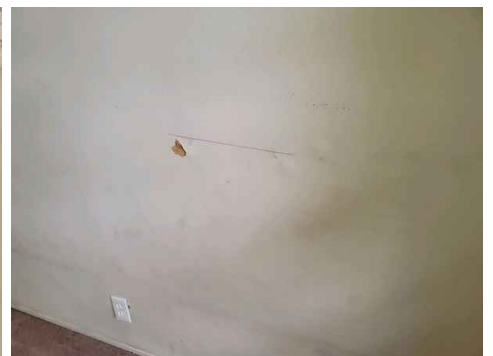
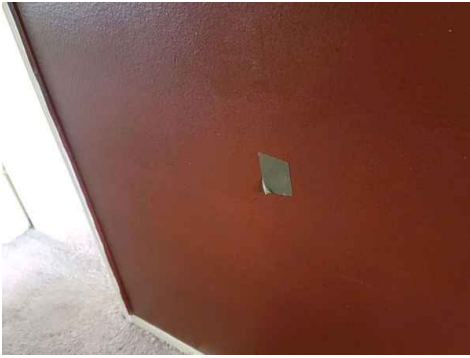
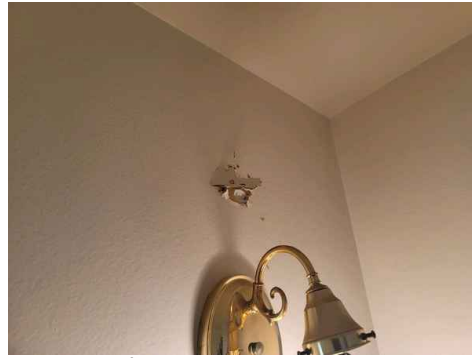
12.8.3 Walls:

DRYWALL DAMAGE

Wall has drywall damage and needs repair. Recommend patching/painting as needed.

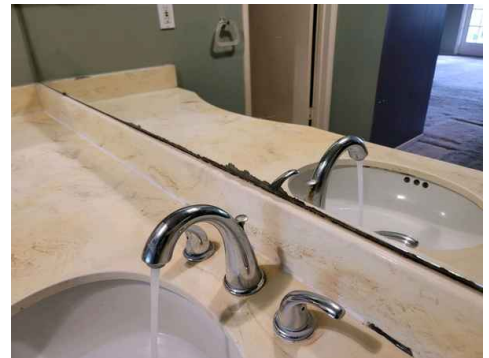
12.8.4 Walls:

CORROSION NOTED ON VANITY MIRROR

The vanity mirror has corrosion noted and should be repaired or covered with trim as desired.

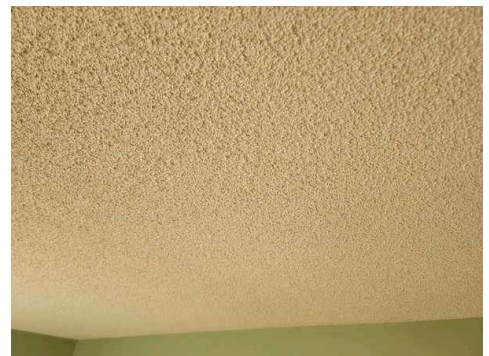
12.9.1 Ceilings:

PRE-1979 ACOUSTIC CEILING

Acoustic ceilings installed prior to 1979 may contain asbestos. Testing for environmental materials is not part of our inspection. Any repair work or removal of these materials should be done by a qualified professional.

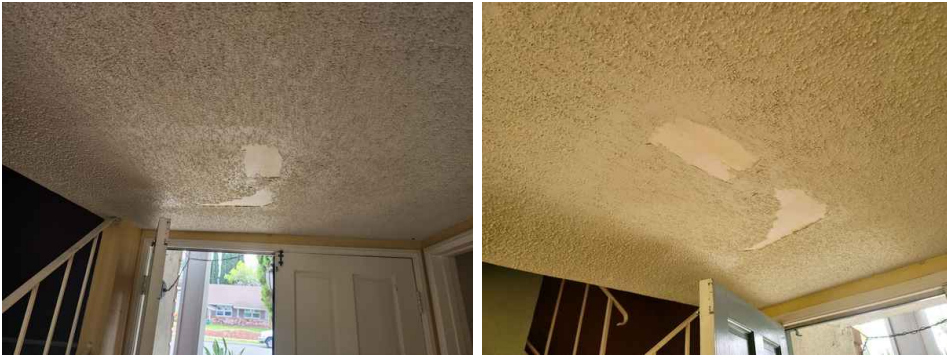
12.9.2 Ceilings:

OLD MOISTURE STAIN(S) NOTED

Old moisture stain(s) to the ceiling were visible at the time of the inspection. These do not appear to be recent, but we recommend checking with the seller(s) determine if they are aware of the leakage and if repair was made.

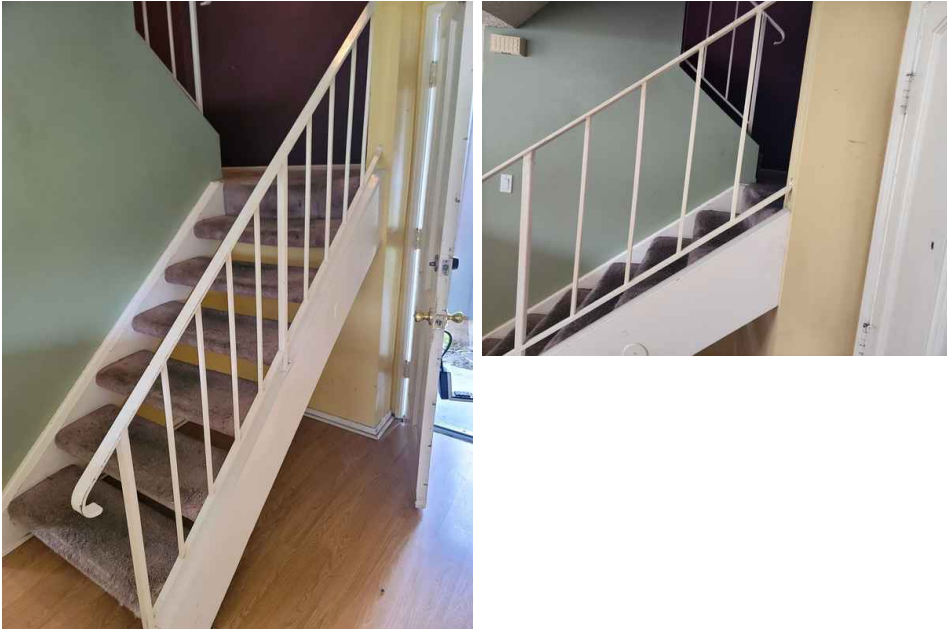
12.10.1 Steps, Stairways & Railings:

BALUSTER SPACING NEEDS UPGRADING

The baluster spacing is not up to modern safety standards. The space between balusters should not allow passage of a 4 inch sphere for child safety. We recommend upgrading or installing a protective element if small children or pets will be present.

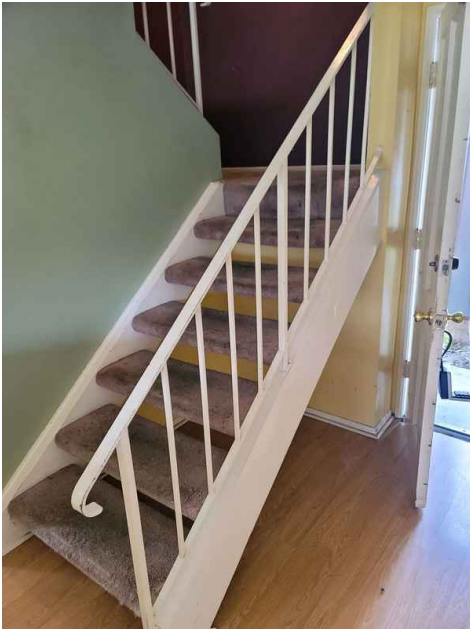
LOOSE BALUSTERS

Handrail balusters were loose. This should be repaired for safety.

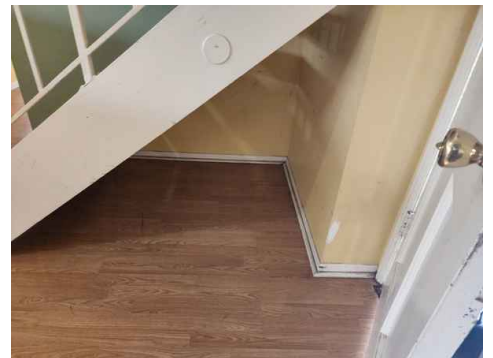
12.10.3 Steps, Stairways & Railings:

OPEN STAIRWELL NOTED

The open stairwell was common at the time of construction. This method is no longer allowed as firewalls are required. This can be done as an upgrade if desired by installing additional framing and fire-rated drywall underneath the stairs.

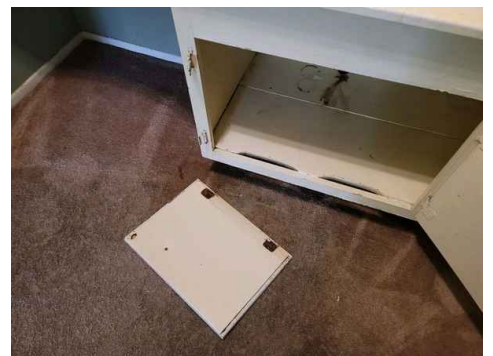
12.11.1 Countertops & Cabinets:

**CABINET DOOR/DRAWER
LOOSE/MISSING**

One or more cabinet doors/drawers were loose/missing and should be repaired.

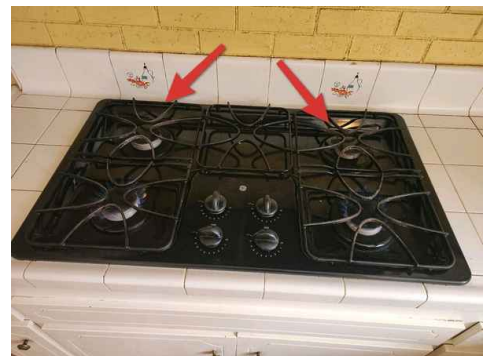
13.1.1 Cooktop:

The electrical igniter(s) on the stove are not working properly and should be repaired as needed.

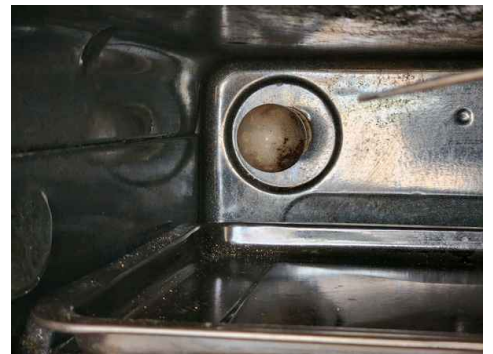
13.2.1 Oven:

OVEN LIGHT NOT OPERATIONAL

The oven light should be replaced to verify proper operation.

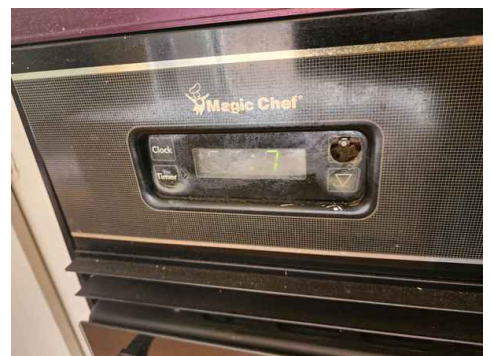
13.2.2 Oven:

MISSING CONTROL KNOBS

Range/Oven was missing control knobs. Recommend contacting manufacturer for replacement parts.

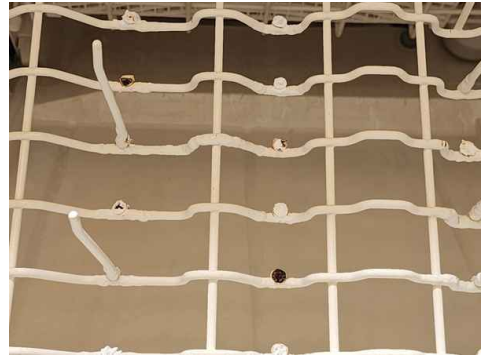
BASKET DAMAGED

The dishwasher basket is damaged and needs repair for proper operation.

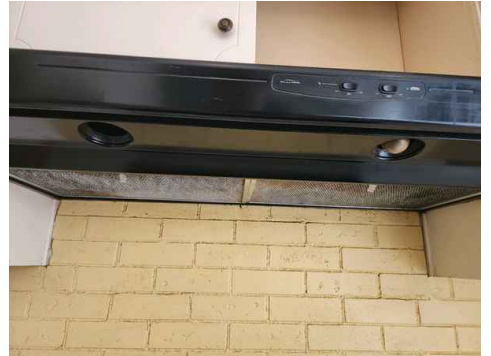
13.6.1 Exhaust Systems:

LIGHT INOPERATIVE

The light should have the bulb replaced and further verified for proper operation.

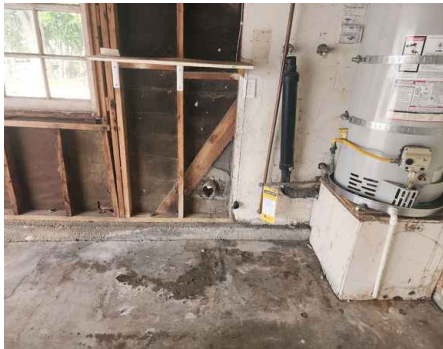
Location:: Location:

Garage

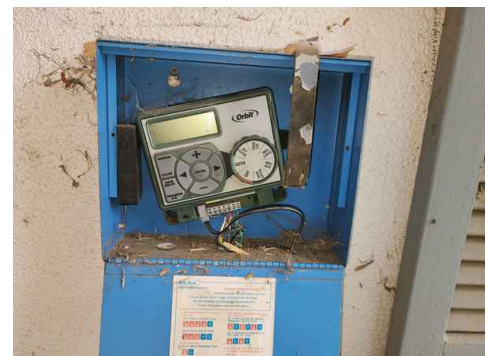
15.1.1 Irrigation Recommendations:

TIMER IS NOT WORKING/MISSING

FRONT EXTERIOR

The irrigation timer should be repaired or replaced as needed.
