Inspection Report

Property Address:
1333 Eighth Ave UNIT 205
San Diego CA 92101

All Pro Property Inspection

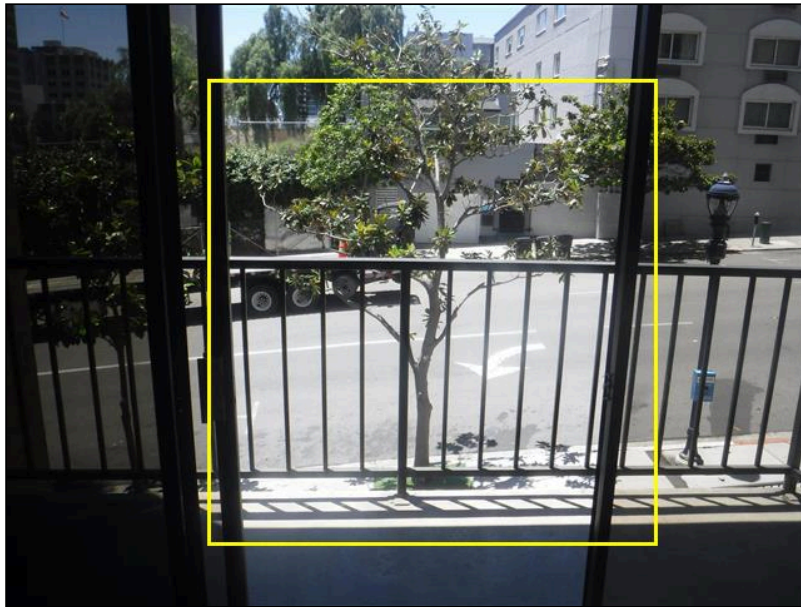
2.1 Item 1(Picture)

(1) The sliding screen doors are missing. We recommend replacing/ installing by a qualified person.

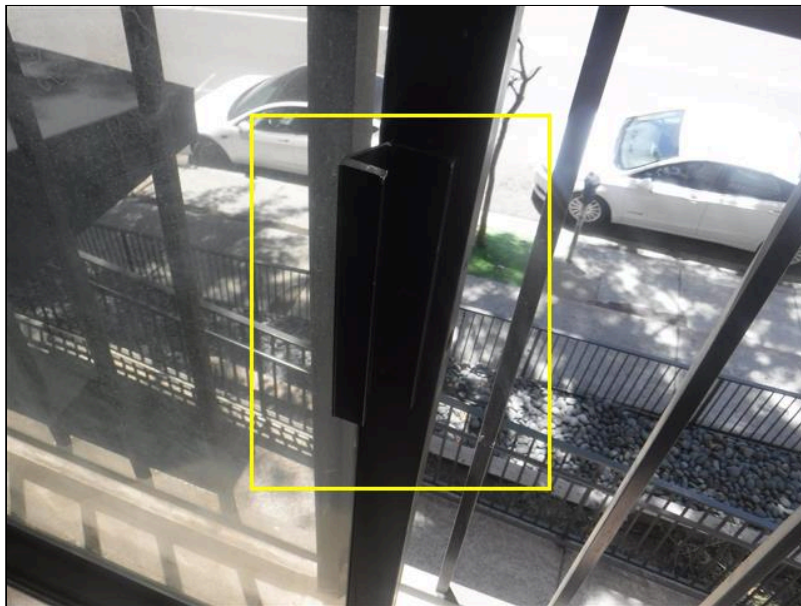
2.1 Item 3(Picture)

(2) The latch is missing at the sliding glass door in the bedroom. We recommend necessary repairs or replacement by a qualified person.

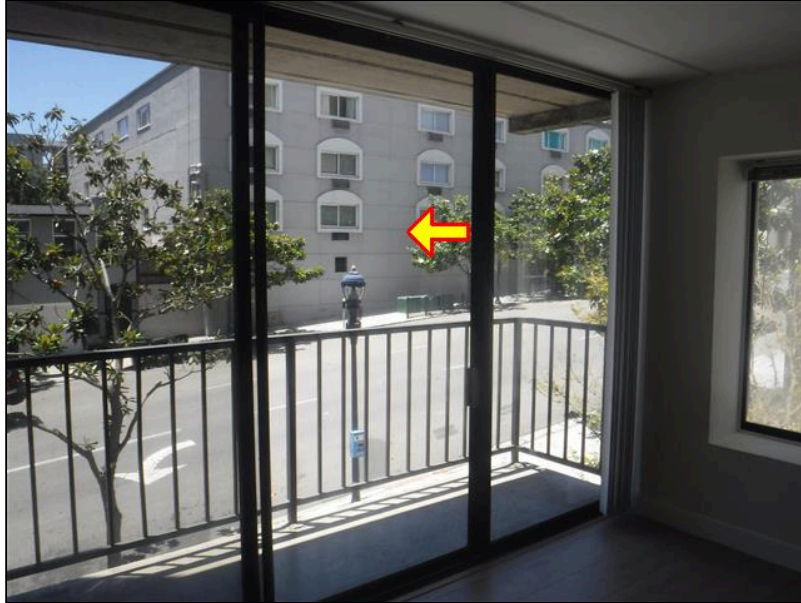
2.1 Item 4(Picture)

(3) The sliding glass doors are mounted with the sliding portion of the doors mounted on the exterior side of the home. This may have common at the time of original construction. However, this may allow the sliding portion of the doors to be easily removed by a would be intruder from the exterior of the house. We recommend having the sliding portion of the door installed on the inside or upgrading the sliding glass doors to the type with the sliding portion of the door mounted on the interior of the home by a qualified licensed door contractor.

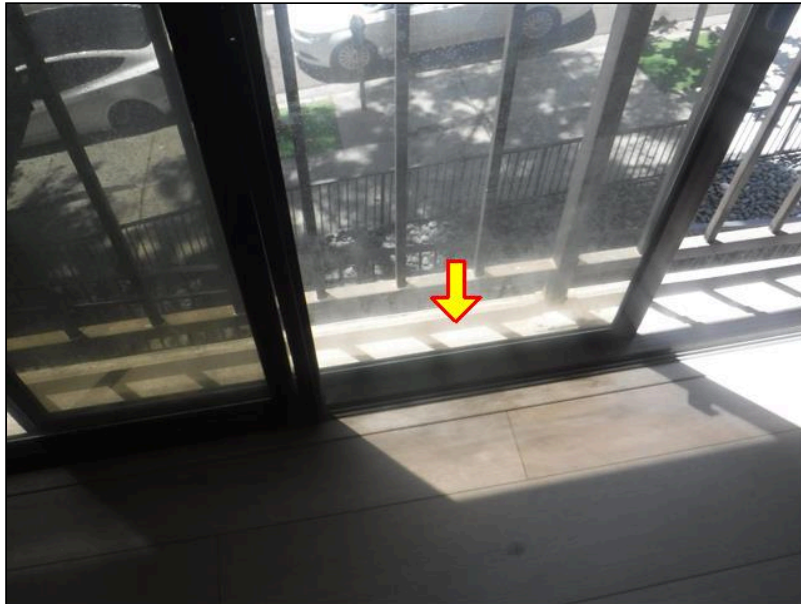
2.1 Item 5(Picture)

(4) The bed room sliding glass door rollers appear to be worn or incorrectly adjusted, which makes it difficult to open and close the door. We recommend having the rollers adjusted, replaced, the track cleaned or other necessary corrections by a qualified person.

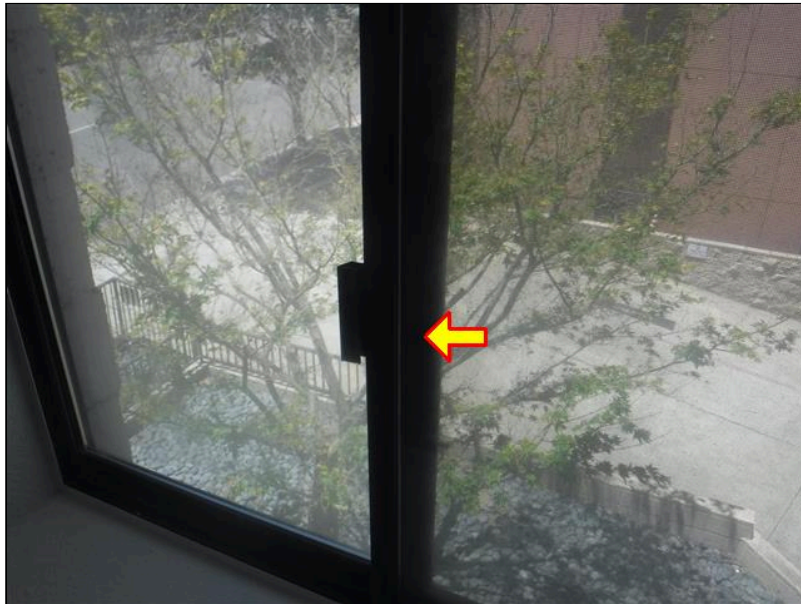
2.2 Item 1(Picture)

(1) A window latch was found to be inoperable at a family room window. We recommend necessary repair or replacement by a qualified licensed window contractor.

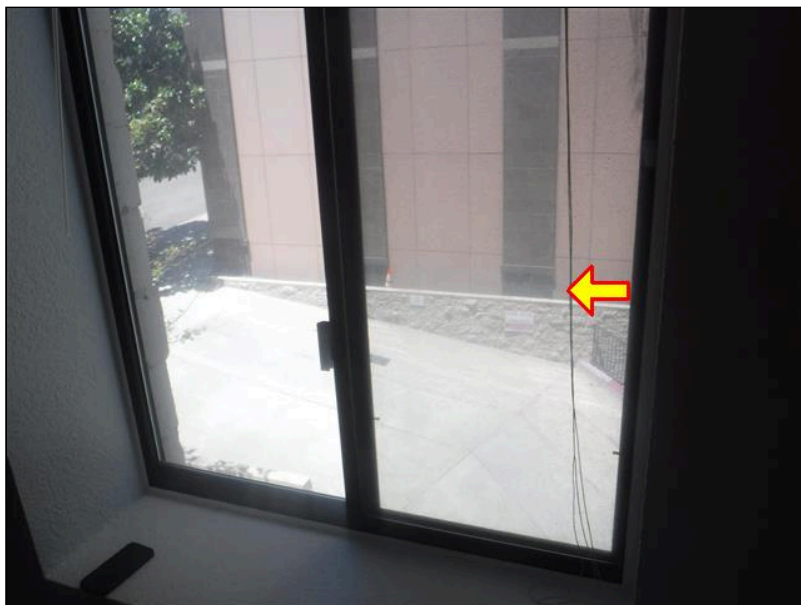
2.2 Item 2(Picture)

(2) The dual pane windows were dirty at the time of the inspection. This limits the inspectors ability to observed fogged windows (failed seals in dual pane windows). We recommend having the windows cleaned and then inspected by this company or a qualified licensed window contractor prior to the end of your contingency period.

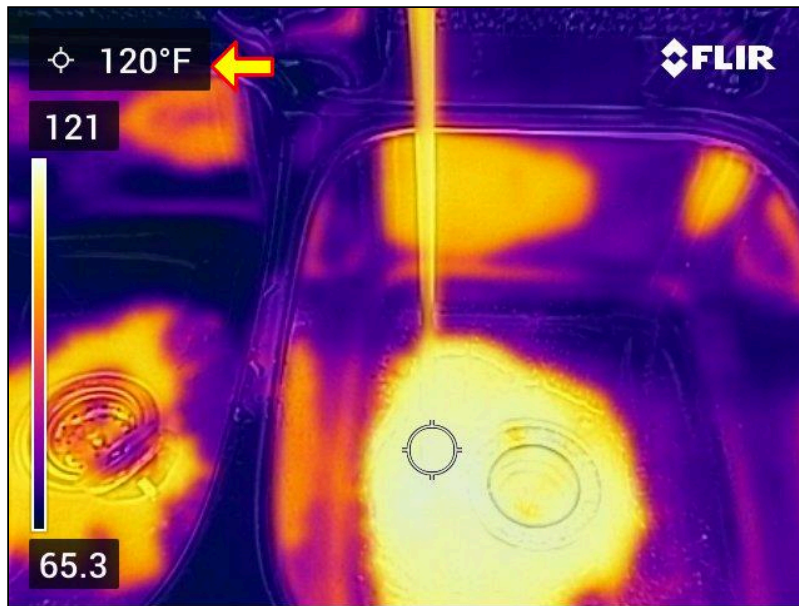
3.0 Item 1(Picture)

There appears to be a community hot water system for this home. We do not inspect community water heaters. If concerned we recommend contacting the HOA.

Note: The temperature of the water was tested using a thermal camera during the inspection and was found to be operating within normal range.

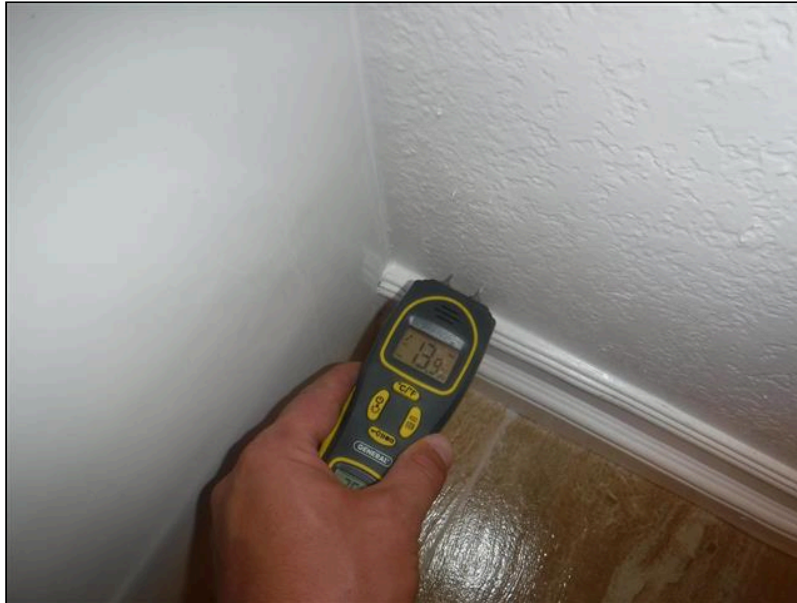
4.0 Item 1(Picture)

(1) A representative sampling for moisture was performed at accessible interior walls using a moisture meter. (*areas prone to moisture, such as kitchens, bathrooms, below grade walls, exterior walls with doors/windows*). An elevated moisture was not detected at the time of the inspection.

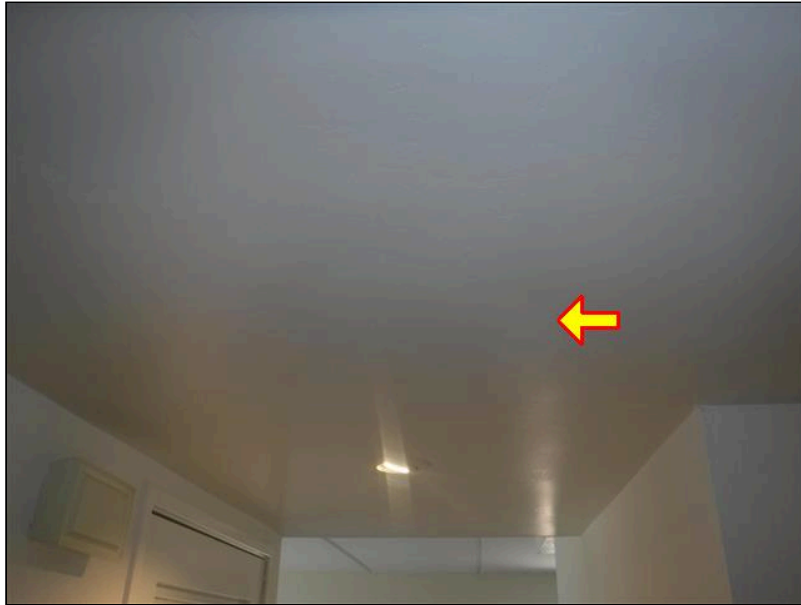
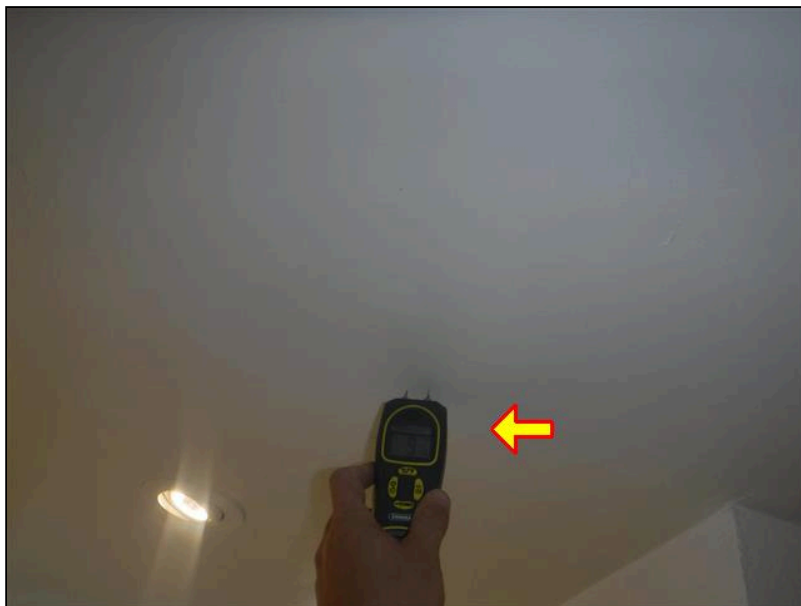
4.1 Item 1(Picture)

(1) Water stain(s) noted at the ceiling in the hallway. These stains were tested for moisture and were found to be dry at the time of the inspection. No elevated level of moisture was detected which may indicate that the staining is old or from a one-time event (such as a tub/toilet over-flow). The stain were dry at the time of the inspection so I could not determine if the leak is still active. Under certain conditions or regular use there may be an active leak. We recommend further evaluation by a qualified licensed plumber prior to the end of your contingency period if concern.

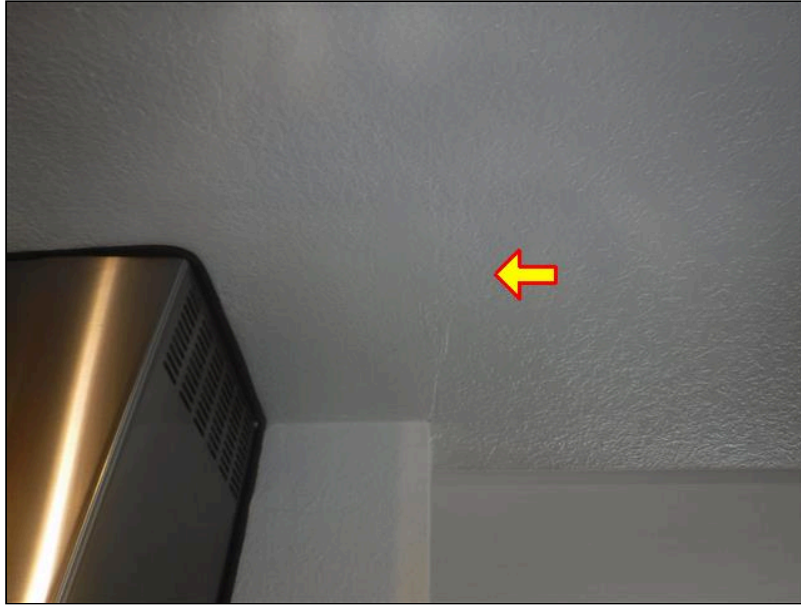
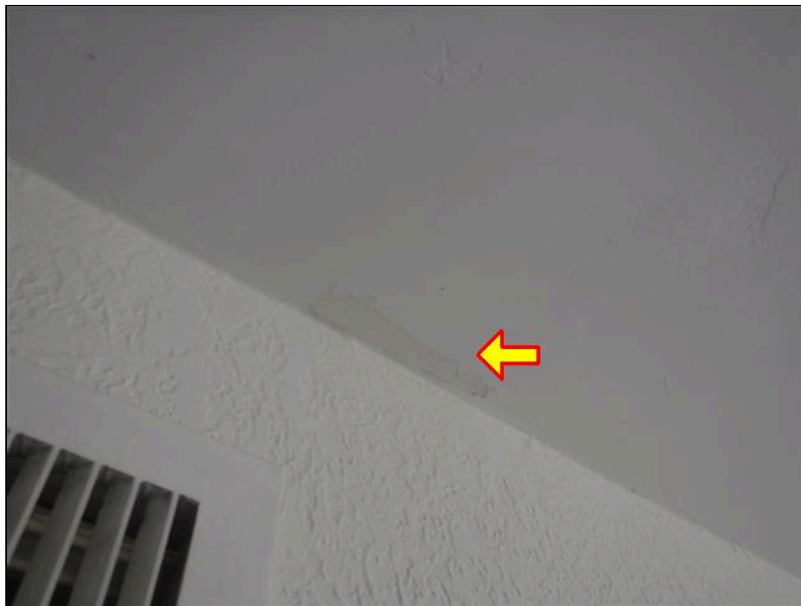
4.1 Item 3(Picture)

(2) The ceiling has typical cosmetic wear in areas. We recommend prep and paint by a qualified person.

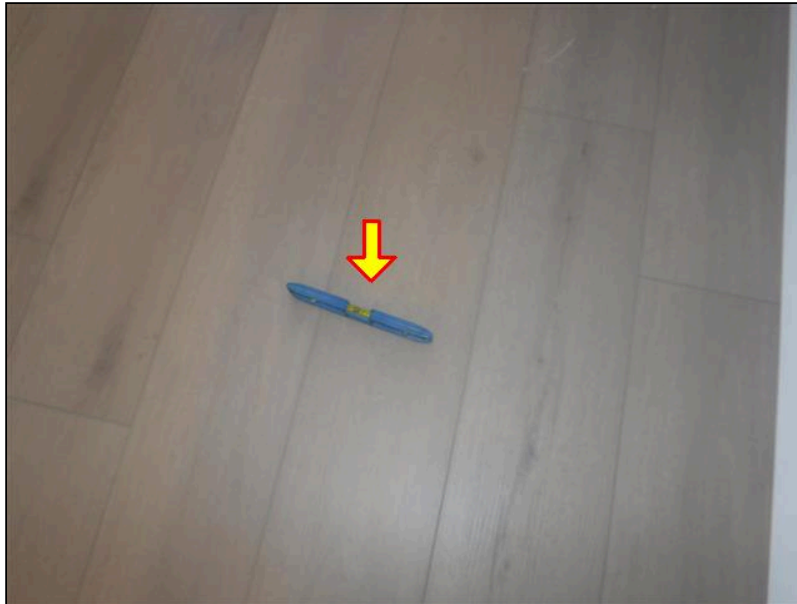
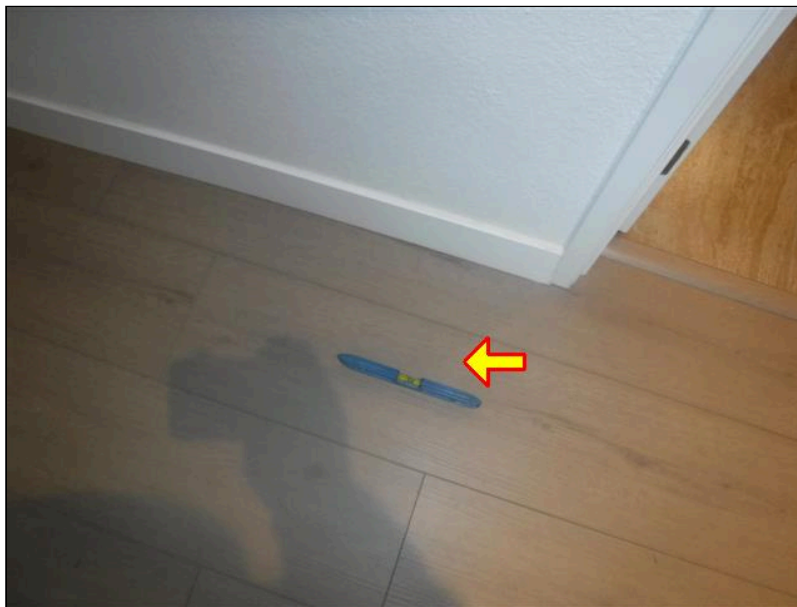
4.3 Item 1(Picture)

The floor is sloping in several areas. Possibly due to flooring installation issues. We recommend necessary repairs by a qualified licensed flooring contractor, if the buyer is concerned.

Note: This did not appear to be a structure issue. However, if structural issues exist it is beyond the scope of this home inspection and should be brought to the attention of the HOA for any necessary repairs needed at this time.

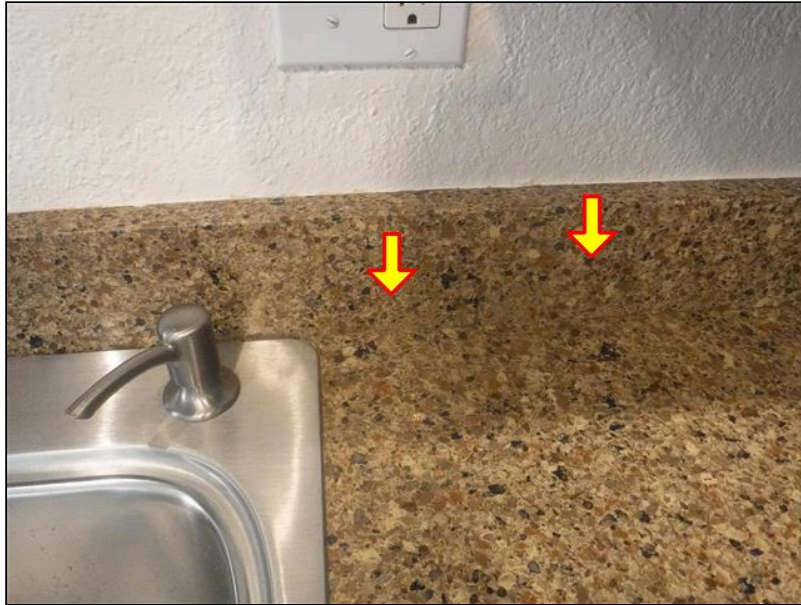
4.4 Item 1(Picture)

locations to prevent moisture intrusion.

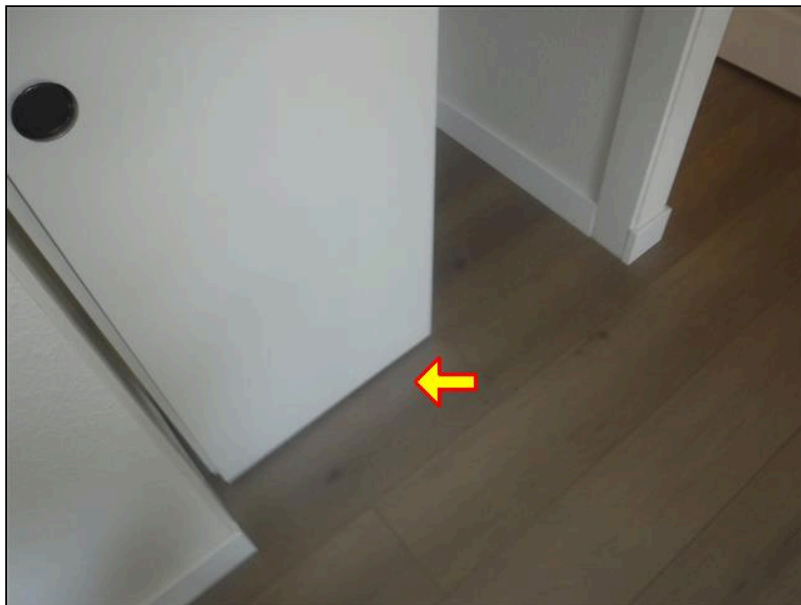
4.5 Item 1(Picture)

(1) Closet door floor guides are missing at one or more bedroom closet doors. This is a pinching hazard. We recommend installing where needed by a qualified person.

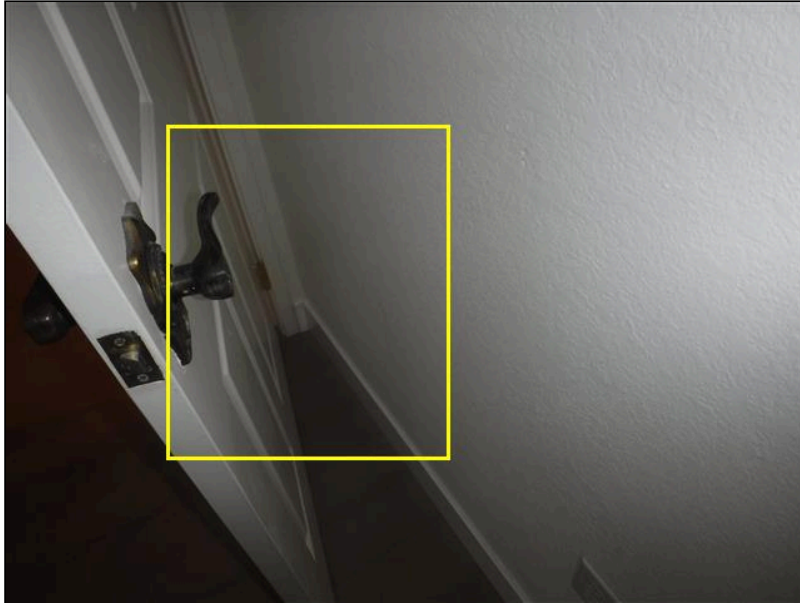
4.5 Item 2(Picture)

(2) Door stoppers are missing at one or more doors. Door stoppers are recommended where door handles contact walls. We recommend adding door stops and repair of any walls by a qualified person.

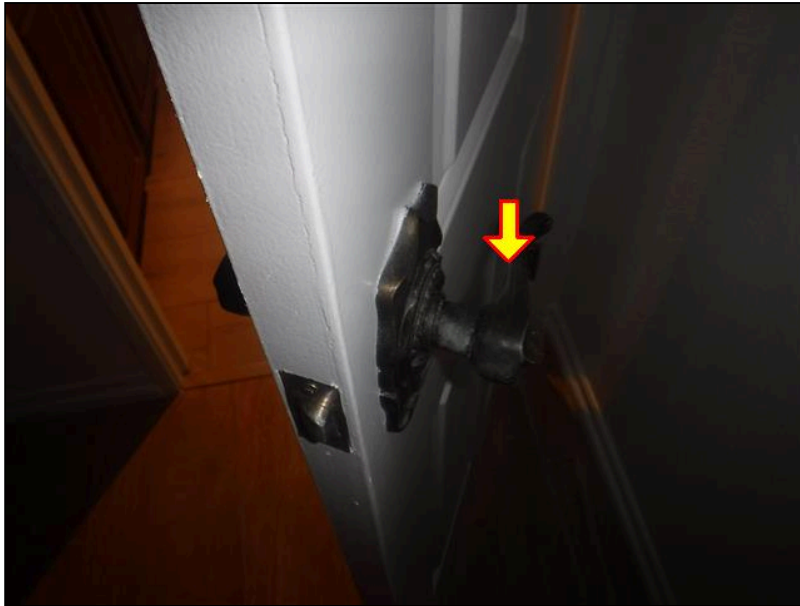
4.5 Item 3(Picture)

(3) The hallway bathroom door lock is not operating correctly. We recommend repairs or replacement by a qualified licensed contractor.

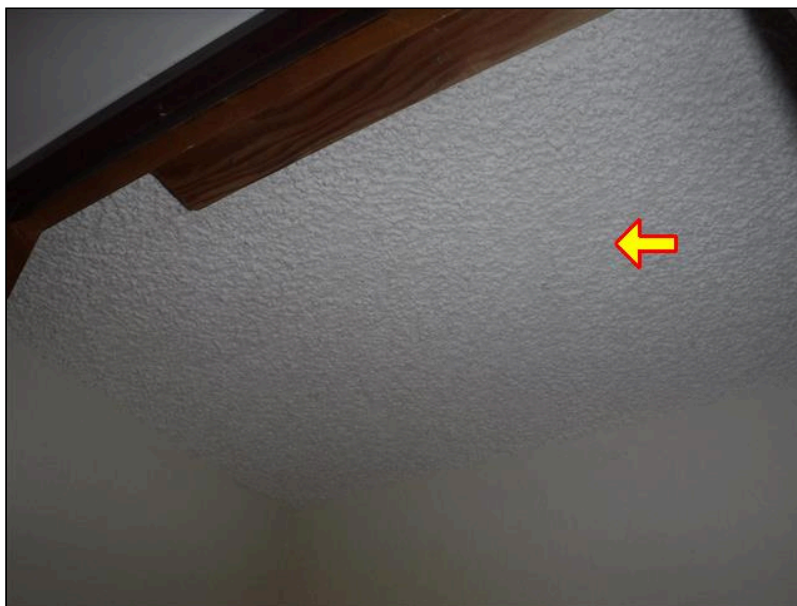
4.8 Item 1(Picture)

(1) There is acoustic texture present at the ceiling. Some of this acoustic texture installed before the 1980's has been known to contain asbestos. It is beyond the scope of this general home inspection for us to test for asbestos. The only way to confirm the presence or absence of asbestos is by having it tested by a qualified person. We recommend having the acoustic texture tested by a qualified person if concerned.

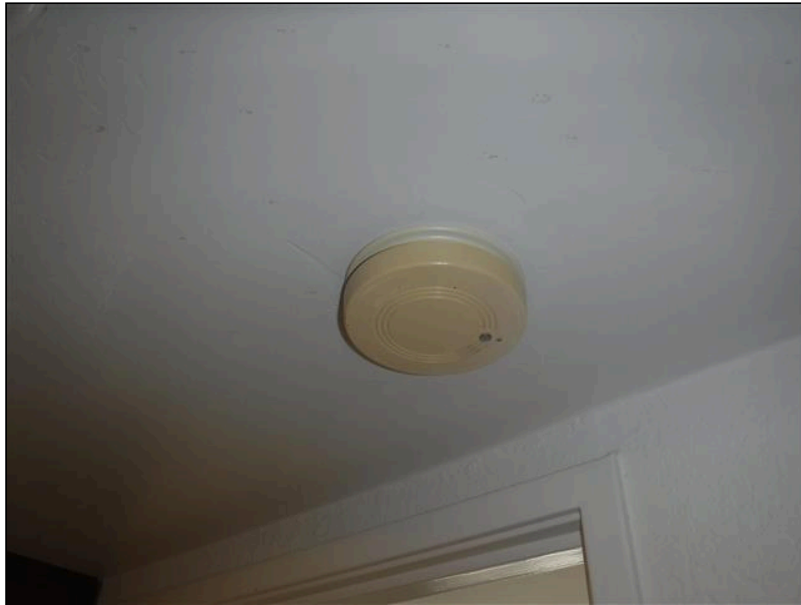
5.0 Item 1(Picture)

There is only one smoke detector present in the common hallway as required at the time of construction. We recommend installing additional smoke detectors where needed to comply with current fire and safety standards and regulations.

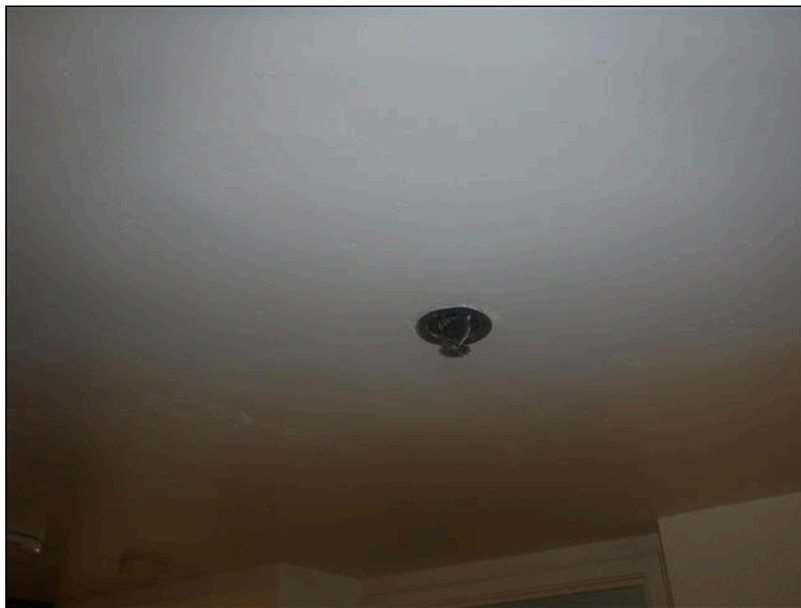
5.3 Item 1(Picture)

There is a fire sprinkler system installed in the condo and was not inspected by this company at the time of the home inspection. Inspecting fire sprinkler systems is beyond the scope of our general home inspection. We recommend periodic tests performed by the HOA. Recommend inquiring with the HOA regarding this system if the buyer is concerned.

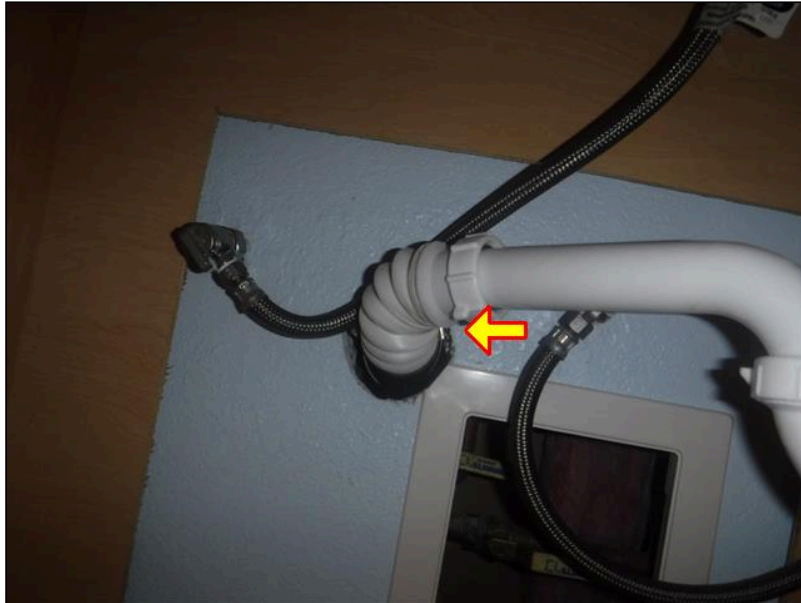
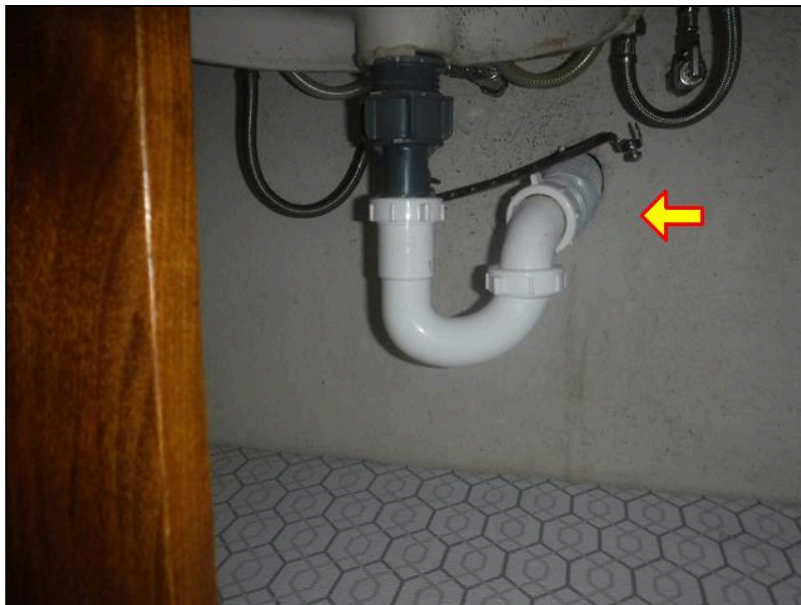
6.0 Item 1(Picture)

(1) A corrugated (flexible) waste pipe is installed at several bathroom sinks. This is a non standard installation because this type of material may hold bacteria and is more likely to become clogged. We recommend replacing this corrugated (flexible) waste pipe by a qualified licensed plumber.

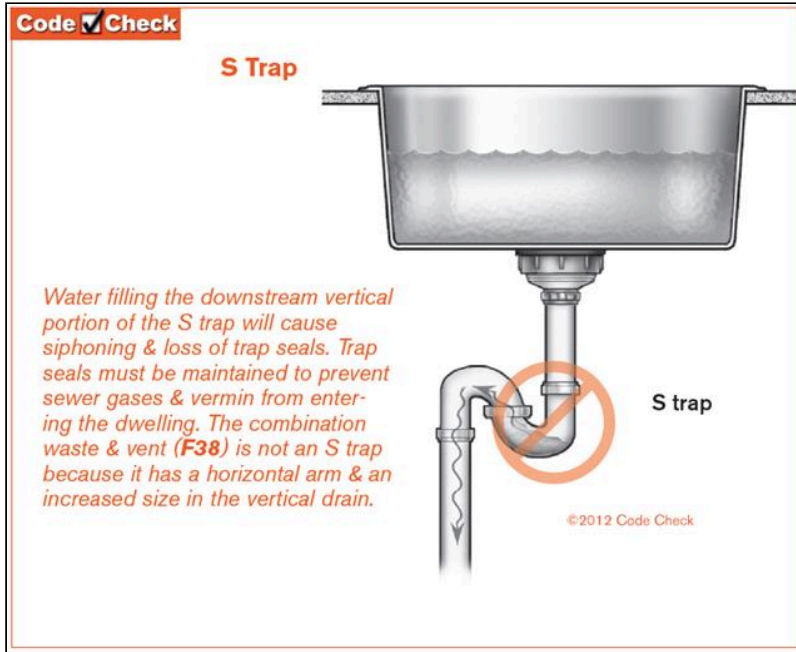
6.0 Item 3(Picture)

(2) There is a non standard trap ("S" Trap) installed at the hall bathroom sink which could siphon water out of the waste trap. We recommend necessary repairs by a qualified licensed plumber.

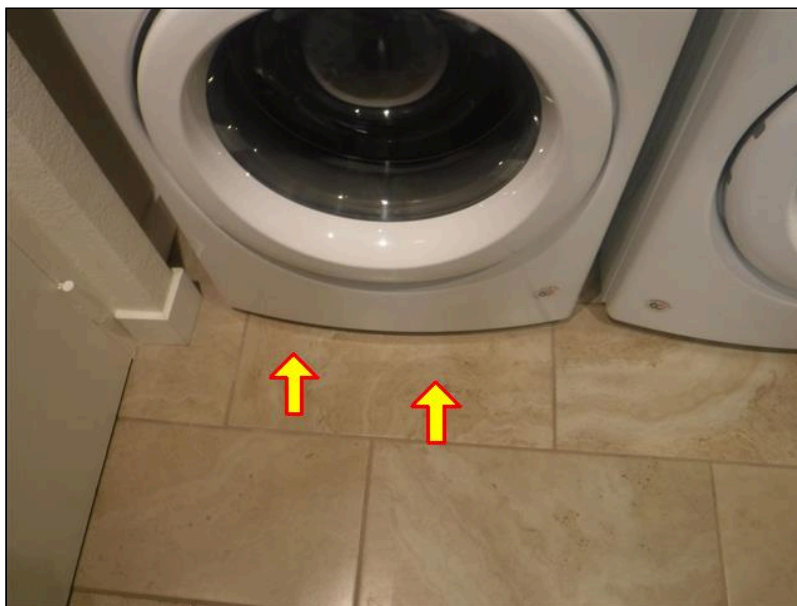
6.0 Item 5(Picture)

(3) A washer pan and drain line is not installed under the washing machine. When a washing machine is installed on a floor level above another finished floor a washer pan and drain line should be installed to help prevent damage from an overflowing washer or a leak. We recommend installing a drain pan and a drain line if possible by a qualified licensed plumber.

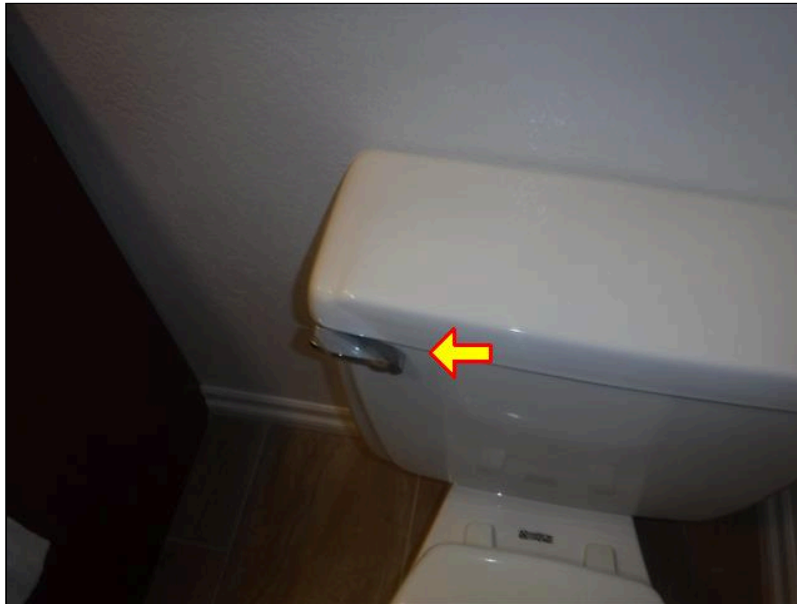
6.2 Item 1(Picture)

(1) Both toilet handles are loose/not adjusted correctly. We recommend repairs or replacement by a qualified licensed plumber.

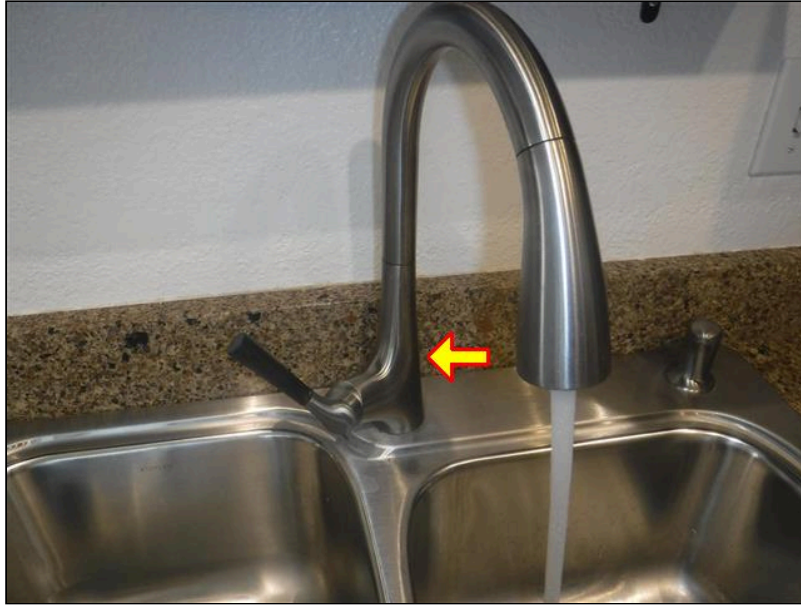
6.2 Item 3(Picture)

(2) The kitchen faucet is loose. We recommend necessary repairs or replacement by a qualified licensed plumber.

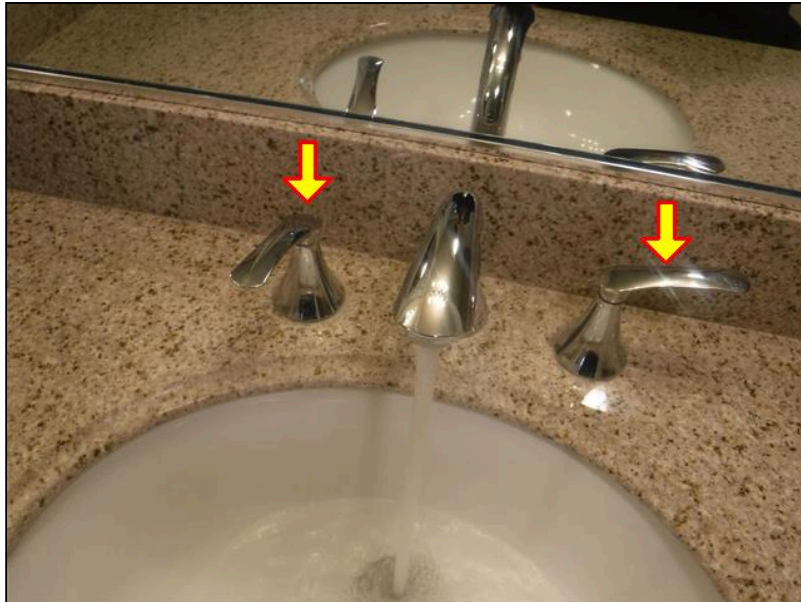
6.2 Item 4(Picture)

(3) The hall bathroom faucet handles are loose/not operating properly. We recommend necessary repairs or replacement by a qualified licensed plumber.

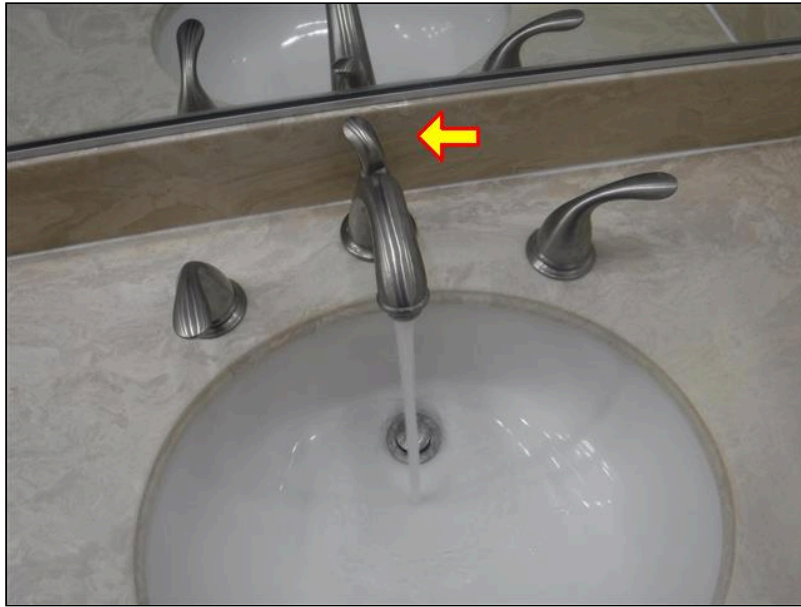
6.2 Item 5(Picture)

(4) The right side primary bathroom sink stopper was inoperable when tested. We recommend necessary repairs or replacement by a qualified person.

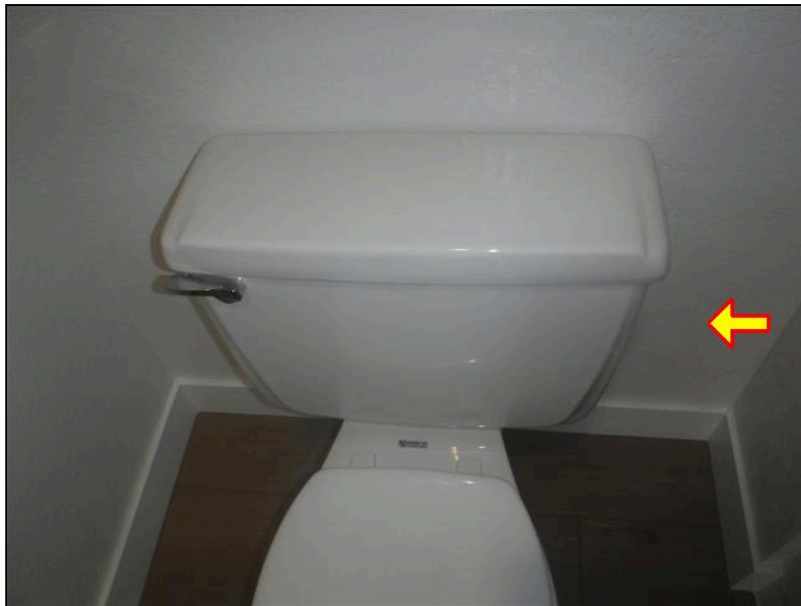
6.2 Item 6(Picture)

(5) The primary bathroom toilet tank is loose on the bowl. No leaks were observed at the time of the inspection. We recommend necessary repairs by a qualified licensed plumber.

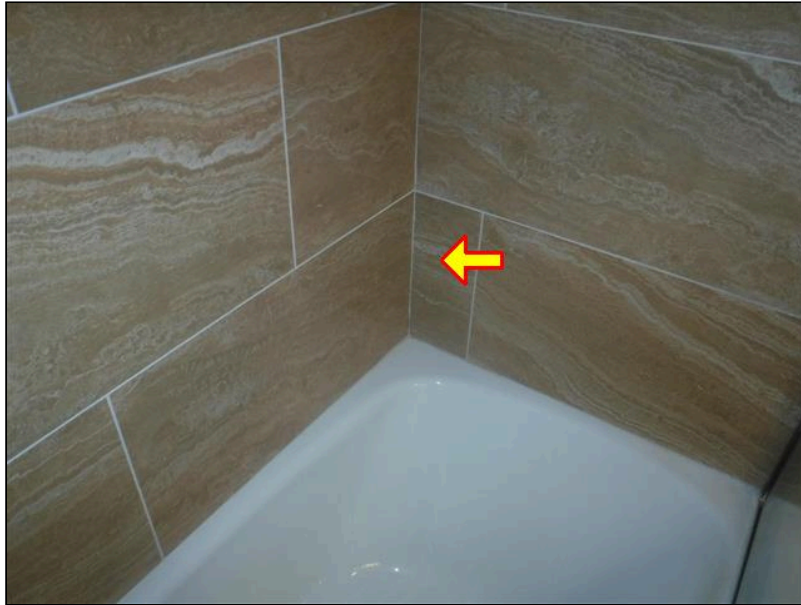
6.3 Item 1(Picture)

scope of our general home inspection. We recommend having the tiles repaired by a licensed tile contractor. Additional repairs may be required when tiles are removed. This area should be evaluated further by a qualified licensed tile contractor prior to the end of your contingency period.

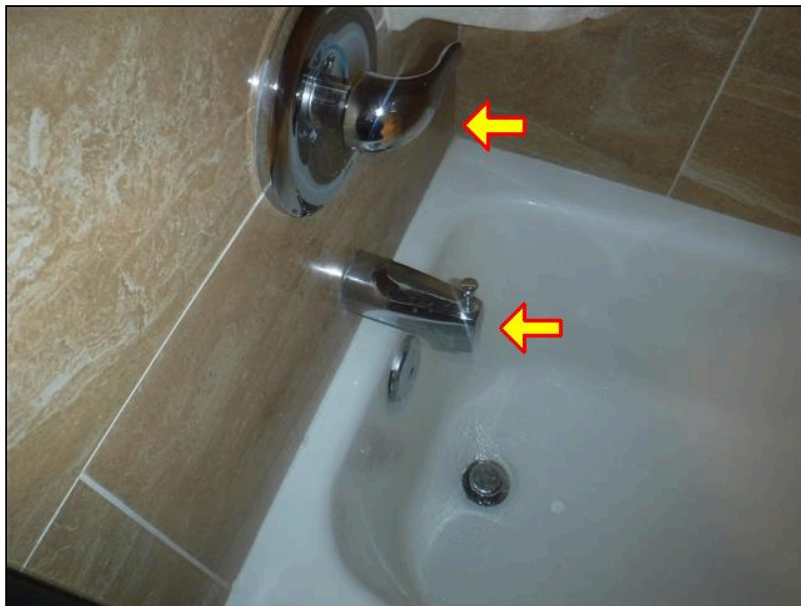
6.3 Item 2(Picture)

(2) The hall bathroom tub faucet handles and tub spout are loose. This condition could allow water to enter behind the tub/shower wall and could put unwanted stress on the water supply pipes. We recommend necessary repairs by a qualified licensed plumber.

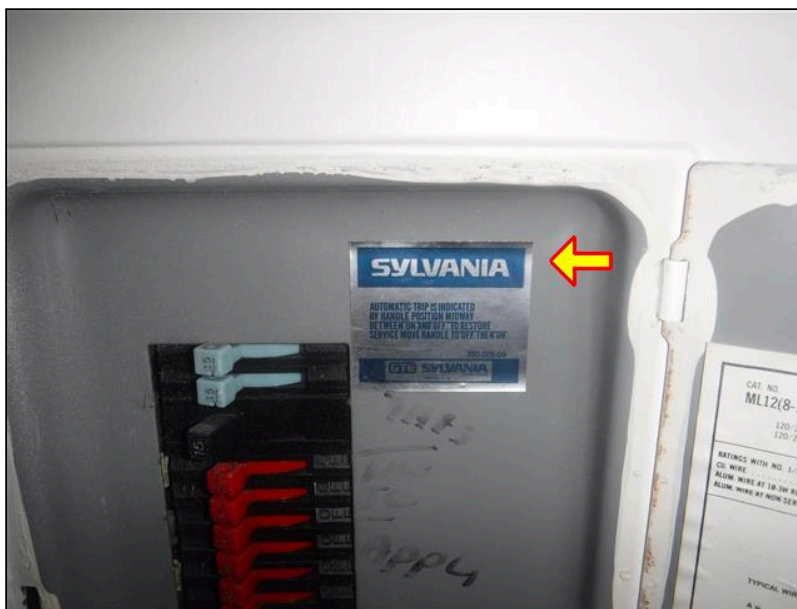
7.0 Item 1(Picture)

(1) There is a Zinsco/ Sylvania brand main electrical panel installed. This type of panel was made with alloy buss bars which are easily dented. Due to this condition, a poor connection with the circuit breakers may develop. This could cause over-heating. We recommend that you consult with a qualified licensed electrician as to the integrity of this electric panel prior to the end of your contingency period.

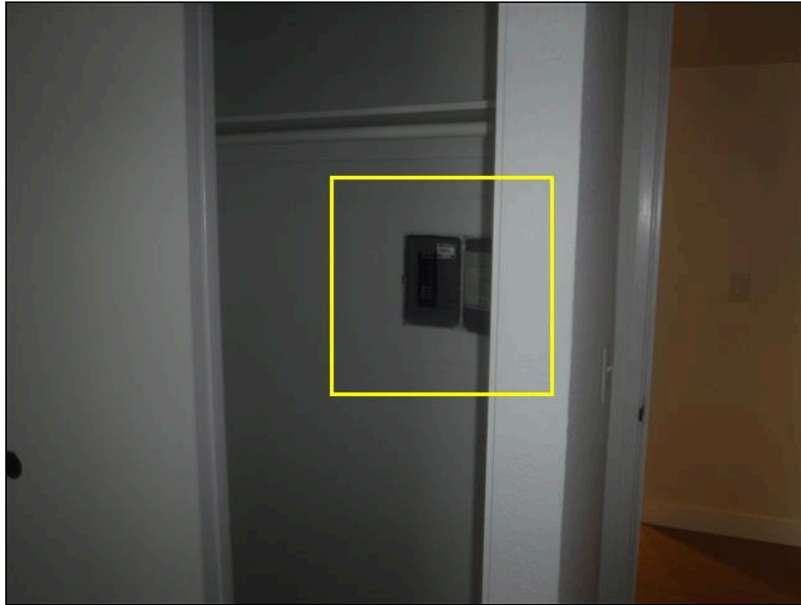
7.0 Item 2(Picture)

(2) There is a sub electrical panel located in a closet. Sub electrical panels are no longer allowed to be installed in closets due to the combustible nature of clothing and inadequate clearances. We recommend having the sub-panel relocated to an approved location by a qualified licensed electrician.

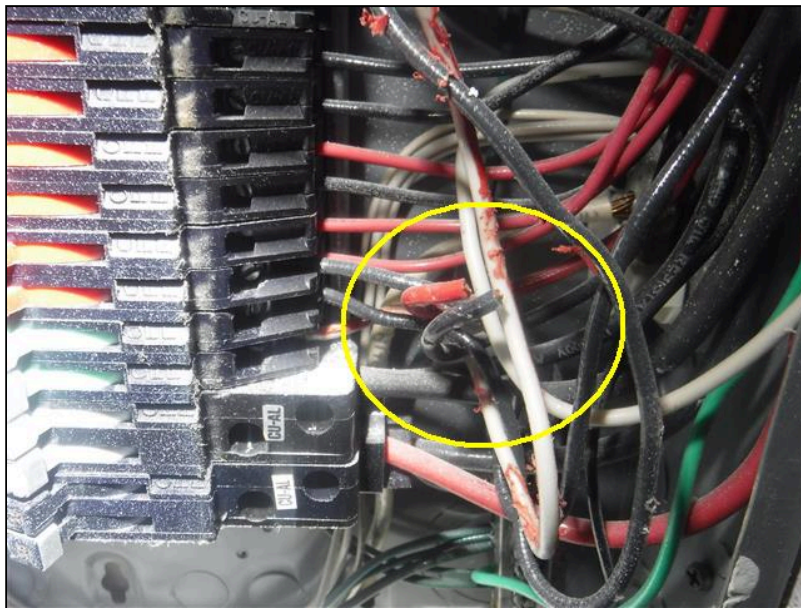
7.0 Item 3(Picture)

(3) There are improperly terminated wires observed in the sub electrical panel. These wires must be properly terminated for safety. We recommend necessary corrections by a qualified licensed electrician.

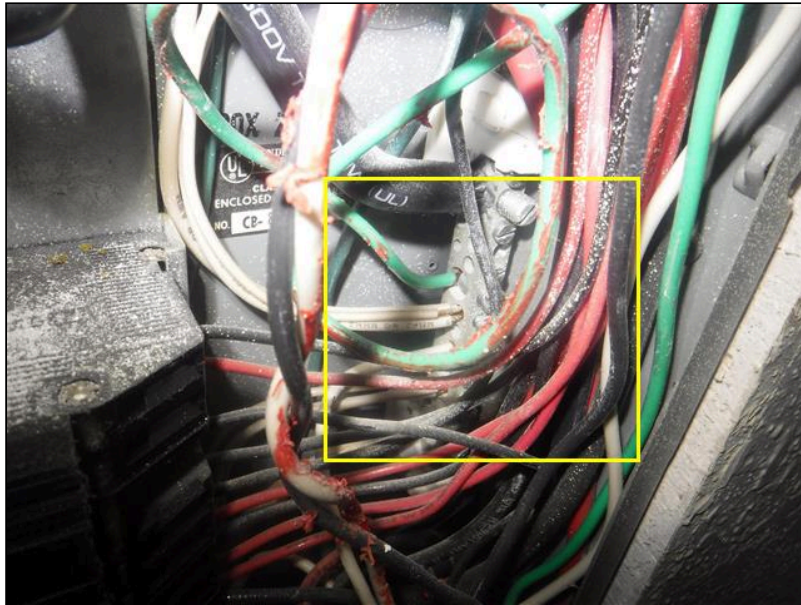
7.0 Item 4(Picture)

(4) Neutrals and grounds are on the same bus-bar in the sub electric panel. Neutrals and grounds in sub electric panels should be on separate bus-bars. We recommend necessary corrections by a qualified licensed electrician.

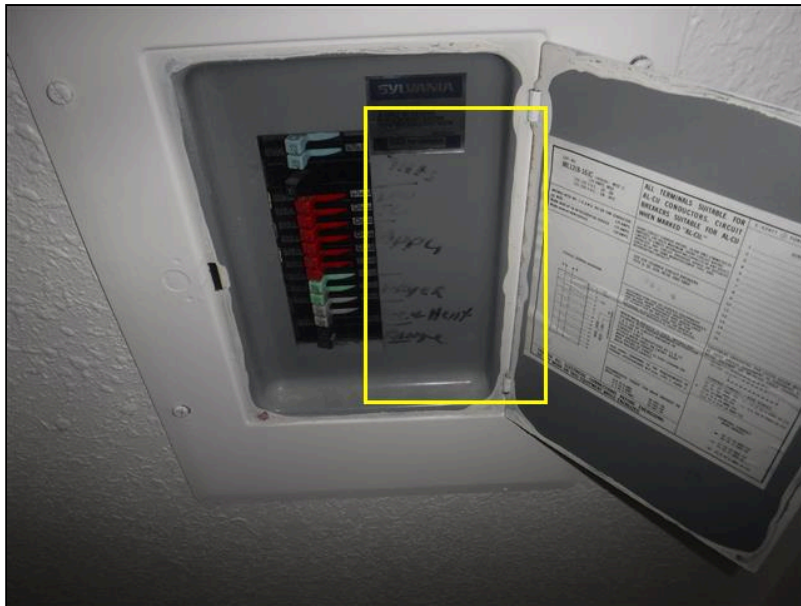
7.0 Item 5(Picture)

(5) The sub panel breakers are illegible or confusing. We recommend having the breakers properly labeled for safety by a qualified person.

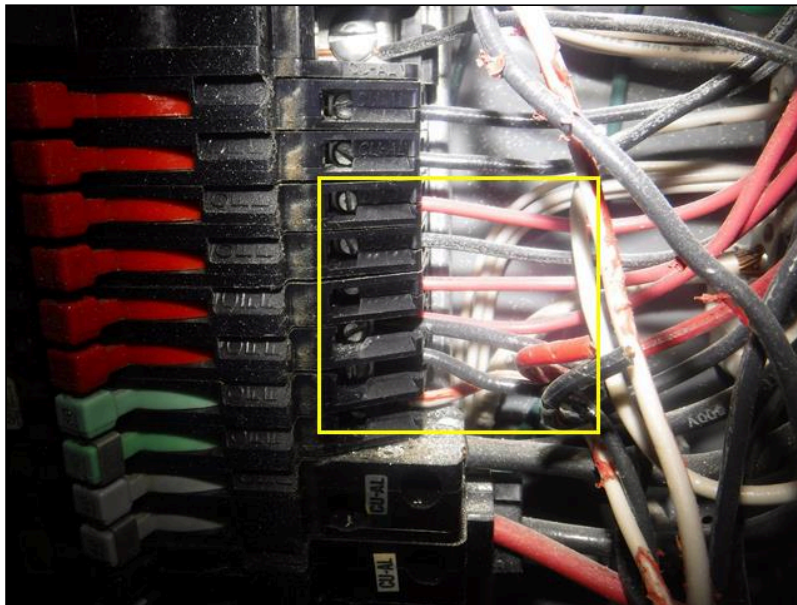
7.2 Item 1(Picture)

(1) Two wires are connected to one circuit breaker in the sub panel. This is non standard and not allowed. We recommend necessary corrections by a qualified licensed electrician.

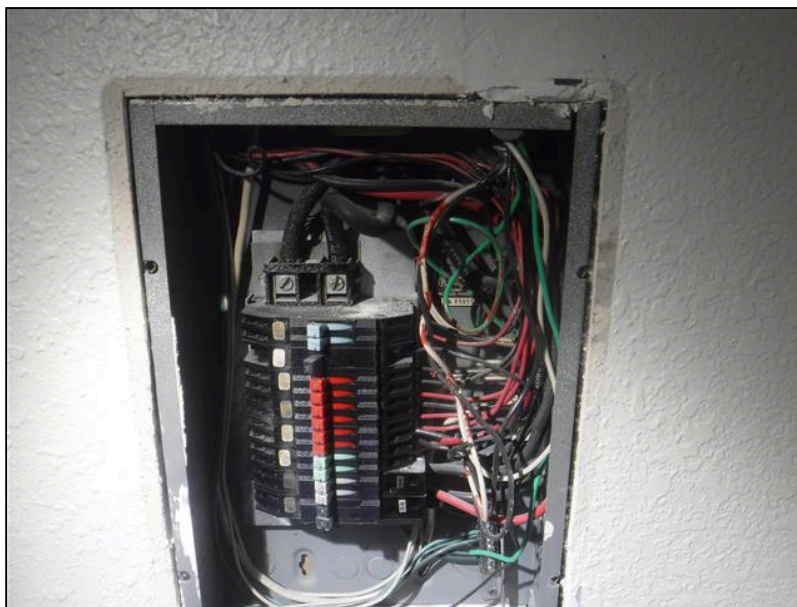
7.2 Item 2(Picture)

(2) Picture inside of the sub electrical panel. The dead front cover was removed at the time of the inspection and the breakers, wiring and grounding were inspected. Appears to be functioning as intended.

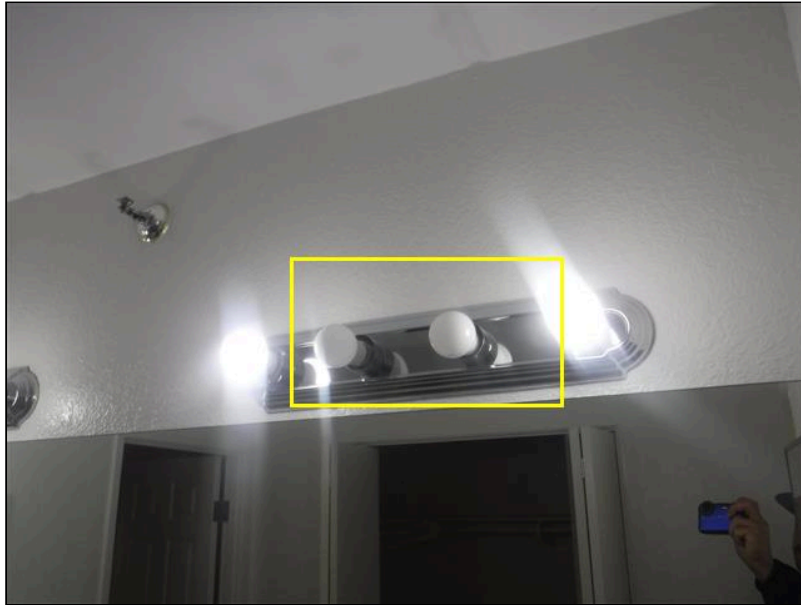
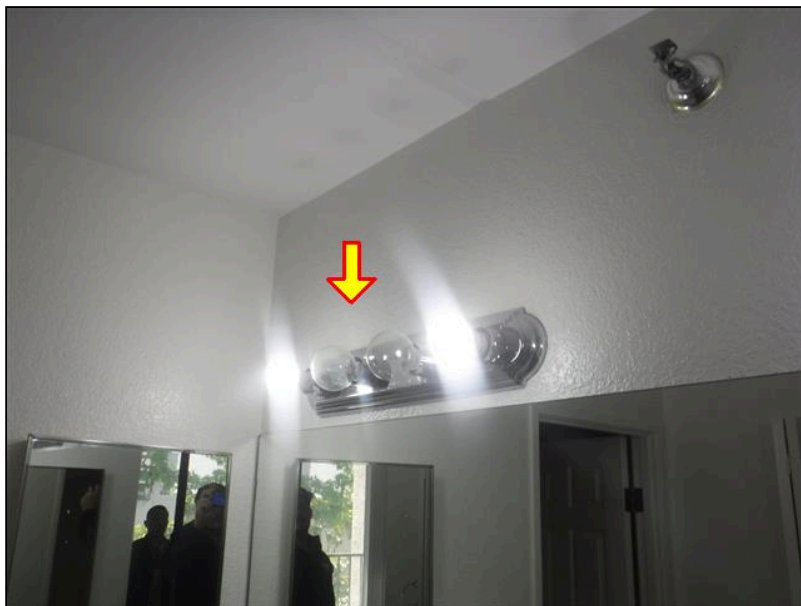
7.4 Item 1(Picture)

Several lights throughout the house did not function when tested possibly due to bad bulbs or a miss wired fixtures. Occasionally there may something wrong with the fixtures which cannot be determined without a working bulb. We recommend asking the seller to demonstrate that theses lights are working prior to the end of the inspection contingency period, or changing the bulbs and testing again. If these lights do not function we recommend further evaluation by a qualified licensed electrician and necessary repairs or replacement as needed.
