Inspection Report

Property Address:
1333 Eighth Ave UNIT 205
San Diego CA 92101

All Pro Property Inspection

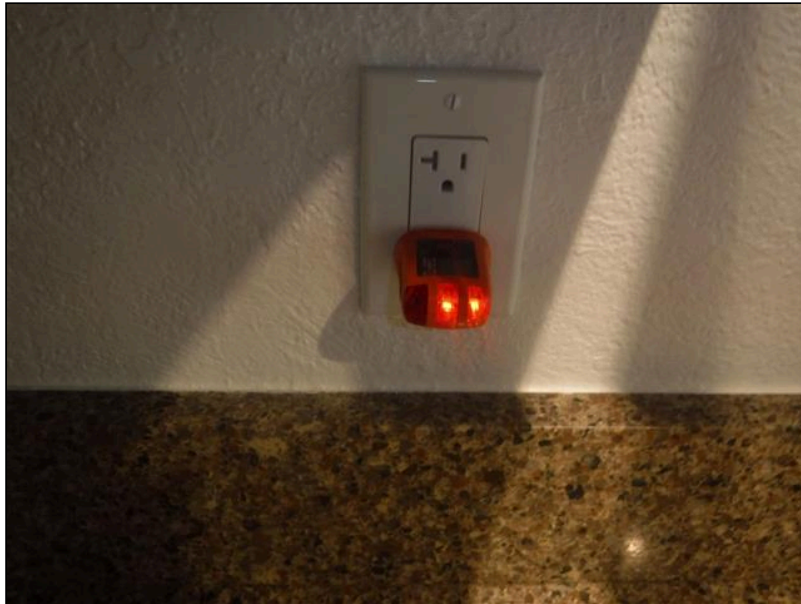
7.5 Item 1(Picture)

for power, polarity and grounding according to our standards-of-practice. These receptacles observed to be ok at the time of the inspection unless otherwise noted.

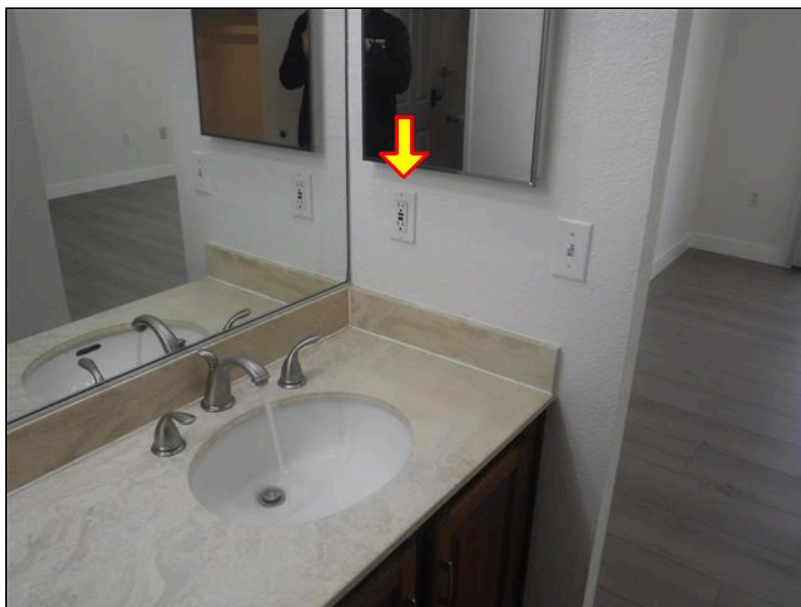
7.6 Item 1(Picture)

(1) There is more than one GFCI receptacle installed on the bathroom circuit. This condition is not a hazard but can cause confusion to reset if one trips. Only one GFCI is required to protect all of the receptacles past the GFCI. We recommend necessary corrections by a qualified licensed electrician.

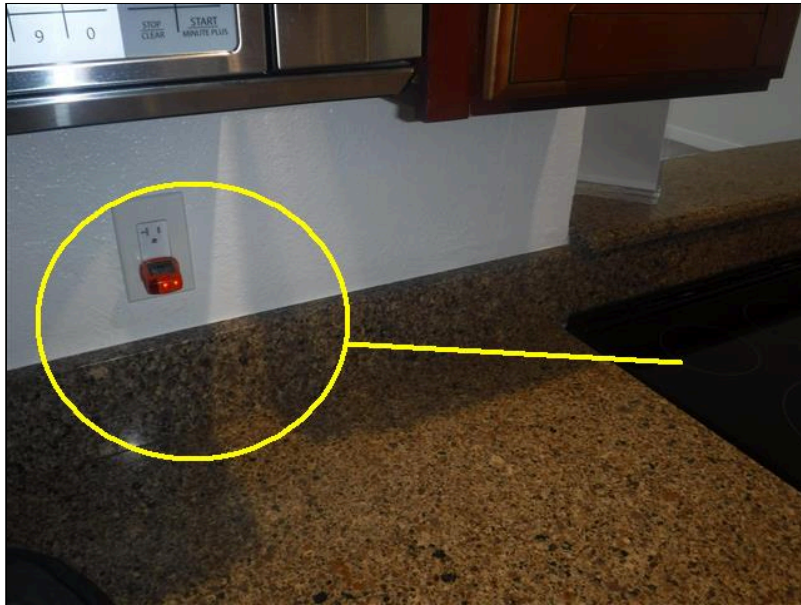
7.6 Item 3(Picture)

(2) We recommend upgrading all receptacles within 6 feet of any plumbing fixtures, outside/ exterior, in the garage, and any non fixed appliance receptacles in the kitchen to GFCI protected receptacles by a qualified licensed electrician for safety.

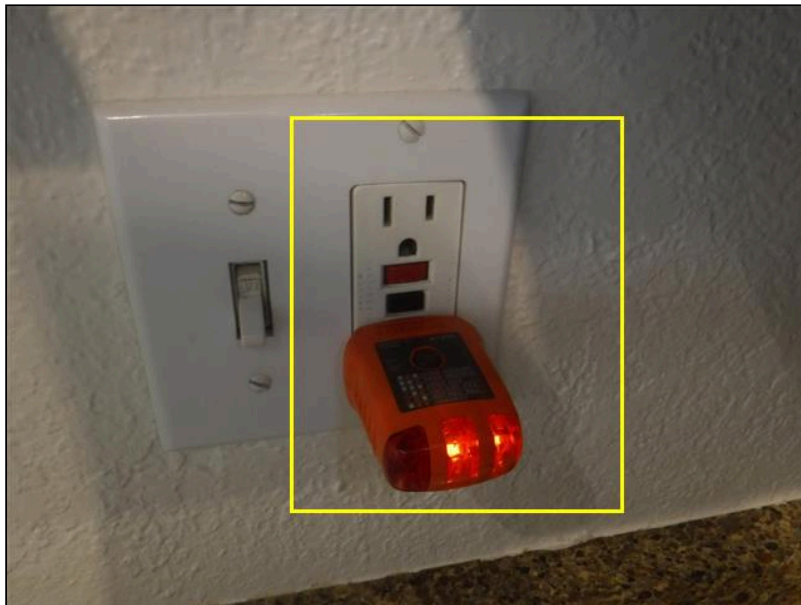
7.6 Item 4(Picture)

(3) The GFCI receptacle located in the kitchen is not operating properly, or has failed as it did not trip when tested. The outlet may be defective or mis-wired. We recommend replacement by a qualified licensed electrician.

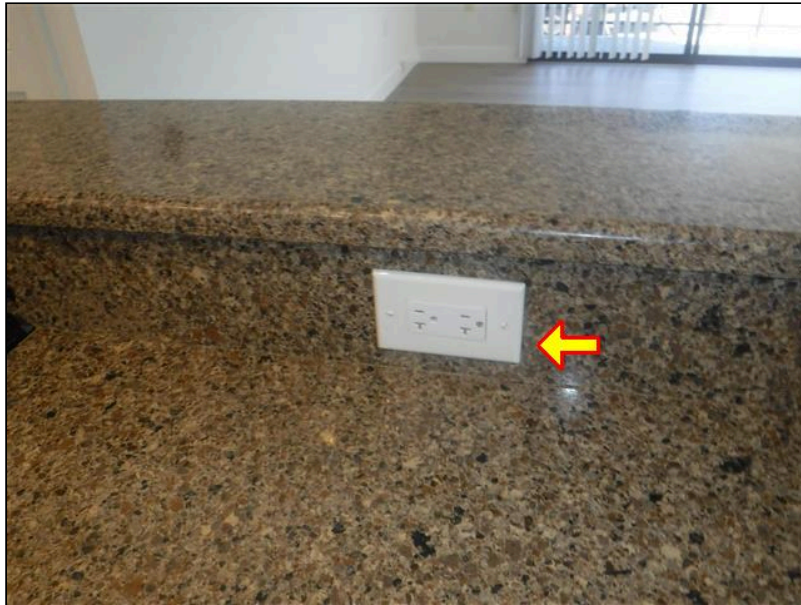
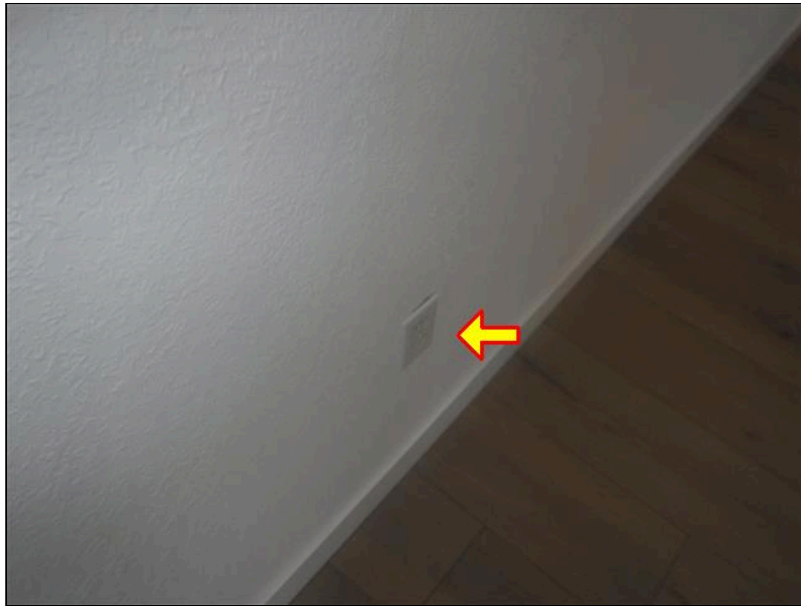
7.8 Item 1(Picture)

Several junction boxes are loose in the wall. This condition could put stress on the conductors which can lead to loose connections. We recommend having these junction boxes secured by a qualified person.

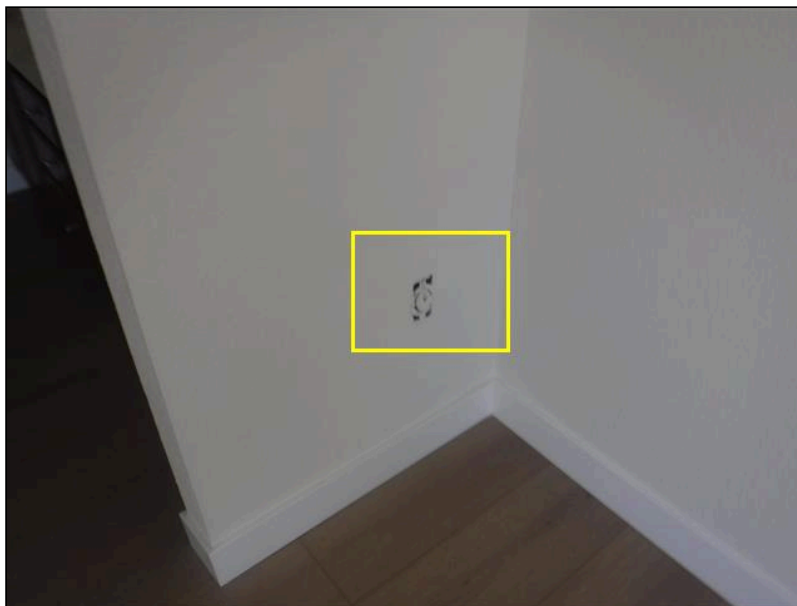
7.9 Item 1(Picture)

One or more cover plates are missing. We recommend replacement by a qualified person.

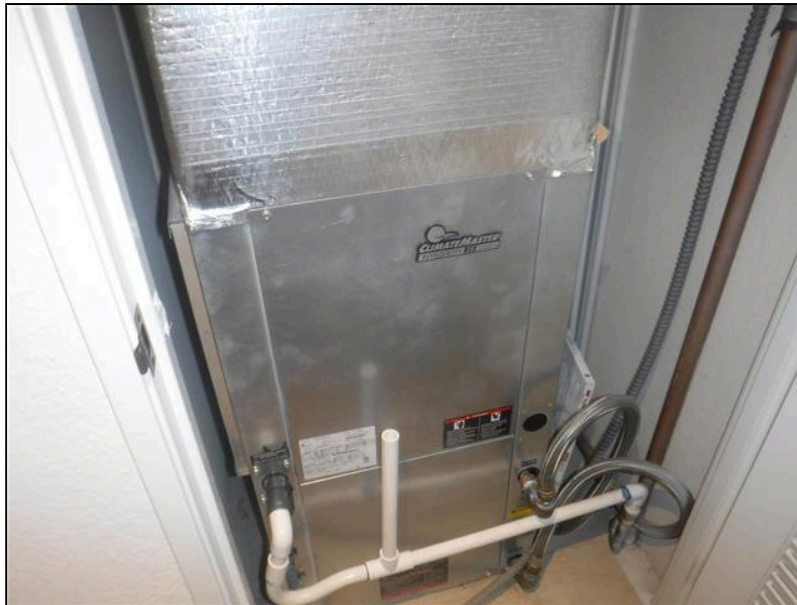
8.0 Item 1(Picture)

The heat pump was tested and produce heat at the time of the inspection. However, the heat pump installed in this home does not appear to be original. We recommend asking the sellers for documentation showing that this unit was installed by a qualified licensed HVAC contractor per the manufactures installation requirements. If documentation cannot be produced, I recommend this heat pump be further evaluated by a qualified licensed HVAC contractor.

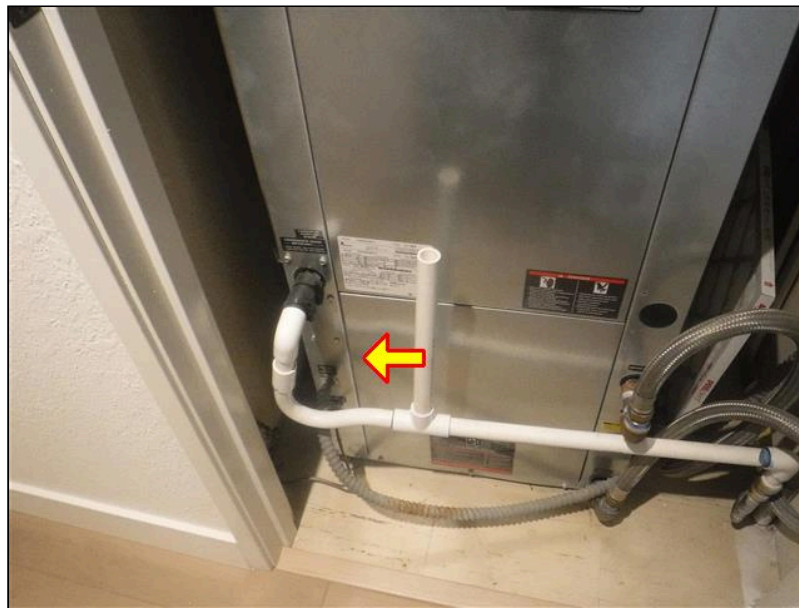
8.1 Item 1(Picture)

(1) No secondary condensate drain line installed. We recommend that a secondary be installed by a licensed plumber as back up to the primary.

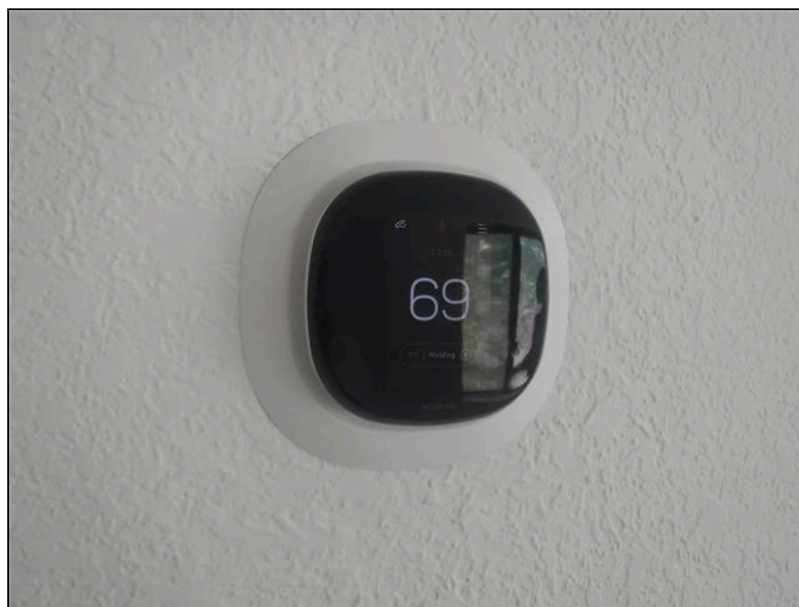
8.2 Item 1(Picture)

The thermostat was operational when used to operate the HVAC system at the time of the inspection. Programmable thermostats are not adjusted and no testing is done to check the accuracy or programmed settings of the thermostat. If concerned we recommend verifying proper operation of the programmable settings prior to the end of your contingency period by a qualified person.

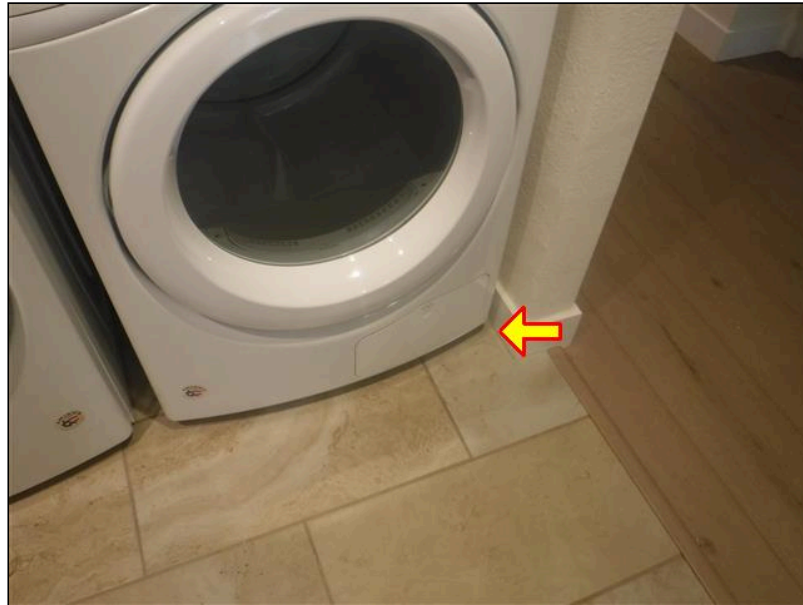
10.1 Item 1(Picture)

There is no dryer vent installed in the laundry room area. We recommend proper installation of a dryer vent which terminates to the exterior of the building by a qualified licensed contractor.

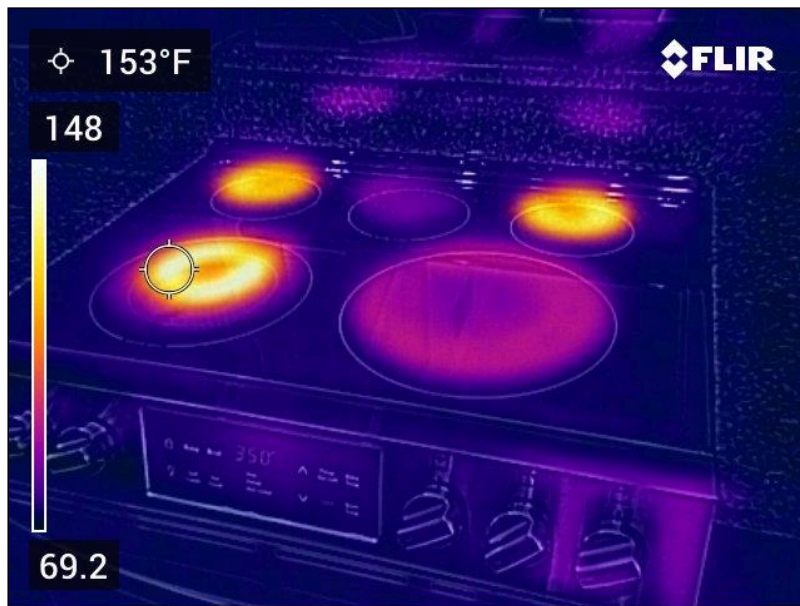
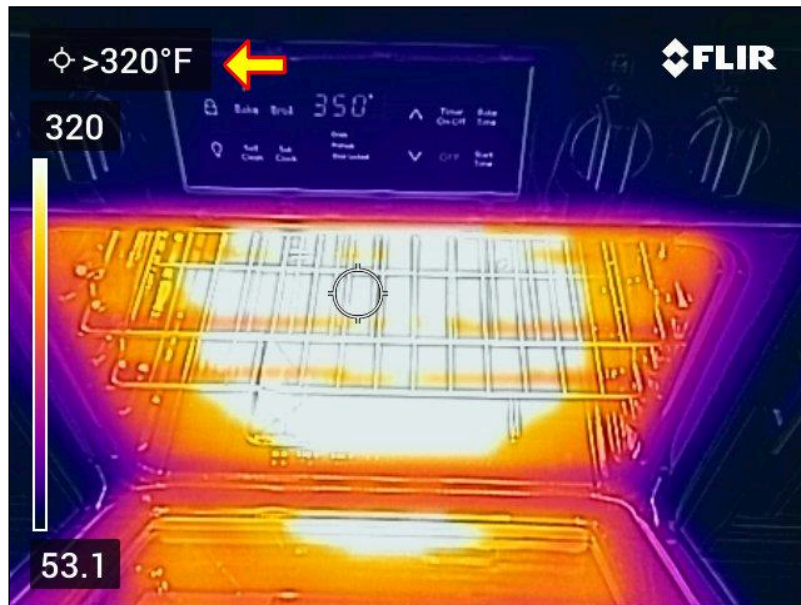
11.0 Item 1(Picture)

The range/oven was tested and was functional at the time of the inspection. This test is not exhaustive and does not confirm the performance, accuracy, or effectiveness of the oven.

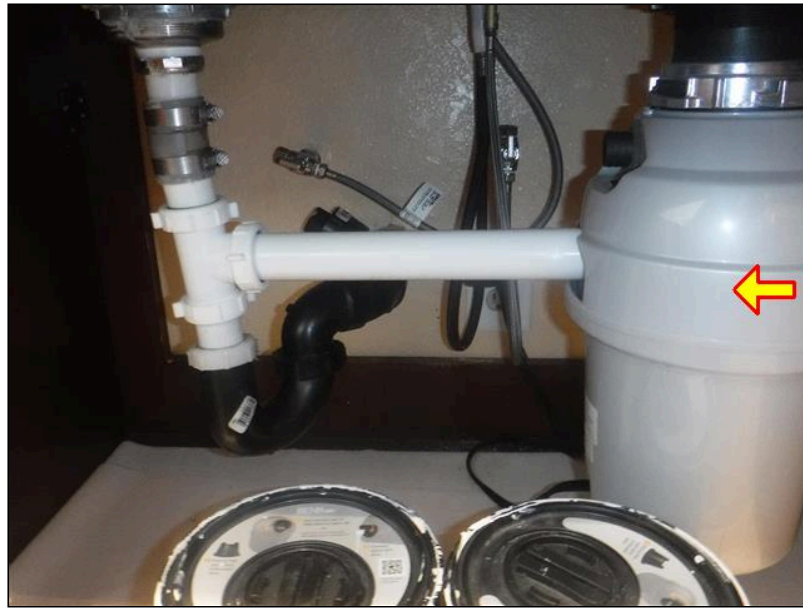
11.3 Item 1(Picture)

(1) The food waste disposer cutting plates are rusted. We recommend replacing as needed by qualified person.

Note: The food waste disposer was tested and functioned properly at the time of the inspection. This is not an exhaustive test and does not verify the efficiency of the unit.

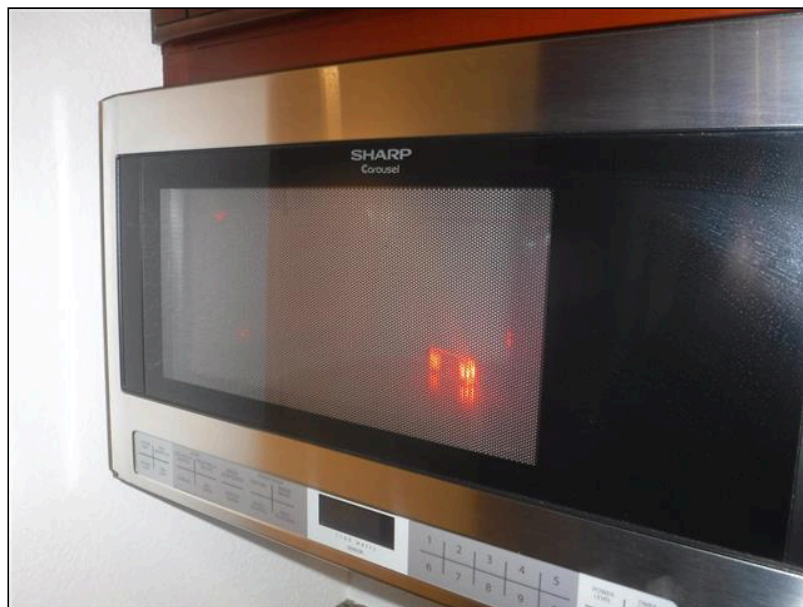
11.4 Item 1(Picture)

performance of the microwave.

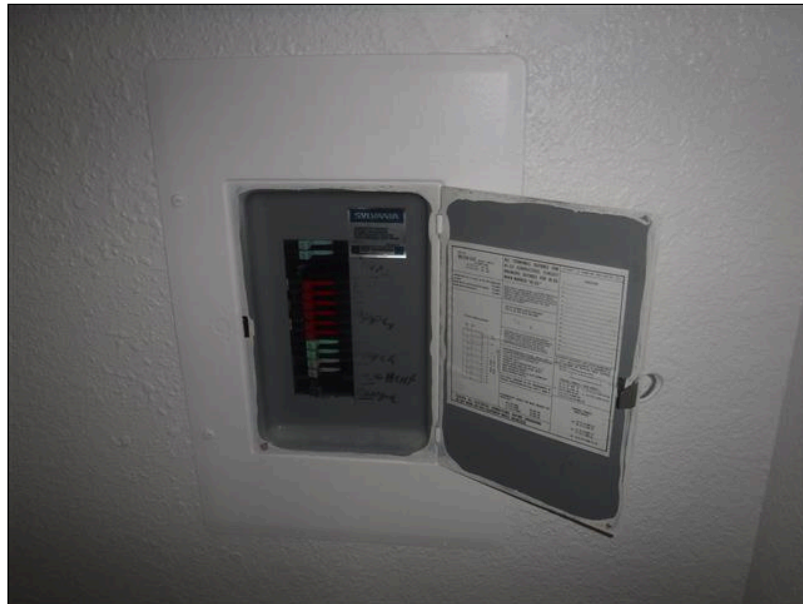
12.3 Item 1(Picture)

The sub-panel is located in a bedroom.
