## HOME INSPECTION REPORT

10883 Whitehorse Rd  
Truckee, CA 96161

Gary Spitsen  
10/20/2026

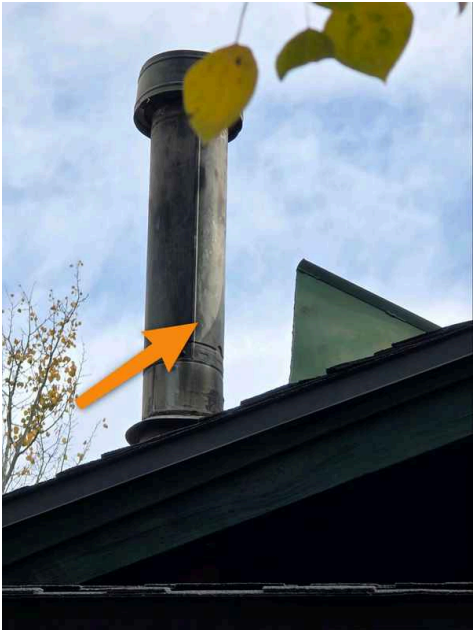
- ⊖ 2.3.1 Roof - Chimney & Roof Penetrations: Gas vent not strapped to snow splitter
- ⊖ 3.1.1 Utilities - Electrical Service: Missing legend
- ⊖ 3.1.2 Utilities - Electrical Service: Missing fastener on electrical service mast

Recommend repair to prevent damage to gas vent.

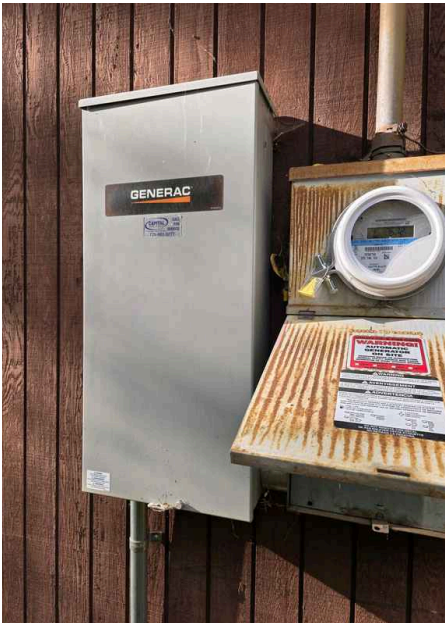
### Electrical Service: Transfer switch not inspected

The inspection of transfer switches is beyond the scope of a home inspection. Recommend evaluation by a licensed electrical contractor.

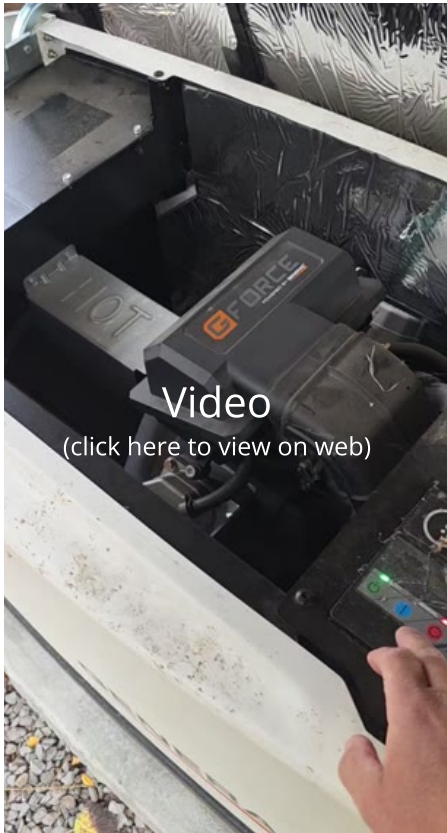
## Electrical Service: Generator

The generator was manually started and appeared to operate normally. General maintenance for home standby generators is recommended every two to four years. If used regularly, maintenance intervals may be more often. Regular maintenance includes changing air filters, oil and oil filters, spark plugs, checking battery charge, sediment traps, valve clearance, and cleaning the generator from dirt and debris inside the enclosure and outside around the unit.

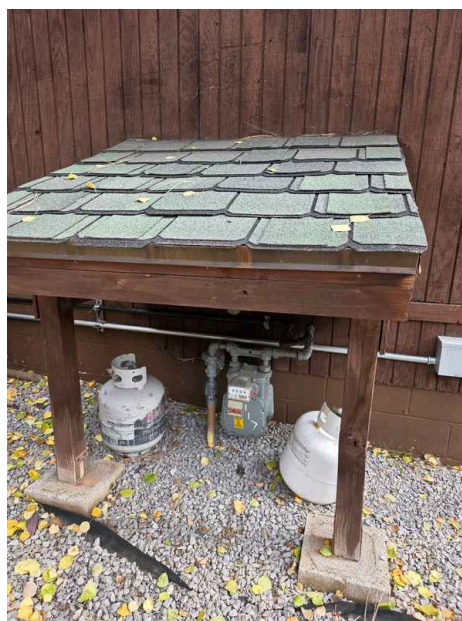
## Fuel Supply: Fuel shut-off location

At gas meter on right side of house

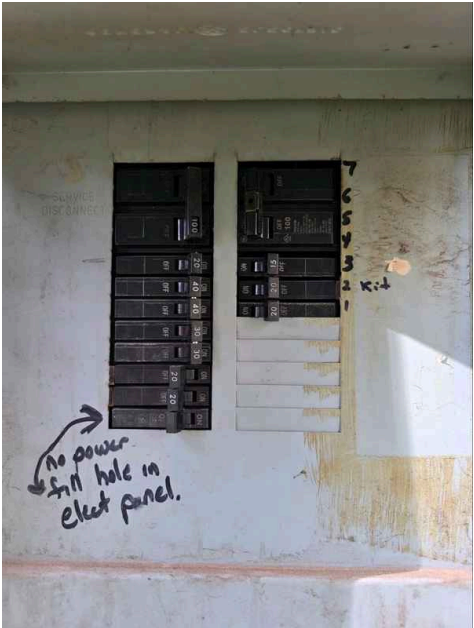
Main Panel

MISSING LEGEND

The legend is missing for some or all of the breakers in one of the panels.

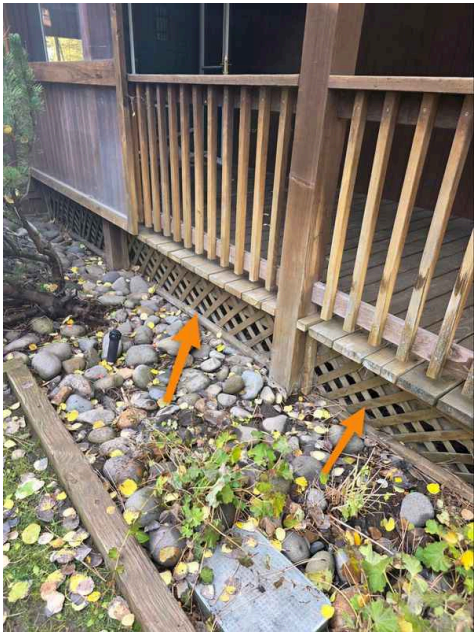
ENTRY DECK

Lattice around the perimeter of the deck prevented a thorough inspection.

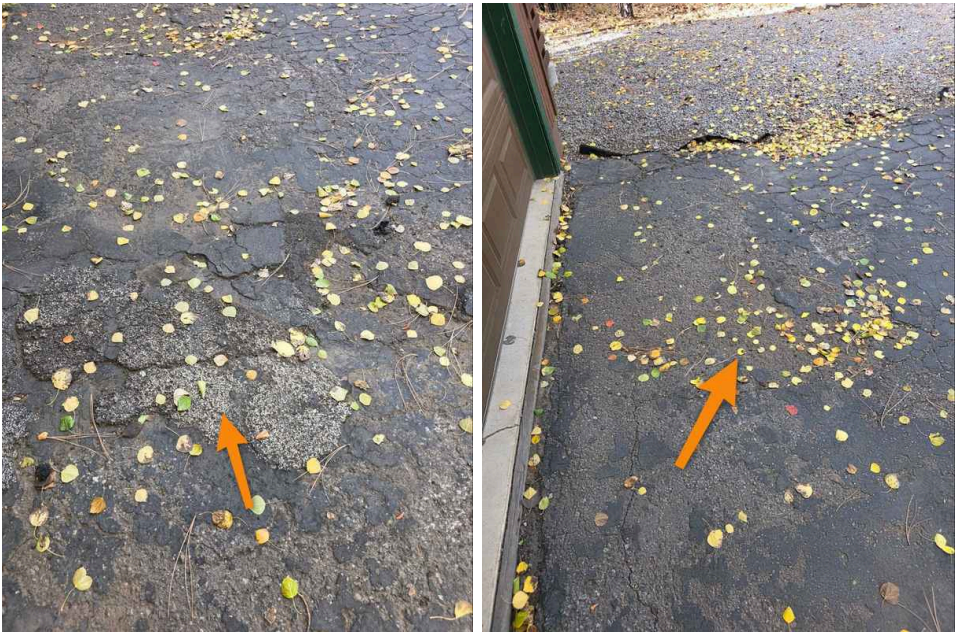
**ASPHALT DETERIORATION - MARGINAL**

Repair and/or monitor for expansion of cracks and further deterioration. Recommend sealing annually to extend life.

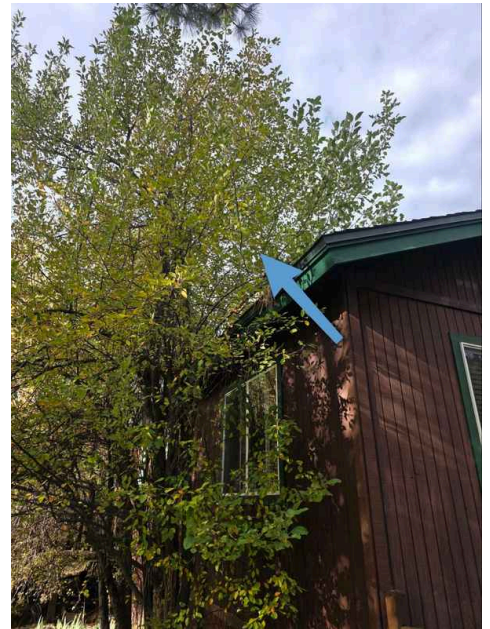
Back of House

**TRIM TREE LIMBS ABOVE ROOF**

Tree limbs within 10 feet of roof should be trimmed to minimize debris & dampness, and to eliminate pathways for wood destroying pests.

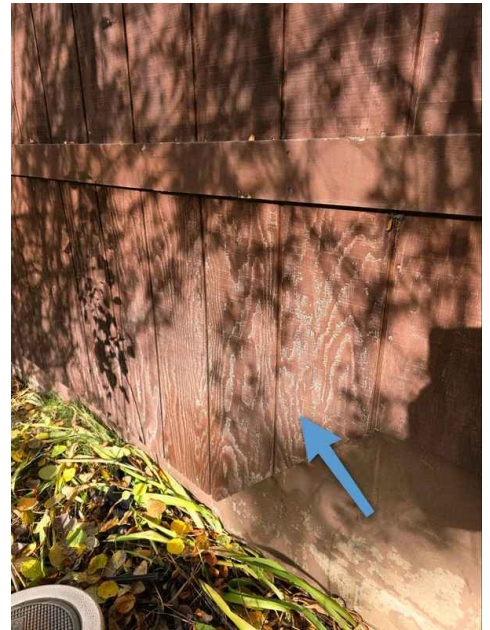
Back of House

##### **RESTAIN SIDING**

Some areas of the siding need to be restained. It is recommended to restain the sun-exposed sides of the house restaining every 2-3 years to maintain the life of the wood. Shadier portions of the siding may not require staining as often.

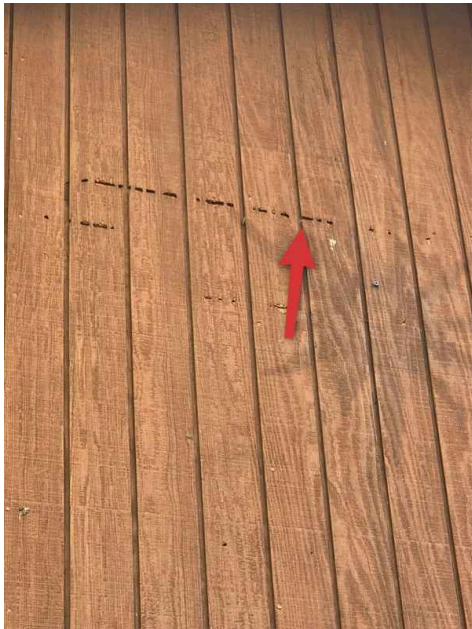
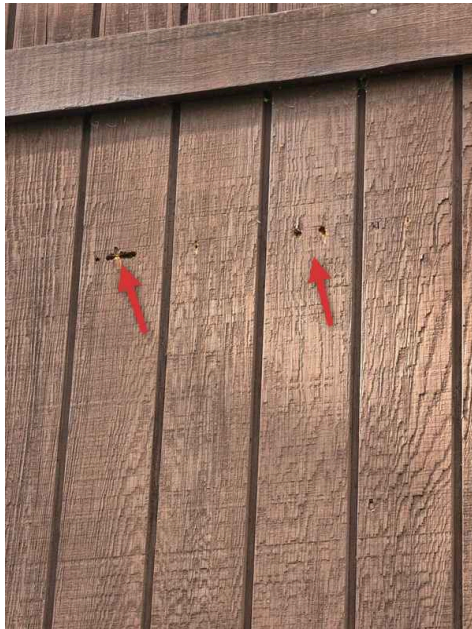
##### **BIRD DAMAGE**

Bird damage observed in some areas of the siding. Recommend repairing these areas to prevent birds from nesting in walls. Hanging reflective material around damaged areas may prevent birds from coming to nest or cause more damage.

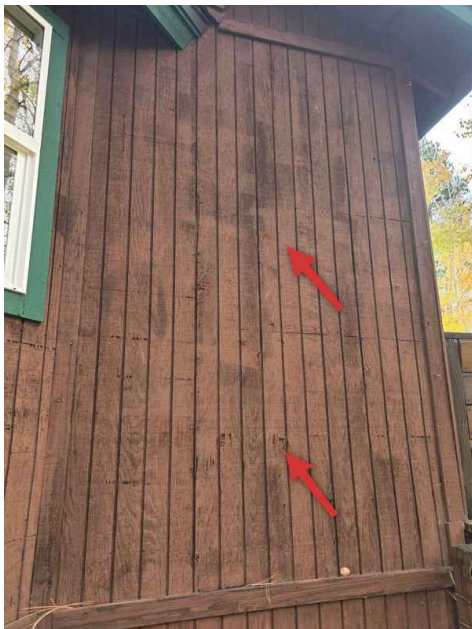
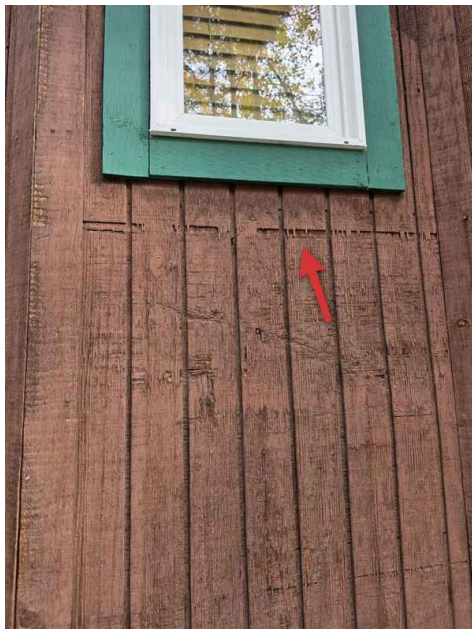
### **DETERIORATED SIDING AND TRIM**

Siding and trim have deteriorated due to moisture absorption, sun exposure, and/or age. Monitor and replace as needed.

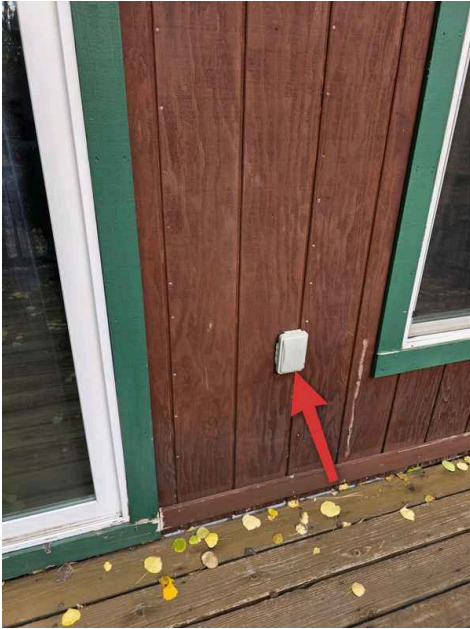
Rear Deck

All exterior outlets should be GFCI protected. Recommend updating for safety.

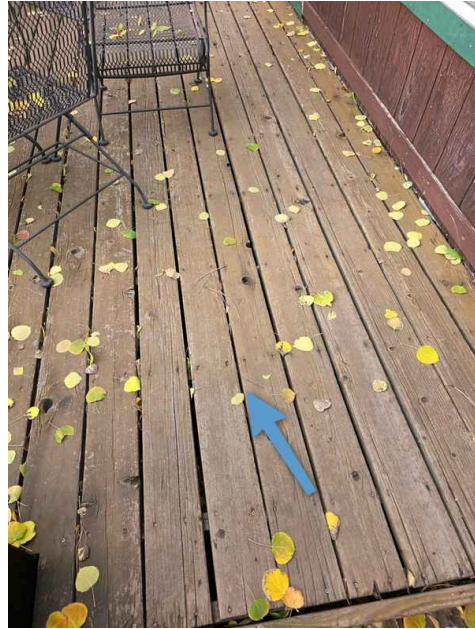
Rear Deck

##### **MISSING FLASHING**

No flashing between the deck and the siding. Flashing at this location helps prevent moisture from getting behind the siding and ledger which can cause damage or decay.

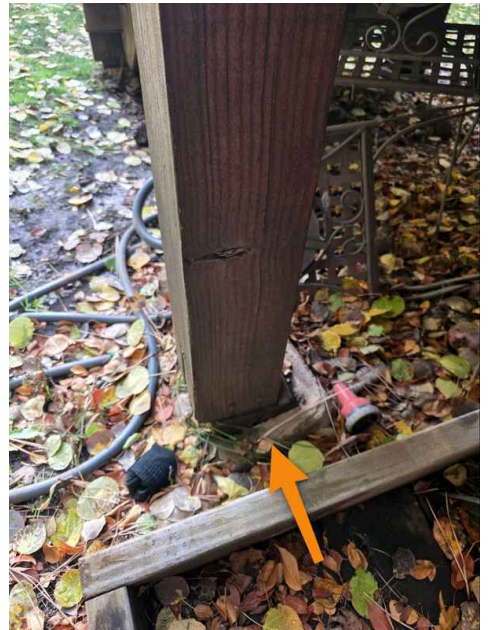
Rear Deck

One or more of the footings have settled over time. Monitor footings for further settlement which could lead to structural instability or failure and replace if necessary.

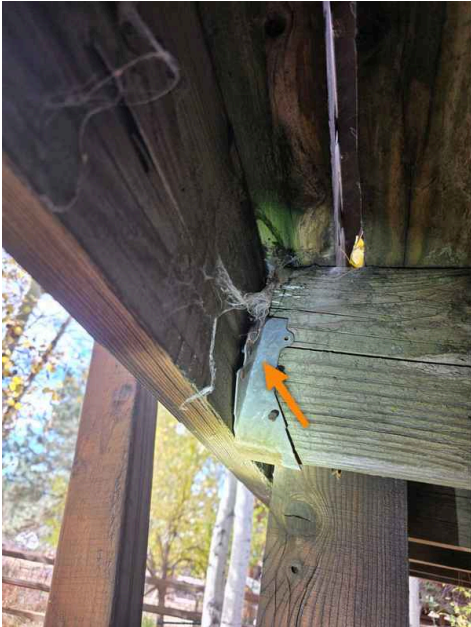
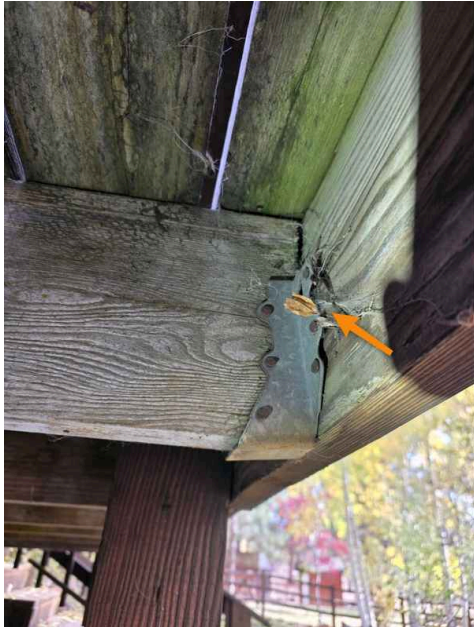
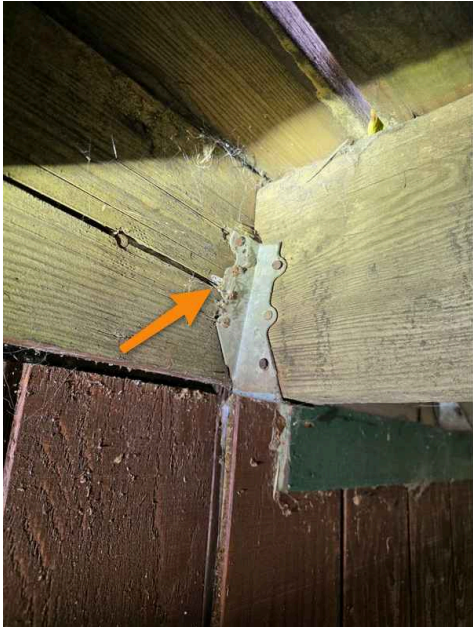
Nails into deck joist hanger are withdrawing. Recommend repair to prevent structural failure.

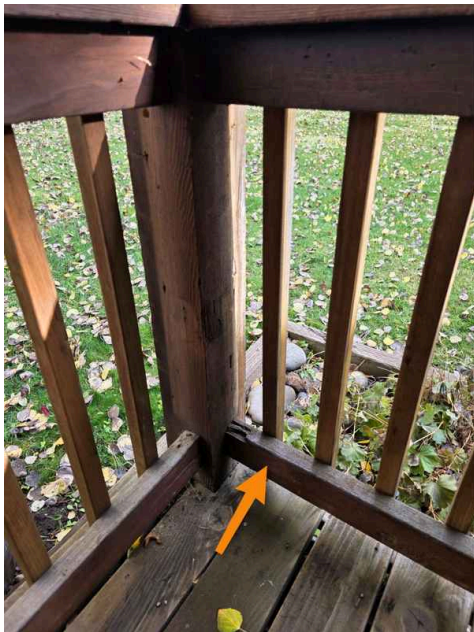
LOOSE RAILINGS

Railings on deck and/or stairs were loose at the time of inspection. If posts supporting railings are bolted to framing, tightening these bolts may easily solve the issue. Additional framing or blocking may need to be installed to achieve the required strength per the current codes.

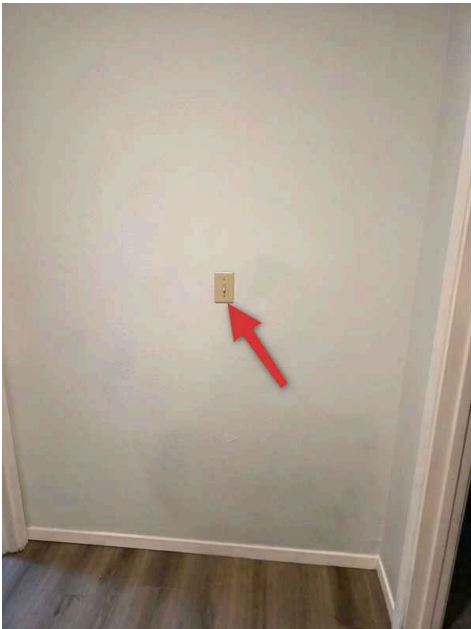
Three-way switch at end of the hallway did operate properly. Contact a licensed electrical contractor for repair.

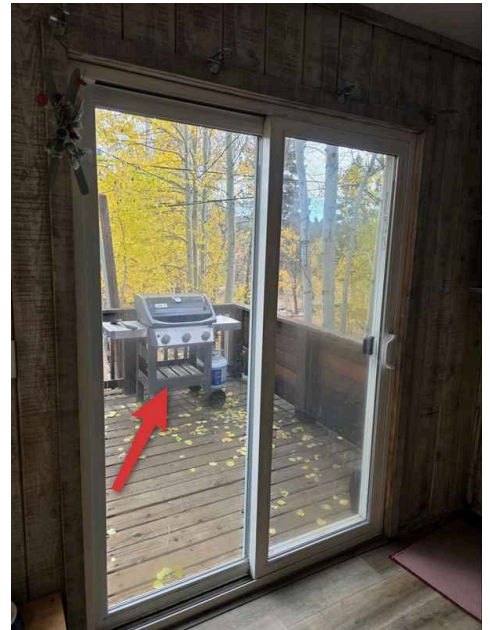
**FAILED SEAL AT PATIO DOOR**

Cloudiness and/or condensation observed in glass at the patio door. This is an indication of a failed seal. A qualified contractor should review for replacement as needed.

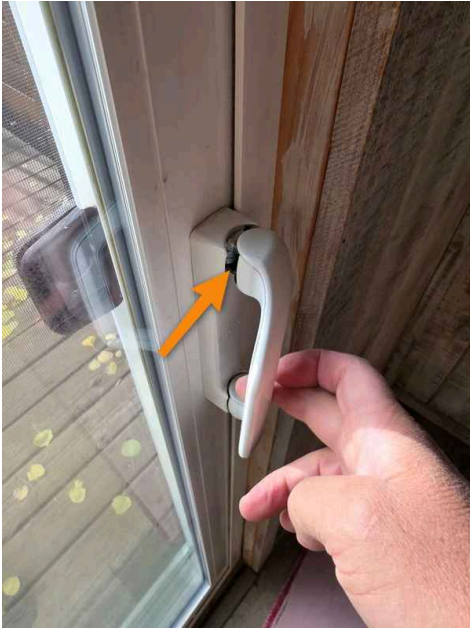
**LOOSE DOOR HANDLE**

Patio door handle was loose. Recommend retightening.

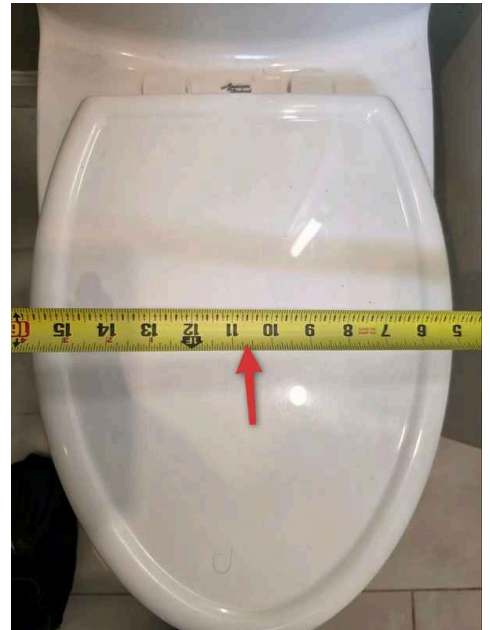
Primary Bathroom

Toilet does not have adequate clearance to adjacent cabinet. Center of toilet should be at least 15" from adjacent cabinetry or shower enclosure.

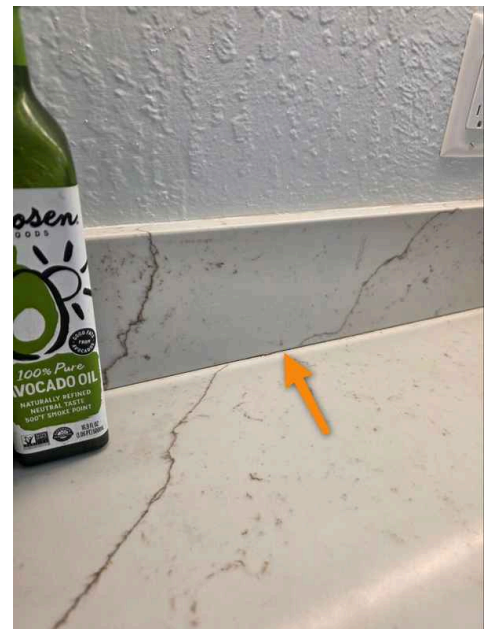
**CRACKED GROUT**

The grout is cracked between the counter and backsplash. Recommend regrouting or sealing area to prevent water from leaking behind cabinet.

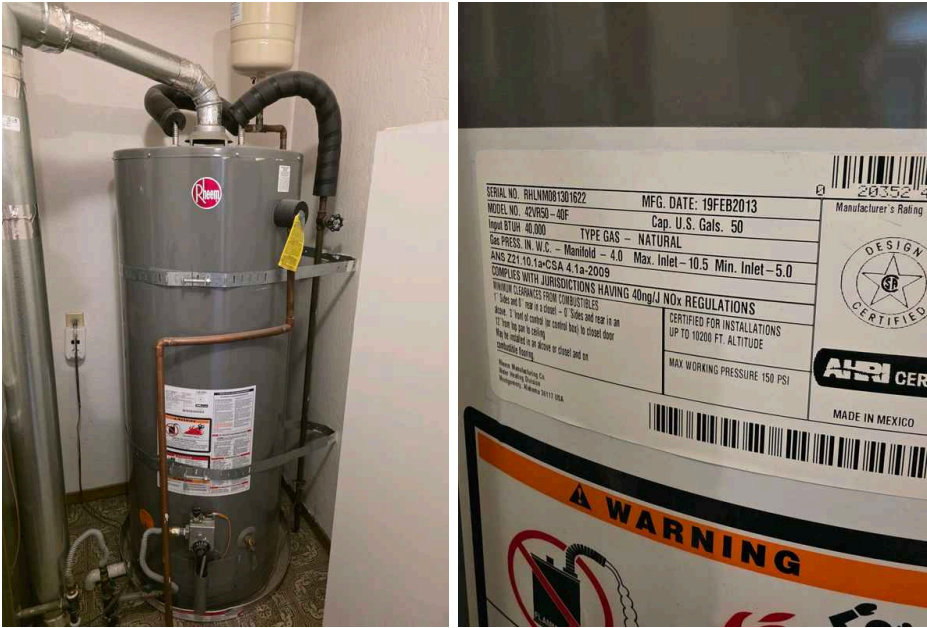
**Water Heater: Location**  
Laundry room

**Water Heater: Manufacturer**  
Rheem

**Water Heater: Year Manufactured**  
2013

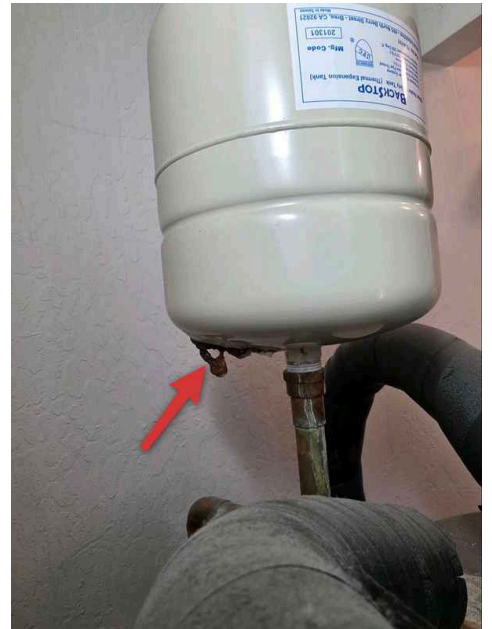
10.1.1 Water Heater  
**ACTIVE LEAK AT EXPANSION TANK**

Contact a licensed plumbing contractor for further evaluation and repair.

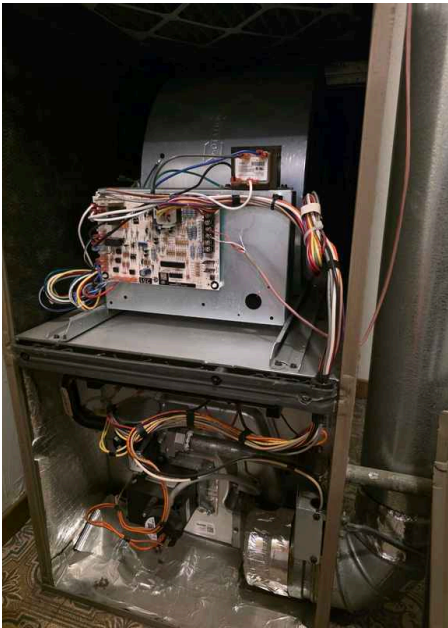
Heating: Type  
Gas fired forced hot air

Heating: Locations  
Laundry room

Heating: Manufacturer  
York

Heating: Date of Manufacture  
2020

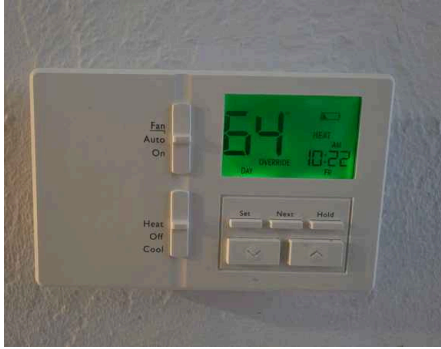
**Thermostats: Type**

Digital, Programmable

Thermostat(s) was turned up to trigger heating and/or air conditioning unit using a manual override. Programming of the thermostat (if applicable) was not tested.

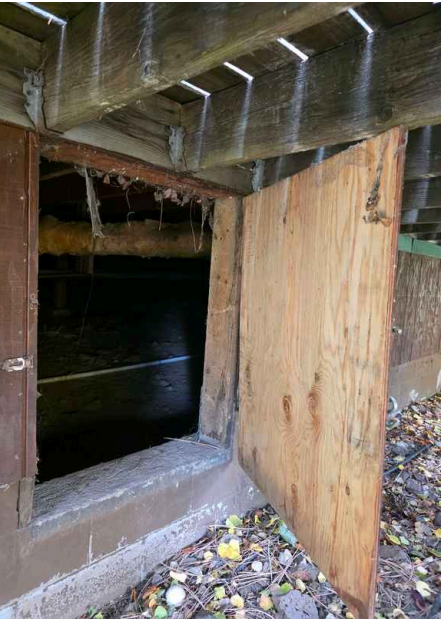
**General: Access Location**  
Under rear deck

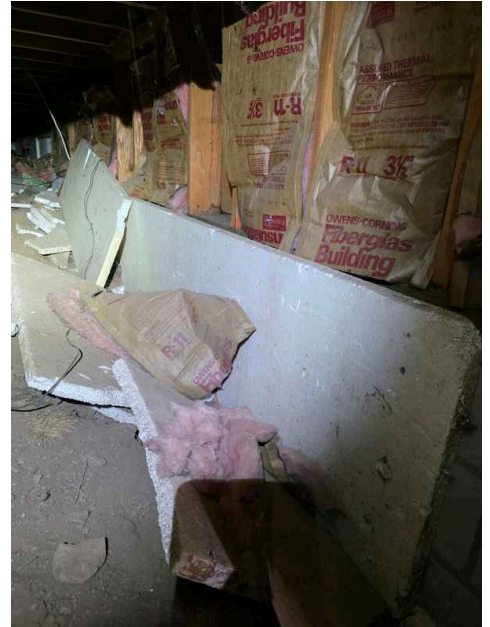
## INSULATION ON STEMWALLS

Rigid insulation covered most perimeter stemwalls. These areas were unable to be inspected.

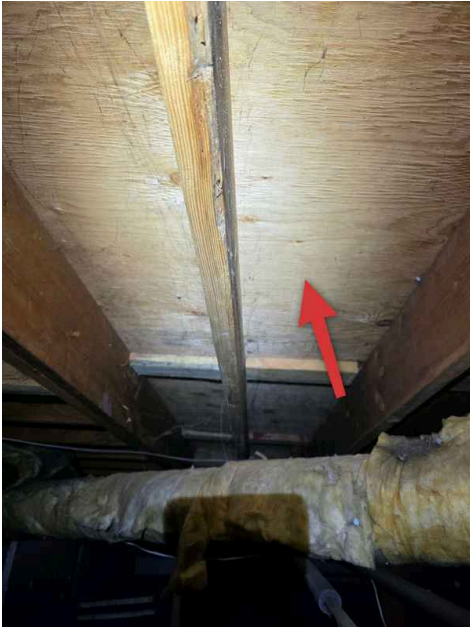
#### 14.4.1 Venting

### PLYWOOD COVERING VENTS

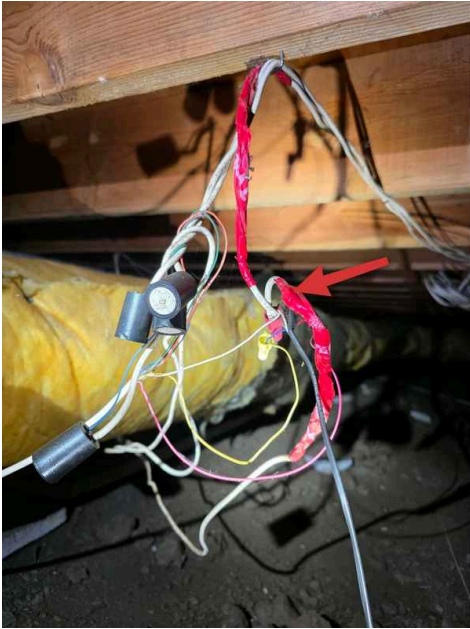
Electrical connection made outside of a junction box. Recommend repair by a licensed electrical contractor.

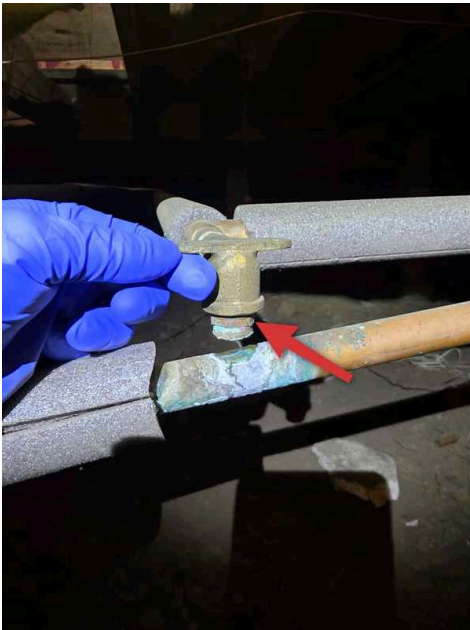
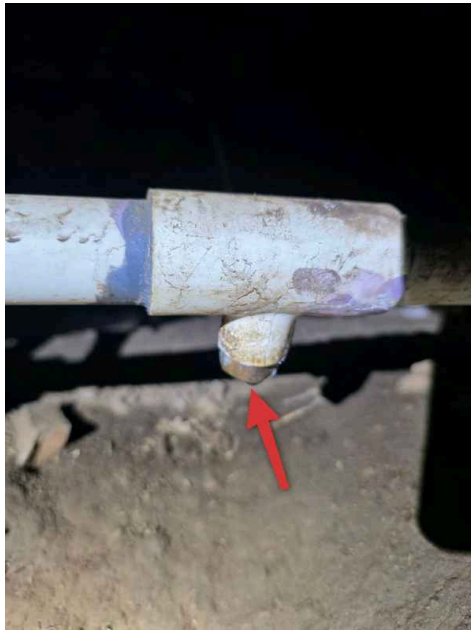
##### **FAULTY STOP AND DRAIN VALVE**

The stop and drain valve was constantly leaking at the time of the inspection. Recommend contacting a licensed plumbing contractor for replacement.

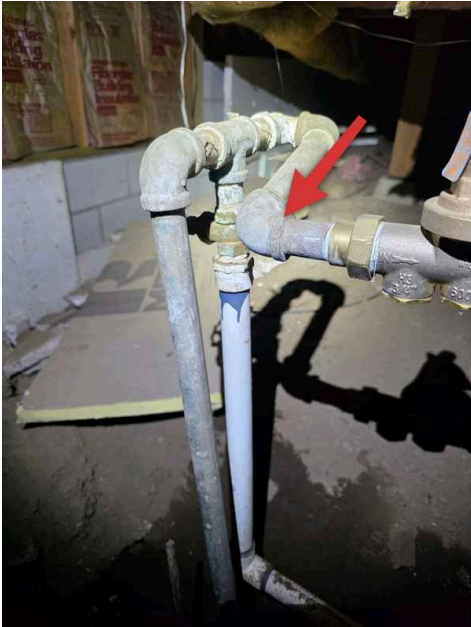
##### **MISSING BACKFLOW PREVENTER**

Install a backflow preventer to prevent backflow from irrigation into domestic water. Install pressure regulator to regulate high water pressure.
