# Sunset Property Inspection

Confidential - Property Inspection Report - Confidential

**1150 21st St Unit 20**  
**Inspection Prepared For: Tyler & Janice Hayes**  
**Agent: -**

**Date of Inspection: 3/1/2026**  
**Year Built: 2007 Size: 1001**

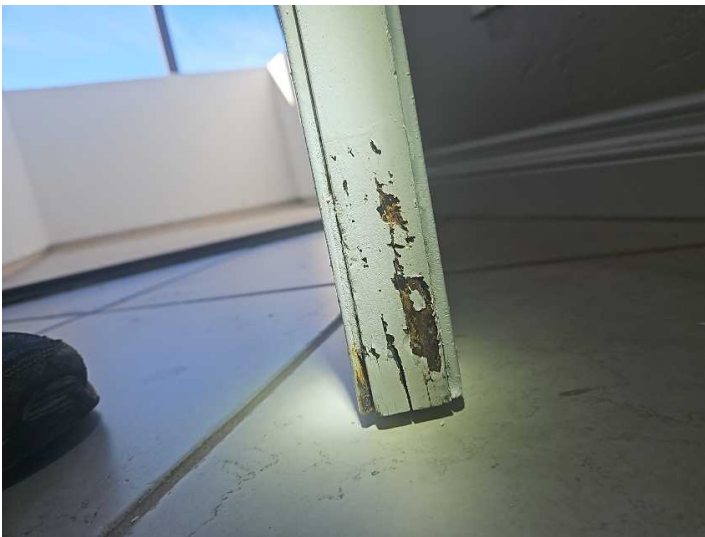
- Moisture damage noted at the bottom of the balcony door. Recommend repairs by a qualified handyman.
- The bottom of the balcony door is rubbing on the threshold. Recommend adjustments by a qualified contractor.

Moisture damage

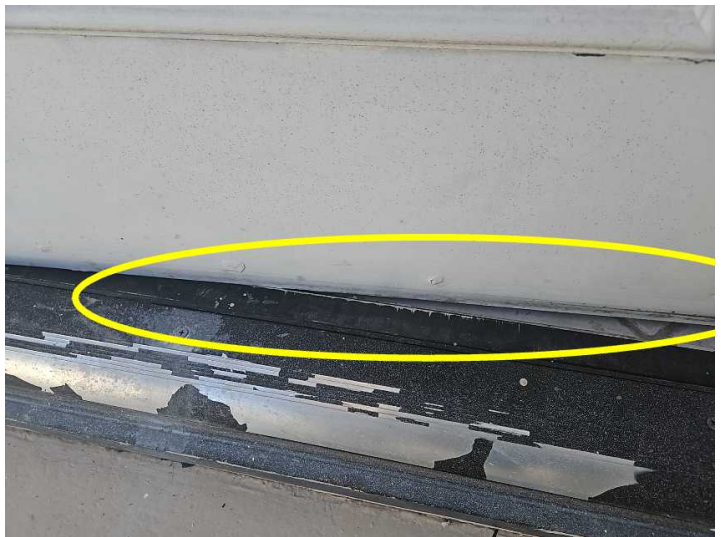
Door rubs on threshold

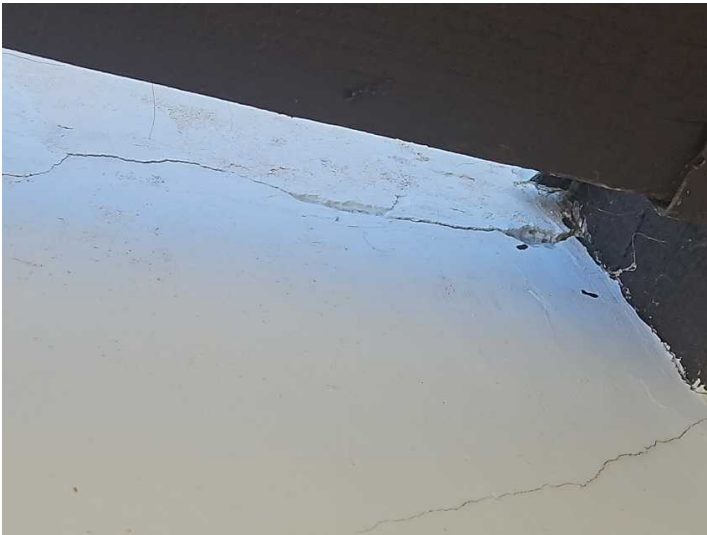
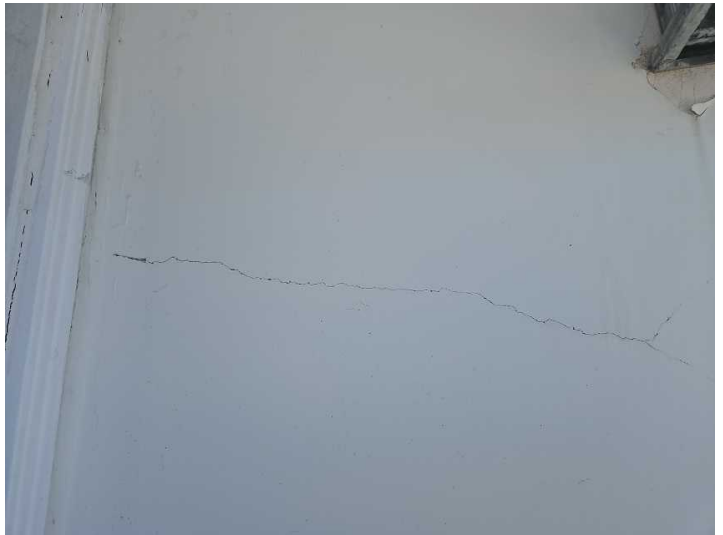
- We recommend sealing holes & gaps in the stucco to keep water infiltration from causing further damage.
- Hairline cracking was observed at the stucco at several areas. The cracks are less than 1/16 inch in width, and generally considered common in this material. These cracks should be caulked and painted where possible. If cracks increase in width, it may indicate that structural movement is occurring. Determining this is beyond the scope of a home inspection.

Crack

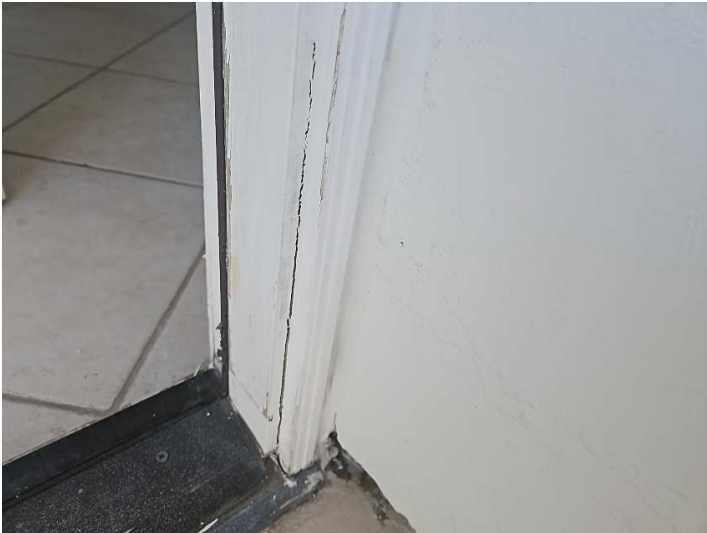
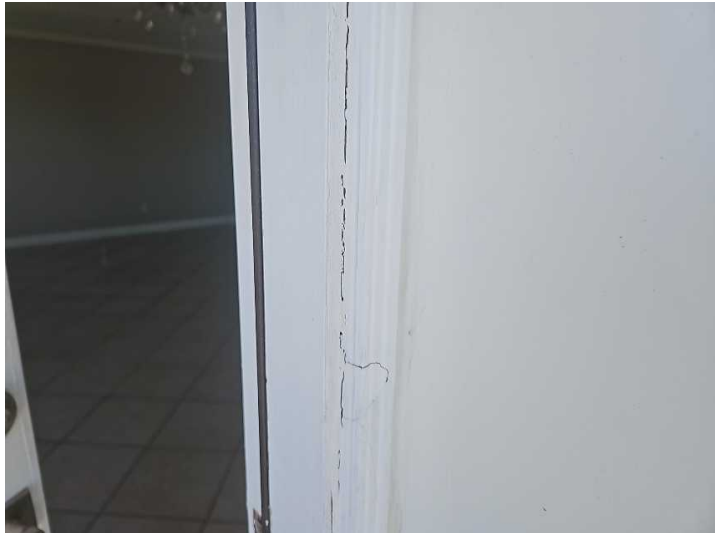
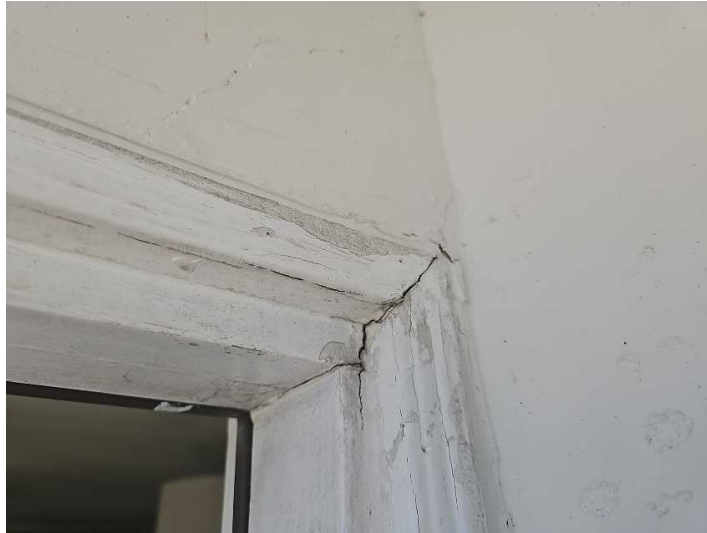
- Trim at balcony door is not properly sealed. Moisture intrusion can occur. Recommend repair by a qualified contractor.

Gap

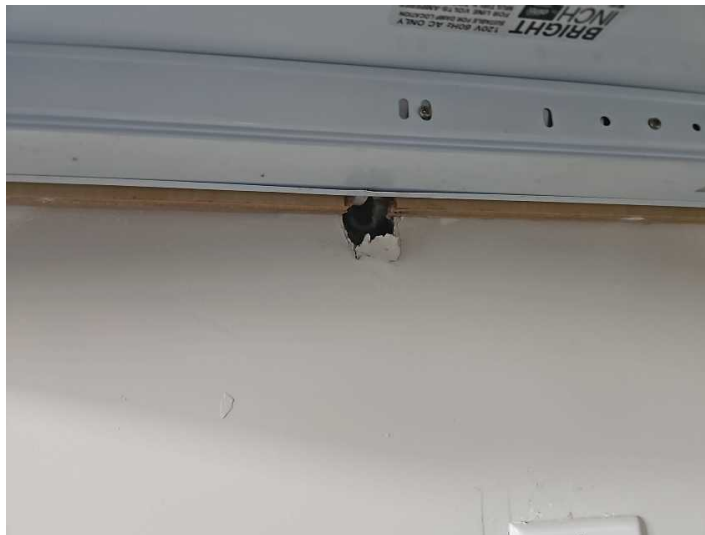
- NOTE: Fresh texture and/or paint observed on walls/ceilings in multiple rooms of the home. Fresh paint can hide or obscure evidence of previous repairs or staining not visible at the time of inspection.
- There is an opening in the drywall below one of the kitchen cabinets. Recommend repair.

Hole under kitchen cabinet

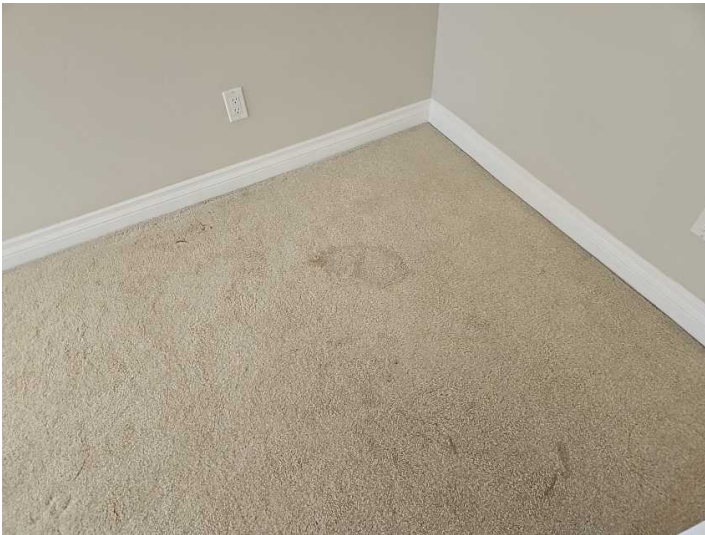
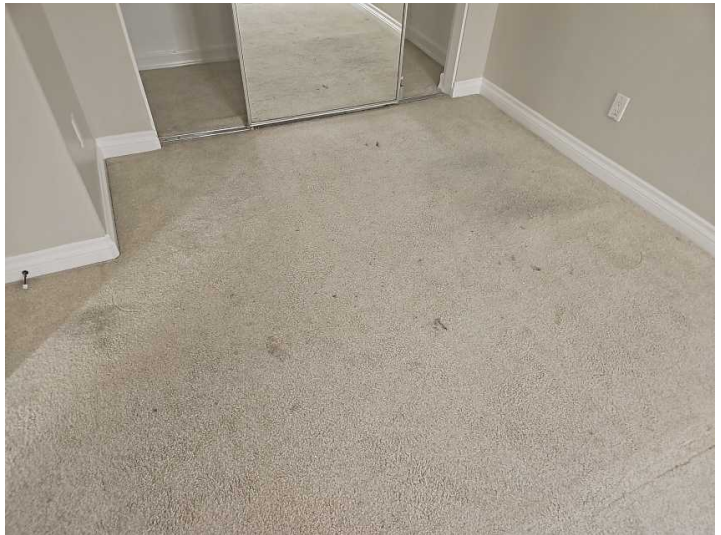
- The carpet is stained in several rooms. Recommend professional cleaning.

Stains

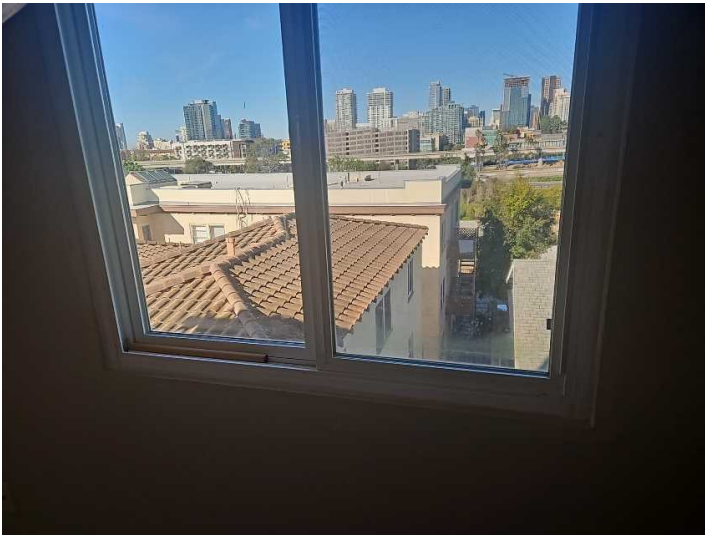
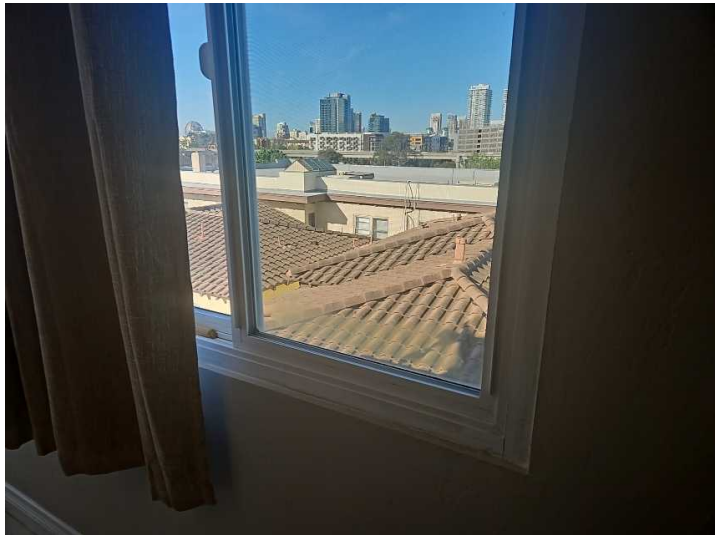
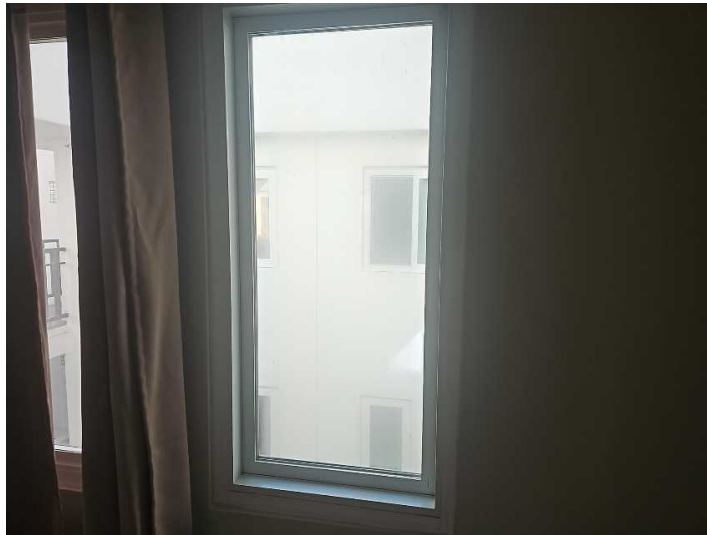
- In accordance with CREIA Standards, we do not test every window in the house, and particularly if it is furnished. We do test every unobstructed window in every bedroom to ensure that at least one provides and emergency exit.
- Cloudiness/condensation observed in thermopane double glazed windows in the living room and guest bedroom. This is an indication of a failed seal. A qualified contractor should review for replacement as needed.

Cloudy window

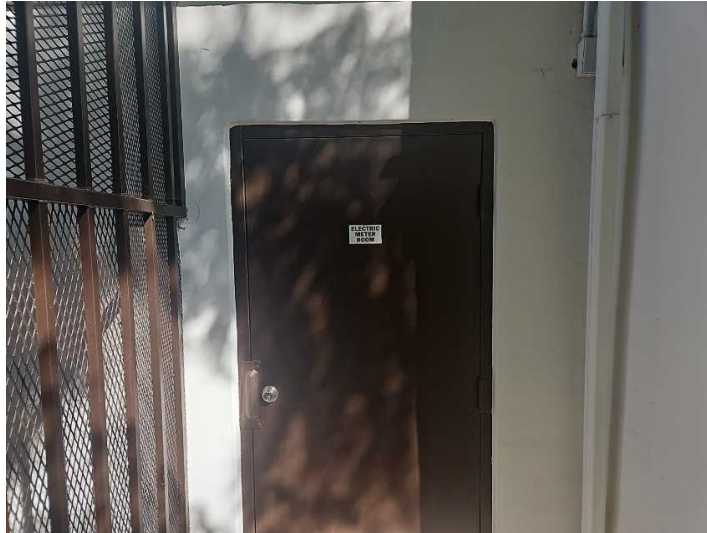
Main panel location

- National safety standards require electrical panels to be weatherproof, readily accessible, and have a minimum of thirty-six inches of clear space in front of them for service. Also, they should have a main disconnect, and each circuit within the panel should be clearly labeled. Industry standards only require us to test a representative number of accessible switches, receptacles, and light fixtures. However, we attempt to test every one that is unobstructed, but if a residence is furnished we will obviously not be able to test each one.

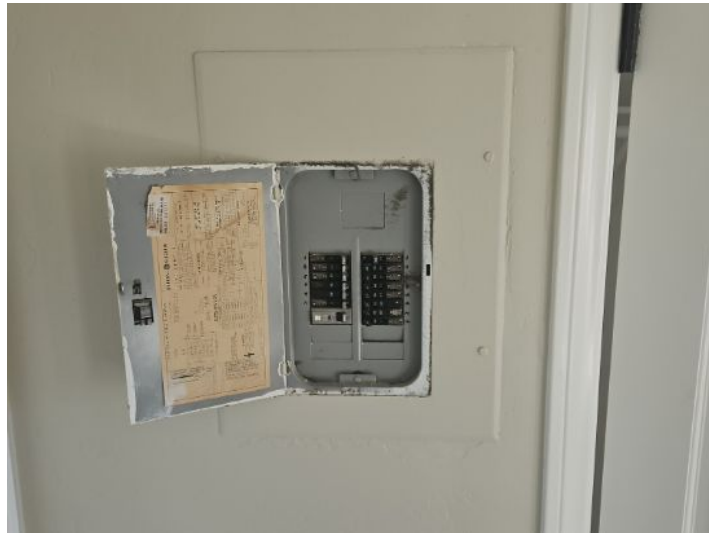
Sub panel location

- The wiring within the panel appeared satisfactory and functional. The auxiliary panel ground & neutral wires are properly un-bonded.

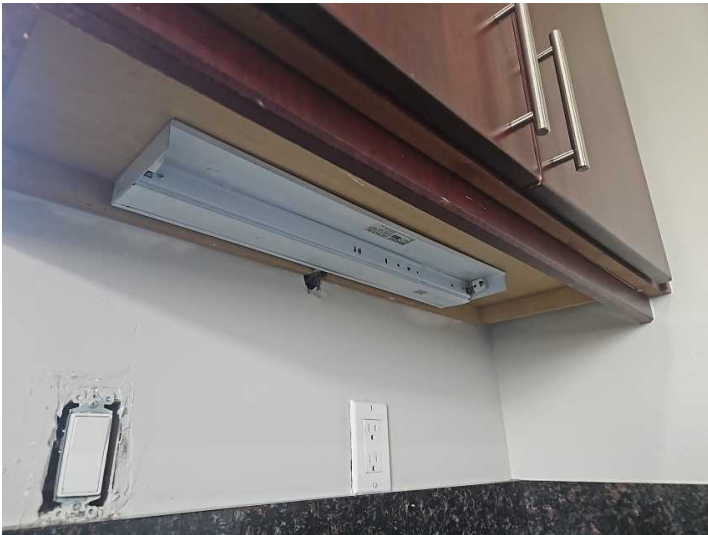
- Missing Outlet Cover. There was an outlet that does not have a faceplate. Missing faceplates expose electrical parts of receptacle outlets, and switches creating a potential shock hazard. For safety reasons all outlets and switches should have secure covers to reduce the chance of electric shock.

Cover missing

Missing bulb and cover

Missing cover

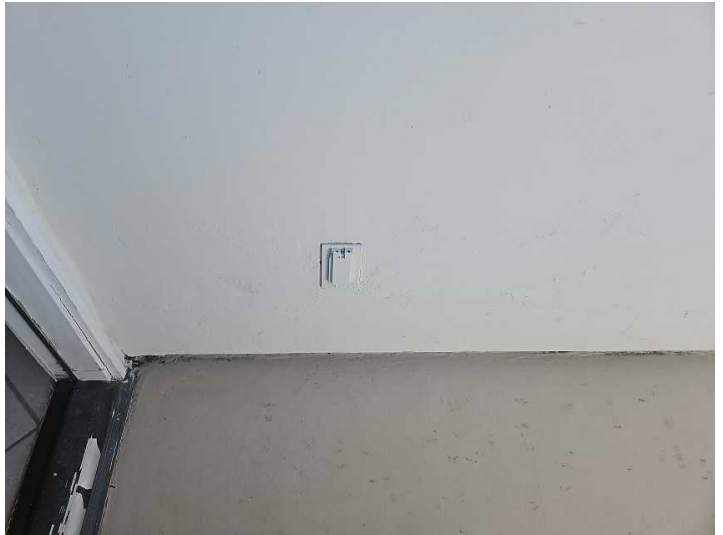
- Receptacles located at the exterior of the home are without the benefit of In-use covers. In-use covers help protect the outlets from moisture while a plug or cord is in use. Installation of proper In-use covers are recommended to be installed at all exterior receptacles by a qualified electrician.

In-use cover not installed

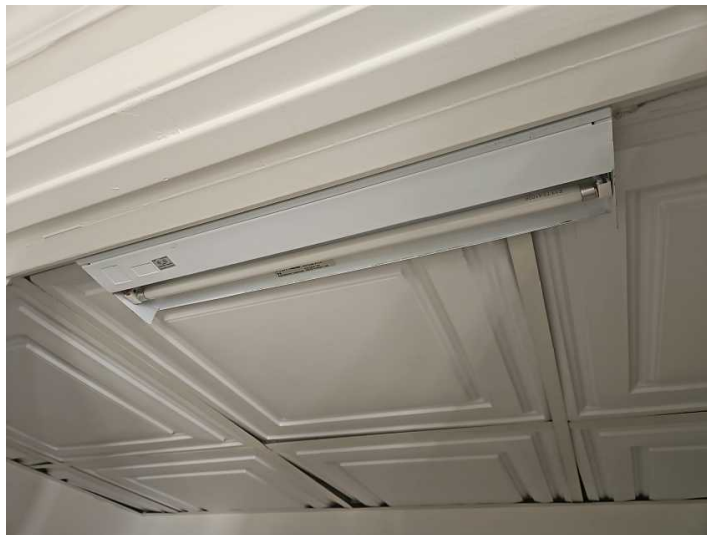
- Bare bulb light fixtures in cabinets or closets are now considered a safety concern. We advise replacing with an approved covered fixture.
- Light fixtures installed at the underside of the kitchen cabinets are missing the exterior covers. The light bulbs and electrical connections are exposed. Recommend repair or replacement by a qualify electrician.

Bare bulb

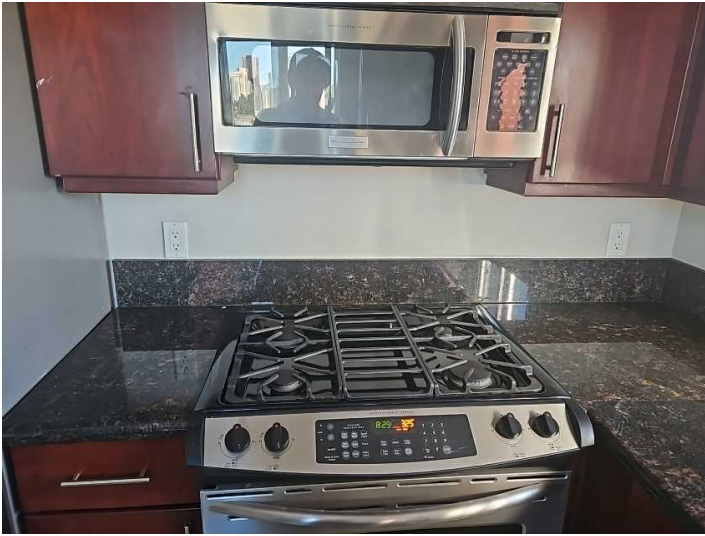
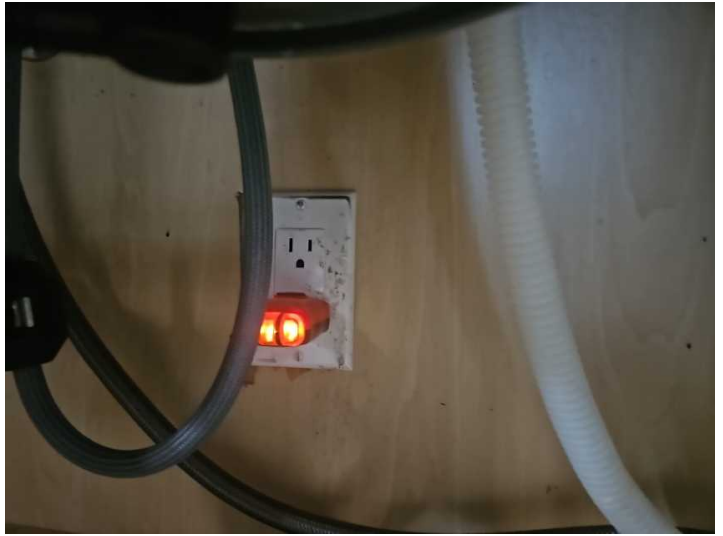
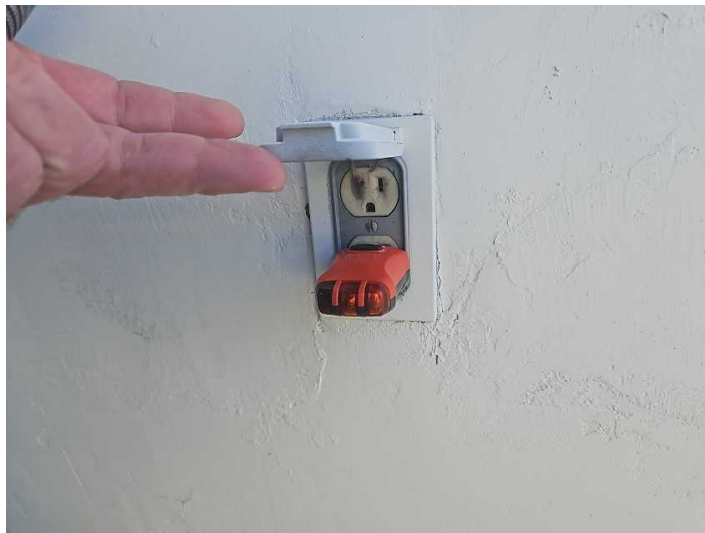
- This house was built prior to the requirement for the installation of GFCI receptacles in certain locations in the house. The locations where GFCI receptacles are required has increased, but it is not required to retrofit older homes unless a remodel takes place. For safety, it is advisable to upgrade all receptacles within 6 feet of a plumbing fixture, in garage, all kitchen counter top outlets, and at exterior, to GFCI protected outlets. A qualified electrician is recommended.

No GFCI present

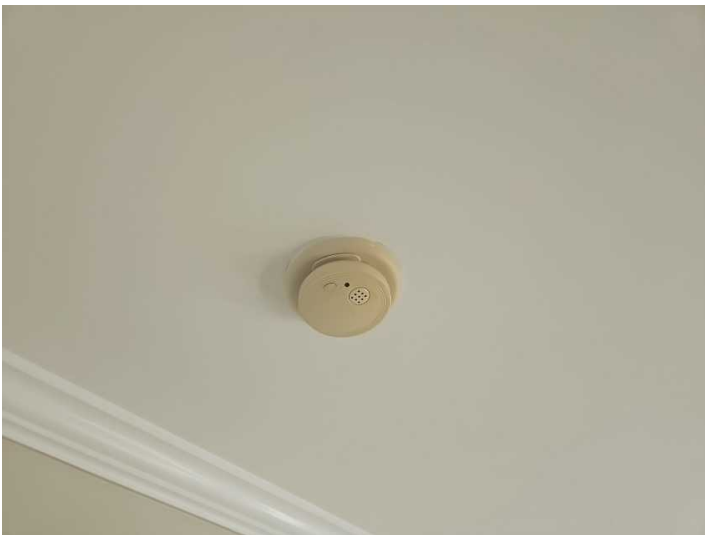
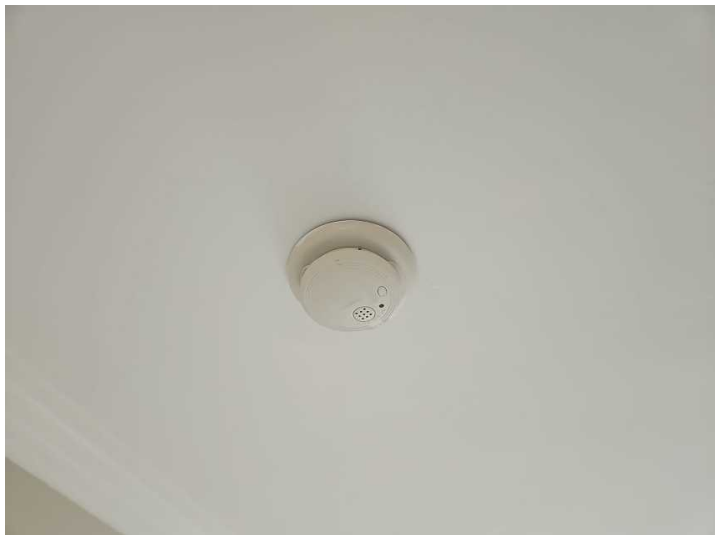
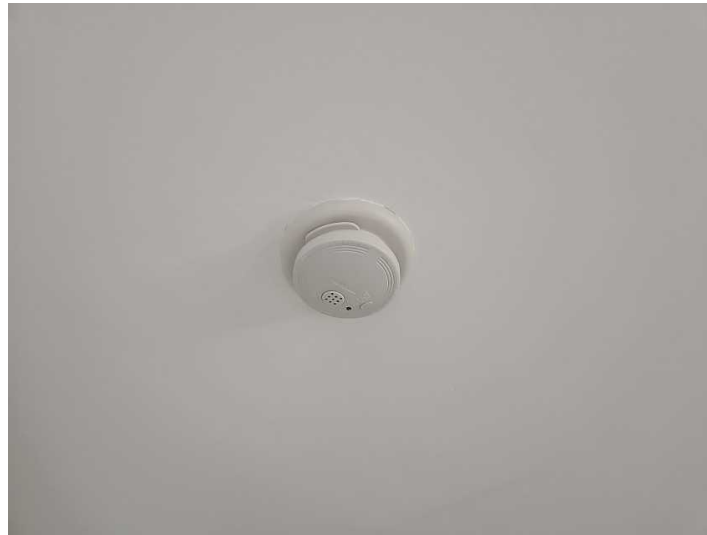
• Old detectors. Primary bedroom unit is chirping. Smoke detectors last 6-10 years. As smoke detectors age, they become less reliable. Recommend upgrading the smoke detectors in this home as a safety upgrade.

Old detector

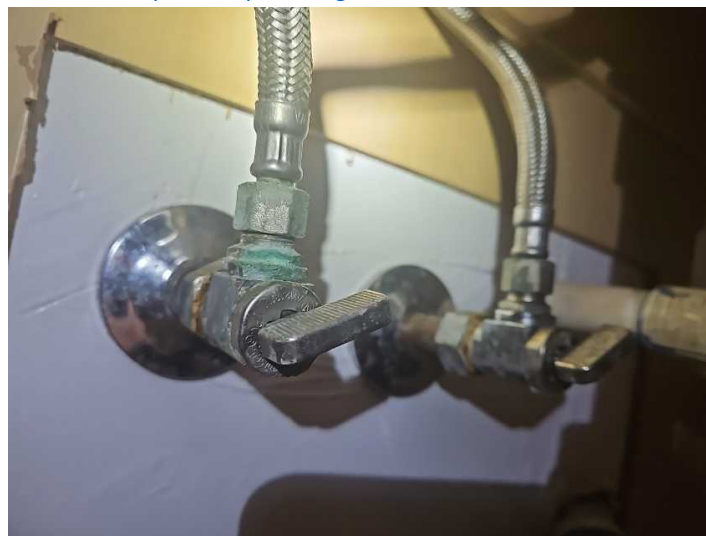
- Corrosion was found at both the water supply shut-off line(s) and valve(s) under the primary bathroom sink. Left uncorrected, the valves and/or lines may eventually leak and lead to moisture intrusion problems (e.g., wood damage, mold). Recommend further review for repairs by a qualified plumber.

Corrosion

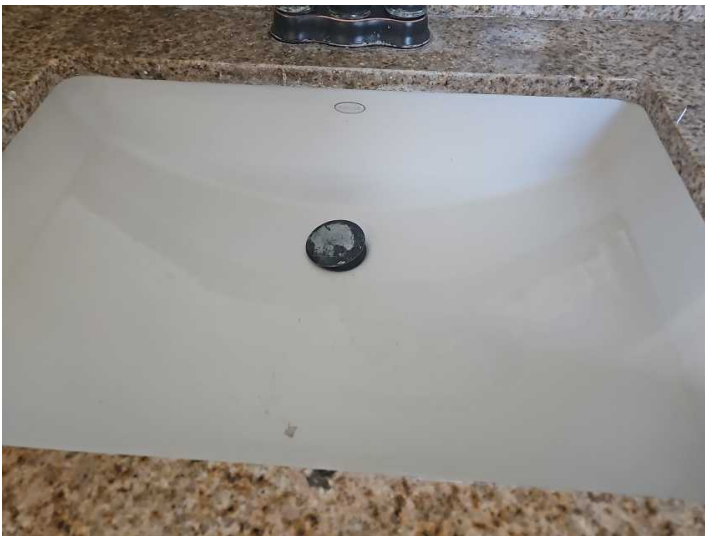
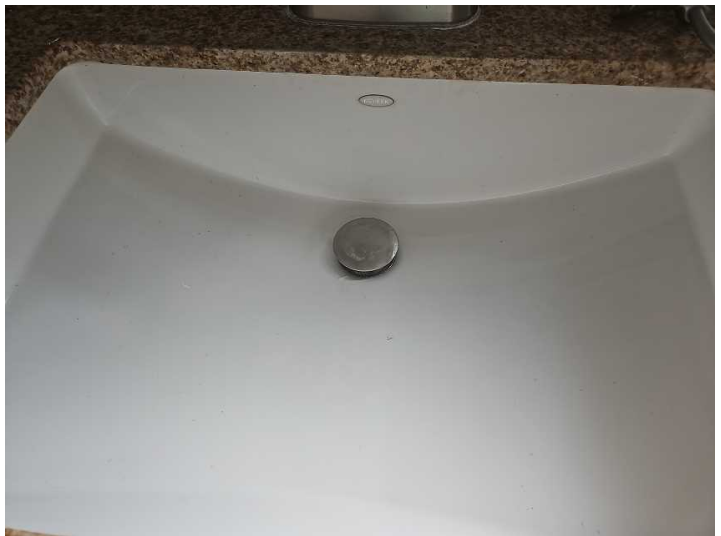
- Stopper is inoperable at both bathrooms. Recommend review for repair or replacement as necessary.

Stopper inoperable

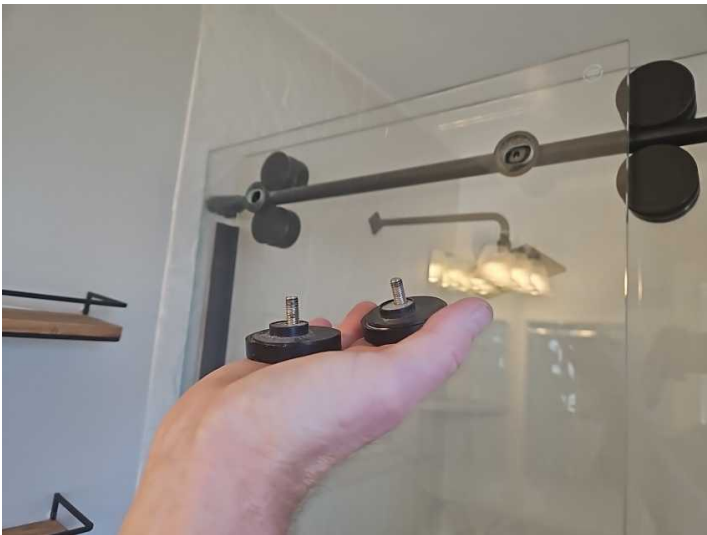
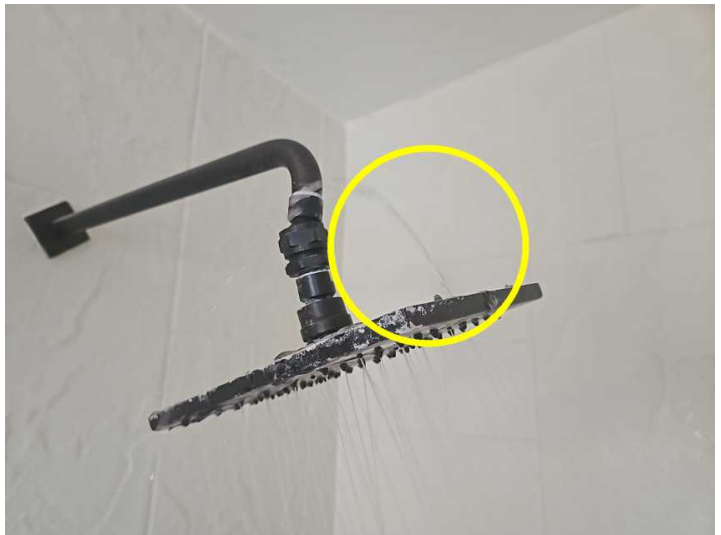
- The primary bathroom shower head leaked while in use. Advise repair or replacement by a licensed plumbing contractor.
- Fasteners were removed from the primary bathroom shower enclosure, glass, stationary wall. The reason for this is unknown. Repairs are needed by a qualified contractor.

Fasteners removed

Shower head leaking

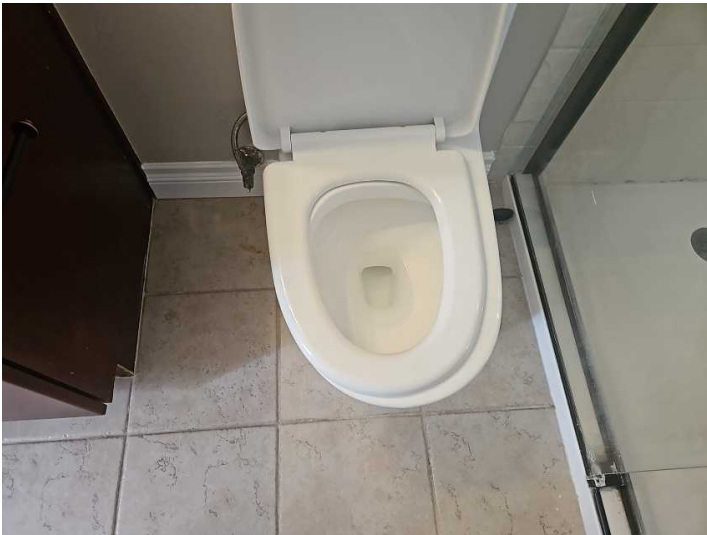
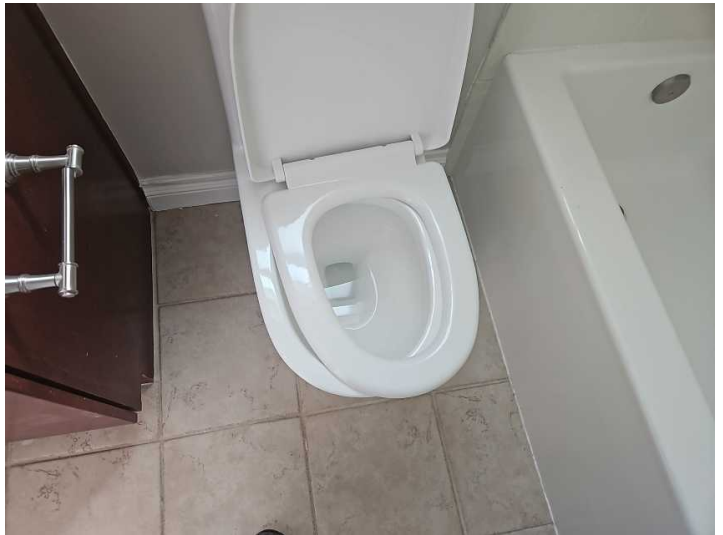
- Seat/lid loose at both bathrooms.

Loose seat

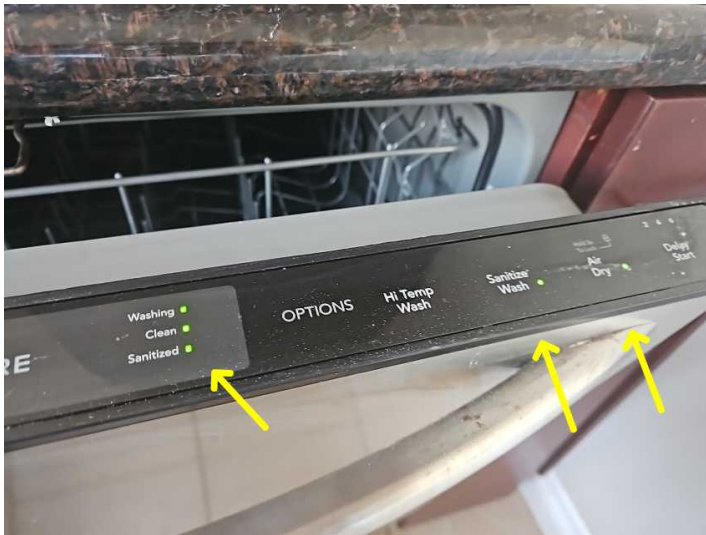
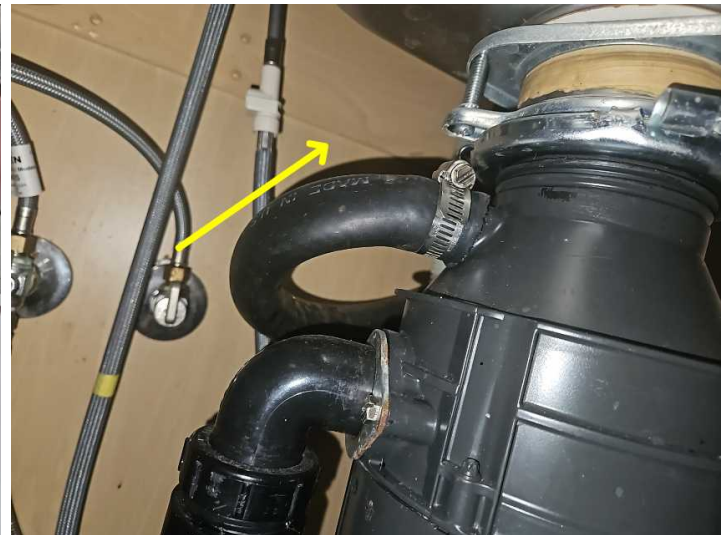
- The drain hose for the dishwasher slopes upward. This hose should slope downward to the drain without collecting water. We recommend adjusting the hose so that it slopes properly to avoid collecting water and debris, which may eventually result in a clog.
- Did not operate. Lights are flashing on the control panel. Recommend further evaluation by a qualified appliance repair person.

Flashing lights

Improper slope

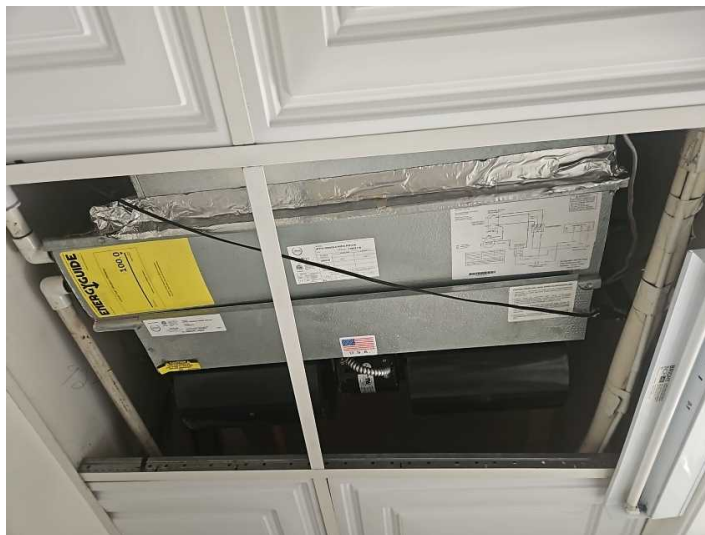
Air handler location

- No deficiencies observed.
- Heat Pump not operated in the Heat Mode due to >65 degree F outside air temperature. See Limitations.
- NOTE: This Heat Pump is an air source type that gathers latent heat from the exterior and transfers it to the interior coil in order to heat the home in winter. When used to cool--the latent heat from the interior is gathered through the interior coil and transferred to the outside air.

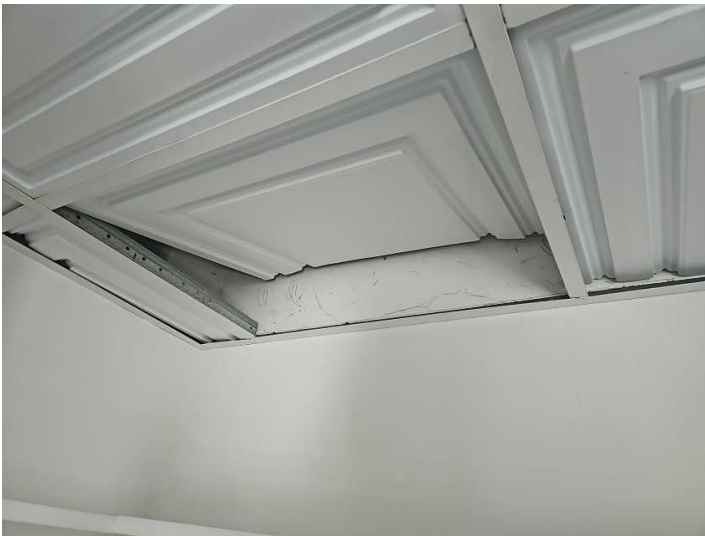
- The return air plenum for the air handler located in the primary bedroom closet ceiling is not properly sealed. Plastic drop down ceiling panels have been installed at the underside of the air handler located in the closet. These panels are being sucked into the air plenum while the system is running. This means that unfiltered air is being pulled into the air plenum from the closet, instead of the filtered air return at the hallway. Unfiltered air and potential dust and debris can enter the air handler and circulate throughout the home. This is a substandard installation that needs further evaluation by a qualified HVAC contractor.

Return air being pulled in through drop down ceiling panel

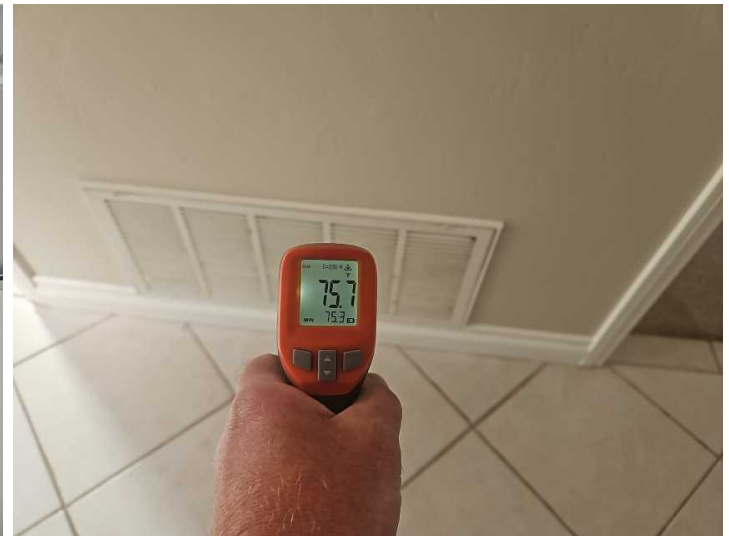
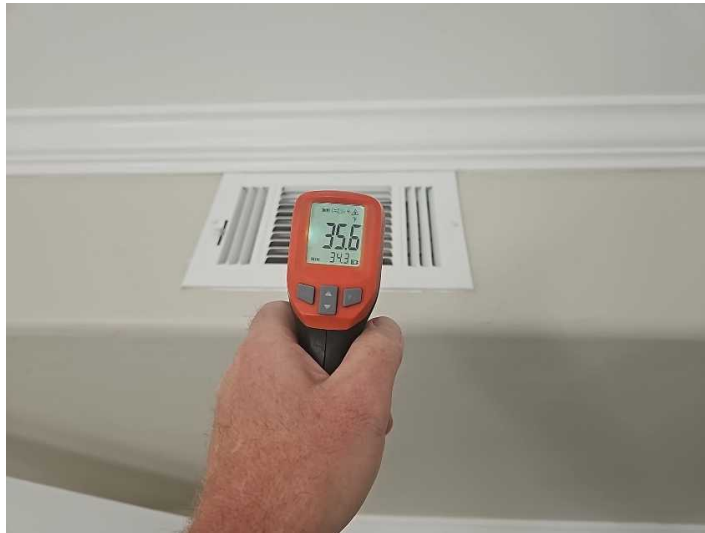
- Air registers appeared working in every applicable room.
- \*\*\*\*\*COOLING\*\*\*\*\*
- An air temperature test was performed by using a thermal camera on the AC system to determine if the difference in temperatures of the supply and return air are between 14 degrees and 22 degrees which indicates that the unit is cooling as intended. Actual measured cooled supply air temp: 35 degrees - Ambient return air temp: 75 degrees. 40 degrees difference (Good Range). This is not an exhaustive test and cannot predict the performance of the AC on extremely hot or humid days.

Room temperature at return

Cooled temperature at register
