# **Cantor Property Inspection**

### **CONFIDENTIAL INSPECTION REPORT**

4268 Witherby Street, San Diego, CA 92103

8/20/2026 1:00 pm to 4:00 pm

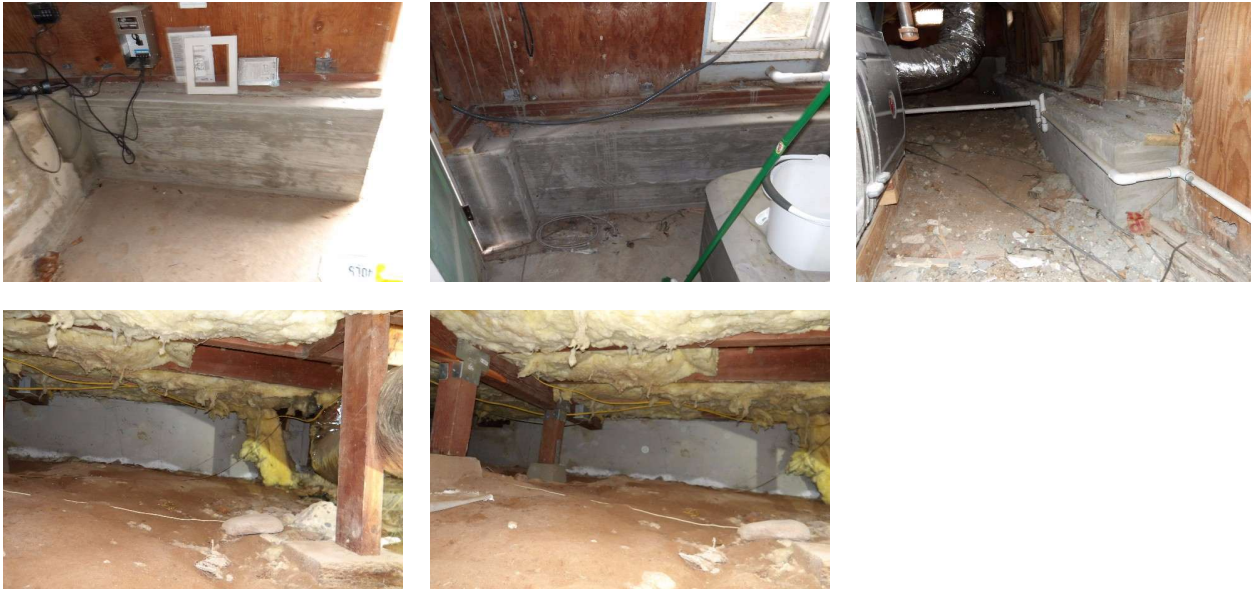
1.7 - The front and rear portions of the foundation appear to have been replaced in the recent past. These replaced areas of the foundation have anchor bolts attaching the house to the foundation and appear to be functional.

The front and rear portions of the foundation appear to have been replaced in the recent past - *Continued*

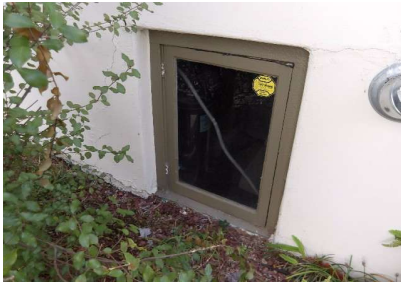
1.12 - The glass door-window to the crawl space does not appear to be tempered safety glass, as required by current building standards. Upgrades are advised by a licensed contractor.

The glass door-window to the crawl space does not appear to be tempered safety glass - *Continued*

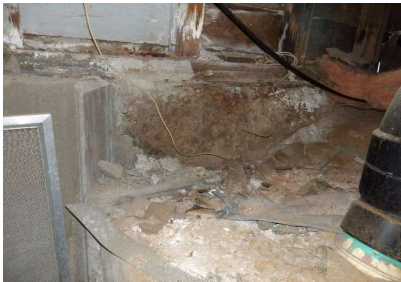
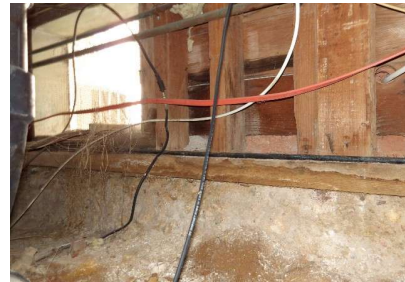
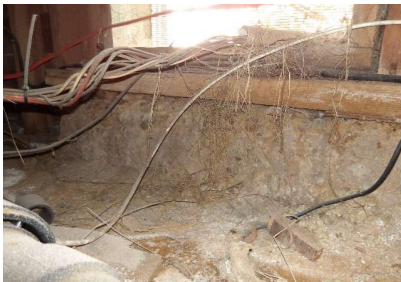
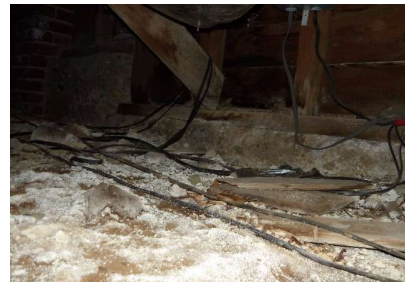
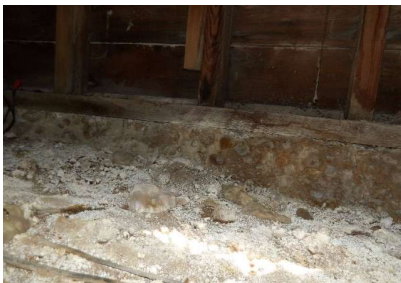
1.13 - There is significant deterioration and damage noted in the concrete foundation (North and South sides of the crawl space). Further evaluation and repair by a licensed engineer and or foundation contractor is advised during the contingency period of the escrow.

1.14 - Concrete on the original portions of the foundation is sloughing off the foundation walls (North and South foundations), due to moisture penetration, which you should be further evaluated and repaired by a licensed foundation contractor during the contingency period of the escrow.

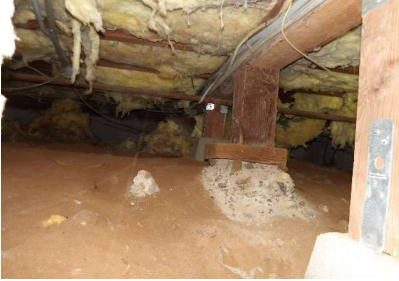
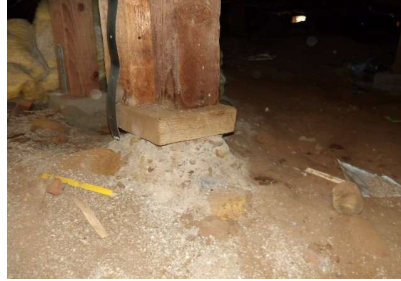
1.15 - There are posts that are bearing poorly on several of the original concrete piers throughout the crawl space. Additionally, the concrete piers are deteriorated. Further evaluation and repair by a licensed foundation contractor is advised.

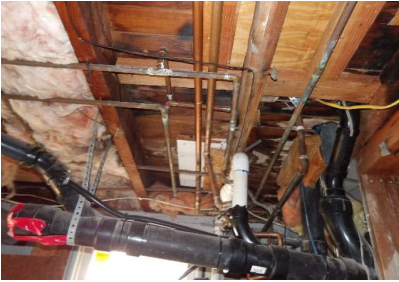
1.16 - There are moisture stains and or damage noted in the sub-floor beneath the floors in the bathrooms and kitchen of the home. Further evaluation and repair by a licensed Pest Control Operator and or contractor is advised.

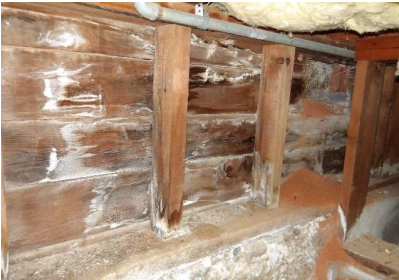
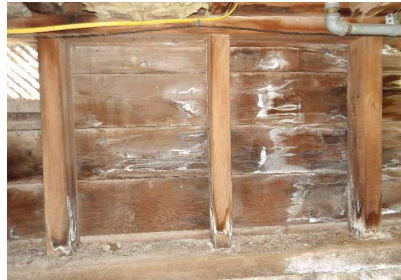
1.19 - Some or all of the cripple walls are not shear paneled, and will remain seismically vulnerable. Upgrading the cripple walls with shear paneling may be desired.

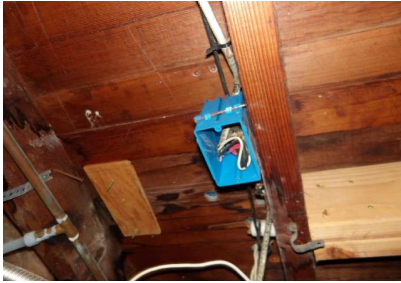
1.21 - There are one or more open electrical junction boxes within the crawl space, that should be sealed to contain any arcing or sparking that would be contained within the box.

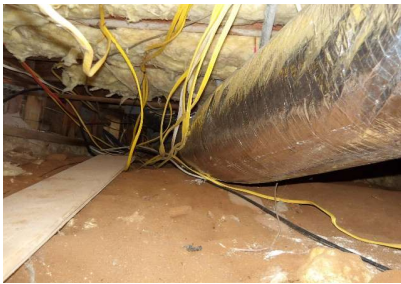
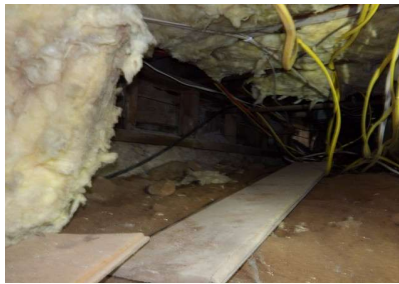
1.22 - There are Romex wires that are not properly secured to the floor framing, are sagging, and in direct contact with the ground. Further evaluation and repair by a licensed electrician is advised.

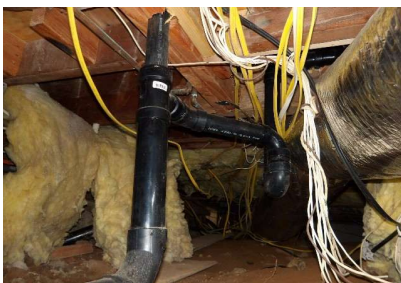
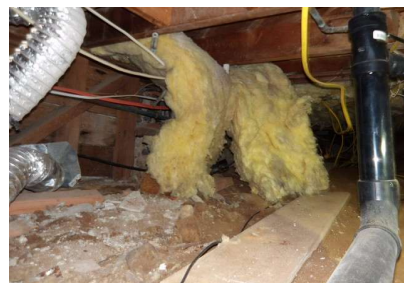
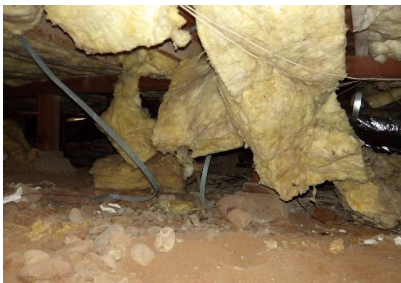
1.25 - Some pieces of insulation are hanging or have fallen from between the floor joists. Properly re-installing the insulation into it proper position is advised.

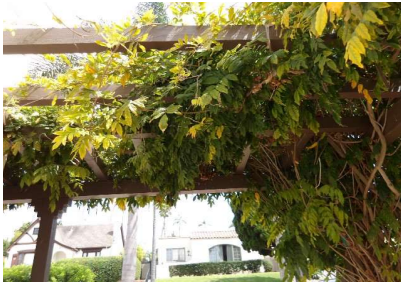
2.2 - Overgrown landscaping was noted at various location throughout the exterior of the home, which should be cut back or removed.

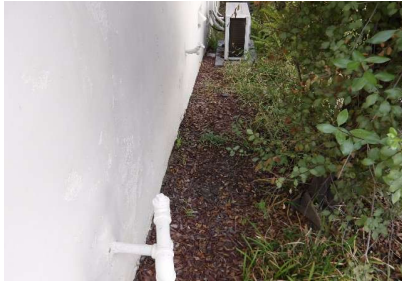
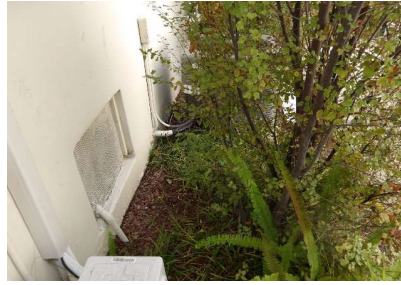
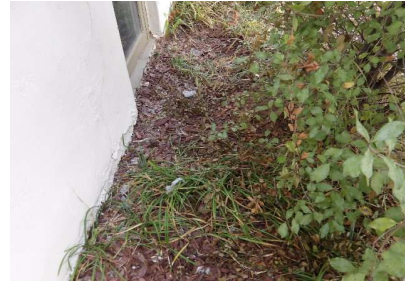
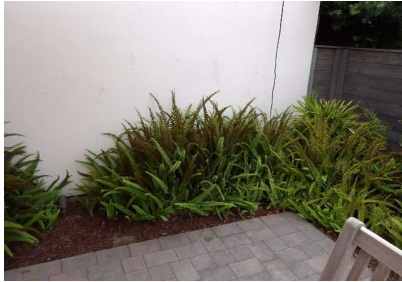
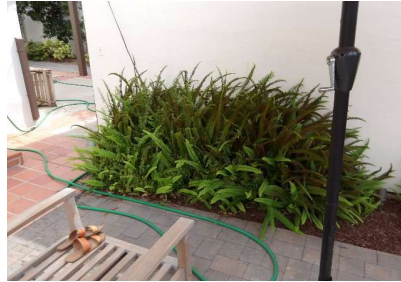
Further evaluation and repair by a licensed foundation-drainage contractor is advised.

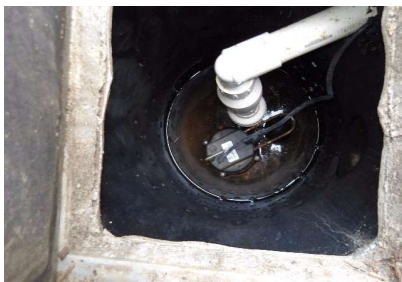
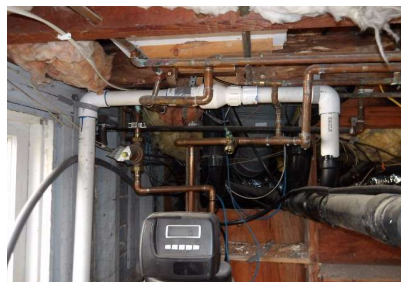
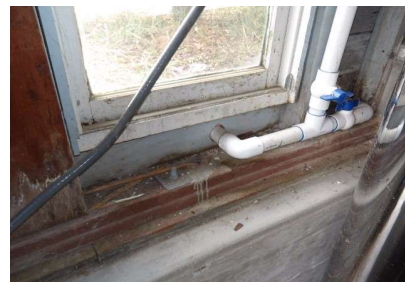
2.10 - The sump pump is improperly tied into the main sewer system, which is not allowed. There appears to be a diverter valve installed in the drain to re-direct the sump pump to an exterior location.

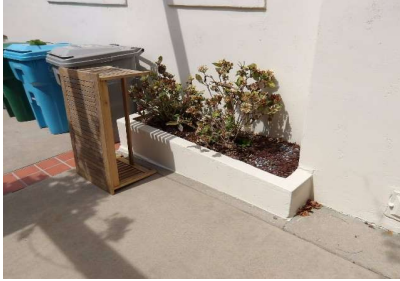
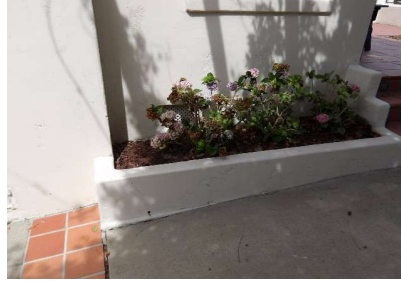
2.11 - The planter areas around the perimeter of the home are a moisture intrusion concern. Further evaluation and repair by a licensed contractor is advised during the contingency period of the escrow.

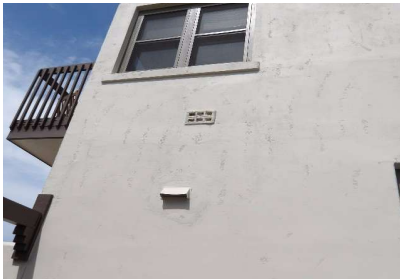
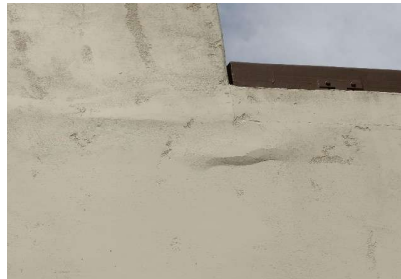
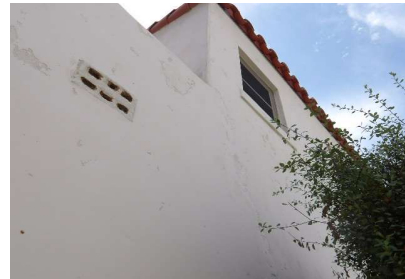
2.17 - Patching and or damage was noted in the stucco at various locations throughout the building. Further evaluation and repair by a licensed stucco contractor is advised.

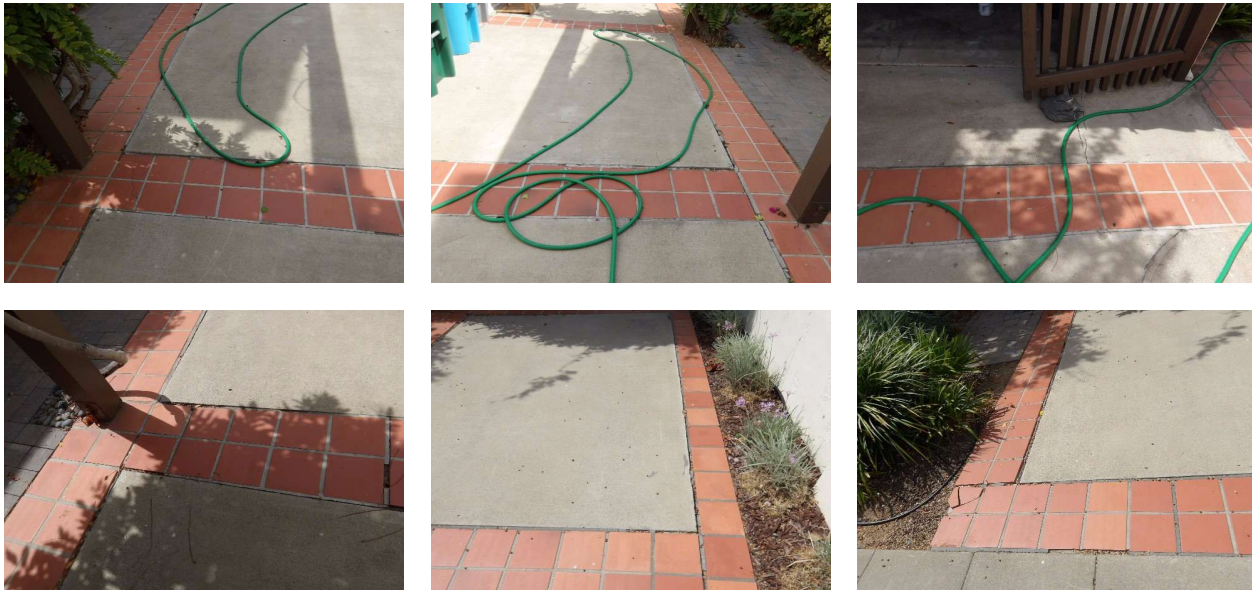
2.19 - The driveway has been cracked, lifted, and or damaged by tree roots from a large tree and or soil movement. Further evaluation and repairs by a licensed foundation contractor is advised.

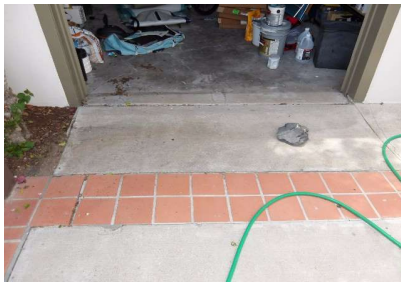
2.20 - Improper drainage was observed, which will direct water towards the garage. The seller stated that water does not enter the garage during heavy rain fall. Further evaluation and proper repair by a licensed foundation contractor is advised.

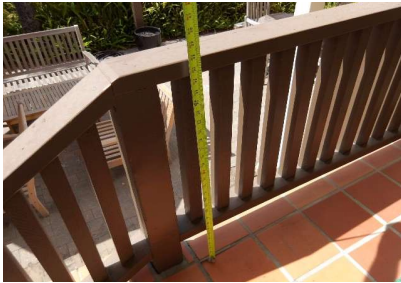
2.31 - The guardrails at the rear porch do not conform to current standards. They should be a minimum of forty-two inches high with pickets spaced no more than four inches for child safety, and you may wish to have them brought into compliance.

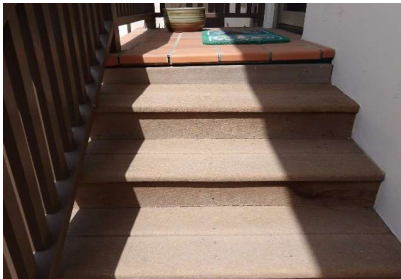
2.32 - Cracking and or damage tiles were noted in the rear porch. Further evaluation and repair by a licensed contractor is advised.

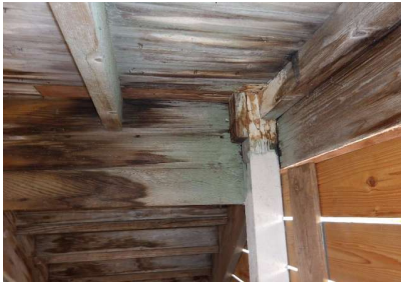
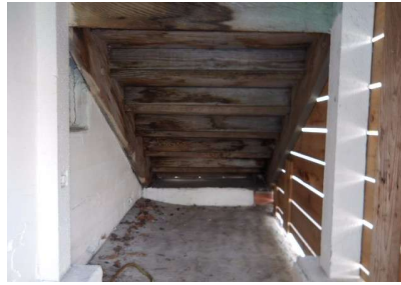
Moisture stains and or termite damage was noted in the wood steps - *Continued*

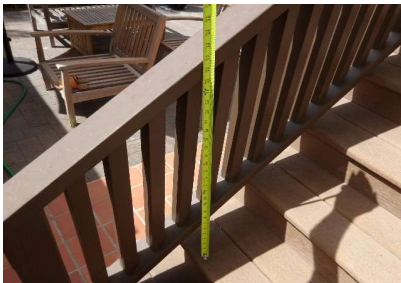
2.34 - The guardrails do not conform to current building standards. They should be a minimum of forty-two inches high with pickets spaced no more than four inches for child safety, and you may wish to have them brought into compliance.

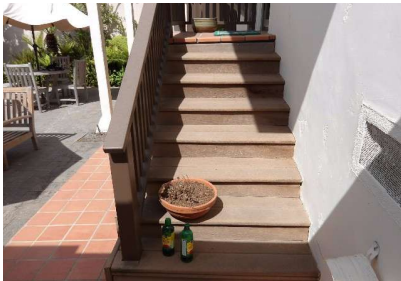
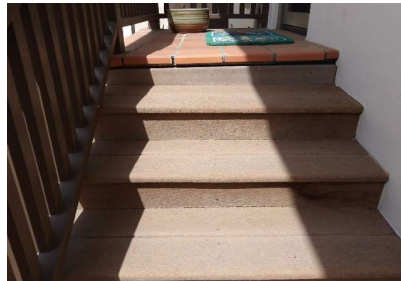
2.35 - The risers are unequal in height, which could prove to be a trip-hazard. The rise should not be less than 4 inches, nor greater than 7 inches. In addition, the dimensions of the risers should not exceed 3/8 of an inch from the smallest dimension on the entire run of the stairs.

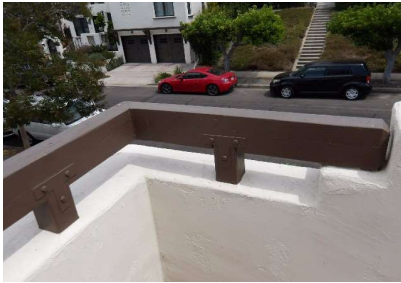
The guardrails do not conform to current standards - *Continued*

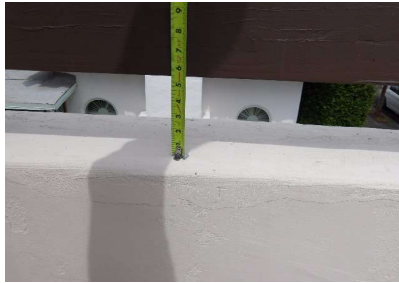
2.37 - The guardrails do not conform to current standards. They should be a minimum of forty-two inches high with pickets spaced no more than four inches for child safety, and you may wish to have them brought into compliance.

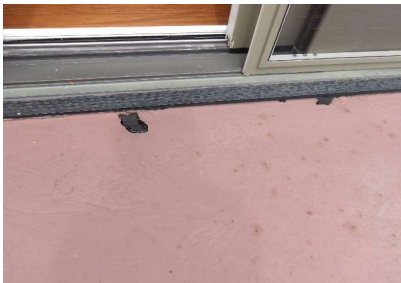
2.38 - Black tar or mastic was noted on the balcony surface near the sliding glass doors, which I was unable to determine its cause. (Possibly used to seal the area under the doors) Further evaluation by a licensed contractor is advised.

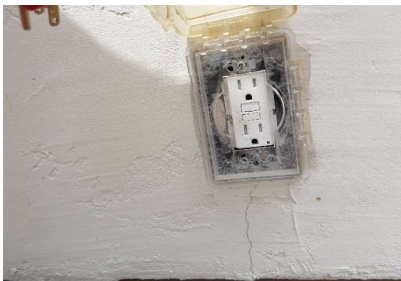
2.43 - One or more ground-fault protected outlets on the balcony was tripped and I was unable to reset the outlet, which should be serviced by a licensed electrician.

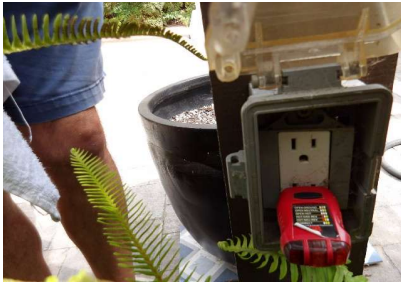
2.44 - One or more of the outlets did not appear to be functional (Rear patio post), which should be serviced by a licensed electrician.

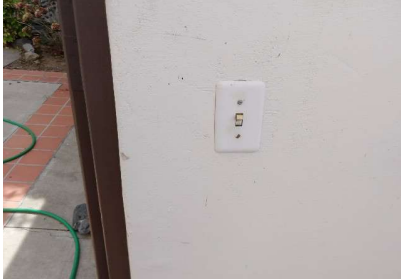
2.45 - One or more outlets or switches are missing waterproof cover plates, which should be installed.

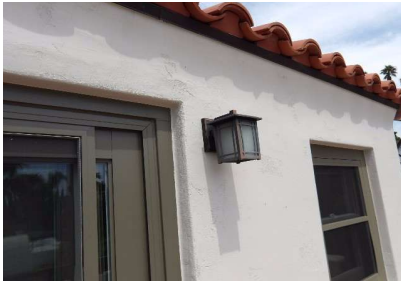
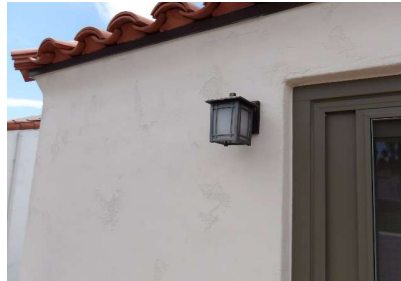
2.48 - There are light fixtures that are damaged, missing, or in need of new bulbs at various locations.

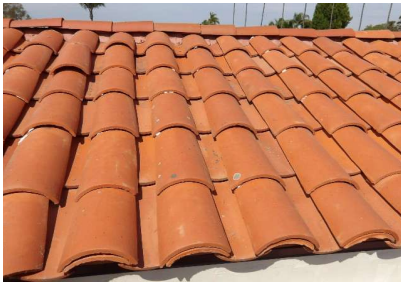
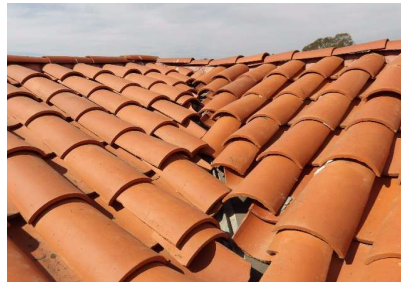
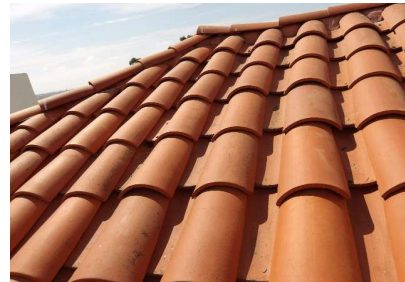
3.5 - The roof is in acceptable condition, but this is not a guarantee against leaks. For a guarantee, you would need to have a roofing company perform a water-test and issue a roof certification.

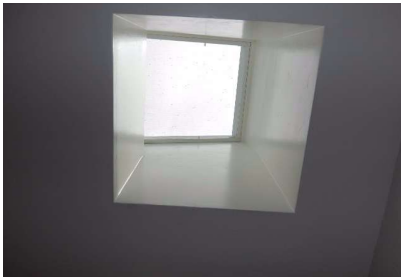
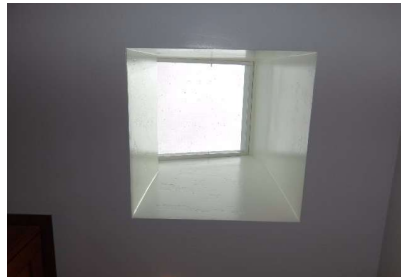
3.8 - Using the wall mounted controls inside the master bedroom closet, I was unable to get either of the skylights to operate. Further evaluation and repair by a licensed contractor is advised.

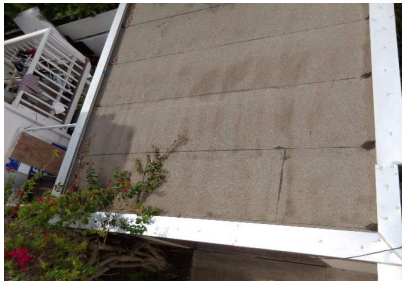
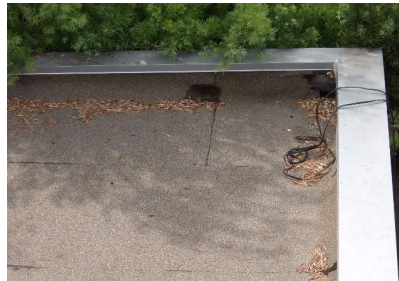
3.14 - Debris was noted on the roof and/or around the roof drains, which may not allow the roof to drain properly. Cleaning the drains now and on a routine basis is advised.

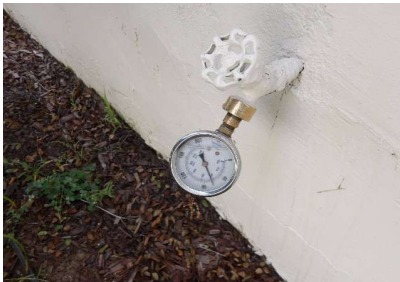
4.2 - A functional pressure regulator is in place on the plumbing system.

4.3 - The water pressure was 60 to 62 PSI when tested.

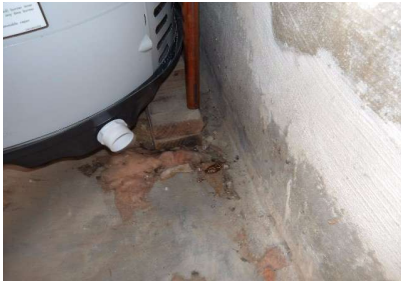
4.16 - The water heater is equipped with a mandated pressure-temperature relief valve and discharge pipe, which is extended to the crawl space floor. The discharge pipe should be extended to the exterior of the crawl space by a licensed plumber.

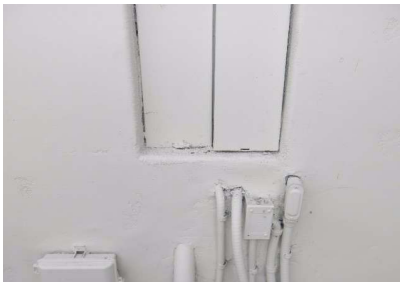
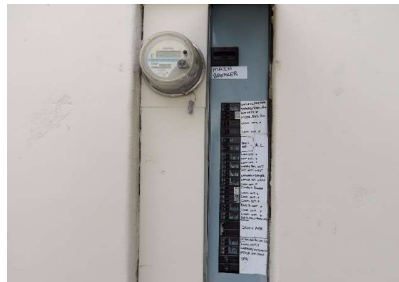
5.7 - The exterior panel and interior panel covers do not close properly, which should be serviced by a licensed electrician.

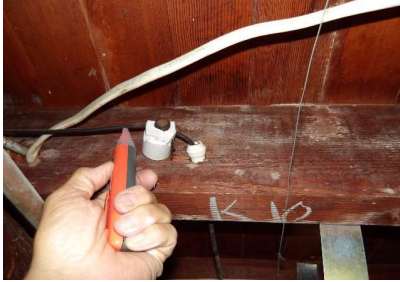
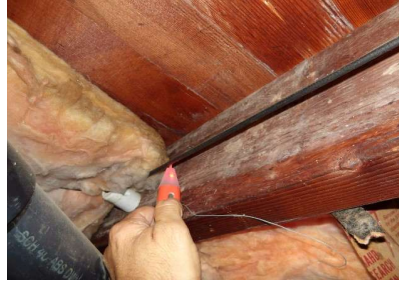
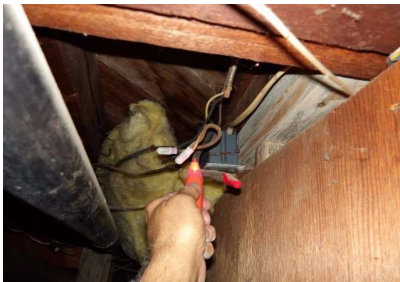
5.12 - Portions of the residence are still wired with the original suspect knob-and-tube wiring (Visible in the crawl space), which should be further evaluated by a licensed electrician and certified as being safe or be replaced.

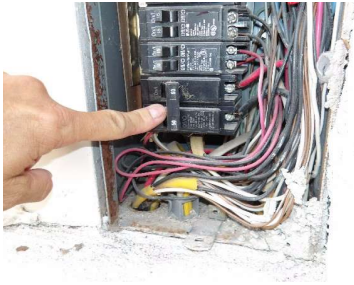
One 50 amp circuit breaker is in the off position - *Continued*

5.15 - One 50 amp circuit breaker is in the off position (Labeled spa). Consult the seller for further information regarding this breaker. The spa has been removed, so the circuit breaker is no longer in use.

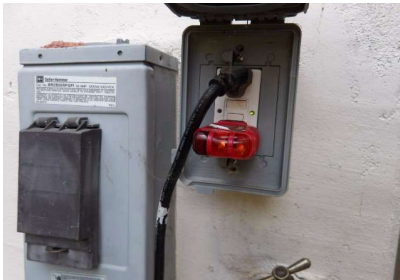
5.18 - The disconnect for the spa that has been removed is no longer functional. The circuit breaker has been removed from the panel.

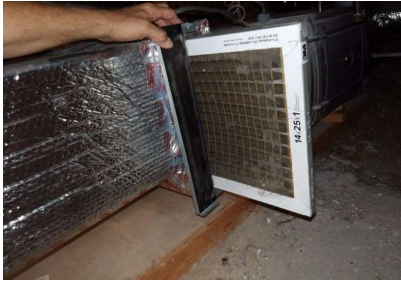
7.9 - The 14 x 25 x 1 filter is dirty and should be changed or washed soon and every two or three months. If filters are not changed regularly, the evaporator coil and the ducts can become contaminated, and can be expensive to clean.

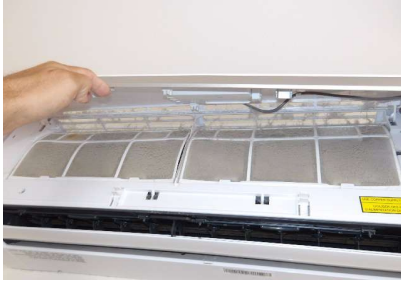
The filter in the mini split is dirty - *Continued*

7.28 - The filter in the mini split is dirty, which should be serviced.

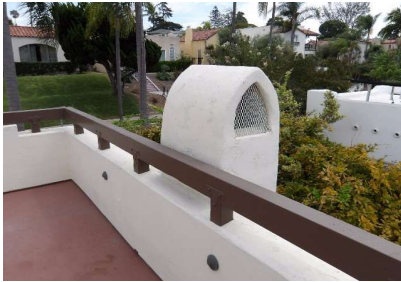
8.3 - The chimney appears to terminate too close to the balcony surface, which may be a health and or safety hazard. Further evaluation and repair by a licensed masonry contractor is advised.

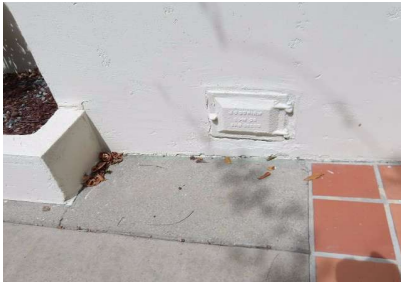
8.10 - The door on the ash box appears to be stuck, and will need to be serviced to work properly.

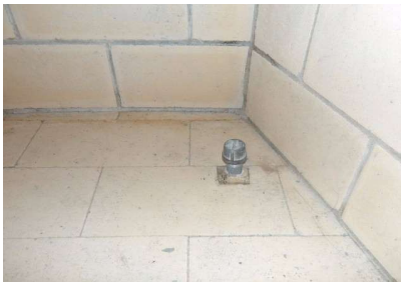
8.11 - The gas pipe for the log lighter is capped off and could not be inspected.

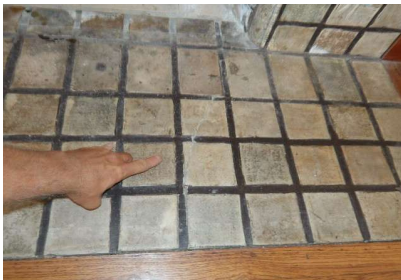
8.13 - There are cracks in the hearth tiles, which you may wish to view for yourself.

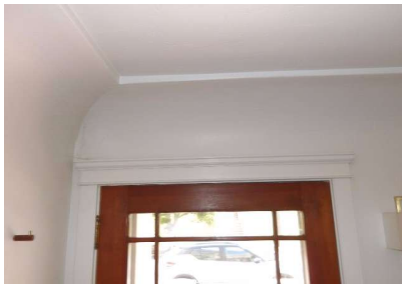
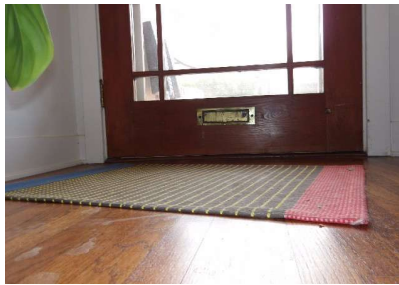
The door and or jamb are slightly out of square - *Continued*

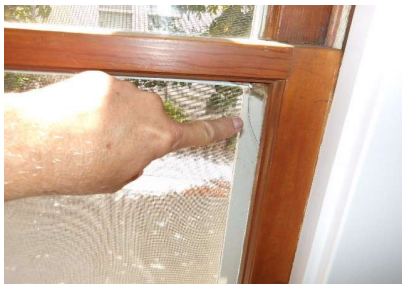
9.10 - One or more window panes are cracked, which you should be repaired by a licensed contractor.

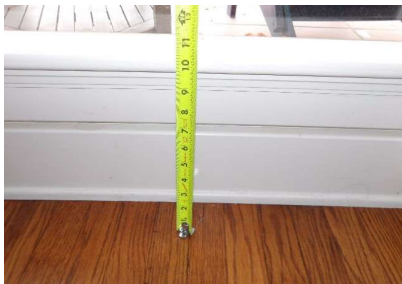
9.11 - The glass in the windows with in 18 inches of the floor does not appear to be tempered safety glass (Front facing fixed pane window), as required by current building standards.

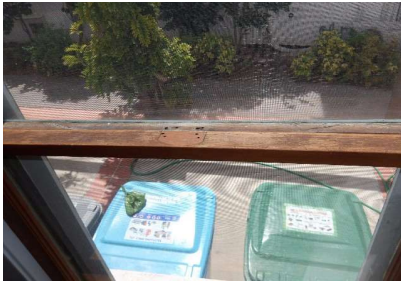
9.20 - One or more window locks are missing, or need to be serviced, to be functional.

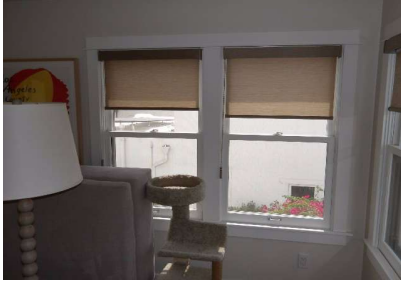
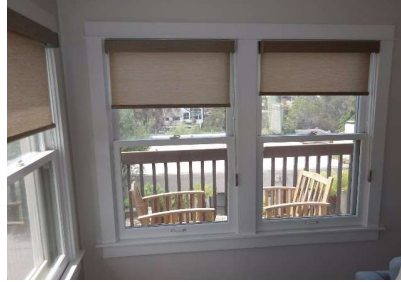
9.27 - One or more windows will need service to work well, such as servicing the hardware.

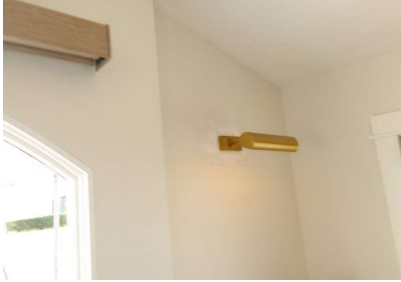
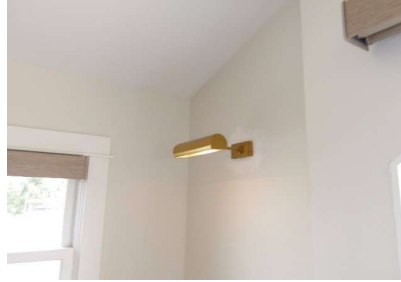
10.6 - There are patched and or damaged areas in the walls and ceiling, which you should question the seller about, or have further evaluated by a licensed contractor.

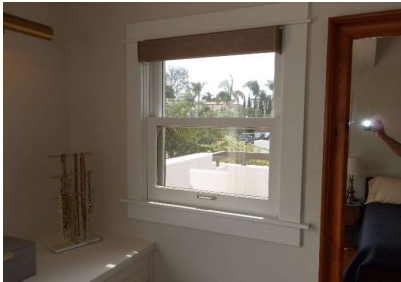
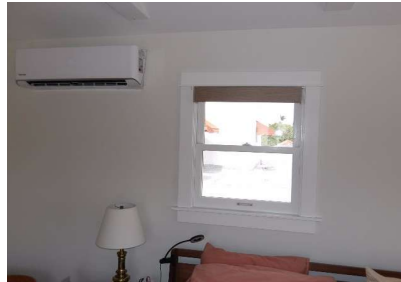
10.8 - One or more windows will need service to work well, such as servicing the hardware.

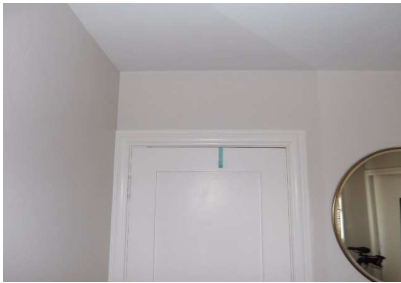
10.26 - The door and or jamb are slightly out of square, which may indicate movement has occurred. Further evaluation and repair by foundation contractor is advised.

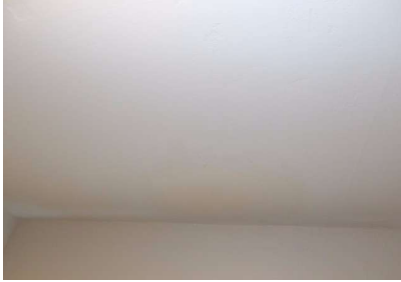
10.30 - There are patched and or damaged areas in the walls and ceiling, which you should question the seller about, or have further evaluated by a licensed contractor.

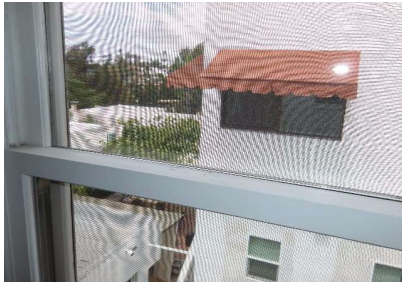
11.6 - A windows lock is missing or does not engage, and should be serviced.

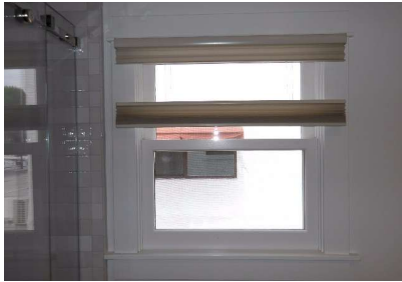
11.7 - A window will need service to work well such as sanding, shaving trimming, or servicing the hardware, etc.

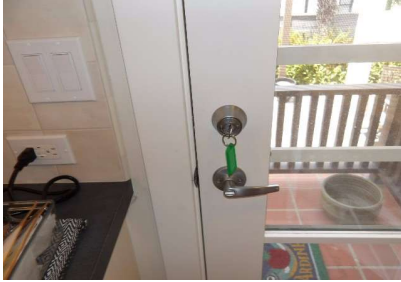
12.3 - The double cylinder deadbolt on the exterior door could prevent or impede an emergency exit, and should be replaced with a safer latch type.

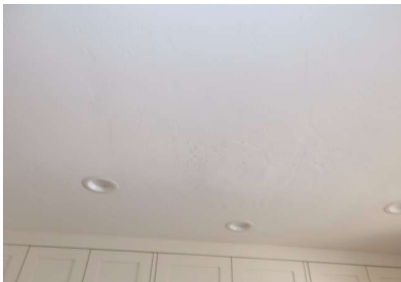
12.7 - There are patched areas in the walls and or ceiling, which you should question the seller about, or have further evaluated by a licensed contractor.

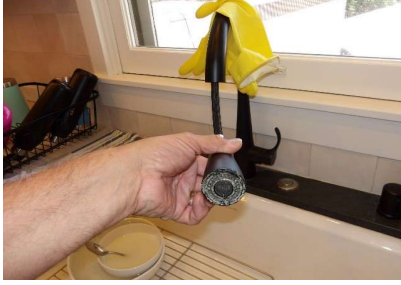
12.14 - The hand held head is corroded and or does not spray uniformly, which should be serviced.

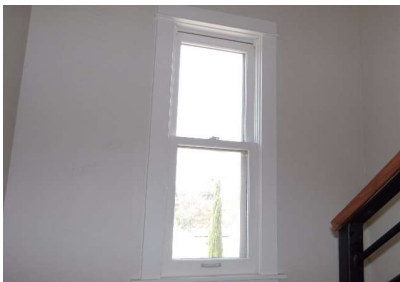
- 15.7 - The glass in the one or more of the windows does not appear to be tempered safety glass, as required by building standards. Upgrades to tempered glass is advised.

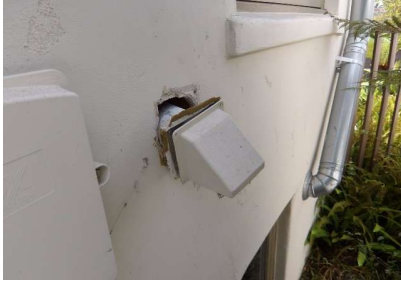
16.19 - The dryer vent is functional and ducted to the exterior of the building, however, the dry duct and or cover are loose on the exterior of the home. Proper repair by a licensed contractor is advised.

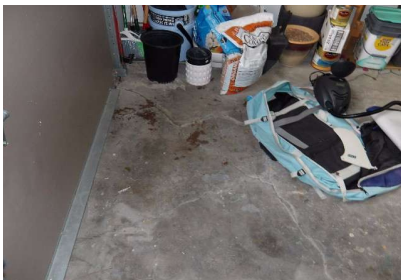
17.2 - The concrete slab is cracked and or the floor is crowned at the center and slopes toward the exterior, which suggests that some heaving or differential settling has occurred. Further evaluation and repair by a licensed engineer and or foundation contractor is advised.

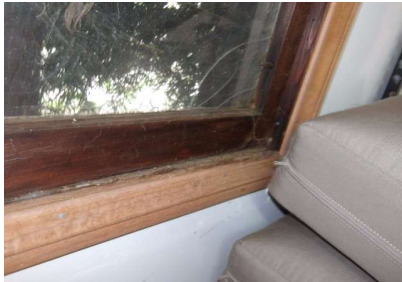
17.3 - There are signs of possible termite activity in the garage framing. Consult the services of a licensed Pest Control operator.

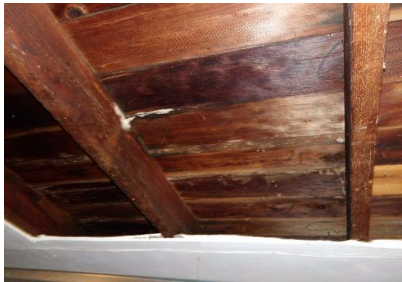
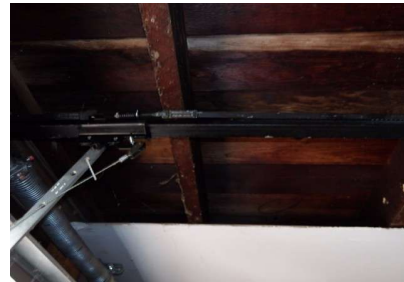
17.4 - There are moisture stains, damage, and or missing drywall on the wall and or ceiling in the garage. Additionally, there is a musty smell noted in the garage. Further evaluation and repair by a licensed roofer and or contractor is advised.

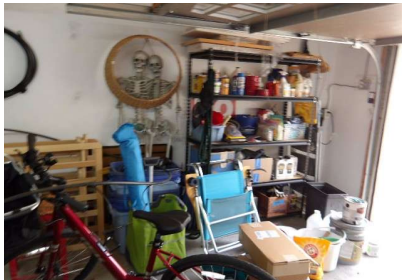
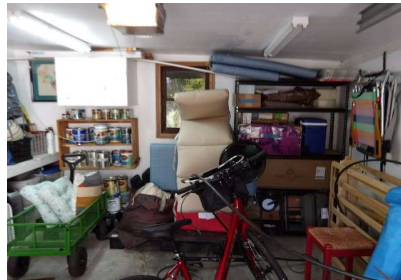
17.5 - Excessive storage and personal items in the garage limited the inspection. Further evaluation when fully visible and before the close of escrow is advised.

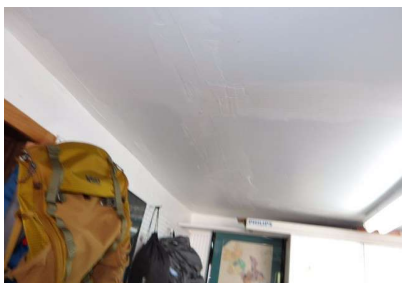
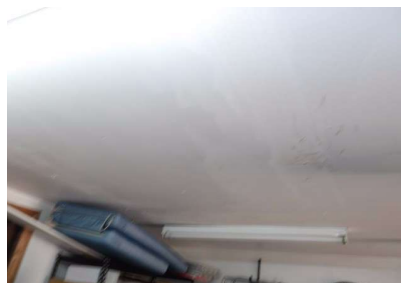
17.6 - There is cosmetic damage and or patching noted in the walls and or ceiling in the garage. Questioning the seller regarding the patched and or damaged areas is advised.

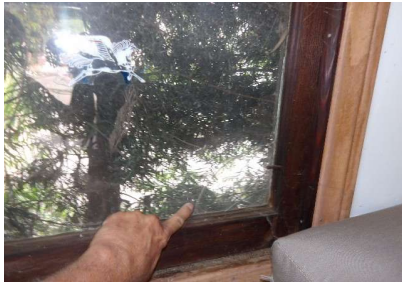
17.7 - One or more window panes are cracked, which should be properly repaired by a licensed contractor.

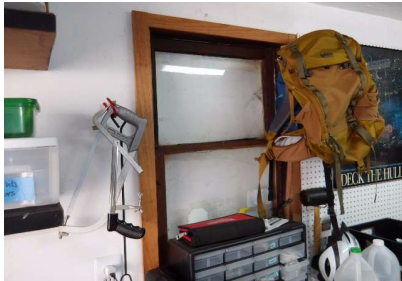
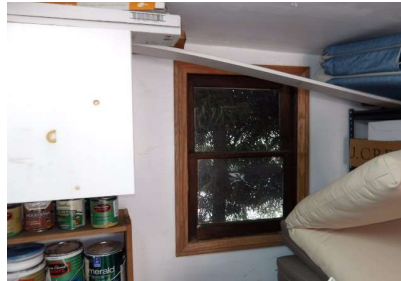
17.8 - One or more windows are stuck or painted shut, which should be serviced.

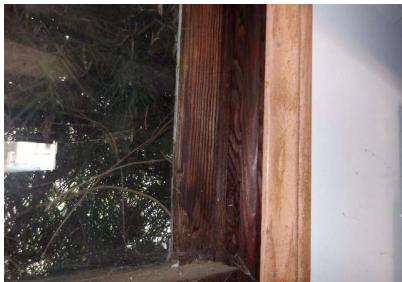
17.9 - One or more windows are moisture stained and or damaged, which should be further evaluated and repaired by a licensed termite inspector.

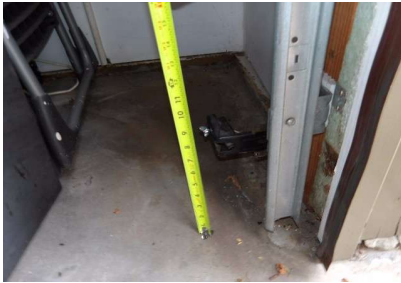
The infra red sensors are functional but located higher than the recommend six inches above grade - *Continued*

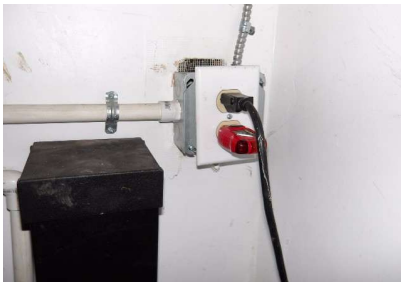
17.19 - One or more outlets were not functional. Further evaluation and repair by a licensed electrician is advised.

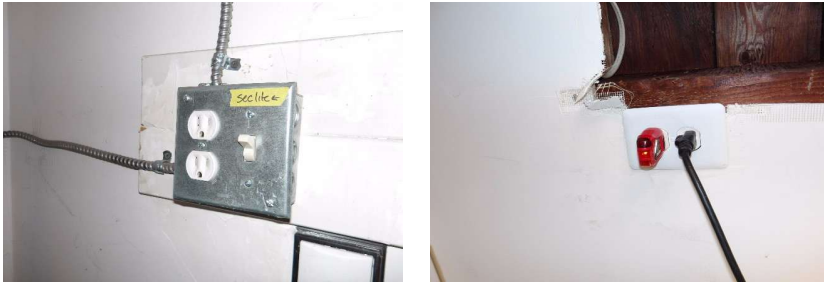
The outlets that were tested are functional however are not ground fault protected - *Continued*

17.20 - The outlets that were tested are functional, however, are not ground fault protected. Installation of ground fault protected outlets is advised by a licensed electrician.

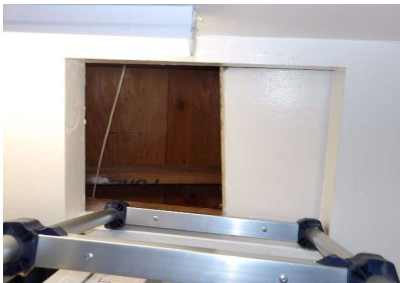
18.3 - The attic access is smaller than would be required by current building standards.
