CAL-WEST PROPERTY INSPECTIONS HOME MAINTENANCE REPORT

2075 Lakeridge Cir 103
Chula Vista, CA 91913

Jeff Brumfield
NOVEMBER 25, 2024

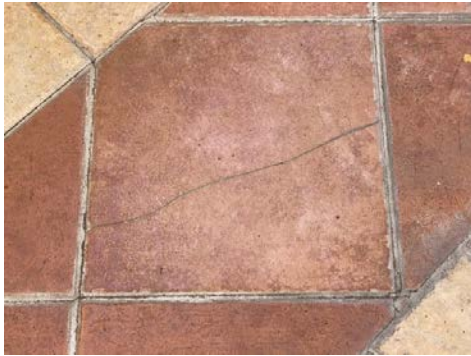
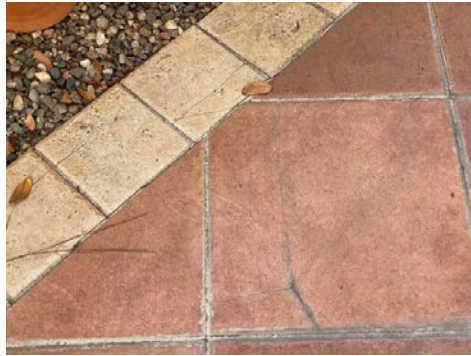
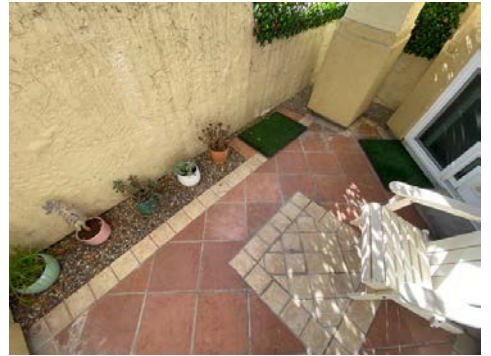
WALKWAY TILE DAMAGE

At the time of the inspection there were one or more areas of the exterior walkway suffering from damaged and deteriorating tile. Correction is advised.

Contact a qualified tile contractor

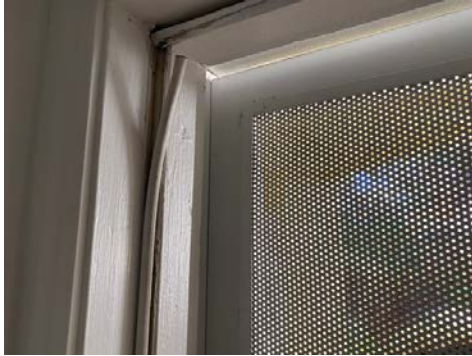
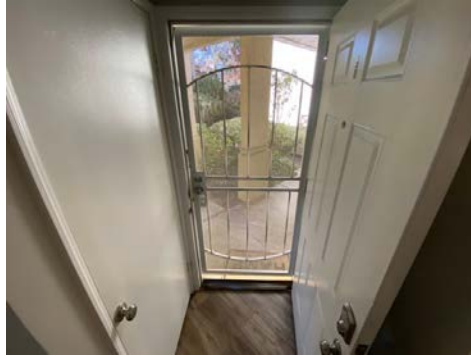
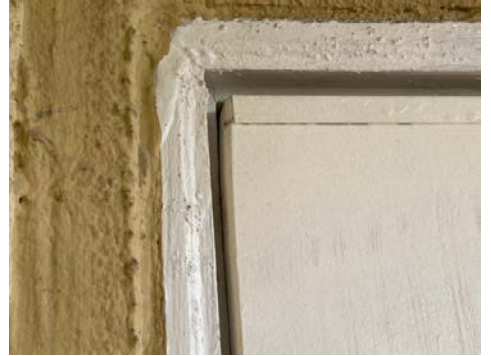
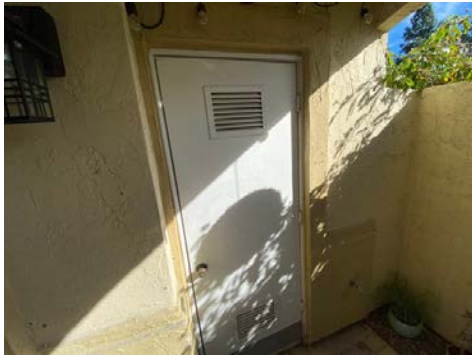
2.6.1 Exterior Doors

DOOR RUBS/STICKS

Contact a qualified door repair/installation contractor.

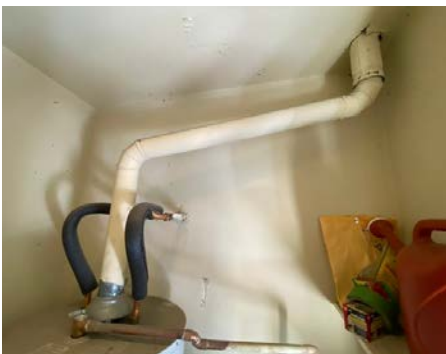
Exhaust Ducting Configuration Picture

The exhaust ducting for the water heater is pictured below. If there are any defects present they will be noted in the report below.

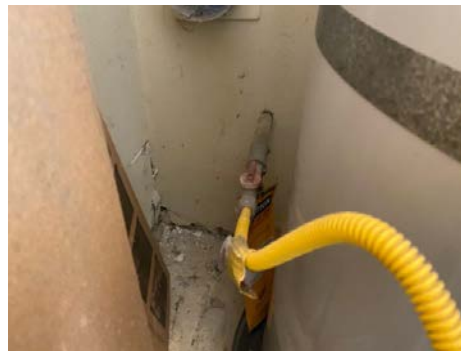
Water Heater : Power Source/Type

Gas

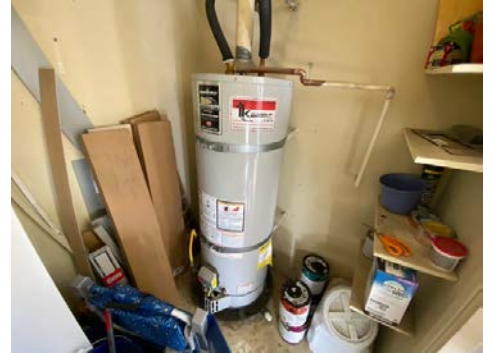
Water heater showed normal signs of wear and tear. Recommend monitoring it's effectiveness and replacing in the near future.

Inspector Notes: Still functional but approaching end of average life due to age

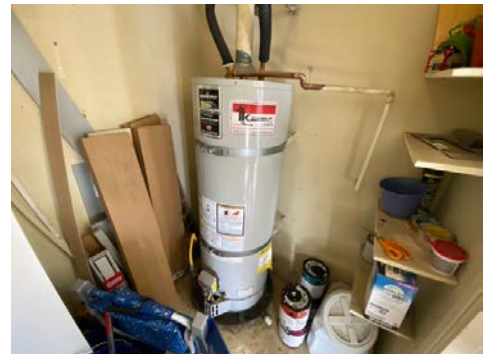
3.1.2 Water Heater

MISSING EXPANSION TANK

At the time of the inspection there was no expansion tank present. Expansion tanks allow for the thermal expansion of water in the pipes. These are required in certain areas for new installs. Recommend a qualified plumber evaluate and install.

Inspector Notes: Expansion tanks were not required when the water heater was installed but is a recommended upgrade.

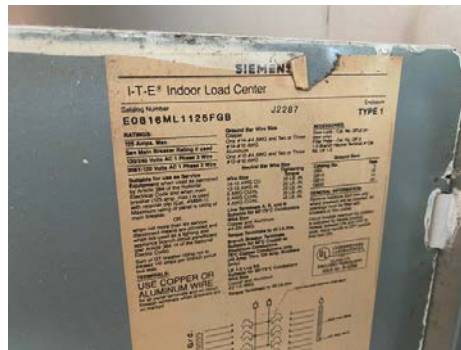
Main Breaker Panel/Meter: Panel Capacity
125 AMP

Main Breaker Panel/Meter: Panel Manufacturer
Siemens

Main Breaker Panel/Meter: Panel Type
Circuit Breaker

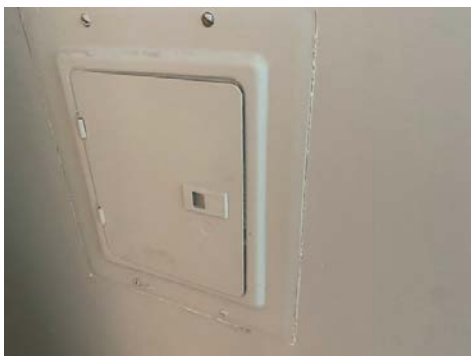
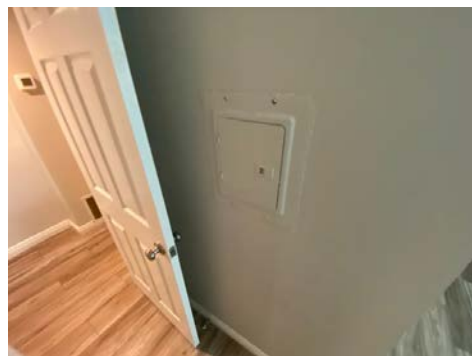
At the time of the inspection the electric panel could not be fully inspected due to a physical obstruction.

Inspector Notes: Painted/caulked shut; could not open cover without causing damage to the wall.

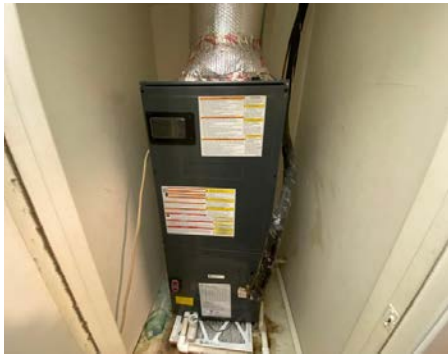
HVAC Equipment: Heater Brand Goodman

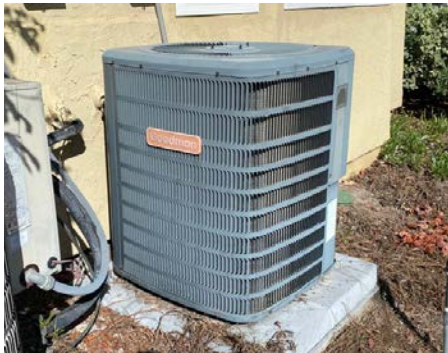
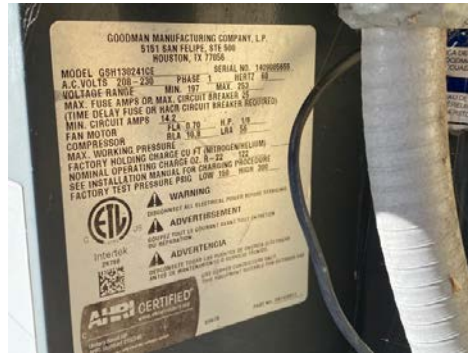
HVAC Equipment: A/C Brand Goodman

HVAC Equipment: Manufacture Date 2014, 2018

HVAC Equipment: AC Unit Tonnage 2 Ton

HVAC Equipment: A/C Energy Source/Type Electric, Central Air Conditioner

HVAC Equipment: General Good Condition

At the time of the inspection the HVAC system was functional and appeared to be in general good condition.

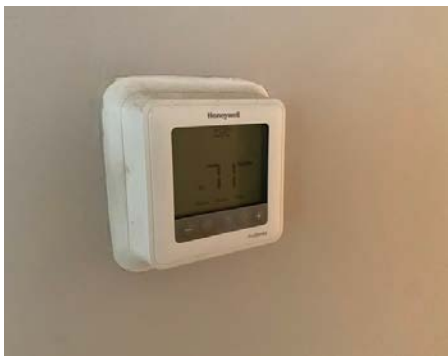
HVAC Controls: Thermostat/Controls Pictures

Hall

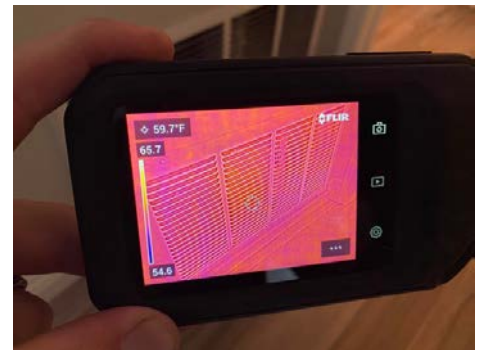
HVAC Ducting & Registers: Return Air Temps - A/C

HVAC Ducting & Registers: Satisfactory Temperature Splits

At the time of the inspection the AC unit was cycled on and brought to operating temperature. The temperature splits were tested by measuring the temperature of the distribution air and checking the difference from the return air to determine the temperature splits. Temperature splits are a good indicator of how well the AC system is performing. Depending on the humidity of a given day an acceptable temperature split difference could be between 12-20 degrees fahrenheit.

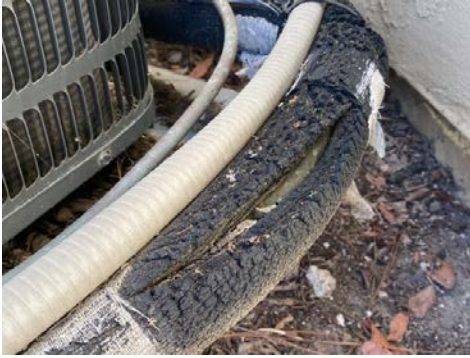
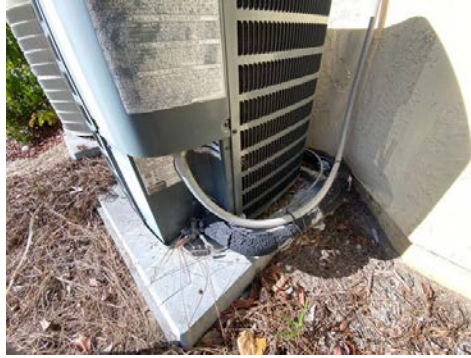
Deferred Maintenance - Minor Repair**LINESET INSULATION DAMAGE**

Lineset insulation damage or deterioration noted at time of inspection. Exposed refrigerant lines can cause energy loss and excessive condensation. Further evaluation and repair by a qualified professional is advised.

Contact a qualified professional.

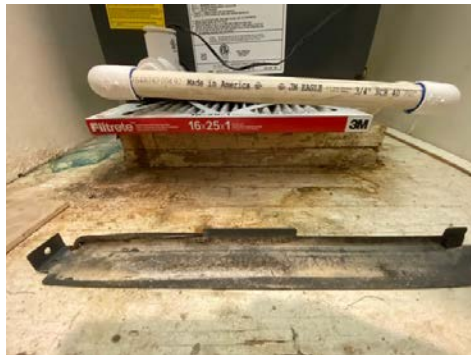
6.2.2 HVAC Equipment

Recommended Improvement**INCORRECT RETURN AIR FILTER**

Contact a qualified professional.

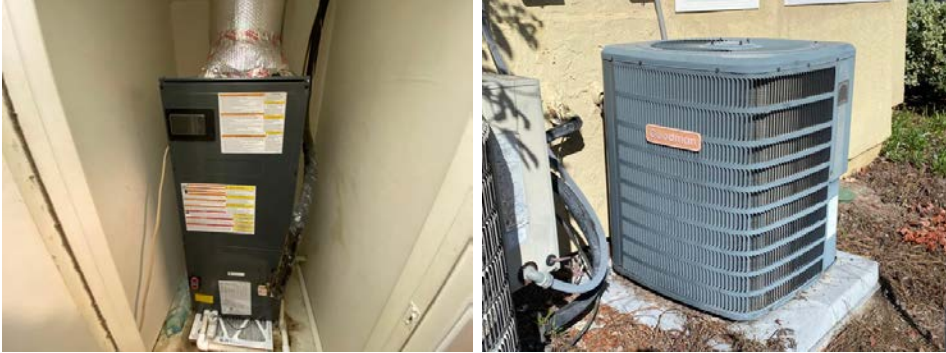
6.2.3 HVAC Equipment

Inspector Notes: AC unit & furnace functional, due to age recommend tuneup/service.

Contact a qualified HVAC professional.

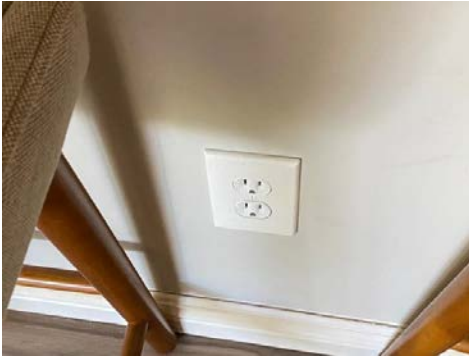
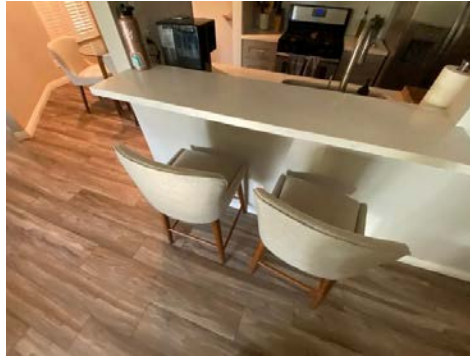
LOOSE RECEPTACLE

At the time of the inspection one or more of the electrical receptacles was loose or not properly secured to the wall. Correction is advised.

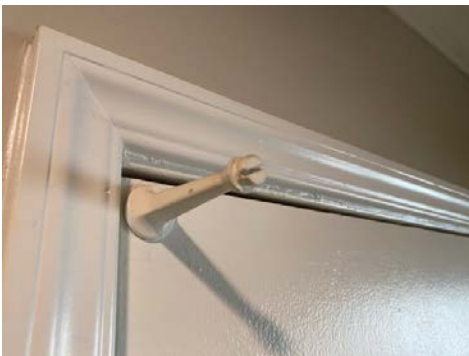
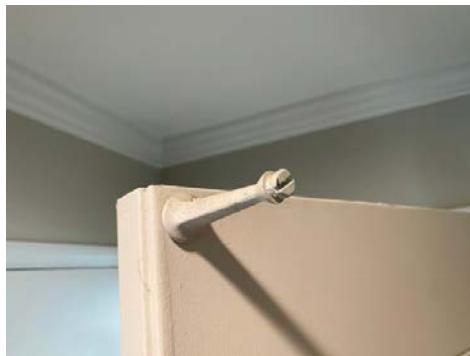
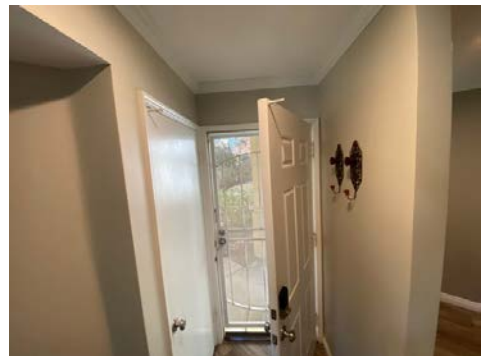
7.5.1 Doors

DOOR STOP CAP/PAD MISSING

At the time of the inspection there were one or more of the door stop pads missing. Correction is advised.

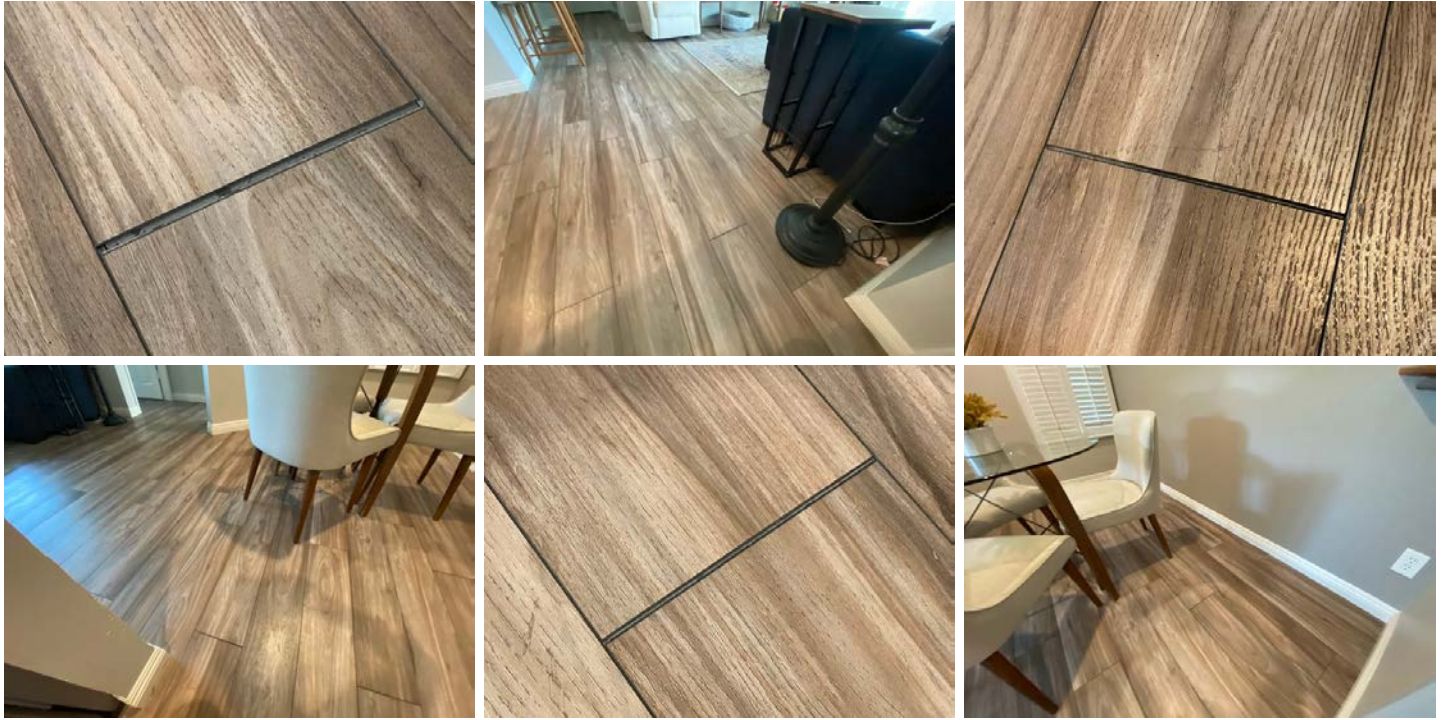
7.8.1 Floors

FLOOR PLANK SEPARATION

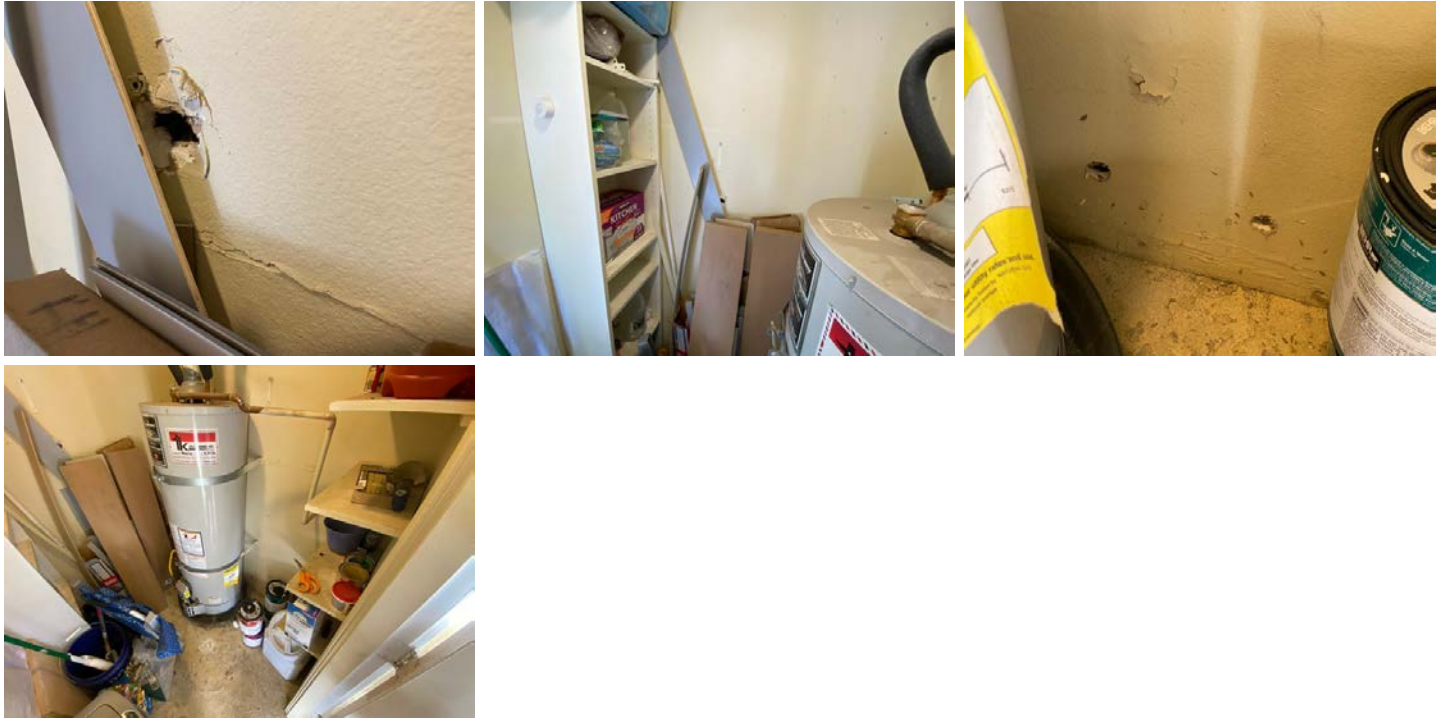
7.9.1 Walls

DRYWALL DAMAGE

At the time of inspection one or more area of drywall were damaged and in need of repair. Correction is advised.

Contact a qualified professional.

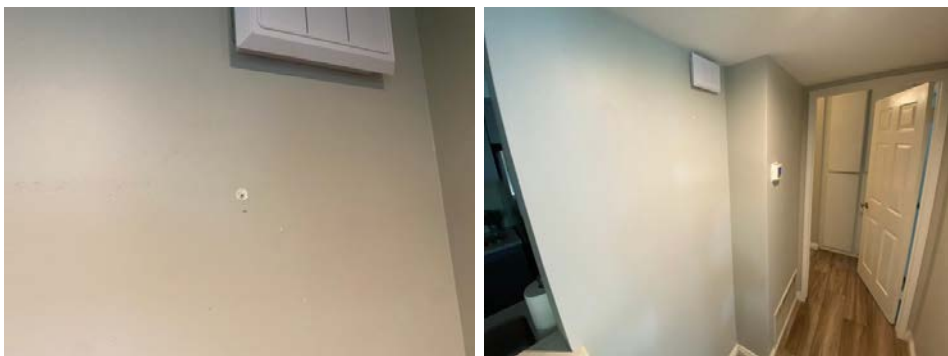
7.9.2 Walls

BLEMS, DINGS AND PAINT TOUCH-UP

At the time of the inspection one or more areas of the walls with blems, scratched, drywall damage, paint touch-up and other minor repairs are needed. Correction is advised.

Contact a qualified professional.

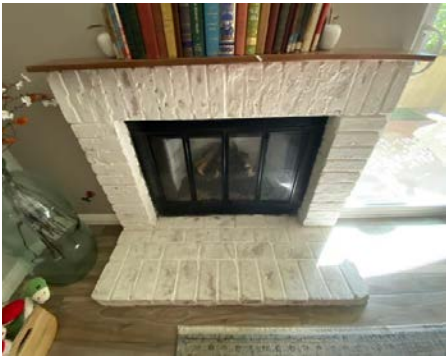
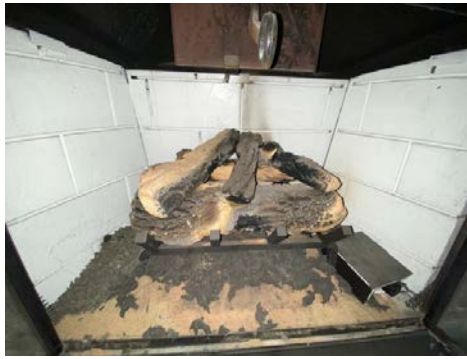
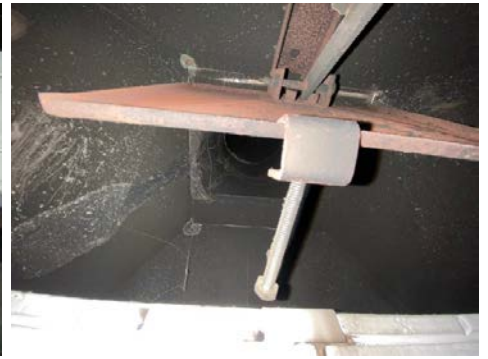
Fireplace Pictures

Fireplace General: Type

Wood or Gas

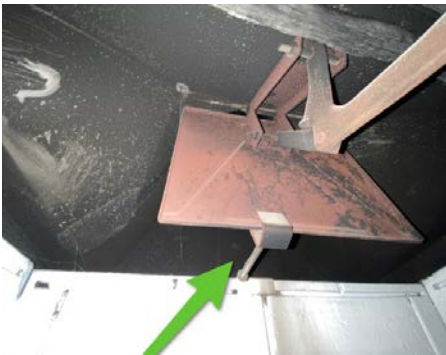
Fireplace General: Damper Clamp Correctly Installed

At the time of the inspection the required damper clamp for gas burning fireplaces was correctly installed and properly functioning. The damper clamp prevents the damper from going to the fully closed position.

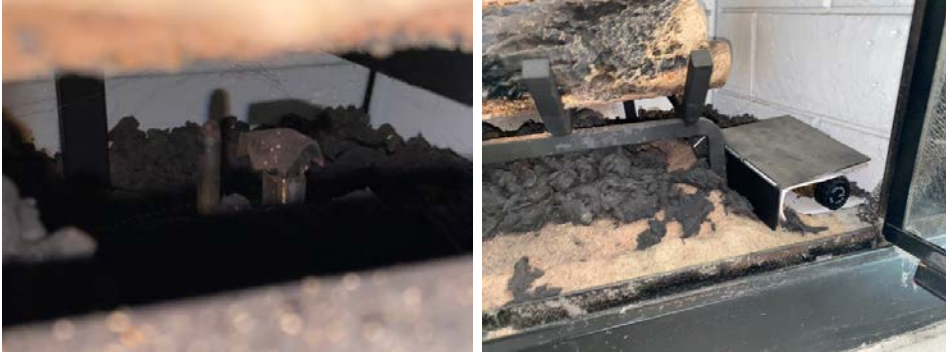
At the time of the inspection the pilot light was turned off for gas fireplace preventing the inspector from performing a complete inspection on the fire place.

Inspector Notes: Fireplace appeared to be in good condition with little evidence of use. It is advised to ask the seller for disclosures related to the fireplace and if there is a reason the pilot light was turned off or if it is off due to non-use.

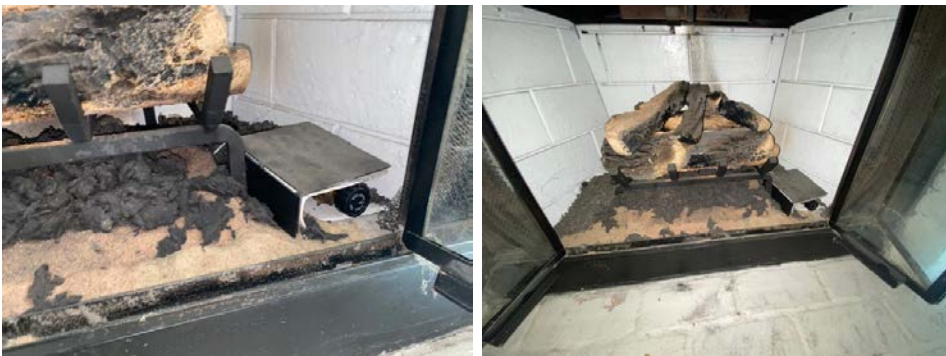
8.1.1 Fireplace General

PILOT STYLE GAS BURNER

At the time of the inspection there were one or more fireplaces with older style gas burners installed which utilize a pilot light style lighting system. Modern gas fireplace burners are more efficient and safer to use. Recommend replacing with a modern style gas burner.

Contact a qualified professional.

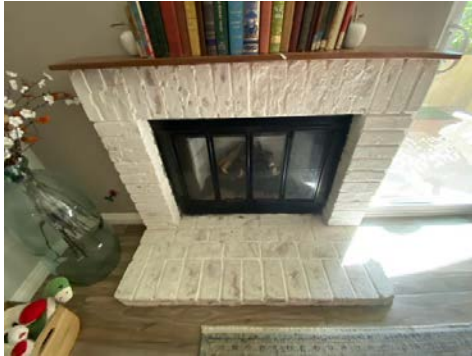
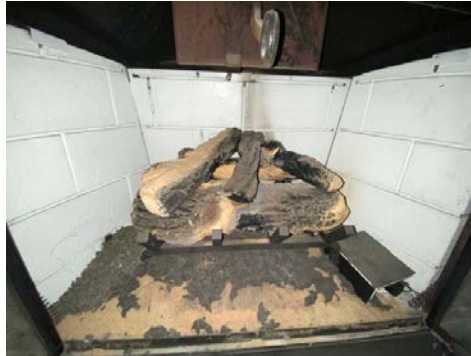
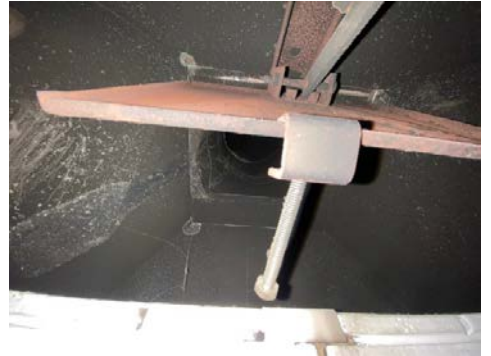
8.1.2 Fireplace General

Fireplace chimneys should be regularly serviced considering the risks associated with damaged and or poor performing chimney structures. Regular cleaning is advised depending on use. Most Southern Californian occupants don't use their fireplace enough to regularly clean and or service them so often times they end up dirty and in need of cleaning for the new owners. Since it's not possible to know the the true condition of the chimney by visually looking up through the firebox, it is advised to have a cleaning and Level 2 chimney inspection performed prior to use.

Contact a qualified professional.

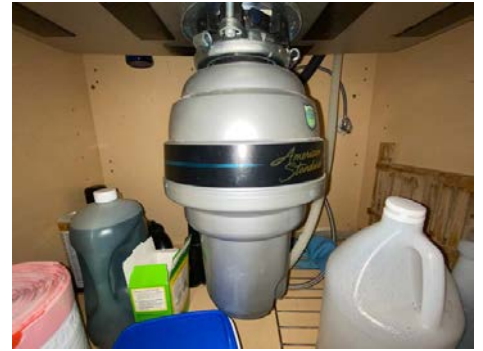
Garbage Disposal: Garbage Disposal Pictures

Operated satisfactory.

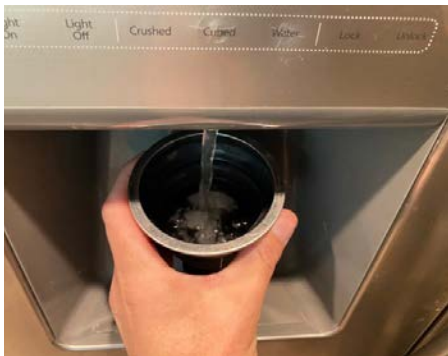
Refrigerator : Ice Maker/Water Dispenser Function Test - Pass

During the inspection the inspector tested the ice and water dispensers at the refrigerator and both the Ice and water dispensers operated correctly.

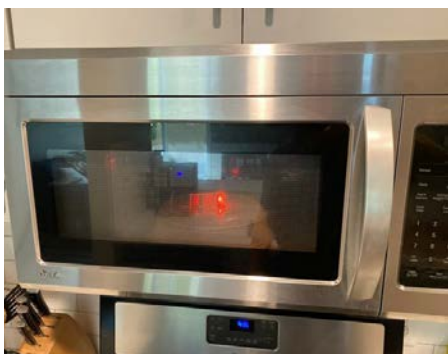
Microwave: Microwave Function Test - Pass

At the time of the inspection the microwave was tested to confirm its operation. This picture represents the testing tool confirming proper operation of the microwave.

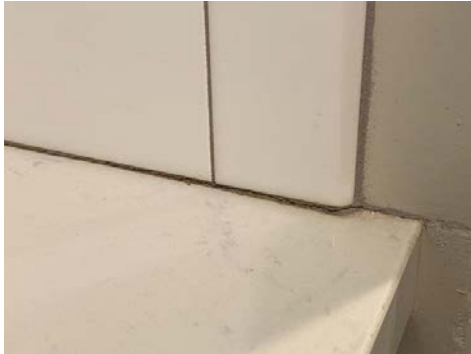
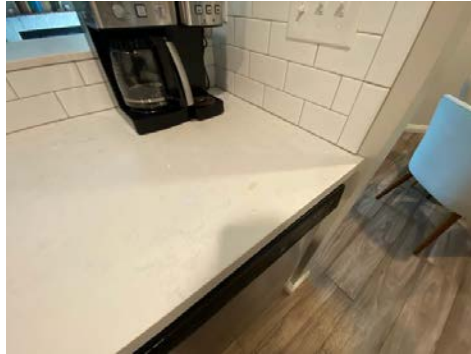
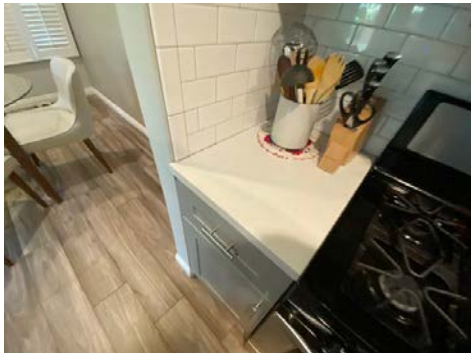
9.2.1 Counter Tops

MINOR GROUT CRACKING

At the time of inspection one or more areas of the countertops suffered from grout cracking. It is recommend to re-grout and seal existing cracks to prevent further water intrusion and deterioration.

Contact a qualified professional.

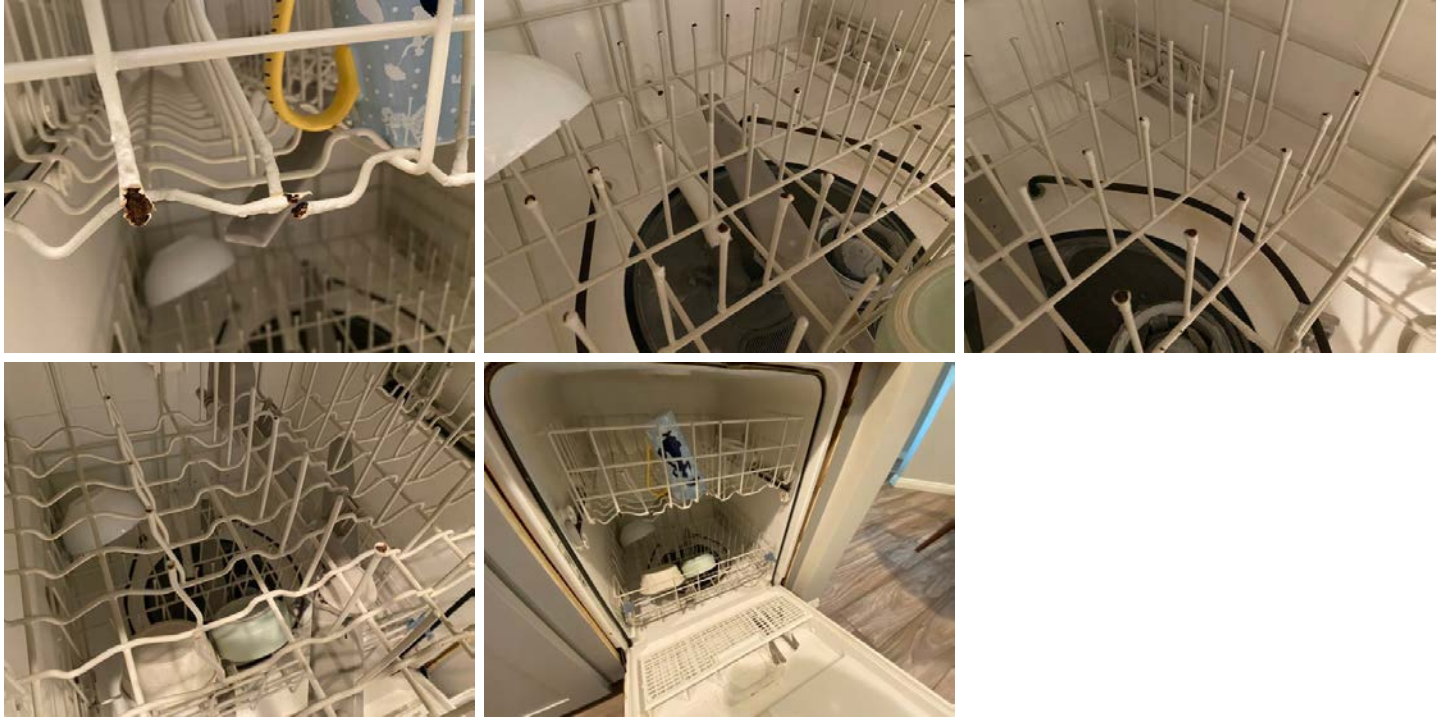
9.5.1 Dishwasher

Deferred Maintenance - Minor Repair**RUST ON DISHWASHER RACKS**

At the time of inspection the dishwasher racks had evidence of rust and deterioration present in one or more areas.

Contact a qualified professional.

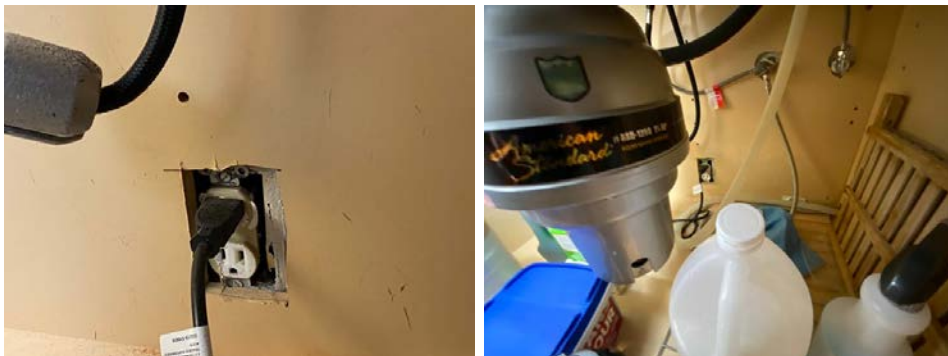
9.12.1 Receptacles, Switches and Circuits

Deferred Maintenance - Minor Repair**COVER PLATES MISSING**

At the time of the inspection one or more receptacles were missing the appropriate cover plate. Recommend installation of cover plates to prevent accidental electrocution and or damage to the receptacle or light switch. Correction is advised.

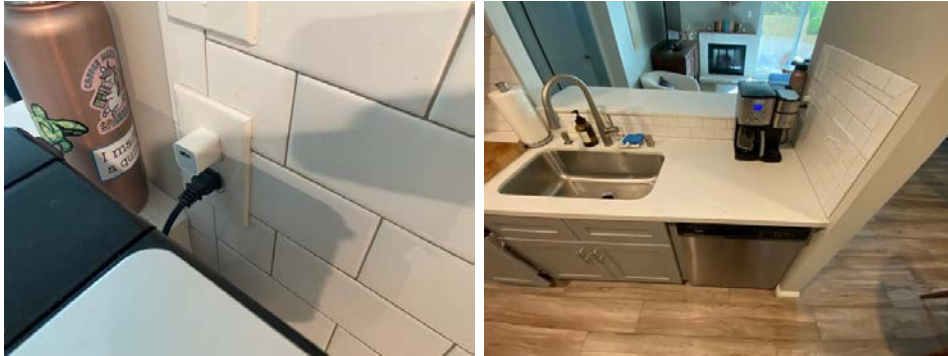
9.12.2 Receptacles, Switches and Circuits

RECEPTACLE NOT GFCI PROTECTED

Contact a qualified electrical contractor.

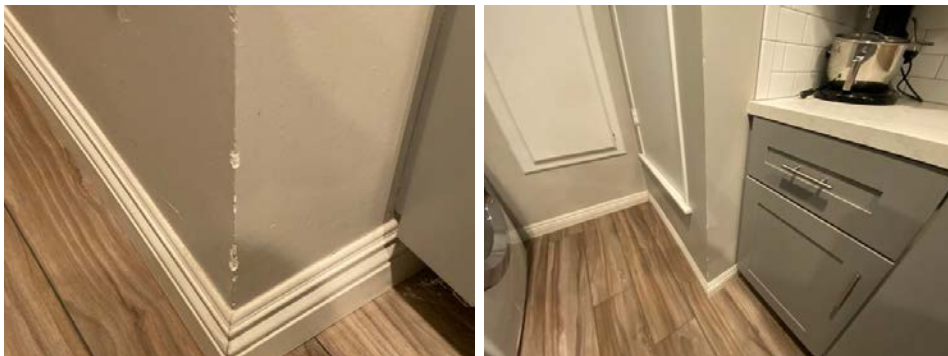
9.14.1 Walls

COSMETIC BLEMISHES, DINGS OR STAINS

At the time of the inspection there were one or more cosmetic blemishes, dings and or stains that affected the aesthetics of the walls. Correction is advised.

Contact a qualified professional.

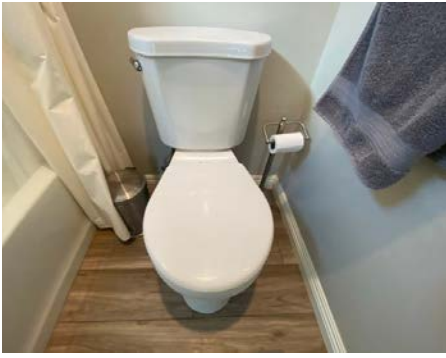
The bathroom fixtures and plumbing connections pictured below show general condition and layout for identification purposes. Comments on material defects, damages, and or maintenance related items will be listed in the report below.

General: Moderate Wear - Minor Repairs Needed

At the time of the inspection the bathroom pictured above was functional and serviceable but showed signs of moderate wear and was in need of minor to moderate repairs.

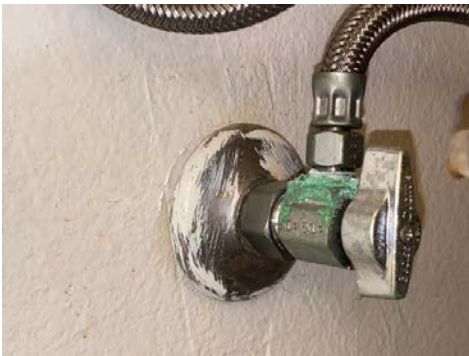
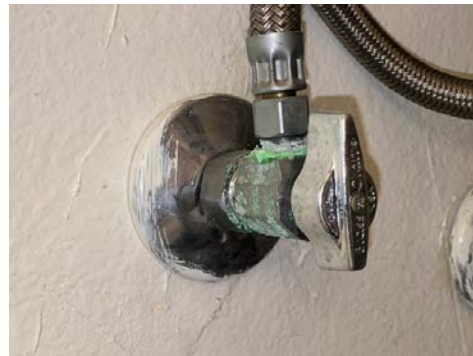
ANGLE STOP CORROSION

At the time of the inspection corrosion was present at the angle stop. It is advised to monitor and replace corroded angle stops before they begin leaking. Correction is advised.

Contact a qualified plumbing contractor.

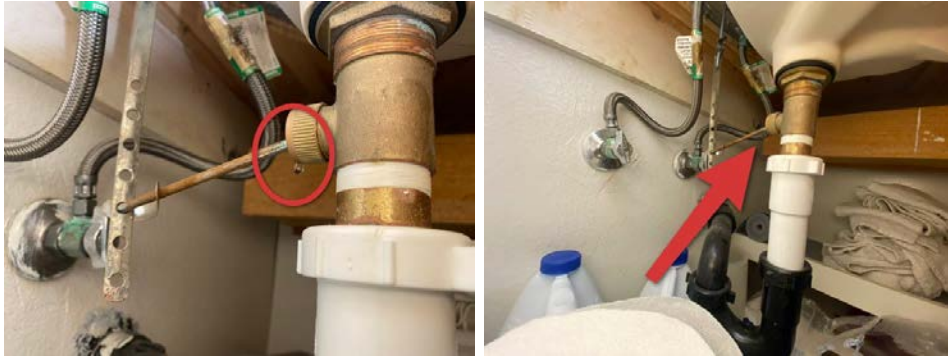
10.2.2 Sinks

ACTIVE DRAINLINE LEAK

At the time of the inspection there were one or more bathroom sinks with an active drain line leak. Correction is advised.

Repaired 12/3/2024 by home owner

Contact a qualified plumbing contractor.

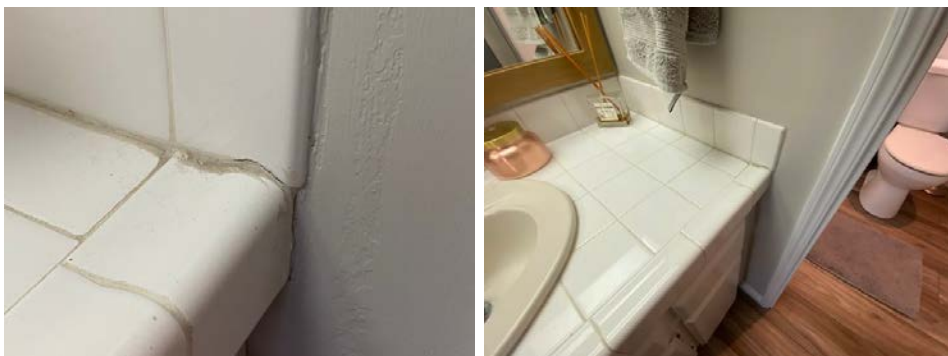
10.3.1 Cabinets & Counter Tops

MINOR GROUT CRACKING AT COUNTERTOP

At the time of inspection there were one or more minor cracks in the grout for the countertops. Correction is advised.

Contact a qualified professional.

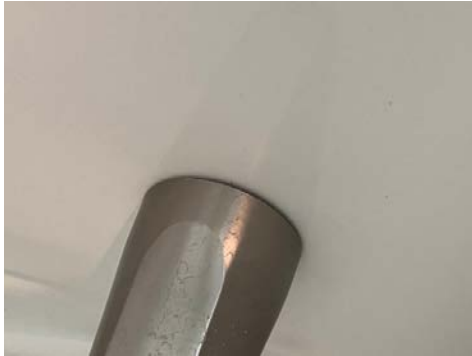
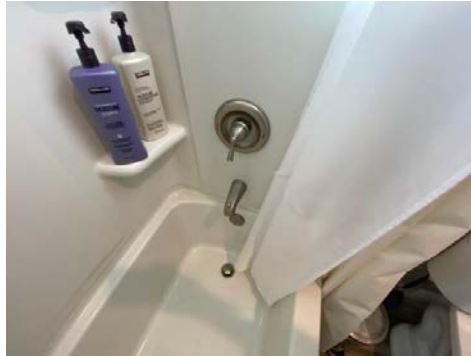
10.4.1 Showers/Bathtubs

At the time of the inspection there were one or more areas of the shower/bathtub in need of caulking repair or replacement. Correction is advised.

Contact a qualified professional.

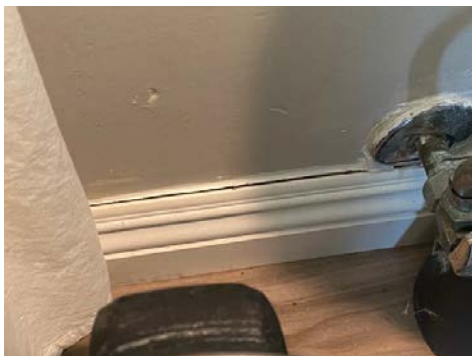
10.6.1 Walls & Floors

At the time of the inspection there were one or more areas of the baseboard that were suffering from minor separation or cracked caulking. Suggest adding additional trim nails to properly secure. Correction is advised.

Contact a qualified professional.

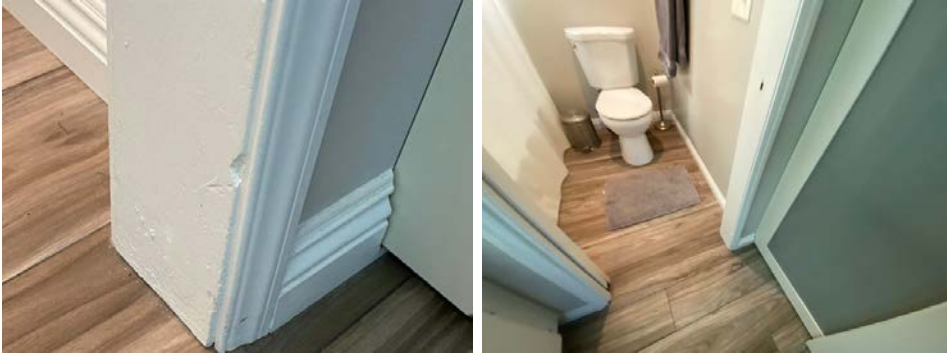
10.10.1 Doors

DOOR TRIM DAMAGE

At the time of the inspection there were one or more areas of the door trim suffering from damage. Correction is advised.

Contact a qualified professional.

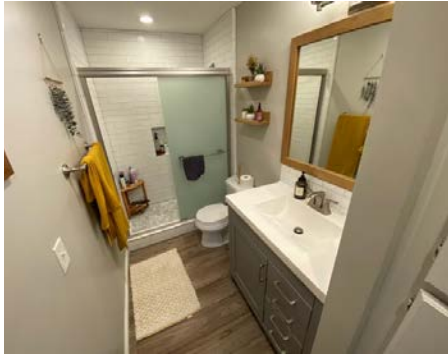
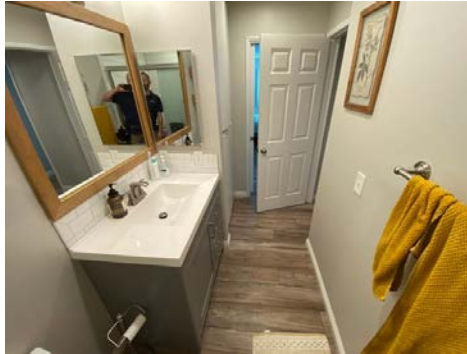
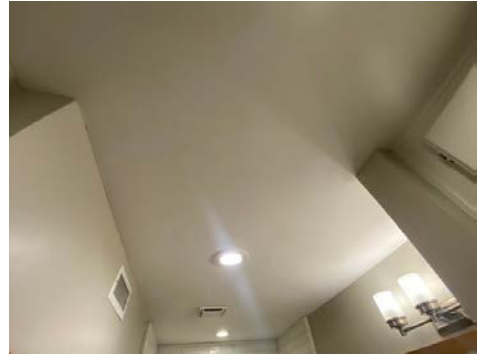
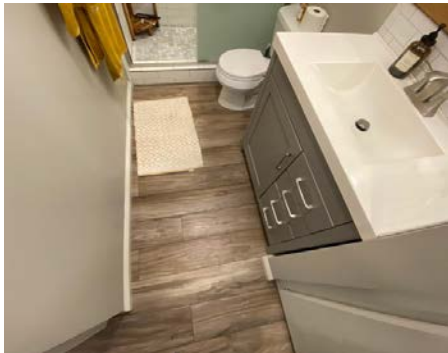
Bathroom Identification Pictures

The bathroom pictured below shows opposing corners of the room, ceiling and flooring for identification purposes. Comments on material defects, damages, and or maintenance related items will be listed in the report below.

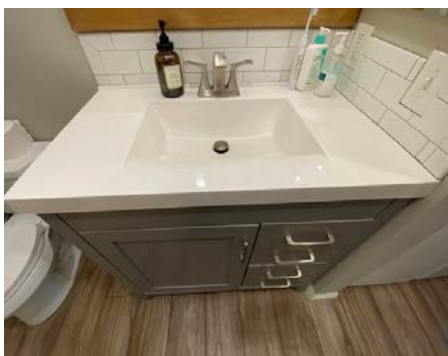
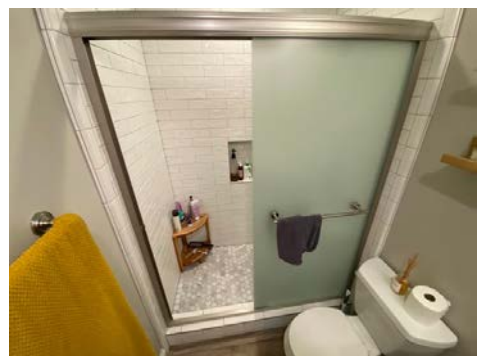
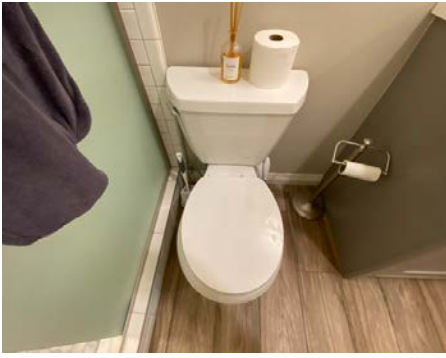
General: Bathroom Fixtures/Plumbing Connections

The bathroom fixtures and plumbing connections pictured below show general condition and layout for identification purposes. Comments on material defects, damages, and or maintenance related items will be listed in the report below.

The the above pictures represent the inspector's observations of minor maintenance and/or non-material defects that do not affect usability of the room or represent major costs and challenges to correct.

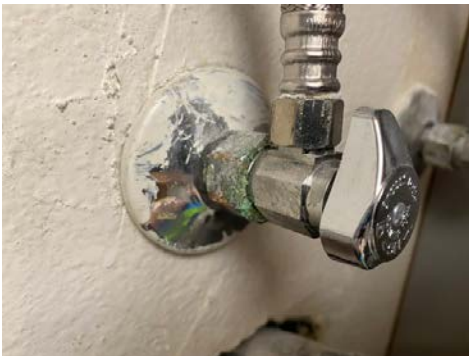
ANGLE STOP CORROSION

At the time of the inspection corrosion was present at the angle stop. It is advised to monitor and replace corroded angle stops before they begin leaking. Correction is advised.

Contact a qualified plumbing contractor.

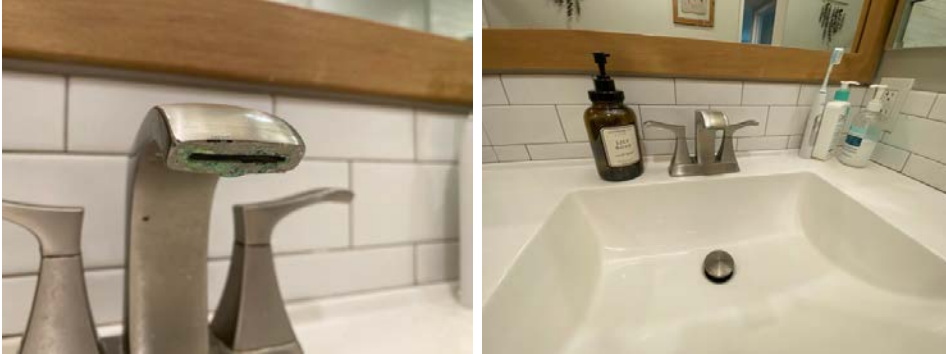
11.2.2 Sinks

CORROSION AT FAUCET FIXTURE

At the time of the inspection there were one or more sink faucet fixtures suffering from corrosion. Replacement is advised.

Contact a qualified professional.

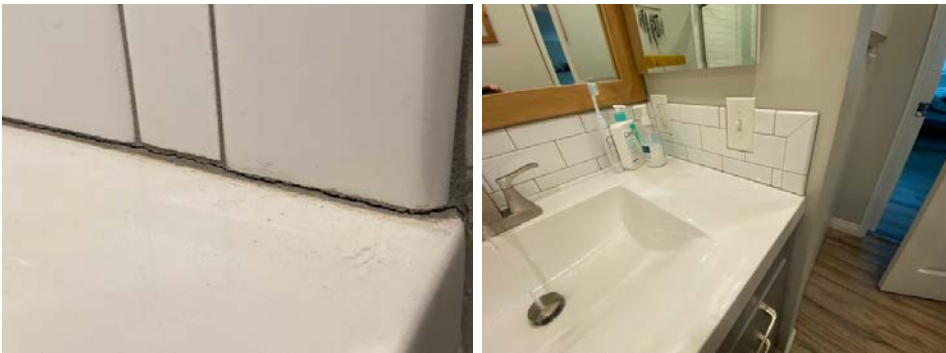
11.3.1 Cabinets & Counter Tops

MINOR GROUT CRACKING AT COUNTERTOP

At the time of inspection there were one or more minor cracks in the grout for the countertops. Correction is advised.

Contact a qualified professional.

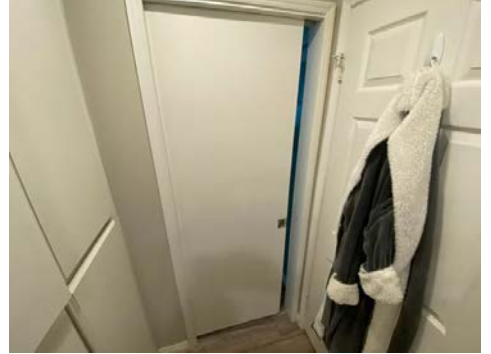
11.10.1 Doors

COSMETIC DOOR BLEM

Contact a qualified professional.

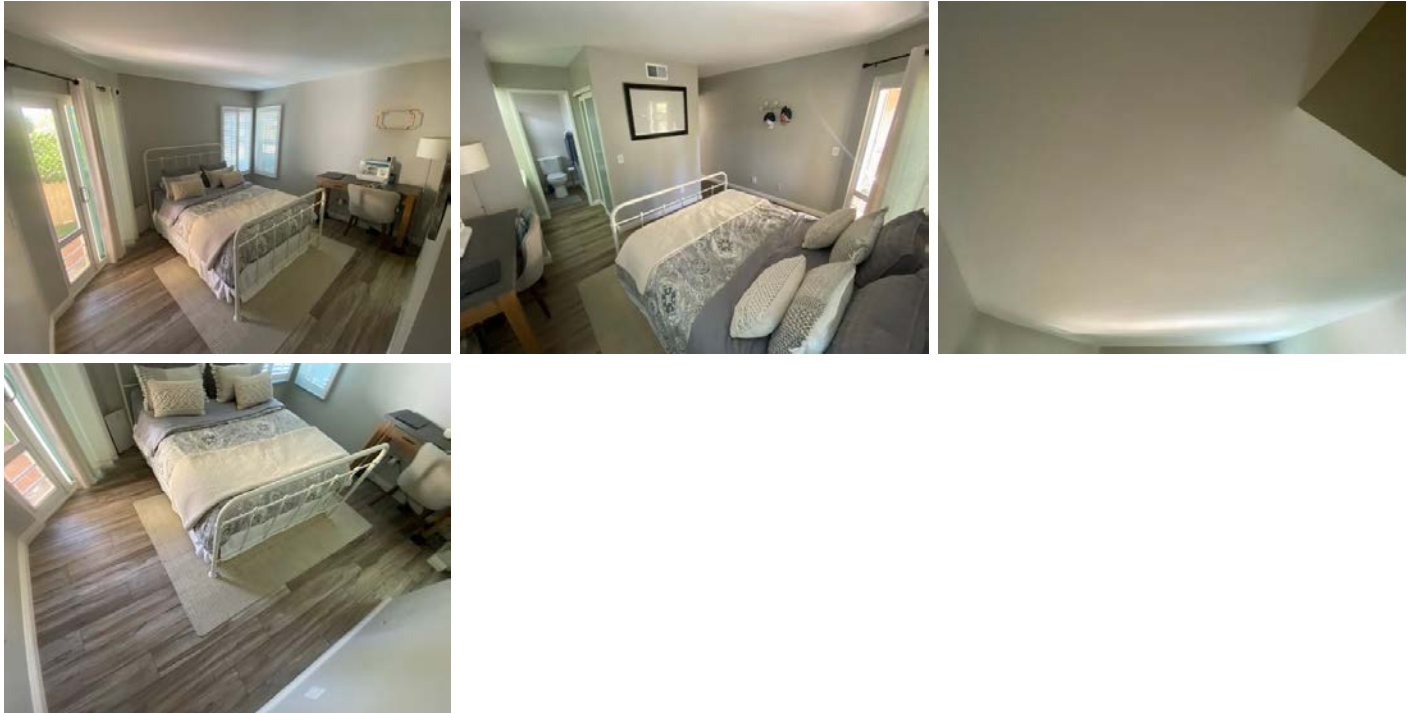
Master Bedroom Identification Pictures

The bedroom pictured below shows opposing corners of the room, ceiling and flooring for identification purposes. Comments on material defects, damages, and or maintenance related items will be listed in the report below.

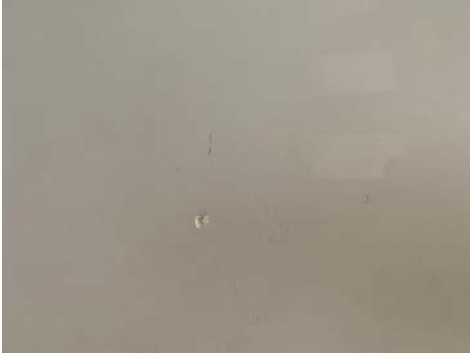
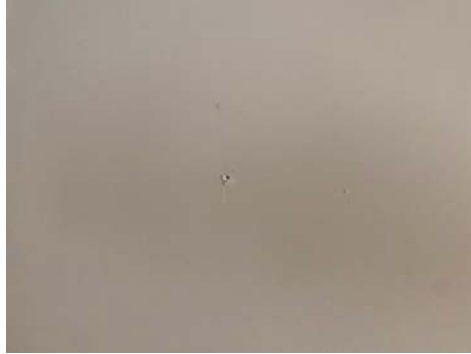
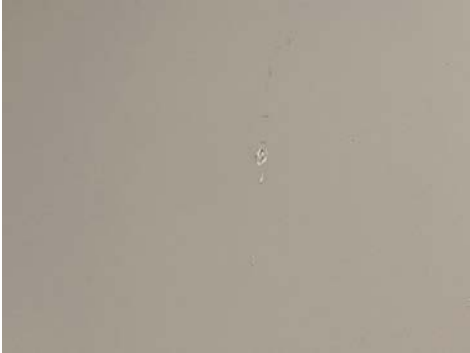
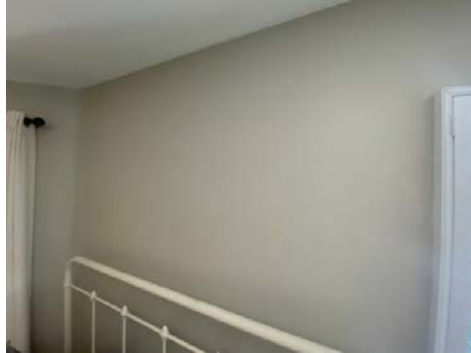
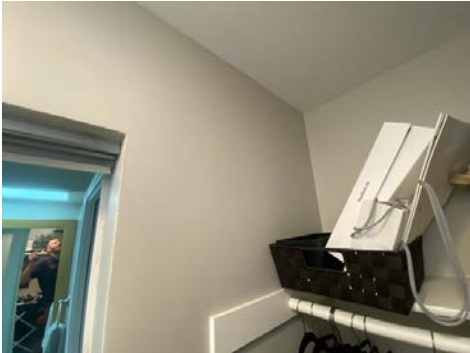
COSMETIC BLEMISHES, DINGS OR STAINS

At the time of the inspection there were one or more cosmetic blemishes and or stains that affected the aesthetics of the walls. Correction is advised.

Contact a qualified professional.

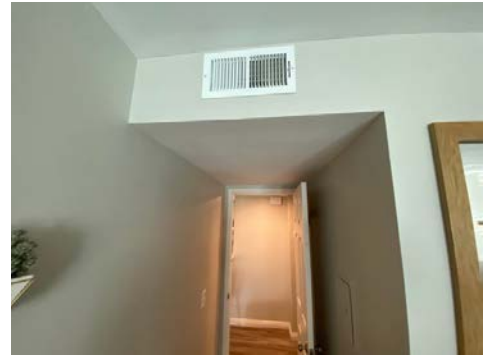
SMOKE DETECTOR MISSING

At the time of inspection one or more smoke detectors and or carbon monoxide detectors were missing at the required locations.

Contact a qualified professional.

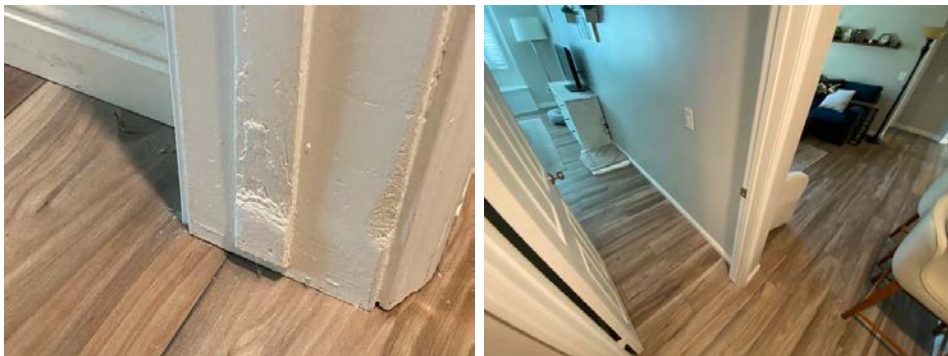
13.5.1 Doors

DAMAGED DOOR TRIM

At the time of the inspection there were one or more doors with damaged trim. Correction is advised.

Contact a qualified professional.

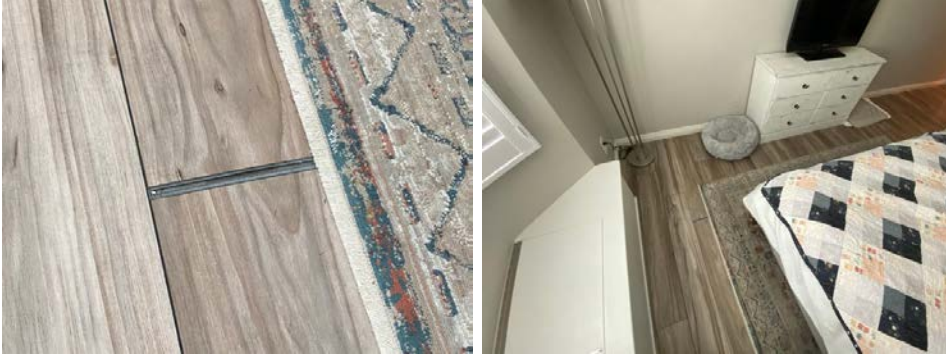
13.8.1 Floors

FLOOR PLANK SEPARATION

Contact a qualified flooring contractor

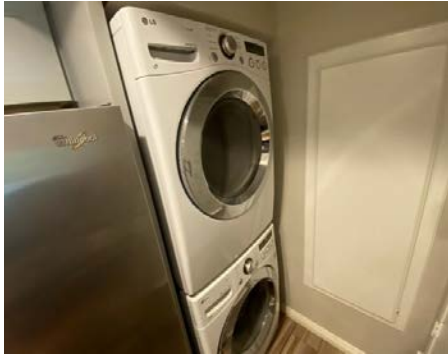
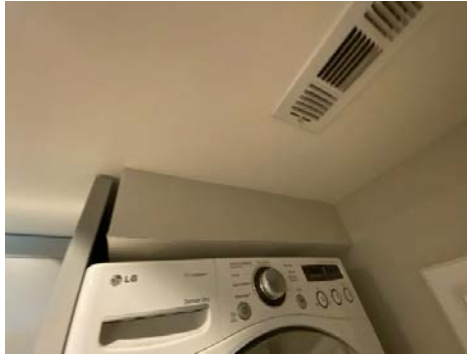
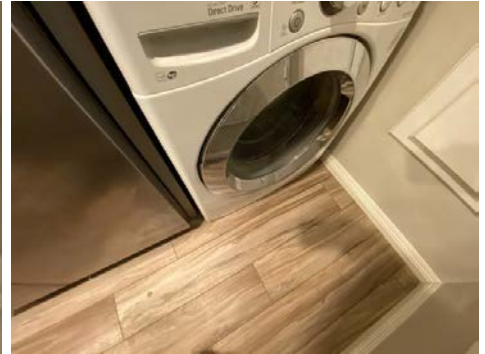
Laundry Room Identification Pictures

The laundry room pictured below shows opposing corners of the room, ceiling and flooring for identification purposes. Comments on material defects, damages, and or maintenance related items will be listed in the report below.

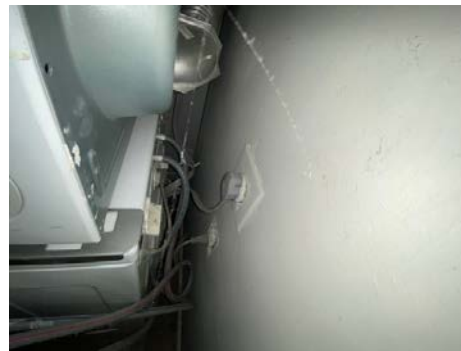
Good Condition

At the time of the inspection the room pictured above was well maintained and in good general condition.
