CAL-WEST PROPERTY INSPECTIONS HOME MAINTENANCE REPORT

2075 Lakeridge Cir 103
Chula Vista, CA 91913

Jeff Brumfield
NOVEMBER 25, 2024

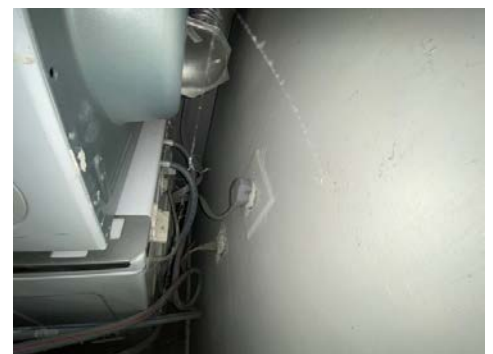
COVER PLATES MISSING

At the time of the inspection one or more receptacles were missing the appropriate cover plate. Recommend installation of cover plates to prevent accidental electrocution and or damage to the receptacle or light switch. Correction is advised.
