# **WOOD DESTROYING PESTS AND ORGANISMS INSPECTION REPORT**

Address 8321 Neva Ave, San Diego, CA 92123

W19731

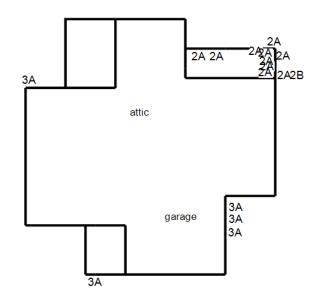
This Diagram is not to scale

FINDINGS: Evidence of drywood termite infestation noted at beam, post, bottom plate, and top plate as

indicated by 2A on the diagram.

FINDINGS: Evidence of termite damage noted at beam as indicated by 2B on the diagram.

FINDINGS: Fungus damage and/or dry-rot noted at roof eaves as indicated by 3A on the diagram.

RECOMMENDATION: Chemically treat visible and accessible infestations. Remove or cover accessible

pellets.

RECOMMENDATION: Repair or replace termite damage at beam. Diverse will prime paint repaired wood.

RECOMMENDATION: Replace fungus damage and/or dry-rot at roof eaves. Diverse will prime paint repaired

wood.
