## RESIDENTIAL INSPECTION

3050 Rue D'Orleans 461  
San Diego, CA 92110

08/04/2025

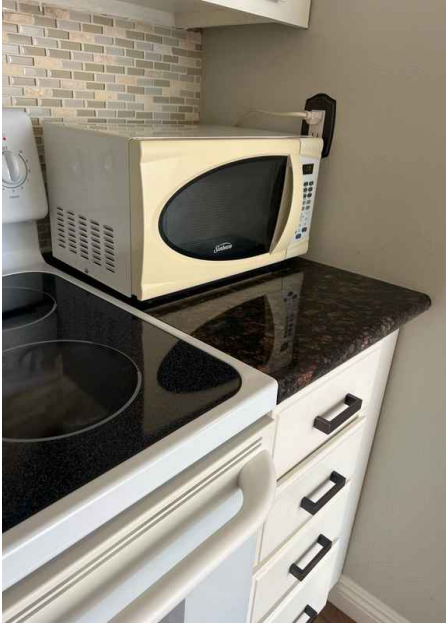
**RANGES AND COOKTOPS: Thermal Image Showing Range Working**

Infrared picture of range/cooktop in operation. This unit appeared to be functional at the time of the inspection.

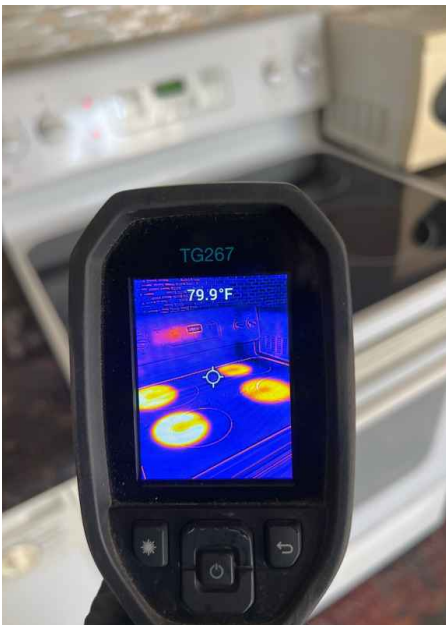
**OVEN: Thermal Image Showing Oven Working**

Infrared picture of oven(s) in operation. The unit(s) appeared to be functional at the time of the inspection.

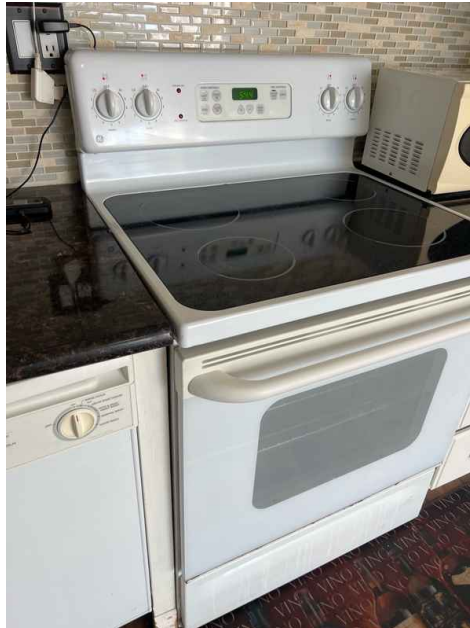
### 2.5.2 RANGES AND COOKTOPS

#### **COSMETIC**

Cosmetic damage noted. Recommend a qualified professional to repair as needed.

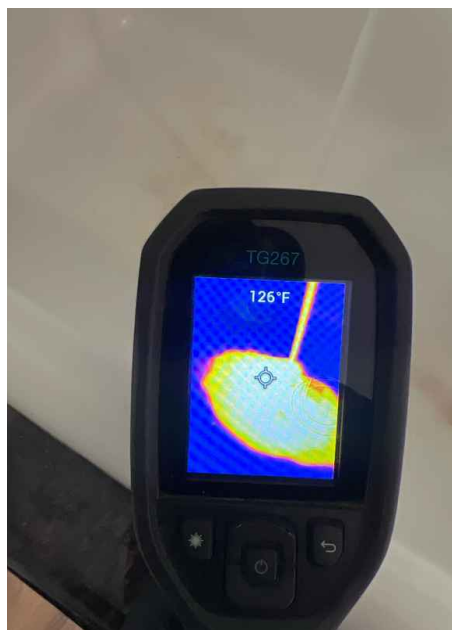
## WATER HEATERS: Thermal Image of Hot Water

Thermal image(s) showing the water heater(s) producing hot water at the time of the inspection.

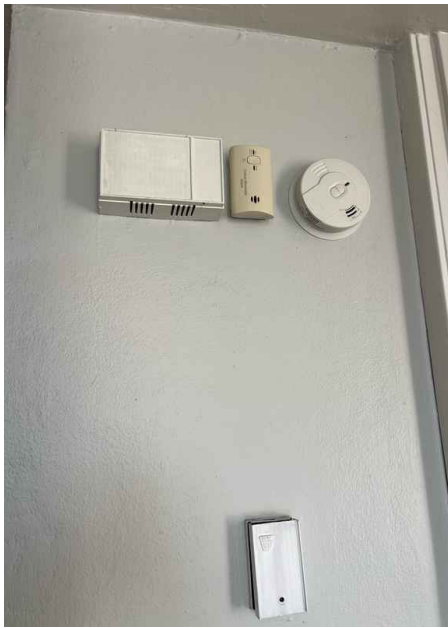
## CARBON MONOXIDE DETECTORS : Single Story - CO Detector Present

A CO detector is located in the common hallway as required. The unit appeared to be functional at the time of the inspection.

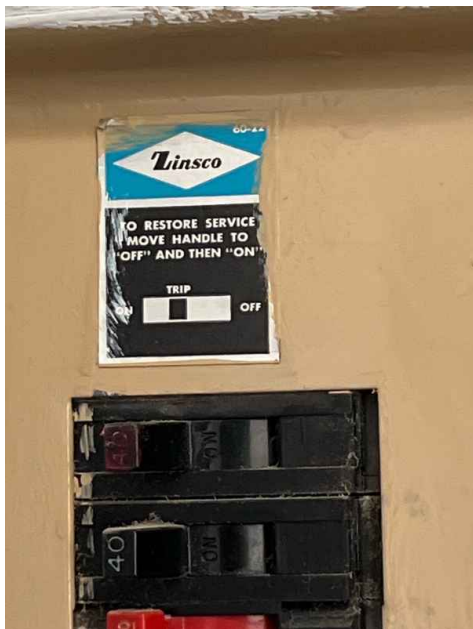
#### 4.3.2 MAIN AND DISTRIBUTION PANELS

##### SCREWS - POINTED

Safety Concerns

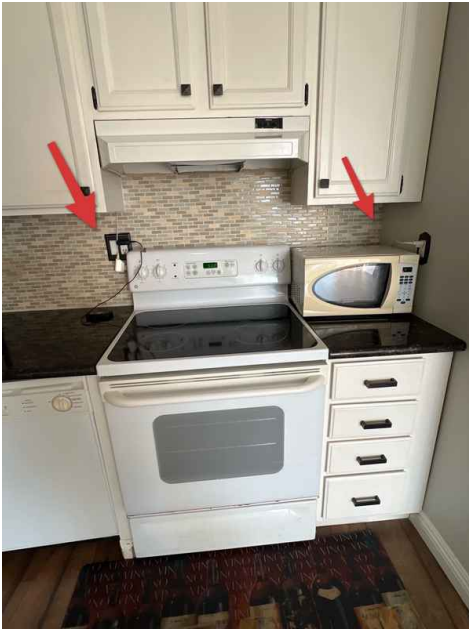
#### 4.11.2 GFCI - (GROUND FAULT CIRCUIT INTERRUPTERS)

##### **LIGHTS/APPLIANCE ON GFCI CIRCUIT**

Attention Items
